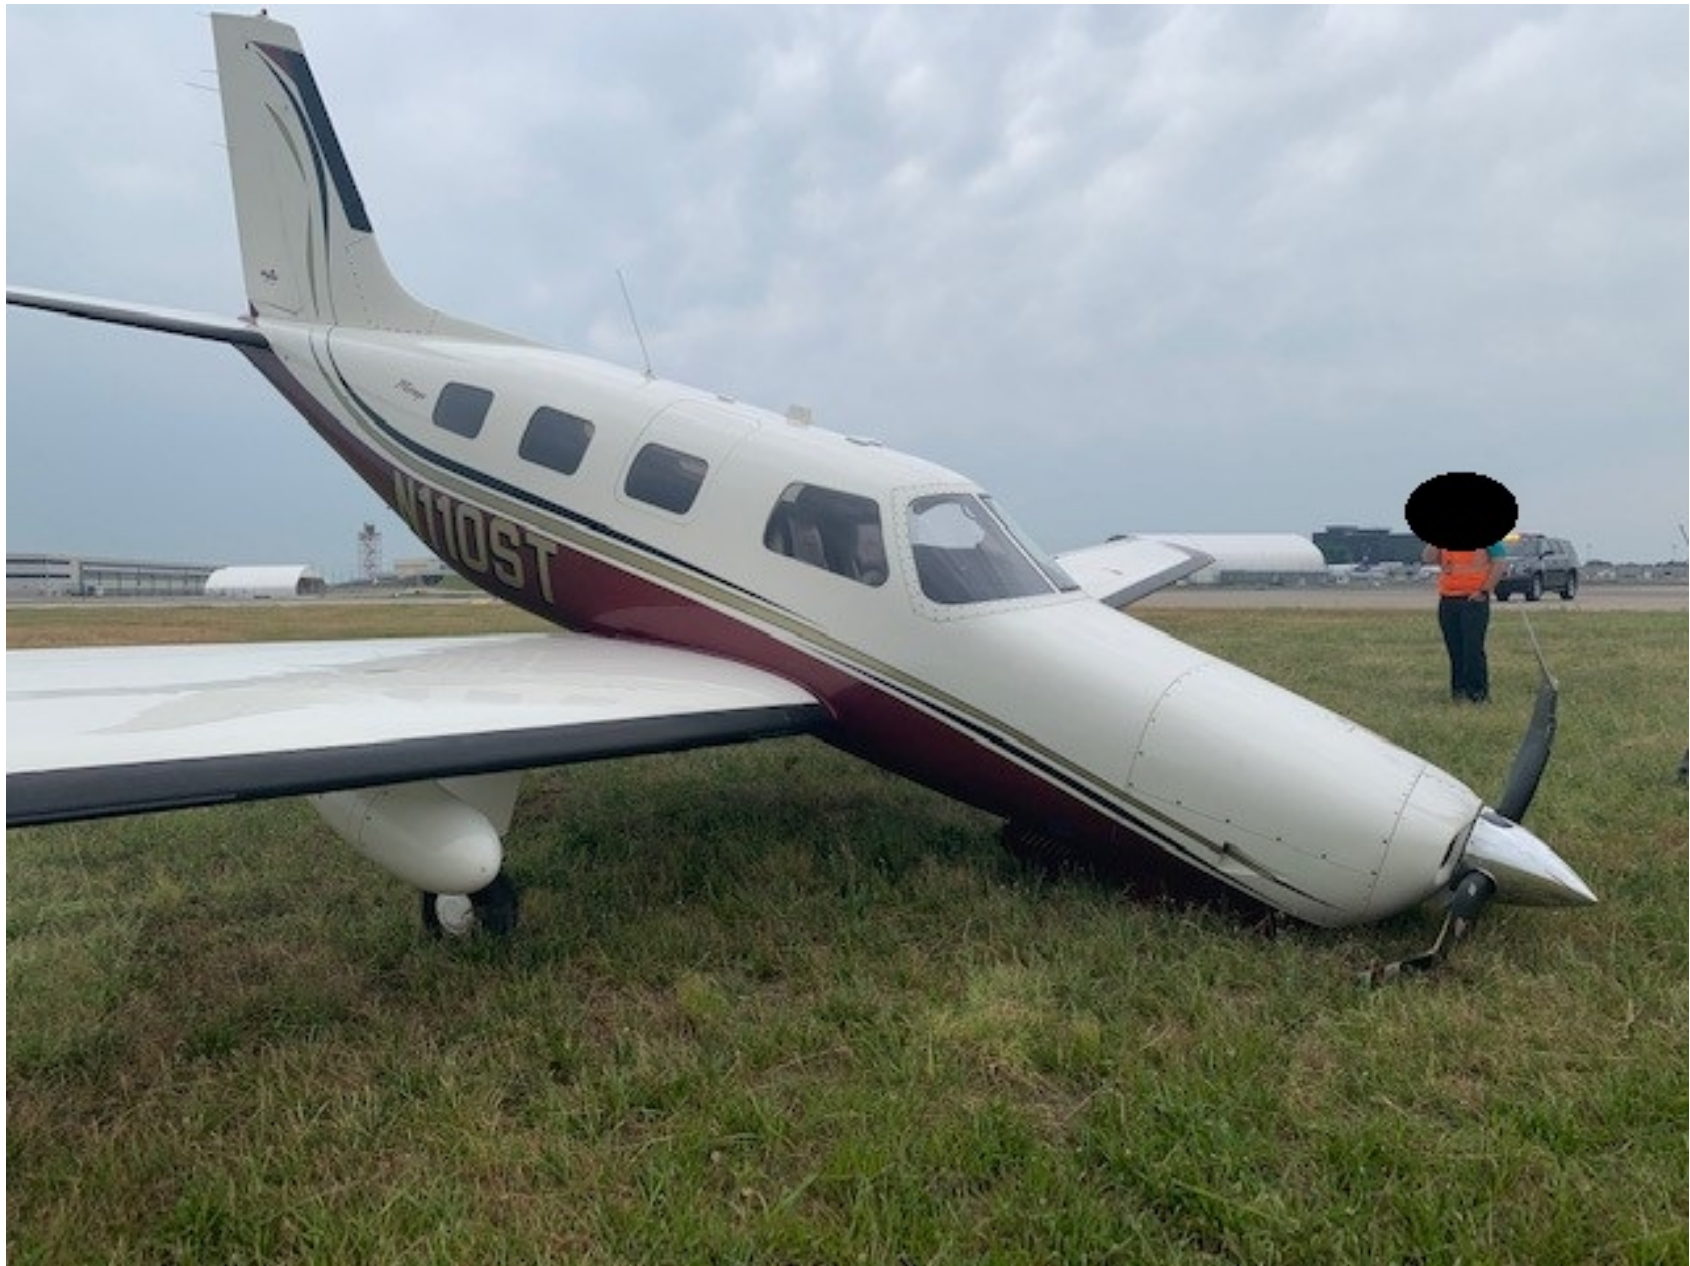
**Photo 1 – Right side view of the airplane at the accident site (courtesy of the Federal Aviation Administration).**

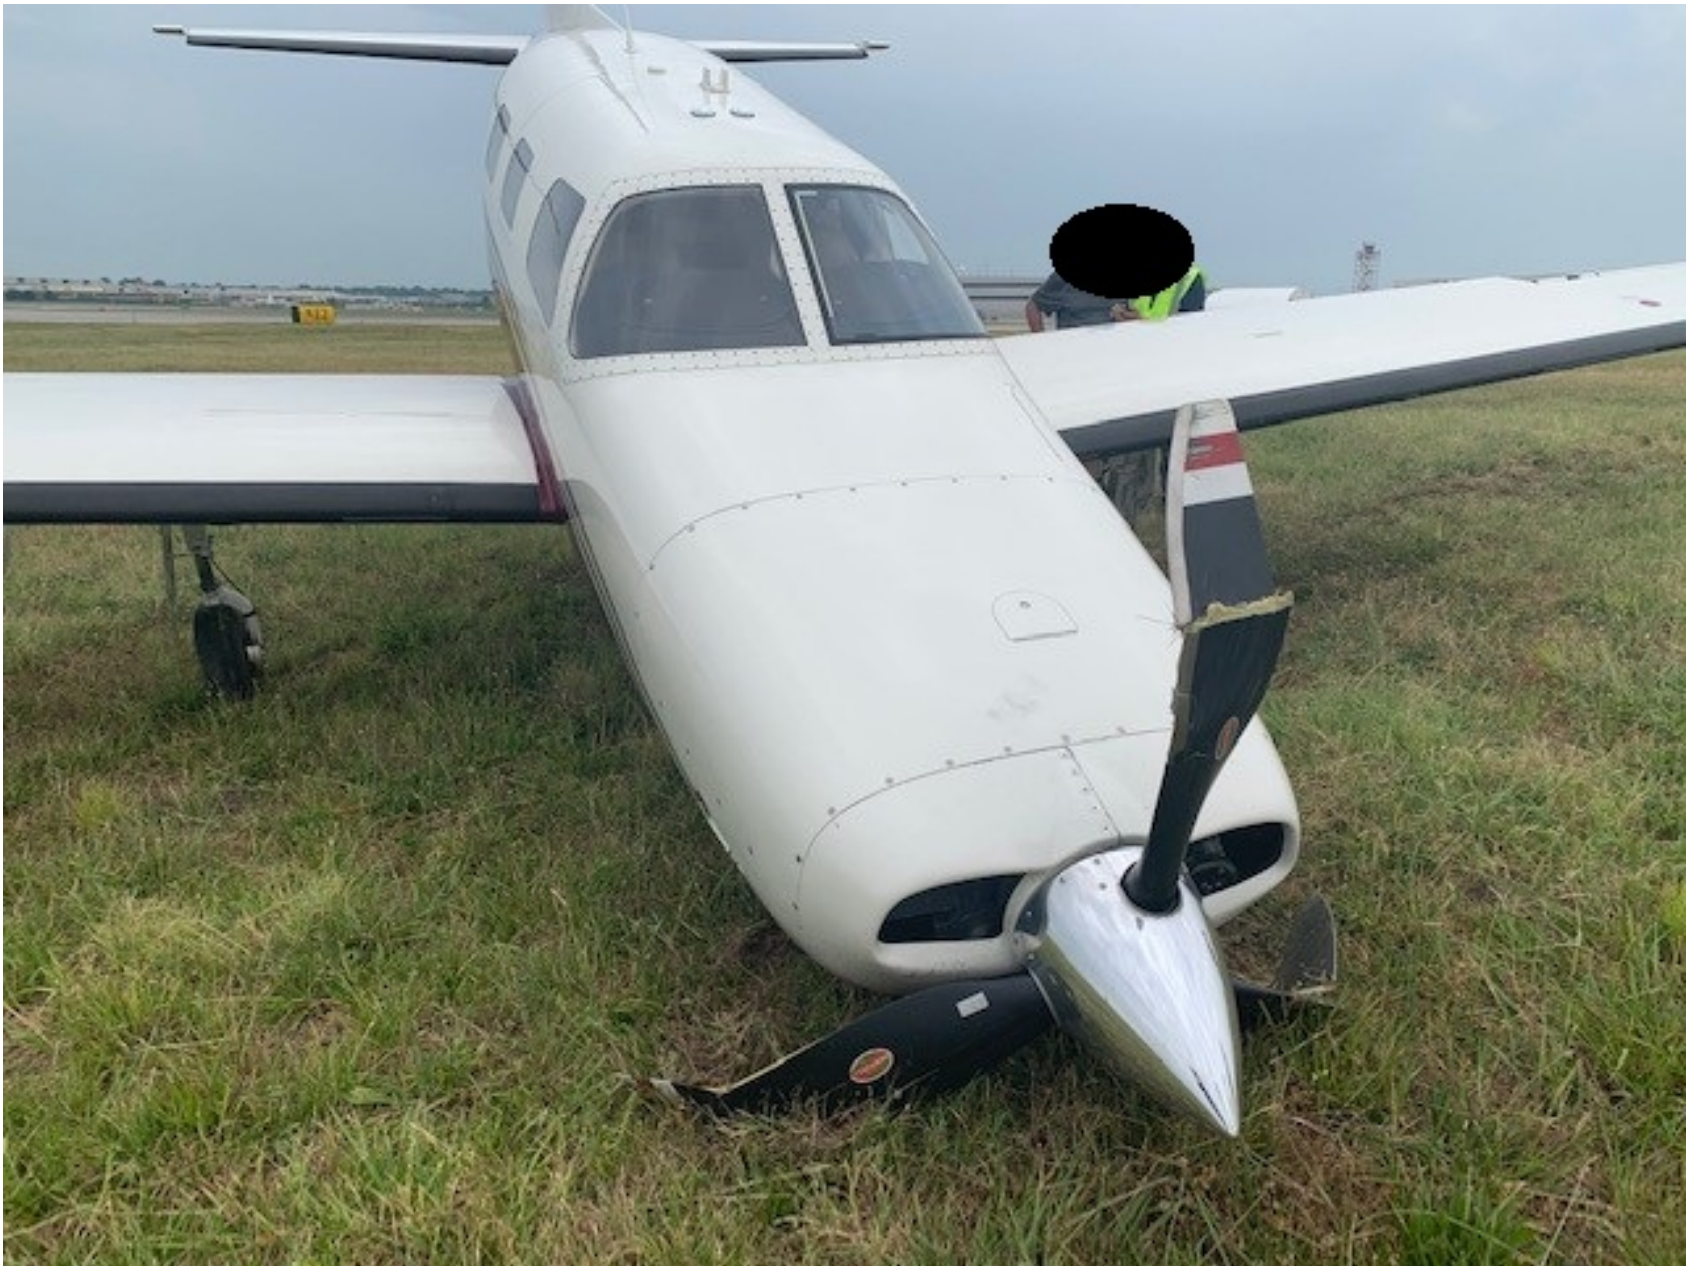
**Photo 2 – Front view of the airplane at the accident site (courtesy of the Federal Aviation Administration).**

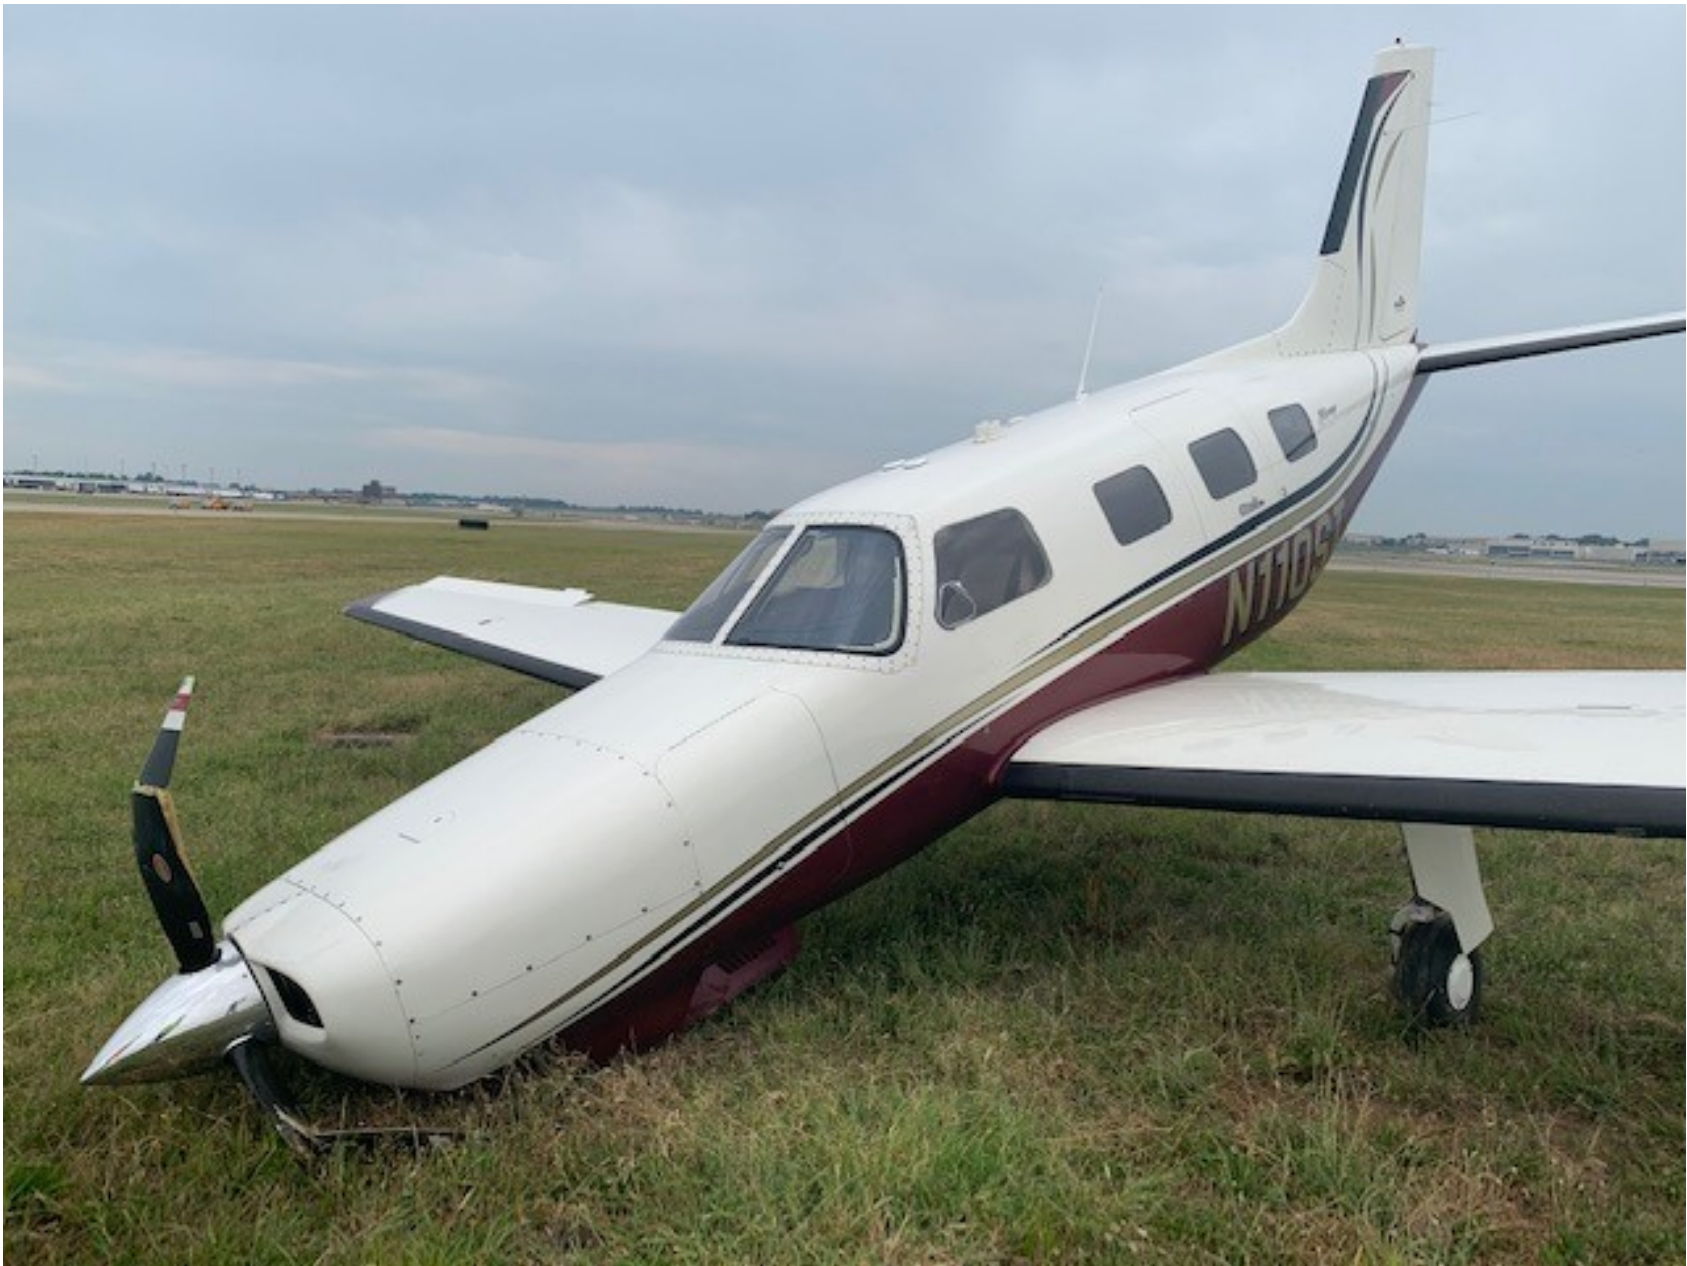
**Photo 3 – Left side view of the airplane at the accident site (courtesy of the Federal Aviation Administration).**

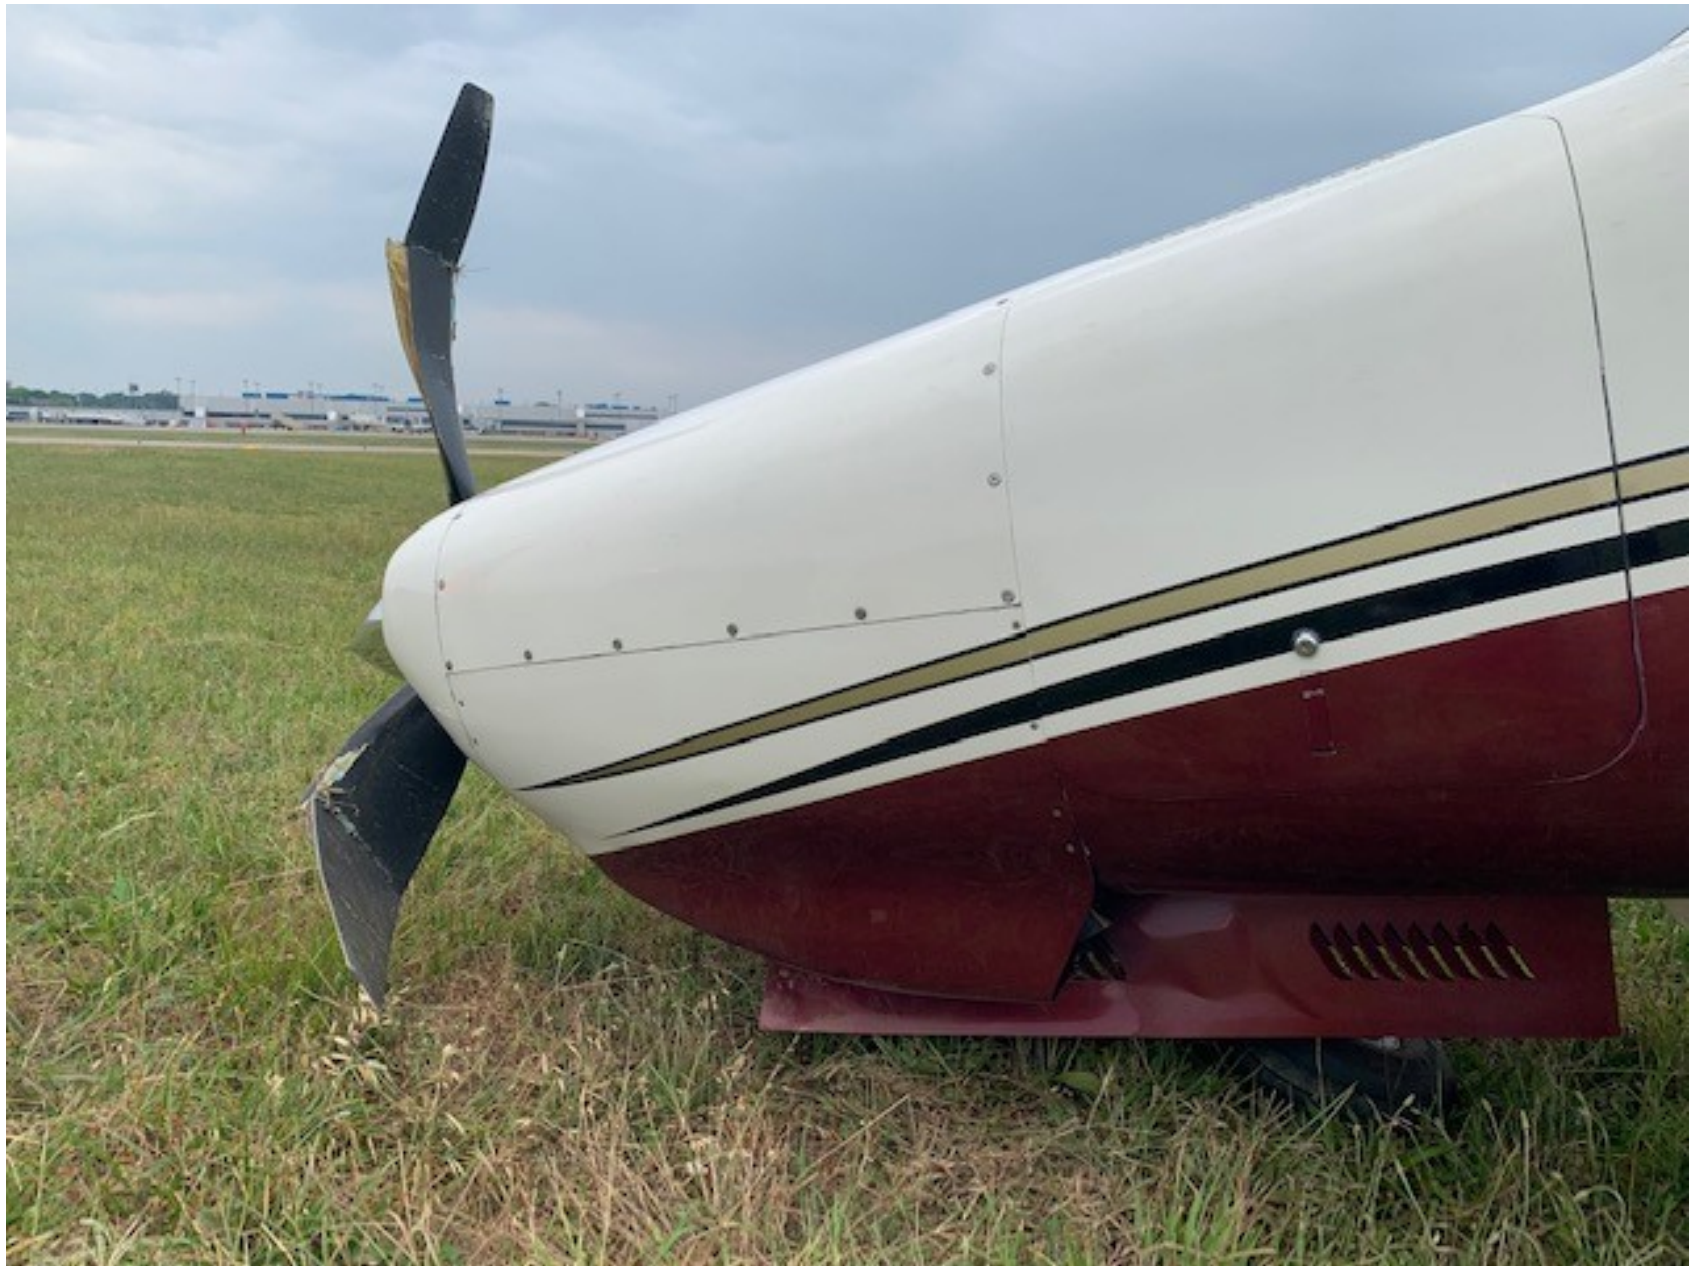
**Photo 4 – Close up left side view of the collapsed nose landing gear at the accident site (courtesy of the Federal Aviation Administration).**

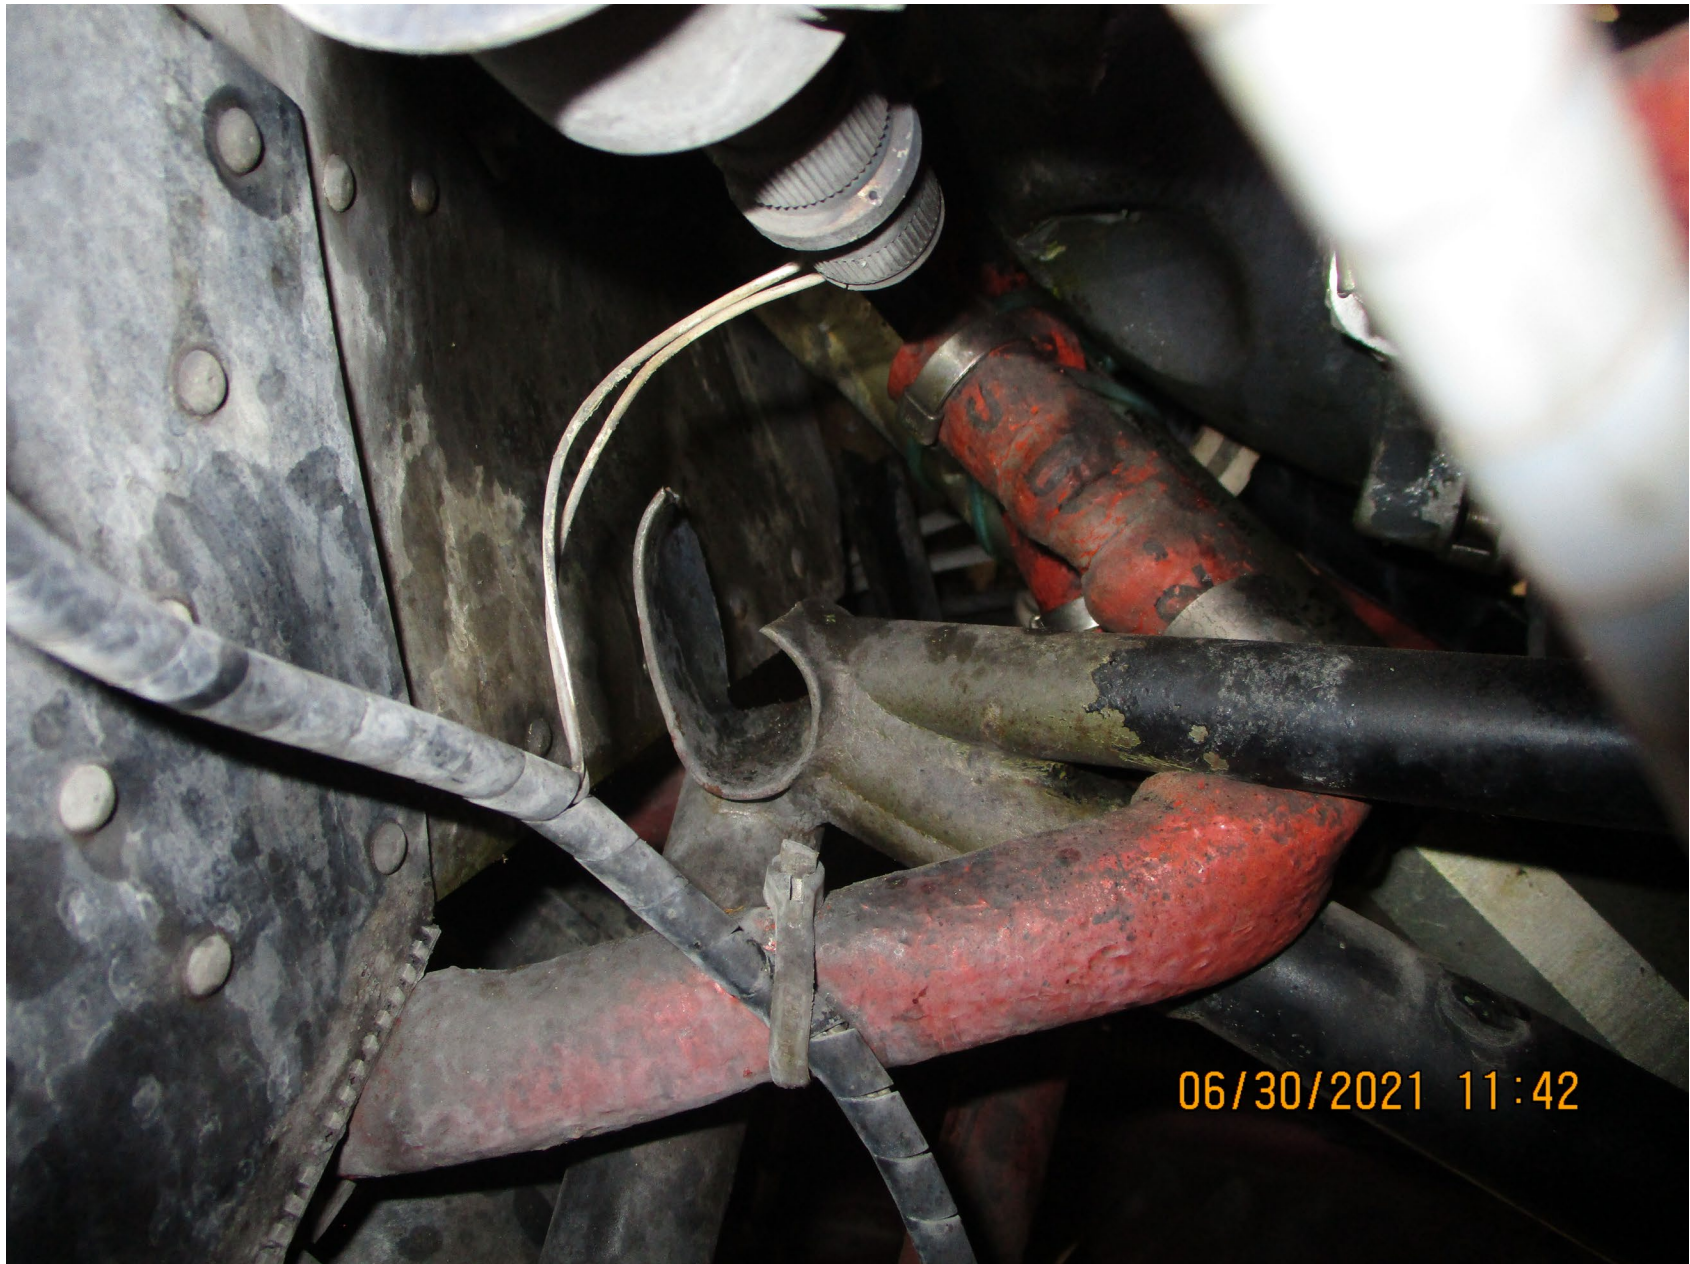
**Photo 5 – Close up view of the fracture sustained to the upper portion of the engine mount (courtesy of the Federal Aviation Administration).**

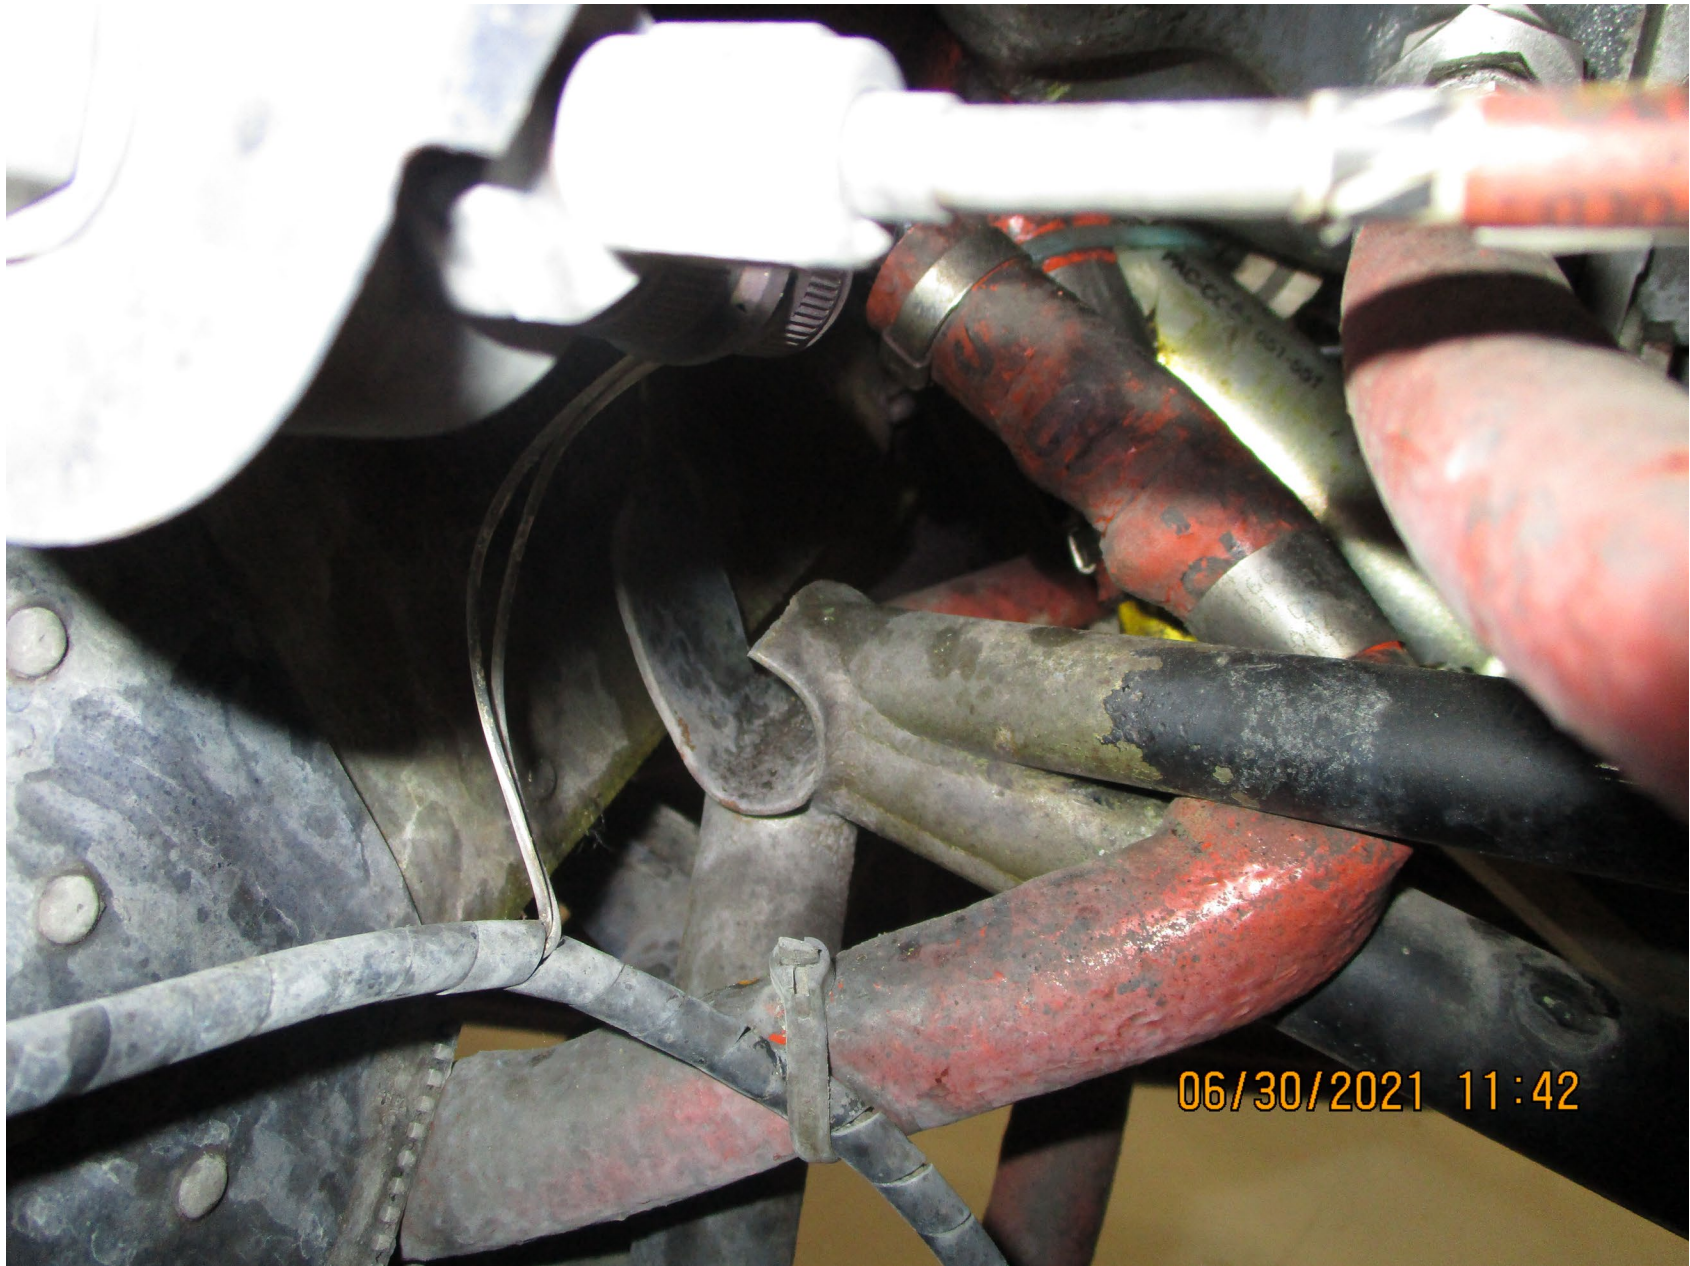
**Photo 6 – Close up view of the fracture sustained to the upper portion of the engine mount (courtesy of the Federal Aviation Administration).**

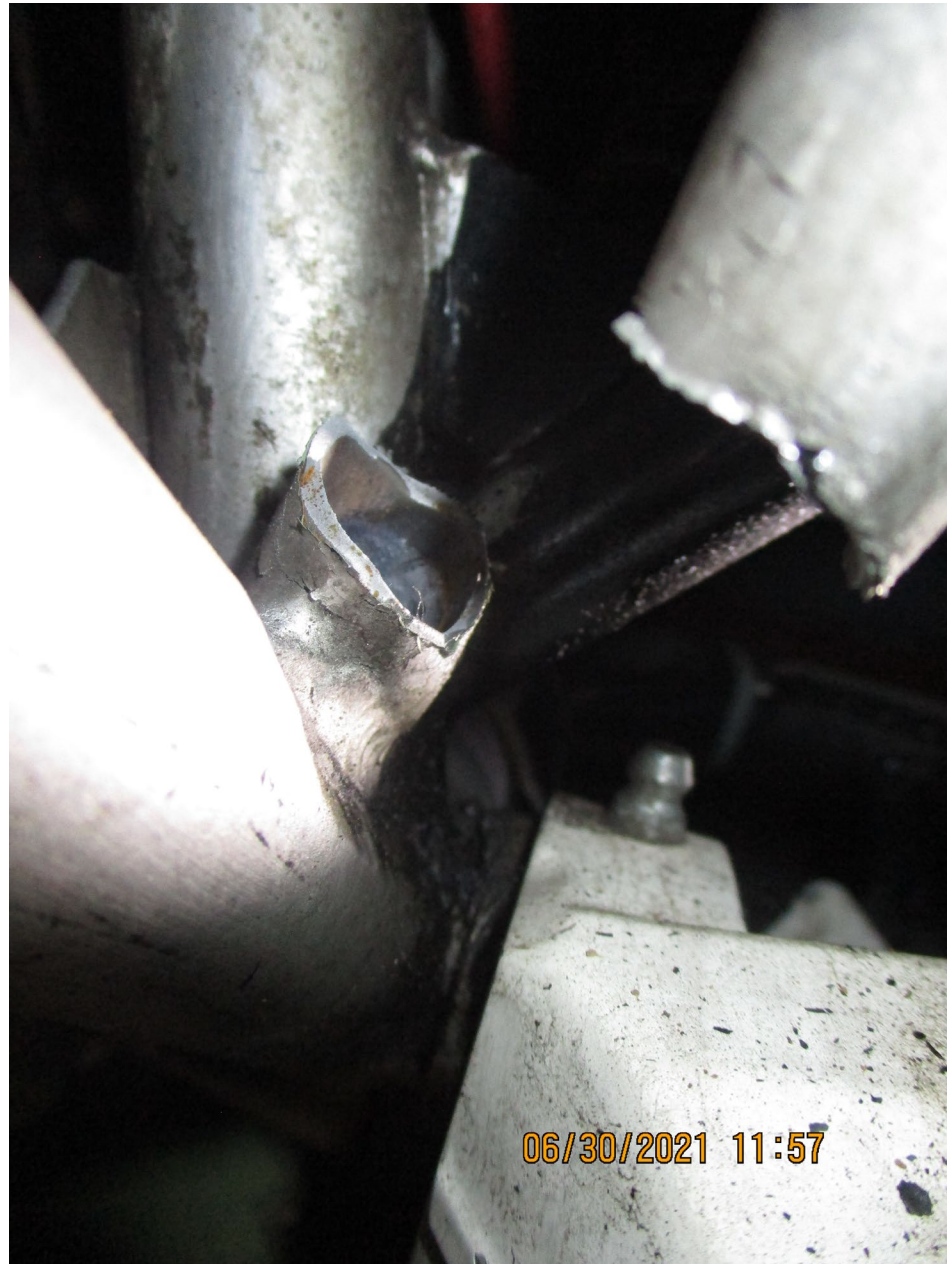
**Photo 7 – Close up view of the fracture sustained to the lower portion of the engine mount (courtesy of the Federal Aviation Administration).**

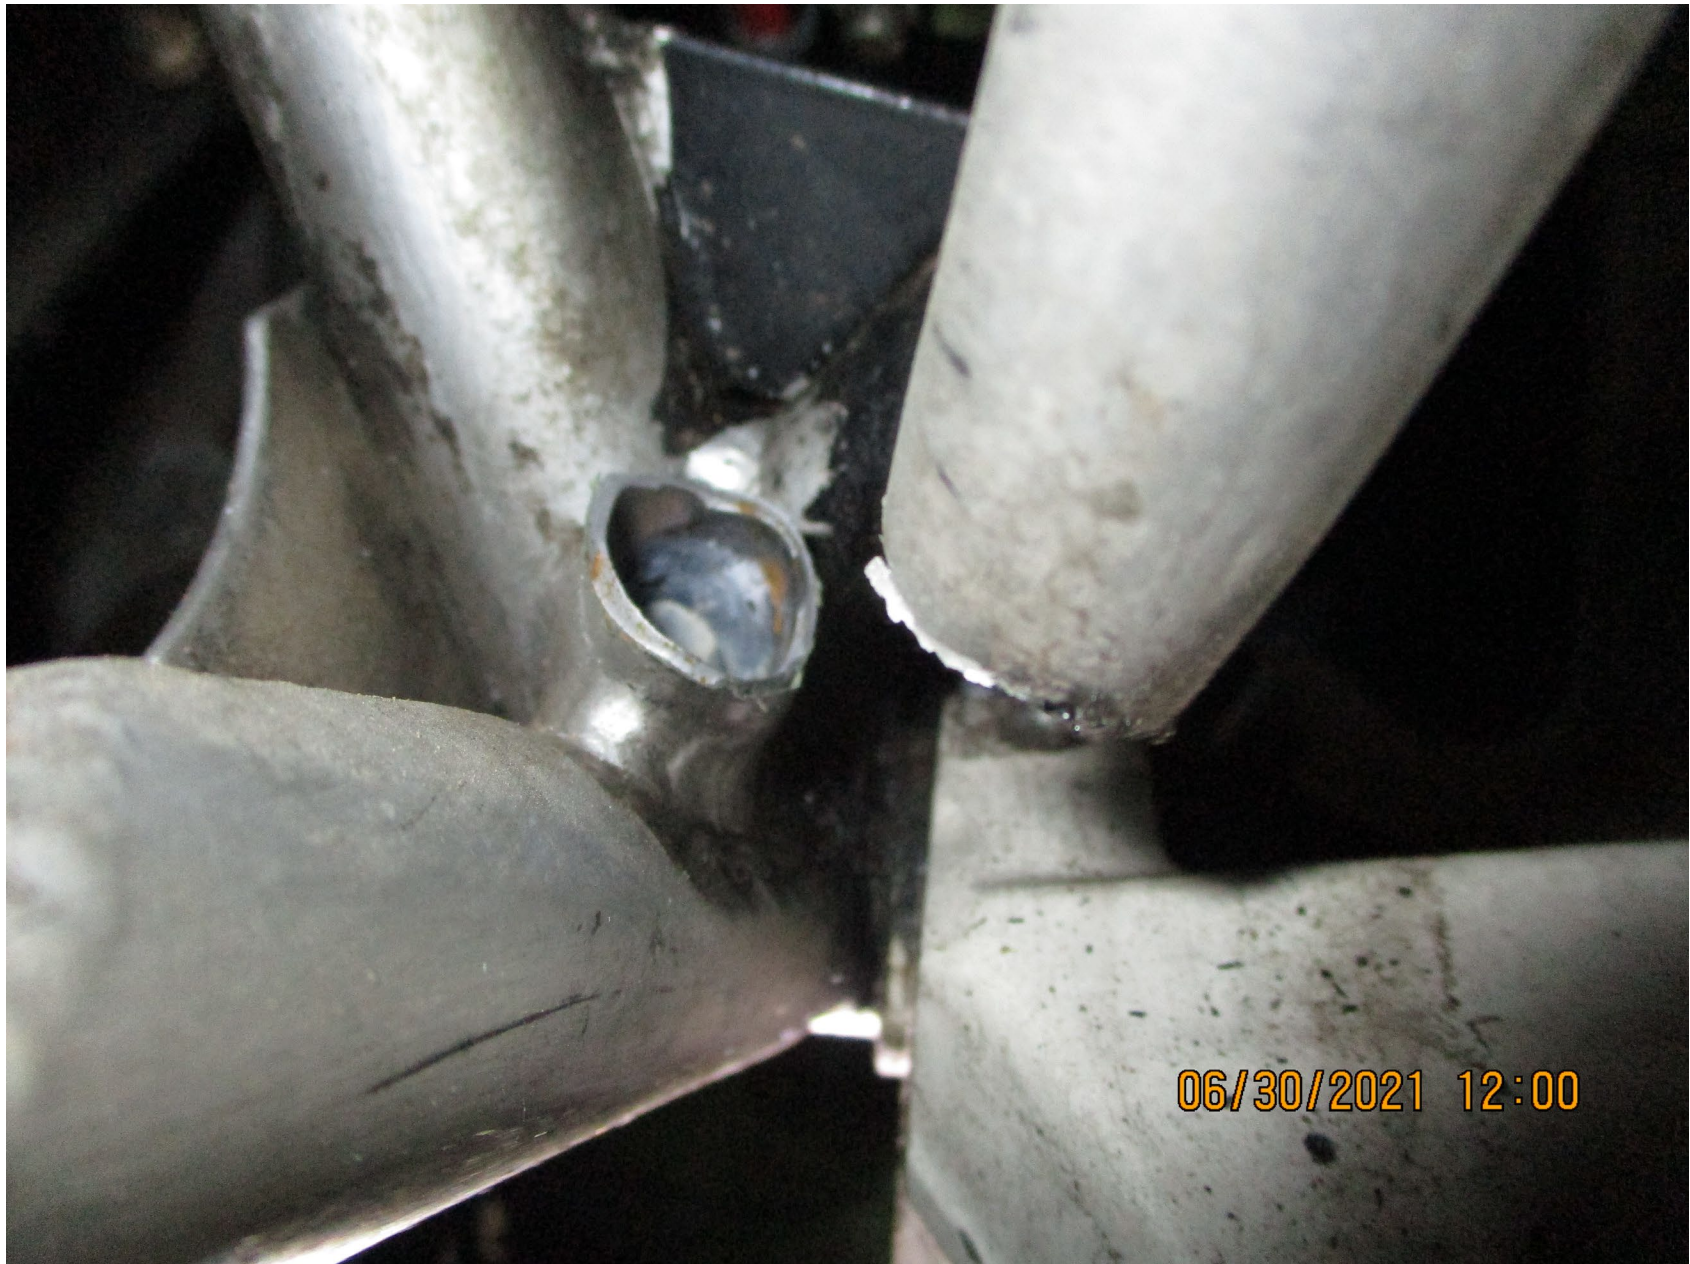
**Photo 8 – Close up view of the fracture sustained to the lower portion of the engine mount (courtesy of the Federal Aviation Administration).**
