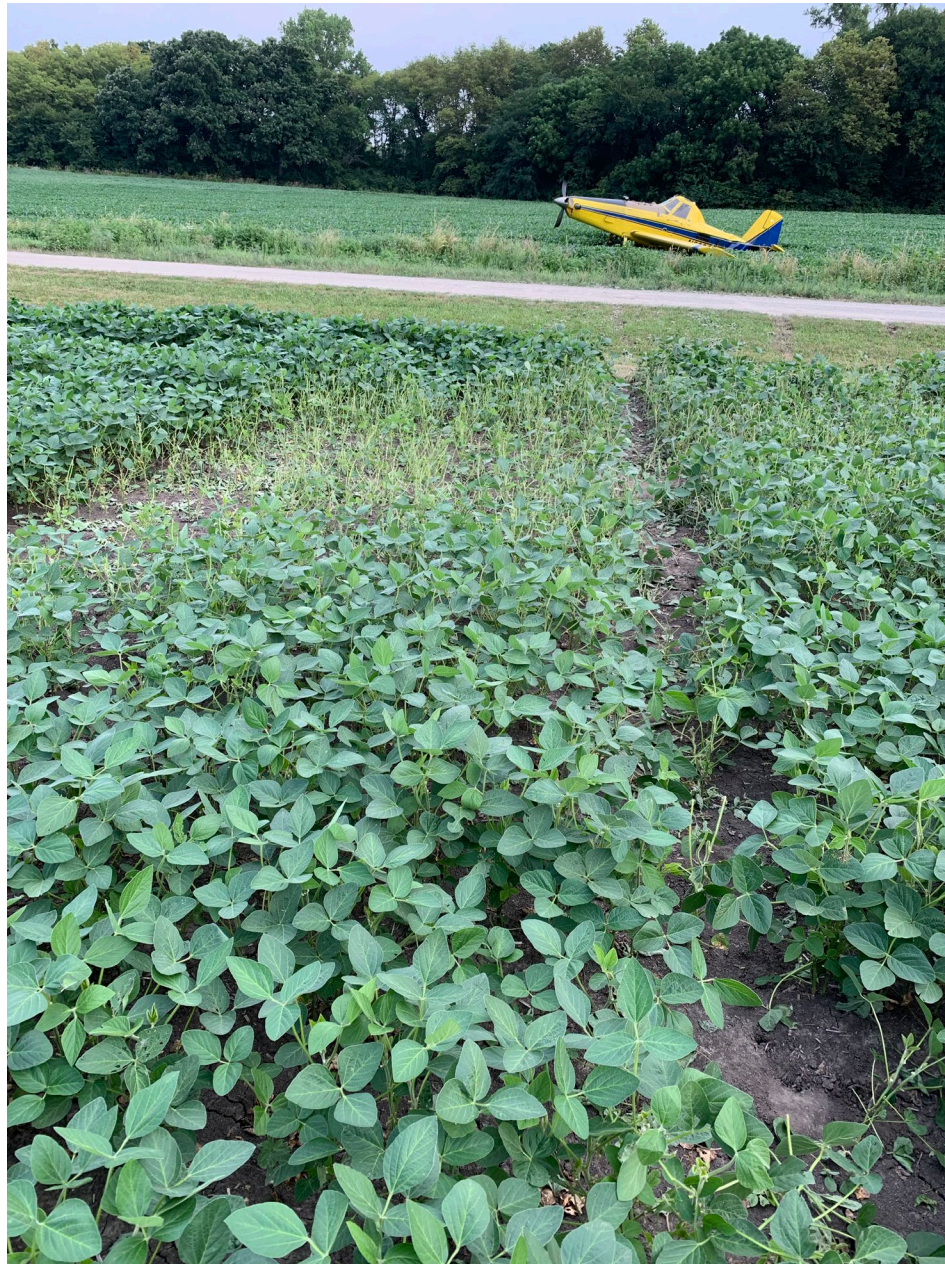
**Photo 1 – View of the airplane after it came to rest in the bean field (courtesy of the Federal Aviation Administration).**

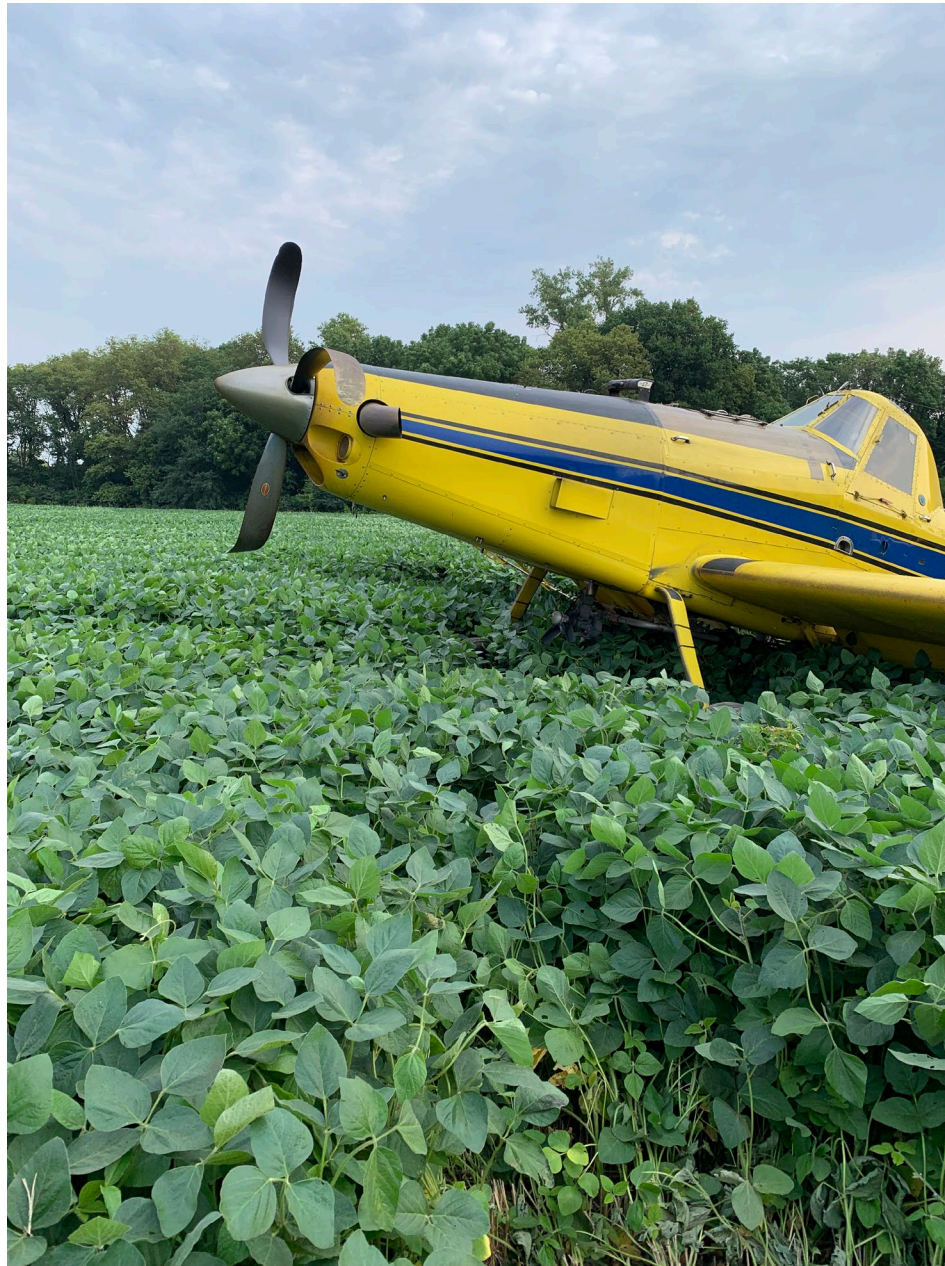
**Photo 2 – View of the propeller and the fuselage in the bean field (courtesy of the Federal Aviation Administration).**

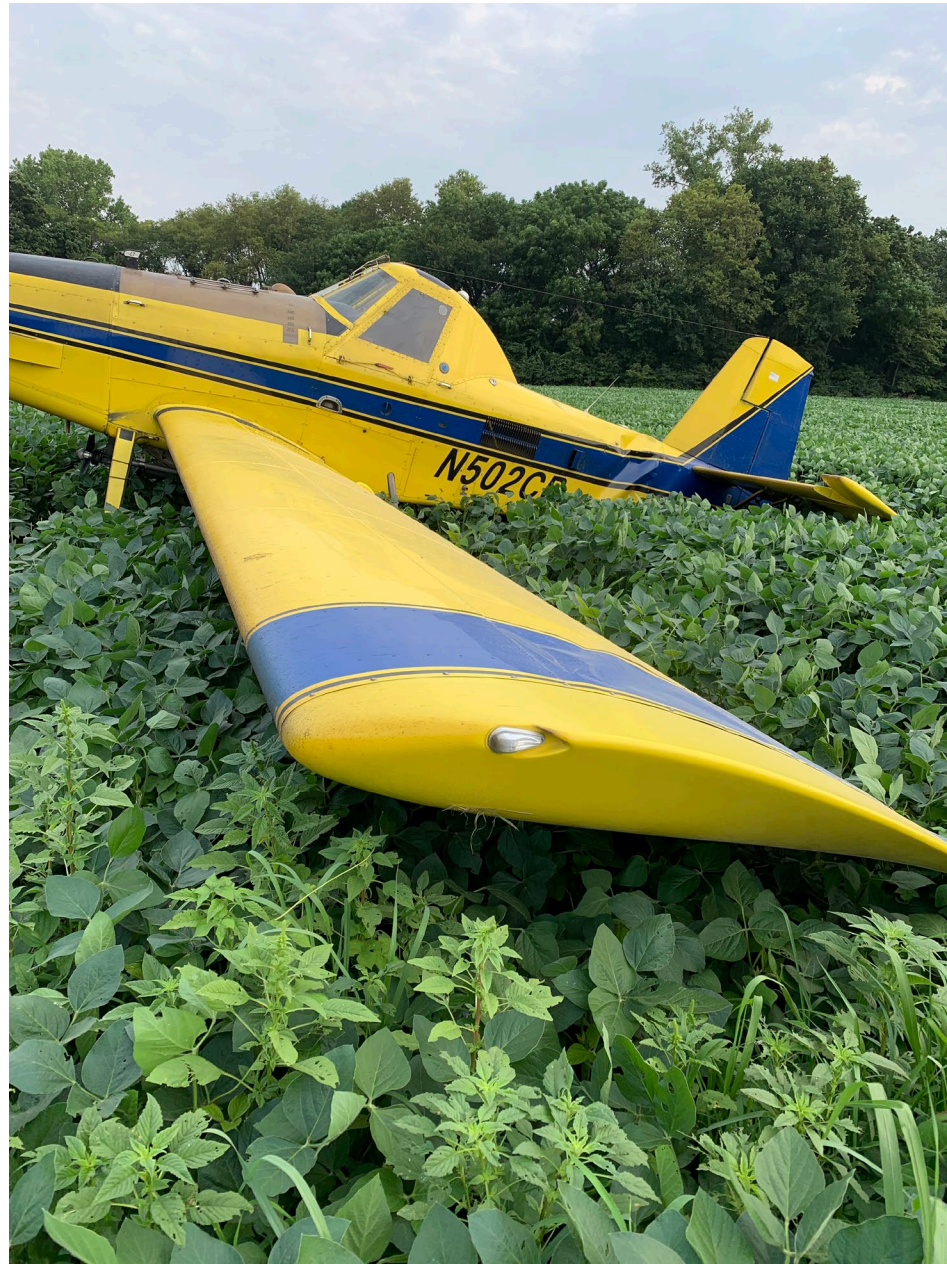
**Photo 3 – View of the fuselage, left wing, and empennage in the bean field (courtesy of the Federal Aviation Administration).**

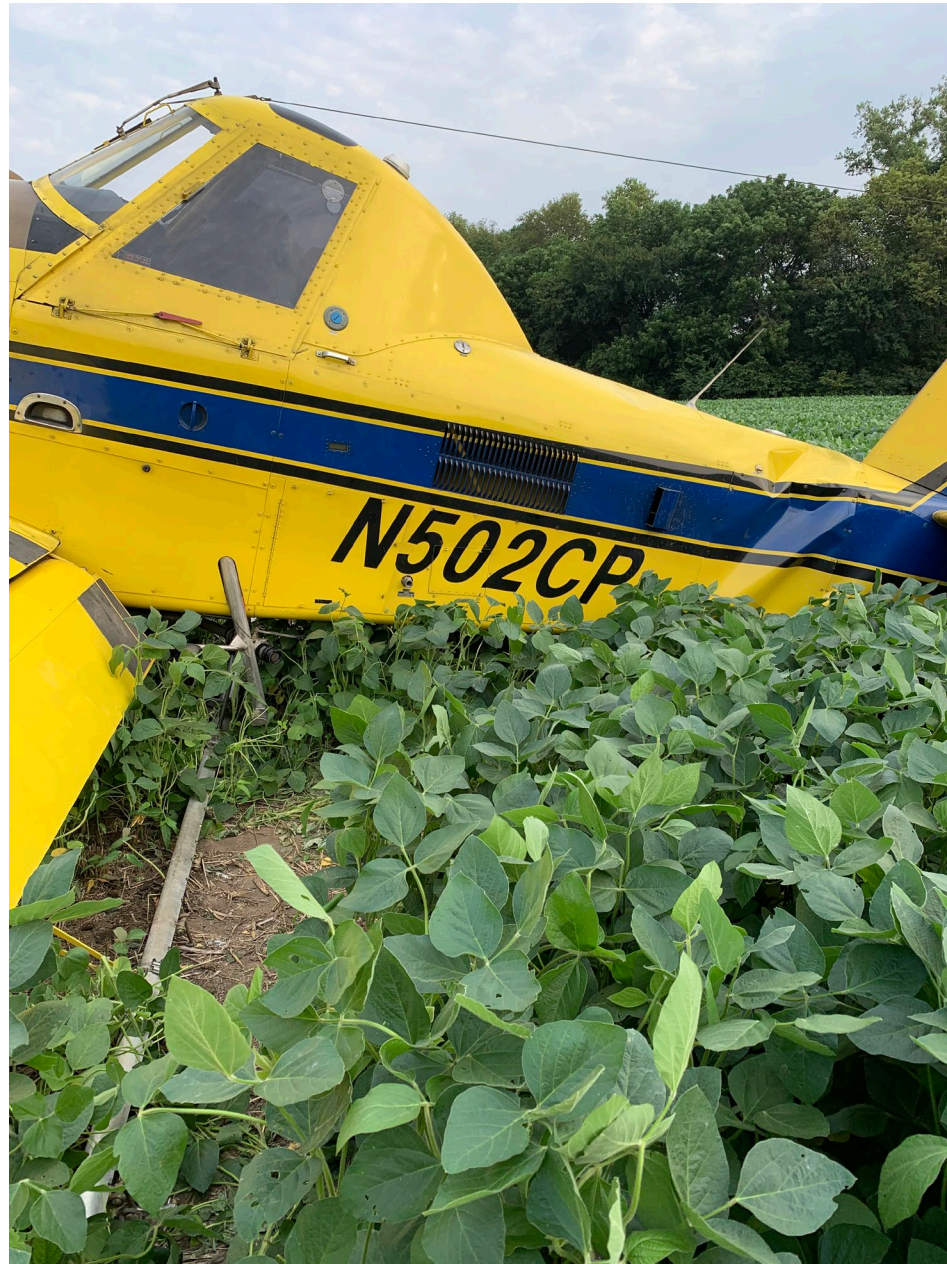
**Photo 4 – View of the fuselage in the bean field (courtesy of the Federal Aviation Administration).**

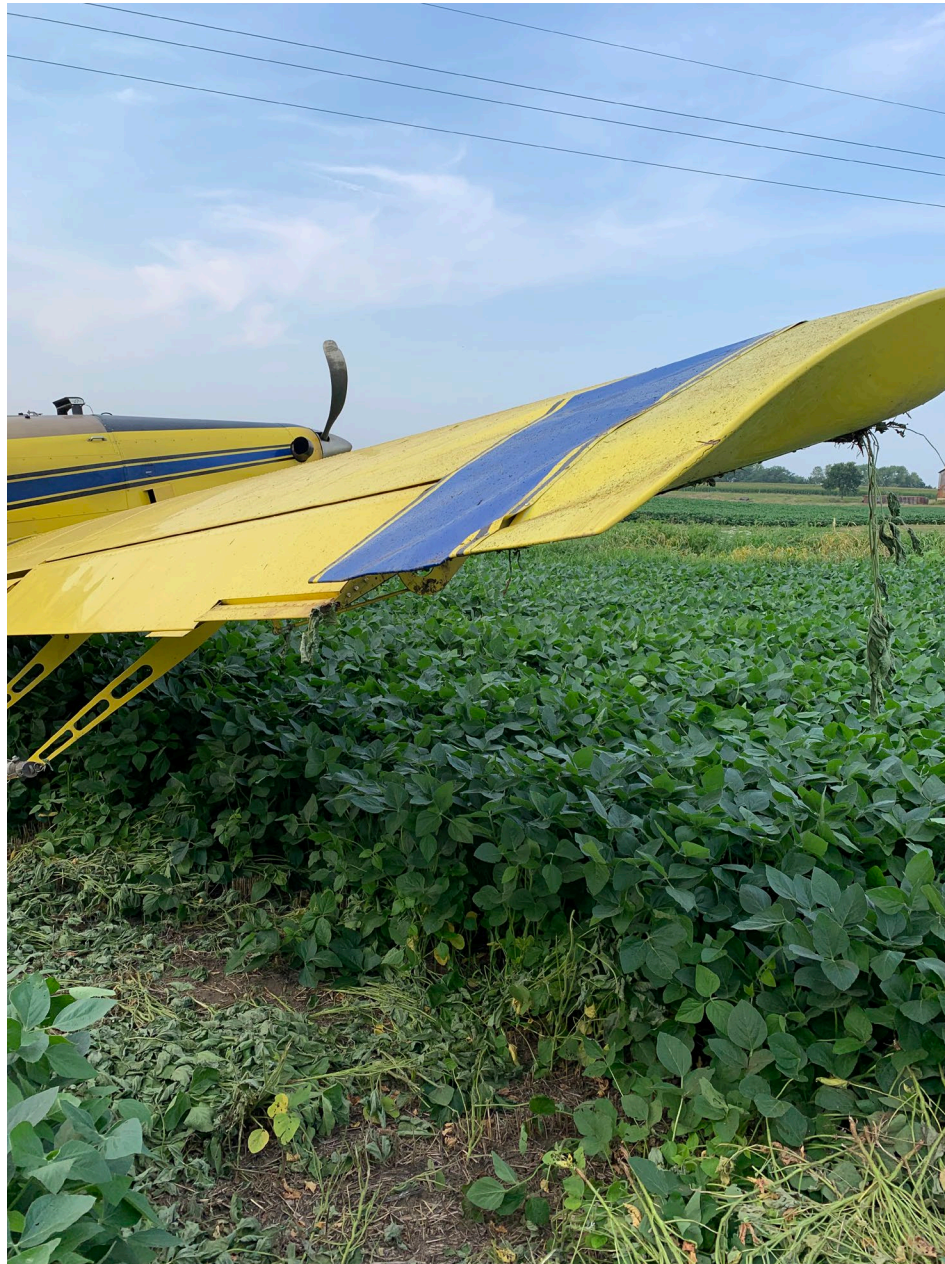
**Photo 5 – View of the right wing in the bean field (courtesy of the Federal Aviation Administration).**

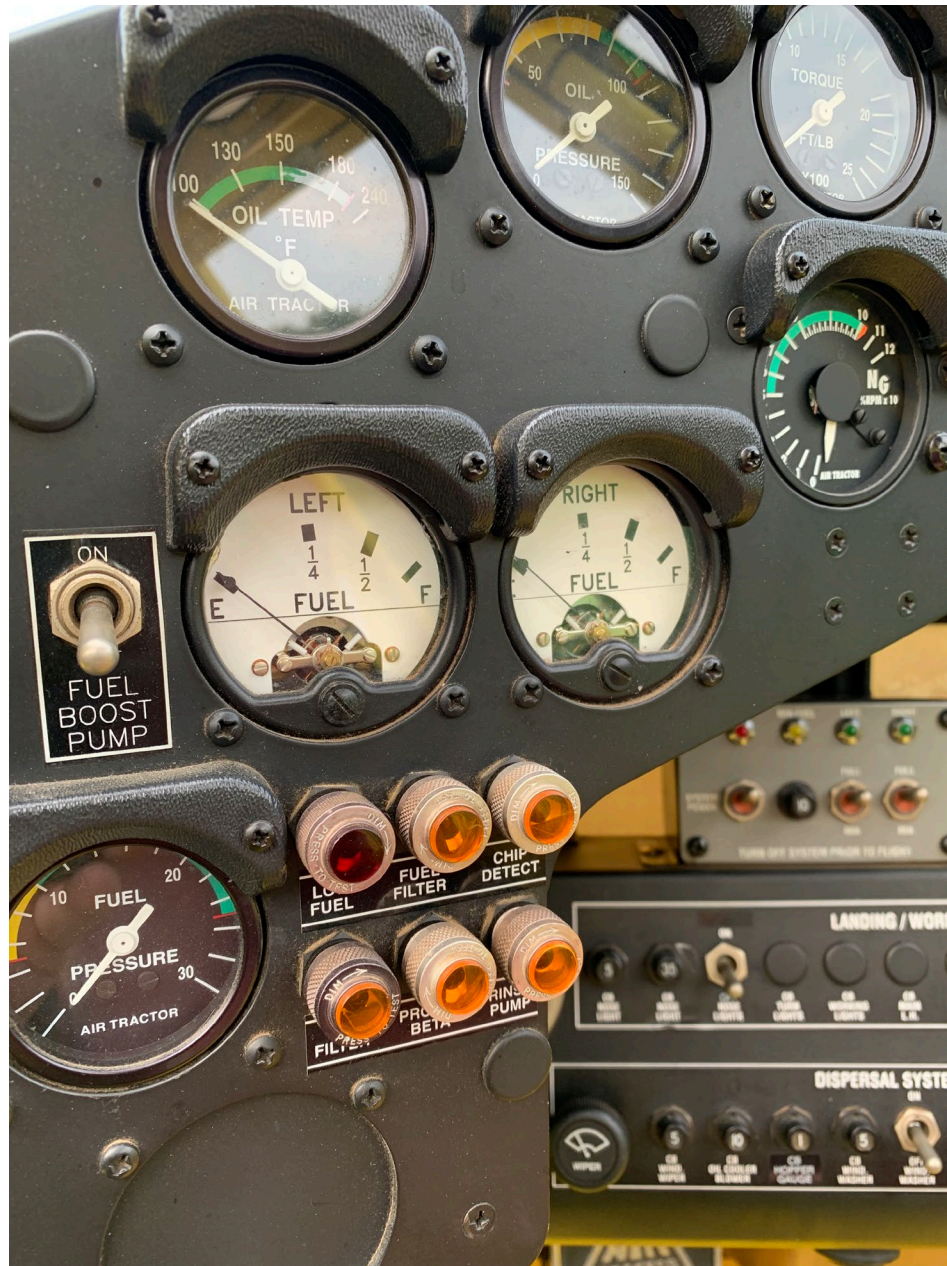
**Photo 6 – View of the left side of the cockpit after the accident (courtesy of the Federal Aviation Administration).**

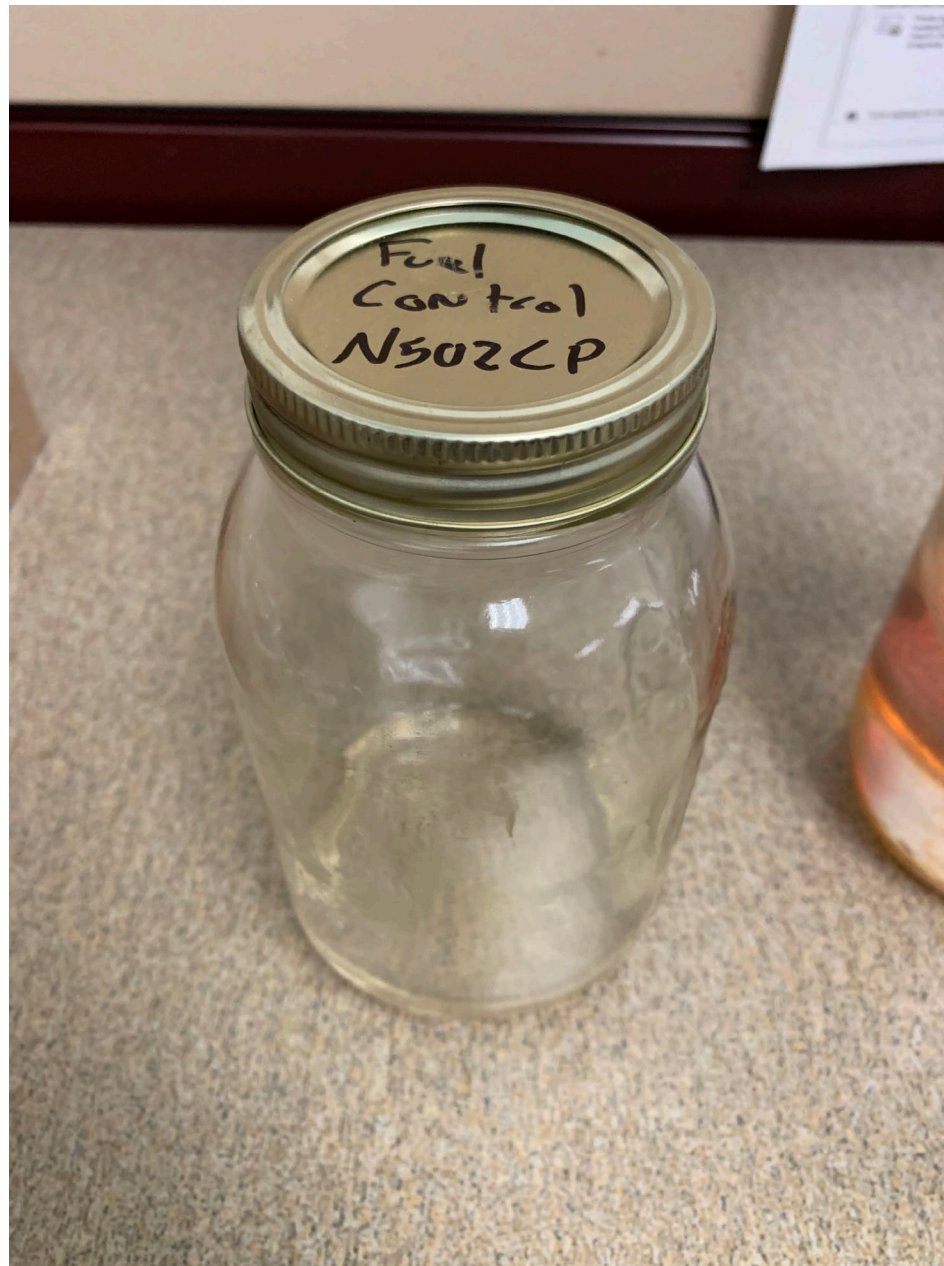
**Photo 7 – View of a glass fuel sample jar, with a sample obtained from the fuel control unit (courtesy of the Federal Aviation Administration).**

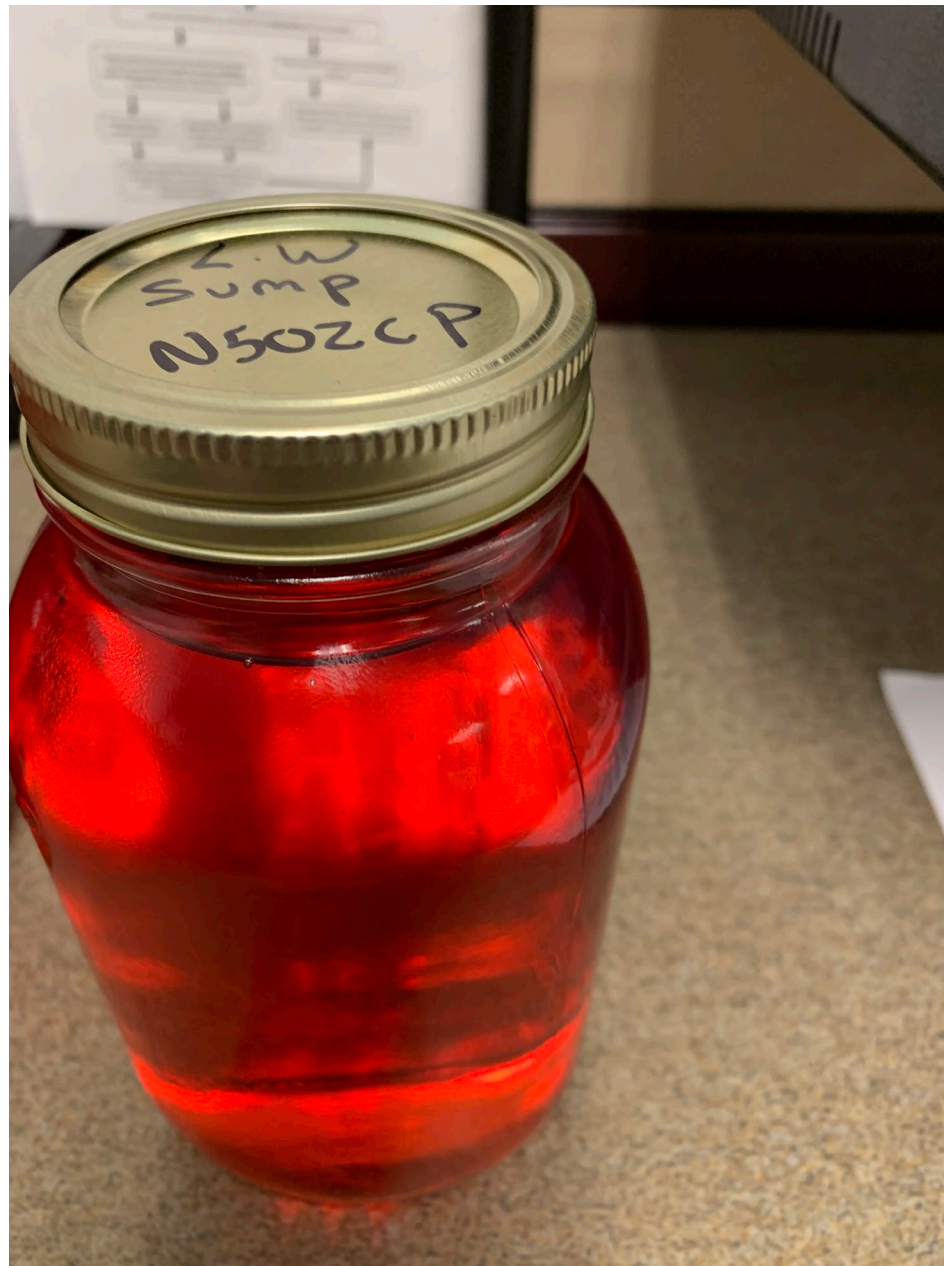
**Photo 8 – View of a glass fuel sample jar, with a sample obtained from the left wing sump (courtesy of the Federal Aviation Administration).**

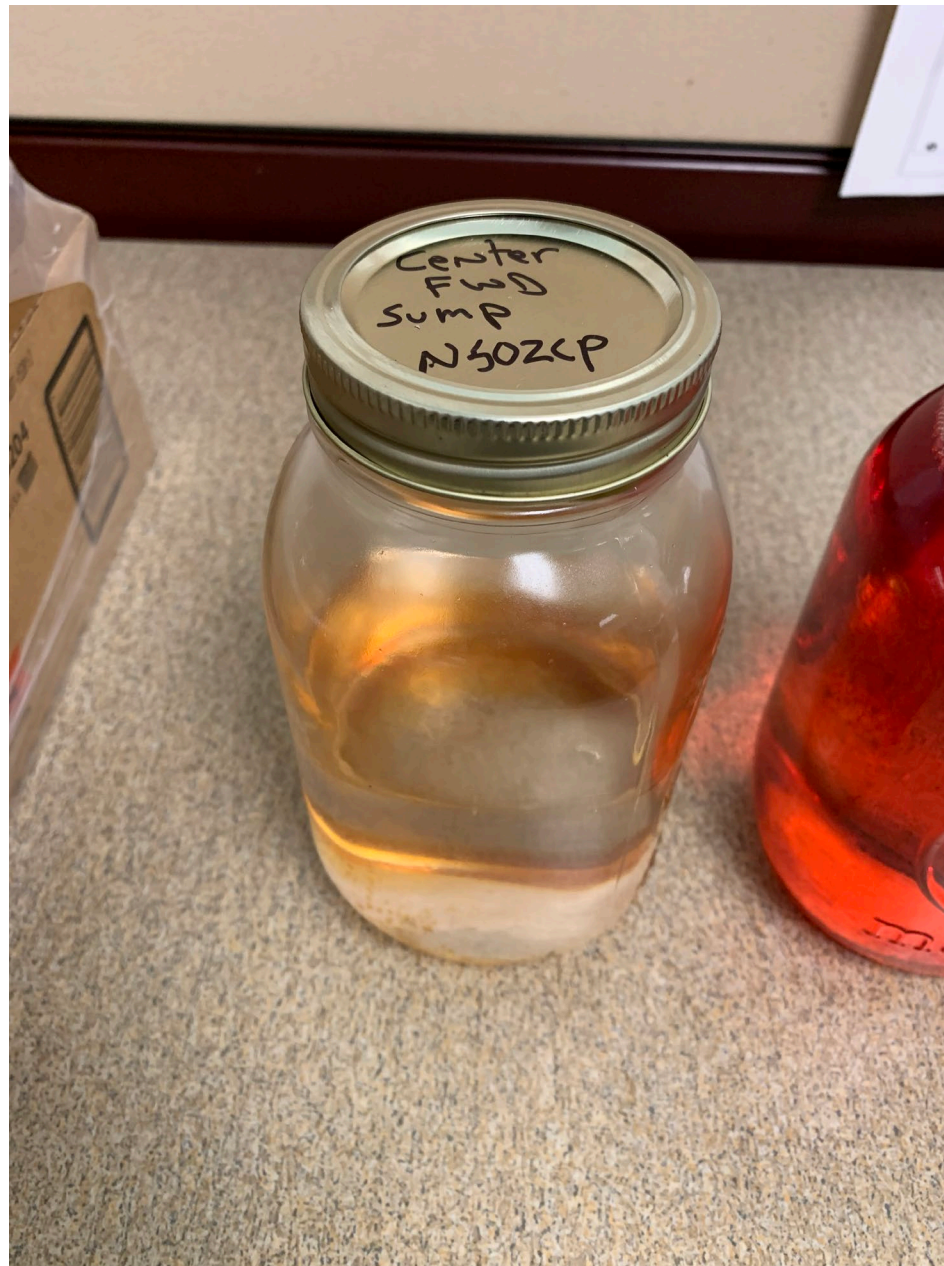
**Photo 9 – View of a glass fuel sample jar, with a sample obtained from the center forward sump (courtesy of the Federal Aviation Administration).**

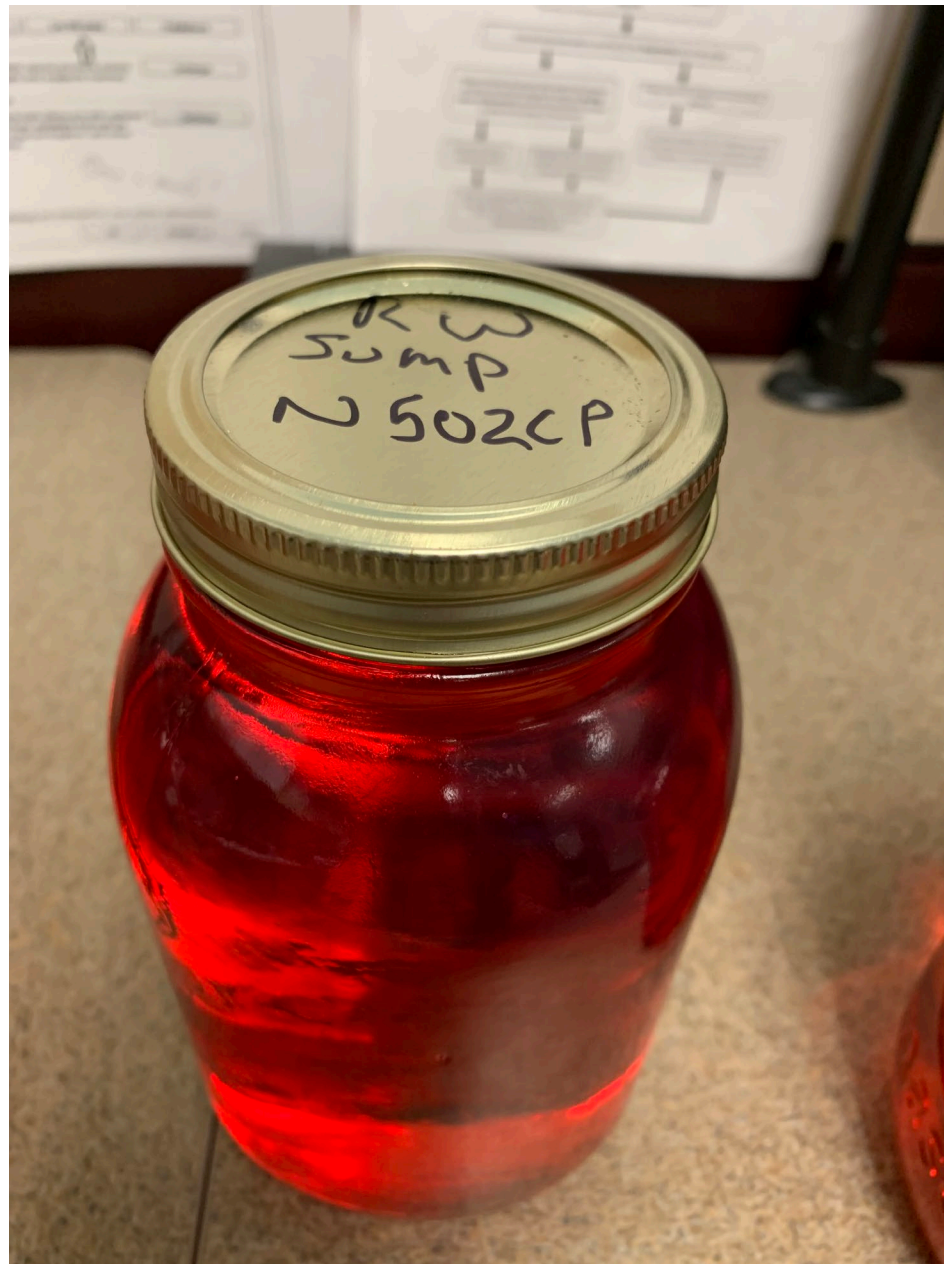
**Photo 10 – View of a glass fuel sample jar, with a sample obtained from the right wing sump (courtesy of the Federal Aviation Administration).**

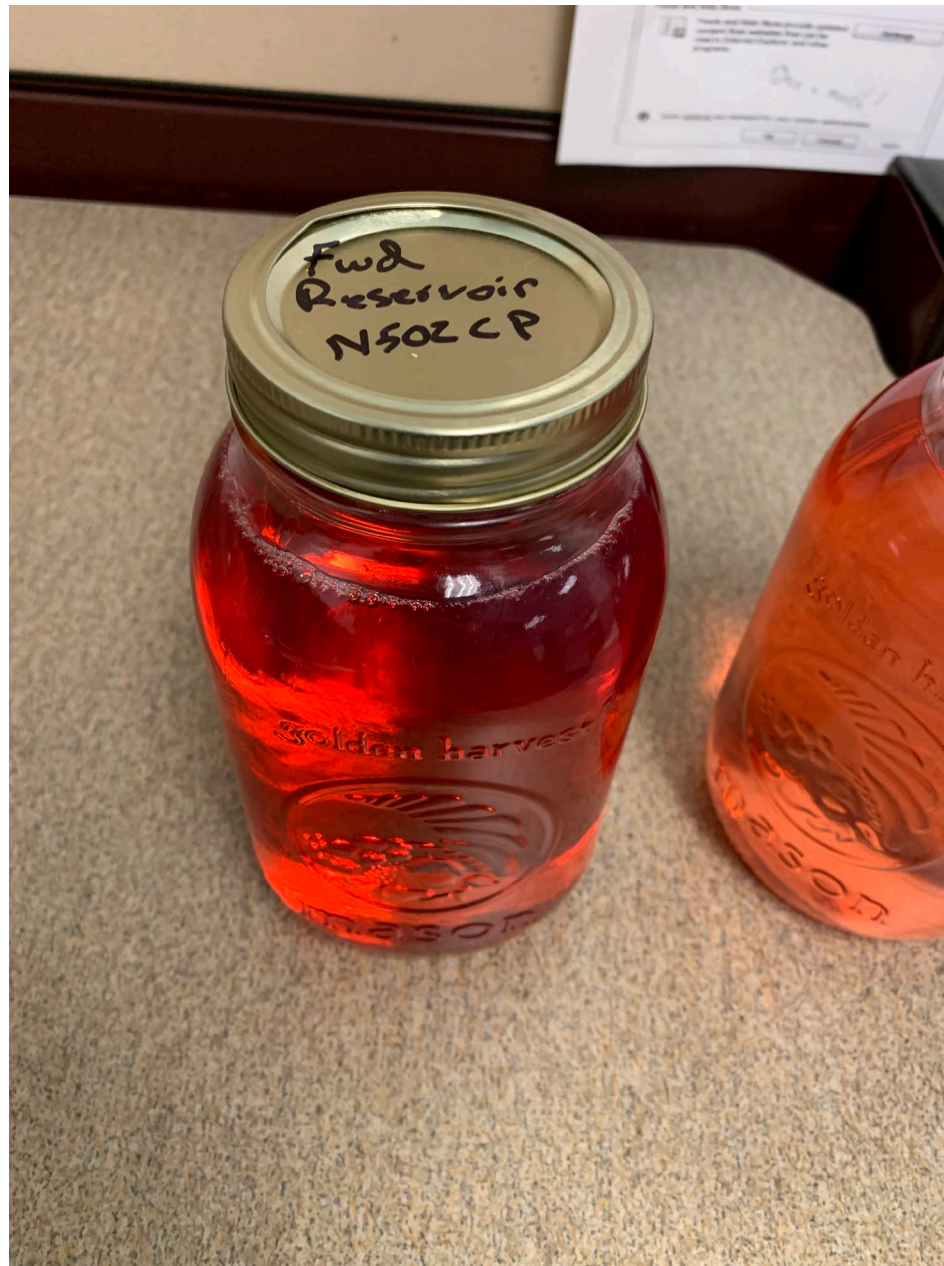
**Photo 11 – View of a glass fuel sample jar, with a sample obtained from the forward reservoir (courtesy of the Federal Aviation Administration).**

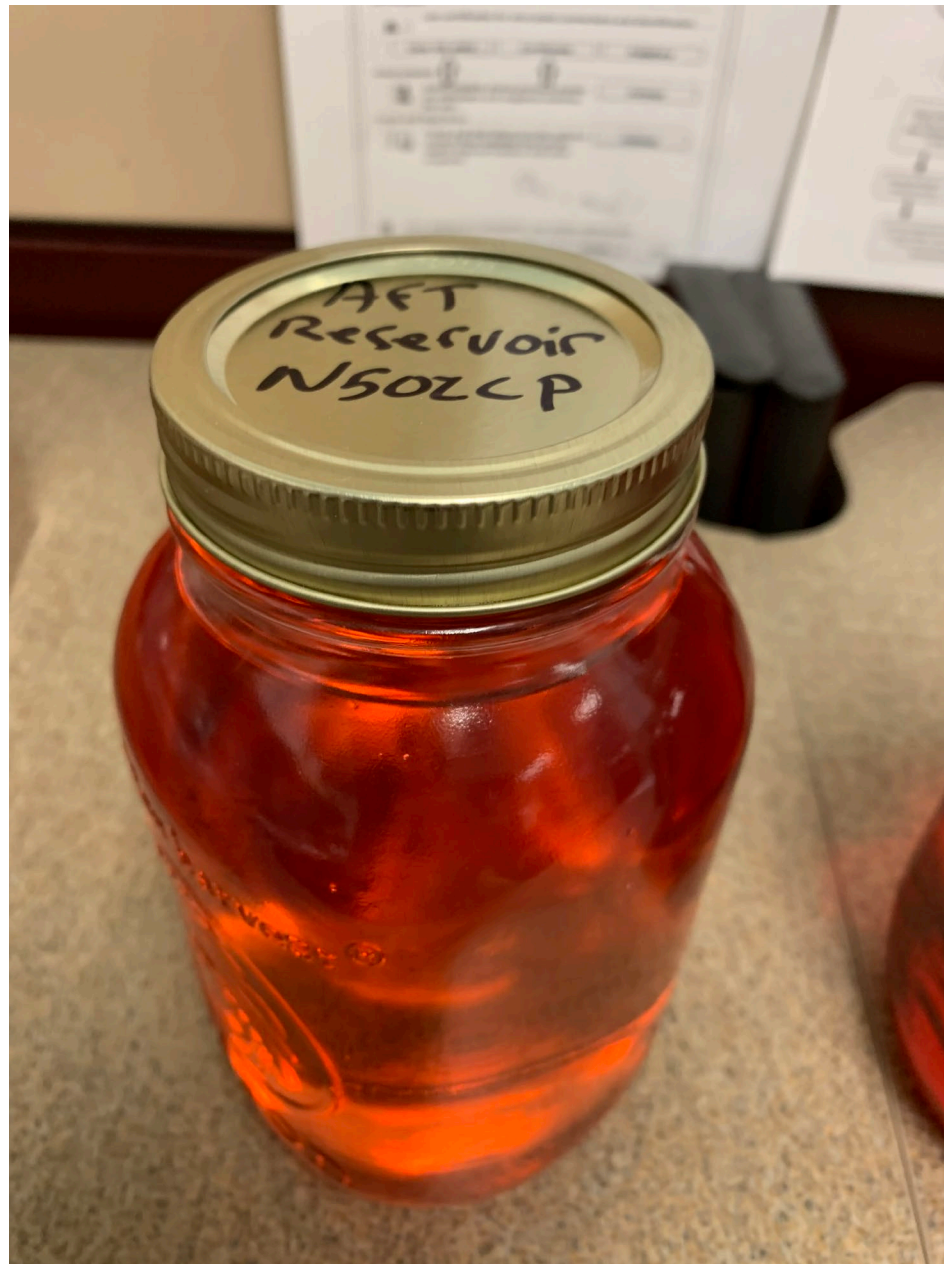
**Photo 12 – View of a glass fuel sample jar, with a sample obtained from the aft reservoir (courtesy of the Federal Aviation Administration).**

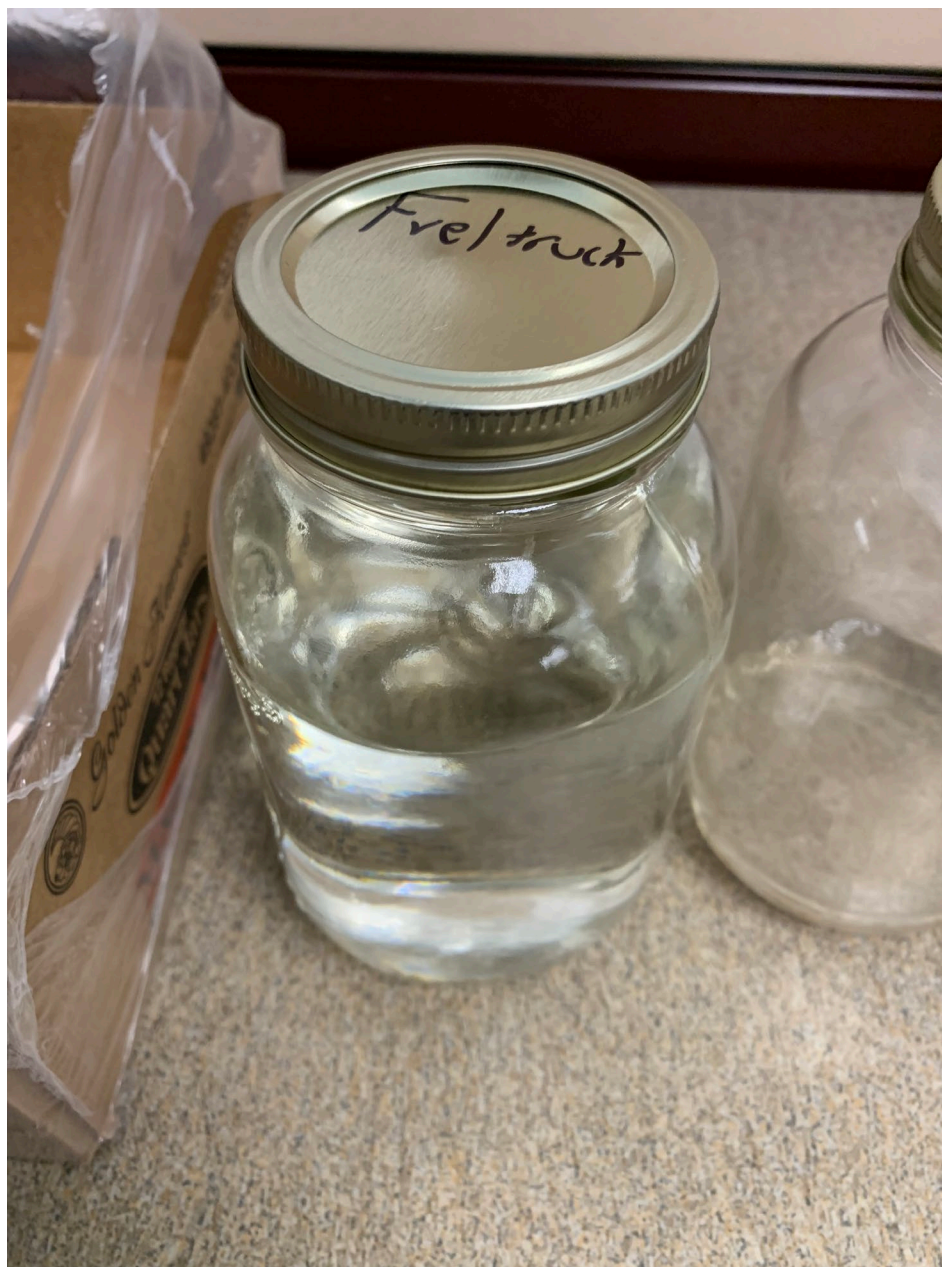
**Photo 13 – View of a glass fuel sample jar, with a sample obtained from the operator’s fuel truck (courtesy of the Federal Aviation Administration).**
