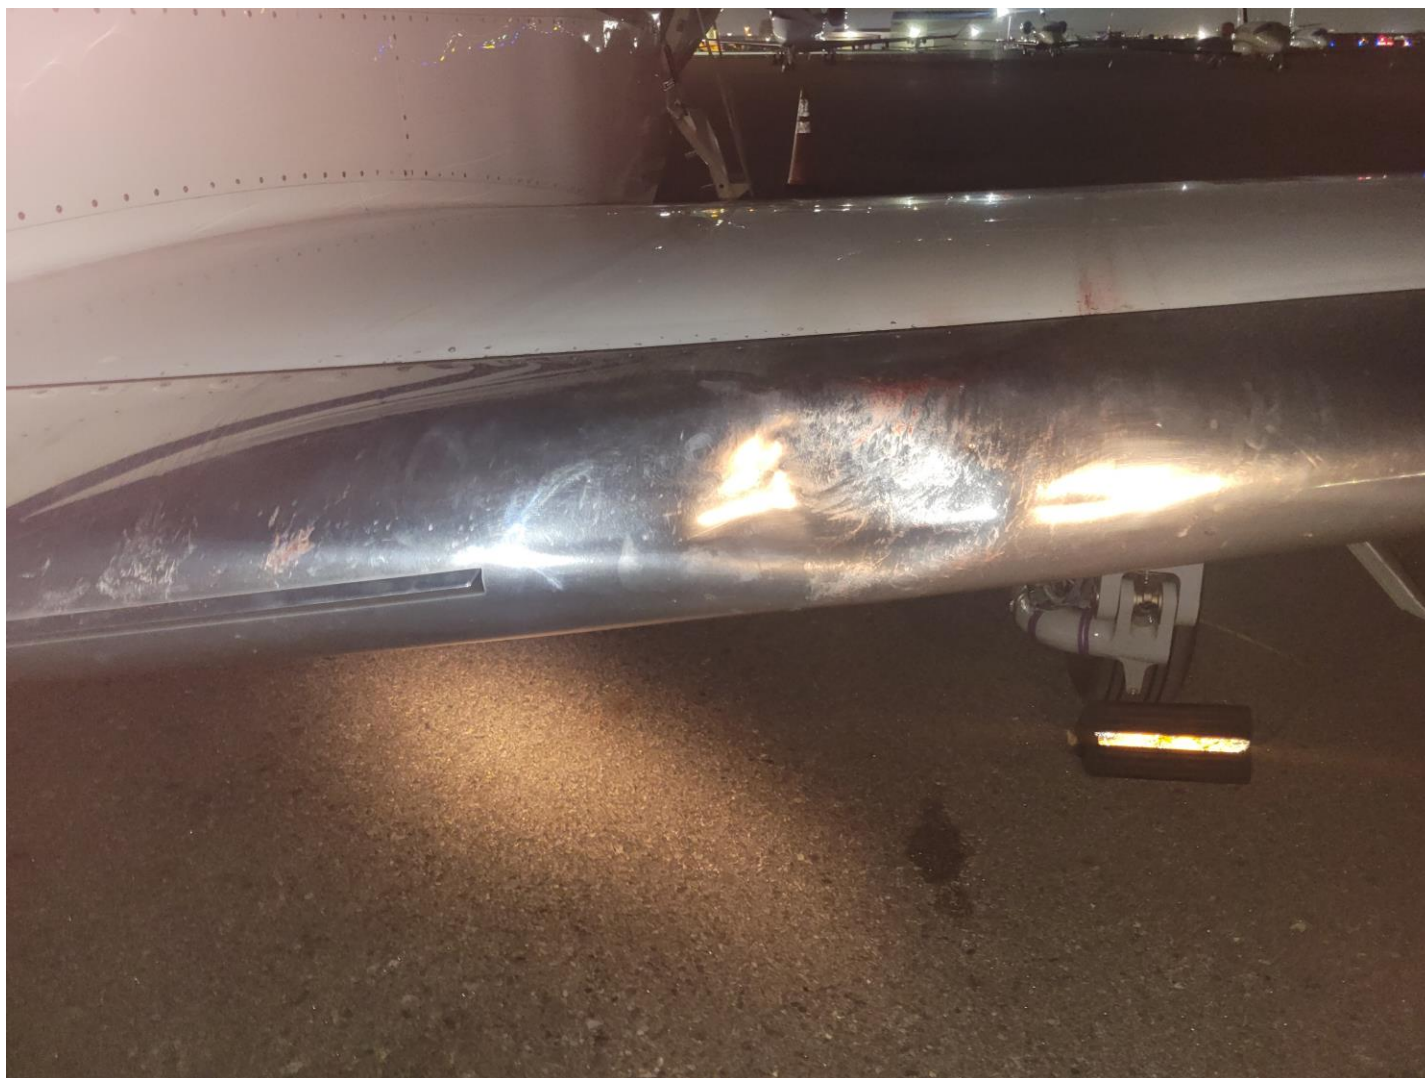
**Photo 1 – Damage to Inboard Left Wing Leading Edge (Courtesy of Operator)**
