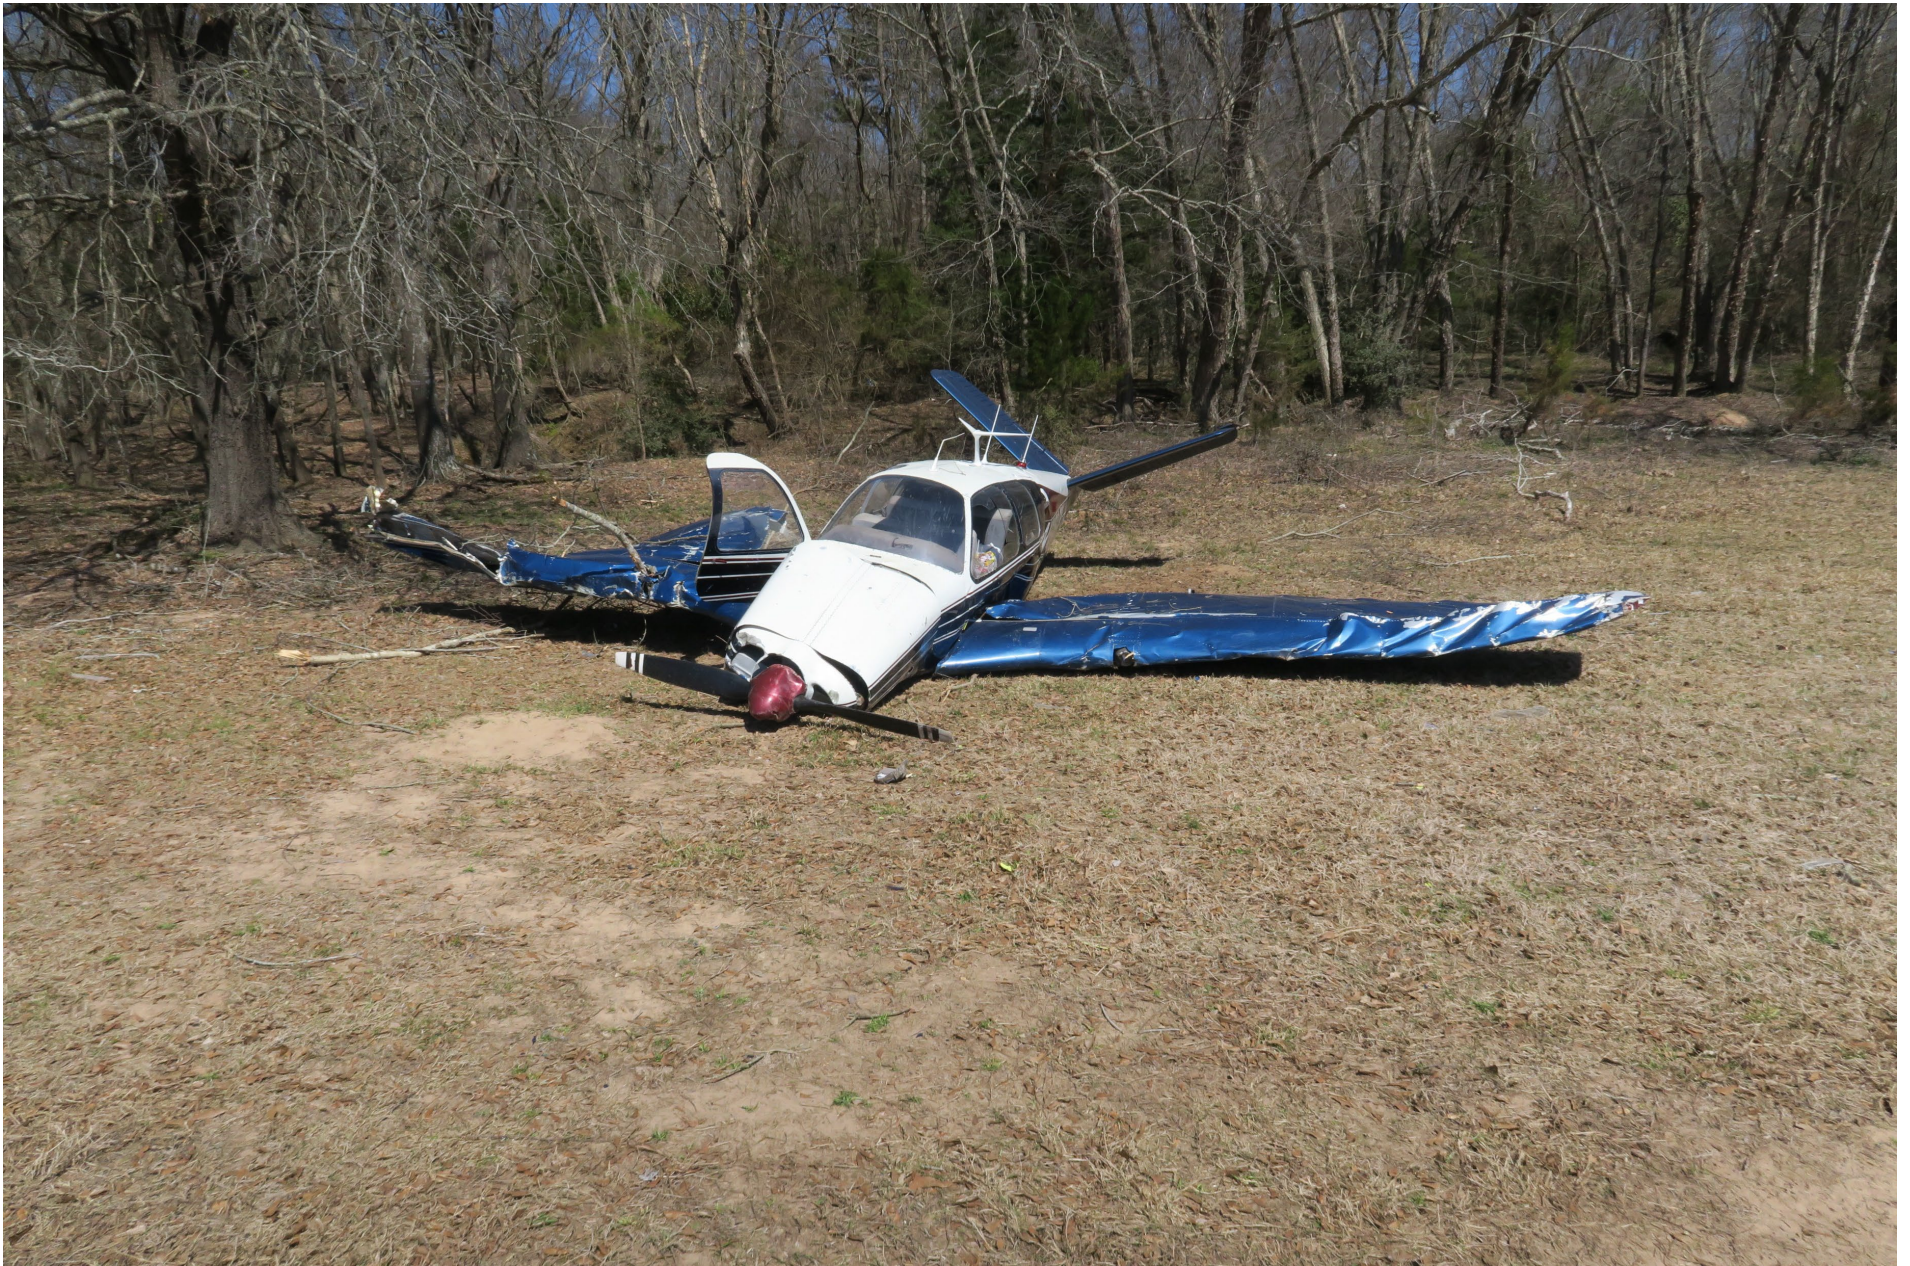
Photo 1 – View of the front of the airplane at the accident site (courtesy of Textron Aviation).

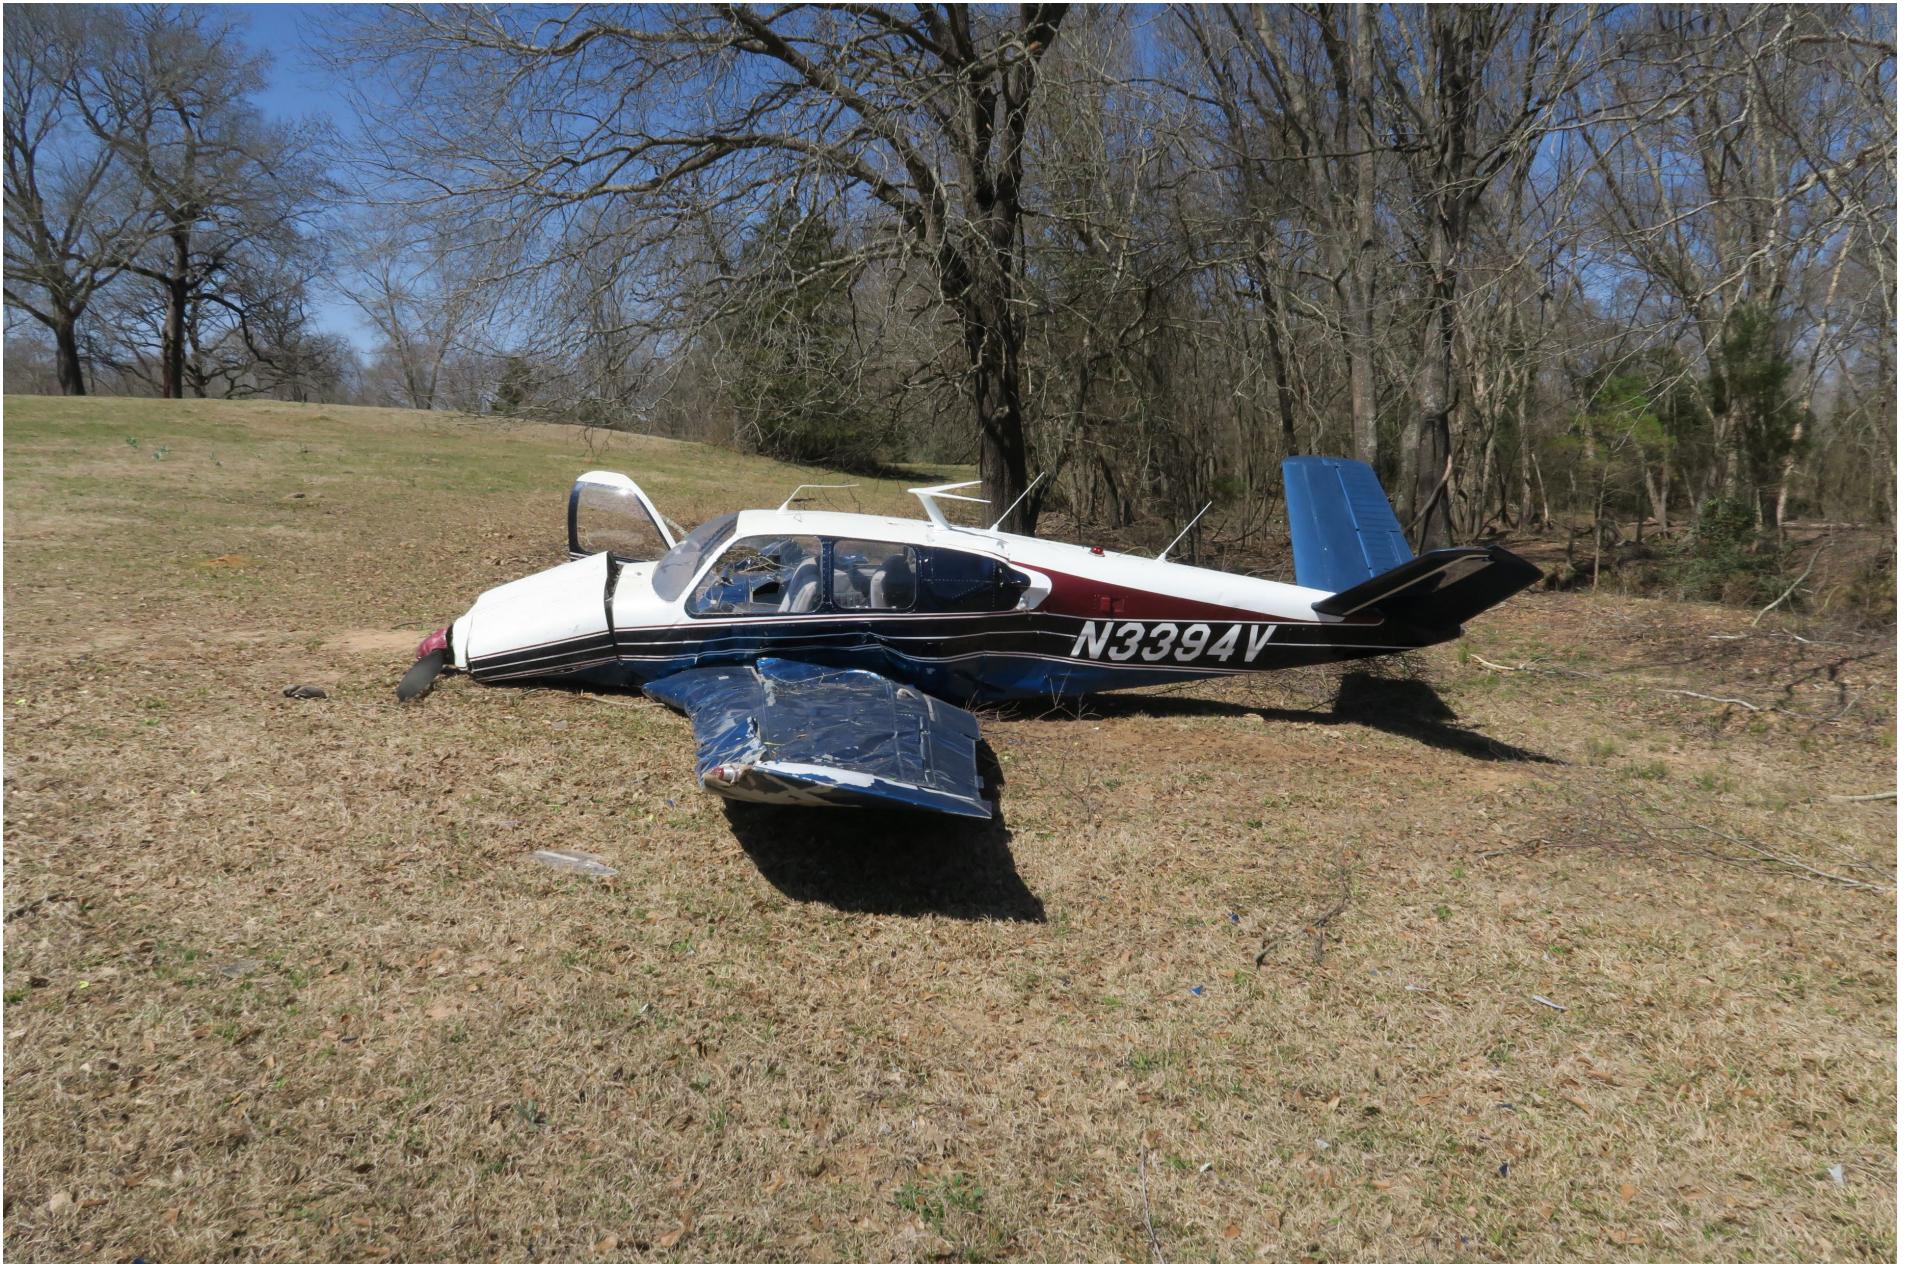
Photo 2 – View of the left side of the airplane at the accident site (courtesy of Textron Aviation).

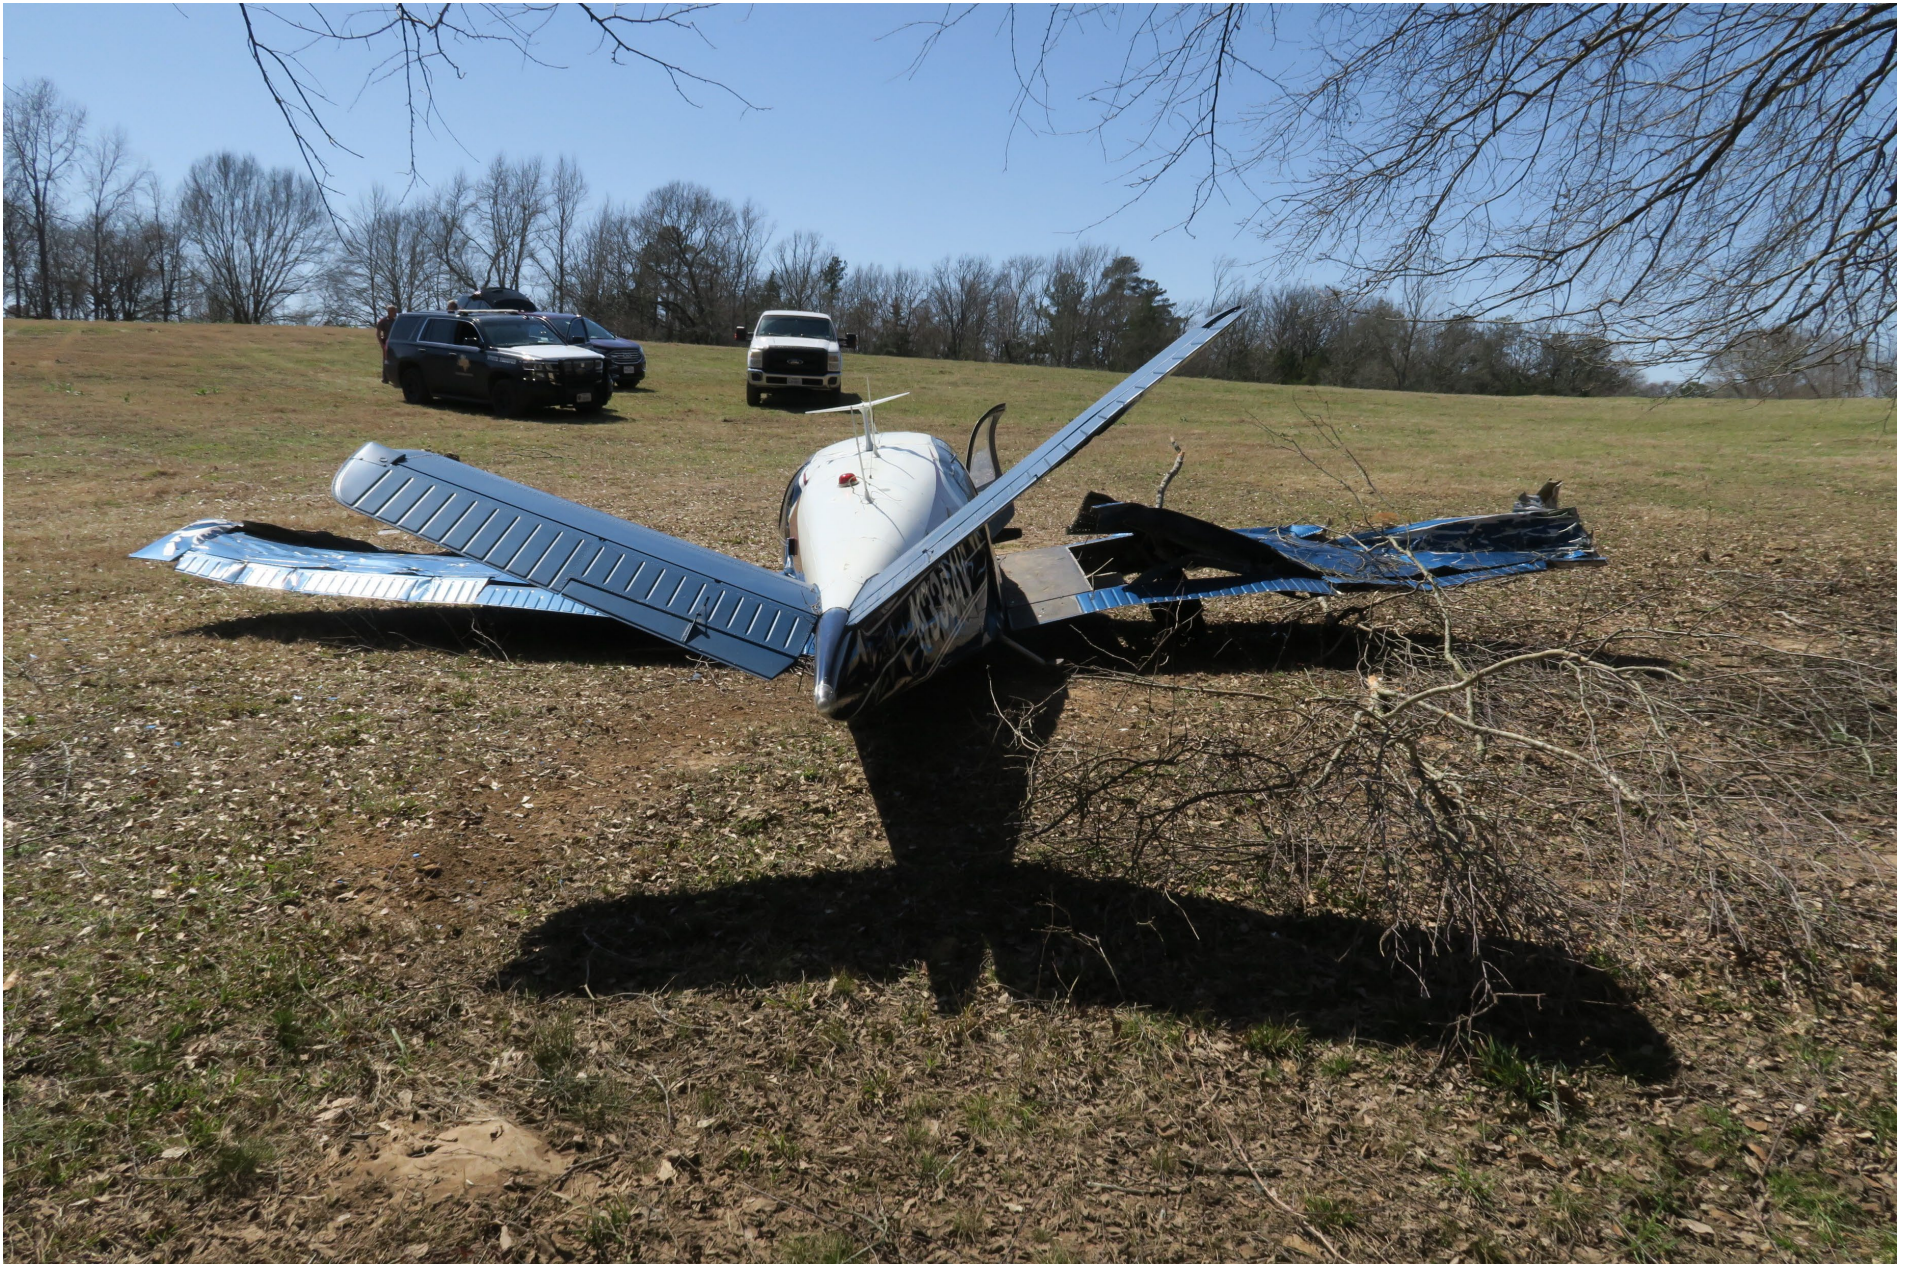
Photo 3 – View of the rear of the airplane at the accident site (courtesy of Textron Aviation).

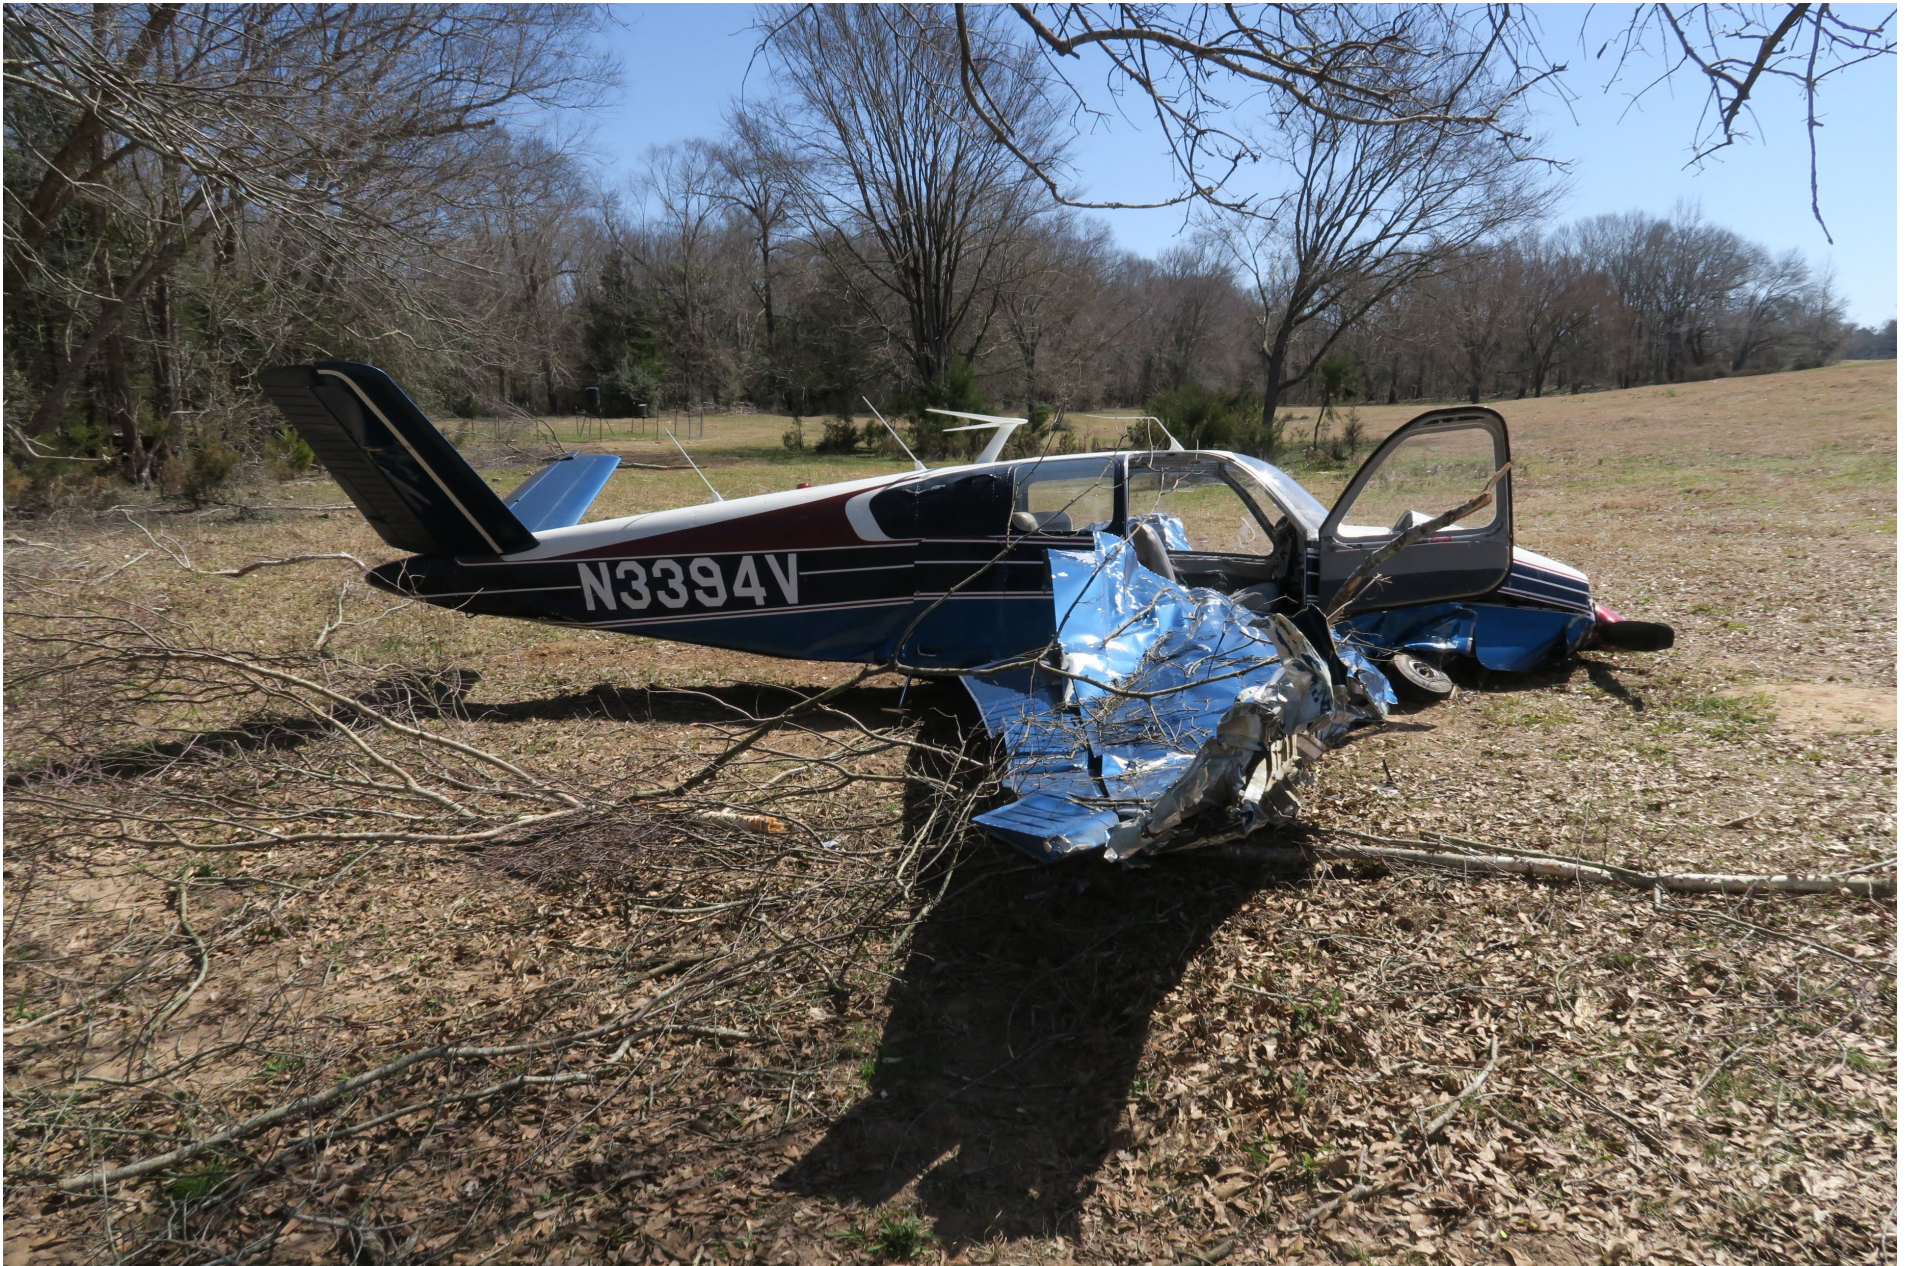
Photo 4 – View of the right side of the airplane at the accident site (courtesy of Textron Aviation).

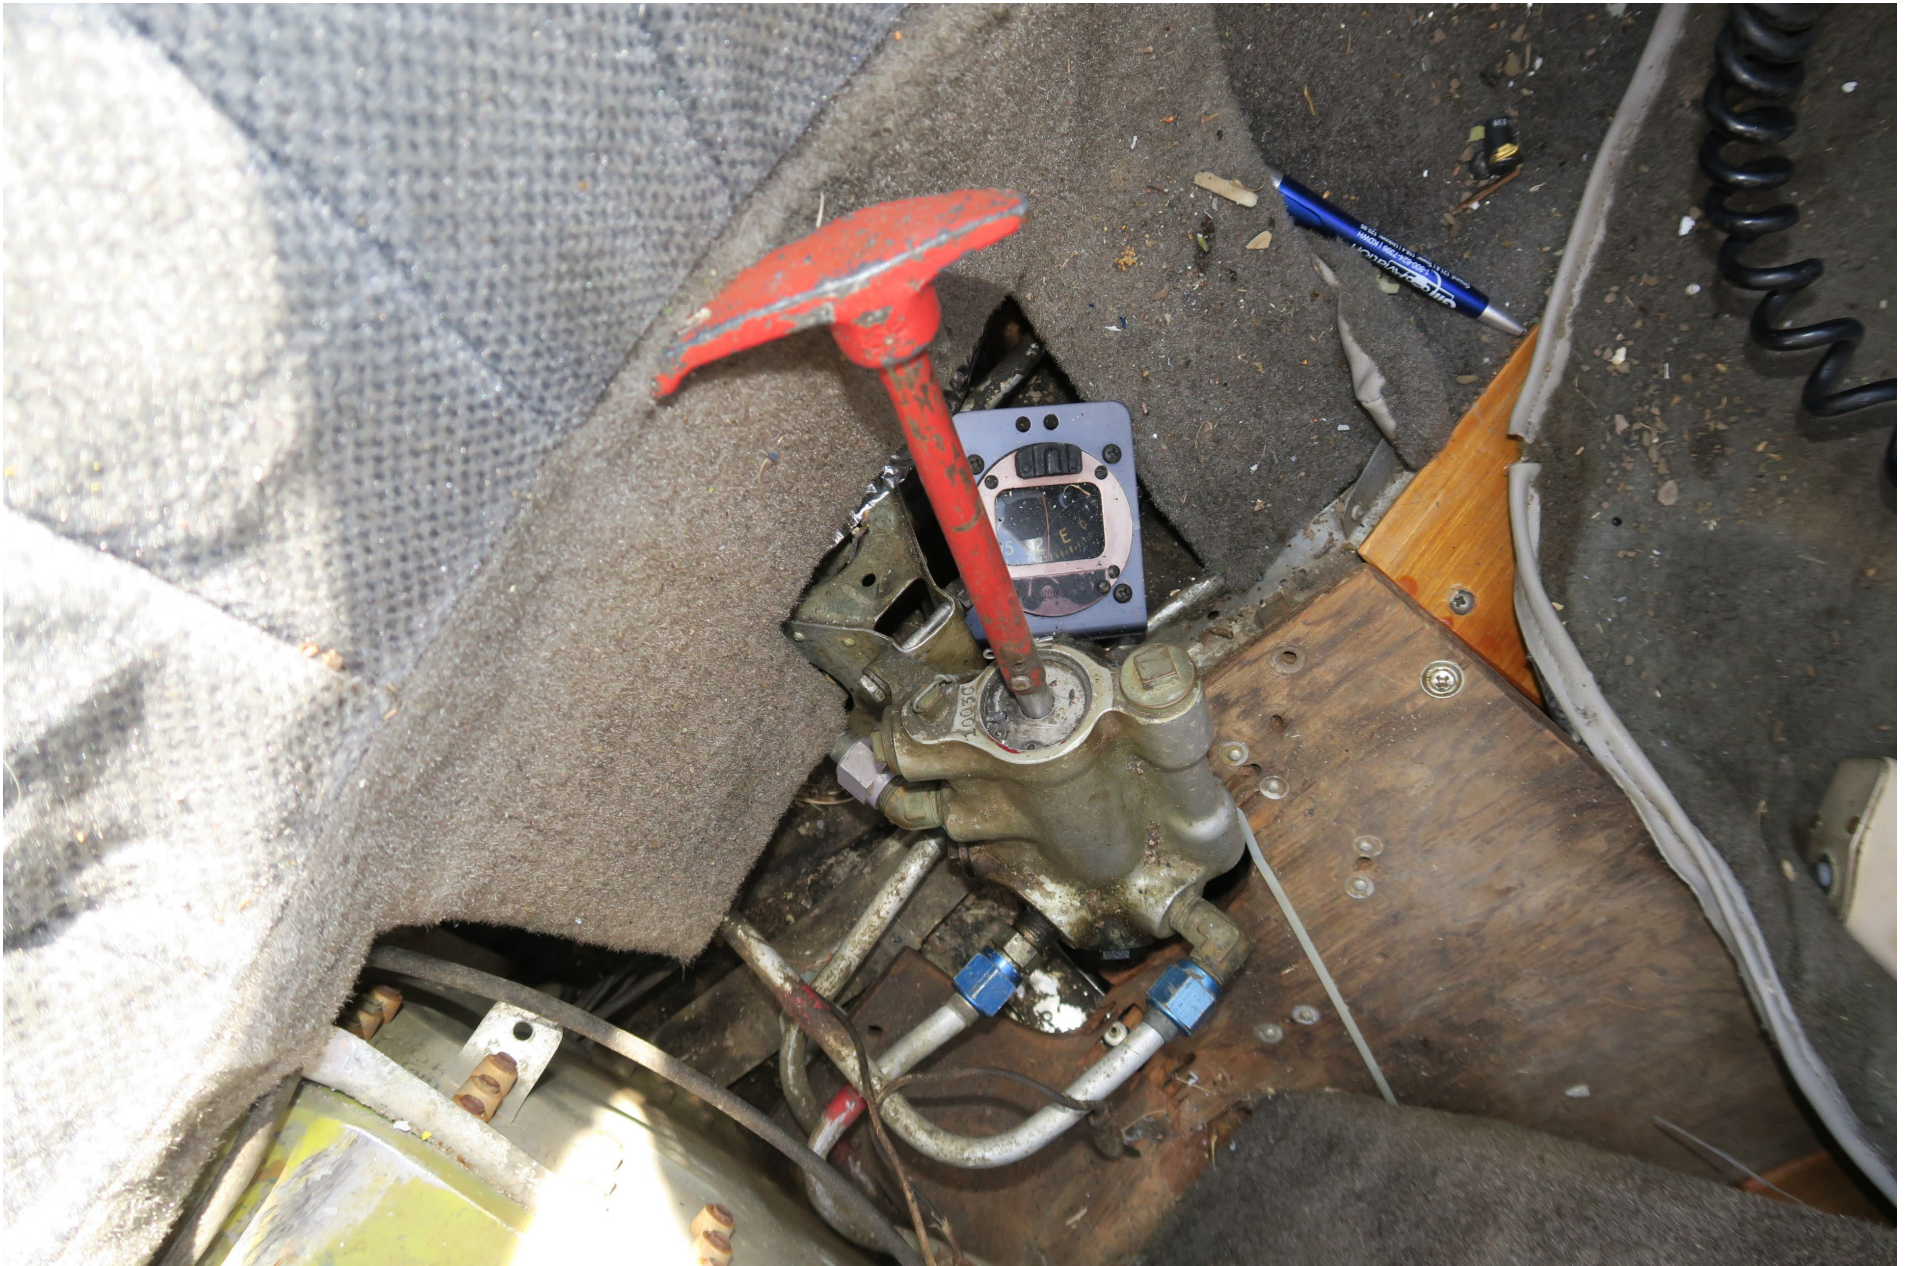
Photo 5 – View of the fuel selector in the cockpit (courtesy of Textron Aviation).

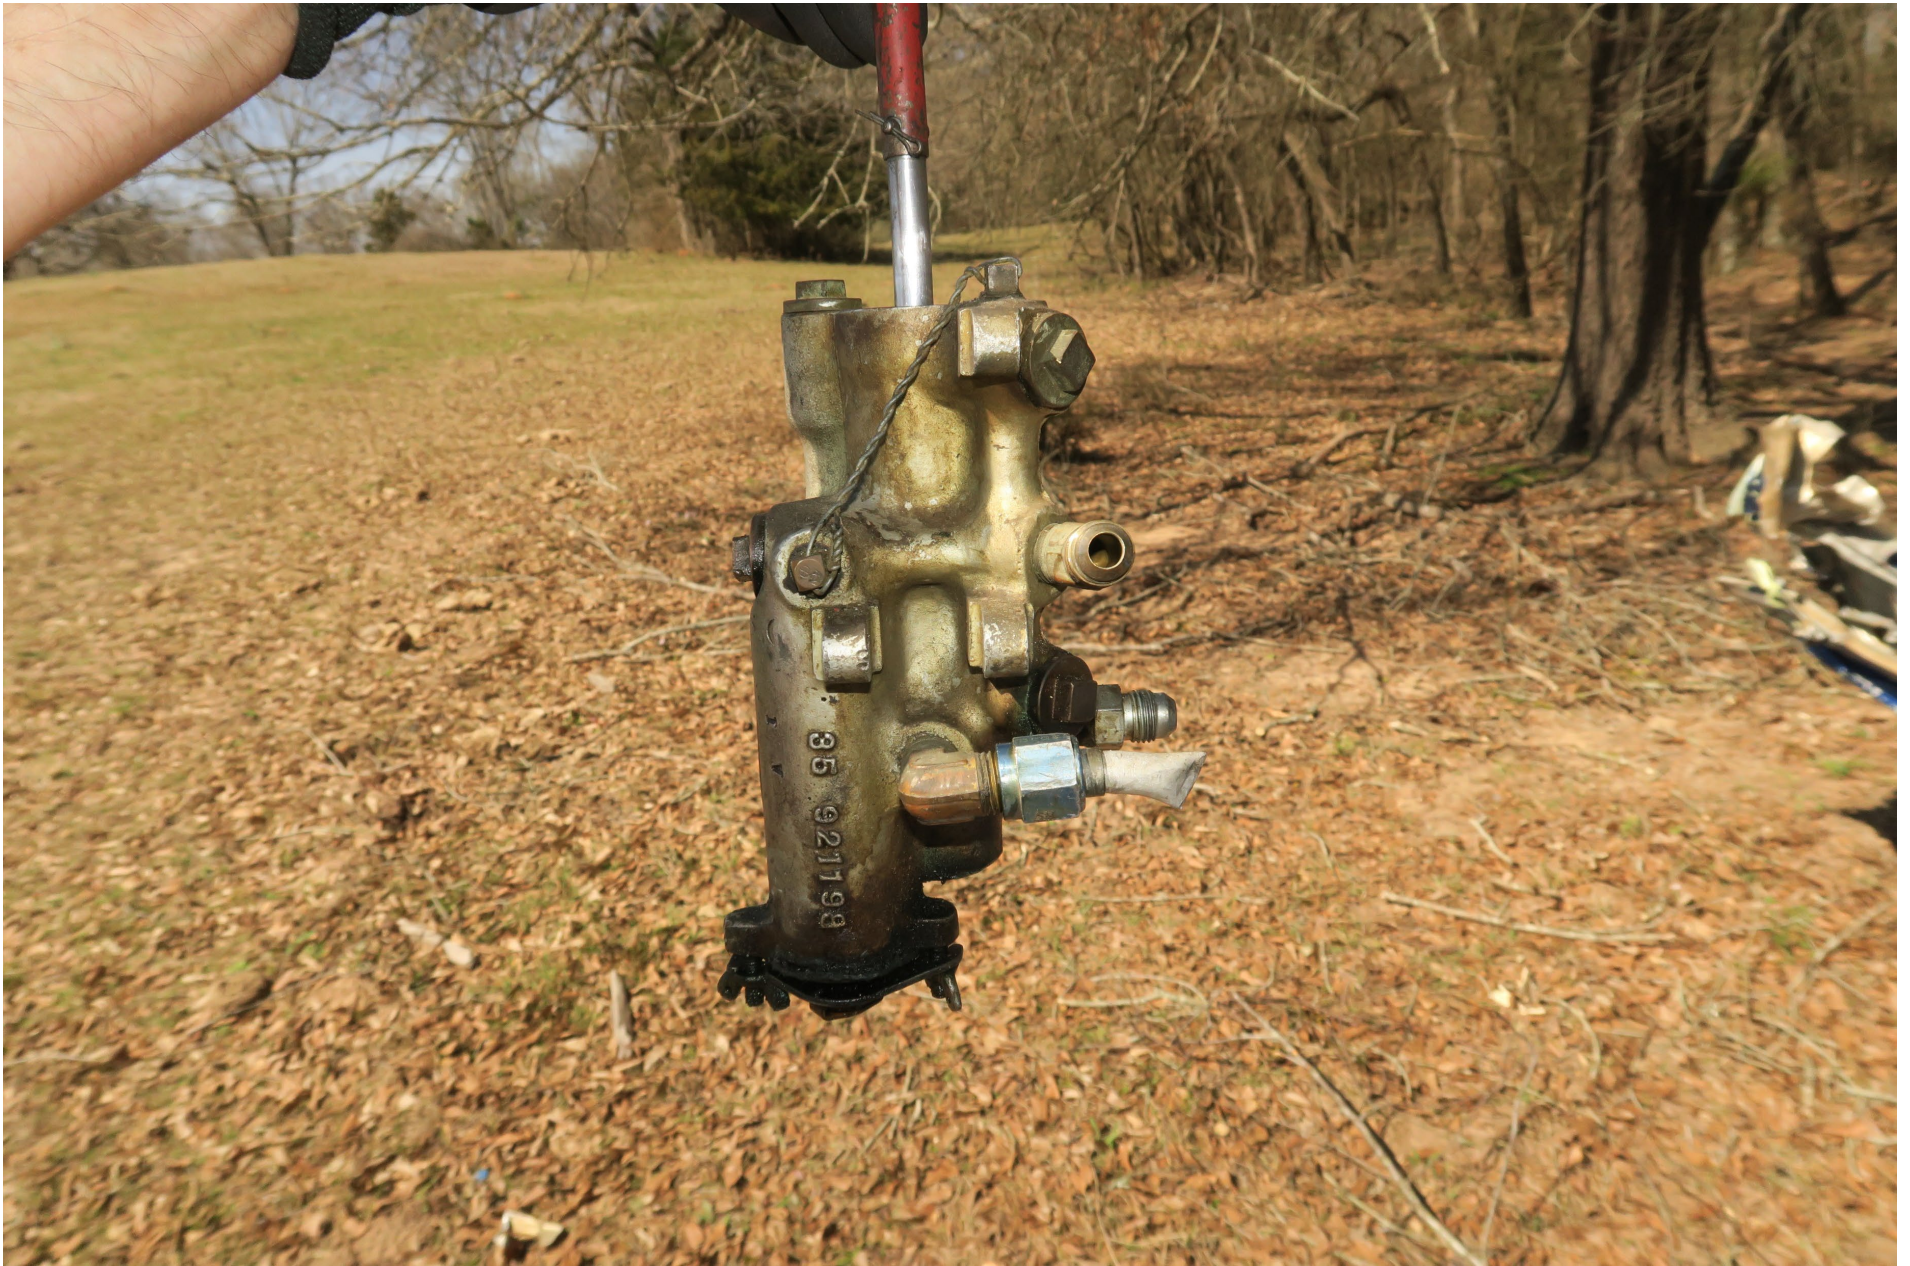
Photo 6 – View of the fuel selector removed from the airplane (courtesy of Textron Aviation).

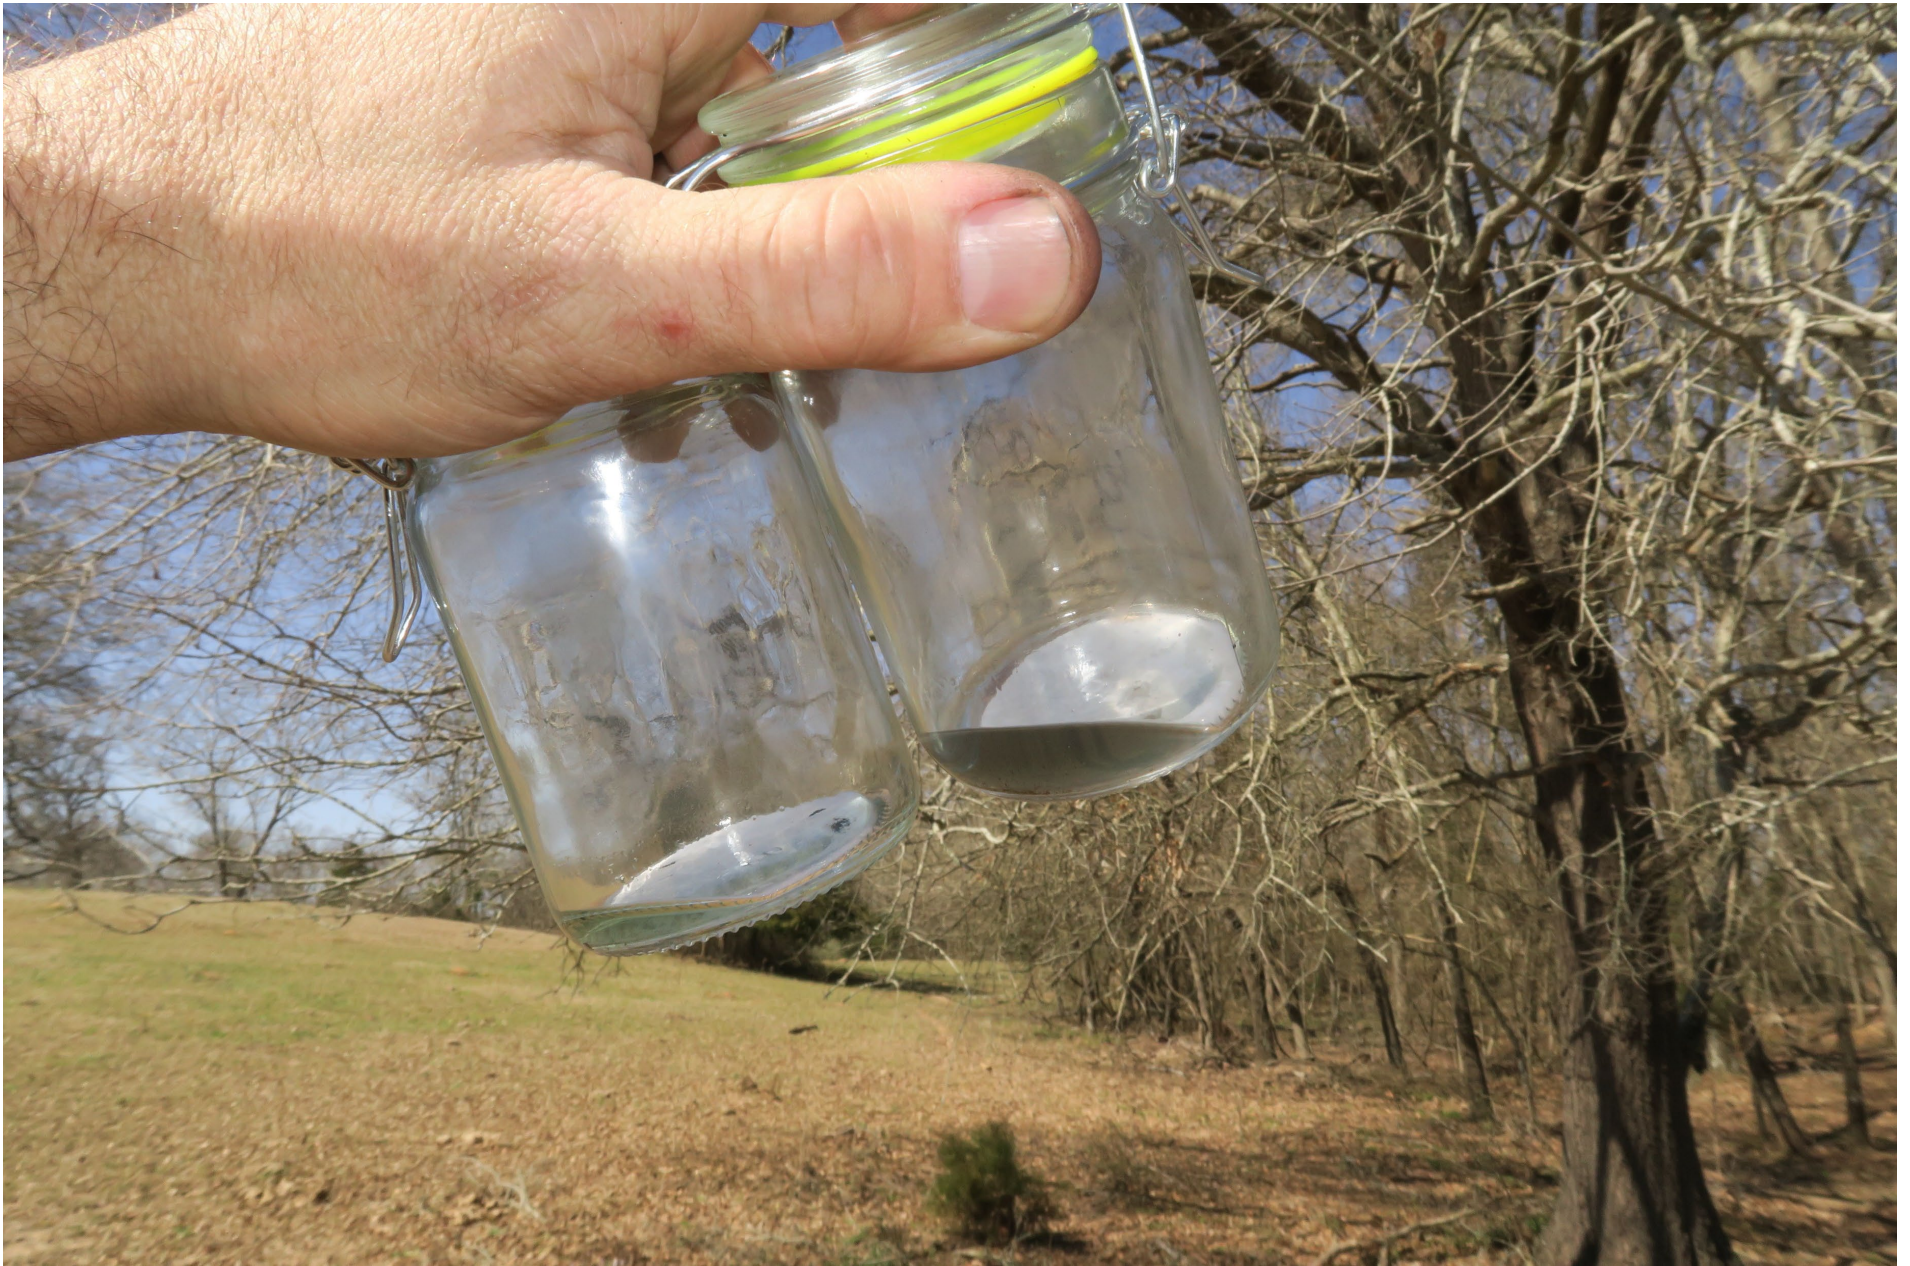
Photo 7 – View of the total amount of fuel obtained from the fuel selector (courtesy of Textron Aviation).

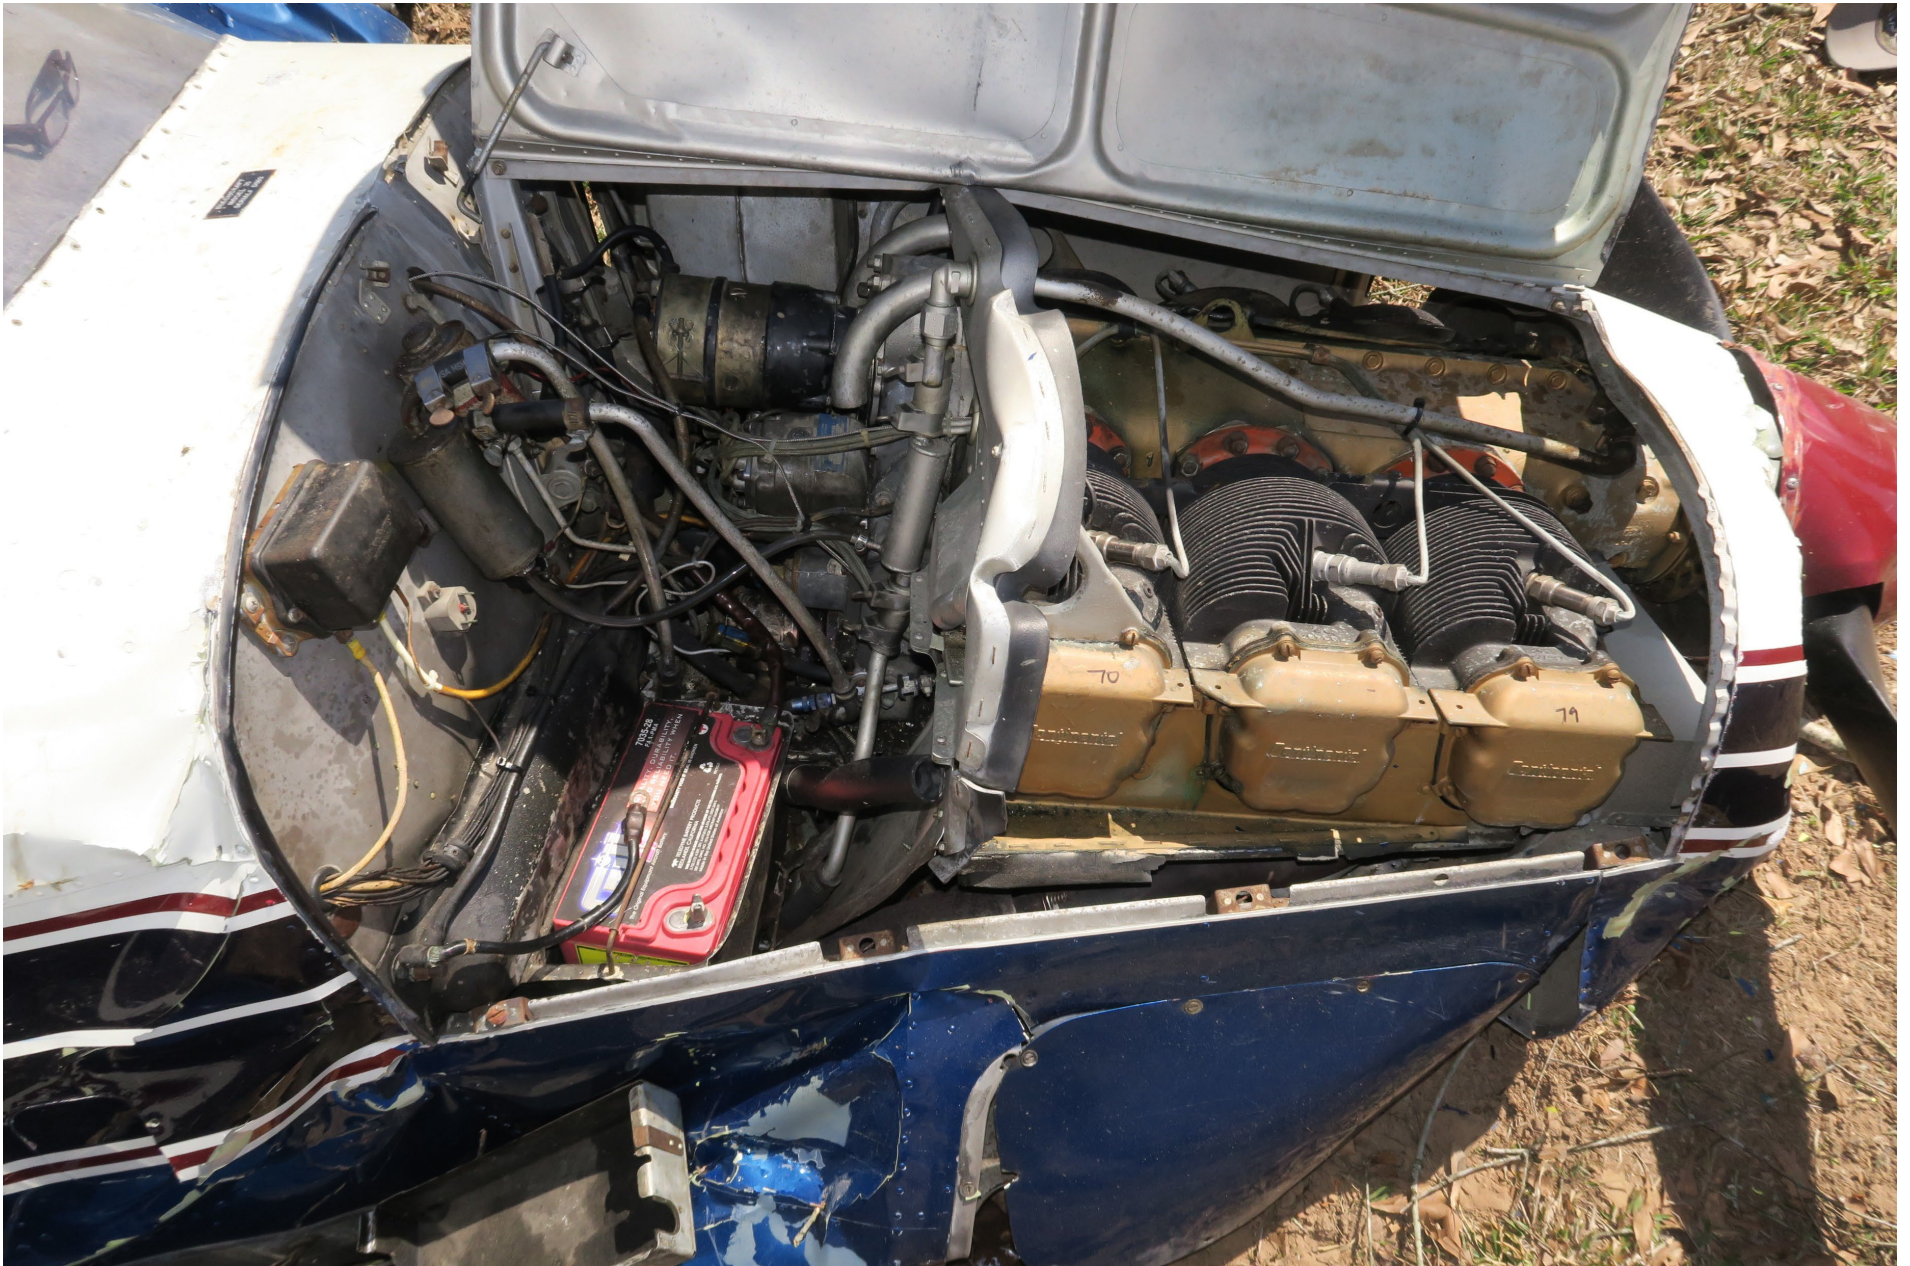
Photo 8 – View of the right side of the engine at the accident site (courtesy of Textron Aviation).

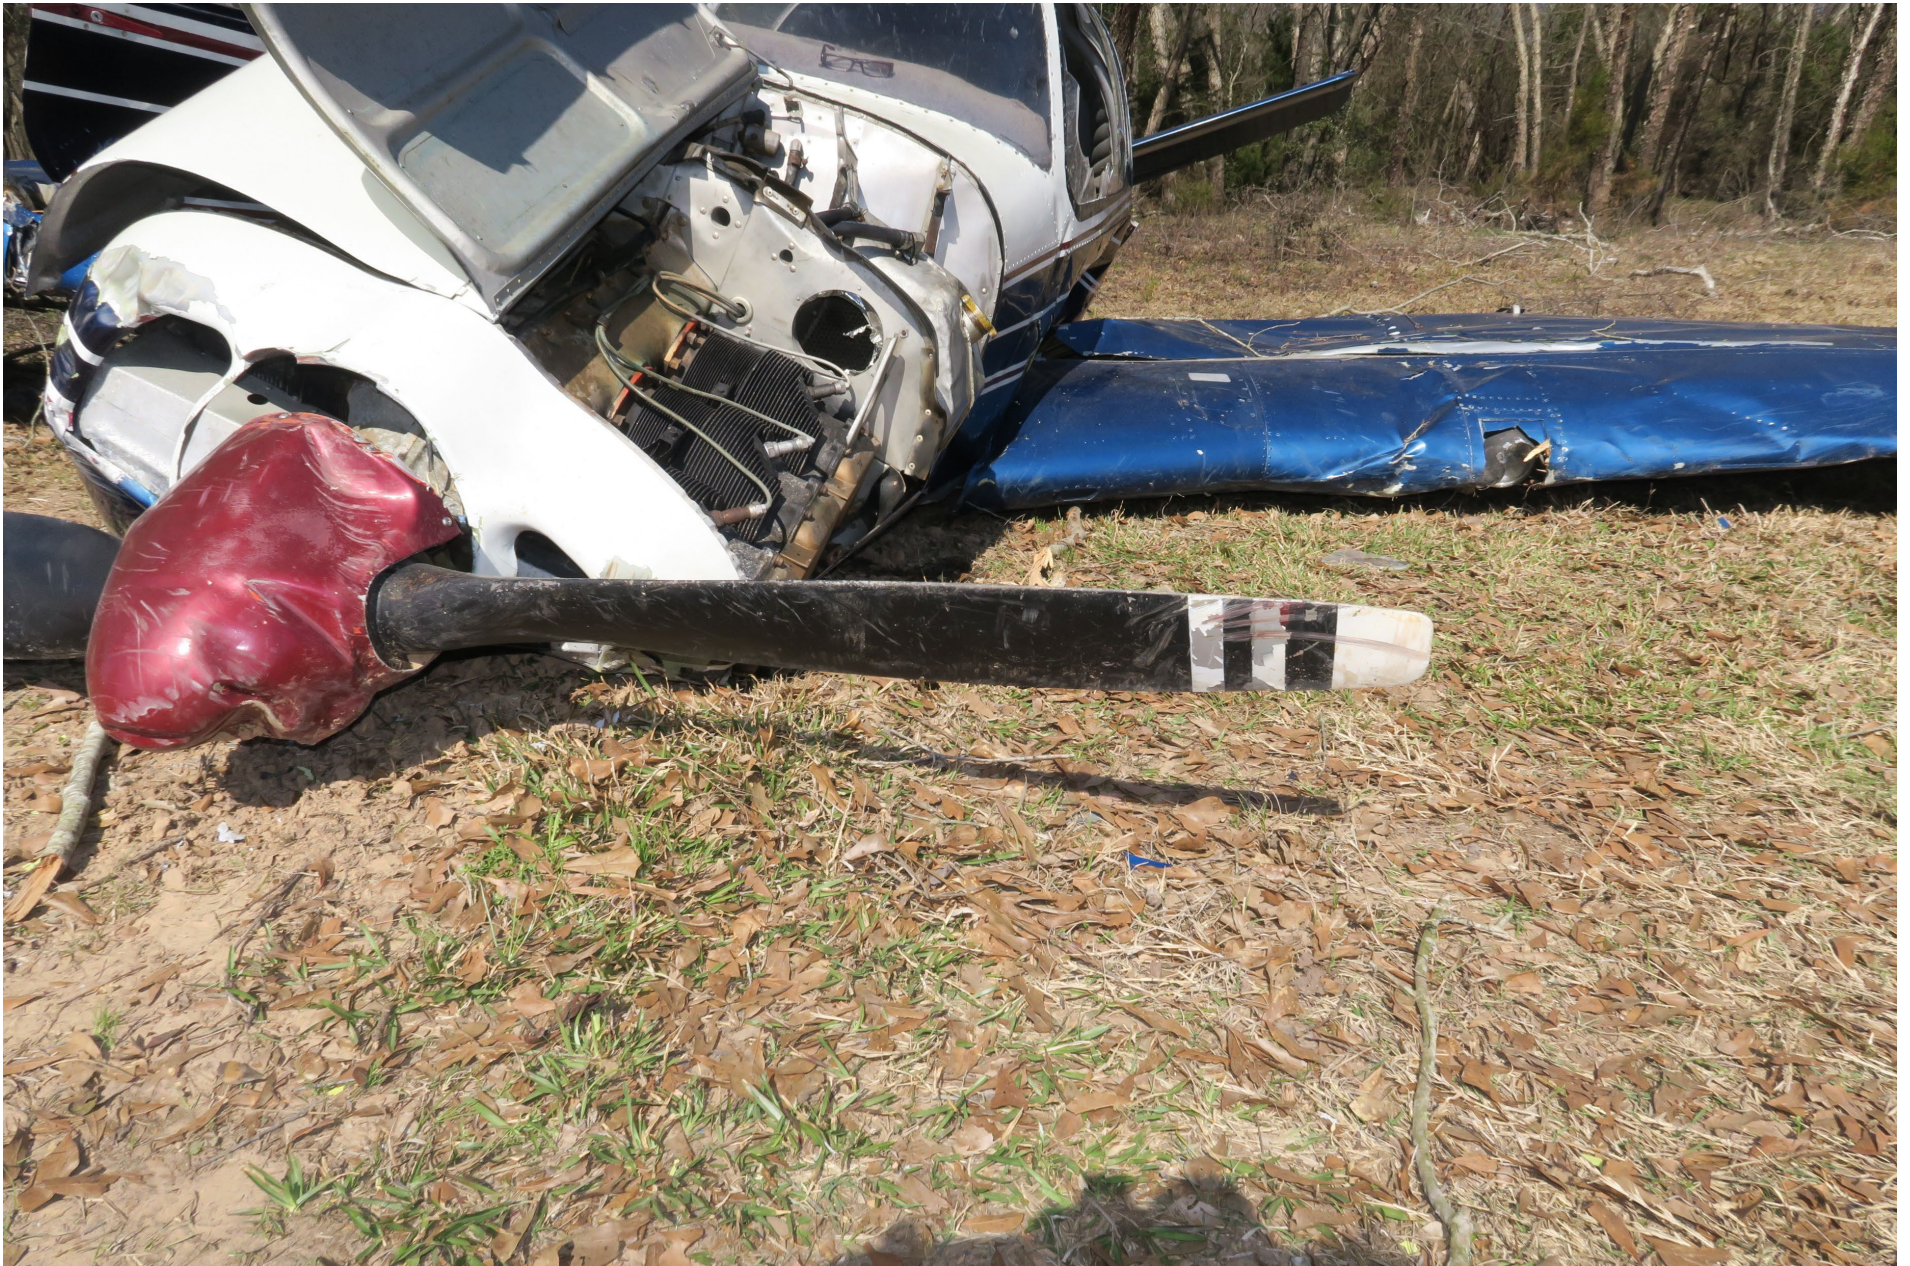
Photo 9 – View of a propeller blade, on the left side of the airplane, at the accident site (courtesy of Textron Aviation).
