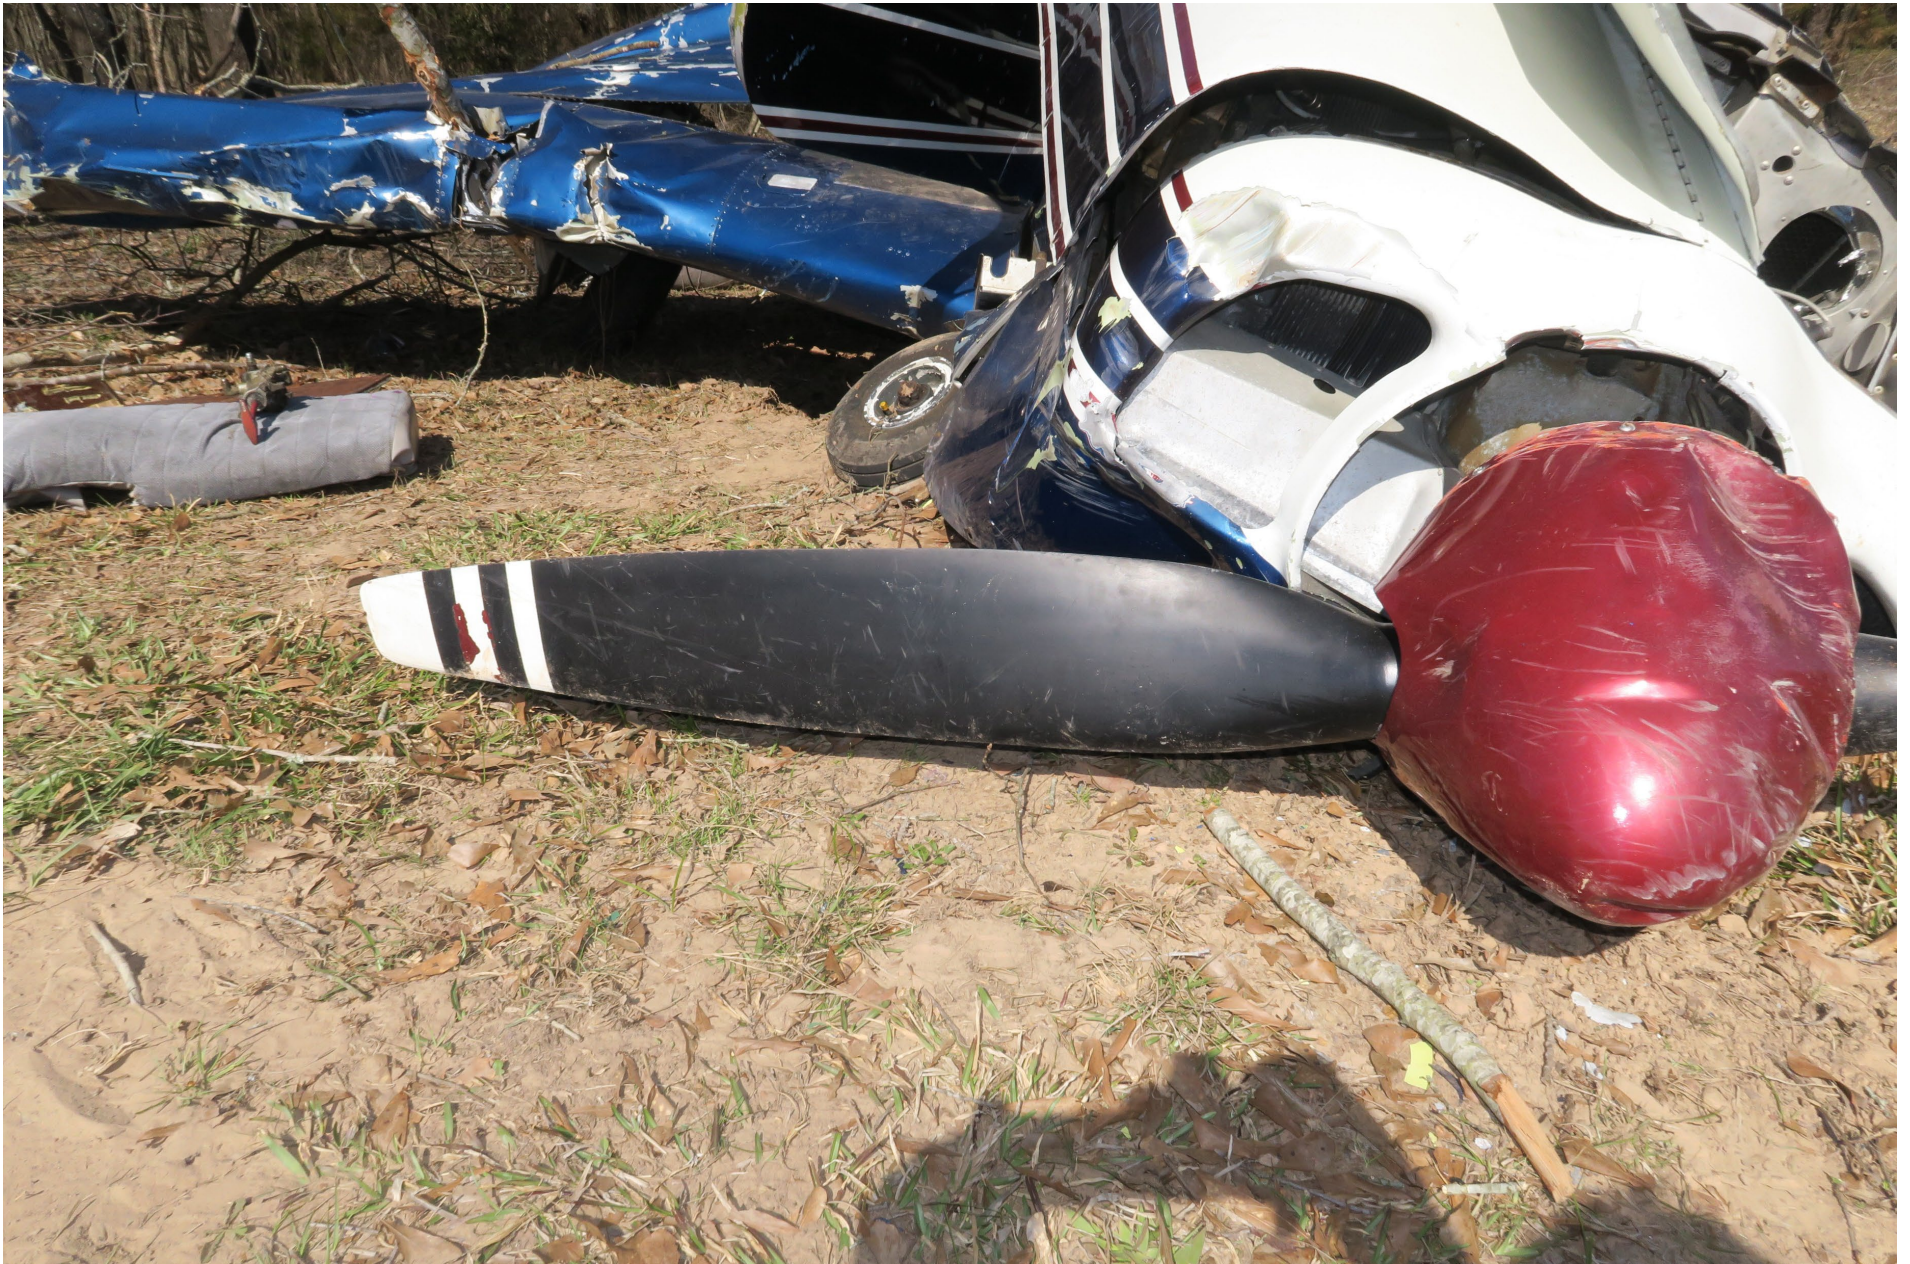
Photo 10 – View of a propeller blade, on the right side of the airplane, at the accident site (courtesy of Textron Aviation).

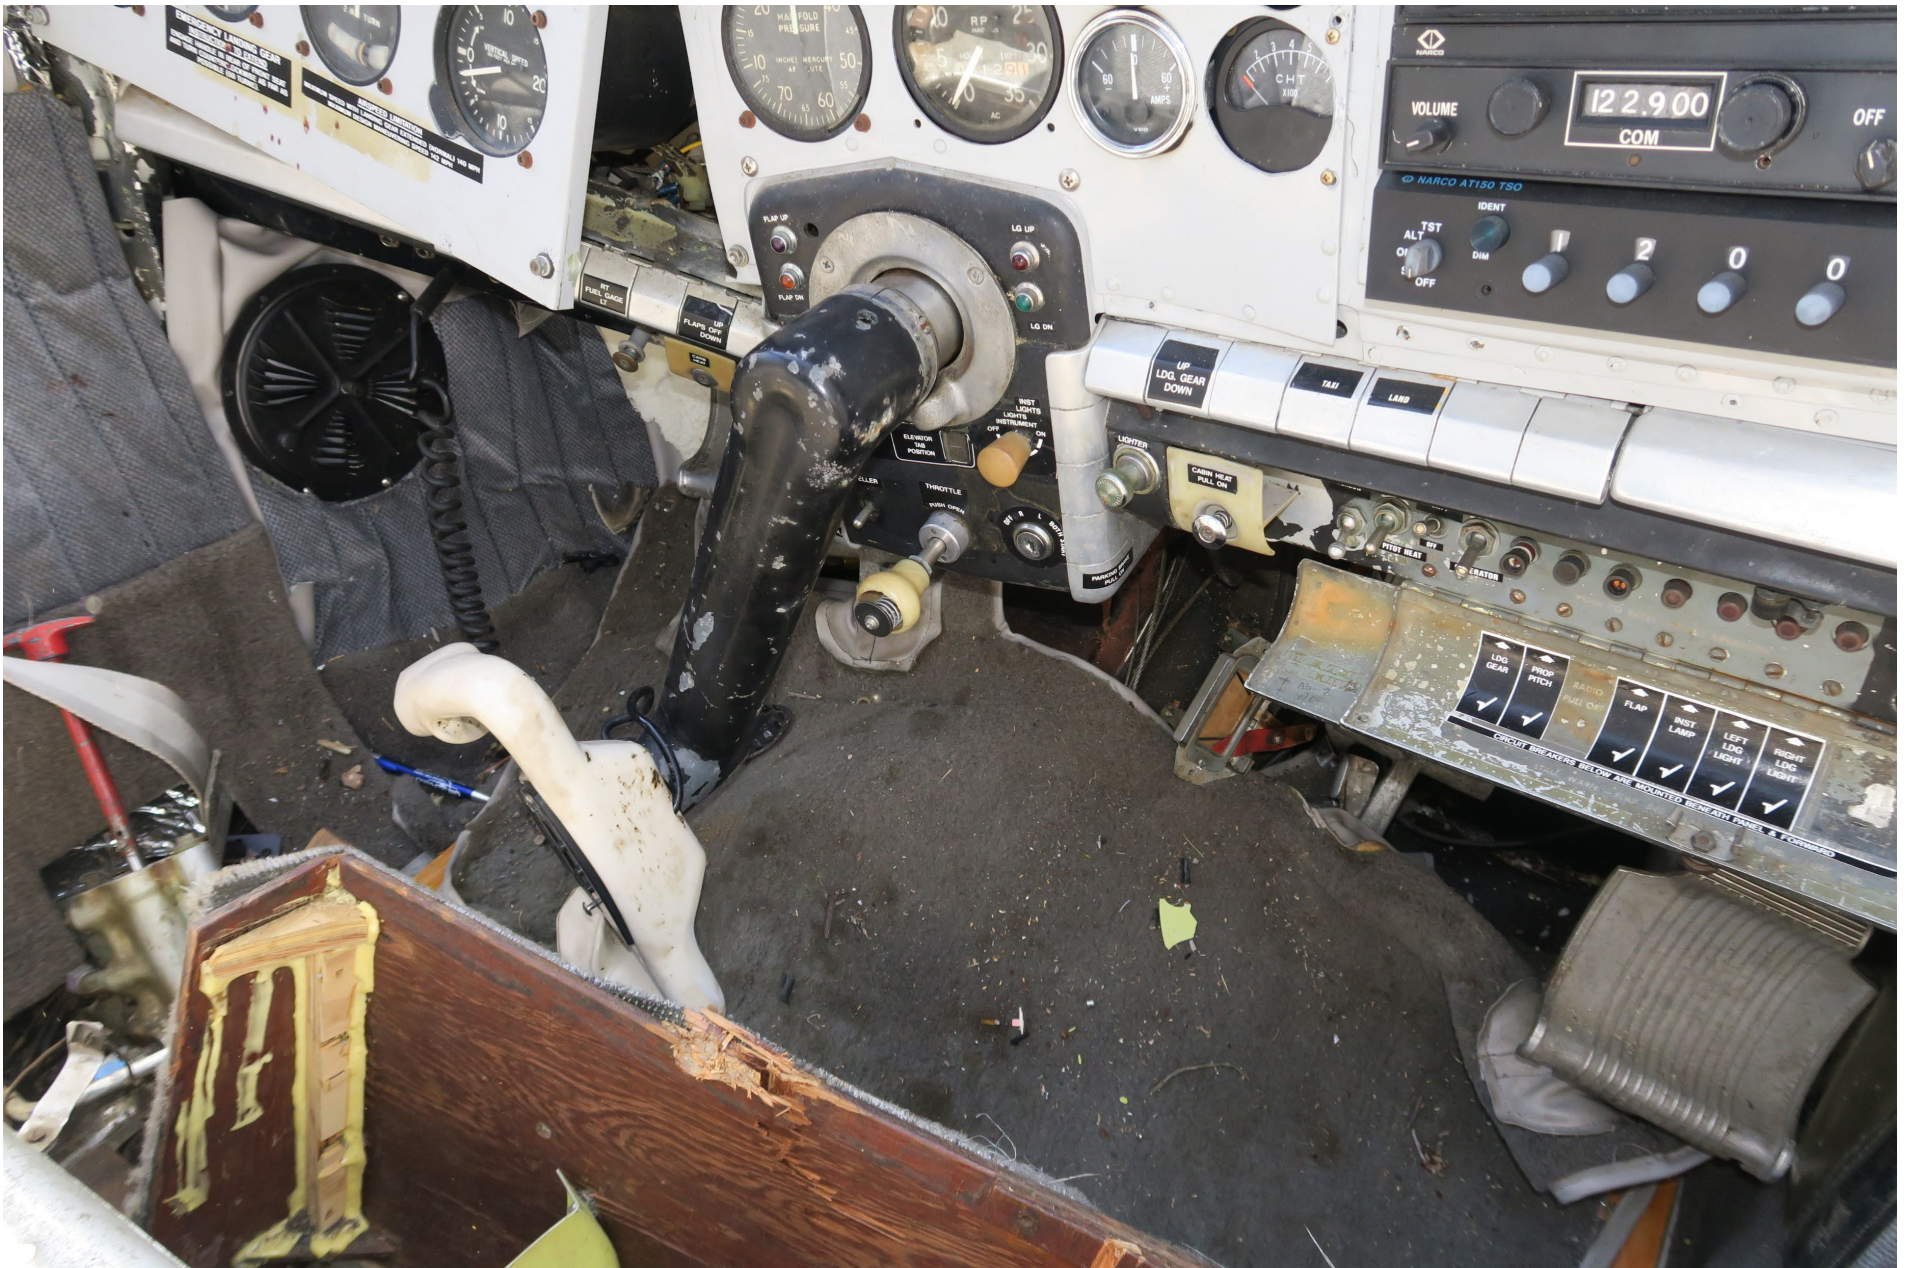
Photo 11 – View of the cockpit area (courtesy of Textron Aviation).

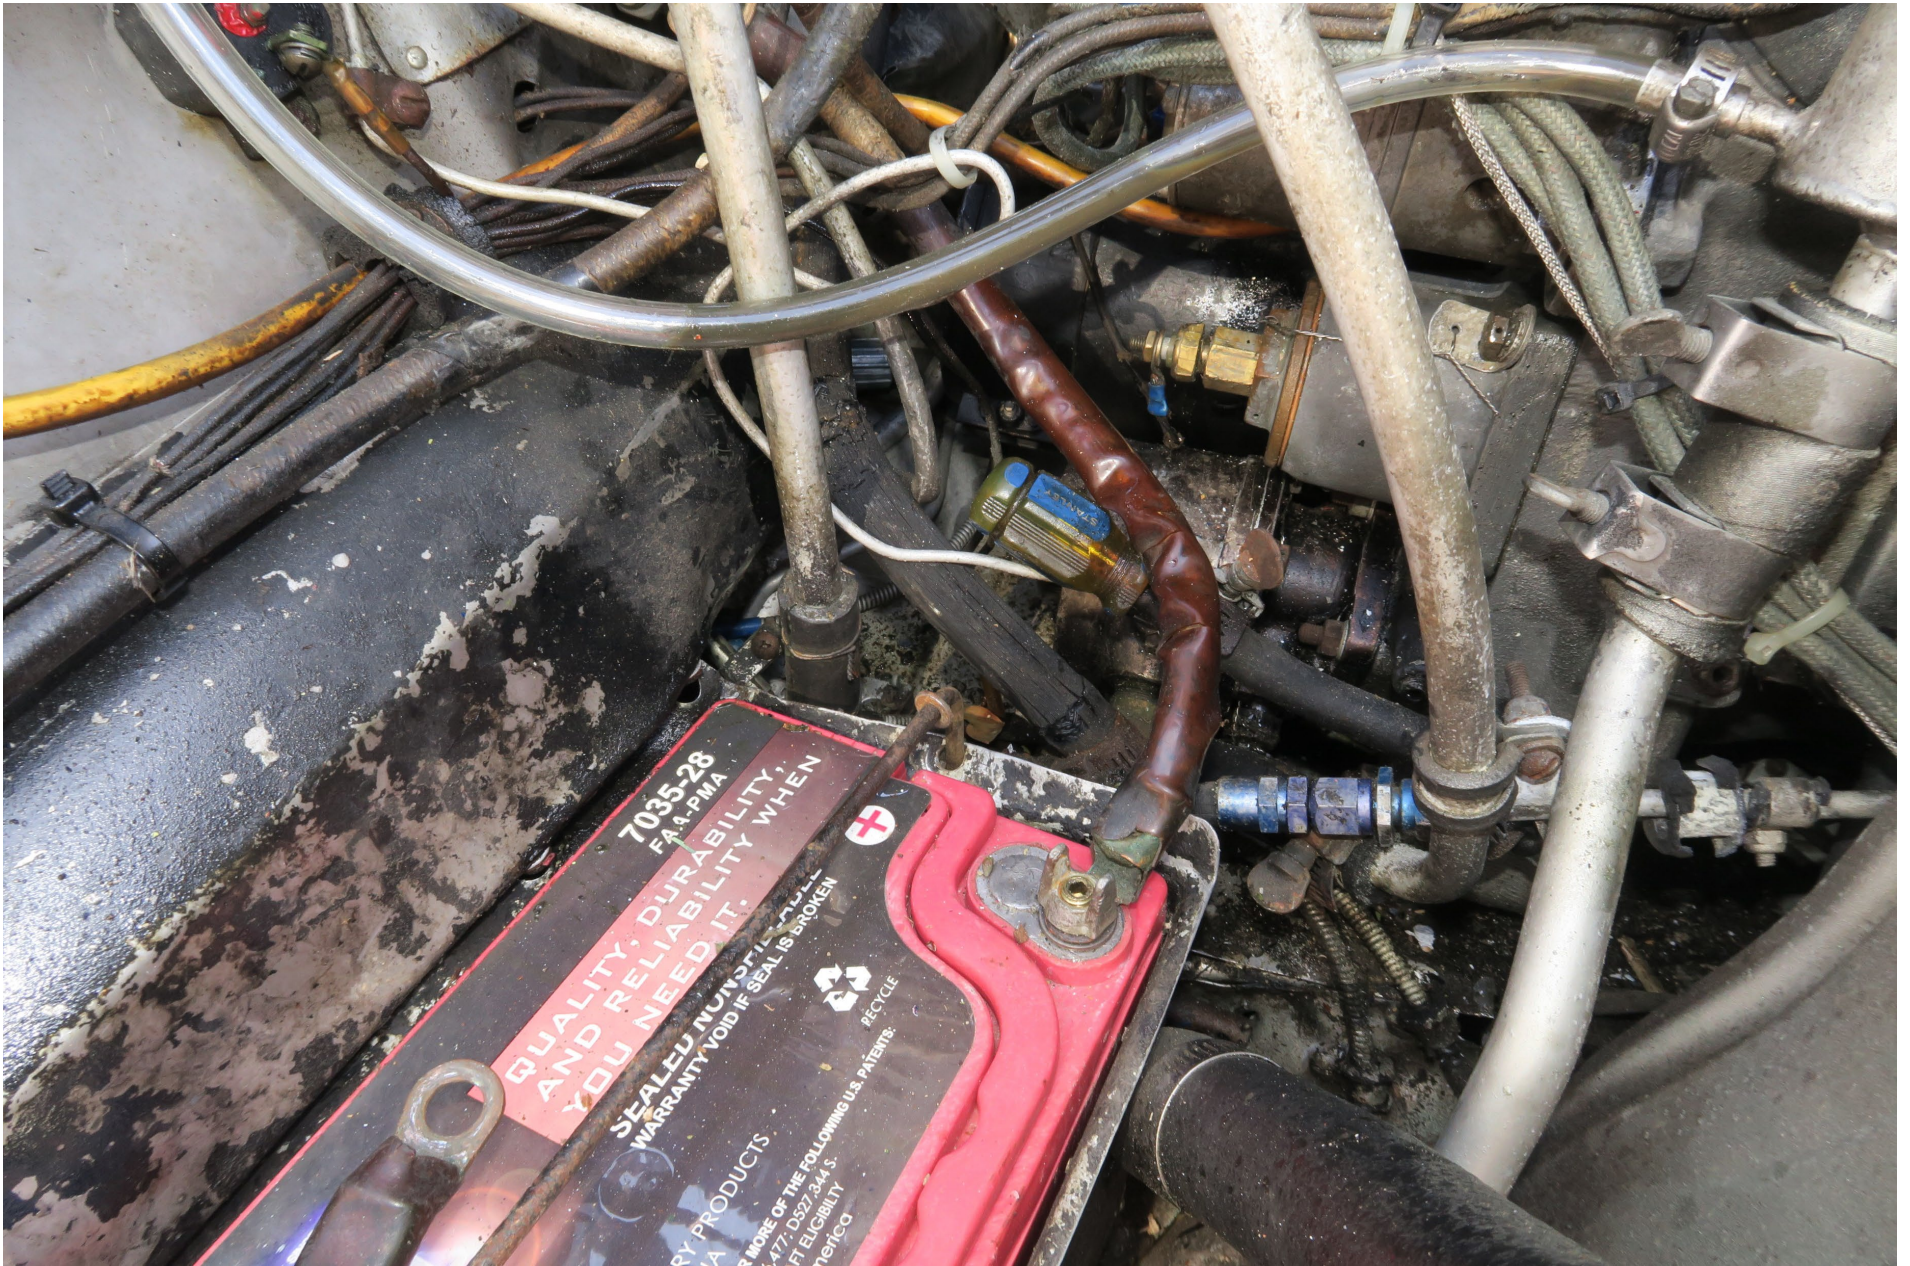
Photo 12 – View of the engine compartment, with a screwdriver plugging a rubber hose (courtesy of Textron Aviation).
