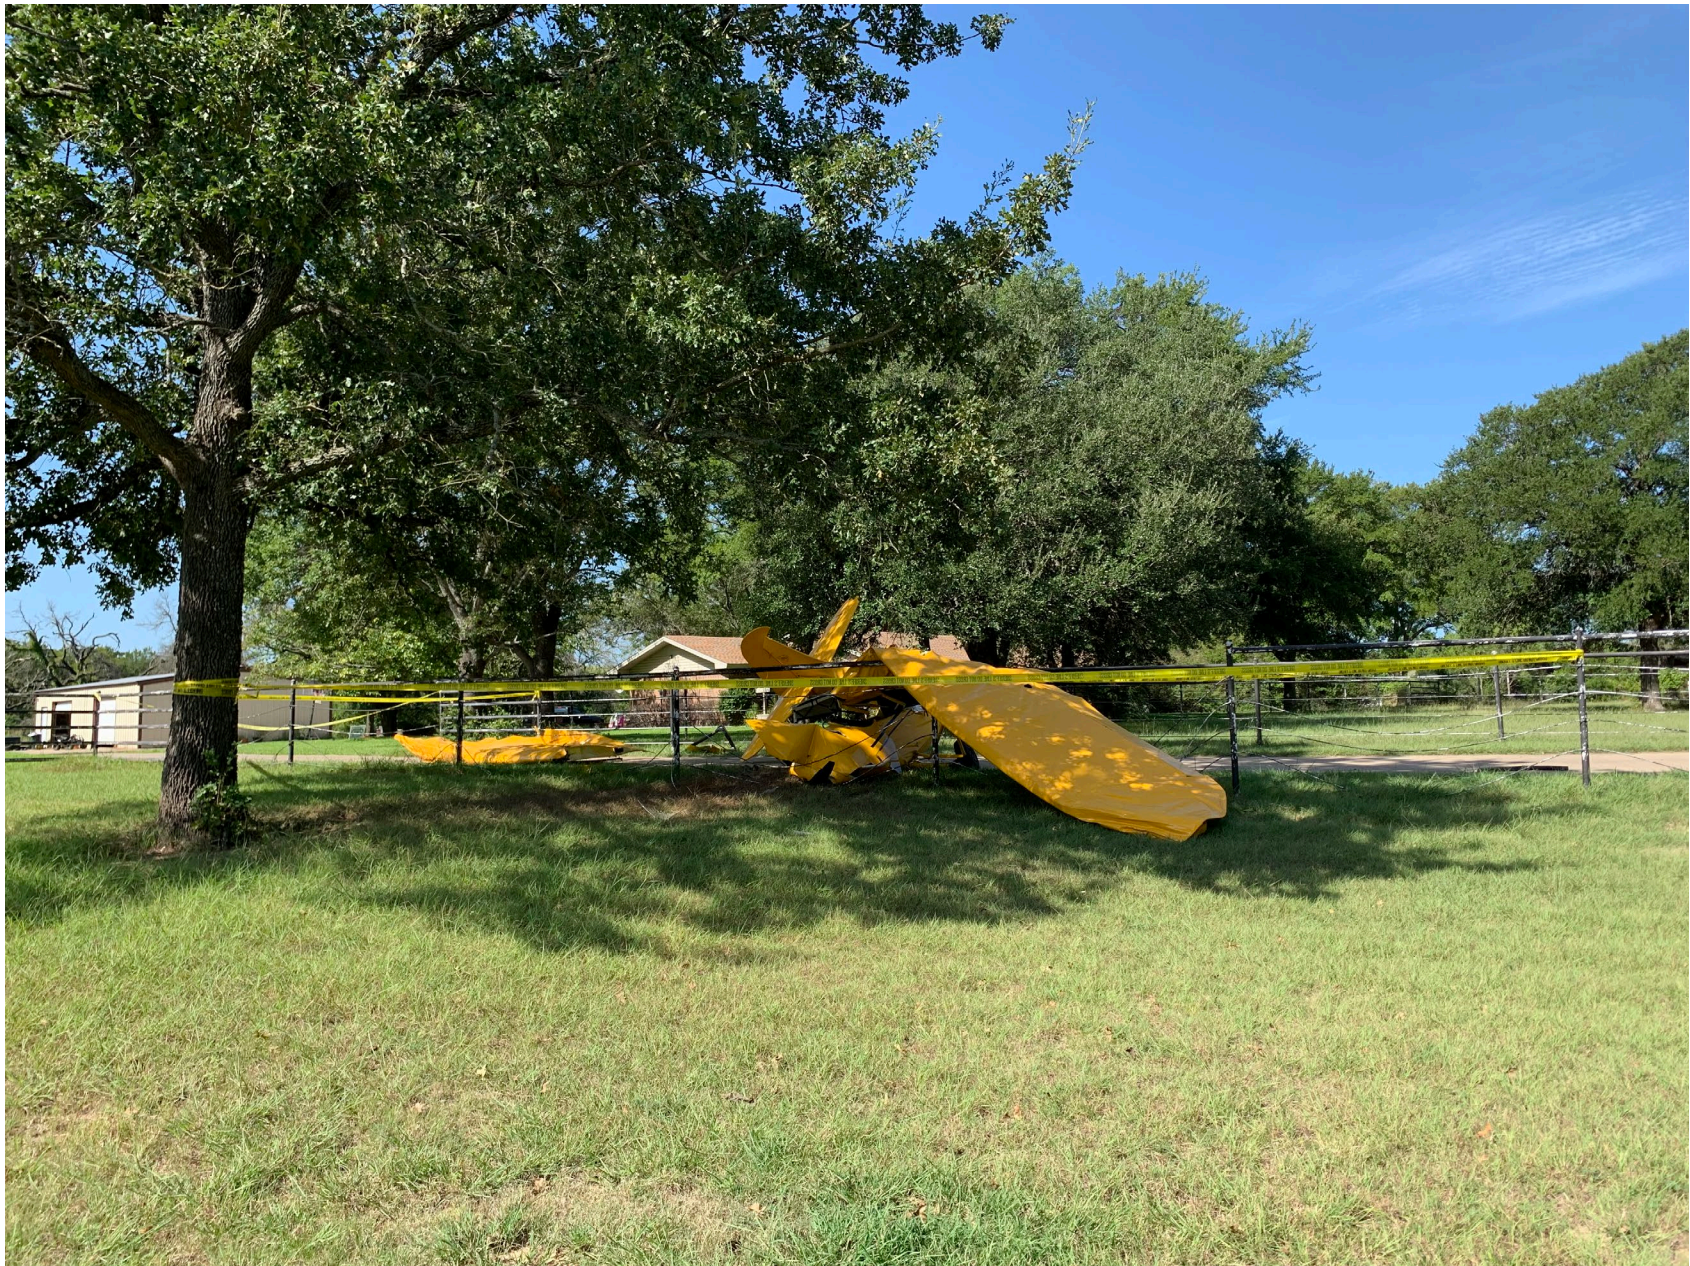
**Photo 1 – Front view of the airplane at the accident site.**

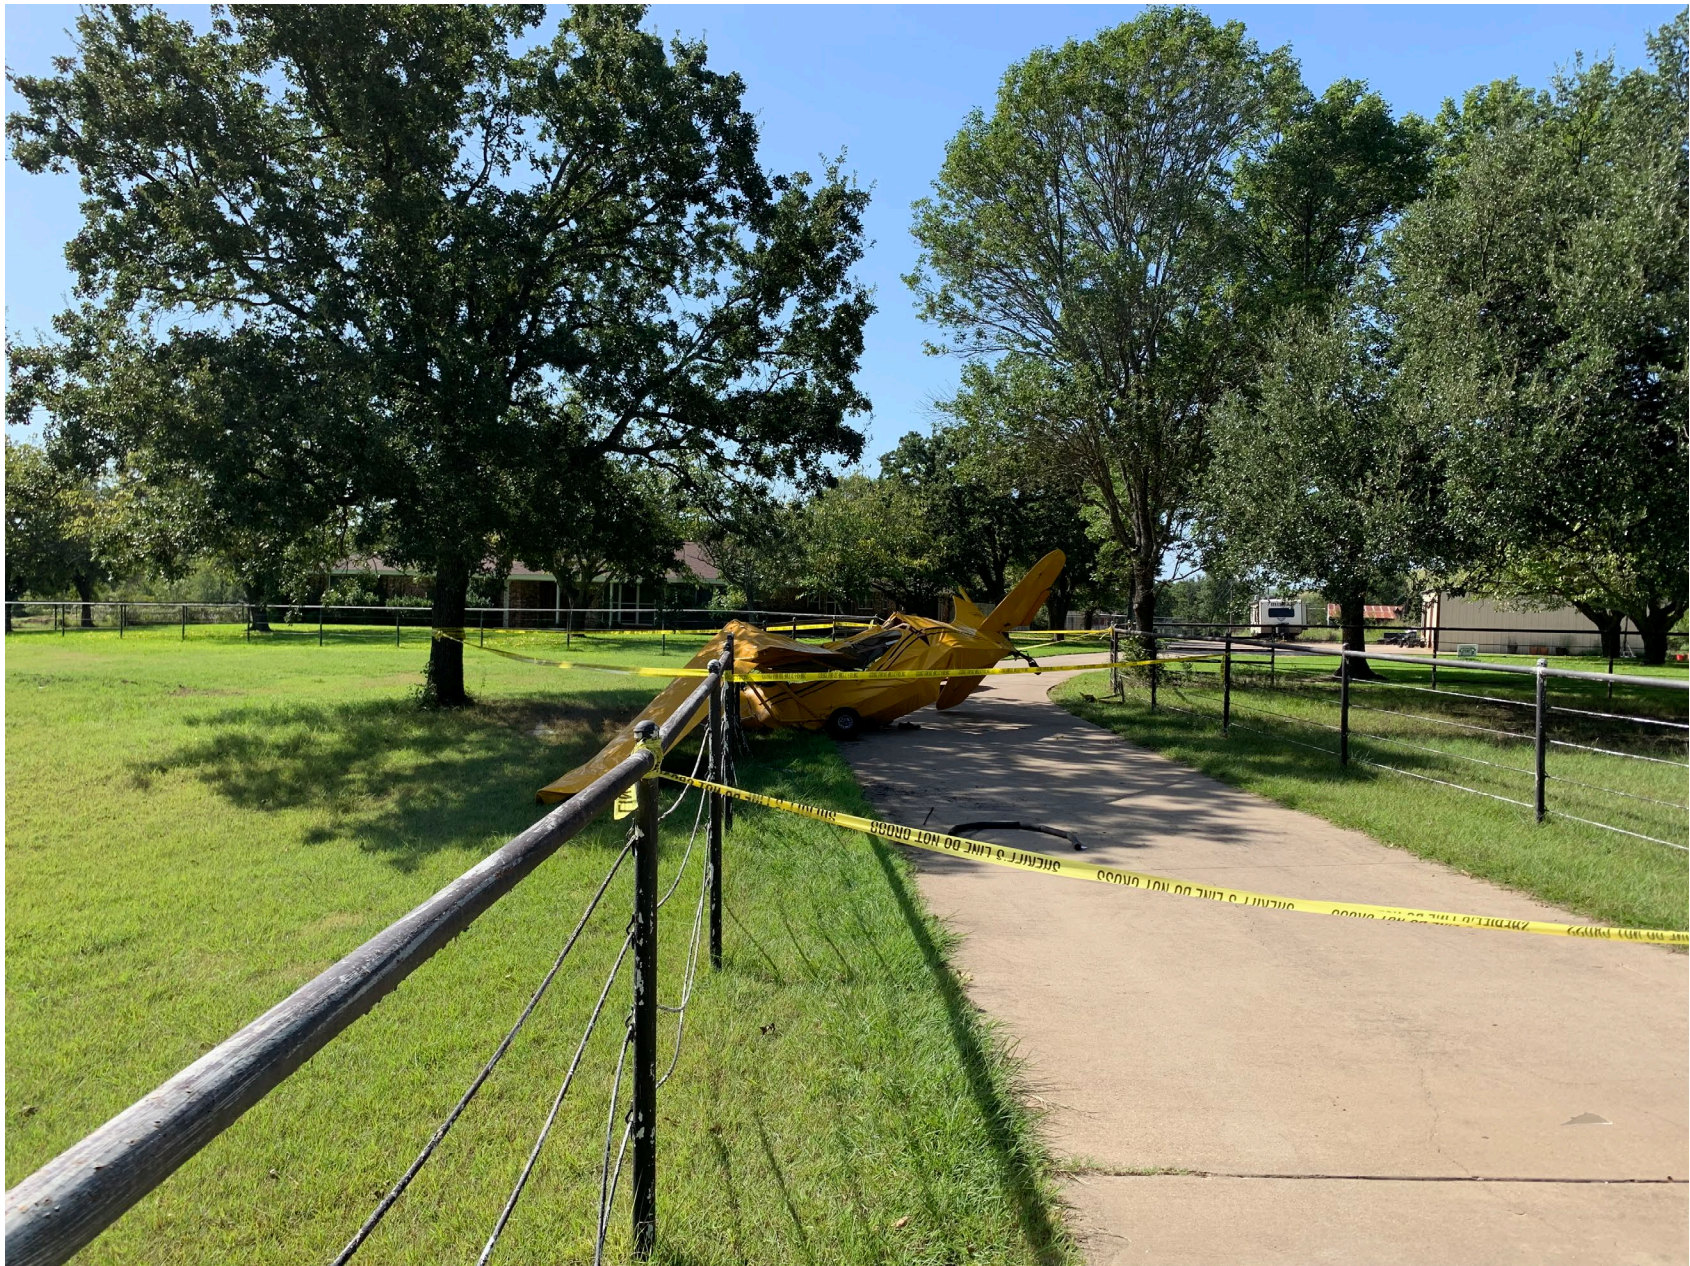
**Photo 2 – Left side view of the airplane at the accident site.**

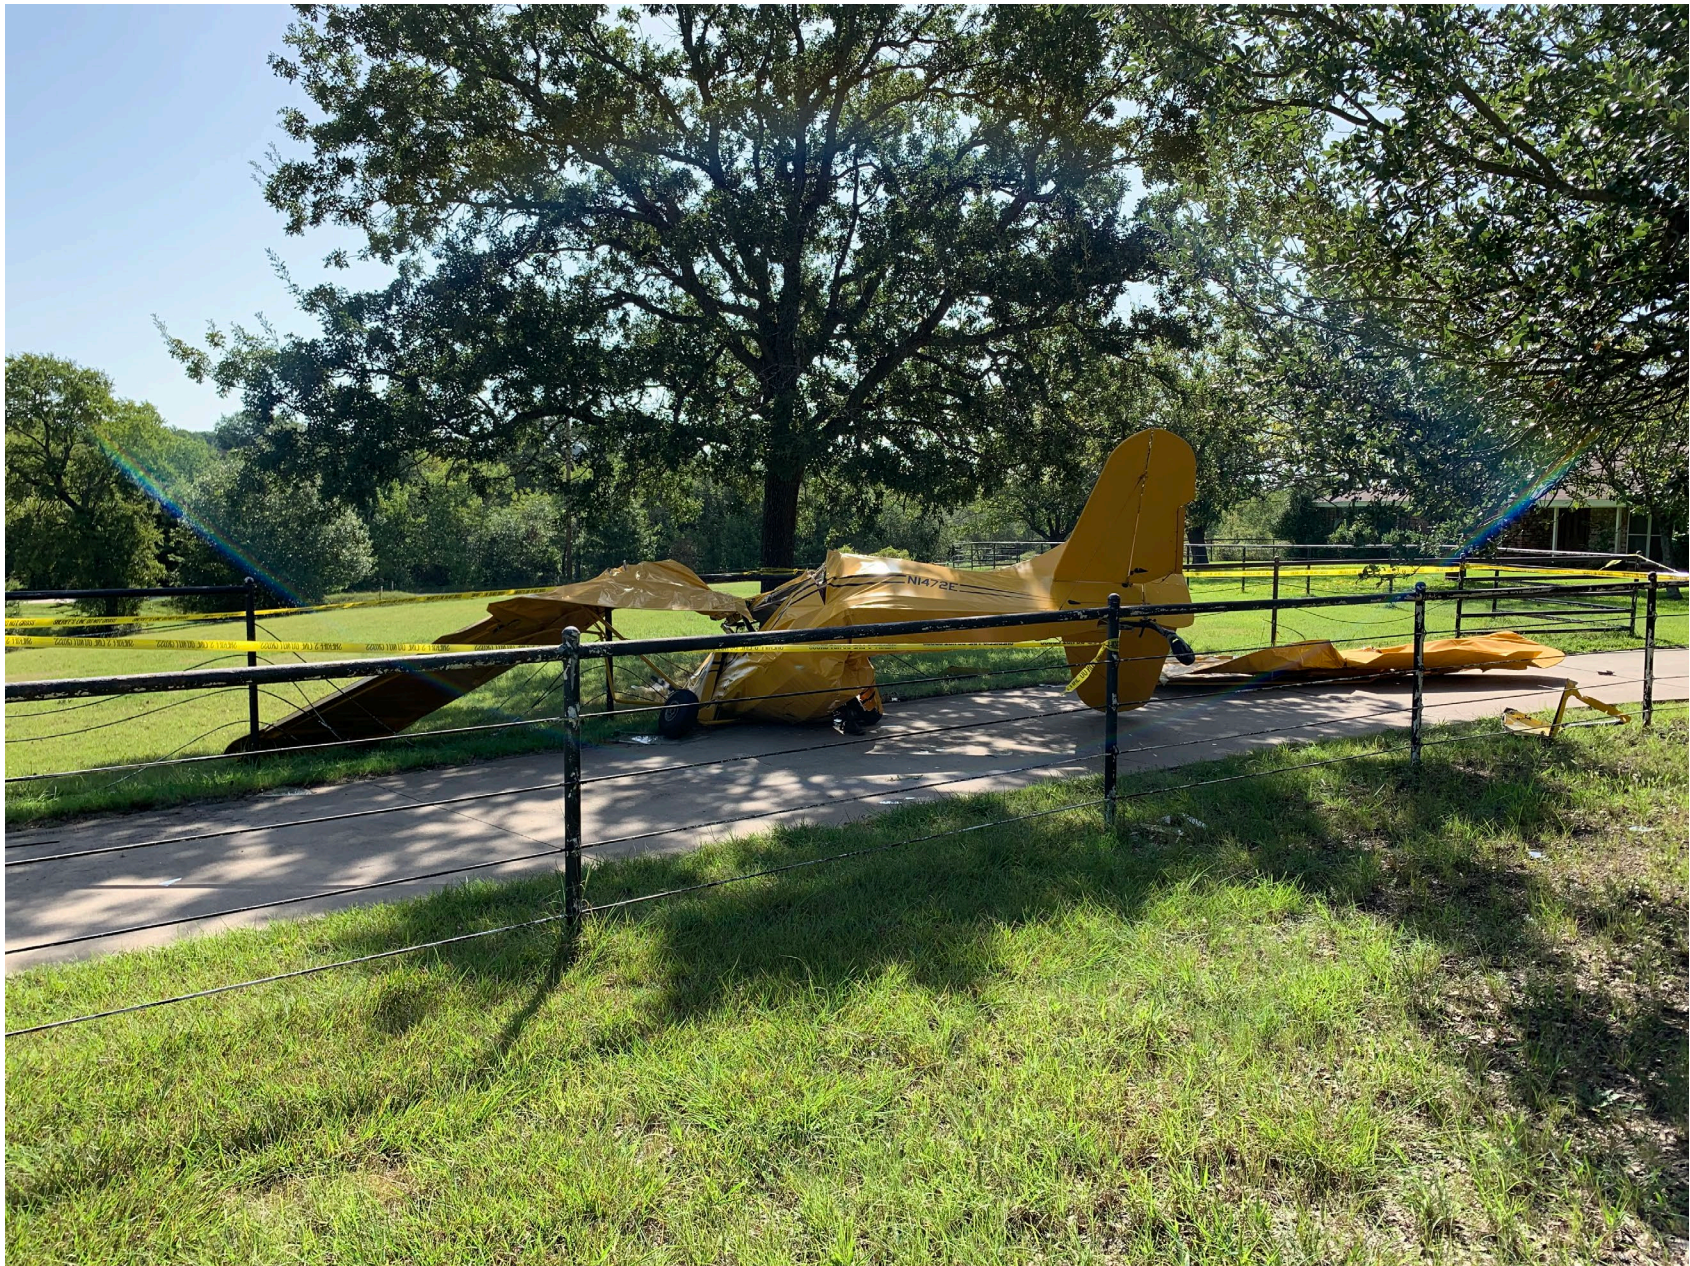
**Photo 3 – Rear view of the airplane at the accident site.**

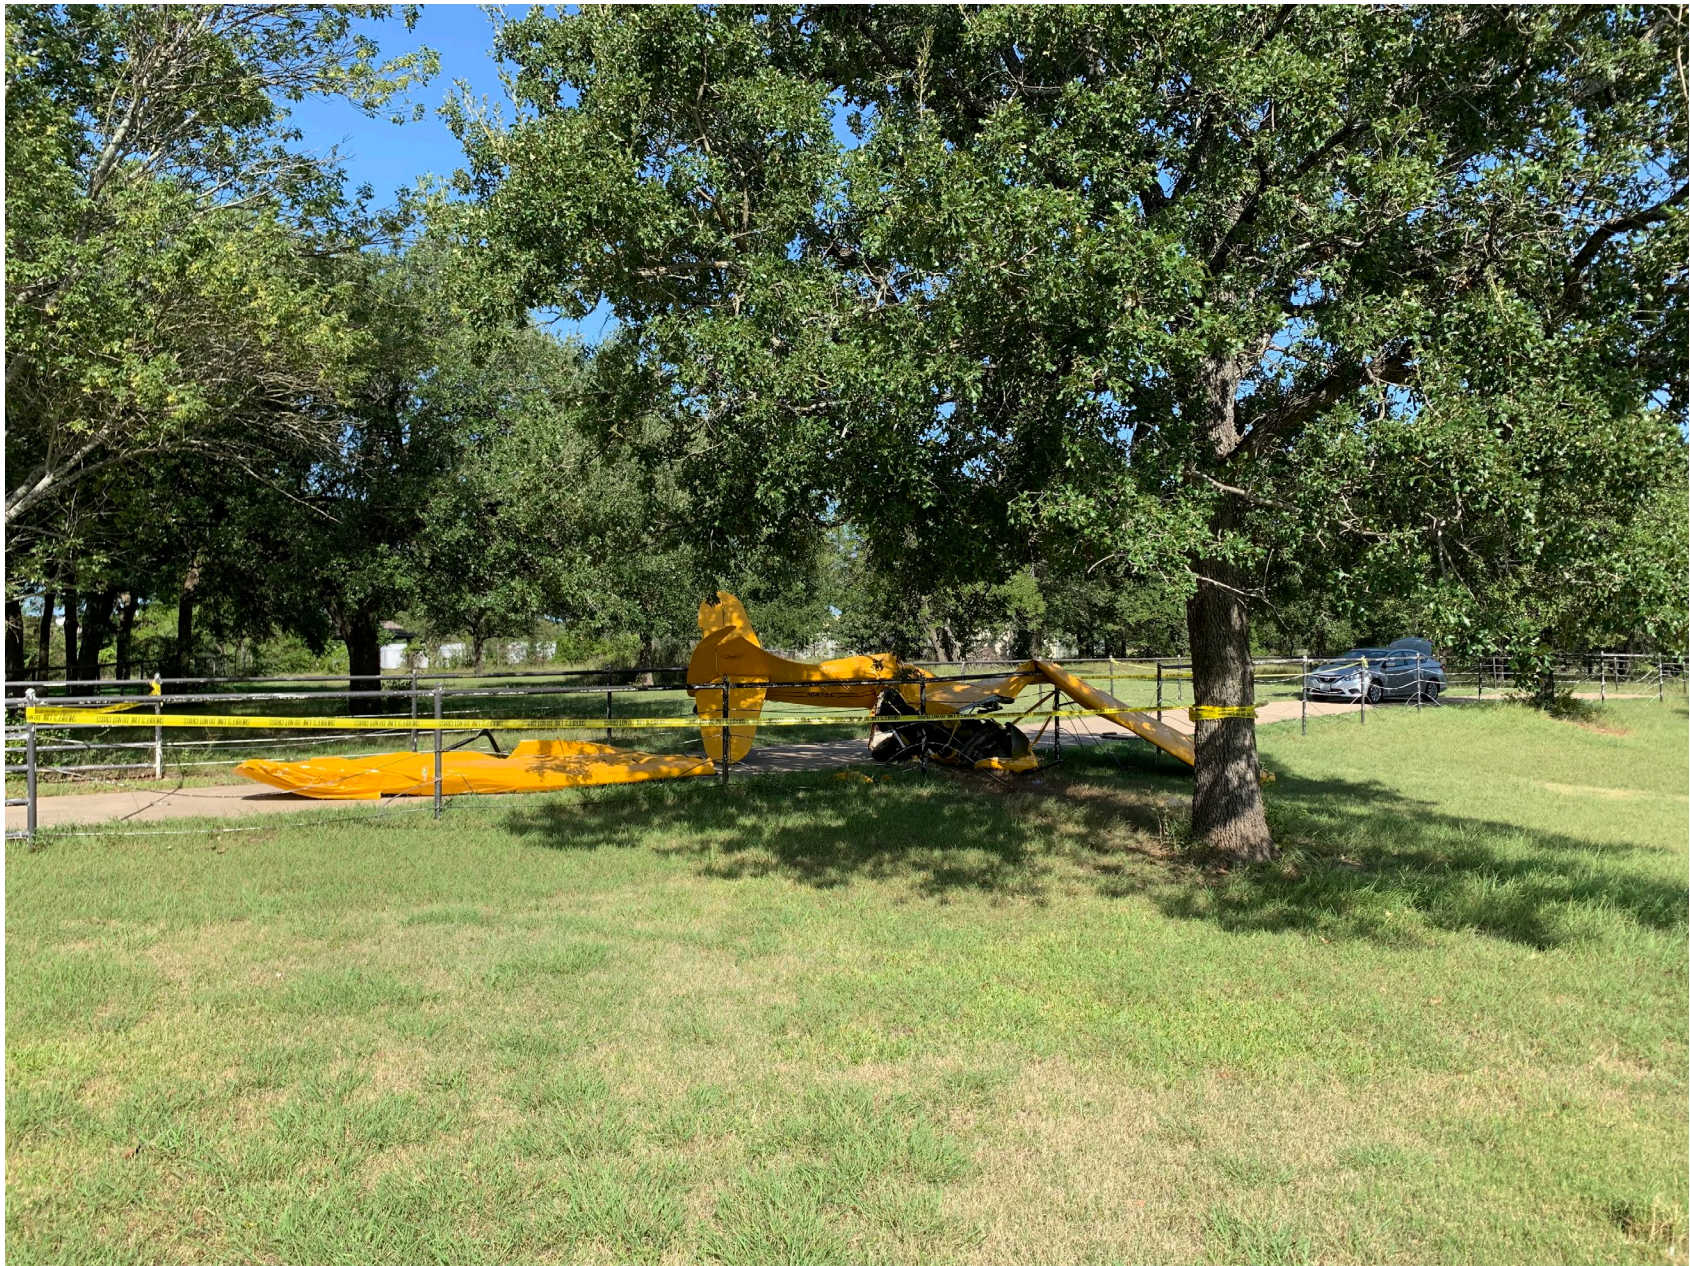
**Photo 4 – Right side view of the airplane at the accident site.**

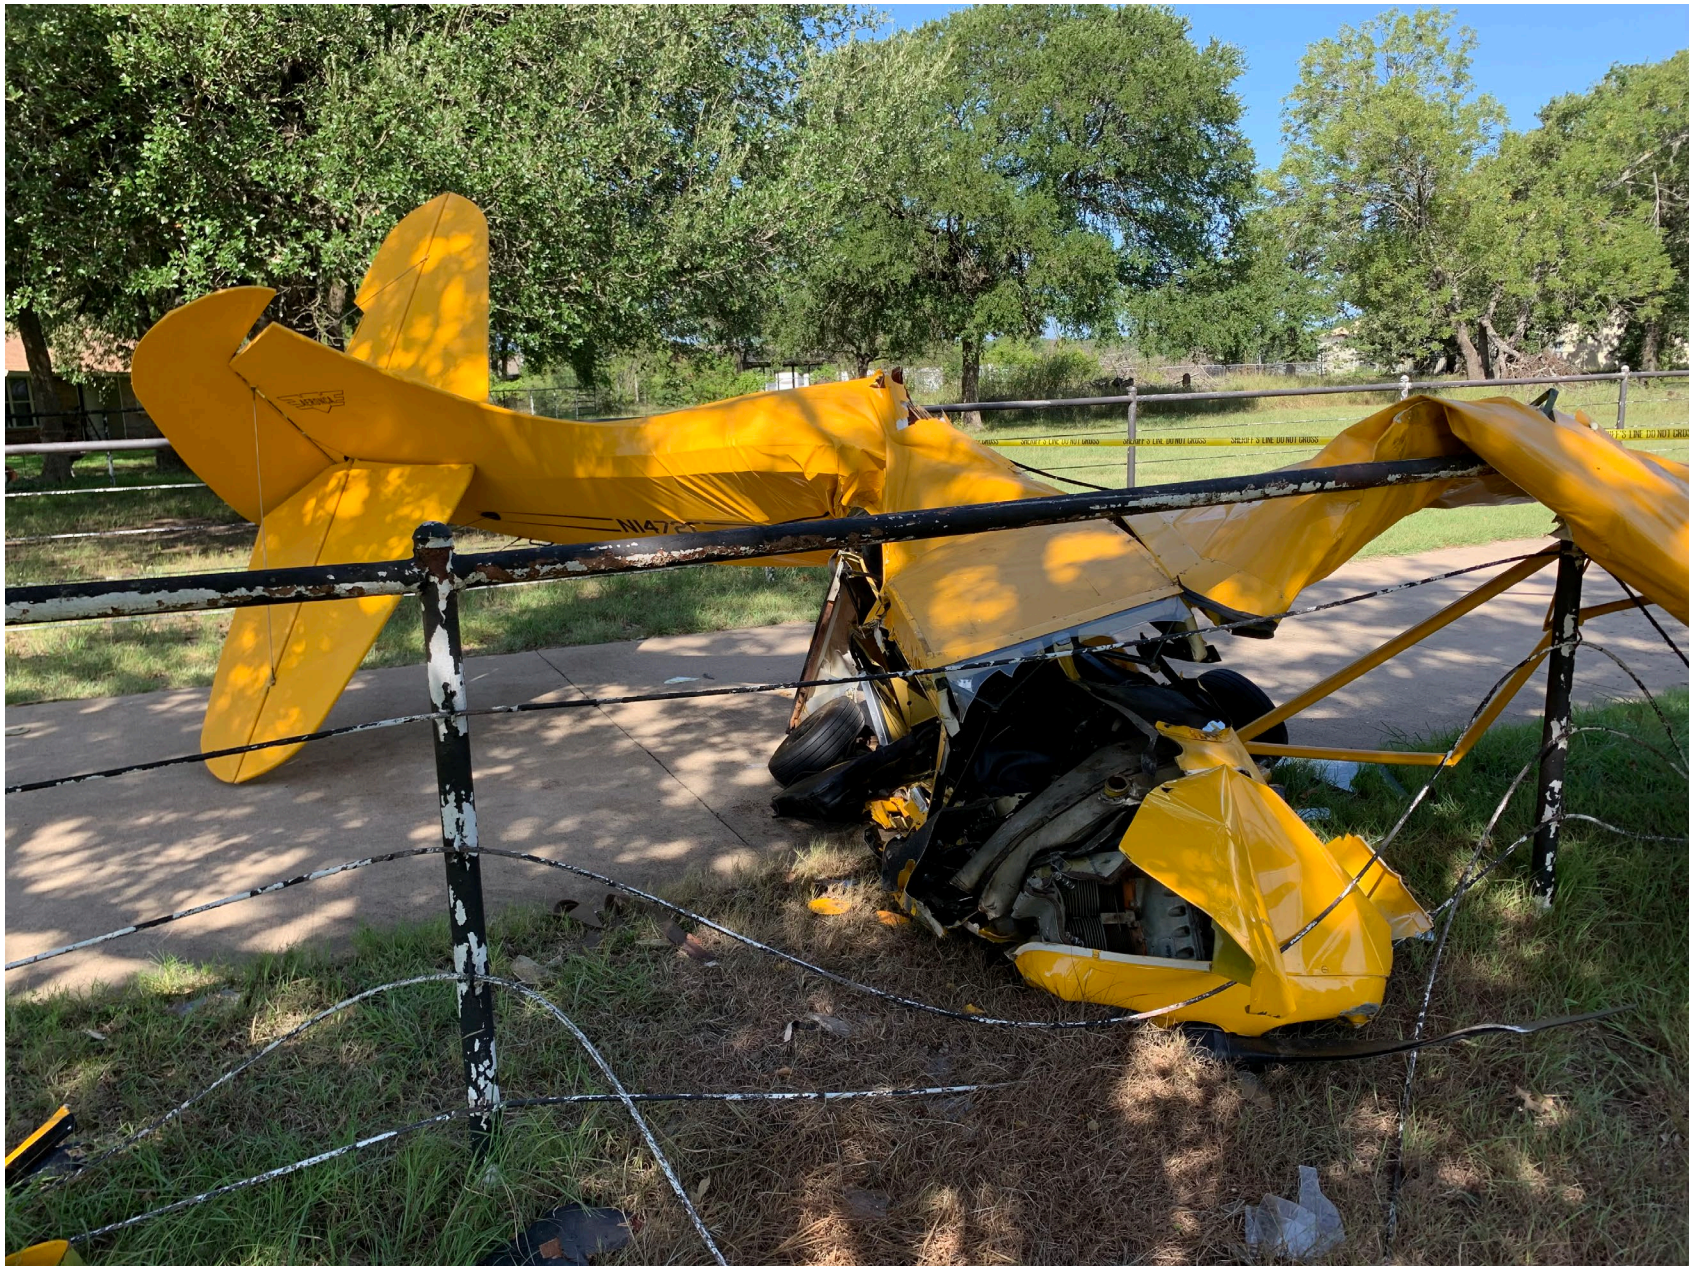
**Photo 5 – Close up view of the front of the airplane at the accident site.**

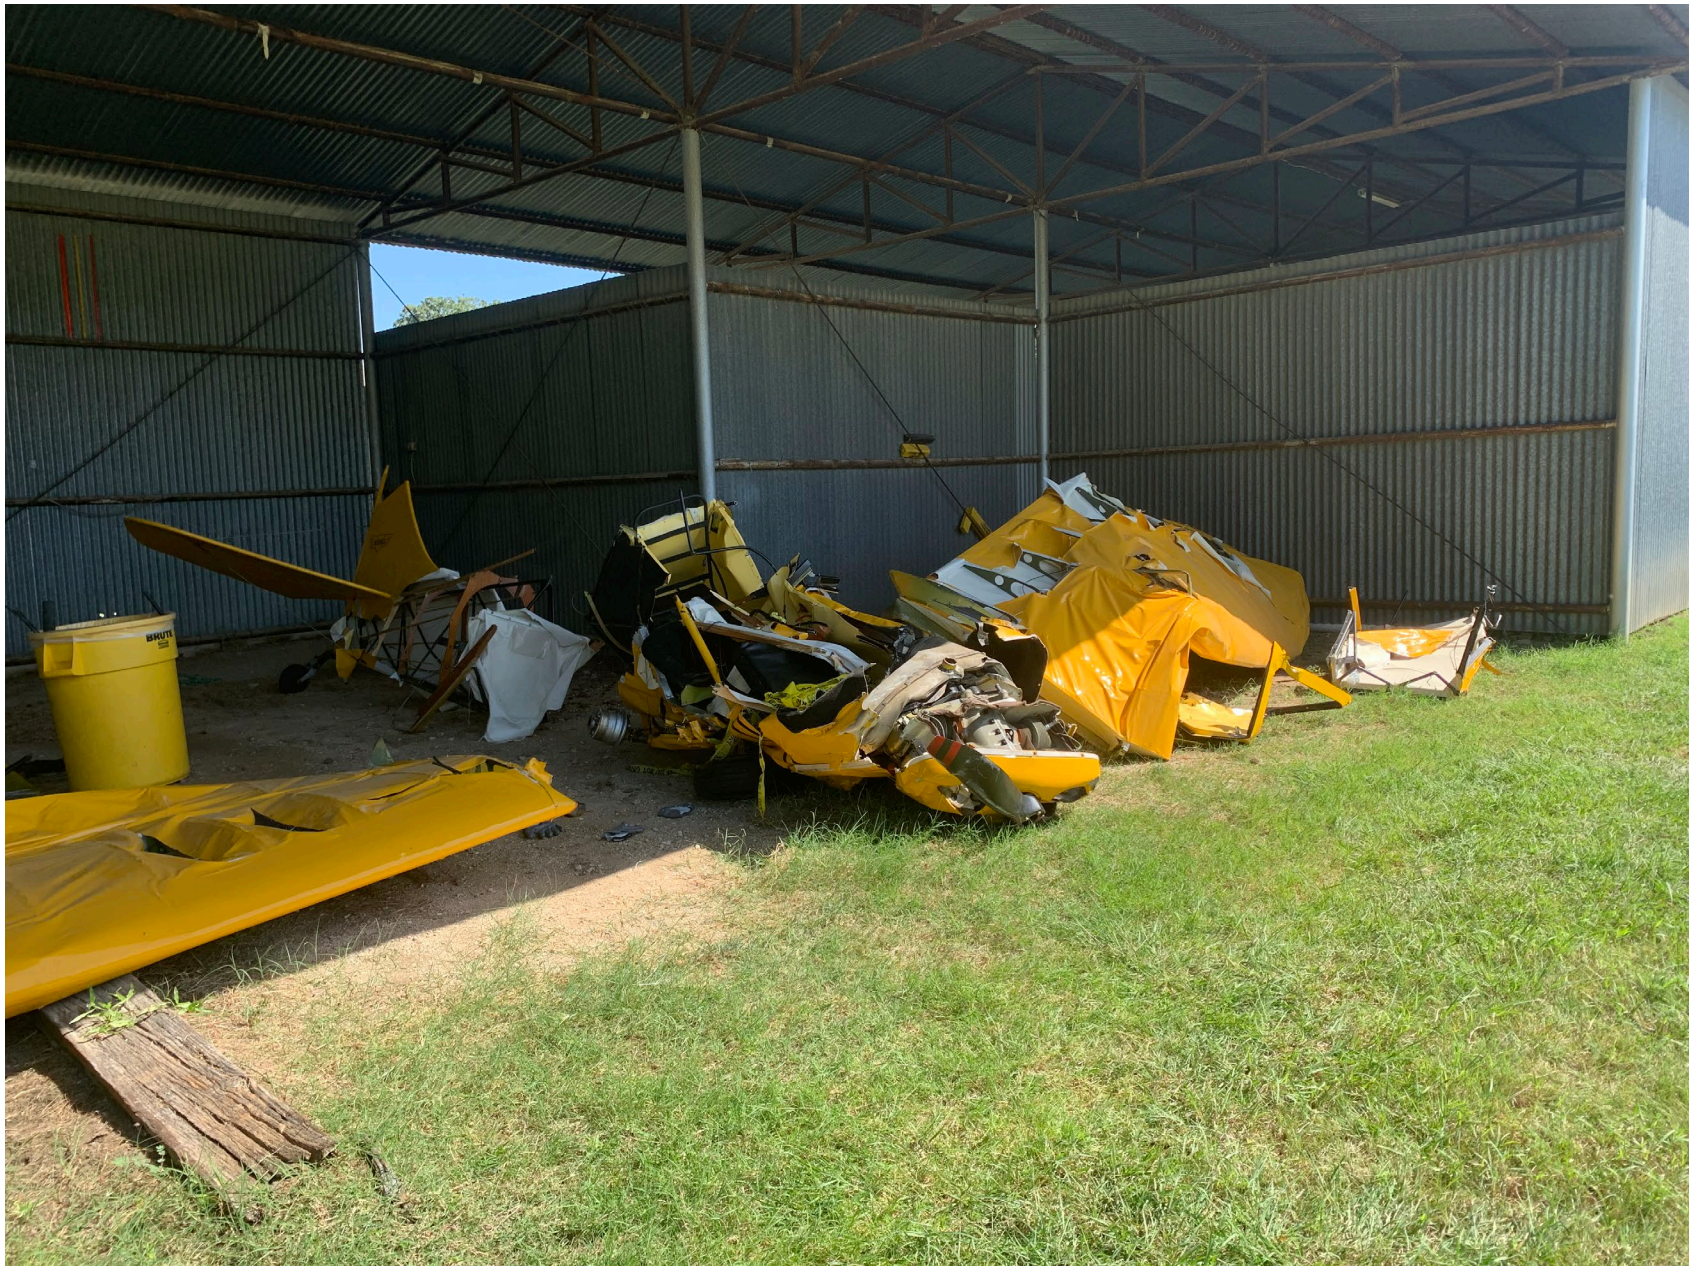
**Photo 6 – View of the wreckage laid out after it was recovered from the accident site.**

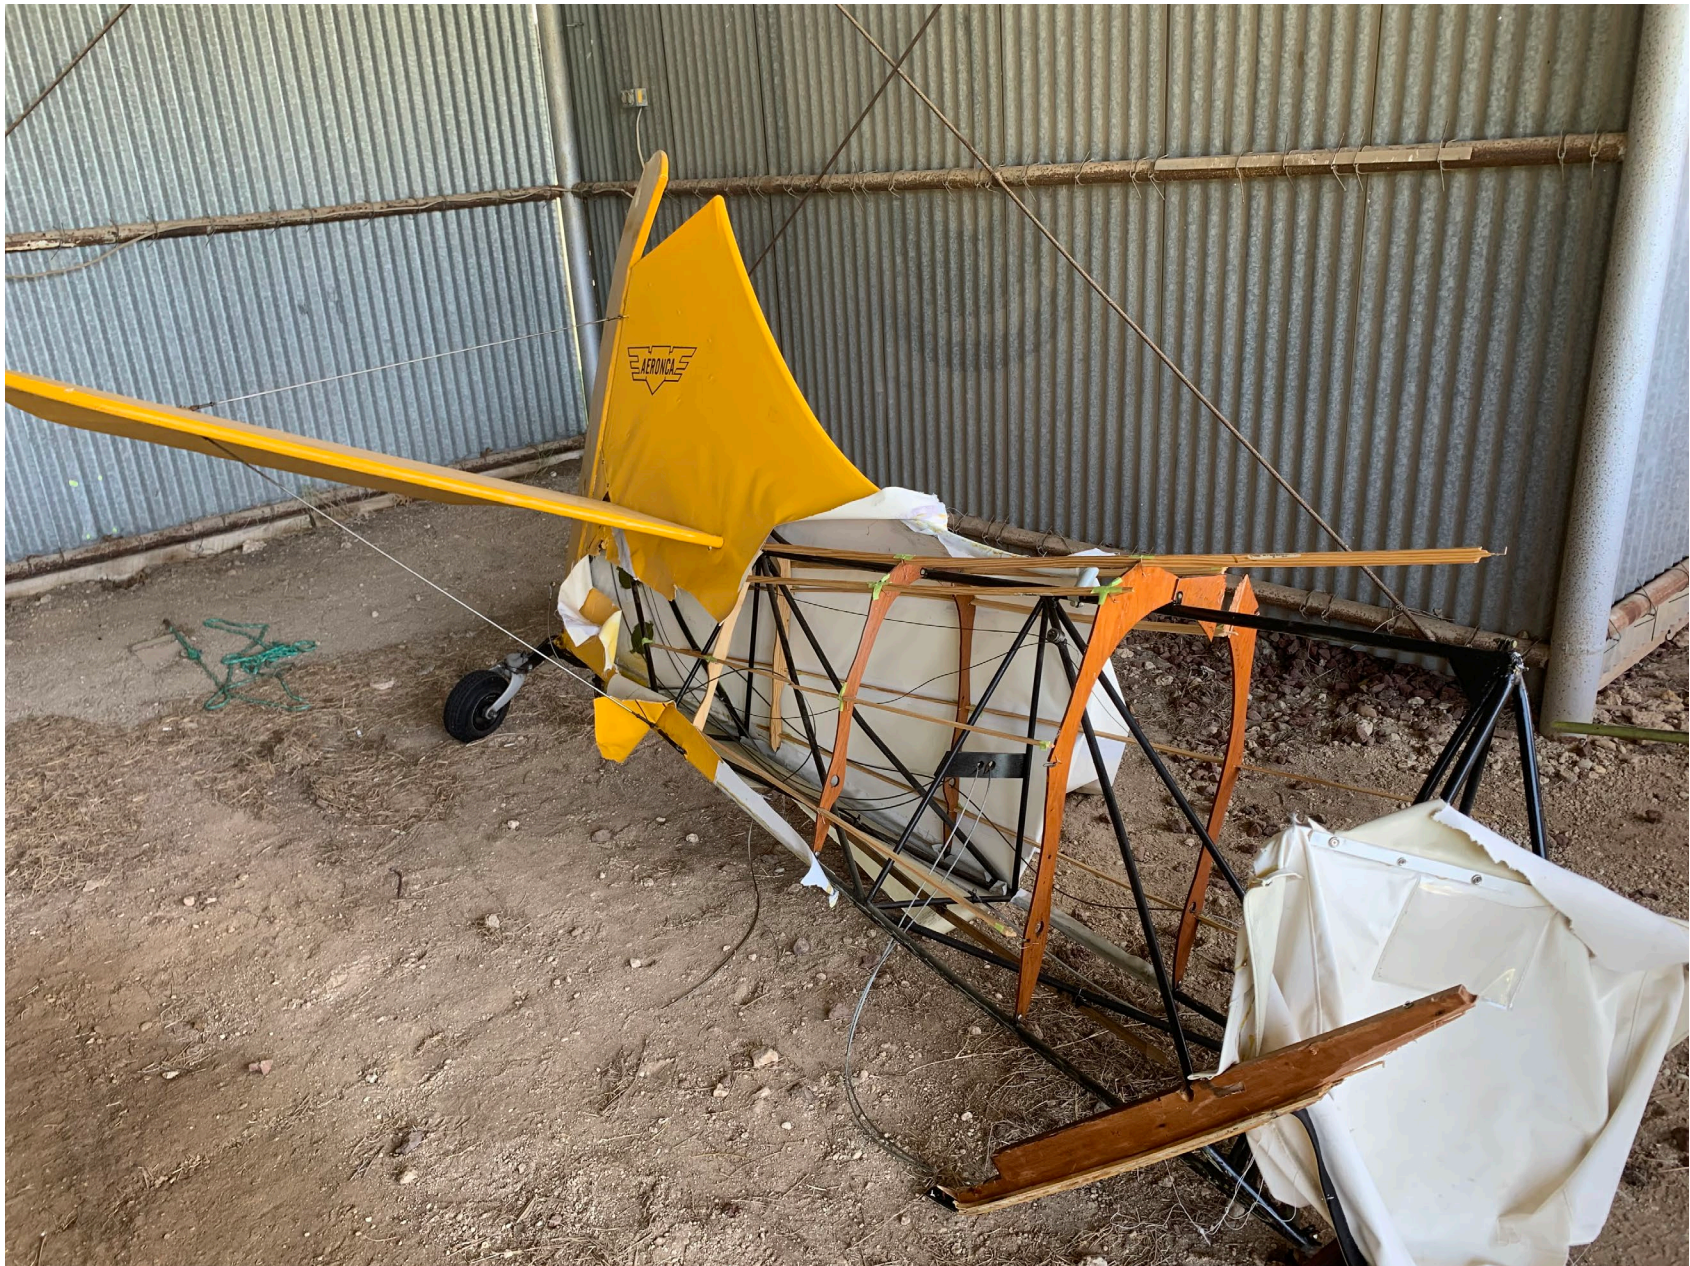
**Photo 7 – View of the empennage, showing the dorsal fin.**

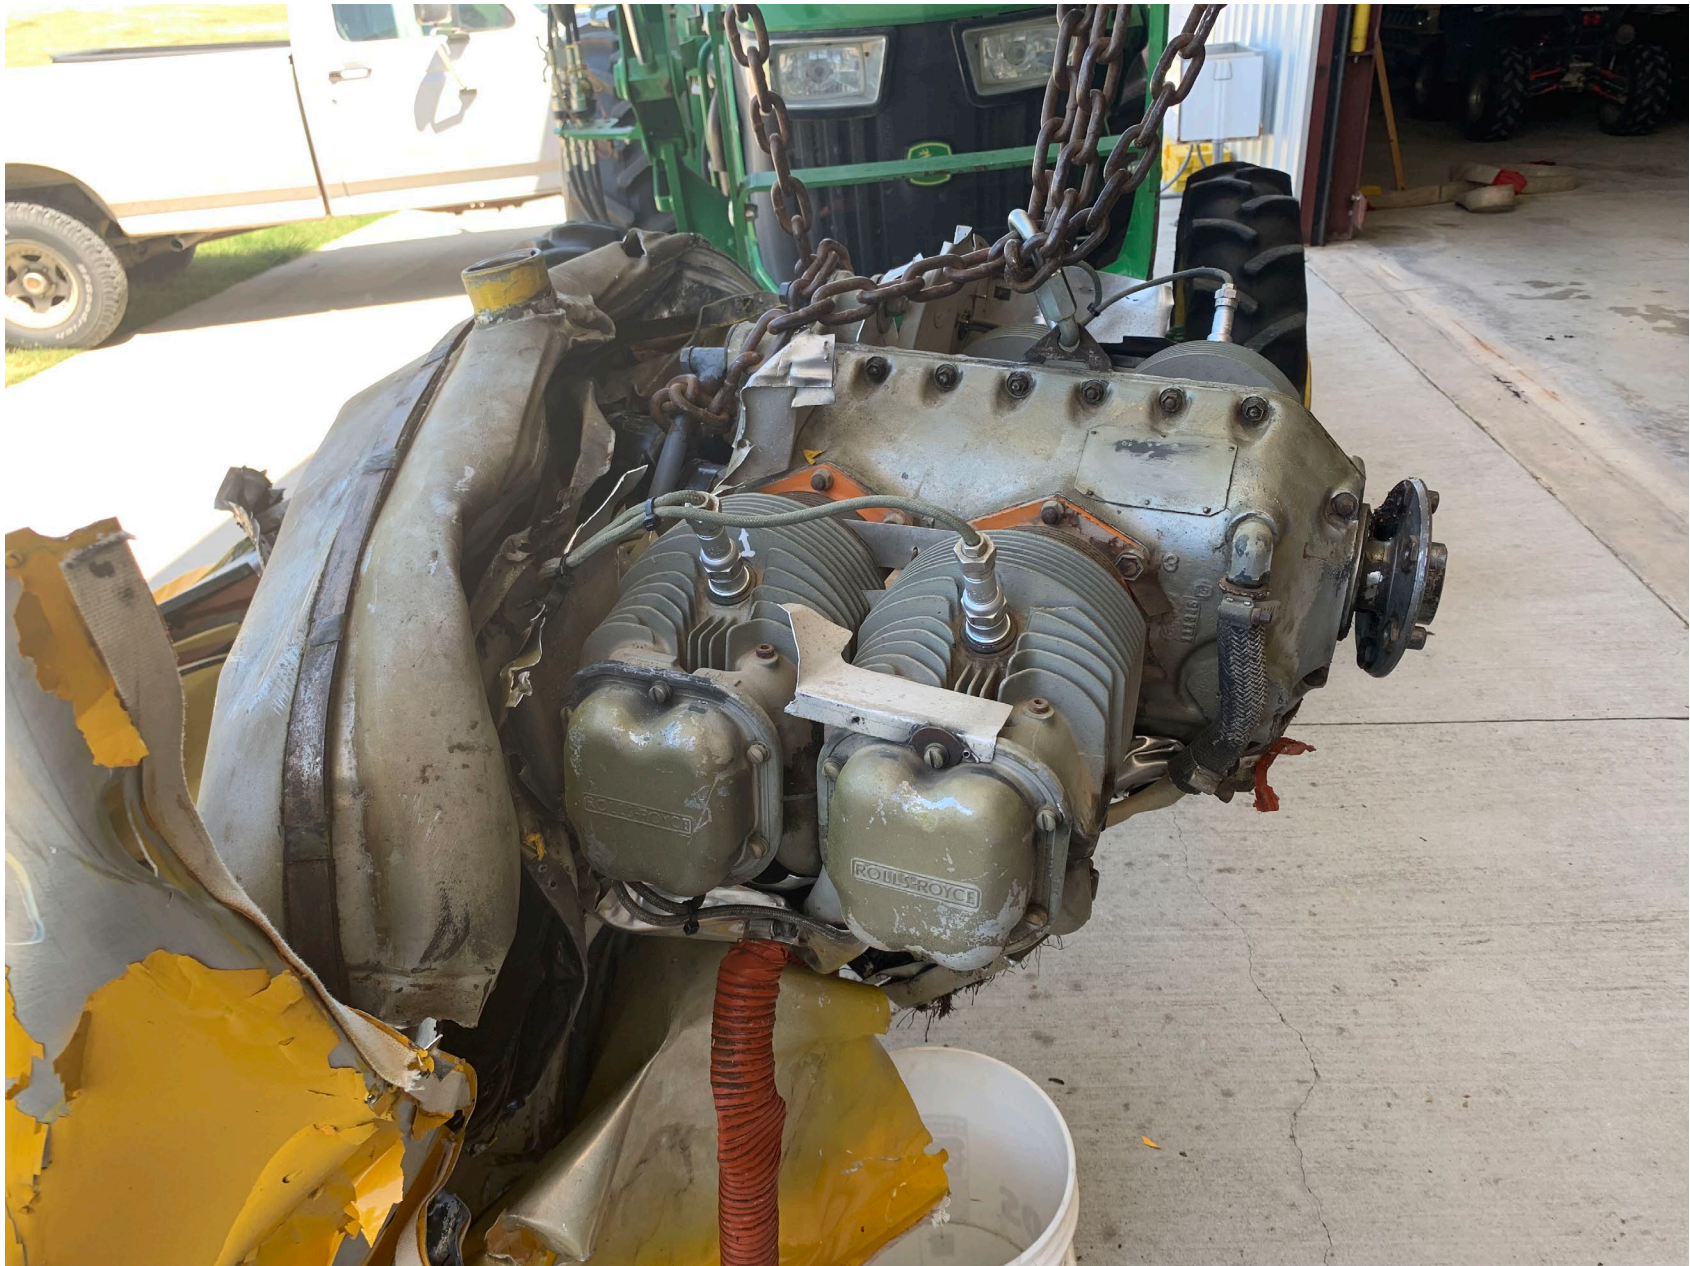
**Photo 8 – View of the right side of the engine during the examination.**

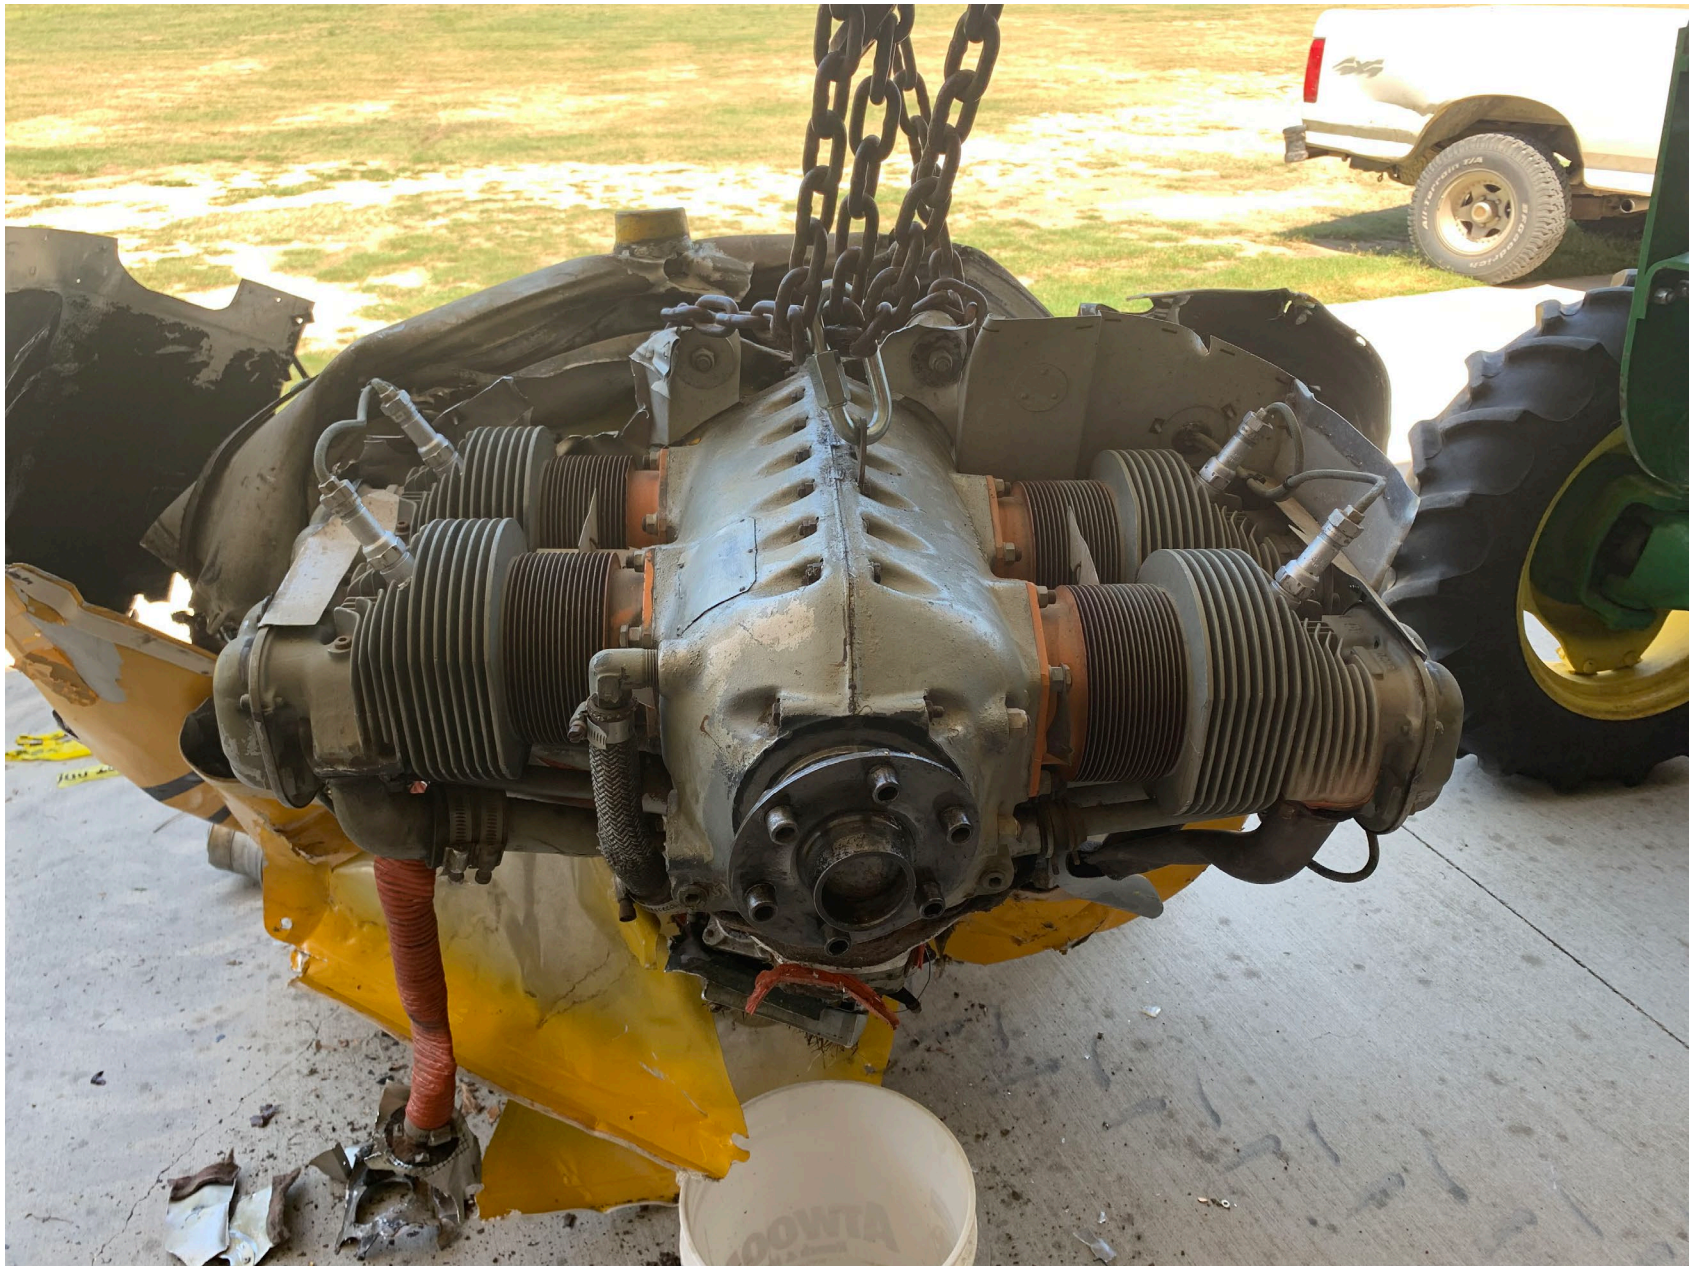
**Photo 9 – View of the front of the engine during the examination.**

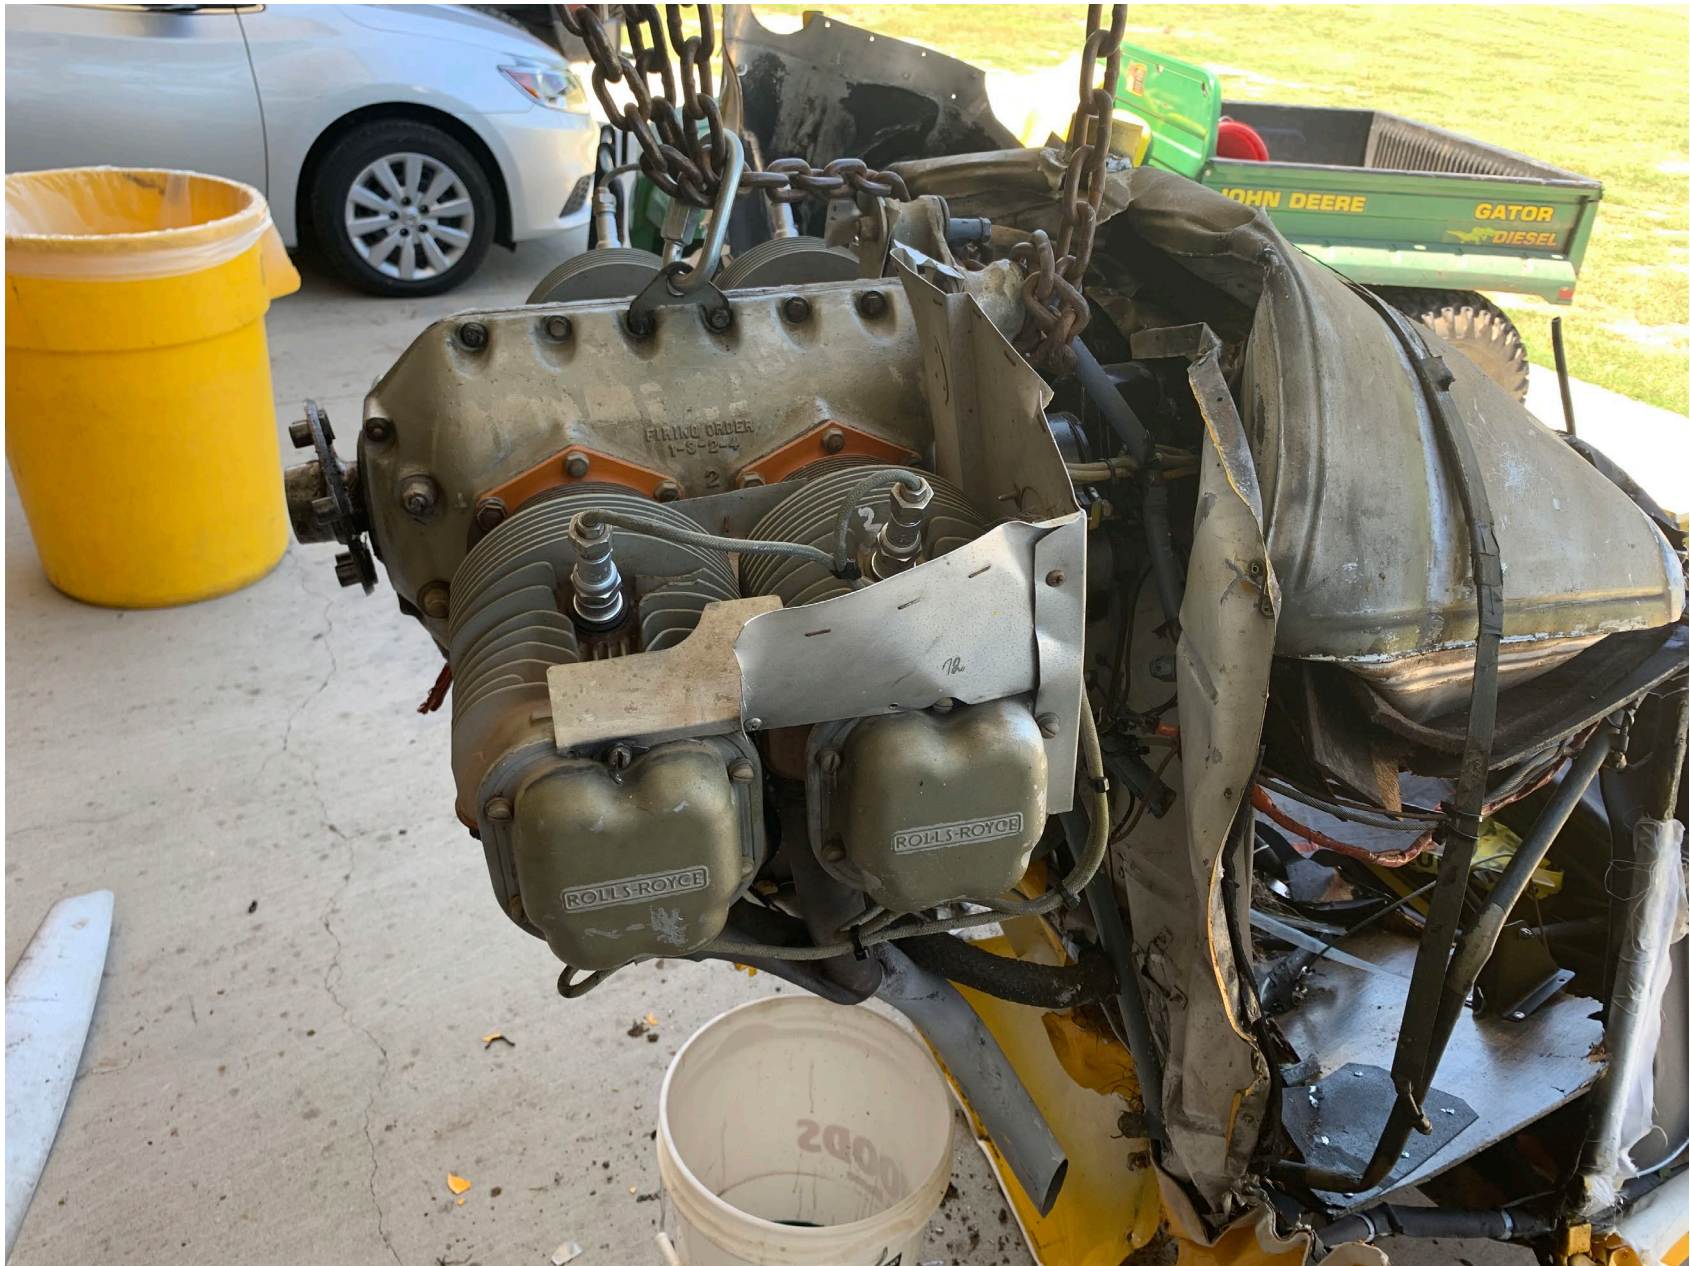
**Photo 10 – View of the left side of the engine during the examination.**
