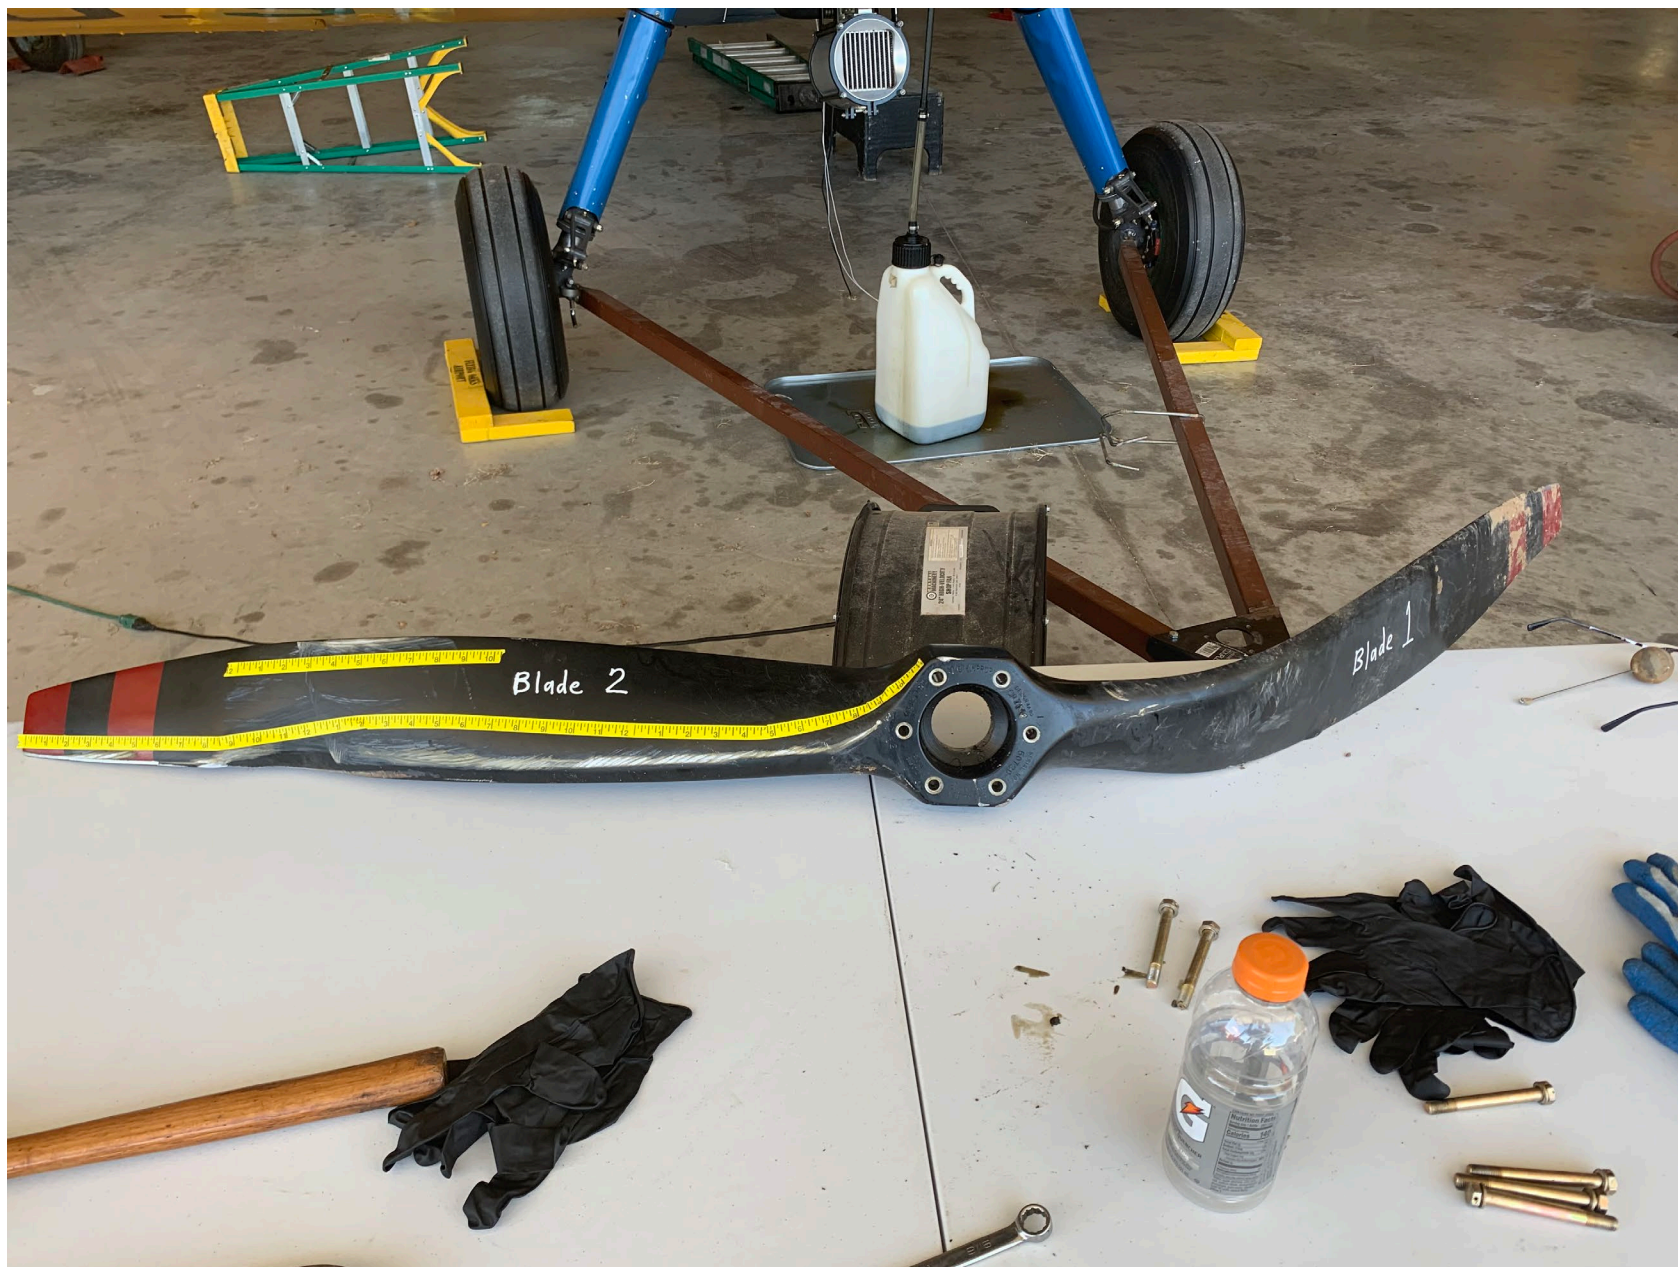
**Photo 11 – View of the propeller removed from the engine.**

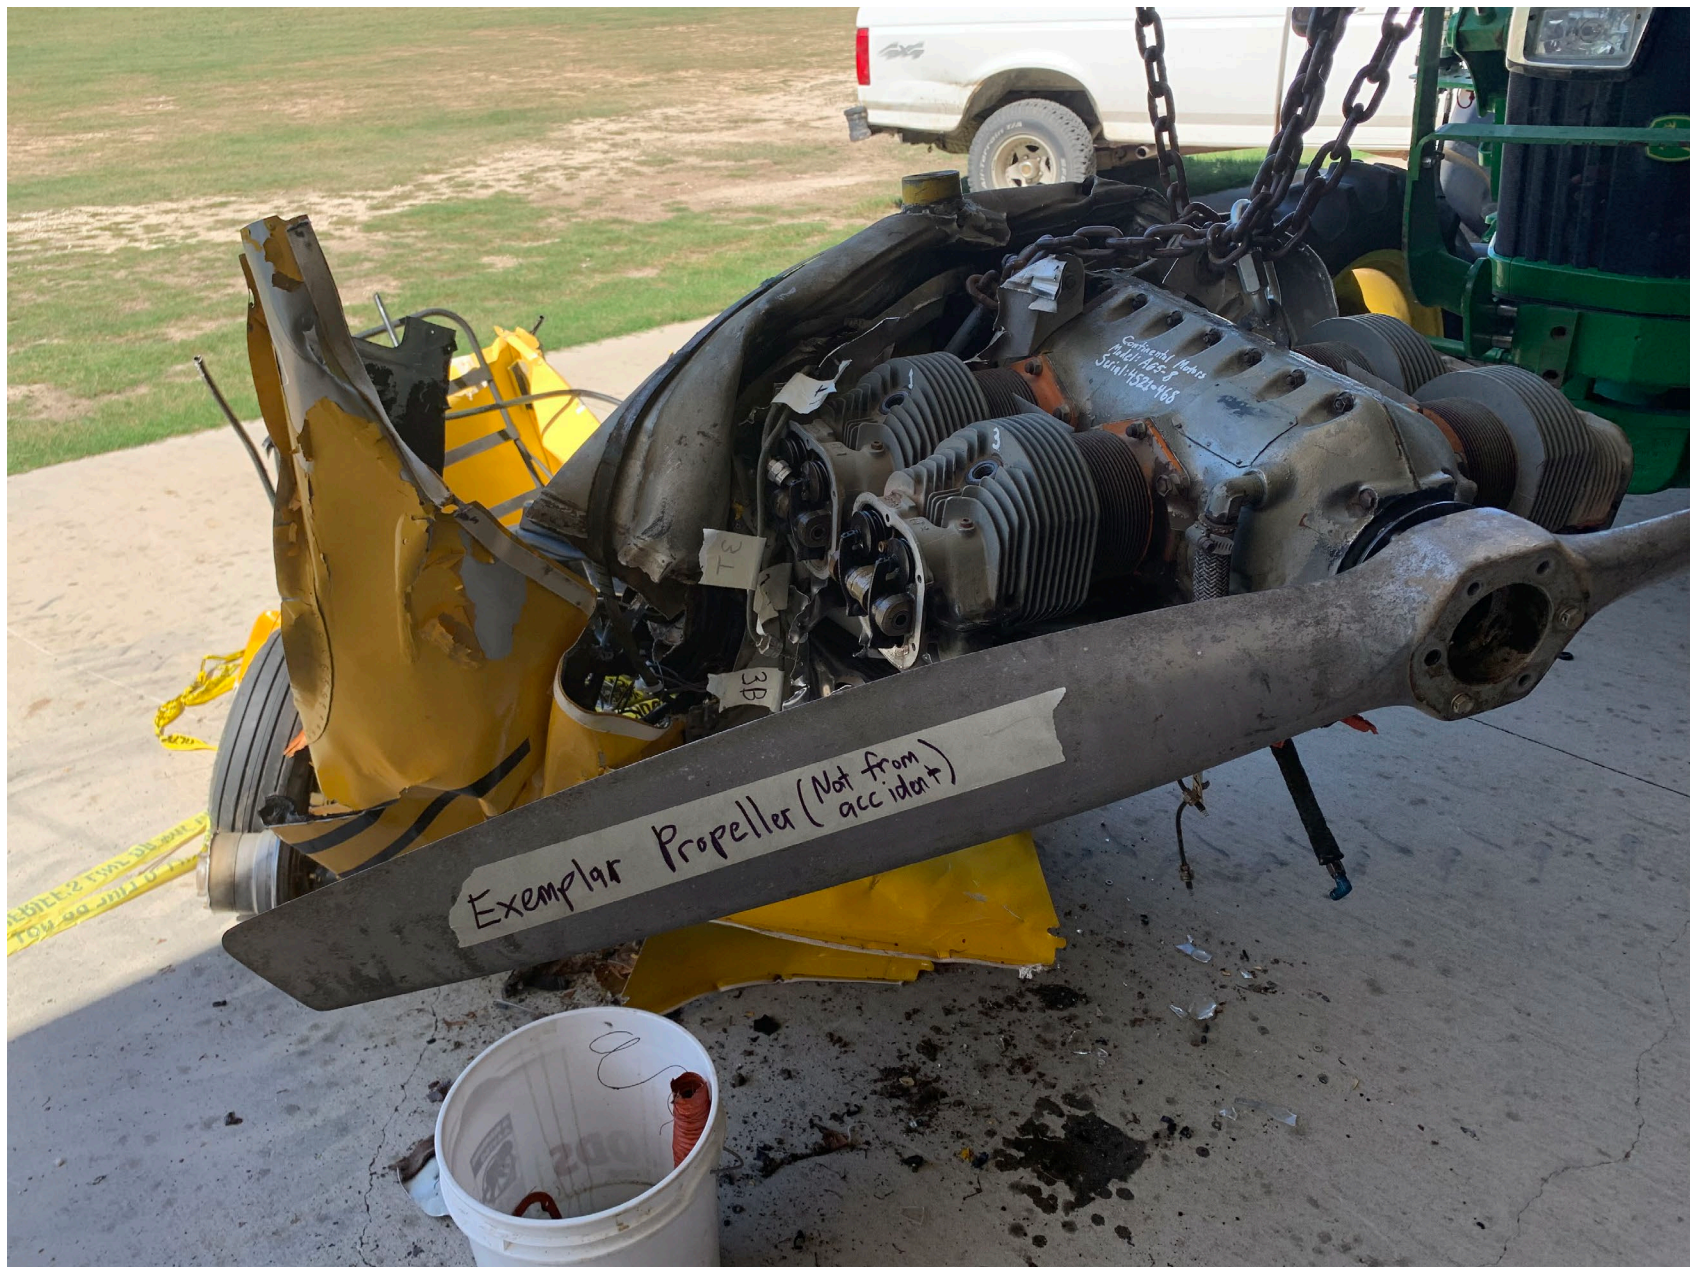
**Photo 12 – View of an exemplar propeller installed on the engine during the examination.**
