CEN23LA107

INVESTIGATION PHOTOGRAPHS

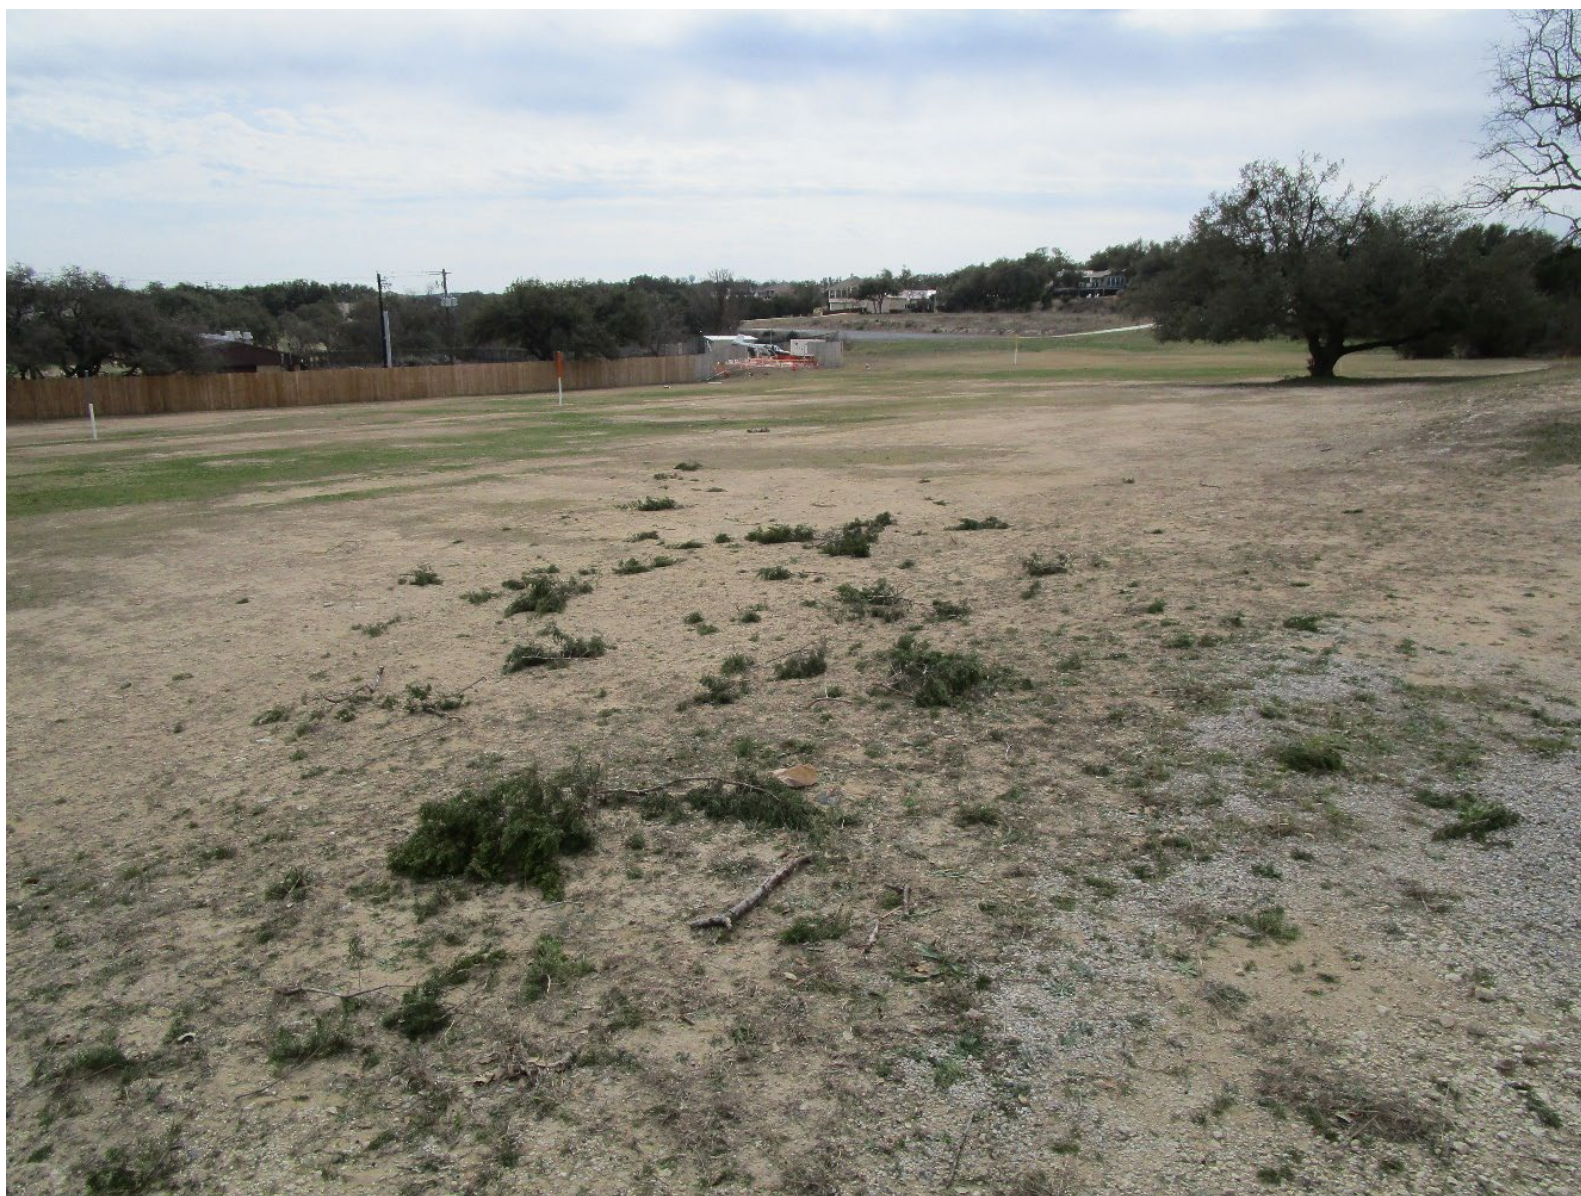
Photograph 1 - View of the accident site (Courtesy of the Federal Aviation Administration)

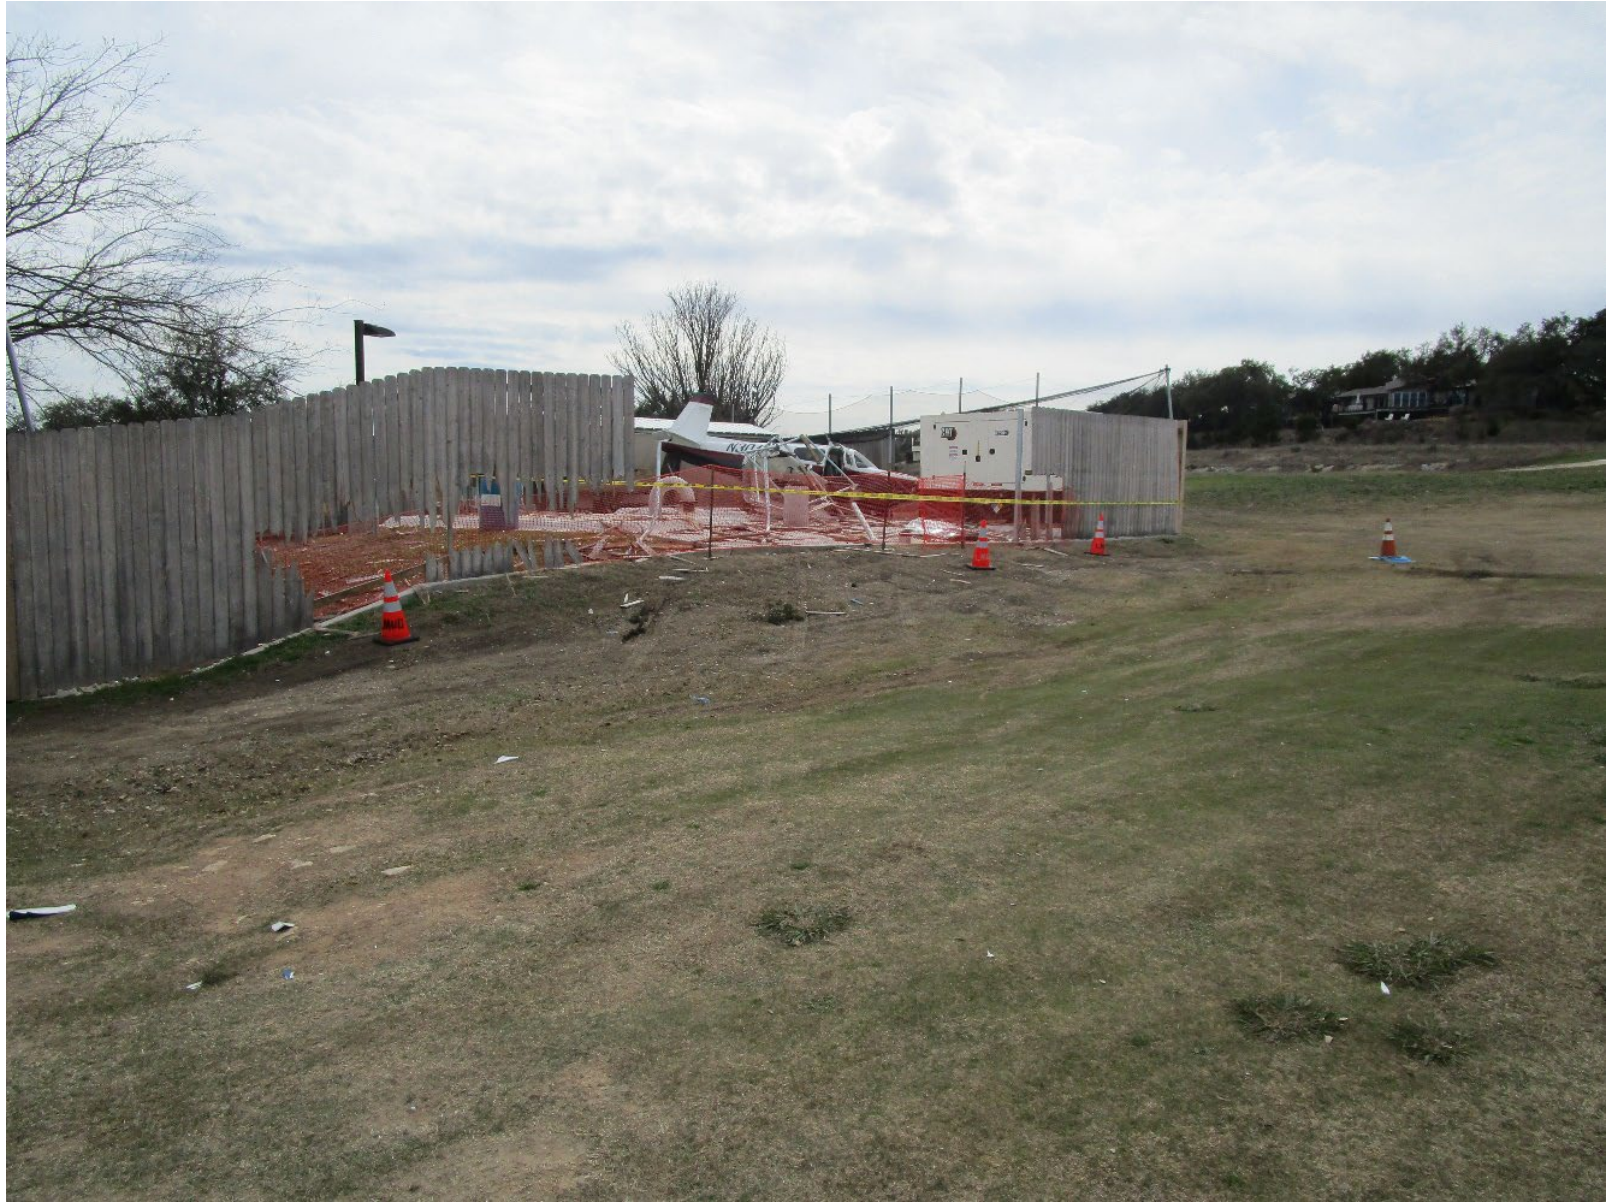
Photograph 2 - View of the accident site (Courtesy of the Federal Aviation Administration)

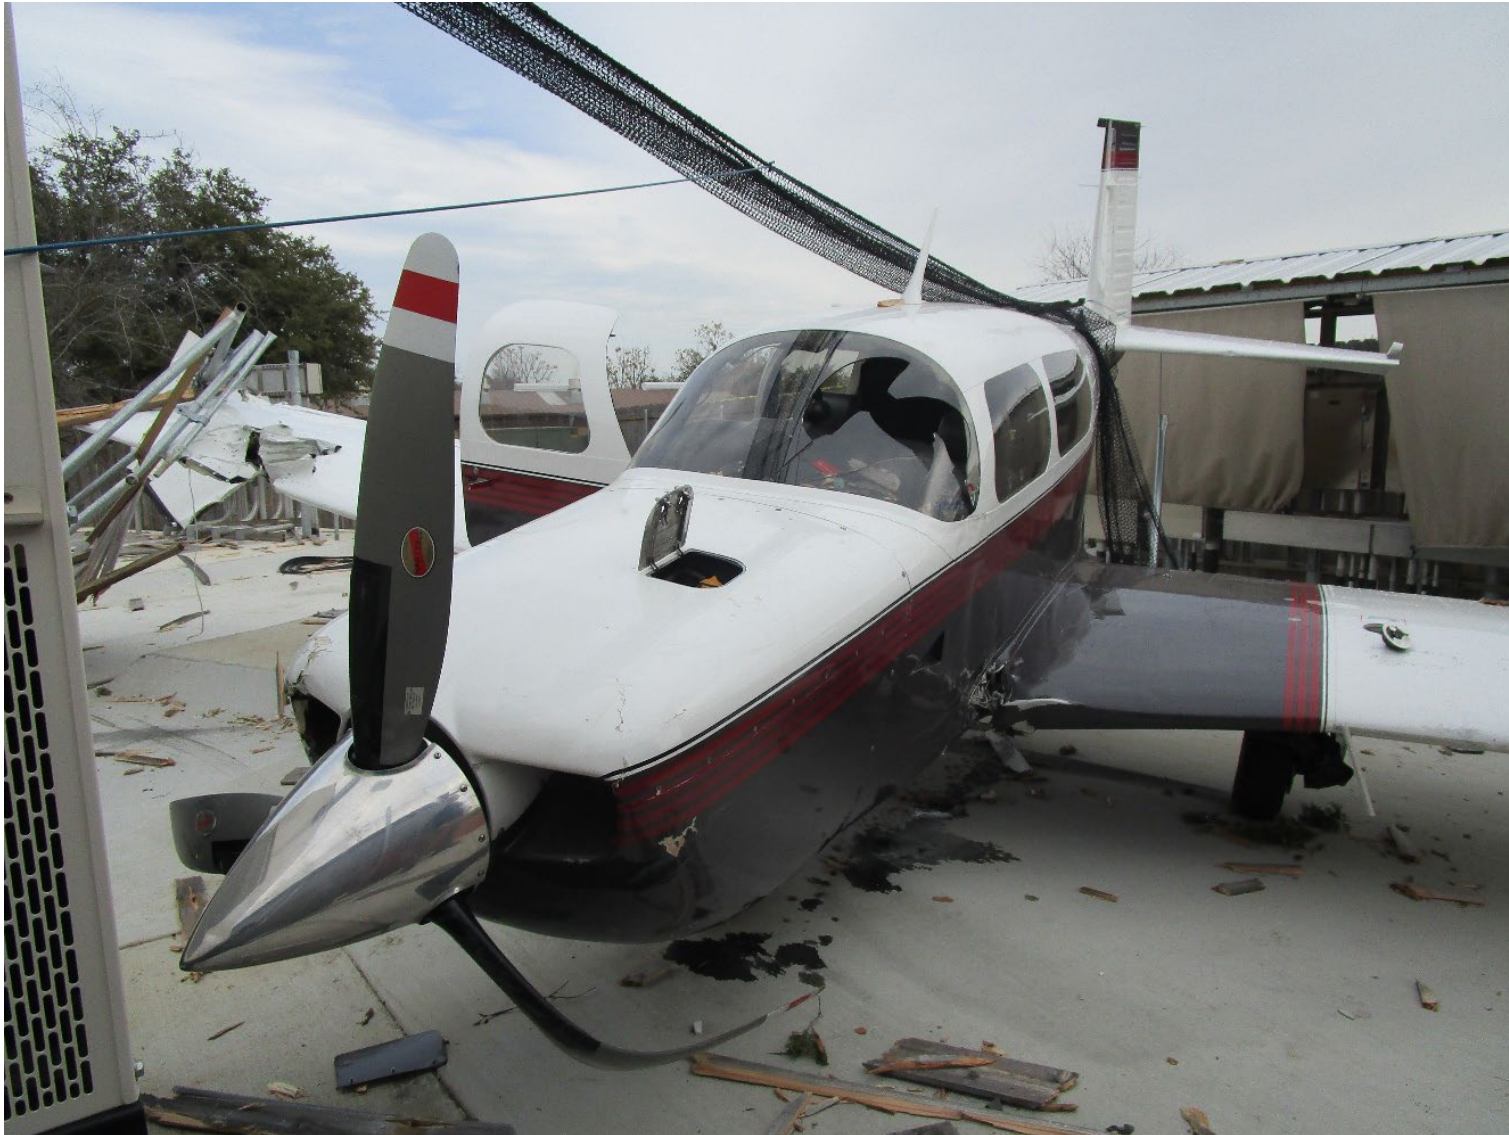
Photograph 3 - View of the front of the airplane at the accident site (Courtesy of the Federal Aviation Administration)

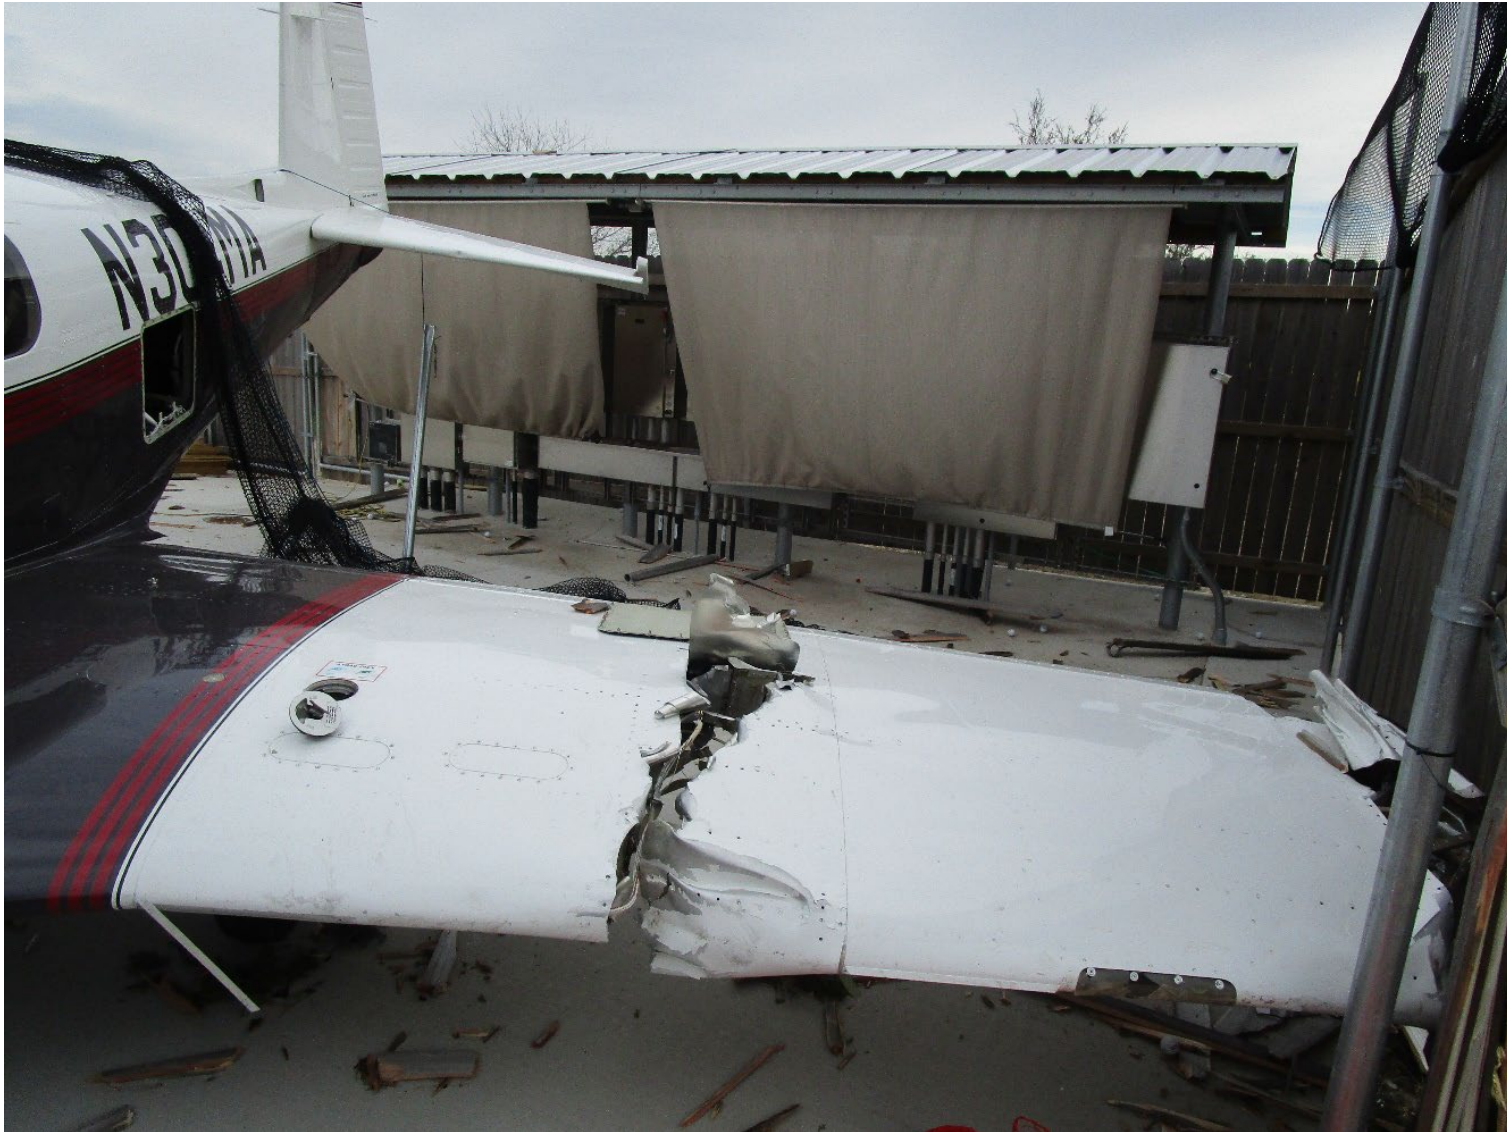
Photograph 4 - View of the left wing at the accident site (Courtesy of the Federal Aviation Administration)

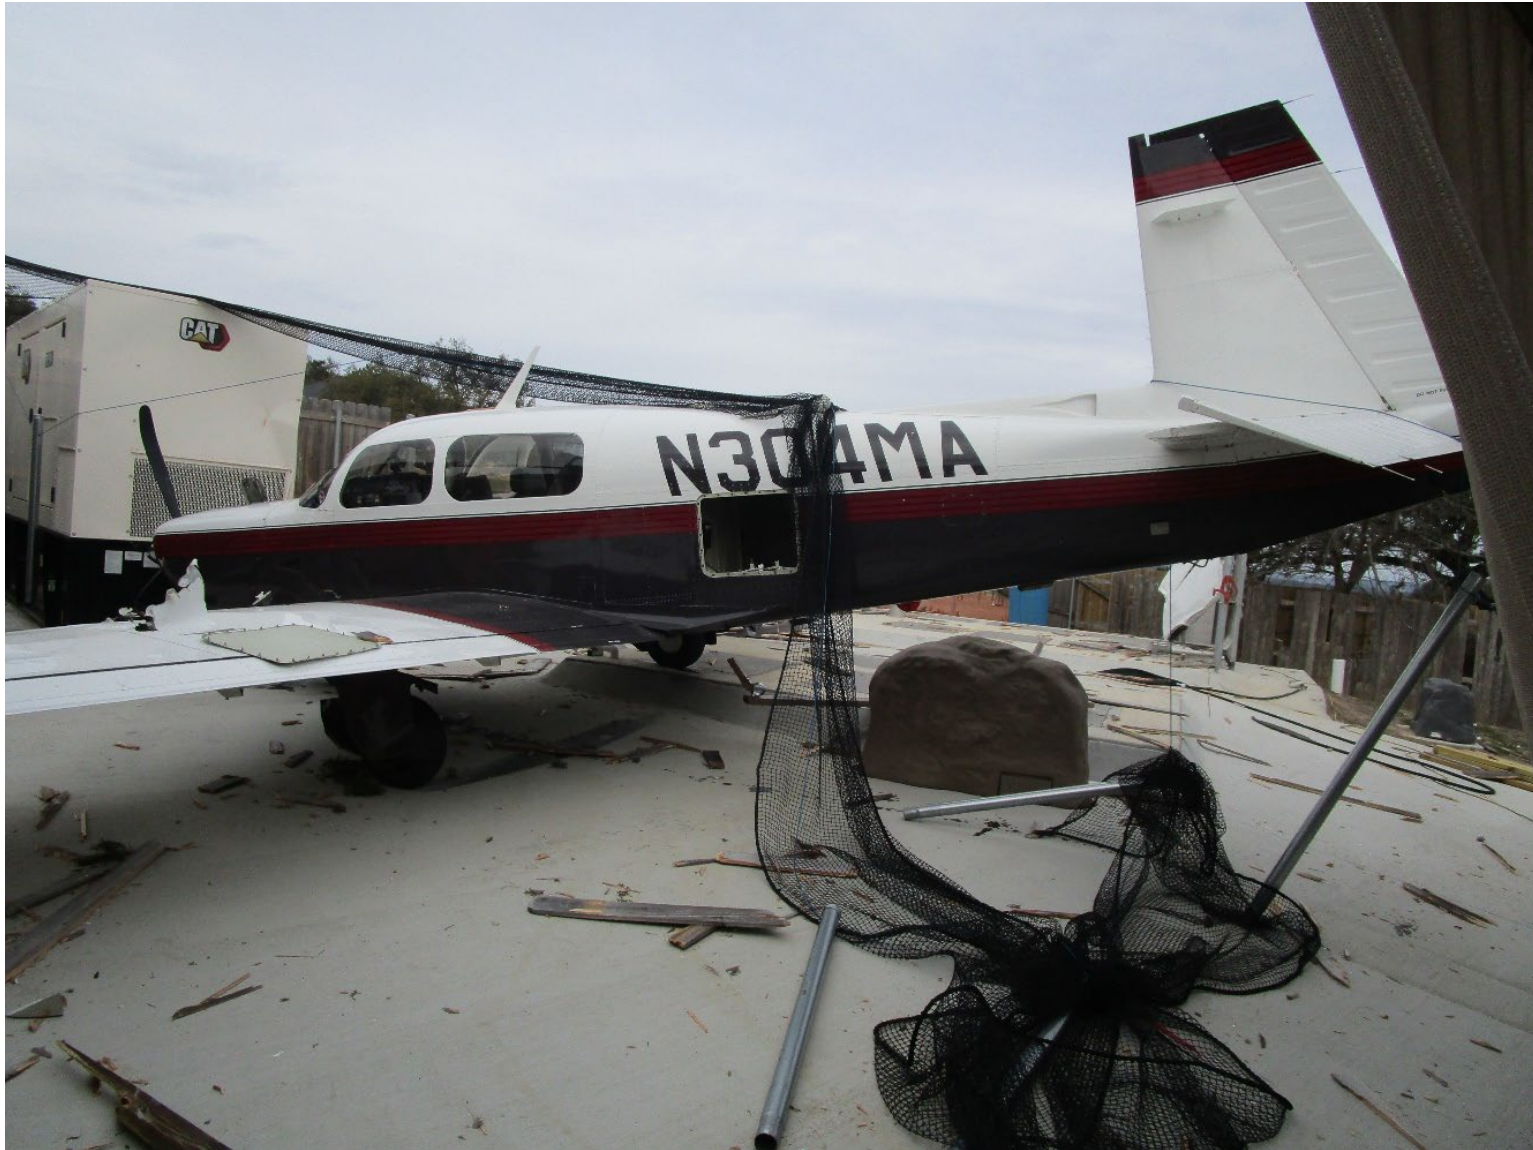
Photograph 5 - View of the left side of the airplane at the accident site (Courtesy of the Federal Aviation Administration)

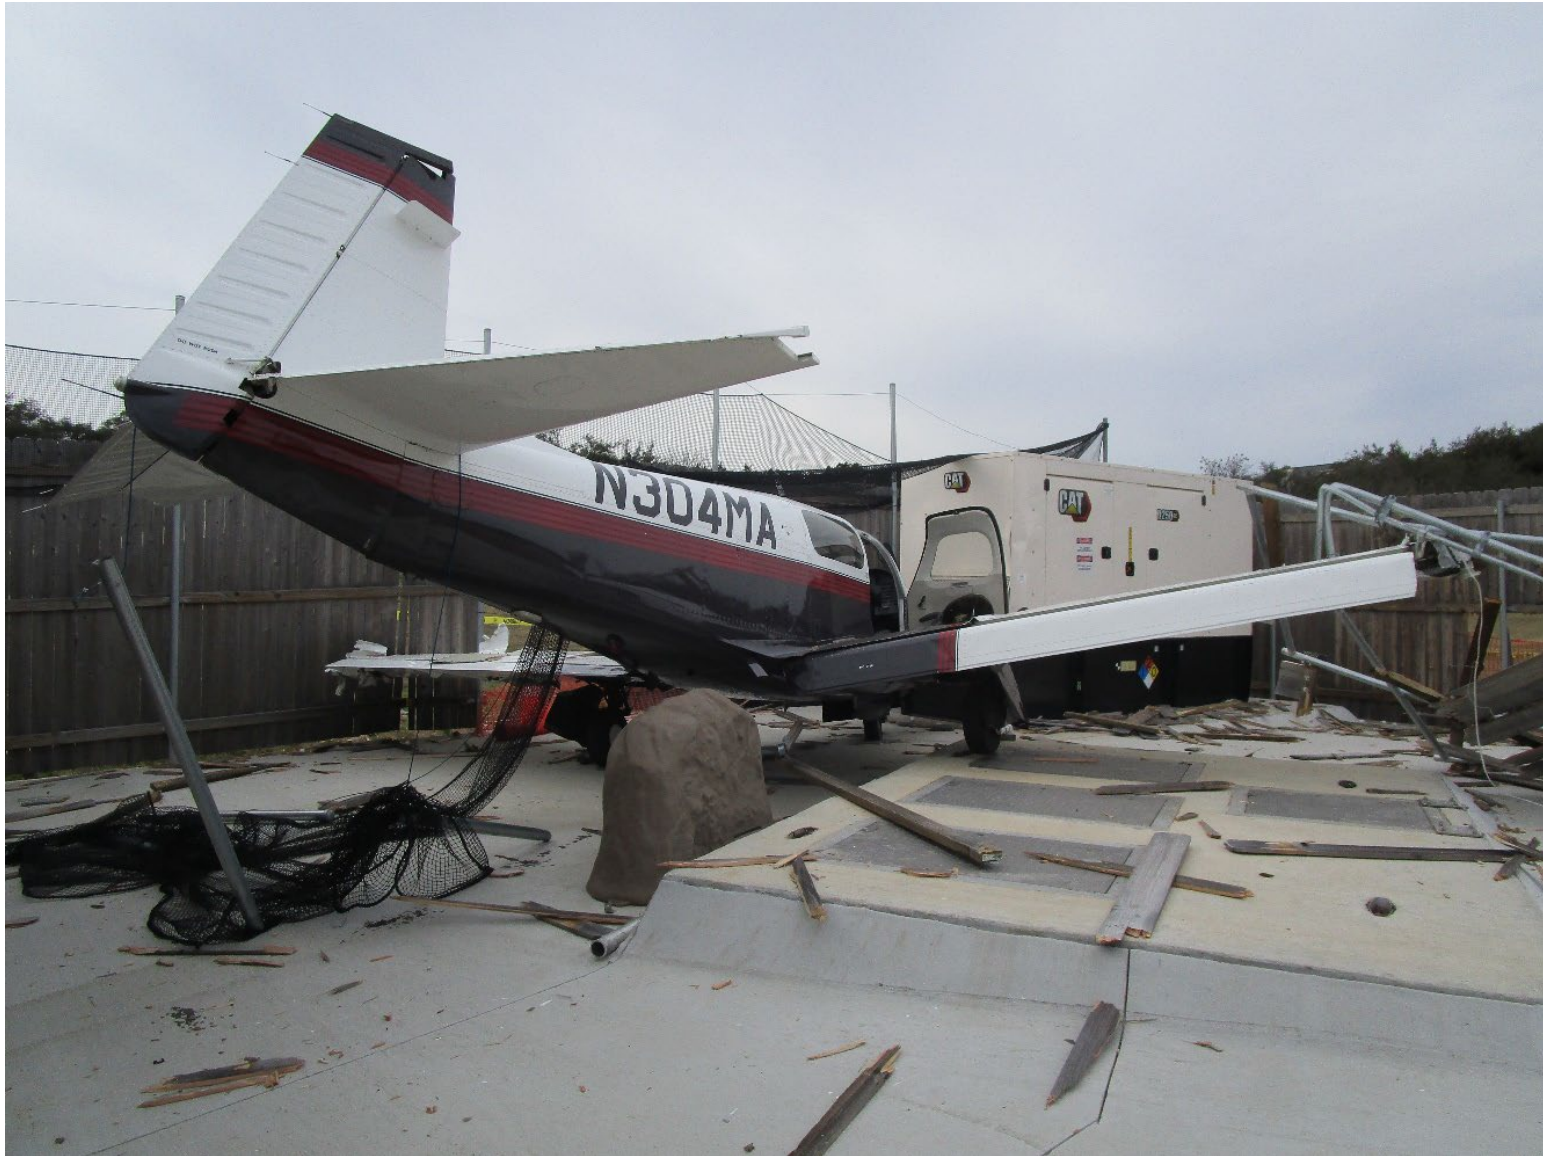
Photograph 6 - View of the right side of the airplane at the accident site (Courtesy of the Federal Aviation Administration)

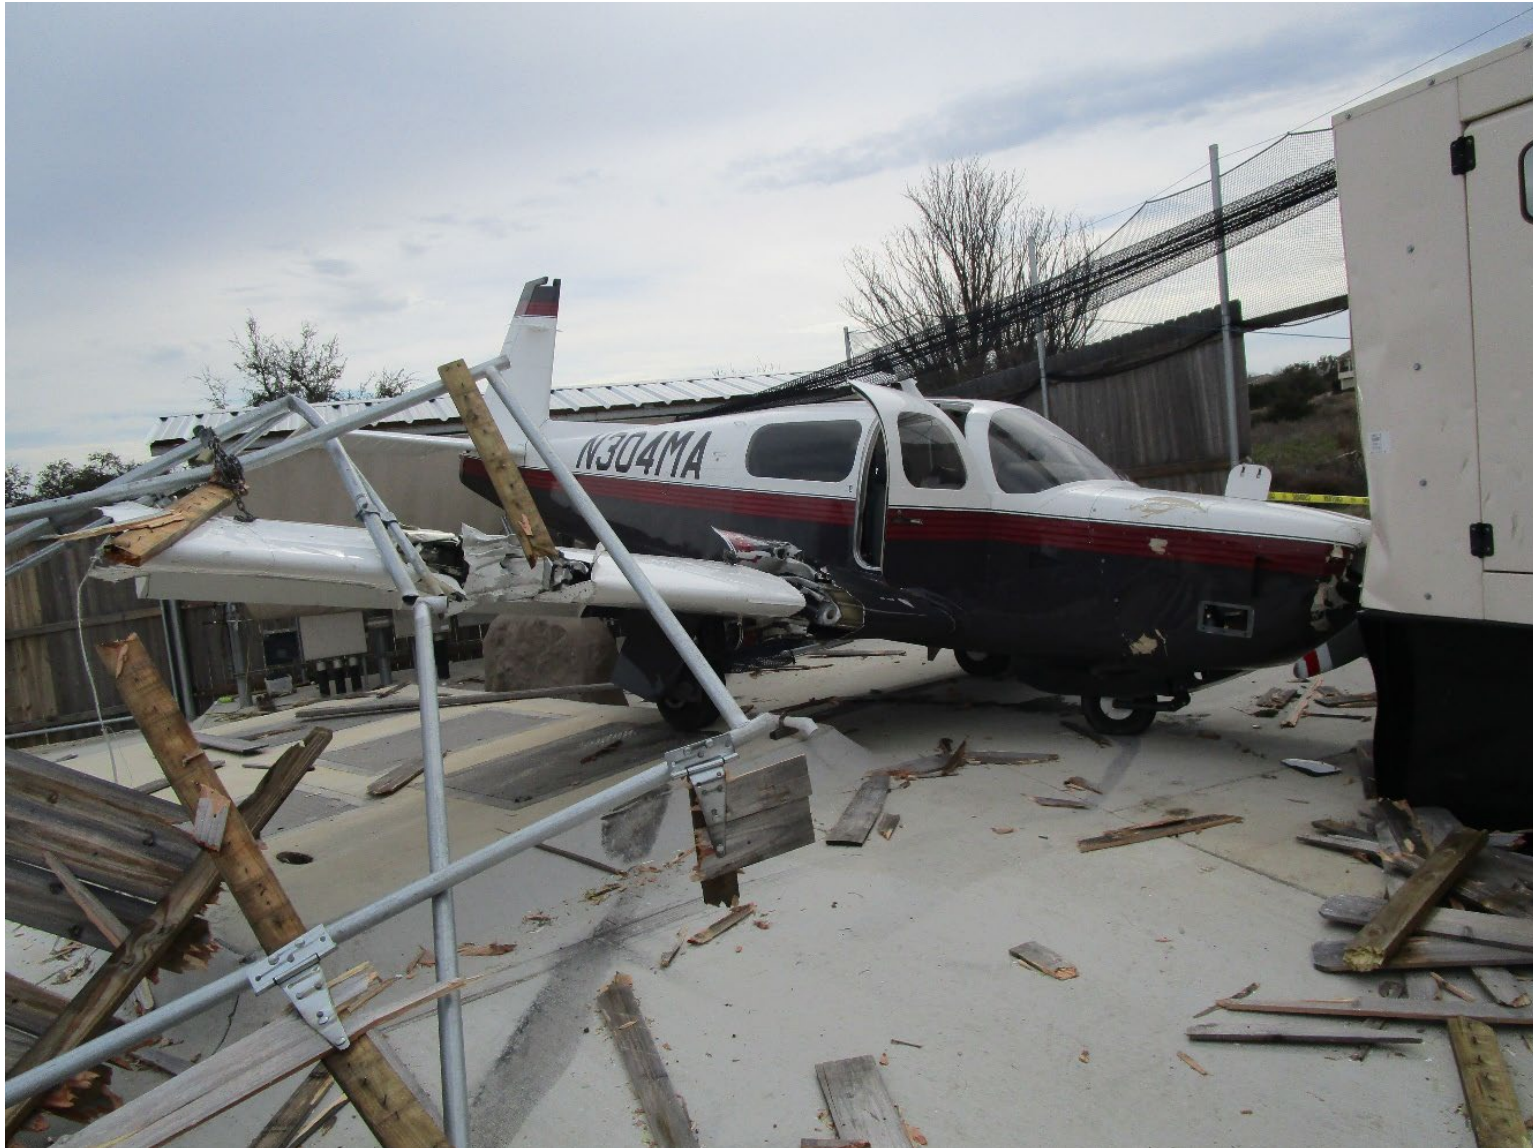
Photograph 7 - View of the right wing at the accident site (Courtesy of the Federal Aviation Administration)

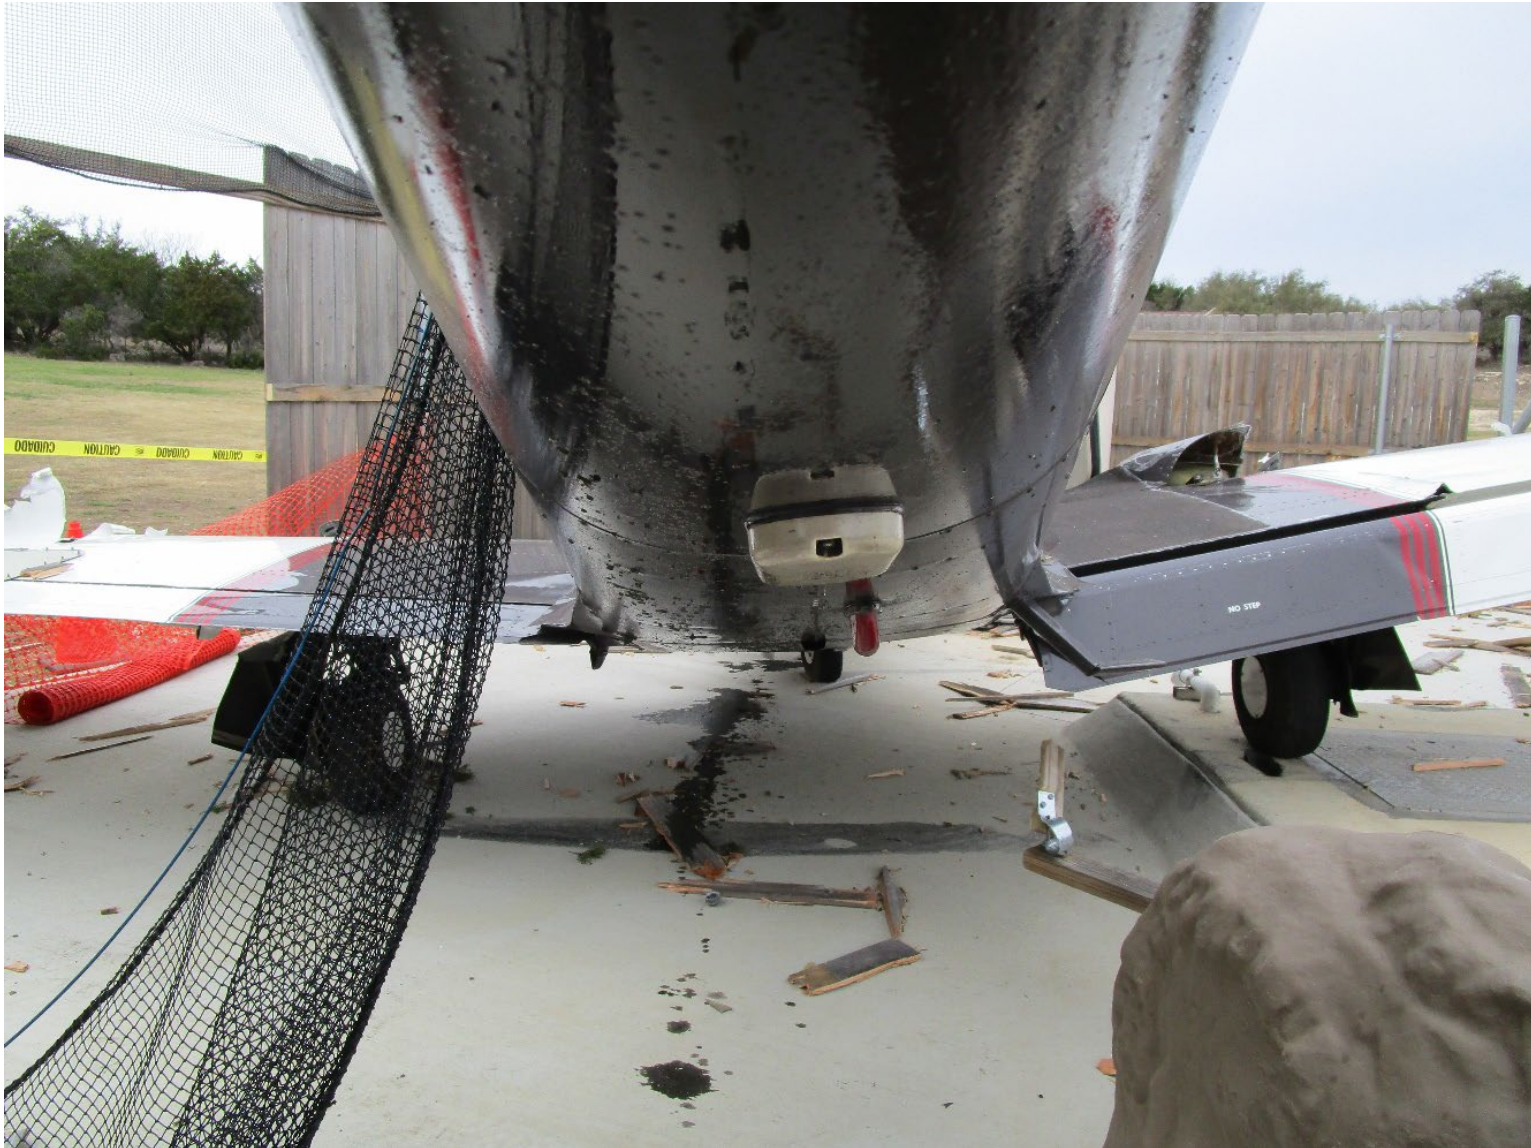
Photograph 8 - View of the underside of the fuselage at the accident site, coated with engine oil (Courtesy of the Federal Aviation Administration)

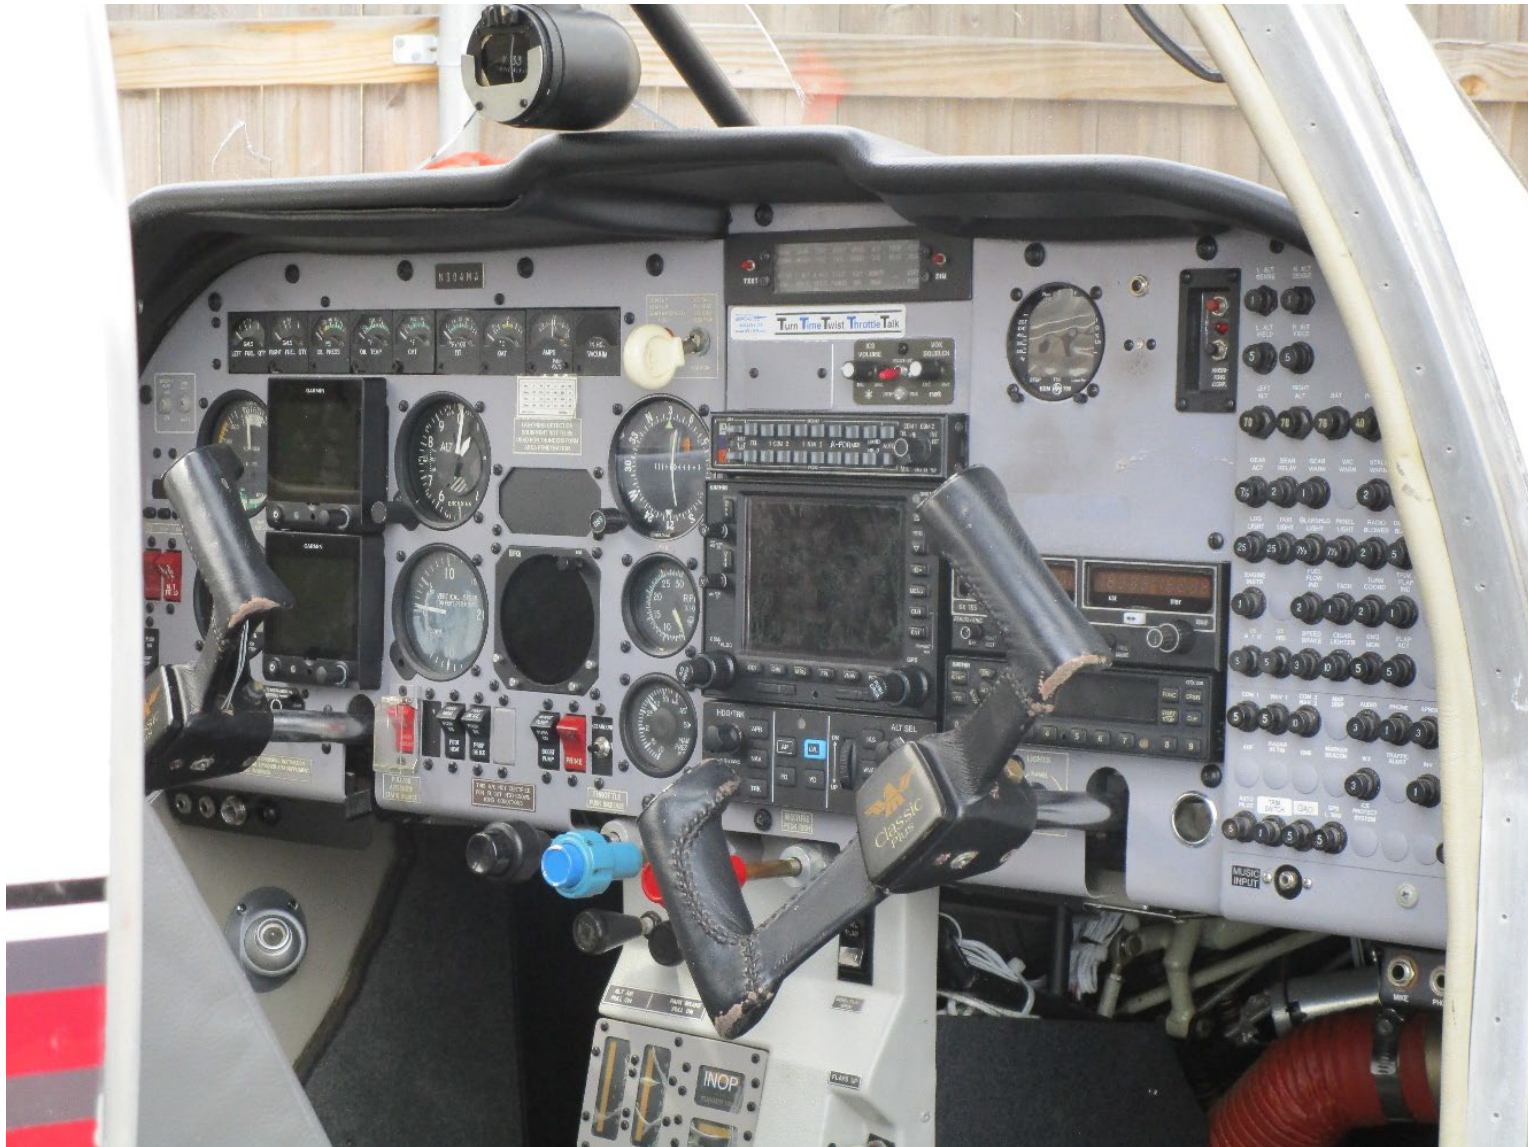
Photograph 10 - View of the cockpit at the accident site (Courtesy of the Federal Aviation Administration)

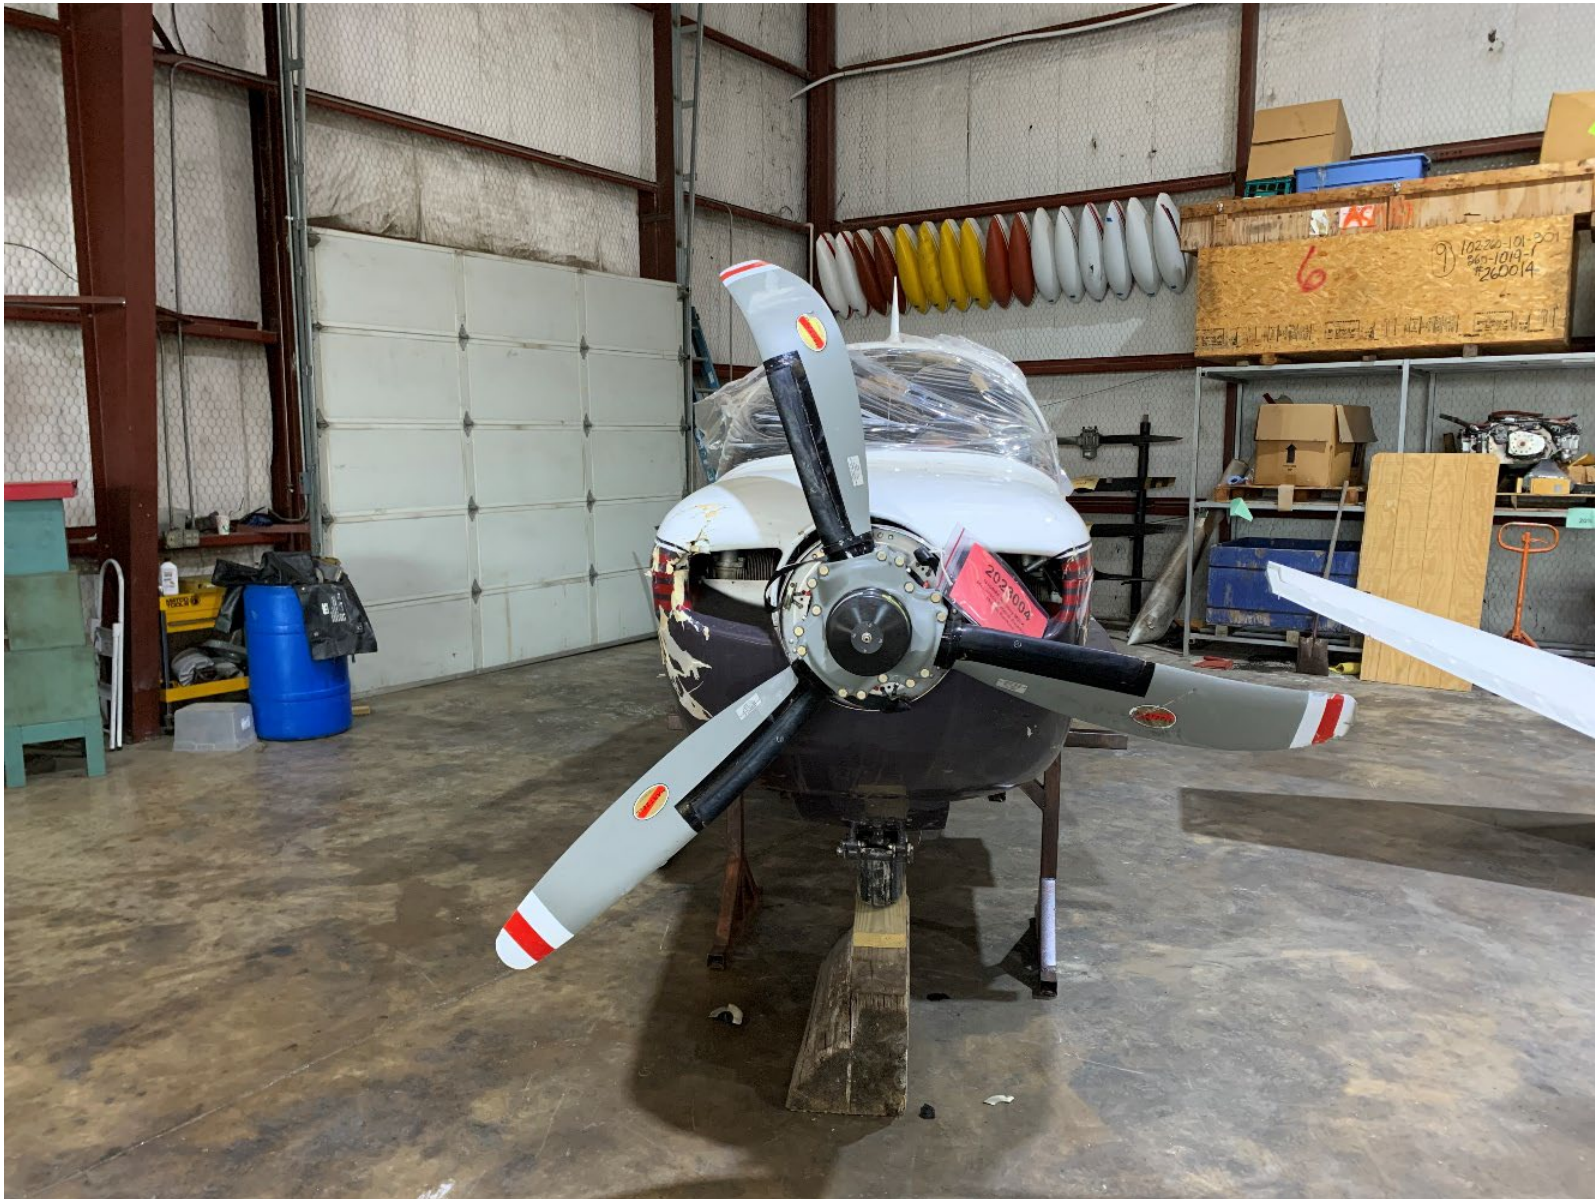
Photograph 11 - View of the front of the airplane at the salvage facility

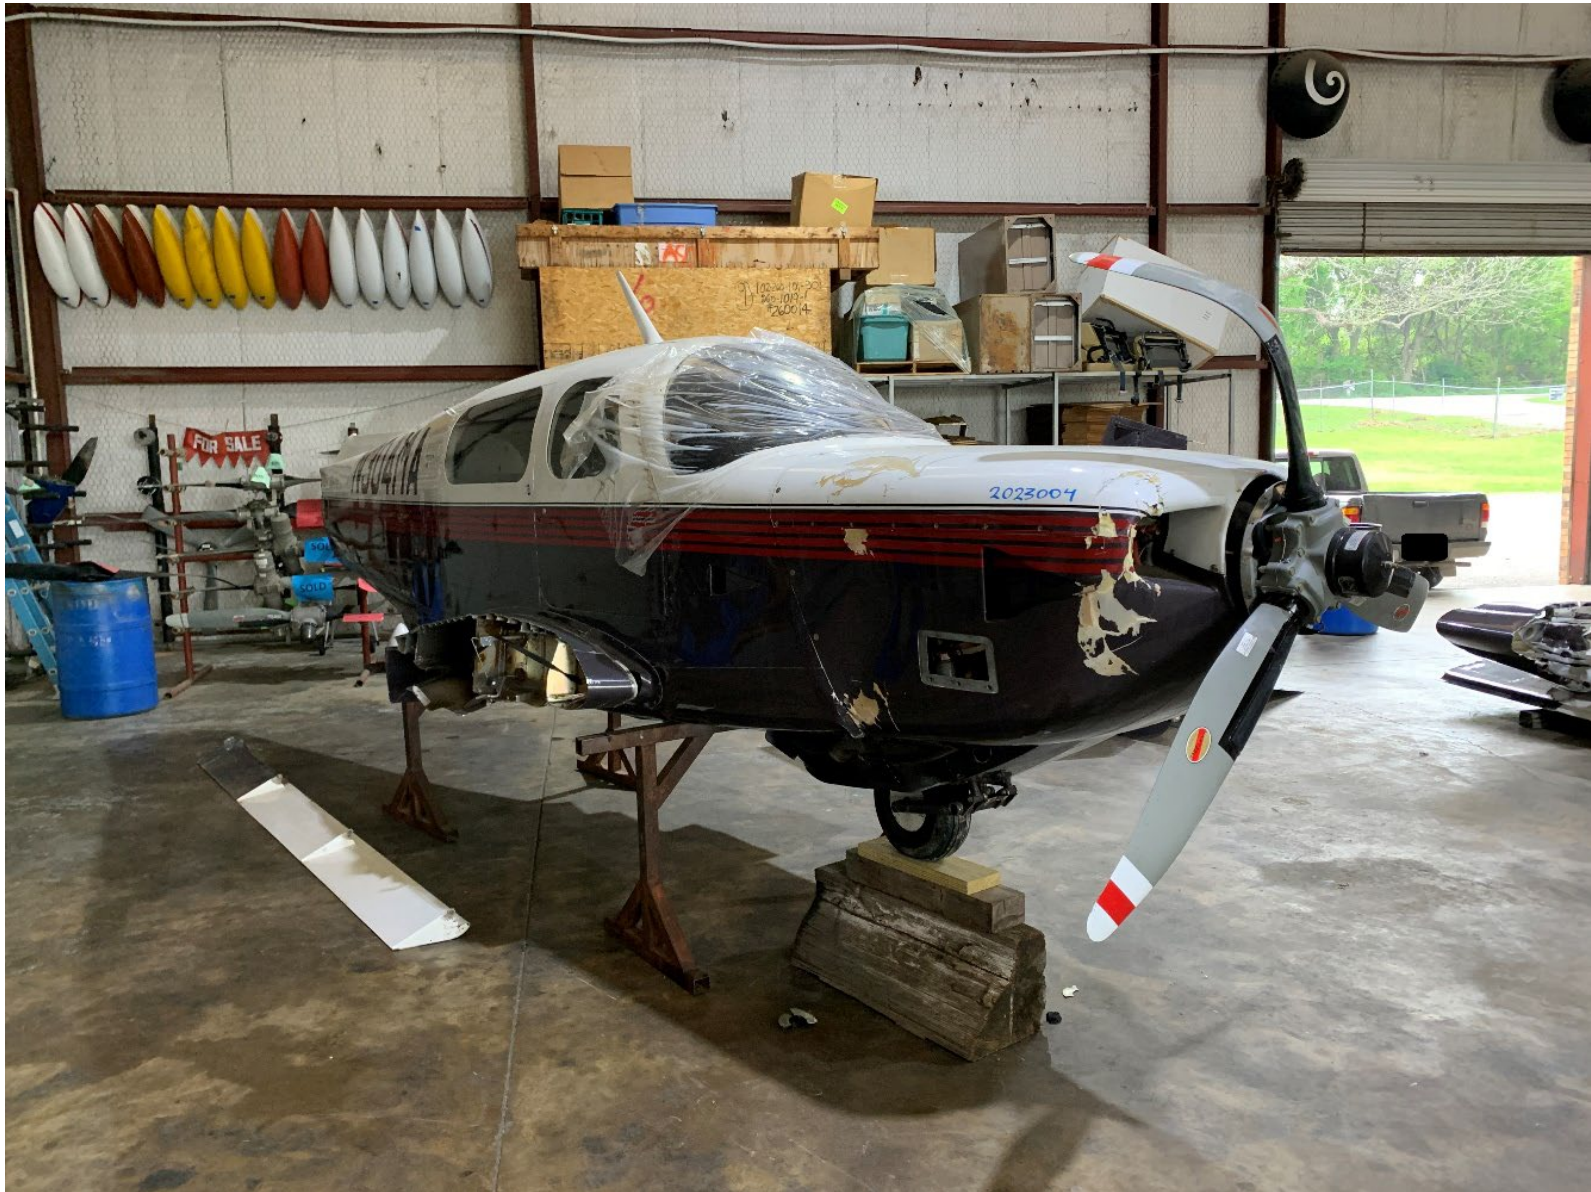
Photograph 12 - View of the right side of the airplane at the salvage facility

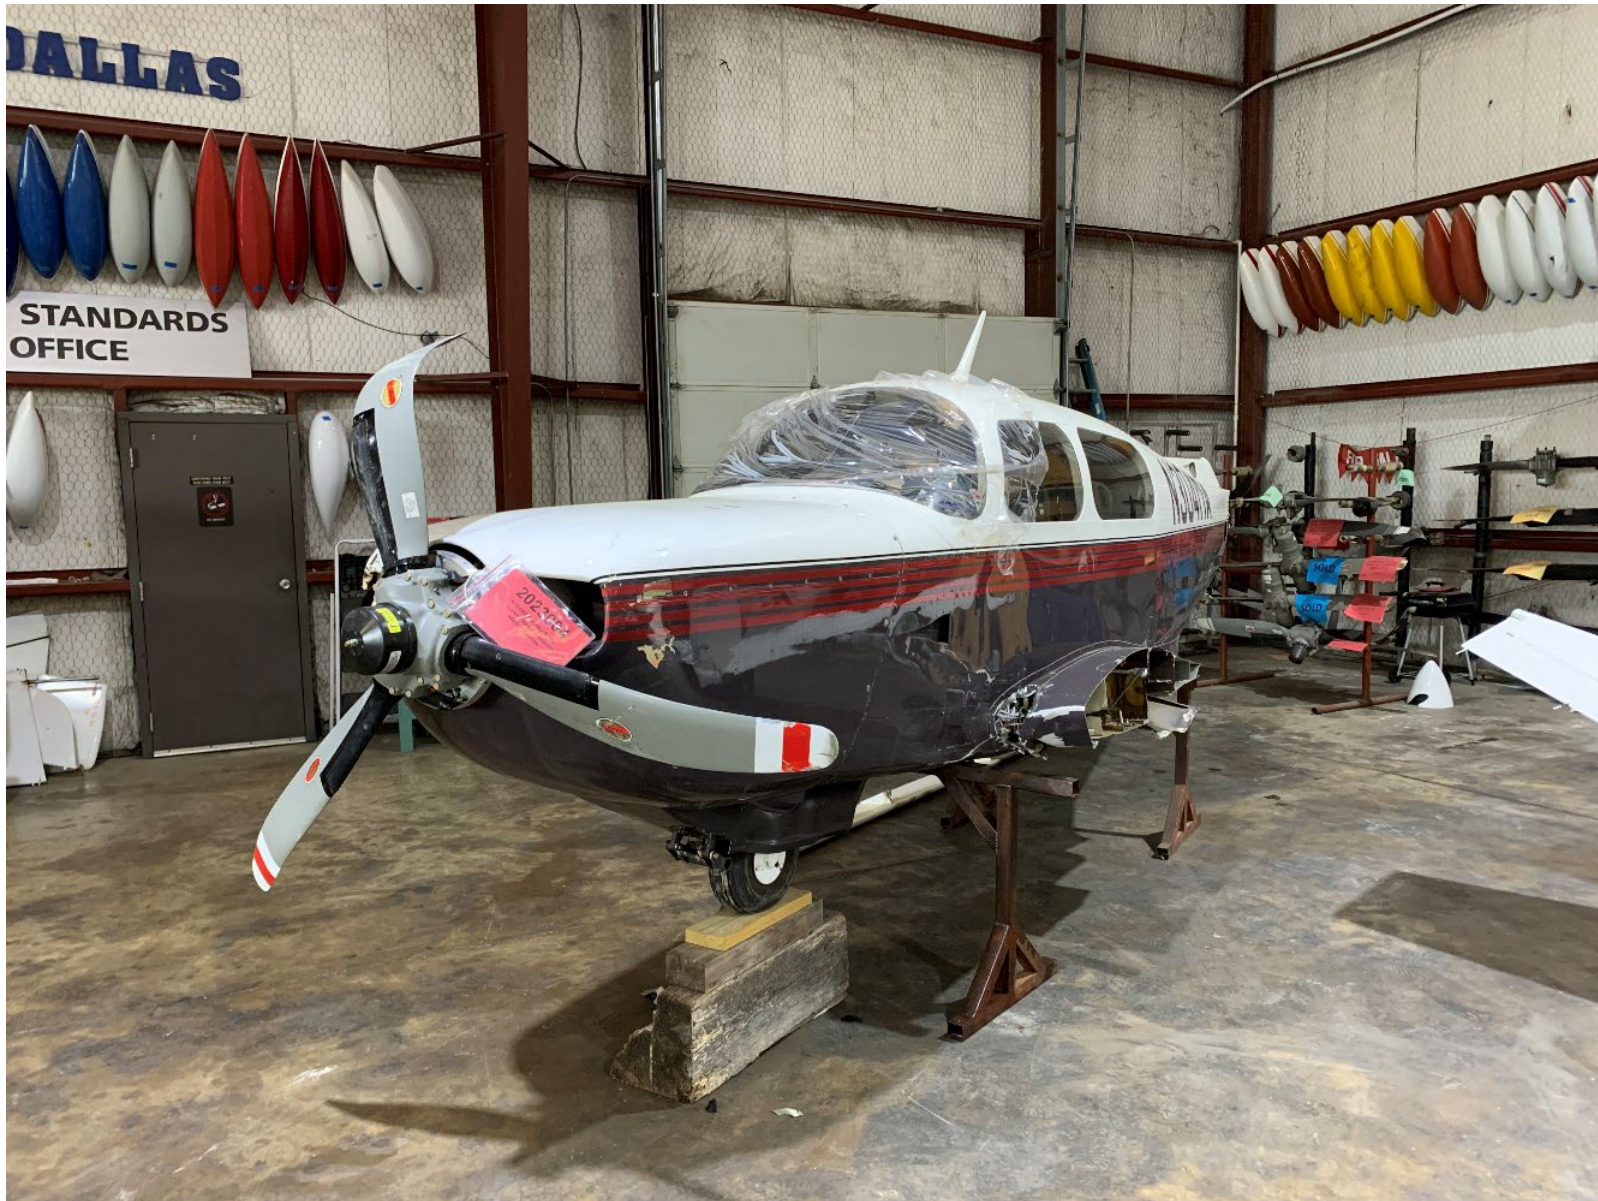
Photograph 13 - View of the left side of the airplane at the salvage facility
