CEN23LA107

INVESTIGATION PHOTOGRAPHS

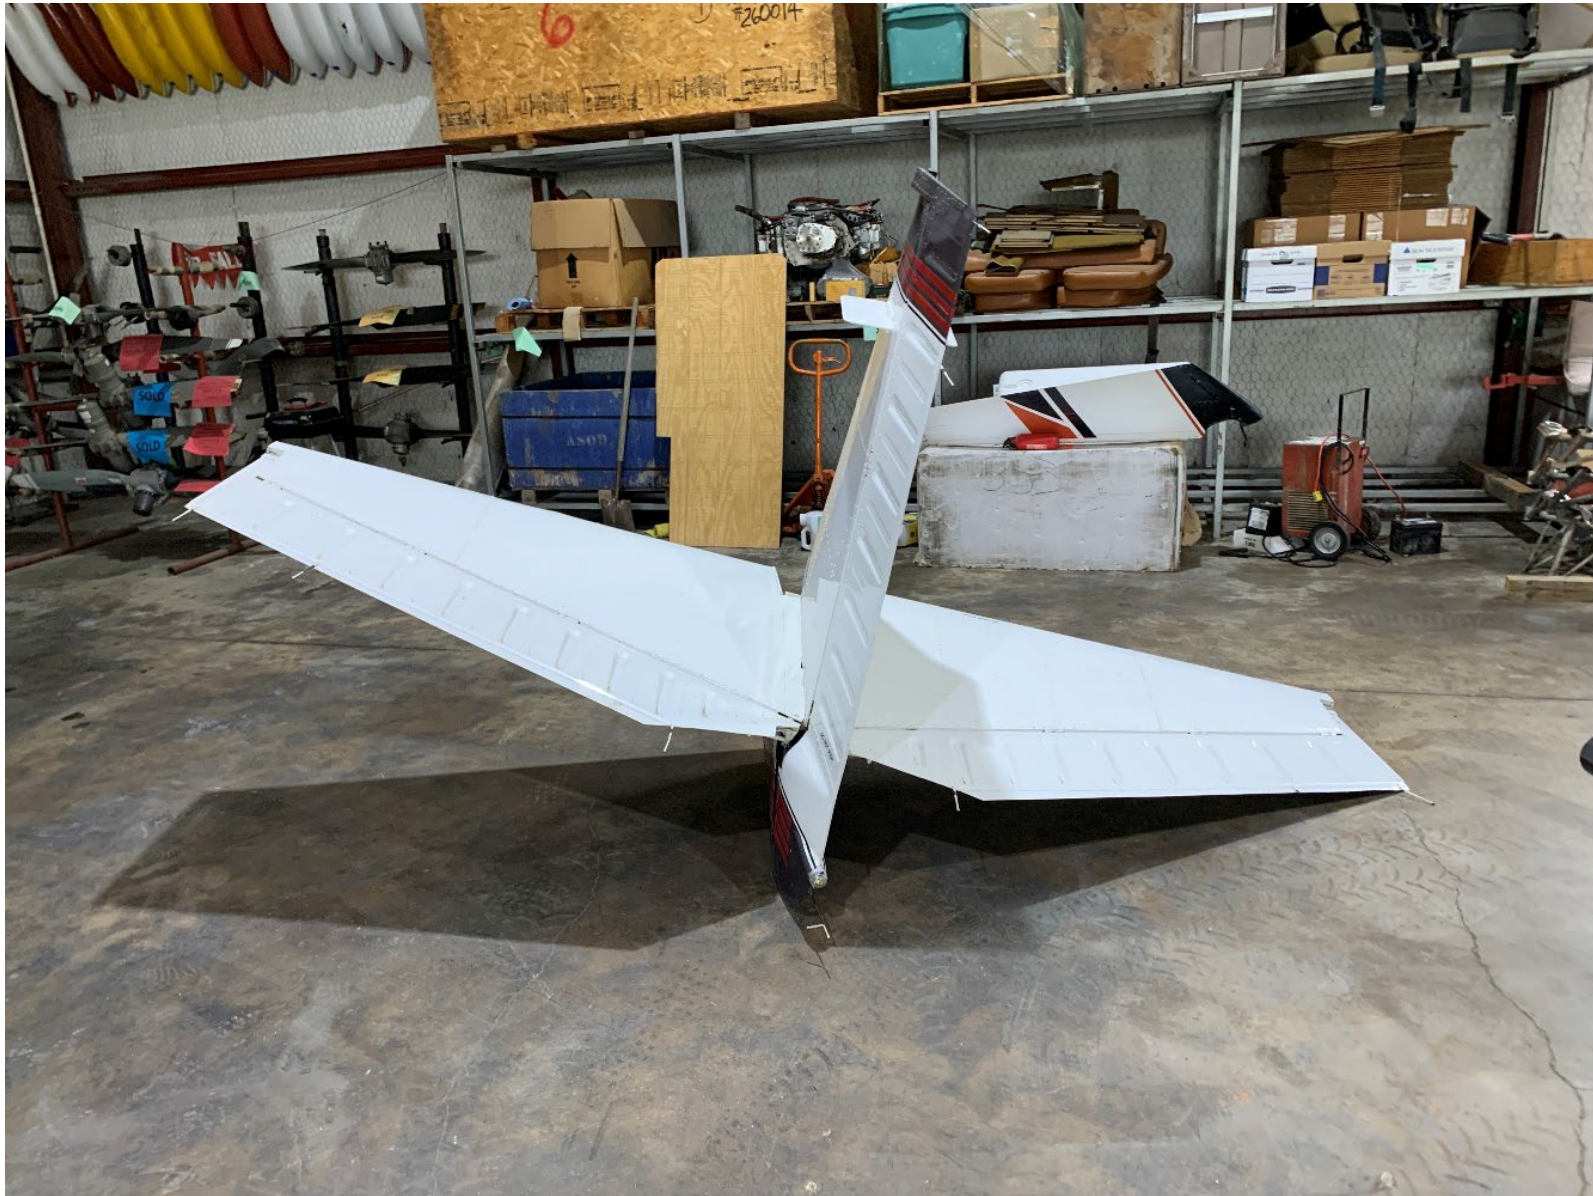
Photograph 14 - View of the empennage at the salvage facility

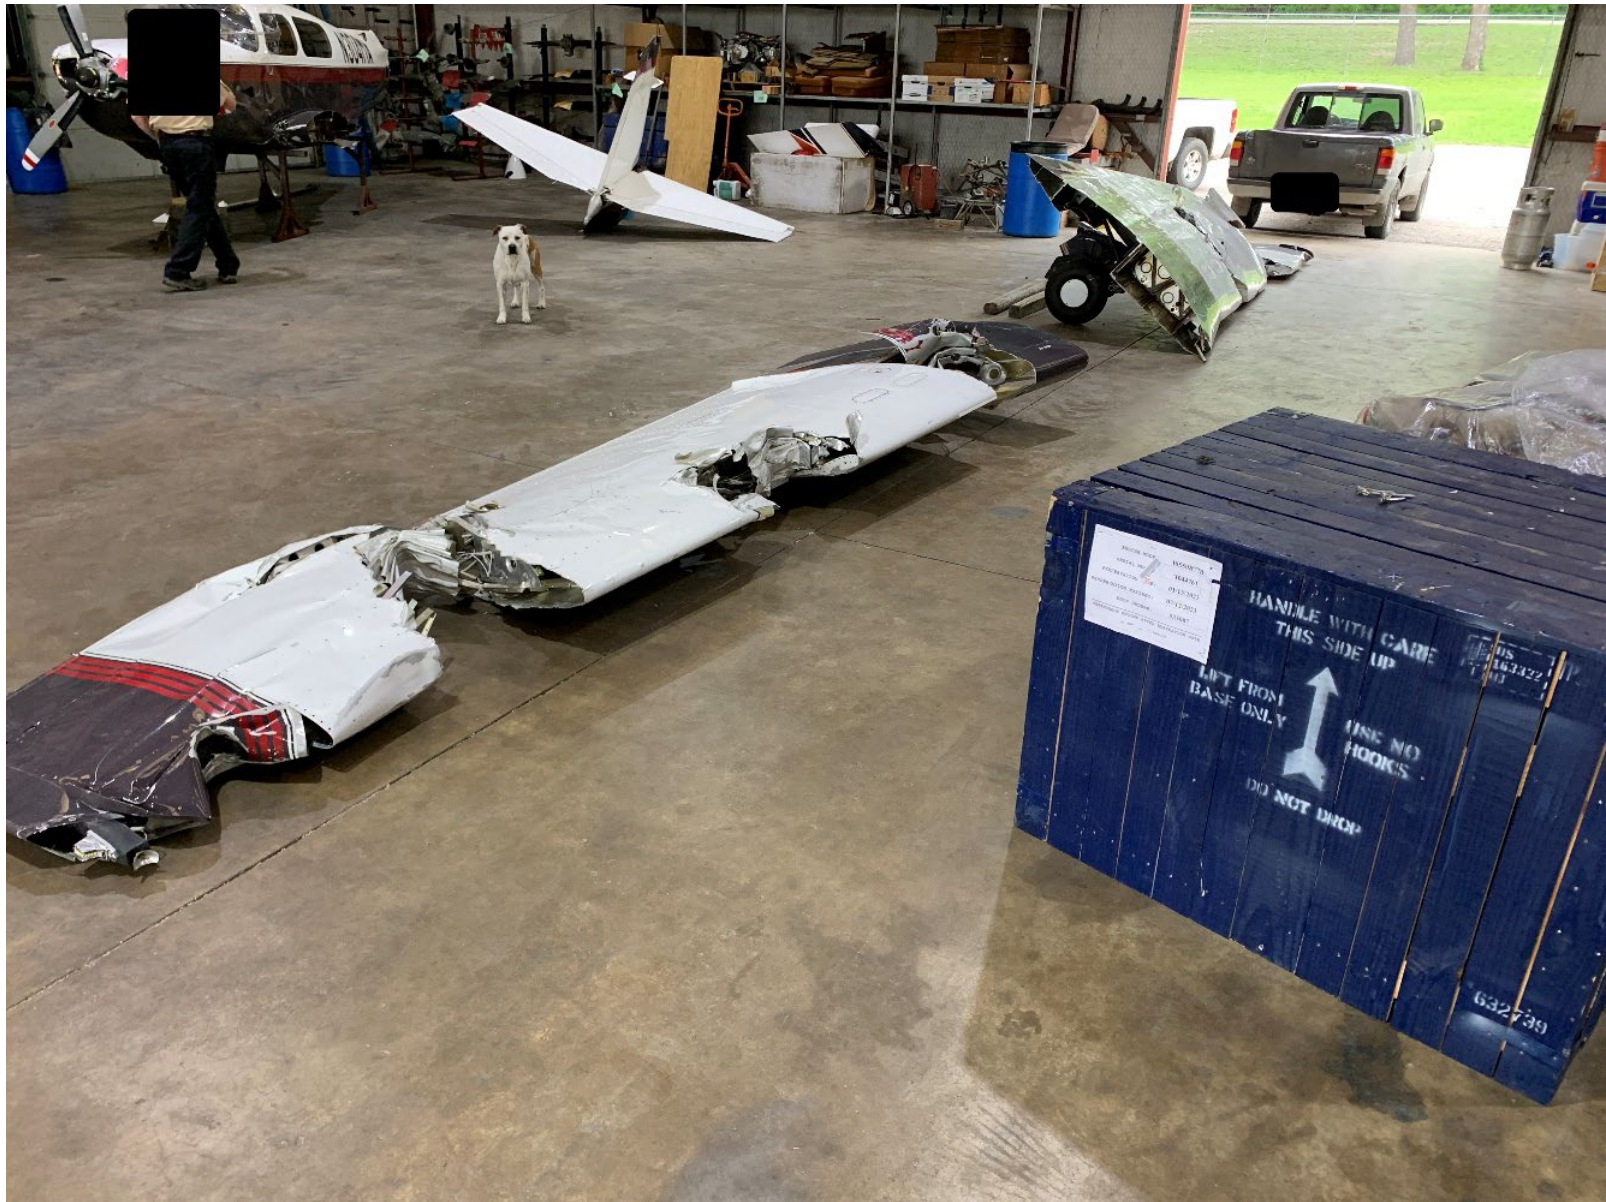
Photograph 15 - View of both wings at the salvage facility

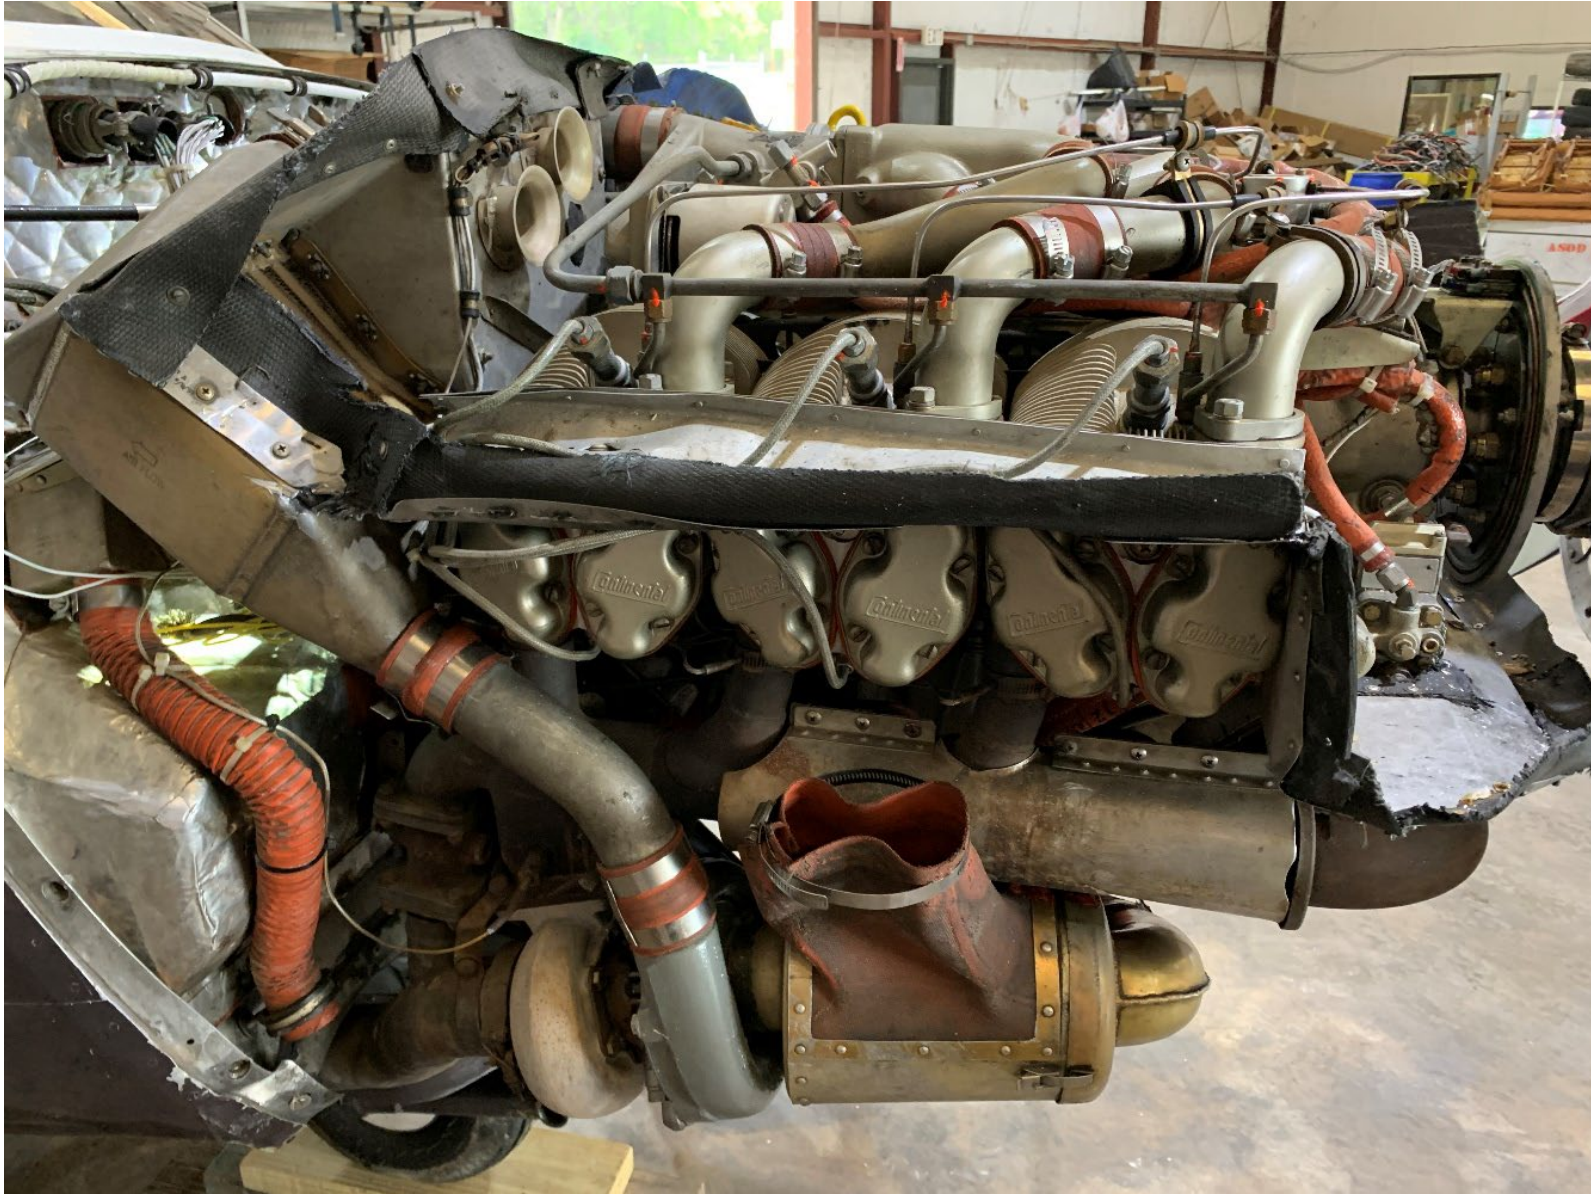
Photograph 16 - View of the right side of the engine at the salvage facility

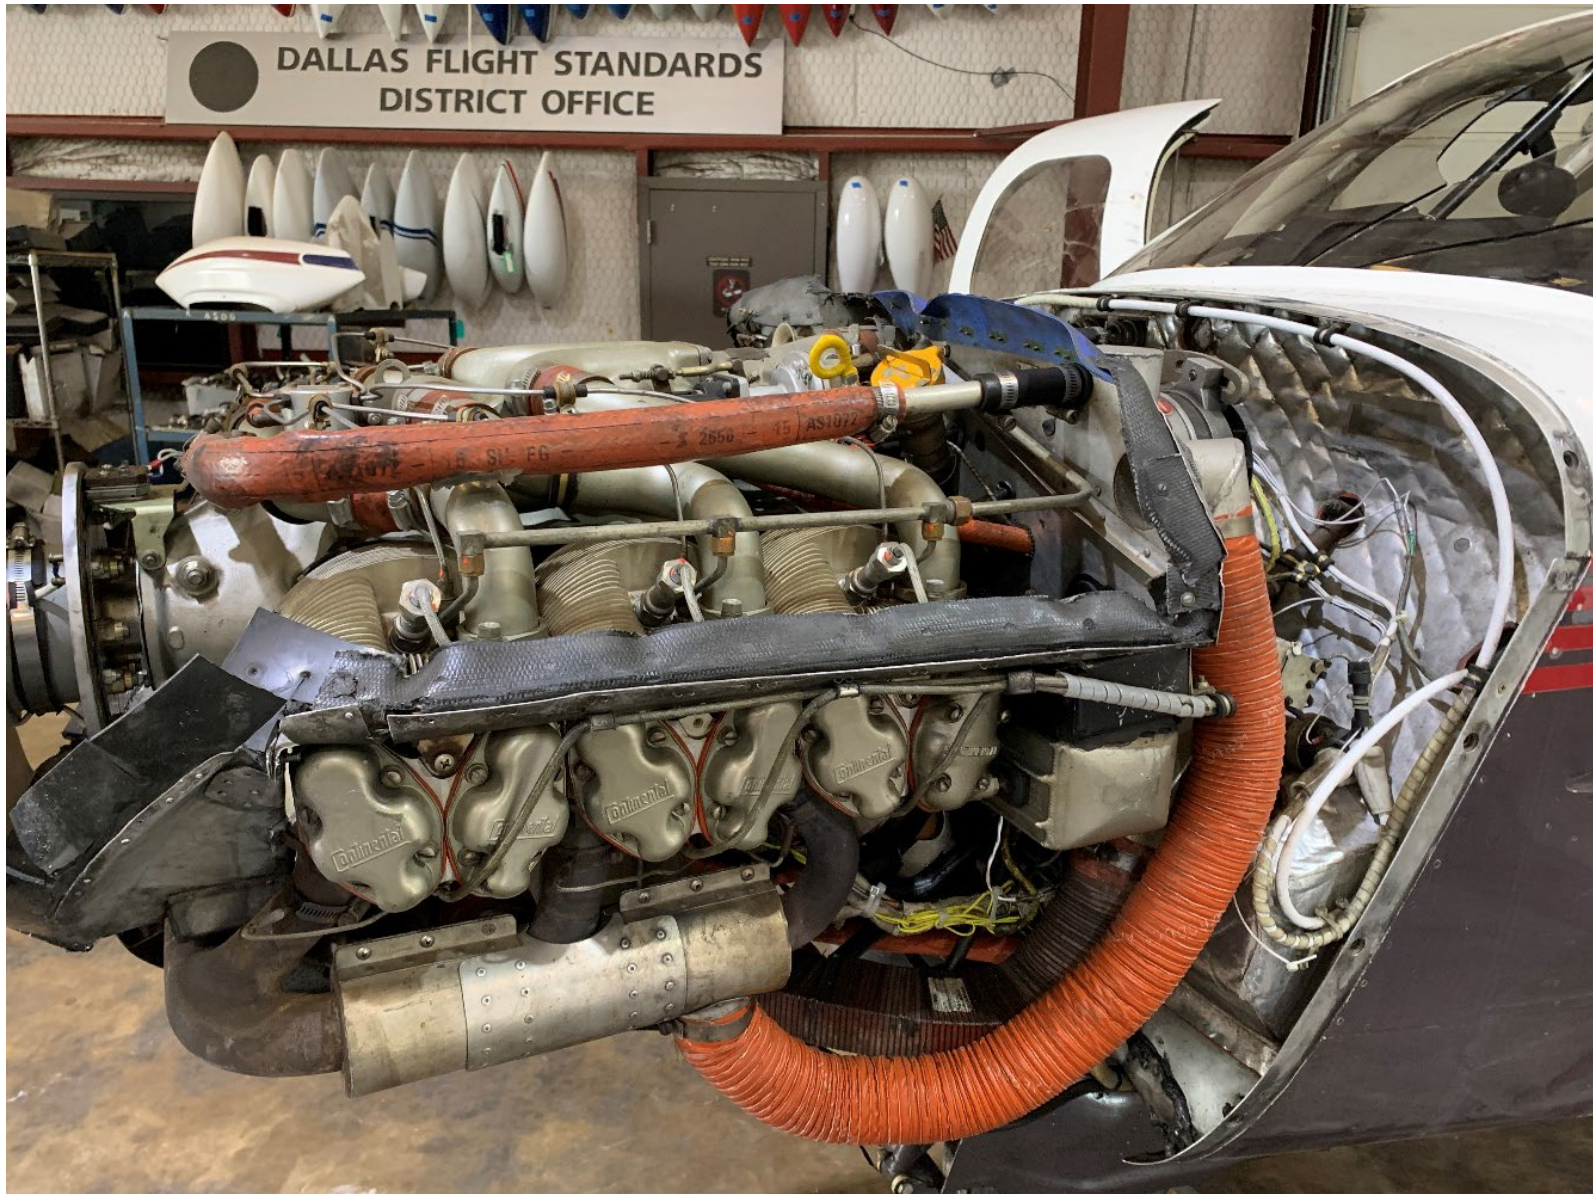
Photograph 17 - View of the left side of the engine at the salvage facility

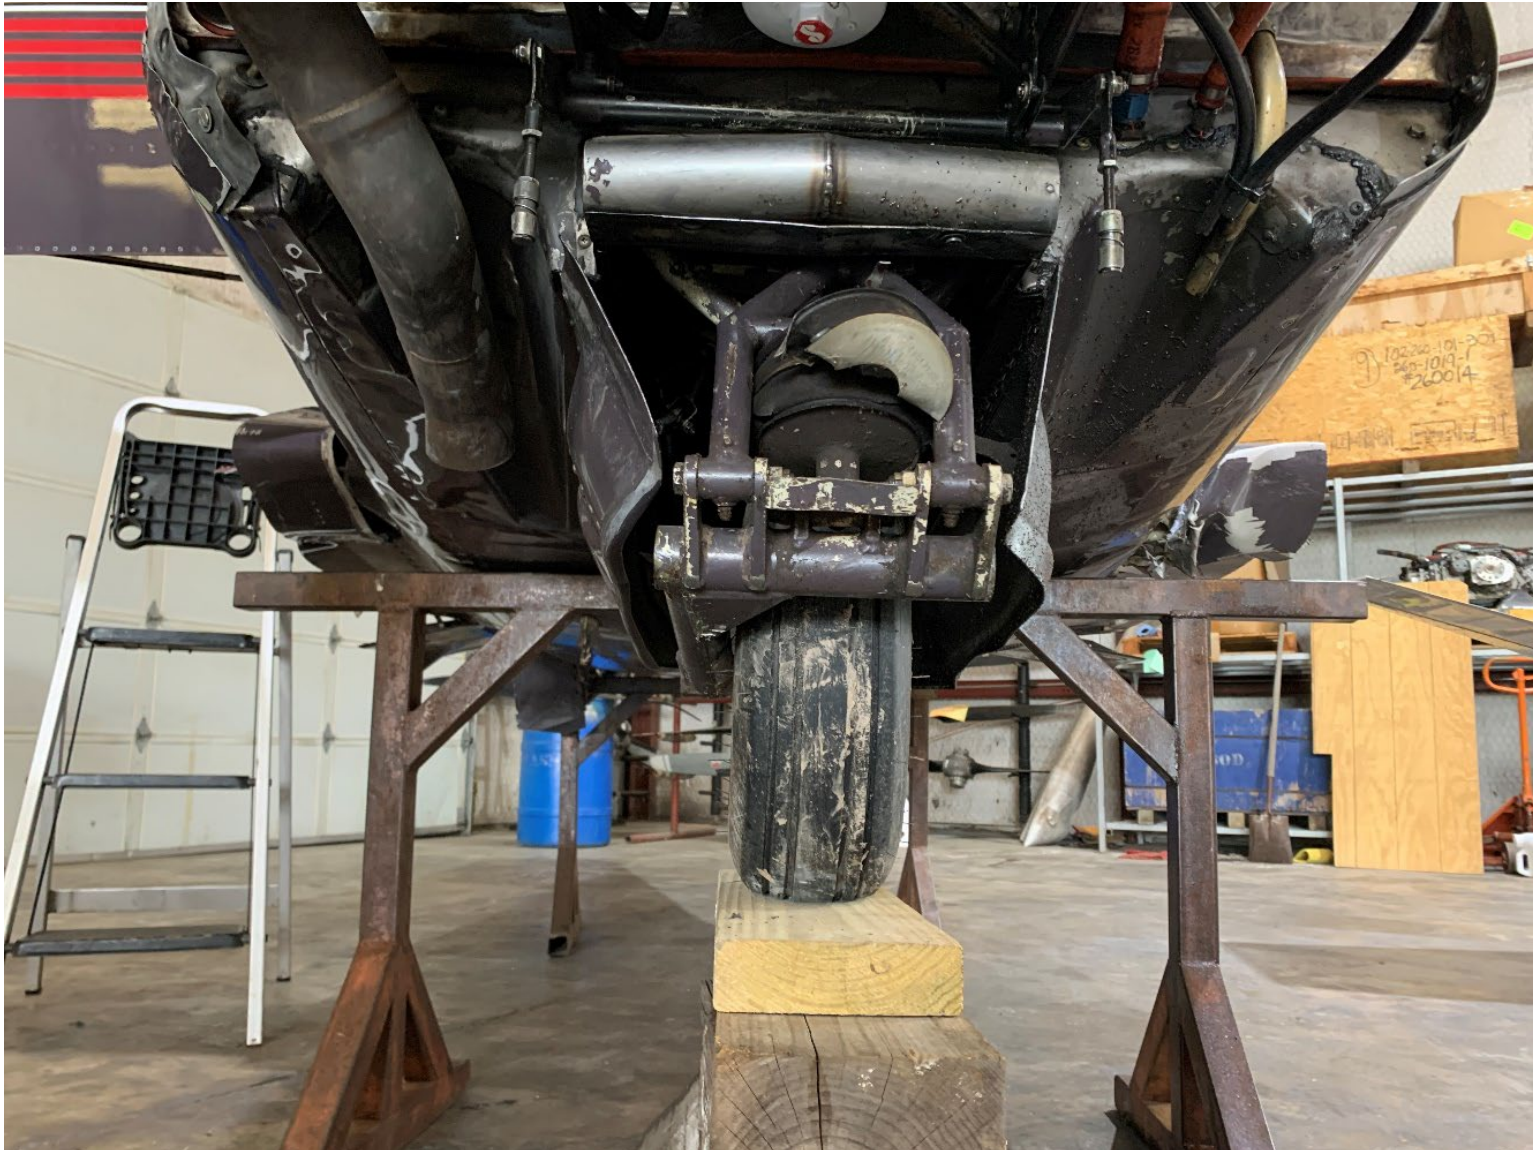
Photograph 18 - View of the underside of the fuselage at the salvage facility, coated with engine oil

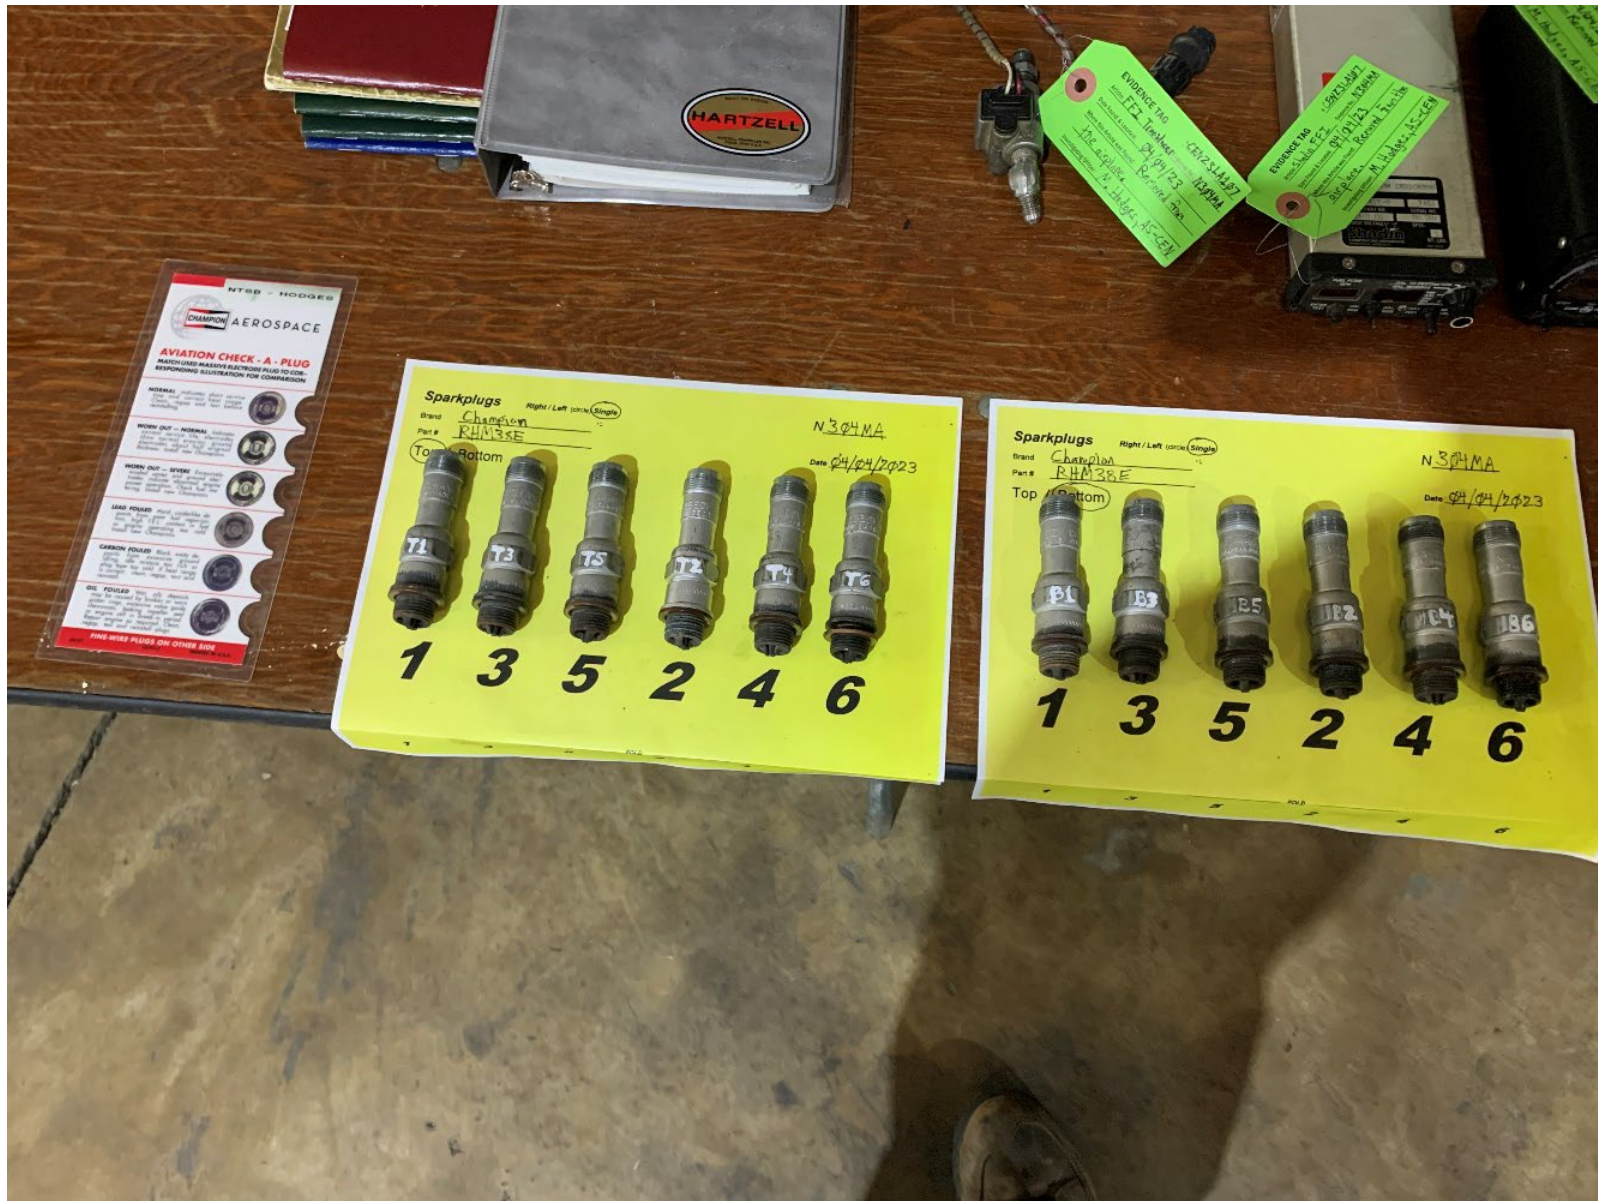
Photograph 19 - View of the spark plugs at the salvage facility

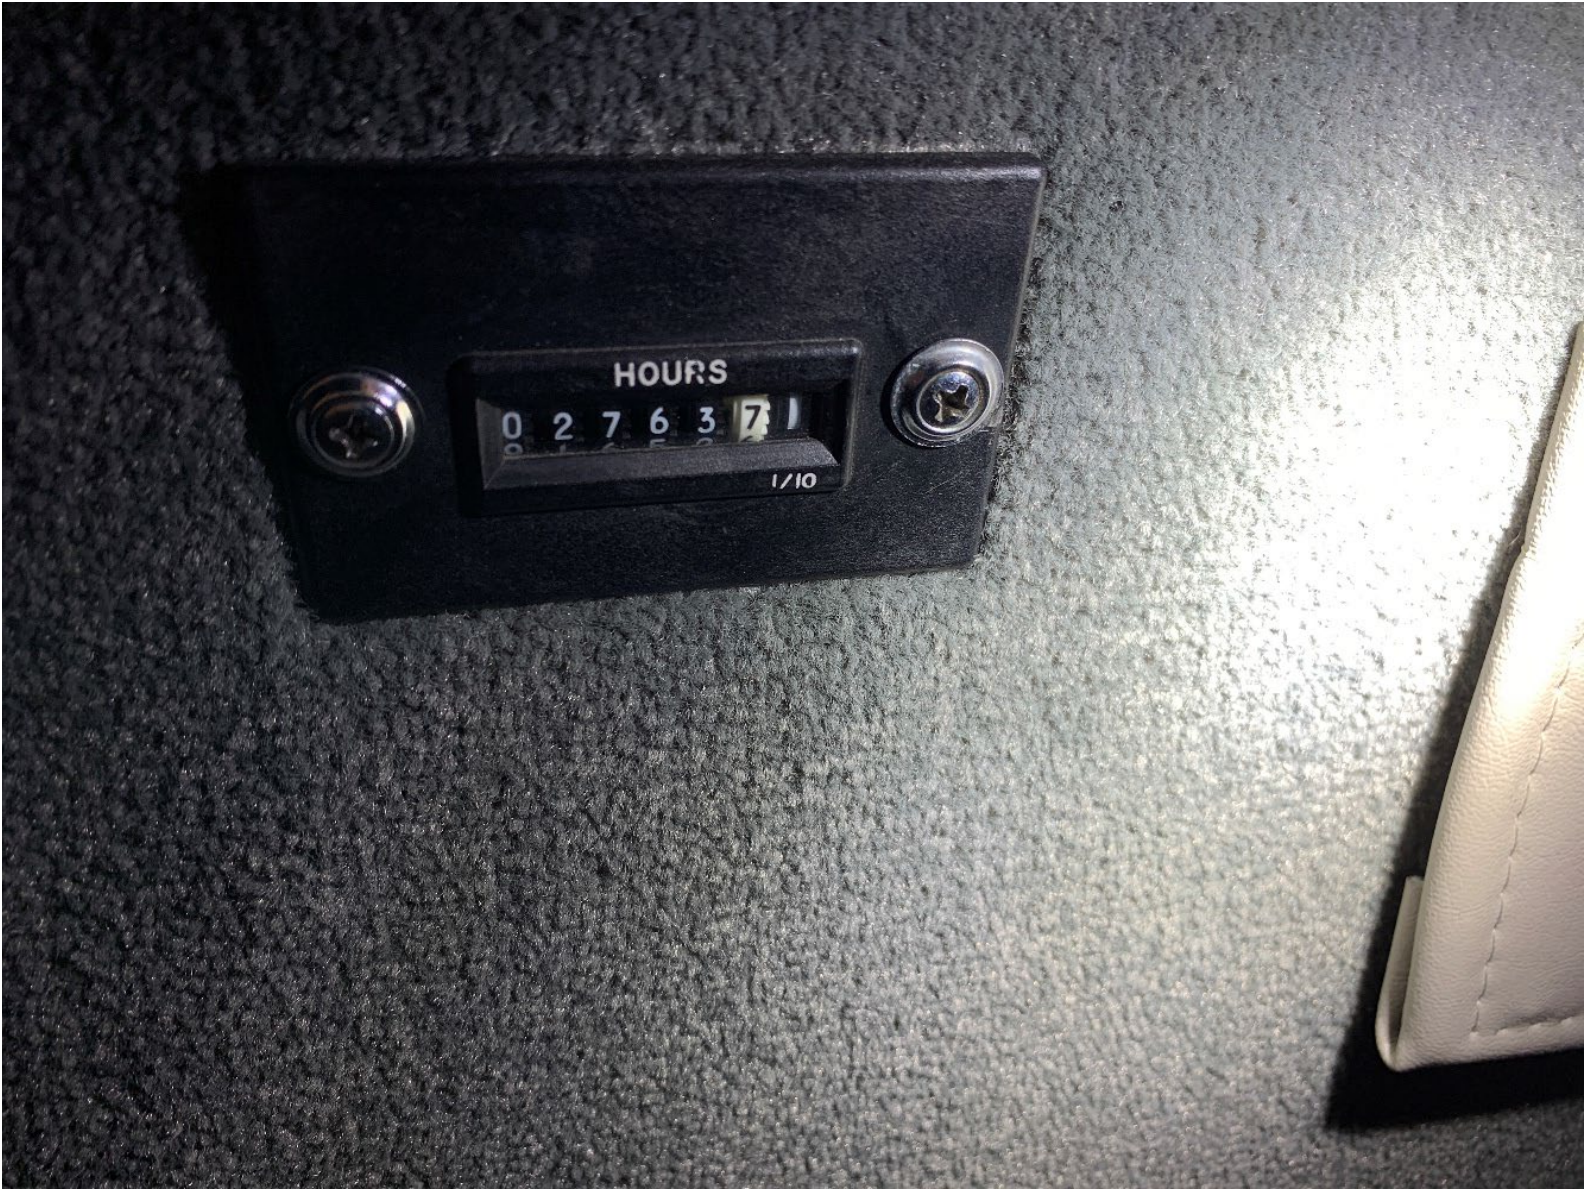
Photograph 20 - View of the Hobbs meter at the salvage facility
