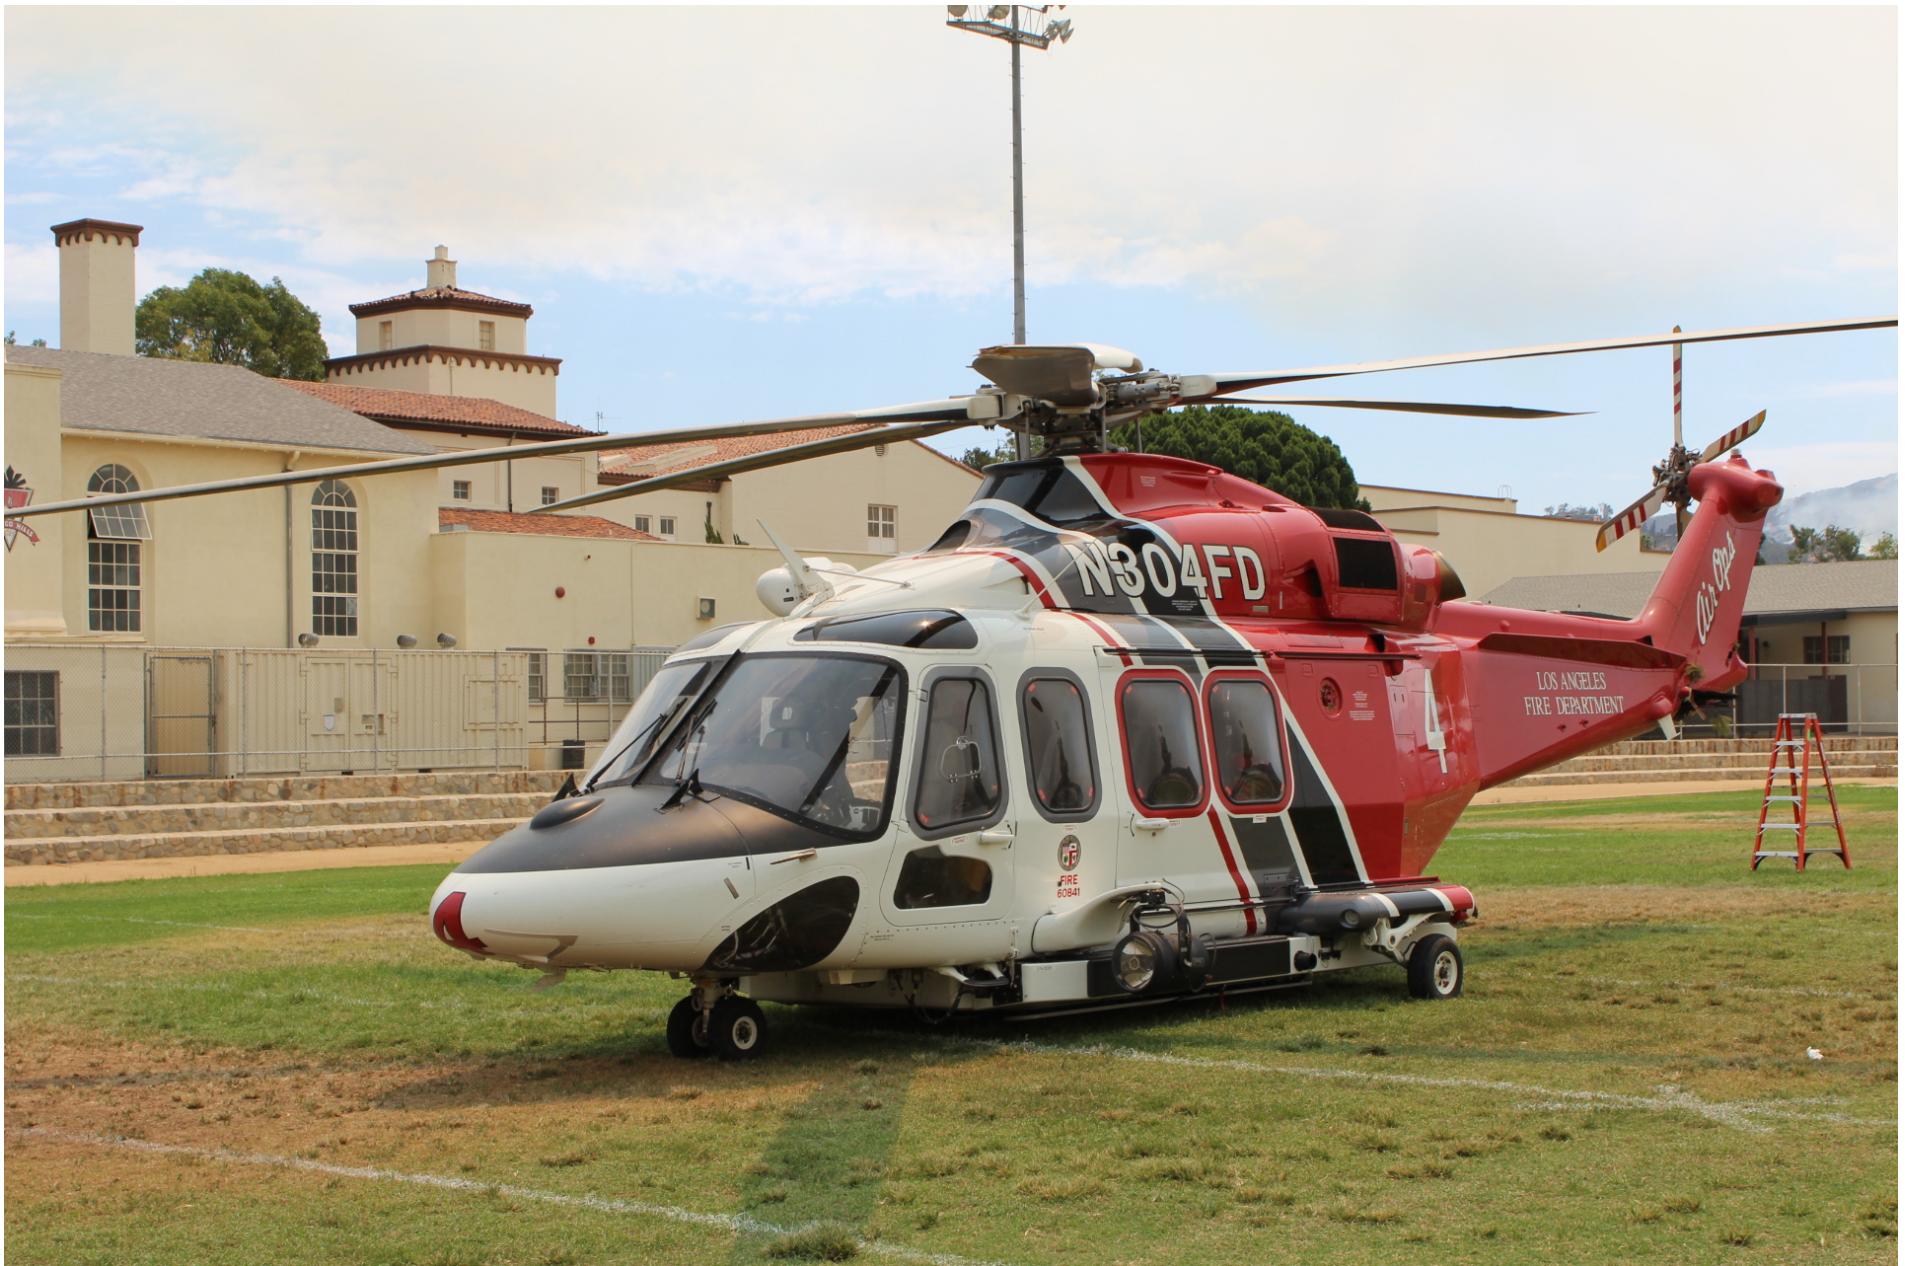
**Photo 3 – Postaccident view of the helicopter equipped with the belly-mounted Simplex Aerospace Model 326 GII Fire Attack System (courtesy of the LAFD).**

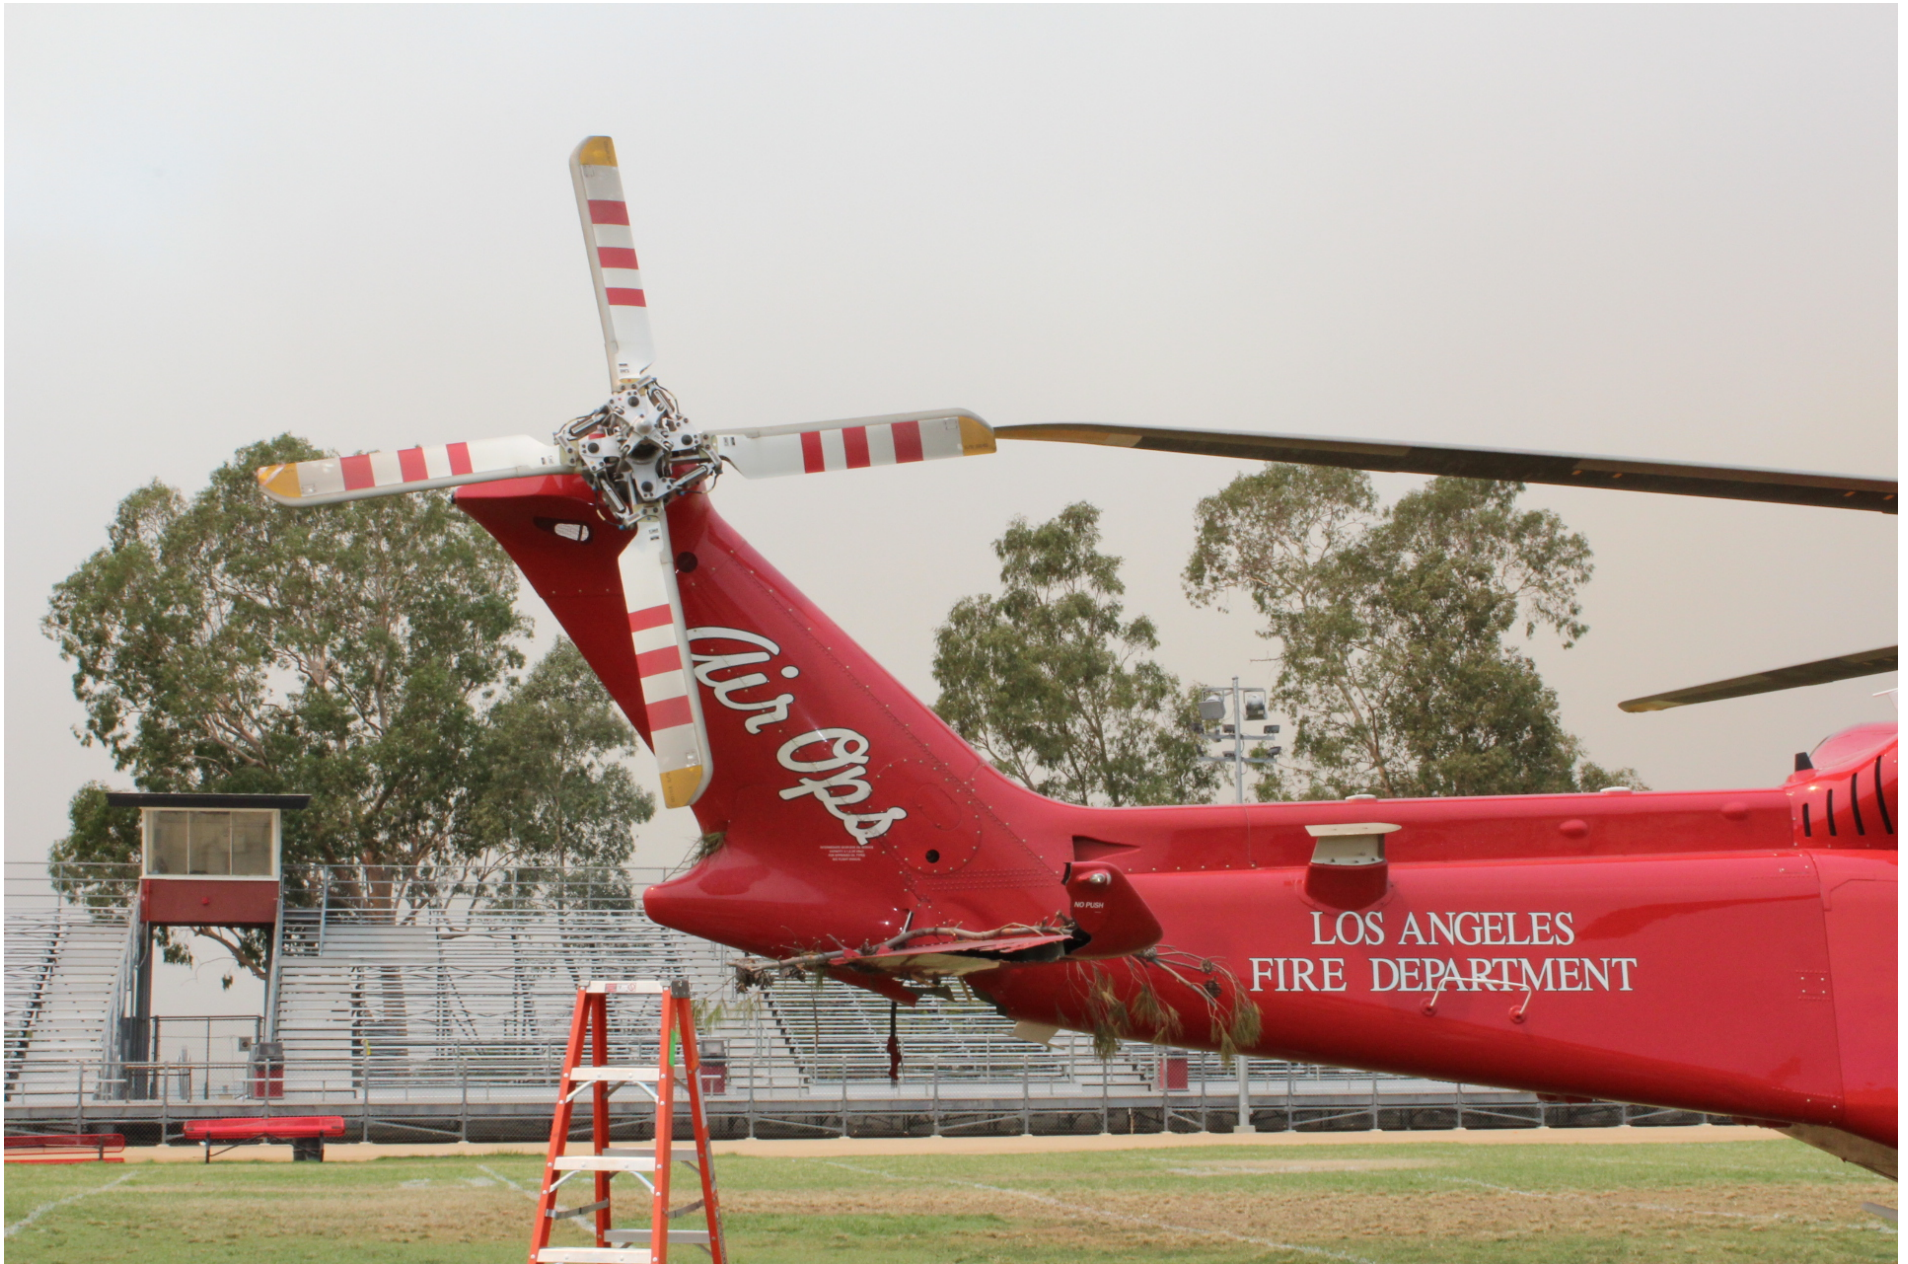
**Photo 4 – View of the substantial damage to the empennage with embedded pine tree branches (courtesy of the LAFD).**

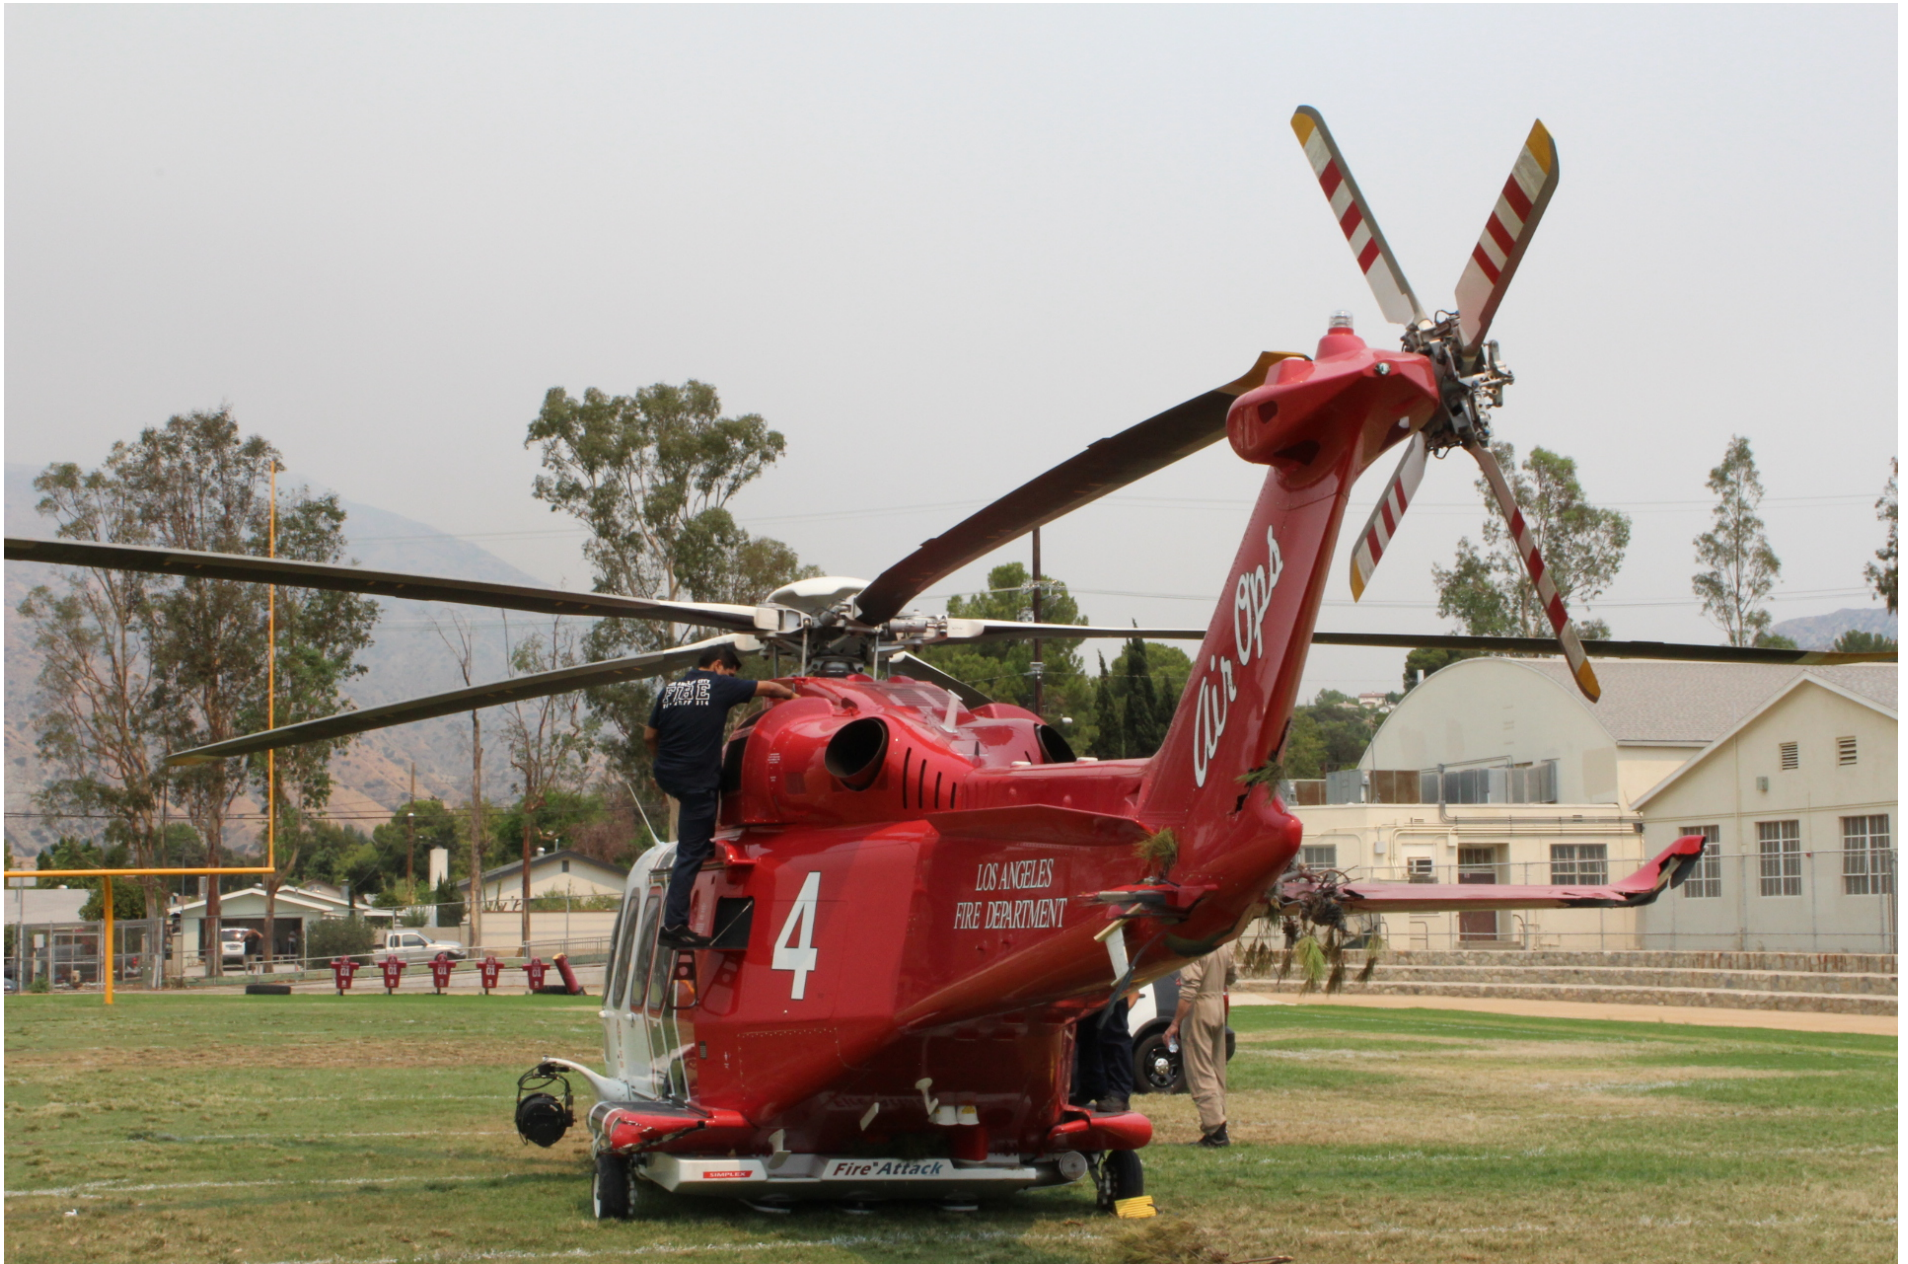
**Photo 5 – View of the substantial damage to the empennage with embedded pine tree branches (courtesy of the LAFD).**

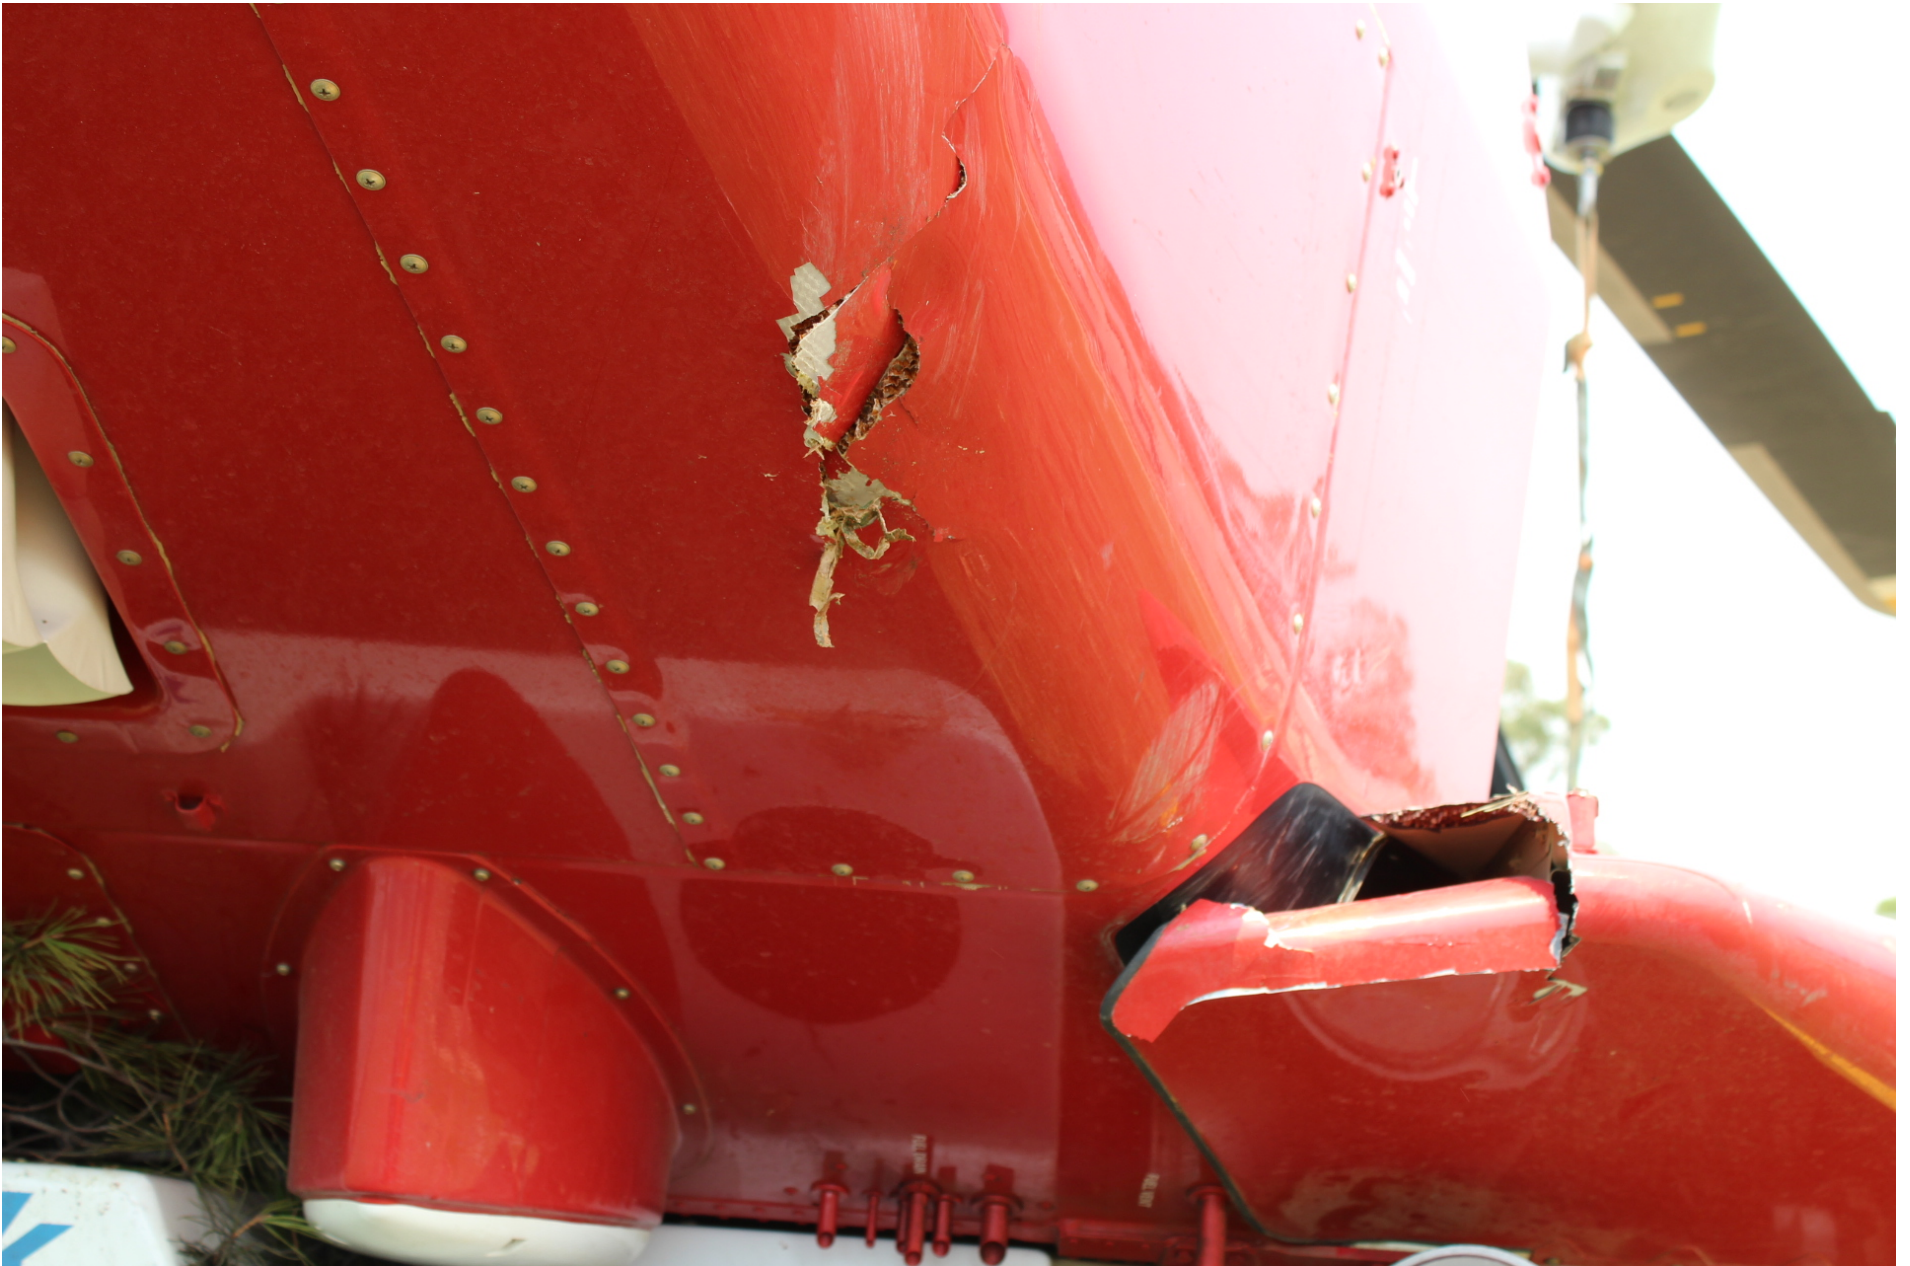
**Photo 6 – View of the substantial damage to the tailboom (courtesy of the LAFD).**

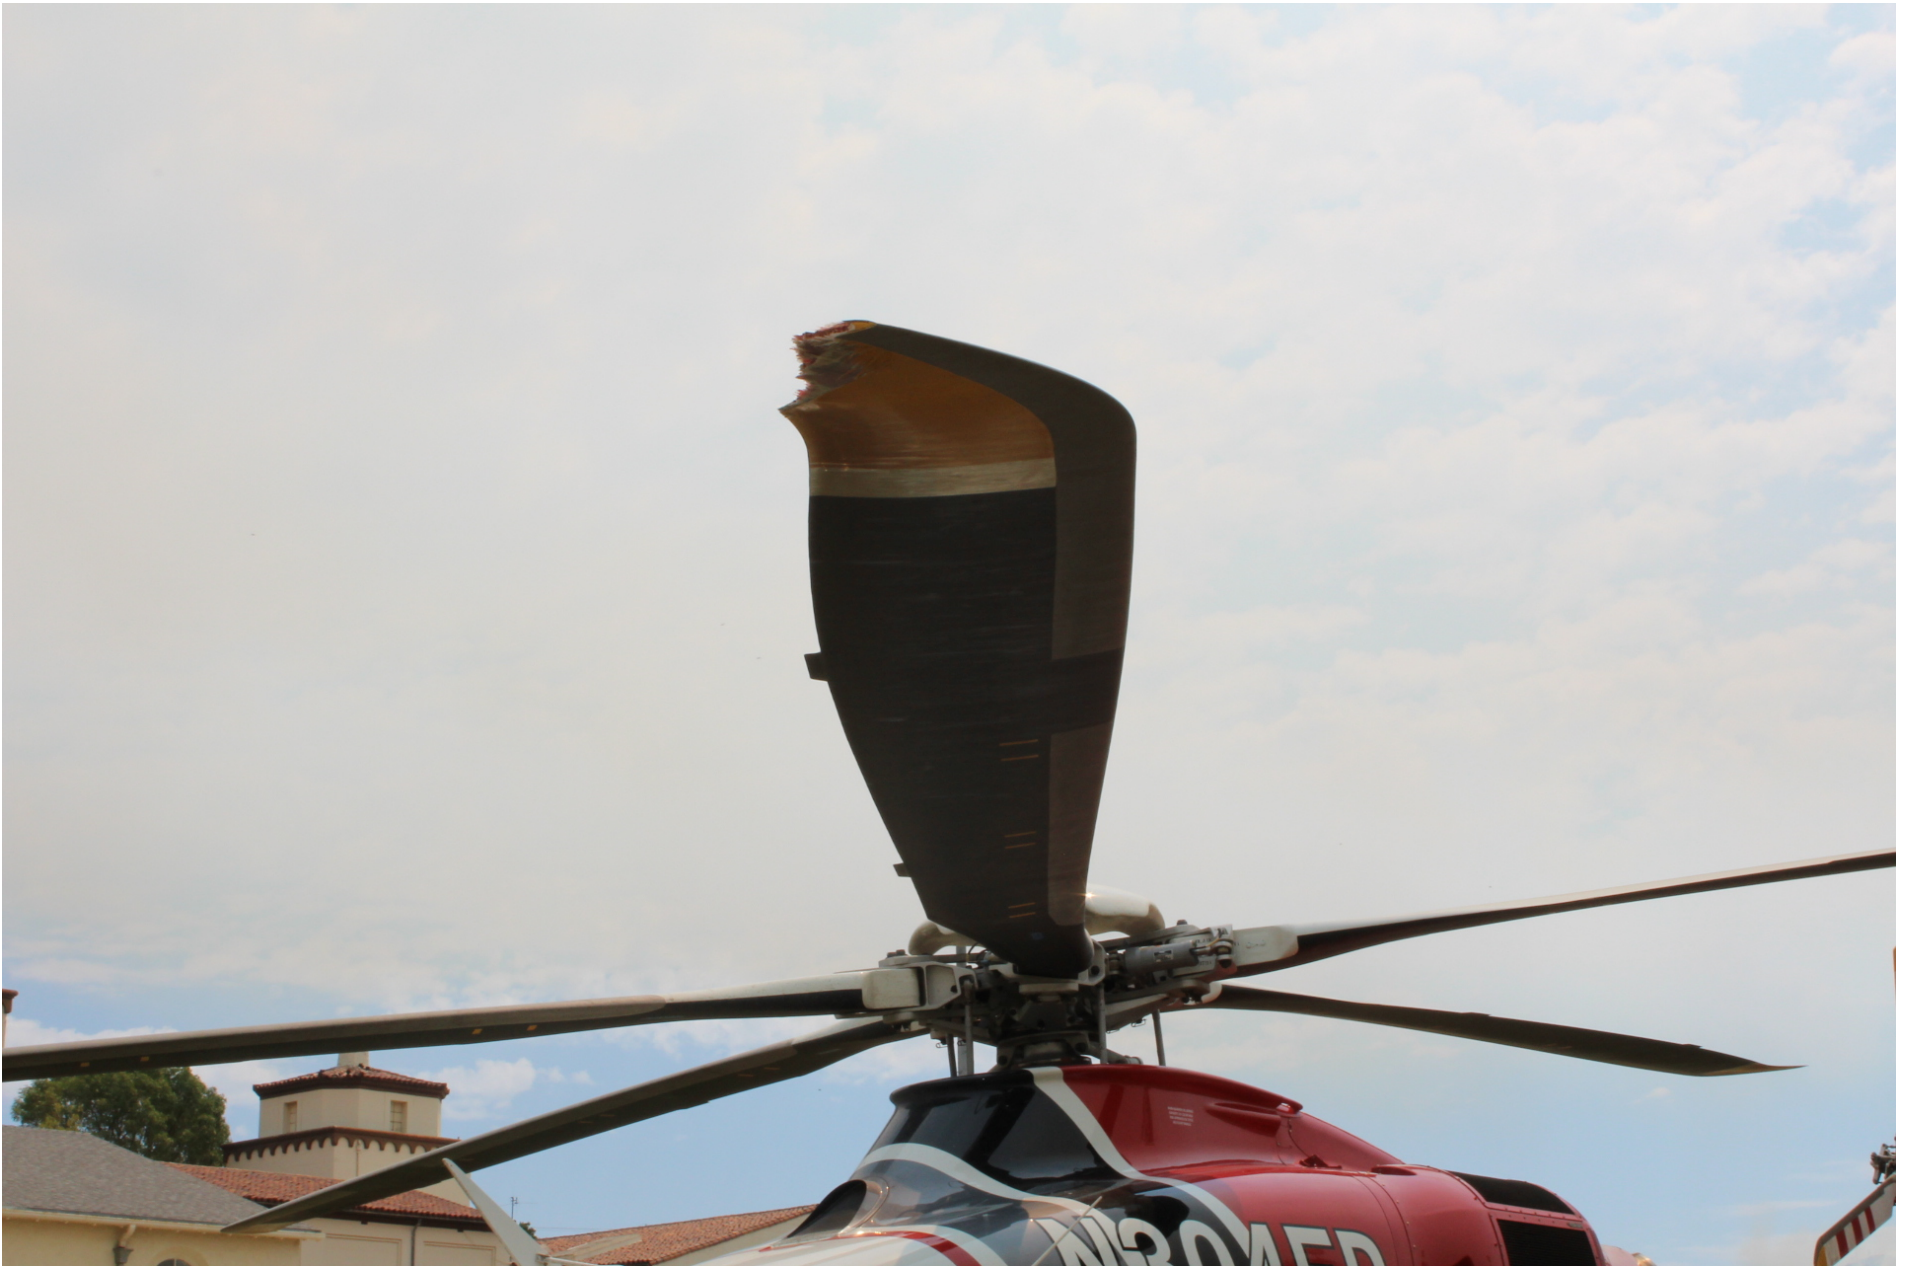
**Photo 7 – View of impact damage to the “blue” main rotor blade (courtesy of the LAFD).**

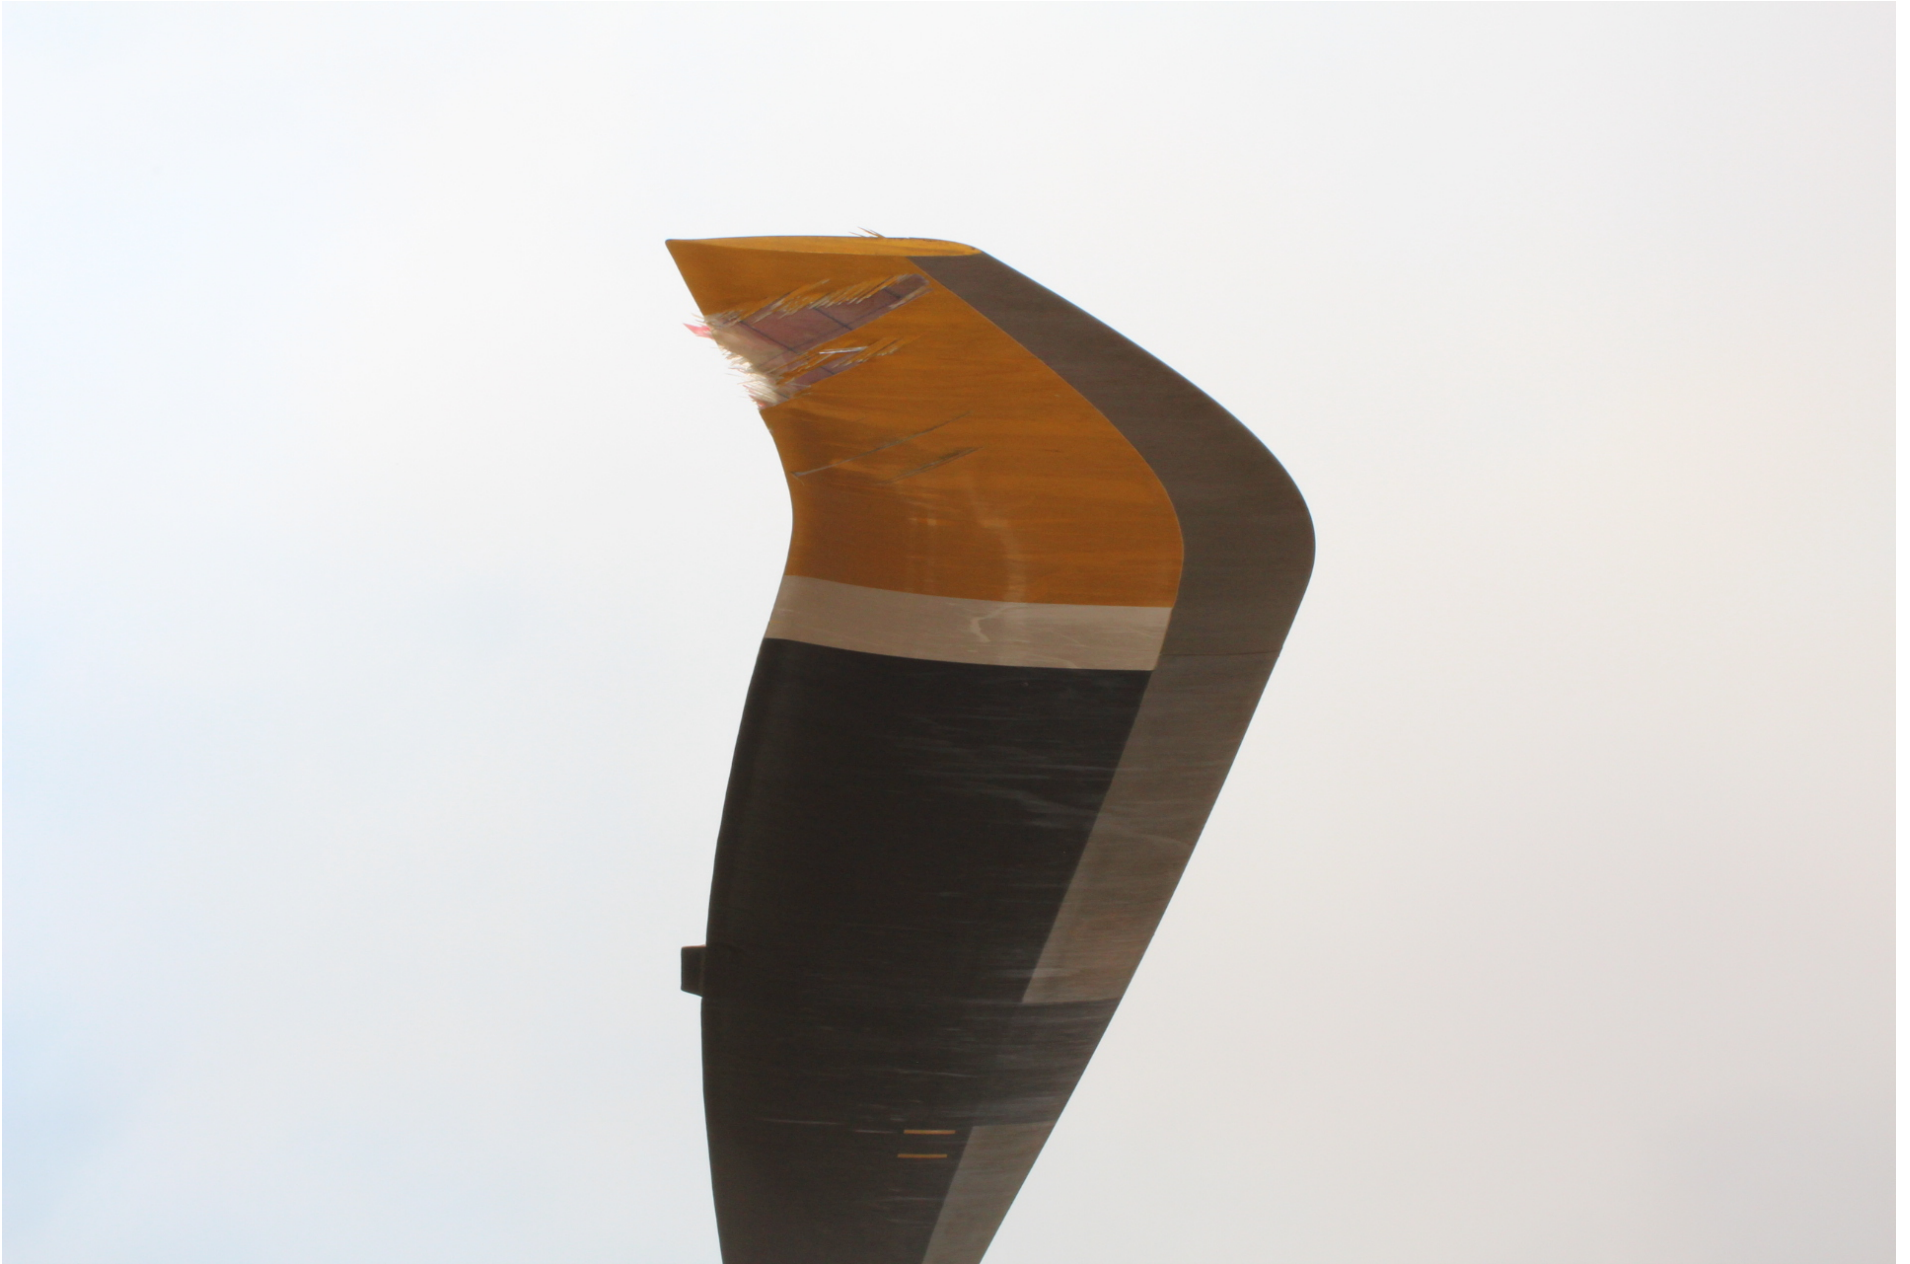
**Photo 8 – View of impact damage to the “red” main rotor blade (courtesy of the LAFD).**
