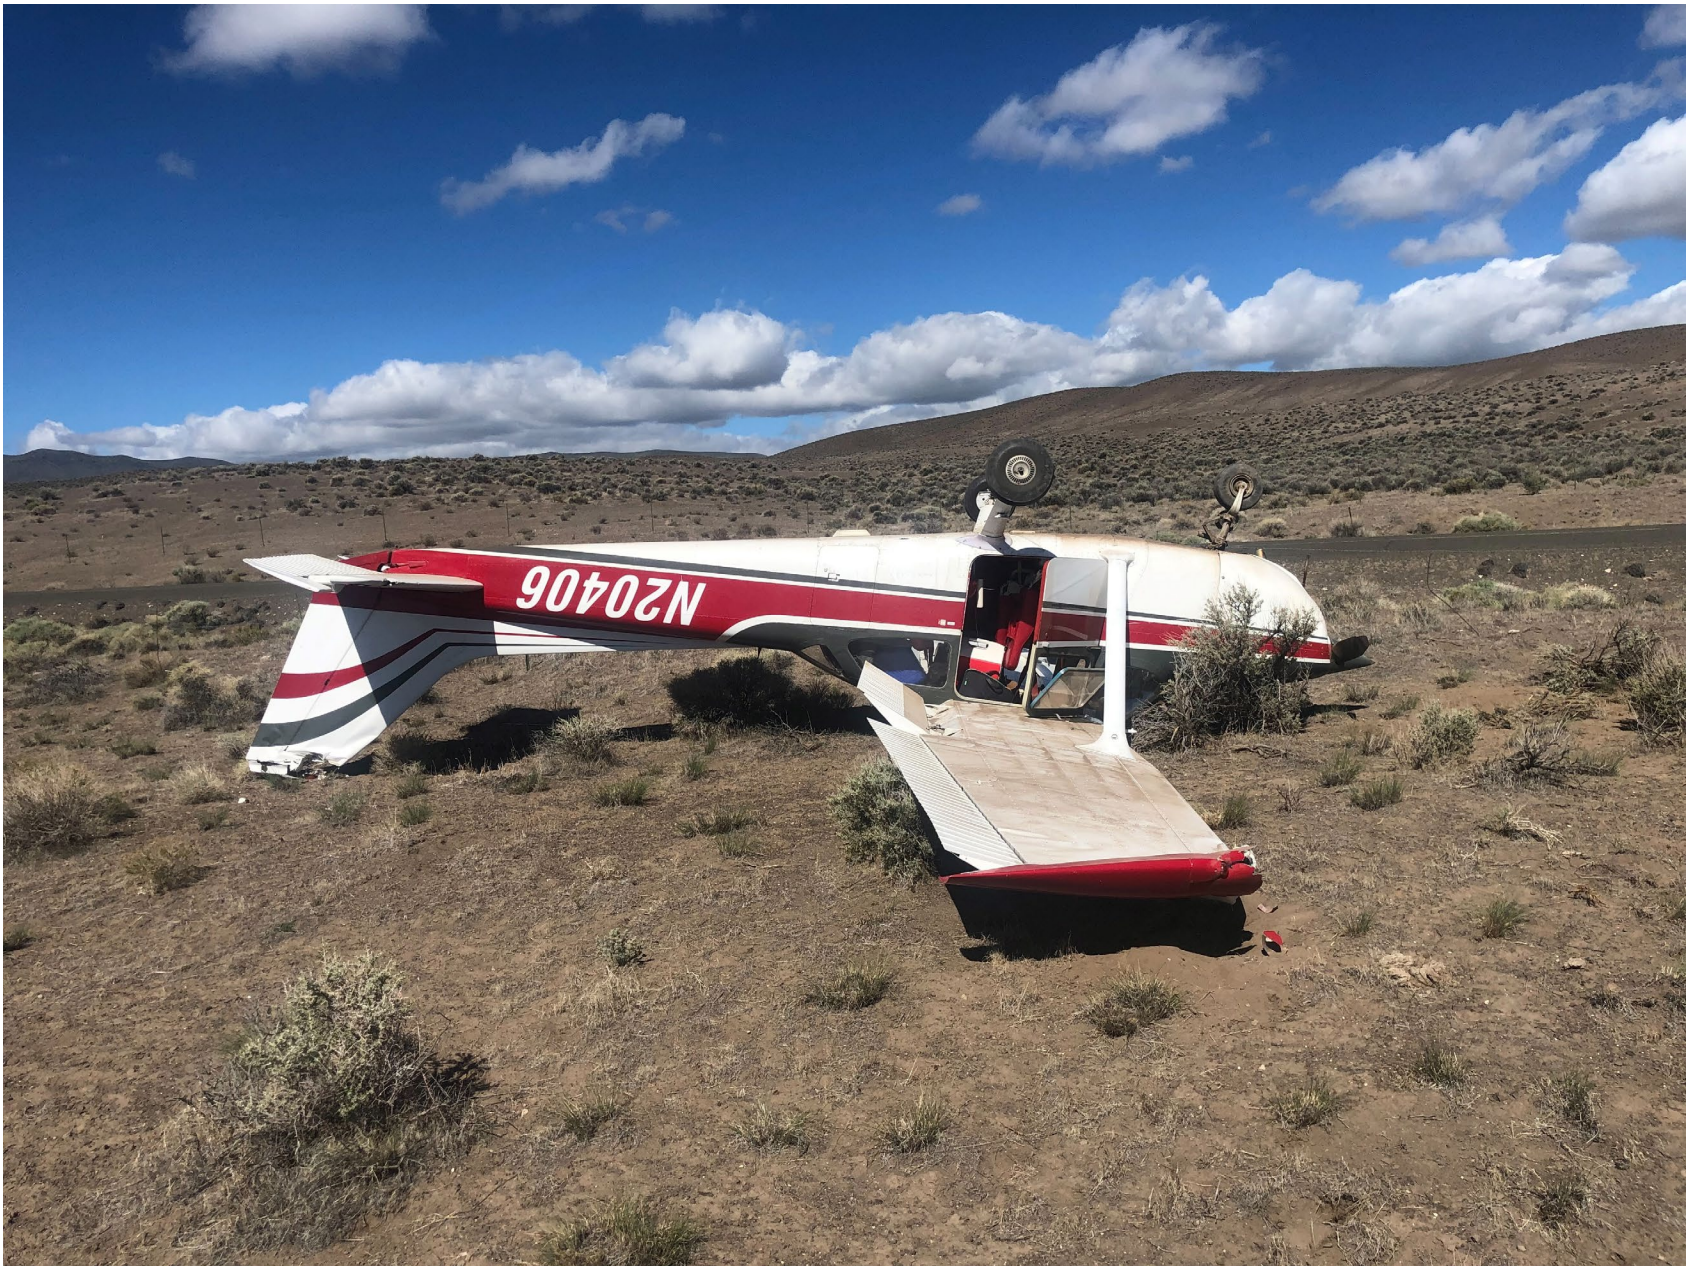
**Photo 1 – View of nosed over airplane (photo courtesy of the pilot)**

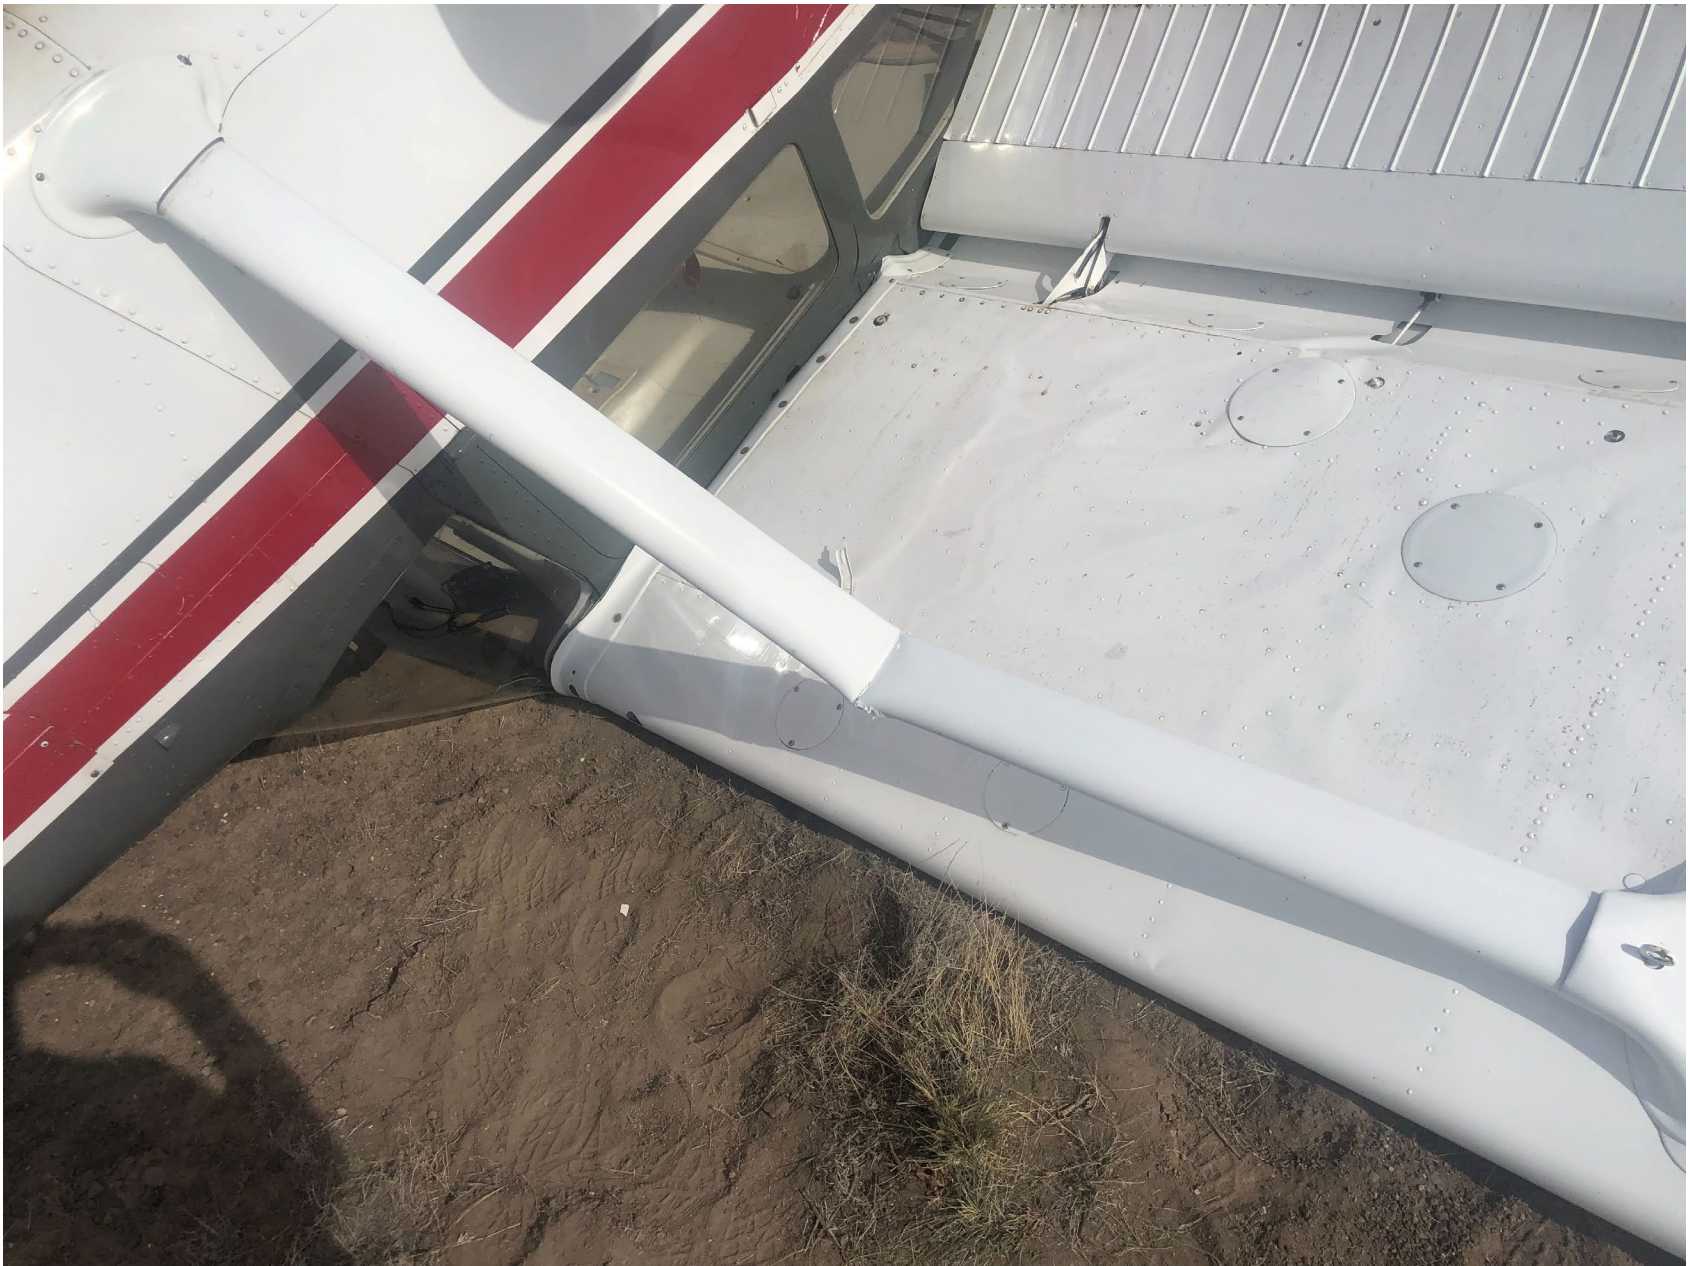
**Photo 2 – View of damaged right-wing lift strut (photo courtesy of the pilot)**

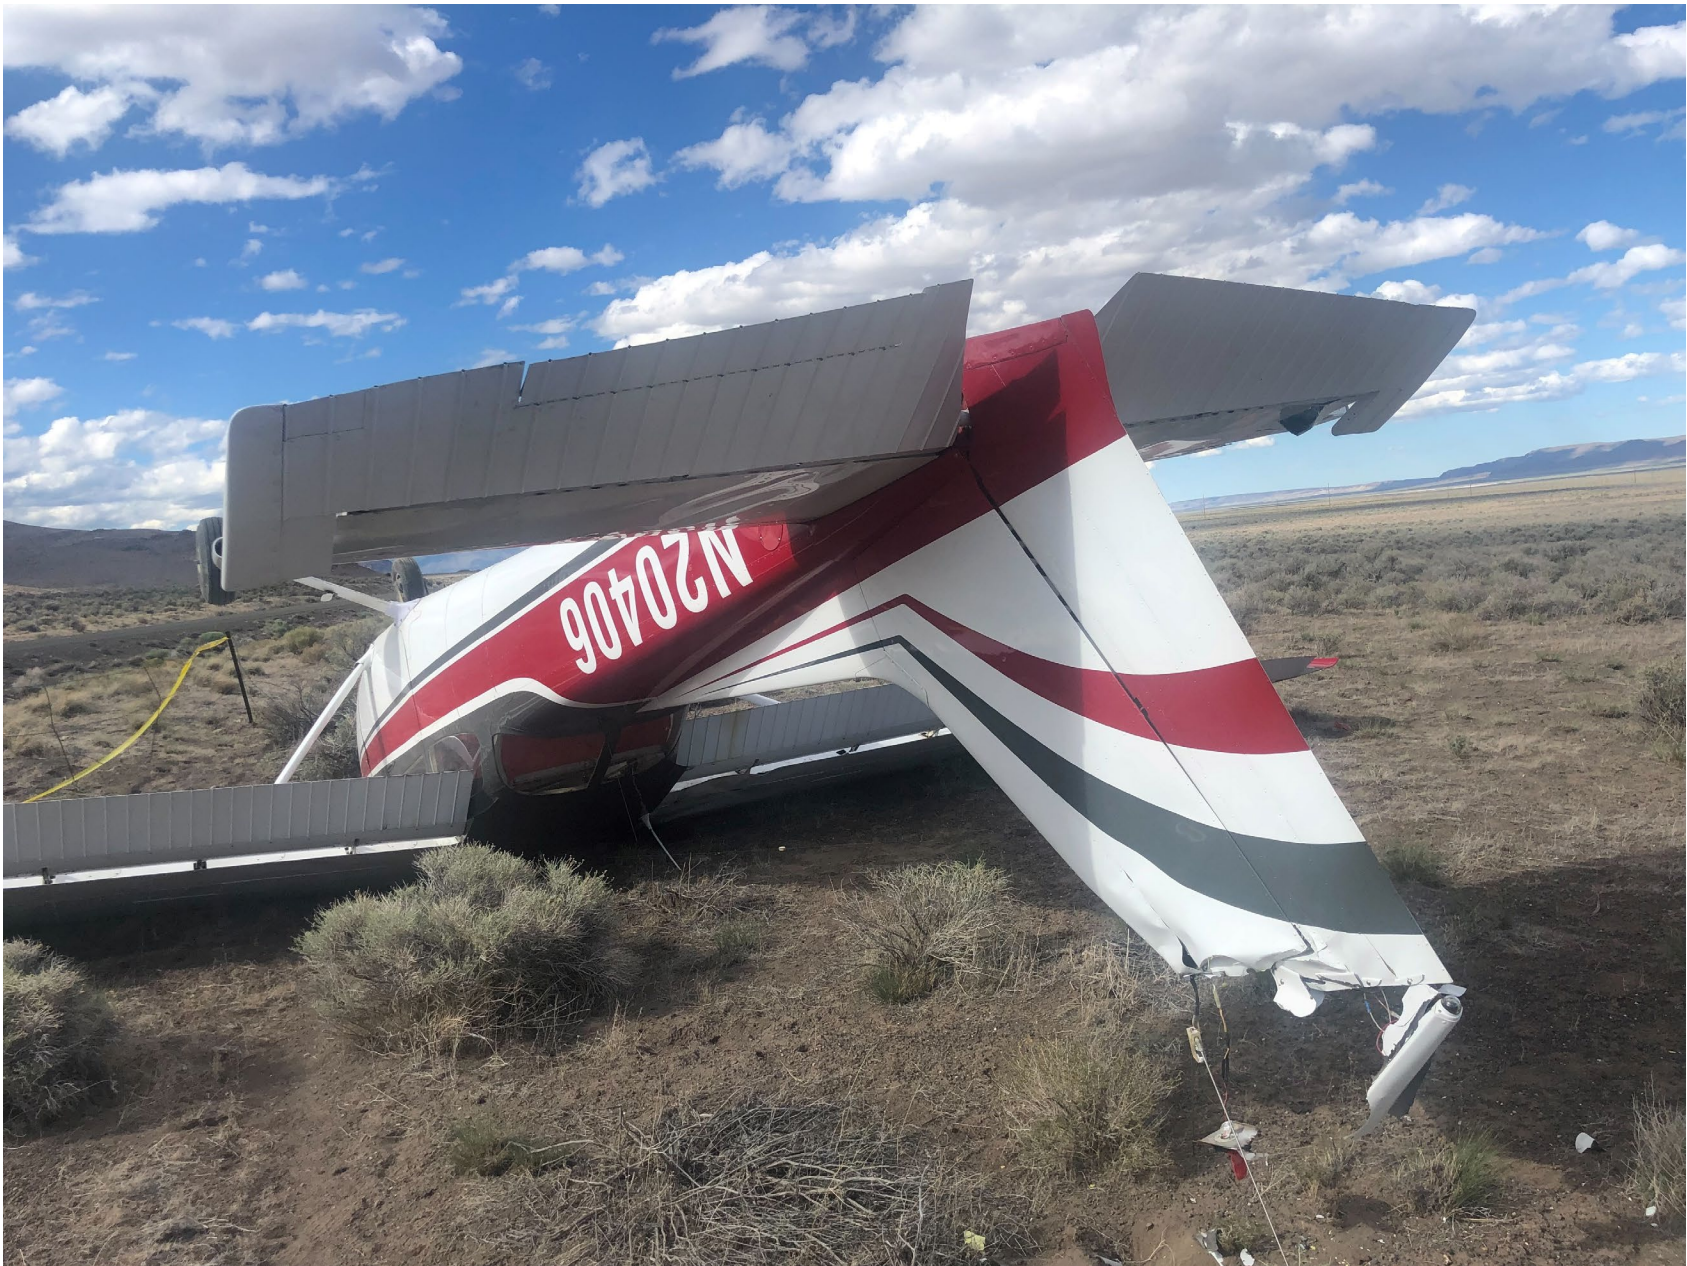
**Photo 3 – View of damaged empennage (photo courtesy of the pilot)**
