WPR19LA006 Accident Pictures:

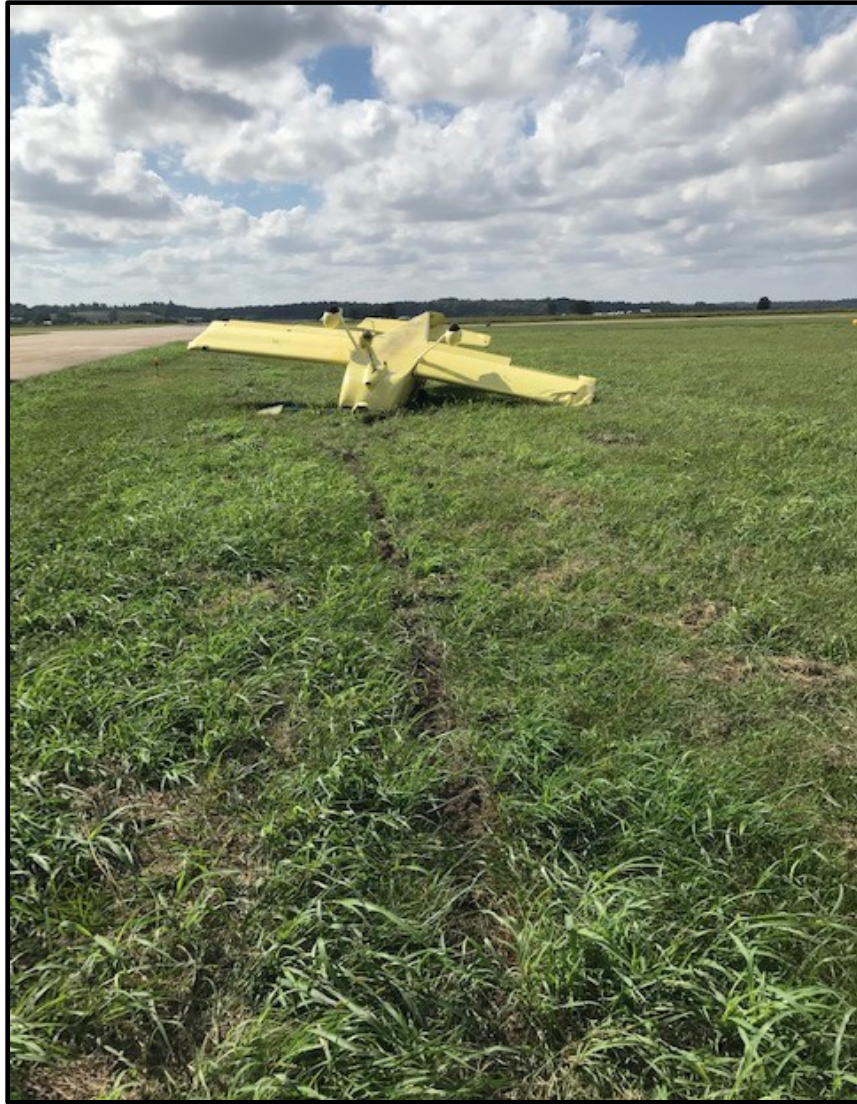
Figure 1: Ground impression leading to airplane wreckage (inverted).

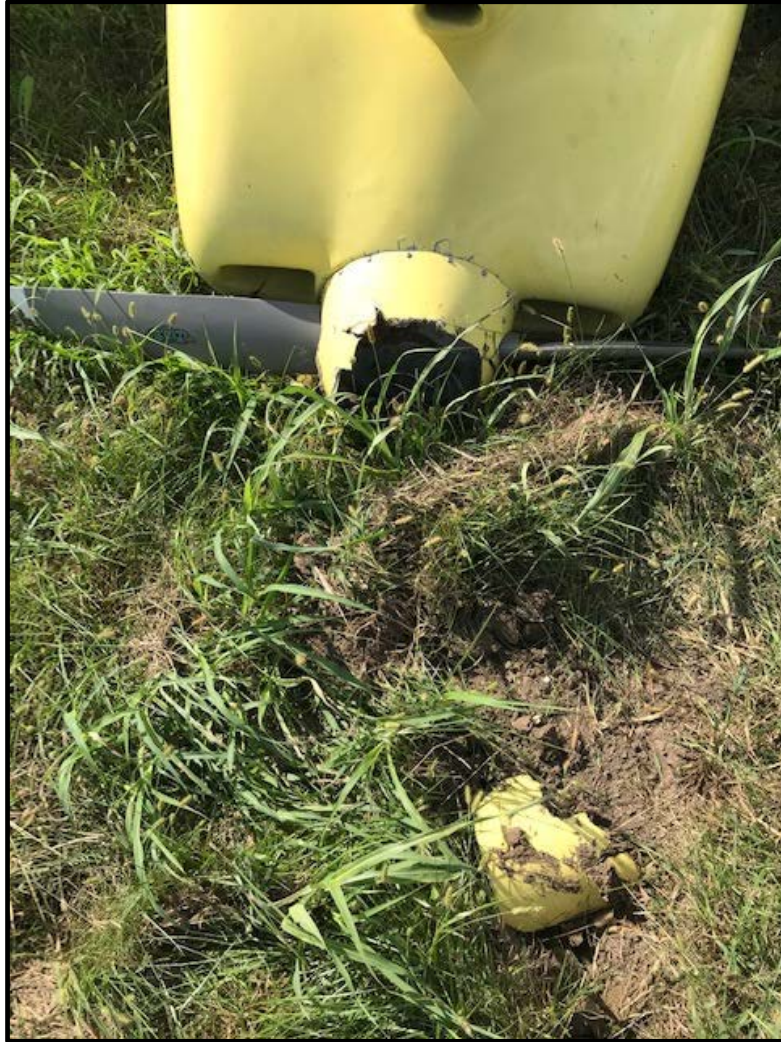
Figure 2: Ground disturbance with separated forward section of spinner located in it.
