National Transportation Safety Board

WPR23FA044

ACCIDENT SITE EXAMINATION REPORT

November 24, 2022

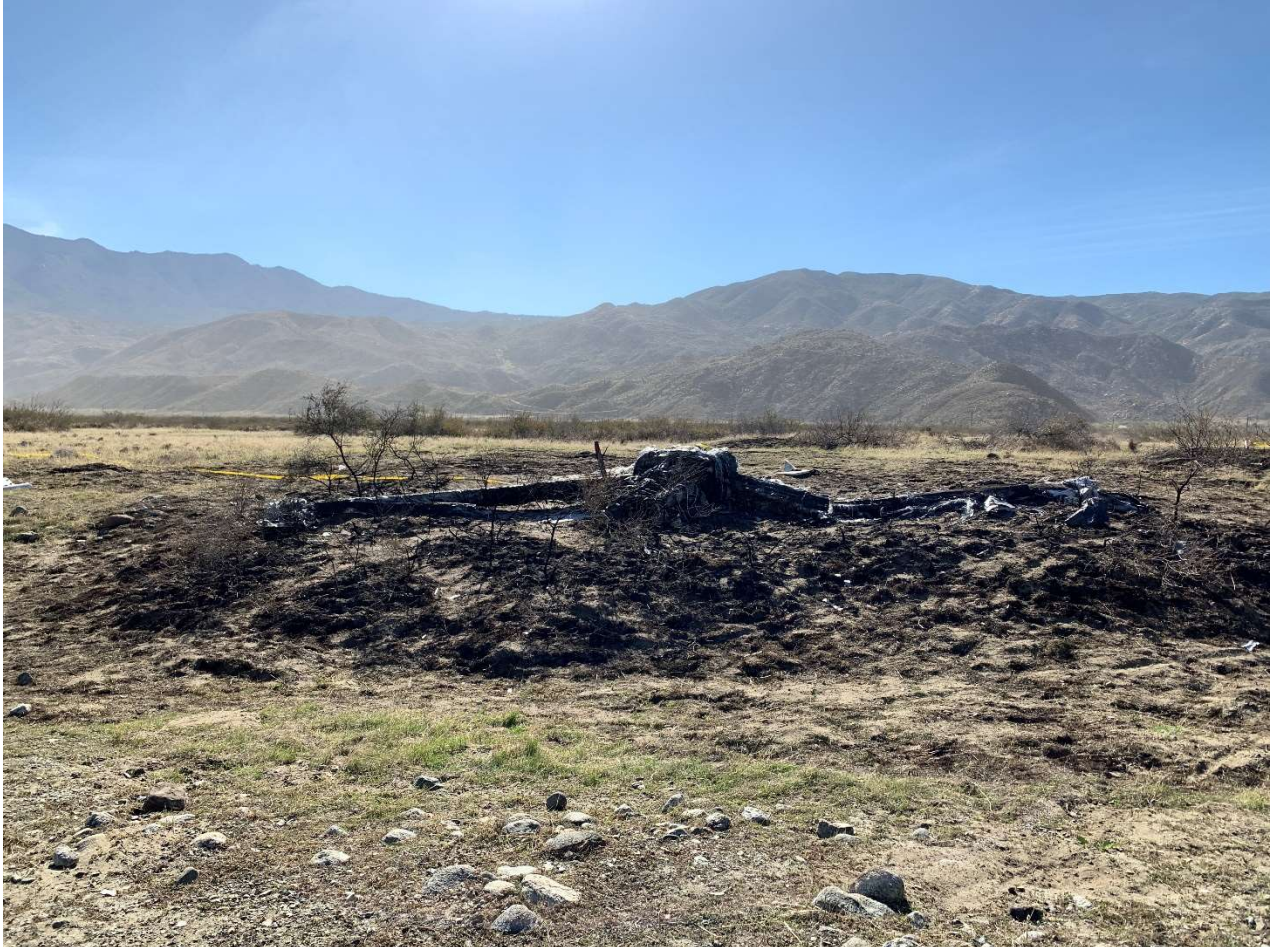
Photo 1 - Main Wreckage

The overall area was flat desert hard packed open terrain with a sandy topsoil. All major structural components of the airplane were located at the accident location. The airplane was involved in a postcrash fire, and the surrounding terrain was fire damaged.

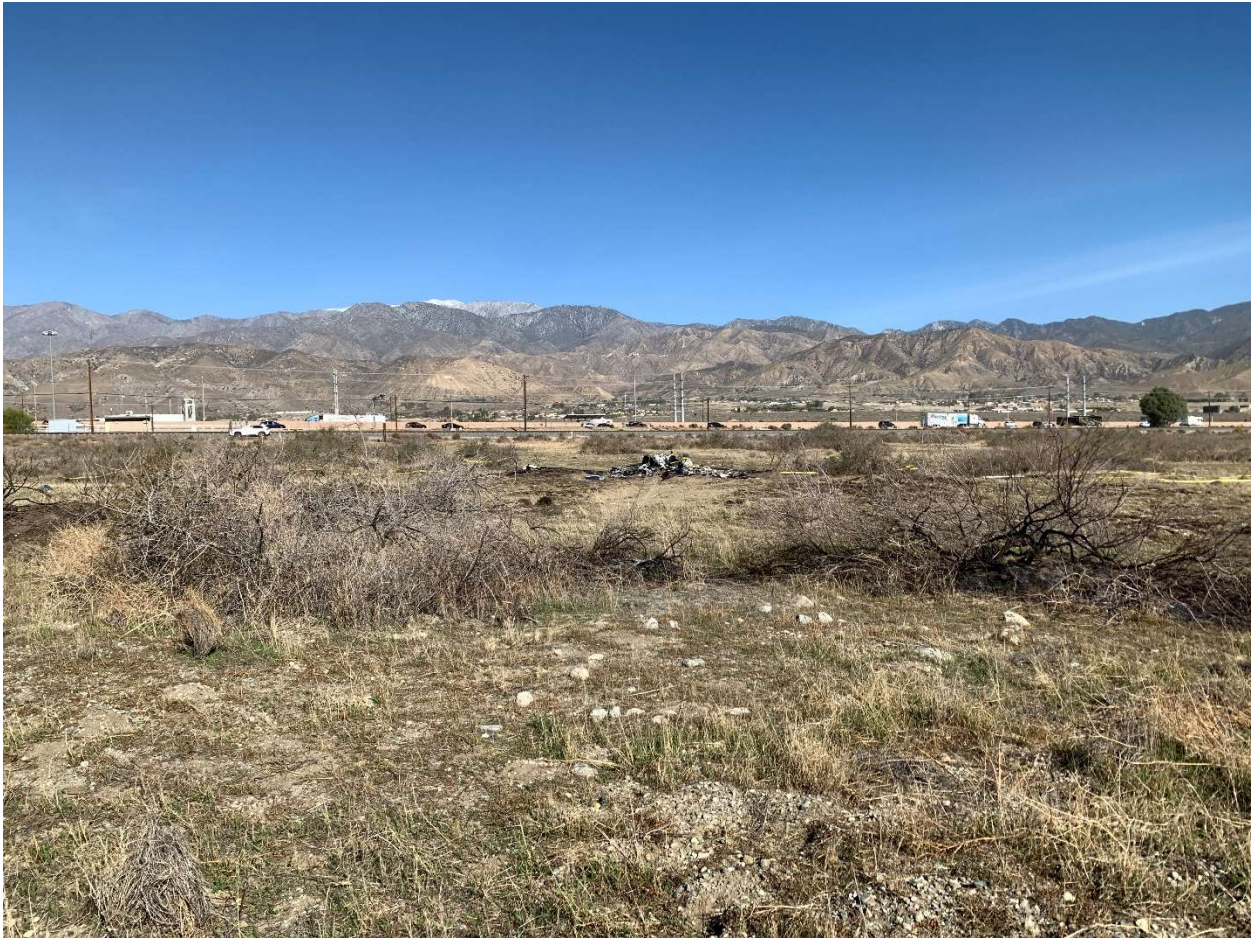
Photo 2 - Accident site looking toward the main wreckage

The first identified point of impact (FIPC) was a burn area and bent/broken scrub trees. It was 86 ft from the FIPC to the main wreckage on a magnetic heading of 020°.

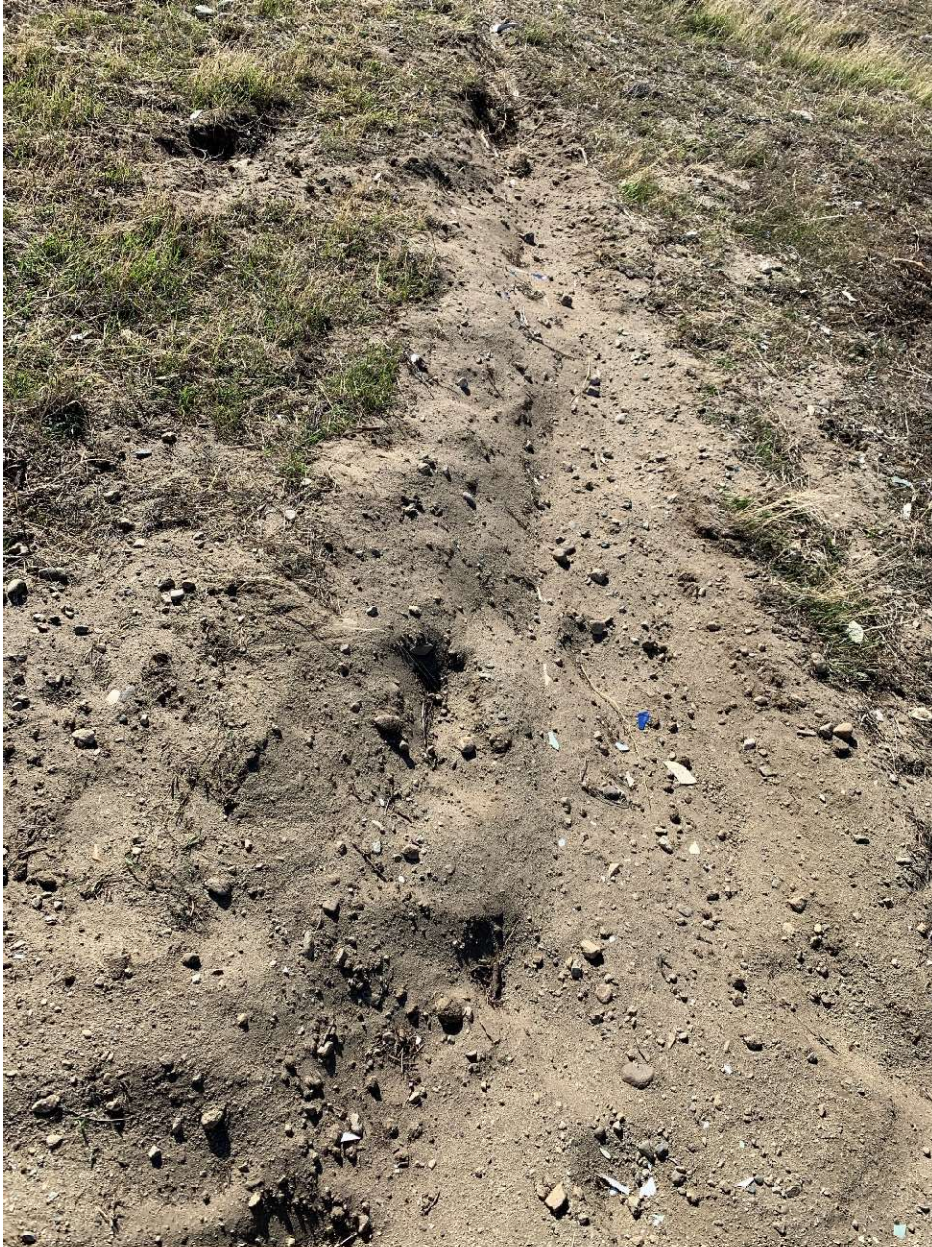
Photo 3 - Debris path

The debris path from the main wreckage to the beginning impression in the soil was 68 ft in length.

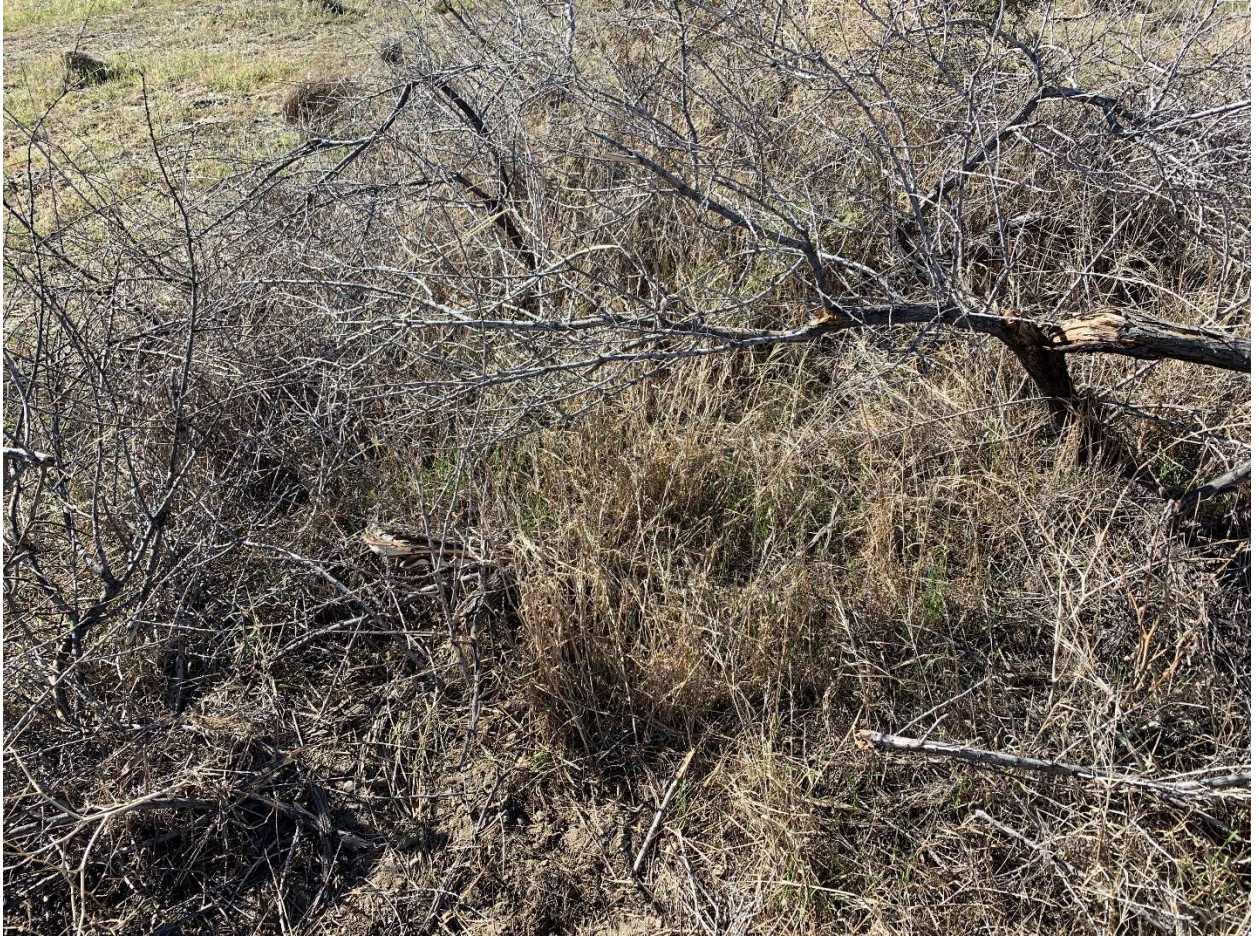
Photo 4 - First identified point of impact (FIPC) was desert scrub trees.

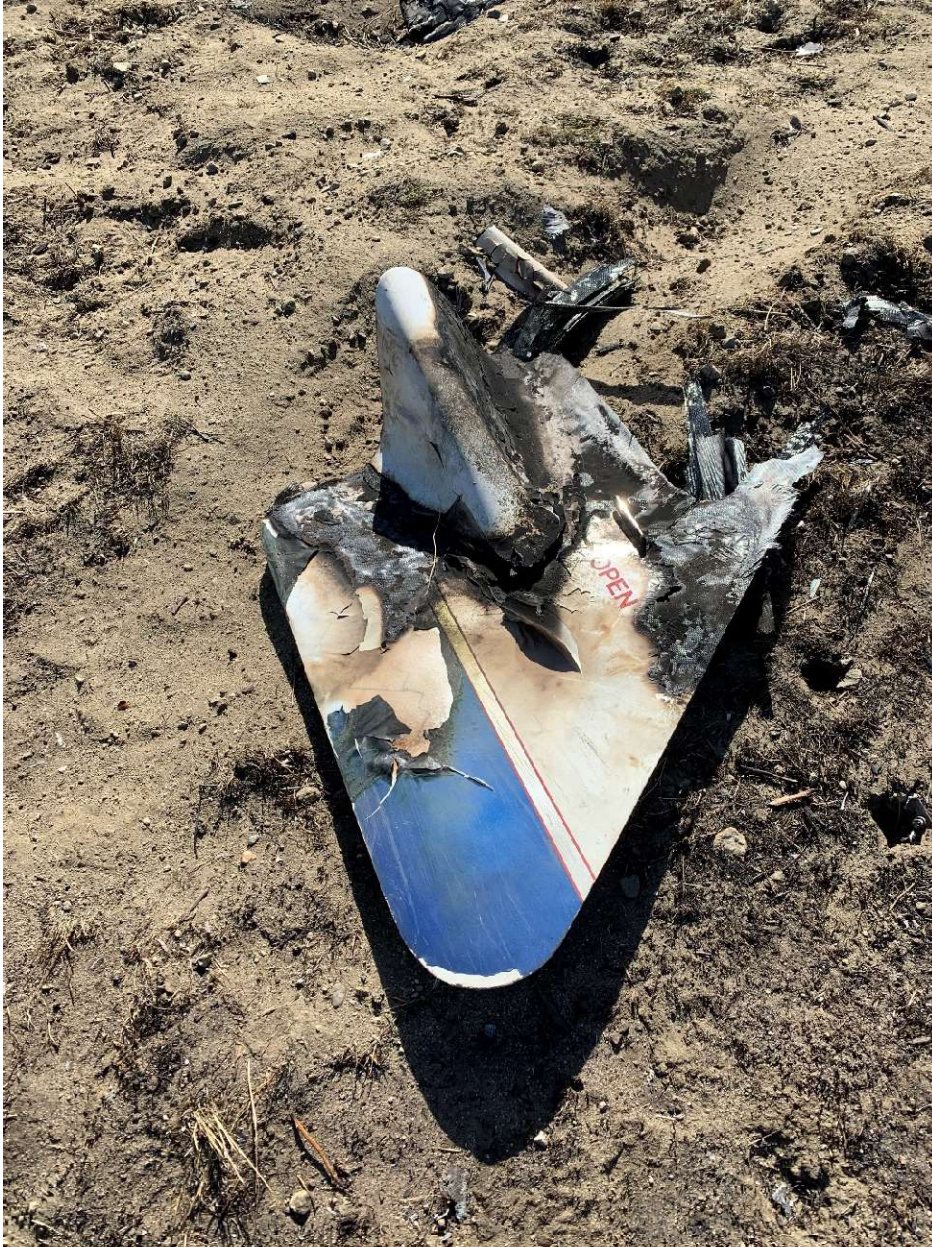
Photo 5 - portion of a door in debris field

A portion of one of the doors was found about 12 ft from the main wreckage in the debris field.

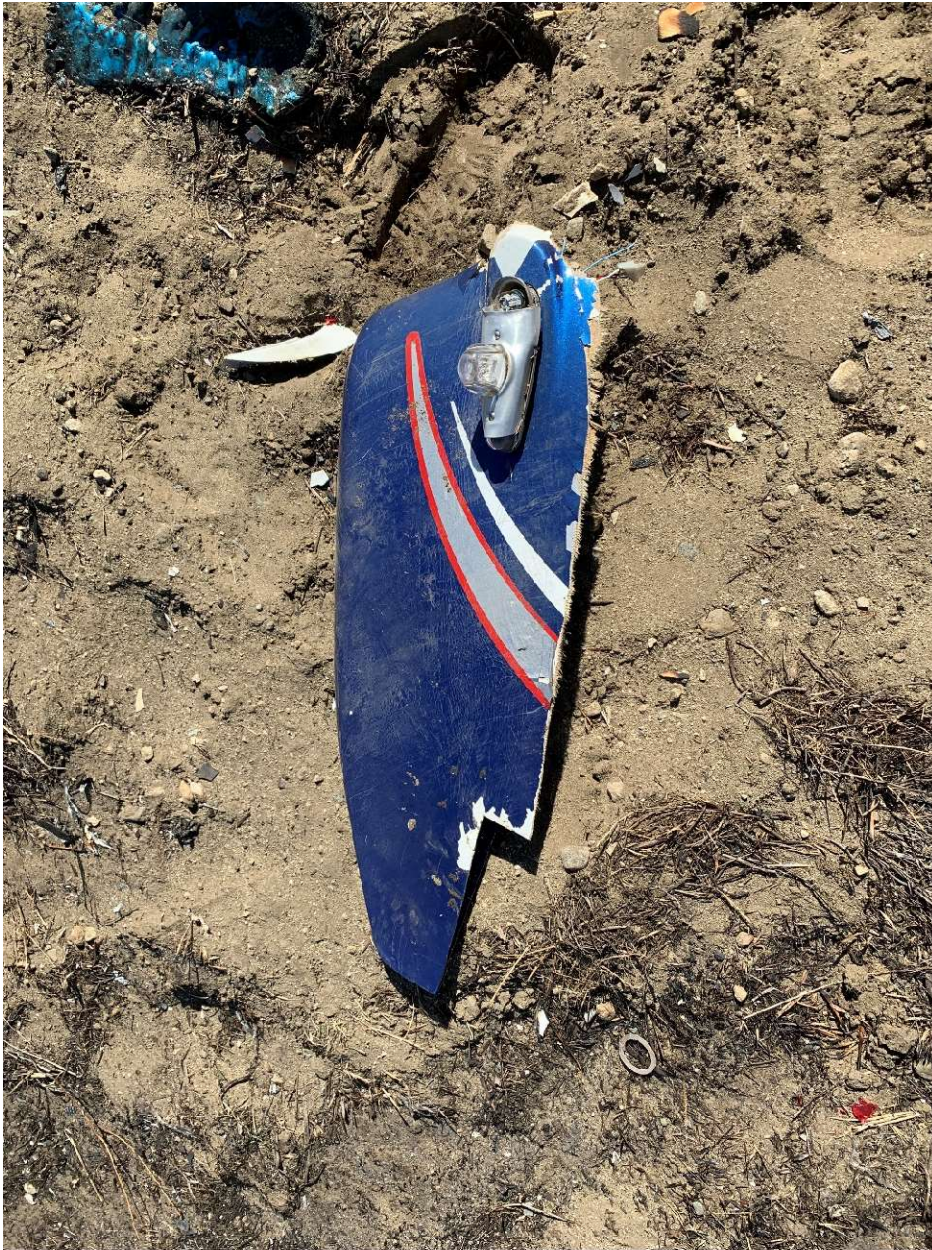
Photo 6 - Left winglet

Part of the left winglet was in the debris field and adjacent from the door by 6 ft.

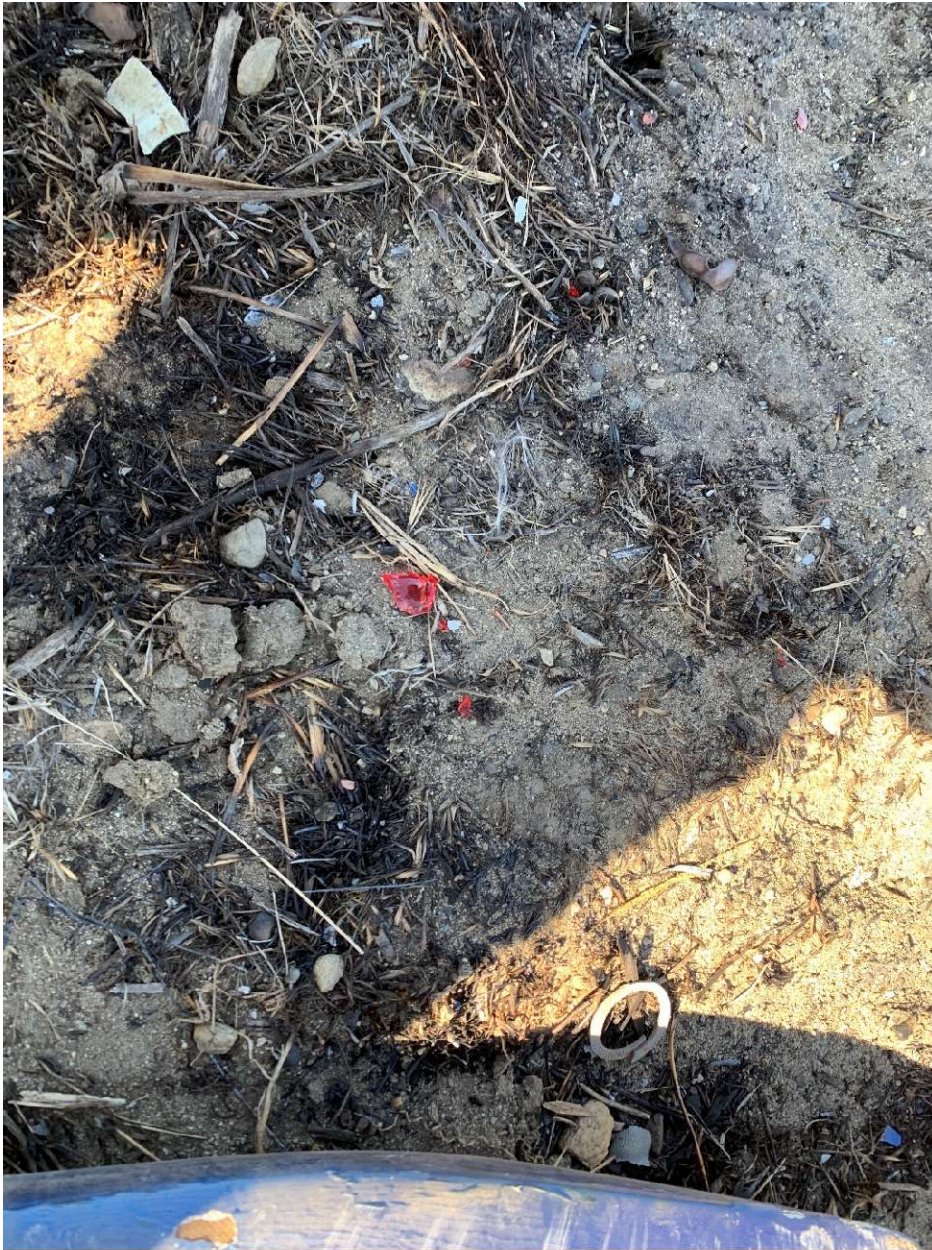
Photo 7 - Red lens

The red lens was found in the debris field about 10 ft to the west of the main wreckage.

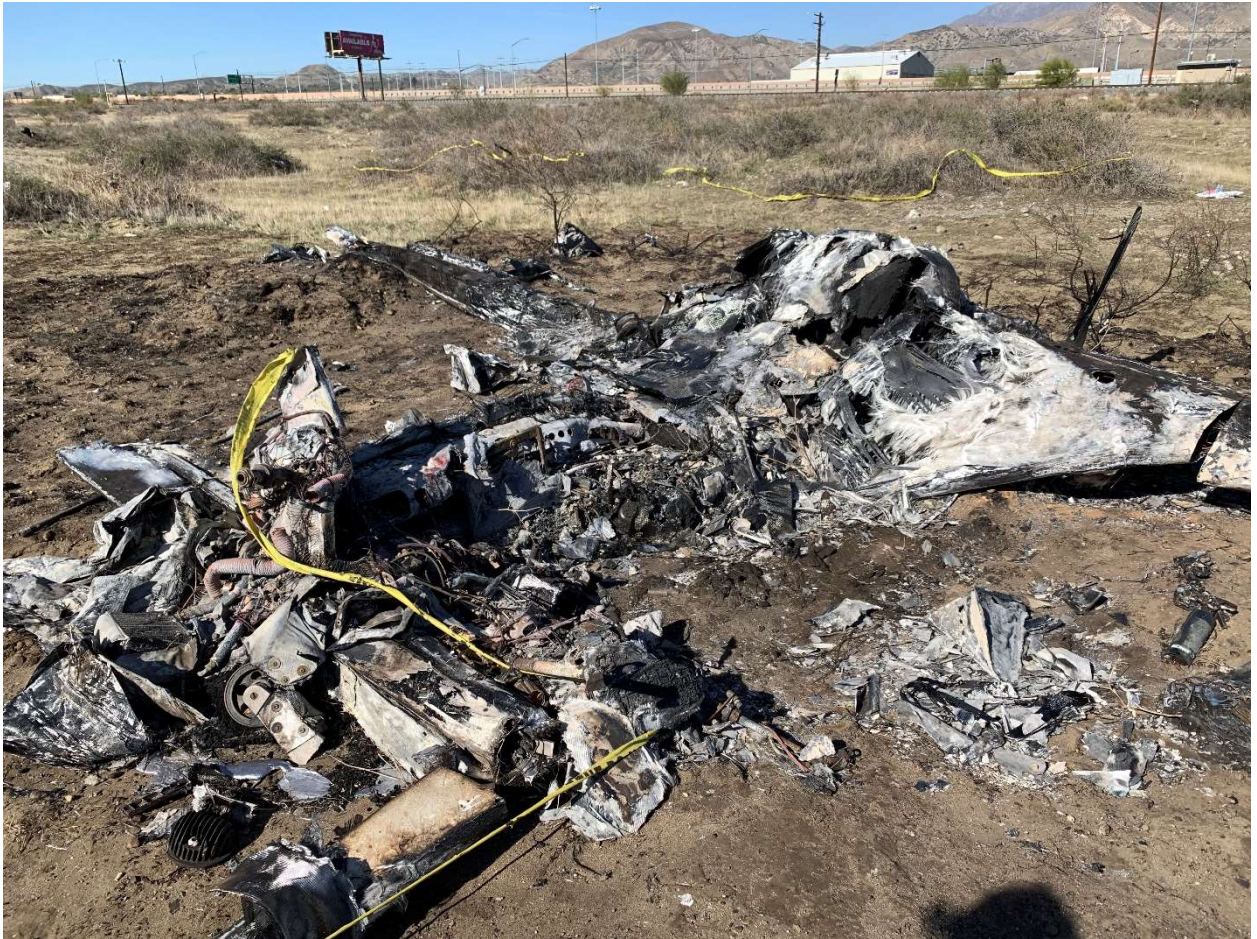
Photo 8 - Main Wreckage

The airplane came to rest upright with the nose facing back toward the airport along a 196° magnetic heading.

The fuselage had been destroyed by both the pre and postcrash fires. The structural members of the airframe were present, both wings, the cockpit area, the canards, the engine, and propeller system. The left canard remained attached to the fuselage and was thermally consumed by fire. The right canard had separated and was in the debris field just east of the main wreckage. The forward elevators remained attached to the fuselage and were mostly thermally consumed. The airplane nose landing gear sustained impact damage and was displaced to the left.

The right wing remained attached to the fuselage at the wing root and sustained impact damage the length of the wing. The right main landing gear remained attached to its mount and sustained impact damage.

The left wing remained attached to the fuselage at the wing root and had impact damage to the wing tip area. The left main landing gear could not be accessed as it was underneath the left wing.

The cockpit area to include the instrument panel and avionics were thermally destroyed.

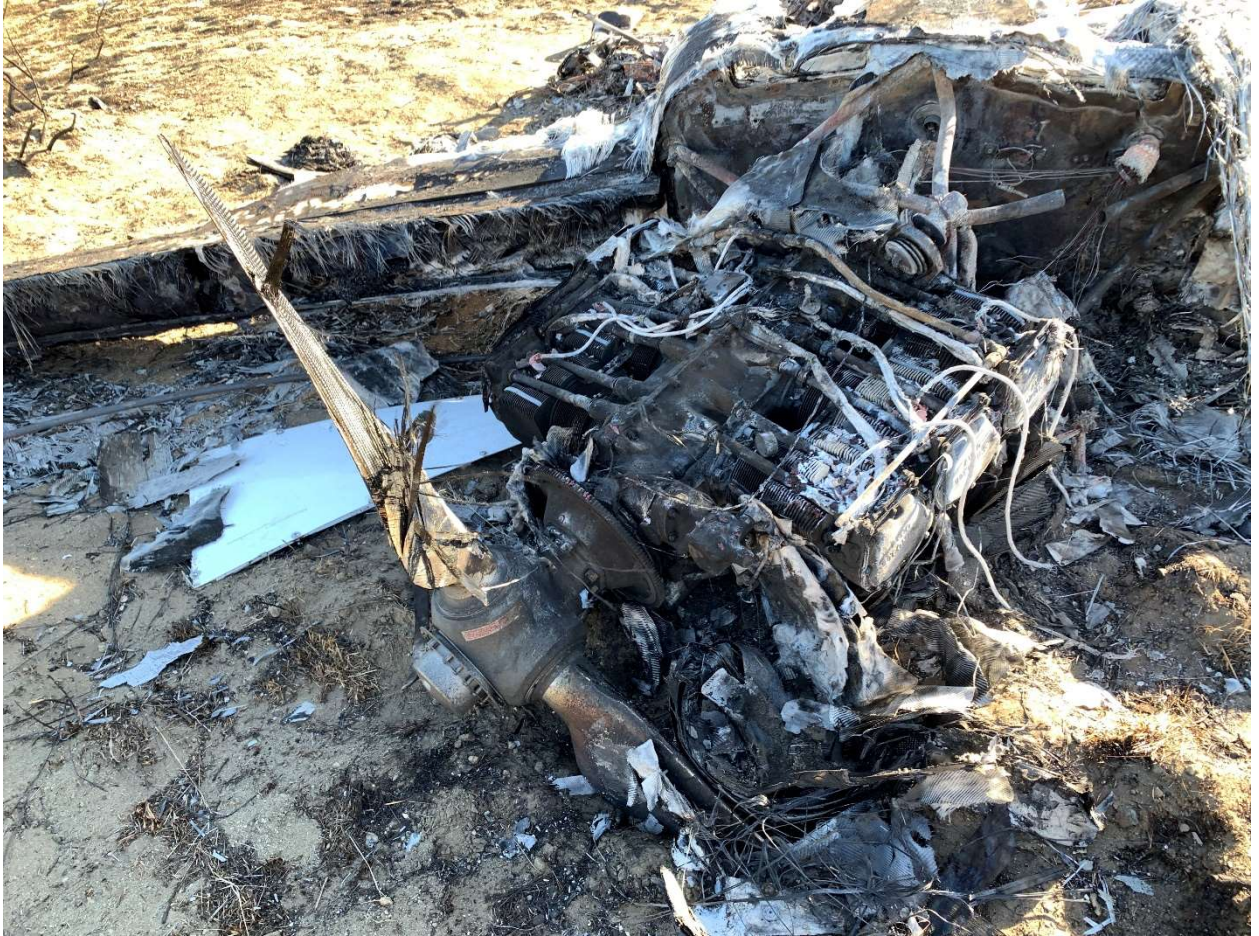
Photo 10 - View of Engine

A Lycoming TIO-540-EXP, serial number L-10748-48 was installed on the airplane. The engine remained attached to the engine mounts; the engine mount had partially separated from the firewall. The engine had sustained thermal damage. All the cylinders, the intake and exhaust remained attached to the engine case. The accessory section also remained attached, and the turbo charger was partially attached. The oil cooler was 26 ft from the main wreckage. The hydraulic pump was 40 ft from the main wreckage.

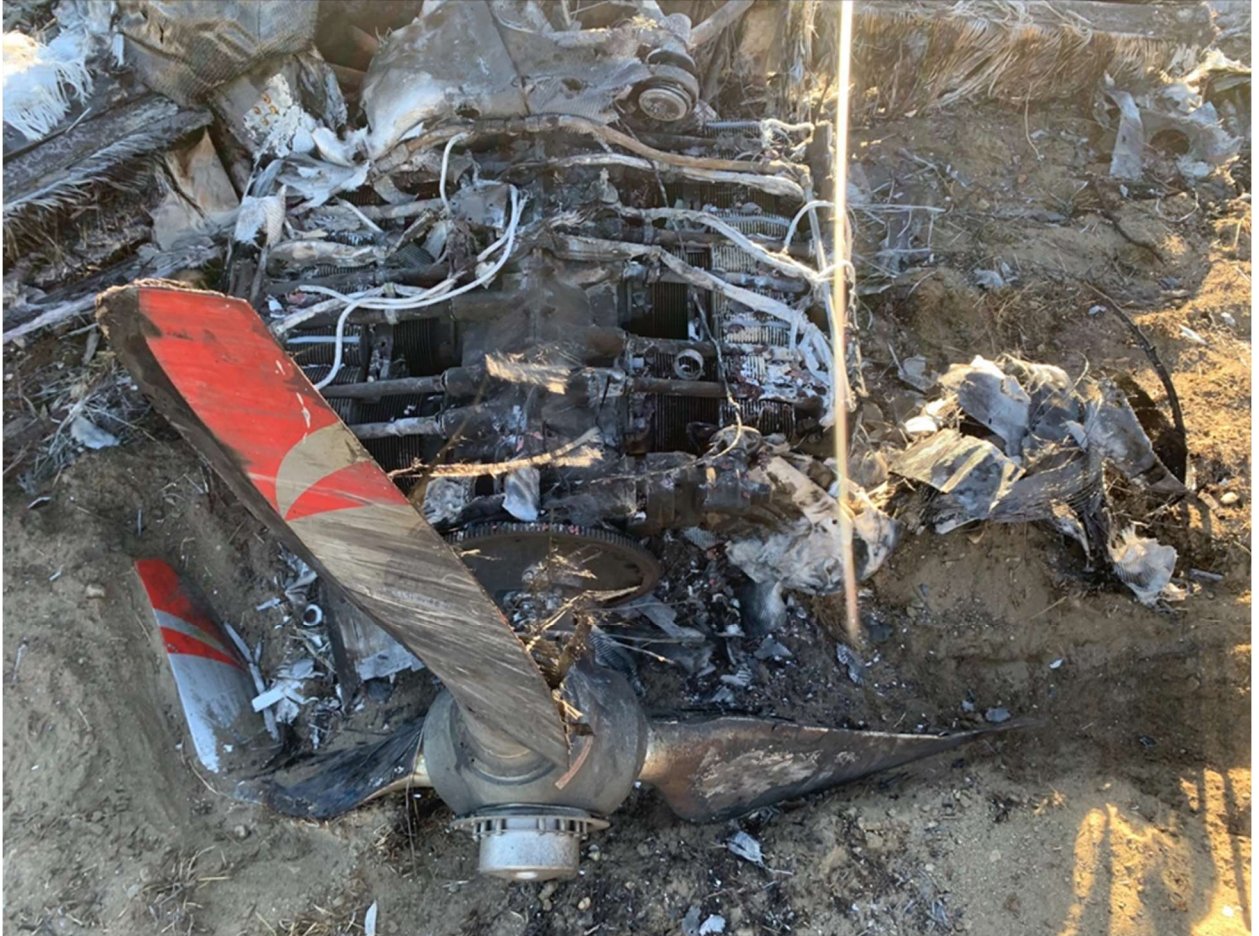
Photo 11 - View of the Propeller system

The 3-bladed propellers remained attached to the propeller hub which remained attached to the engine at the crankshaft. One propeller blade had chordwise striations. Two of the propeller blades were bent aft about mid span and partially embedded into the ground.
