NATIONAL TRANSPORTATION SAFETY BOARD

ACCIDENT SITE EXAMINATION SUMMARY

WPR21FA272

Location: Dinsmore, CA
Date: July 15, 2021
Aircraft: Mooney M20J, N4474H
NTSB Investigator-in-Charge: Maja Smith

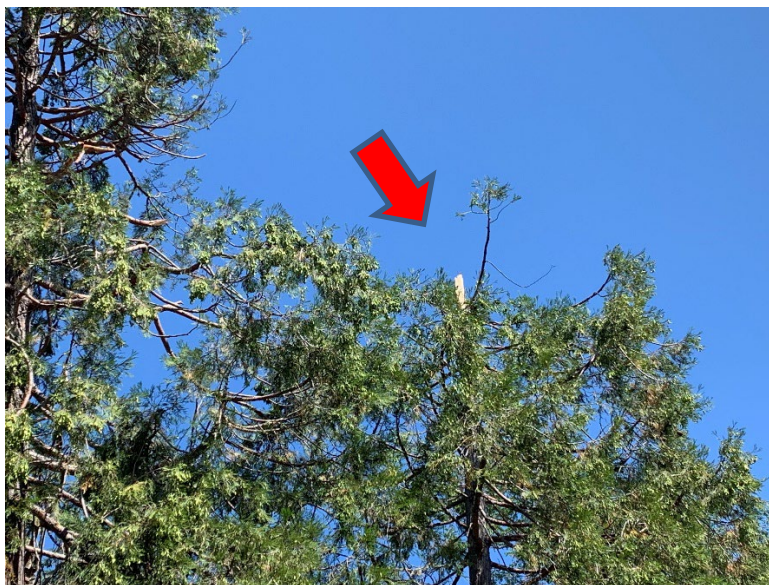
Examination of the accident site revealed that the airplane's right wing impacted about 30-foot-tall redwood tree. A portion of the right wing was separated and located on the ground adjacent to the tree.

Image 3 – First point of impact (treetop)

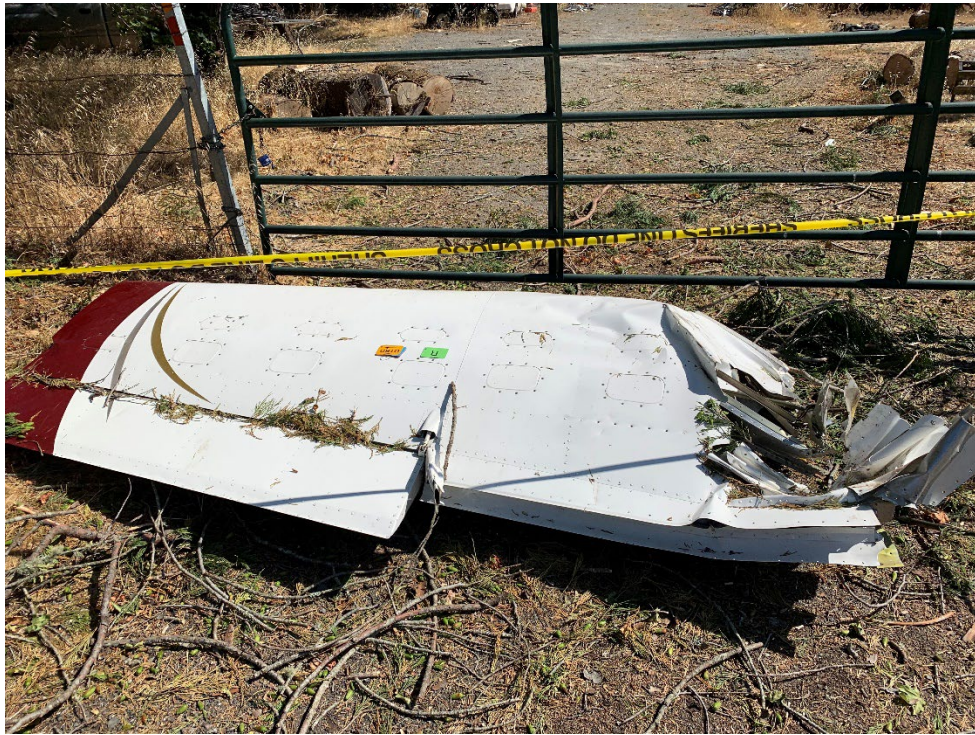
Image 4 – Right wing

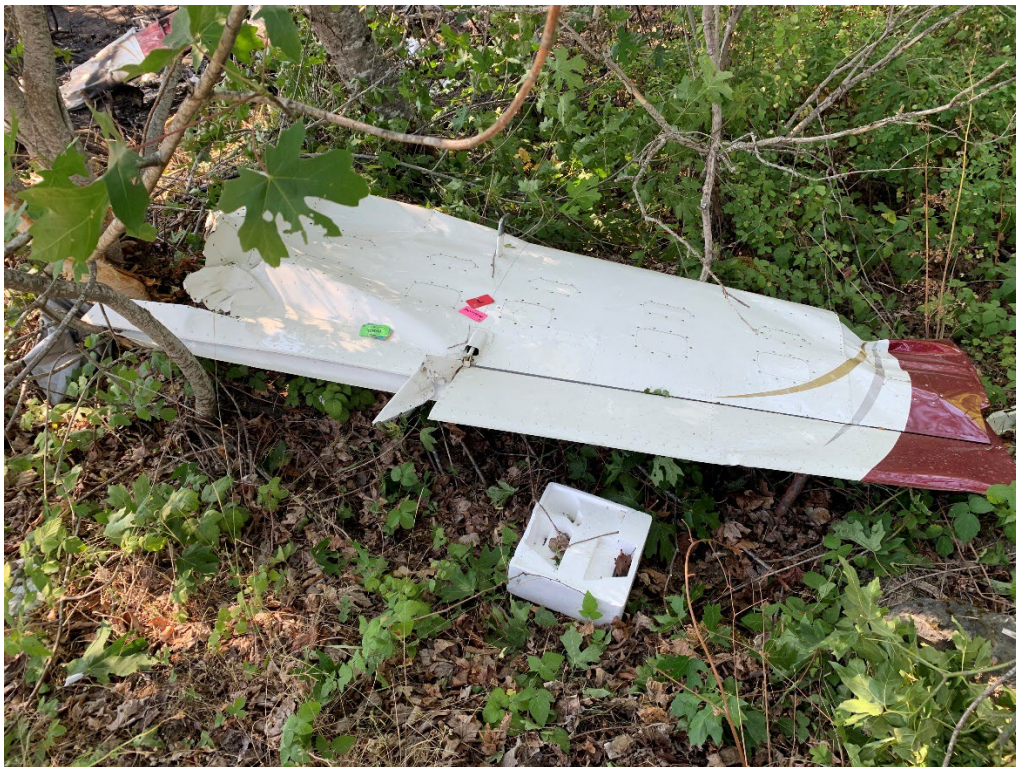
The rest of the airplane came to rest about 120 ft and on the heading of 170° from the first point of impact and came to rest inverted. Outboard portion of the left wing separated on impact with the ground/vegetation and was found about 10 ft from the rest of the wreckage.

Image 5 – Left wing

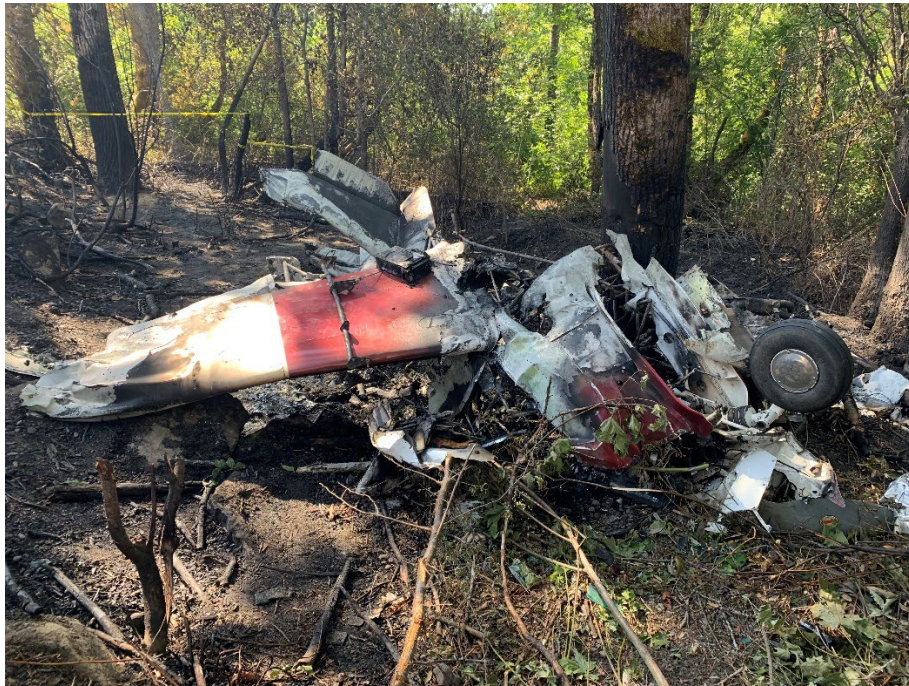
Image 6 – Main wreckage

The main wreckage consisted of the propeller, engine, cabin, fuselage, inboard portions of both wings, and the empennage. These components were charred, melted, damaged by the impact and burned by the post-impact fire. The nose landing gear was in the extended position and locked. Both propeller blades were attached to the hub, but the propeller separated from the airframe. The instrument panel was mostly consumed by the fire.

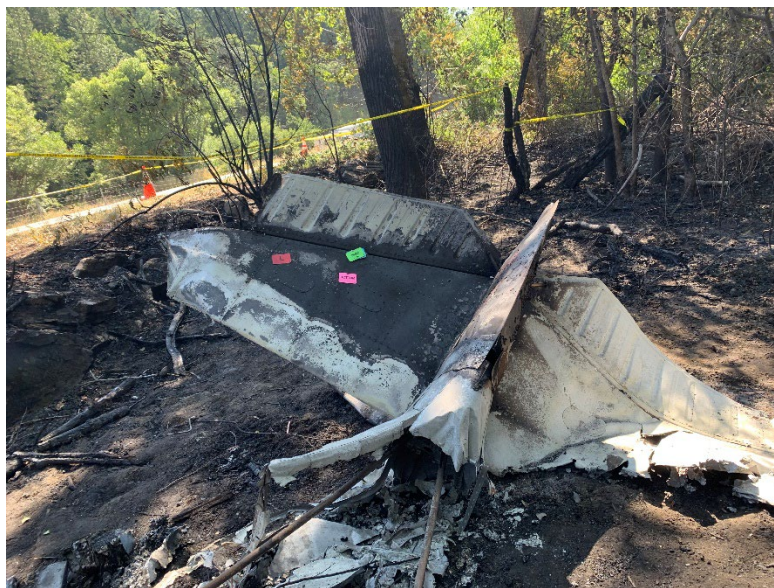
Image 7 – Empennage

Flight control cable continuity was confirmed from each cockpit control to the associated flight control through connecting rods.
