## **NATIONAL TRANSPORTATION SAFETY BOARD**

# **ACCIDENT SITE EXAMINATION SUMMARY**

**WPR22FA011**

Location:	Reserve, New Mexico
Date:	October 15, 2021
Aircraft:	Cessna 175, N7584M
NTSB Investigator-in-Charge:	Maja Smith

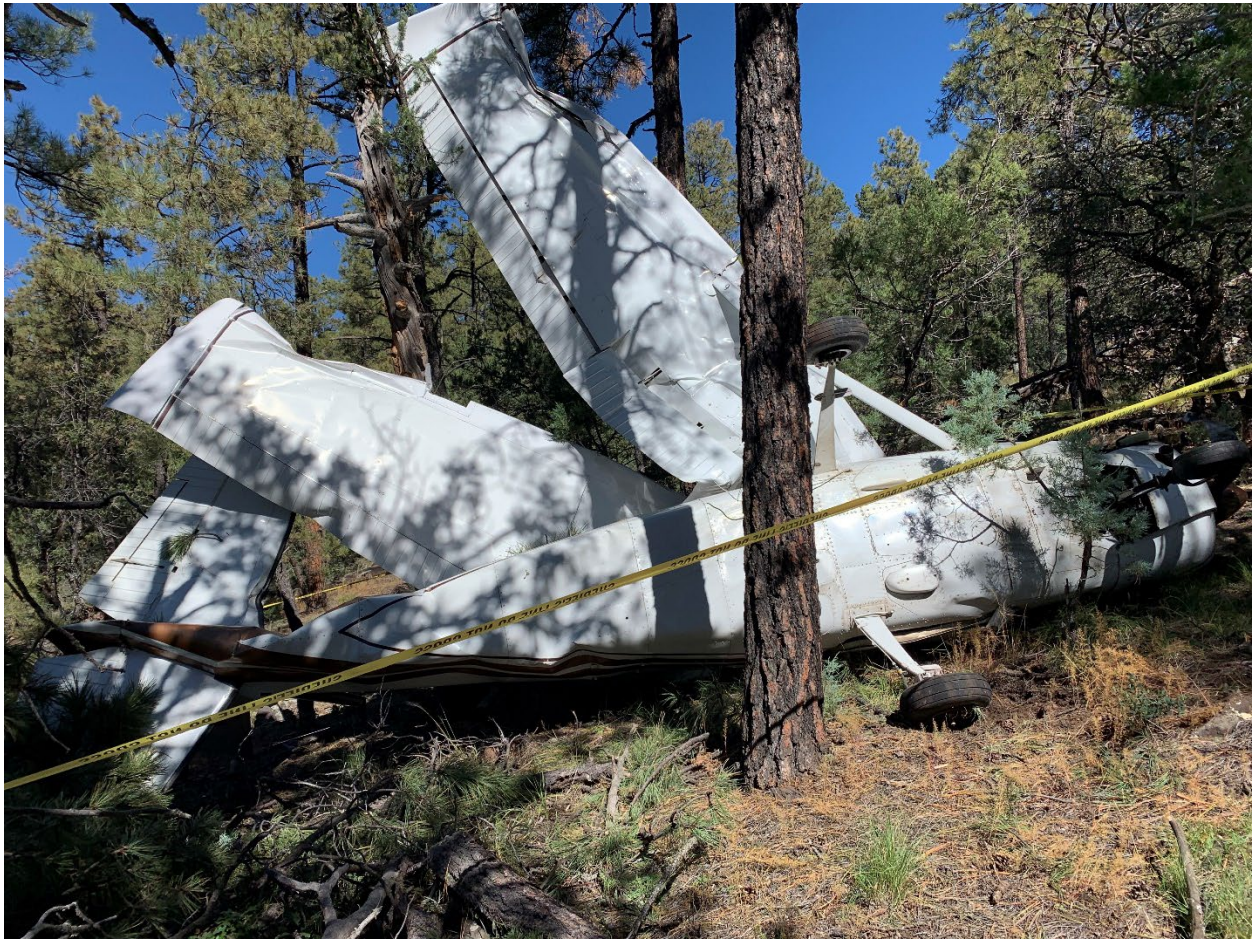
The first point of impact (FPOI) was identified as the top of a pine tree located about 100 ft downhill from the airplane wreckage. The tree height after the impact was estimated to be about 70 ft.

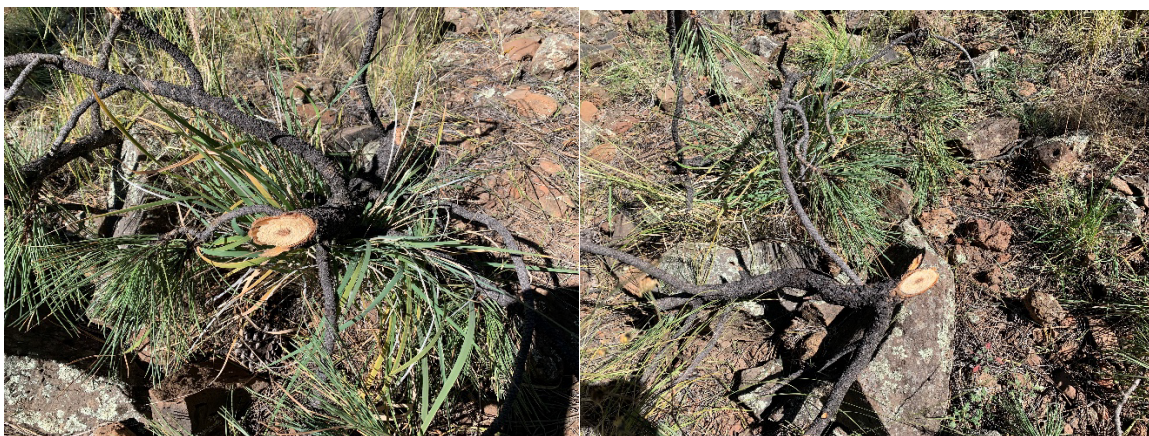
Two branches from the impacted trees found on the ground revealed signatures of propeller strikes.

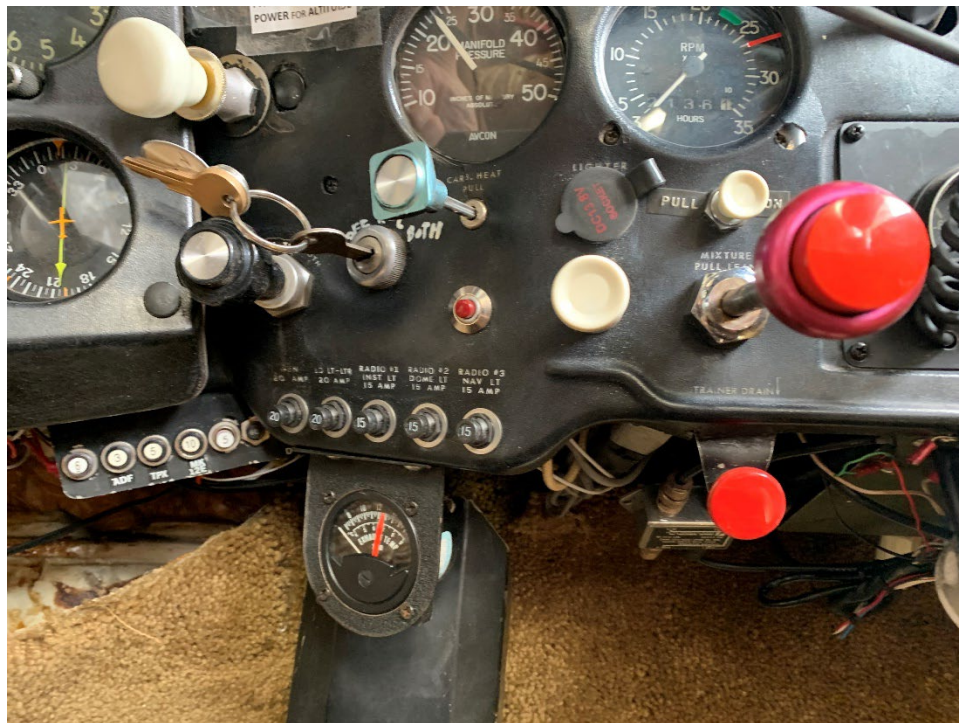
Figure 4. Partial view of instrument panel

Instrument panel revealed impact damages, but most gauges were readable; however, their accuracy could have been compromised as a result of the impact.

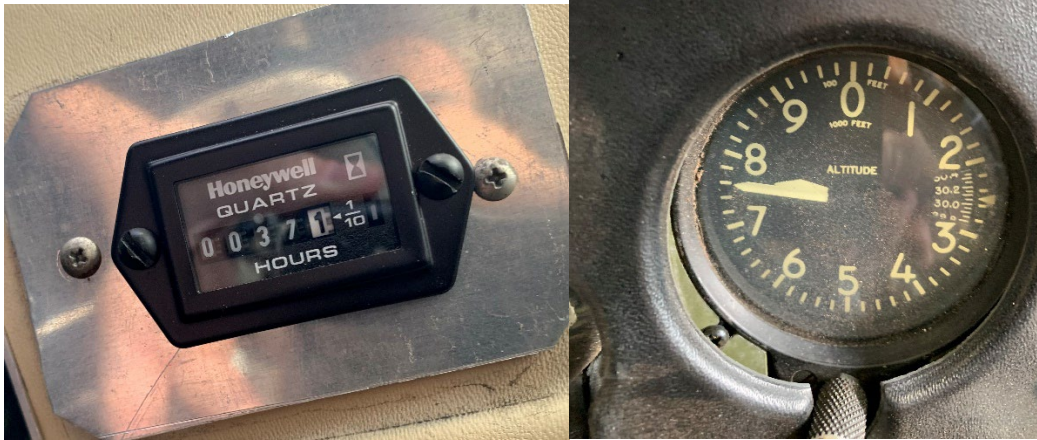
Figure 5. Hobbs meter and altimeter gauge

Hobbs meter indicated 371 hours, manifold pressure indicated 22.8 inHg and the altimeter indicated about 7,600 ft with the altimeter setting of 30.05.

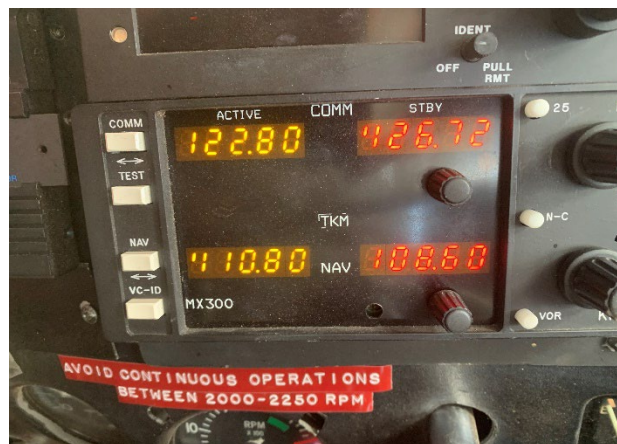
Figure 6. Comm panel

The battery was installed and operational. Turning it on displayed last used radio communication frequencies.

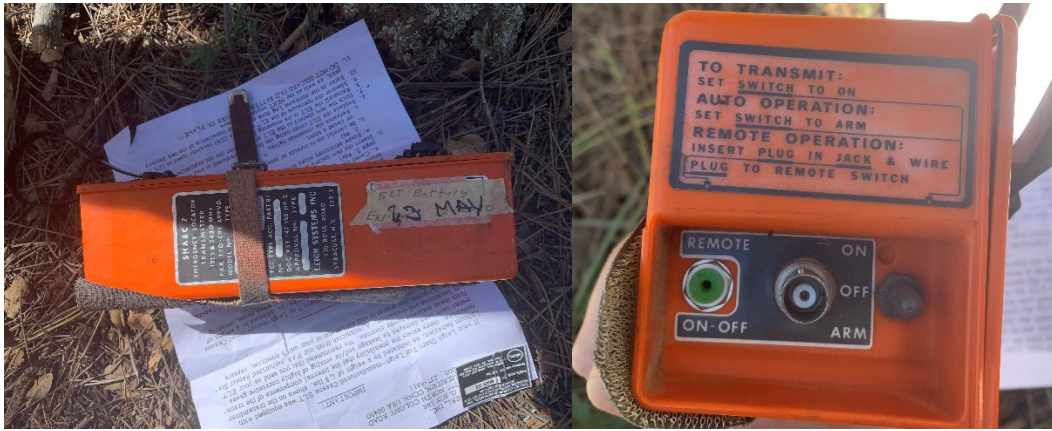
Figure 6. ELT

The ELT was installed and found in OFF position.
