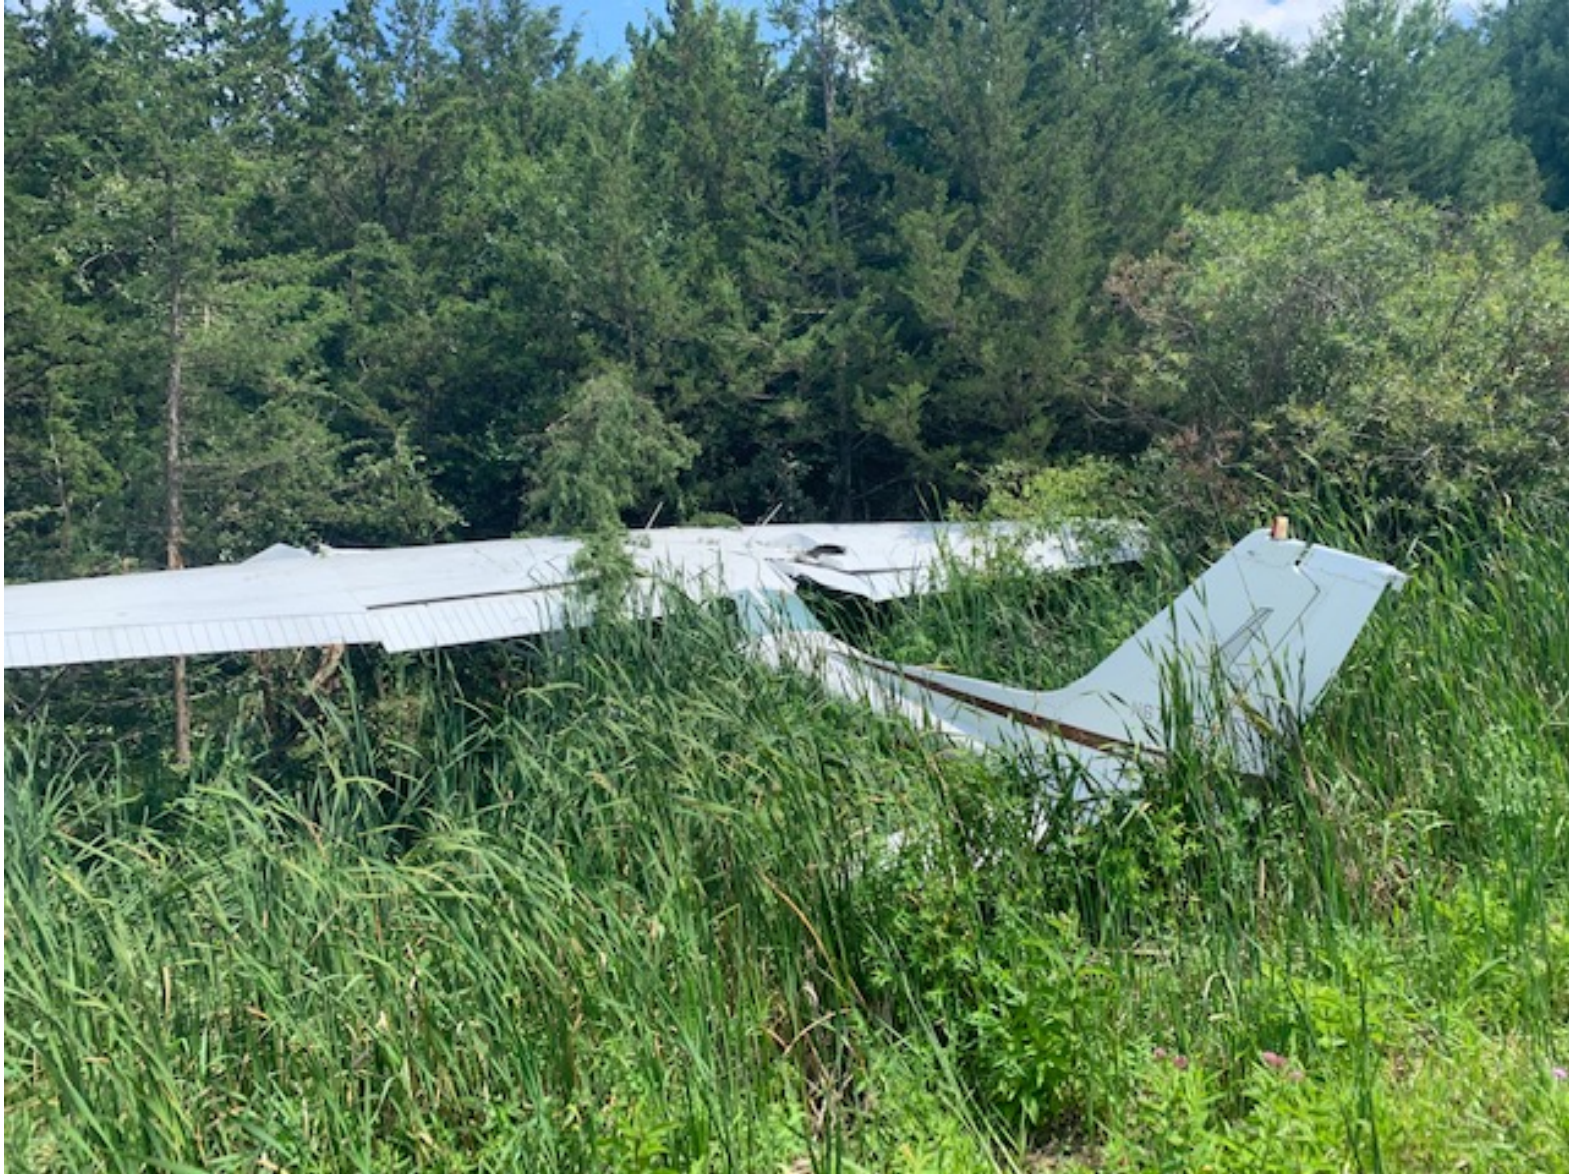
Photo 1 – Left aft view of airplane in the trees and brush. (Courtesy of FAA)

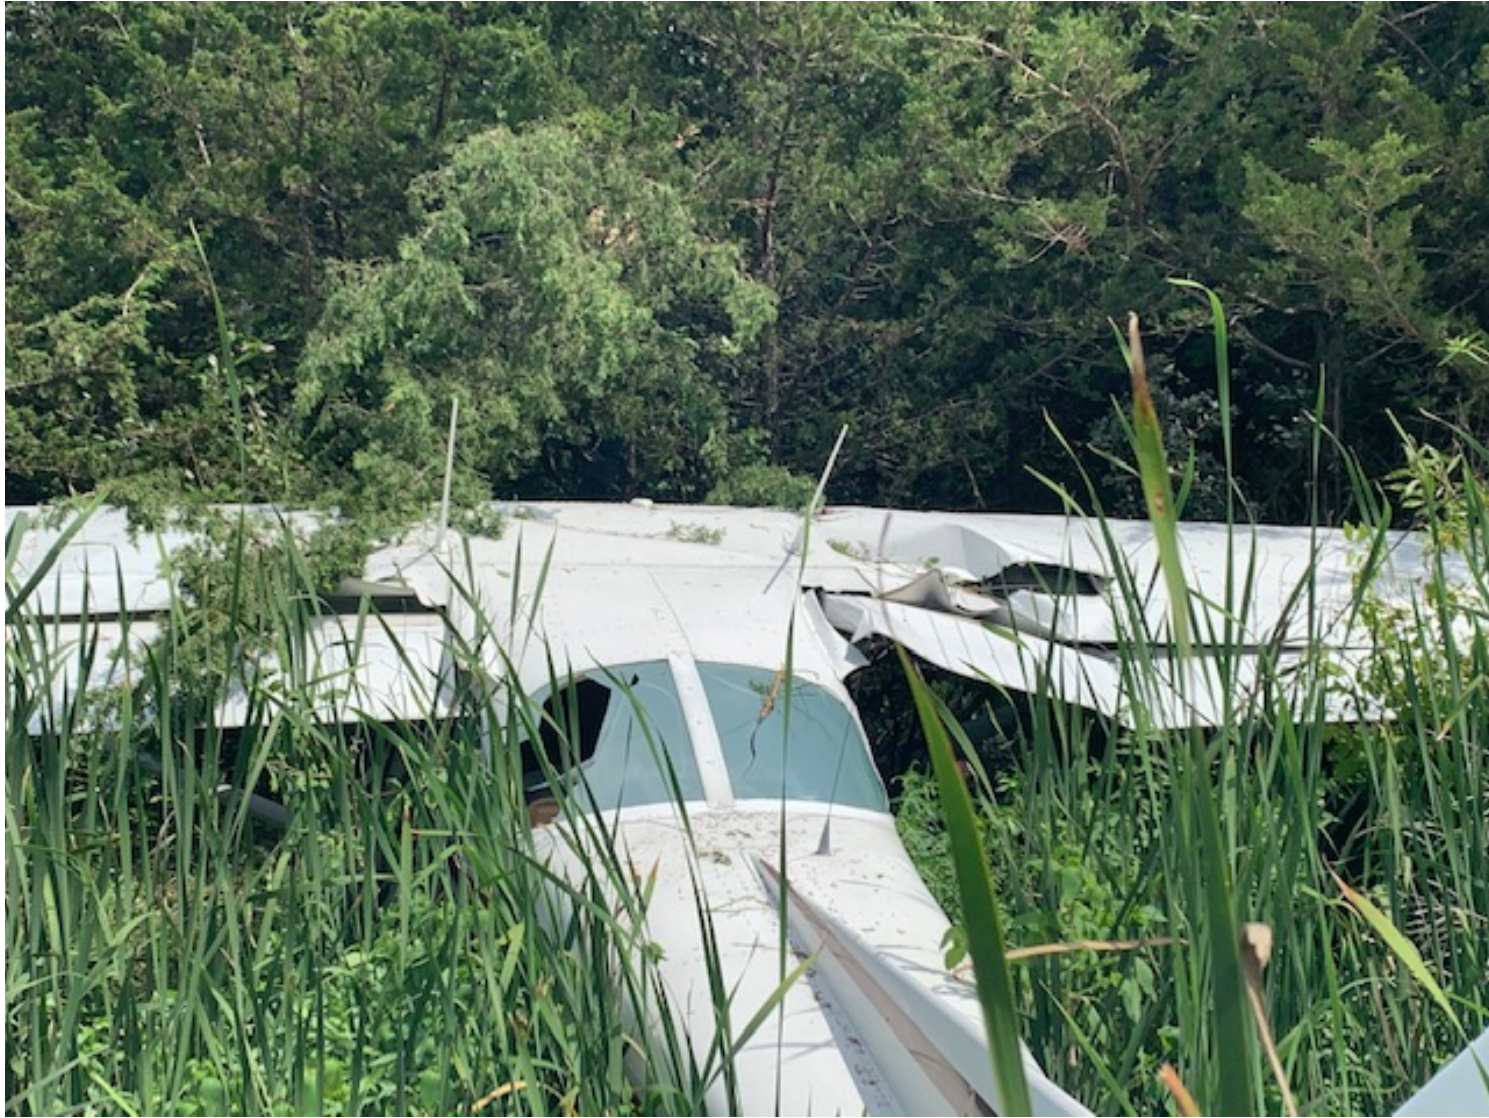
Photo 2 – Aft view looking forward. Note crumpled wings and flaps. (Courtesy of FAA)

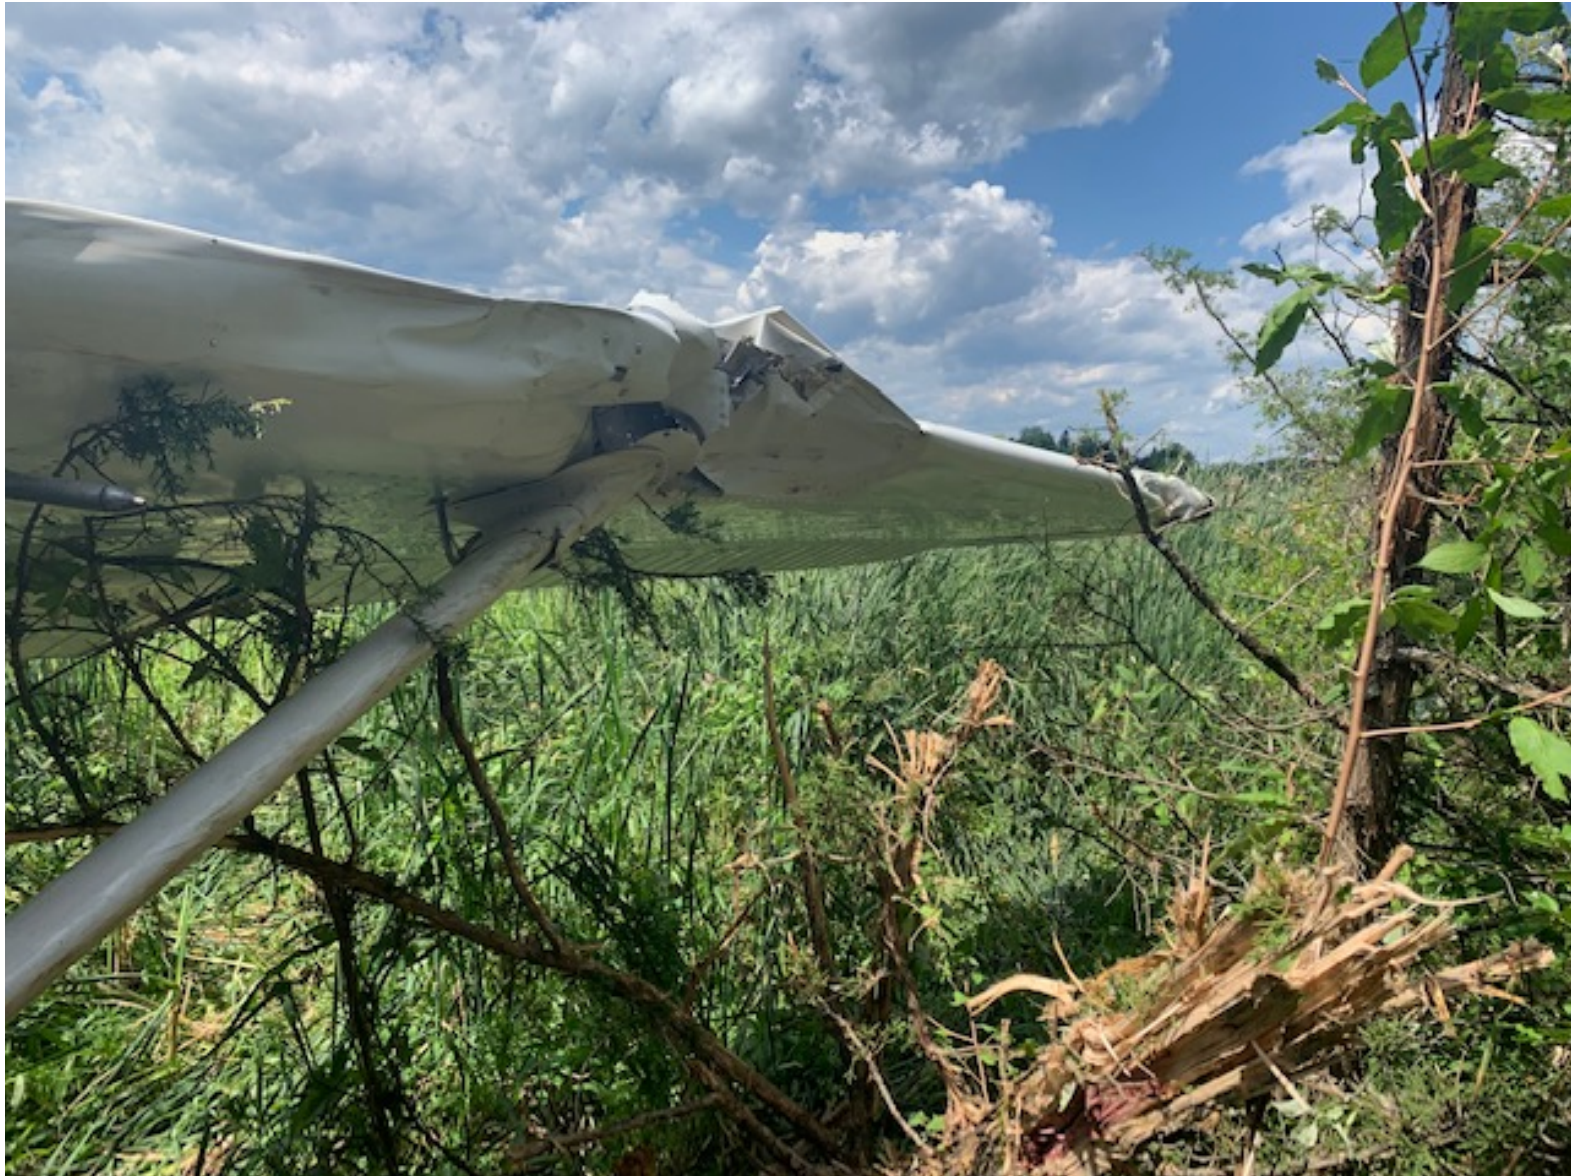
Photo 3 – Left wing leading edge and strut damage. (Courtesy of FAA)

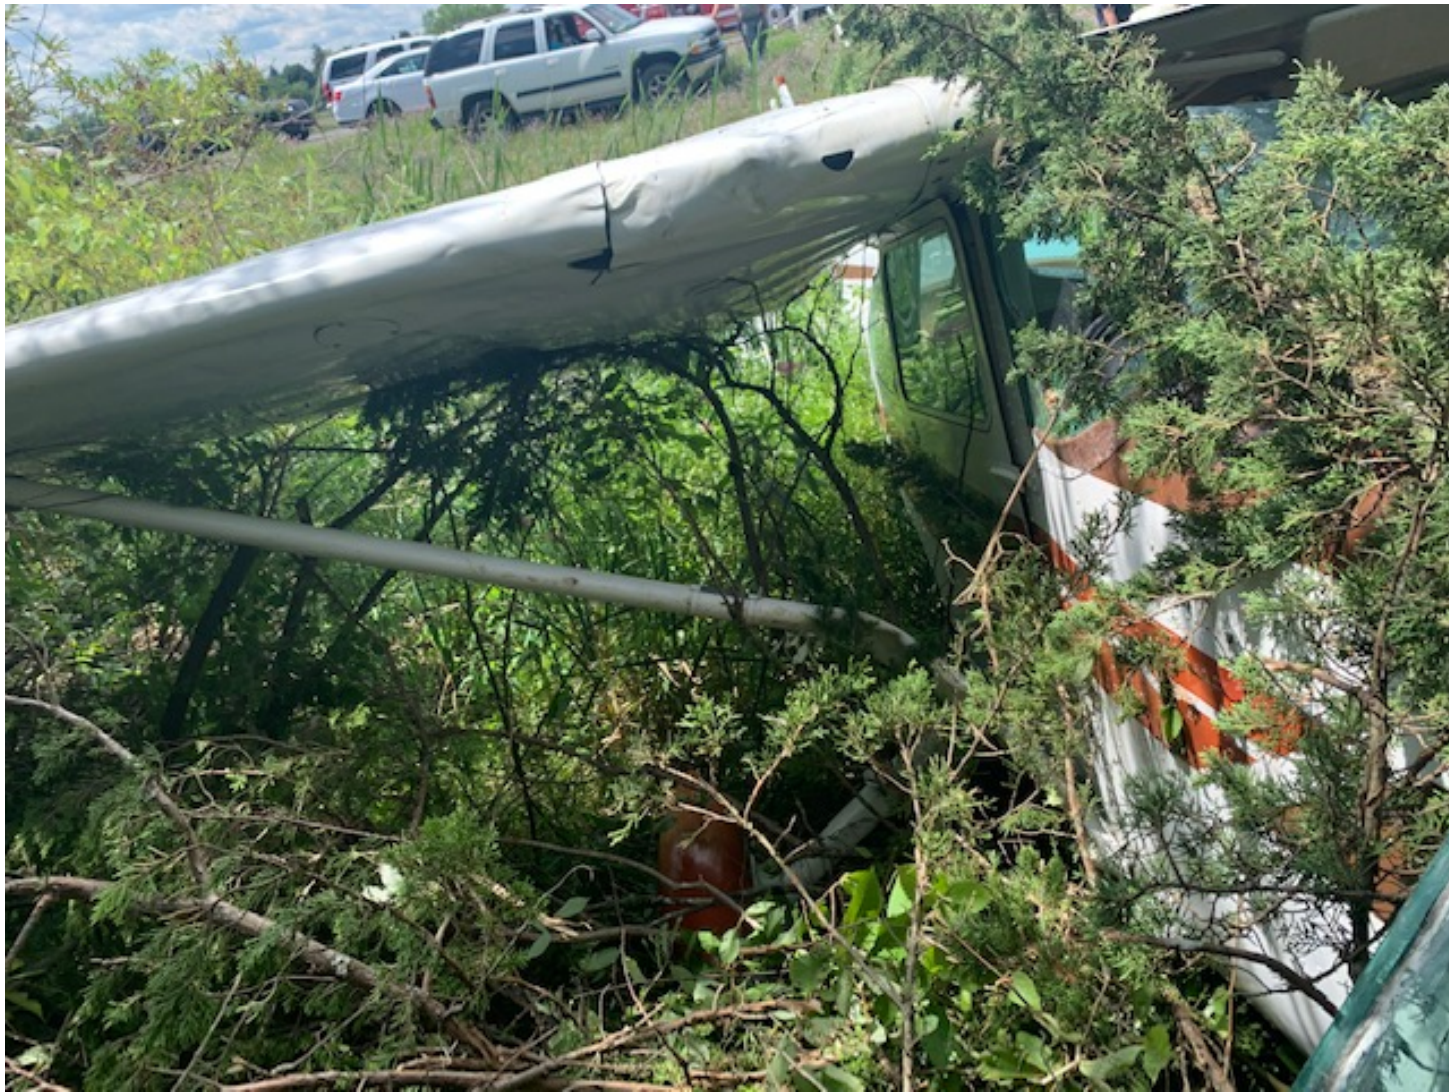
Photo 4 – Right wing leading edge damage. (Courtesy of FAA)

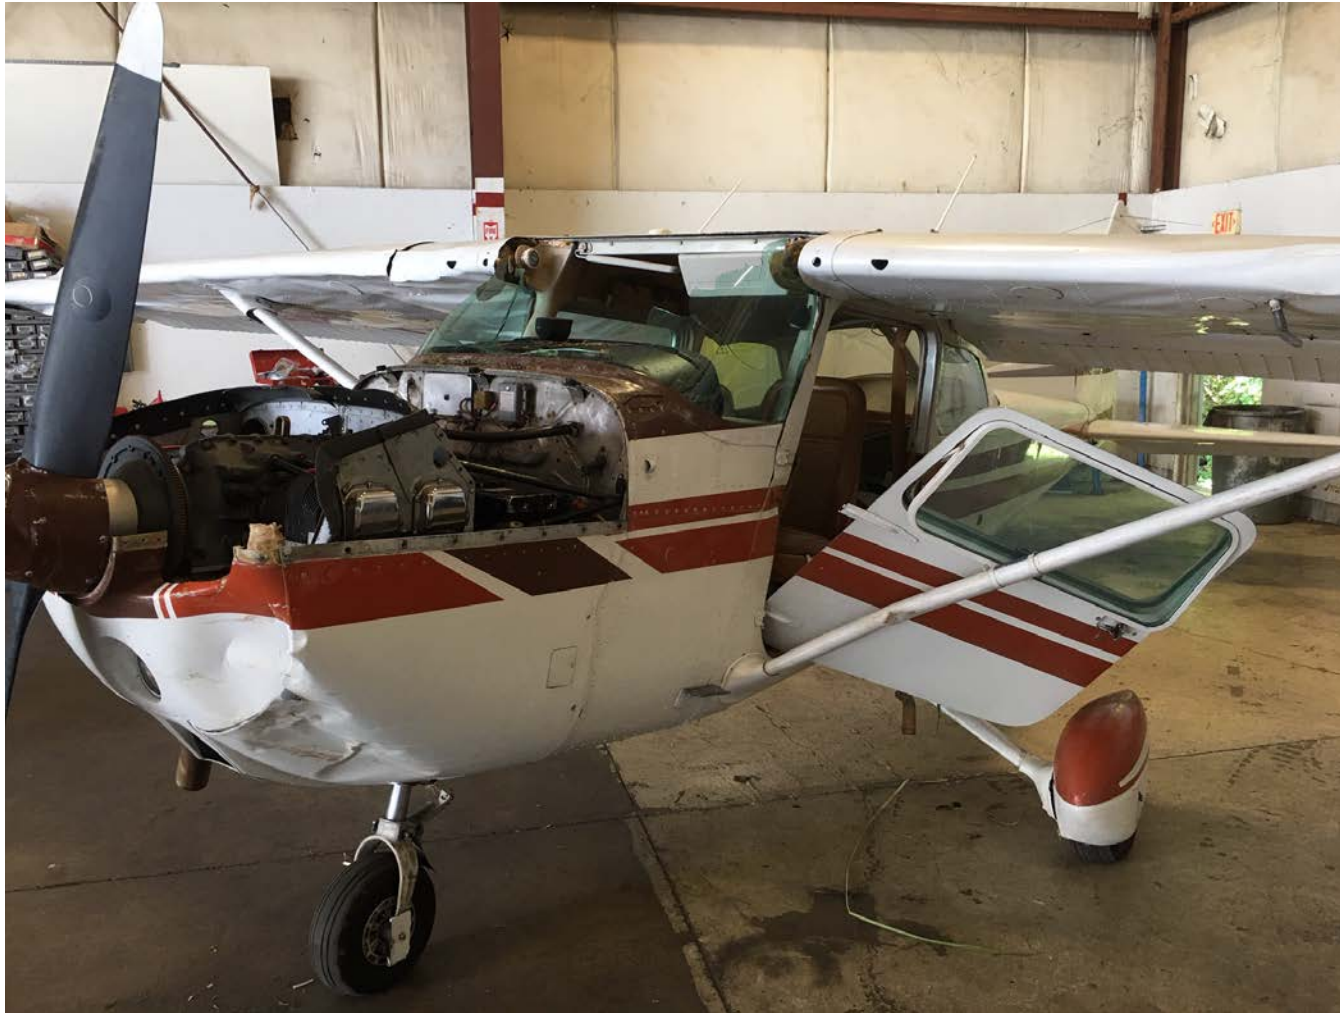
Photo 5 – Overall view of airplane damage after recovery to hanger. (Courtesy of Richmor Maintenance)

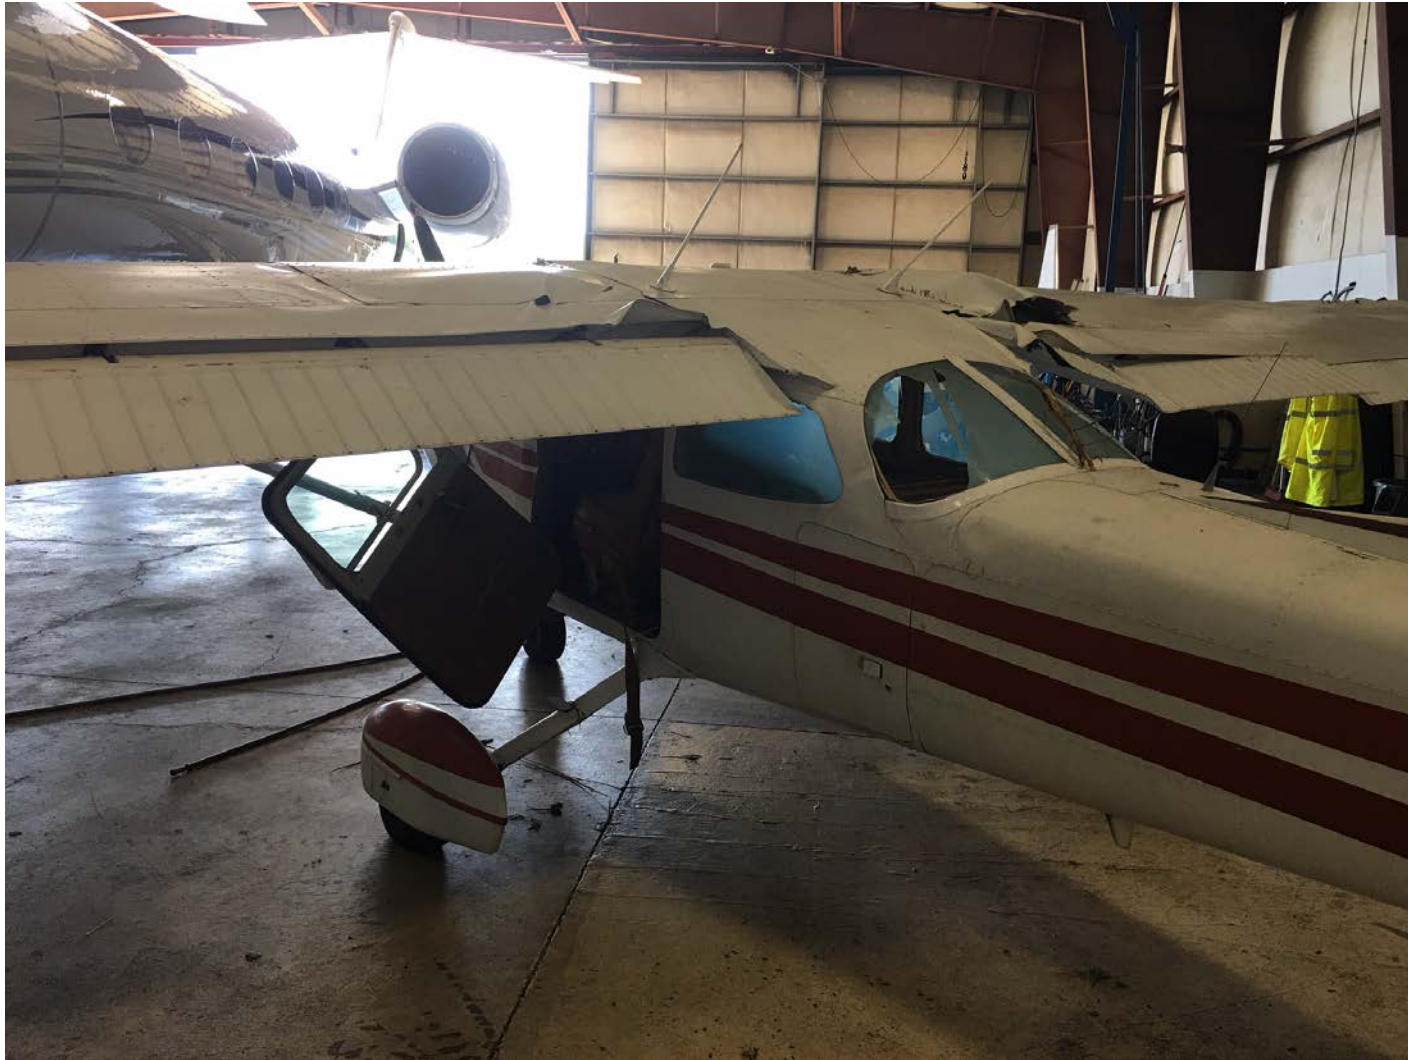
Photo 6 – Left aft quarter view of airplane damage after recovery to hangar. (Courtesy of Richmor Maintenance)

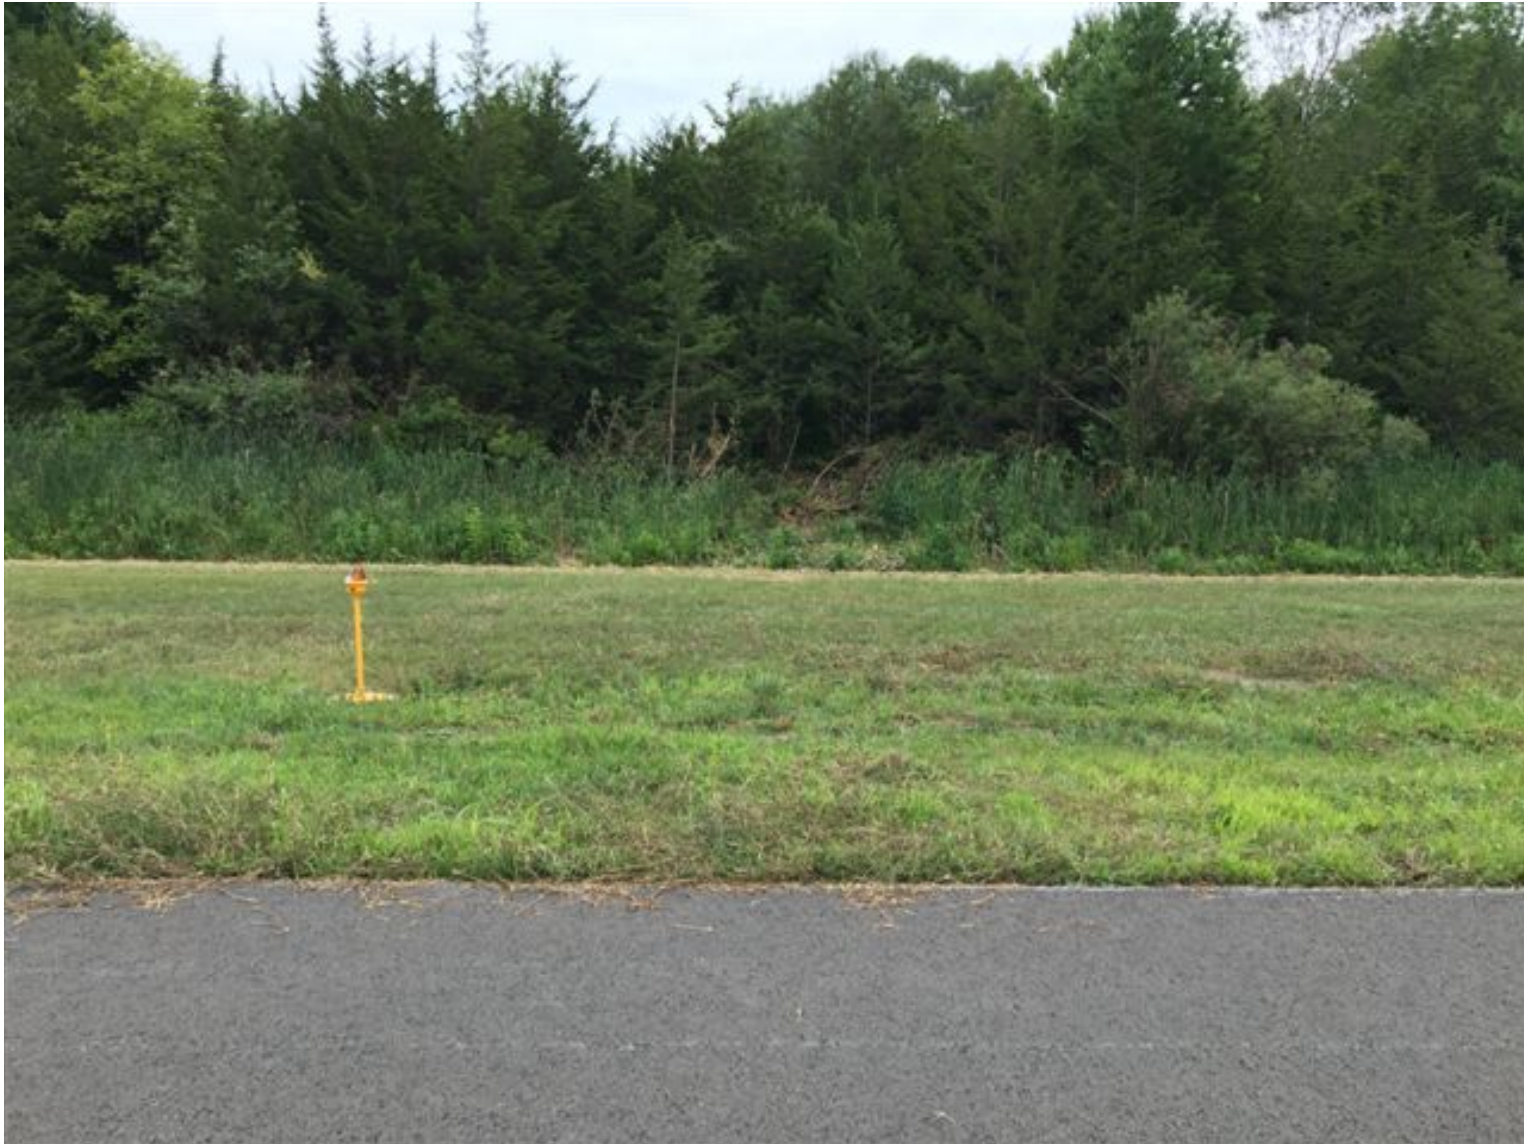
Photo 7 – View of trees and brush adjacent to runway 21, where the airplane entered. (Courtesy of Richmor Maintenance)
