ERA24LA011

INVESTIGATION PHOTOGRAPHS

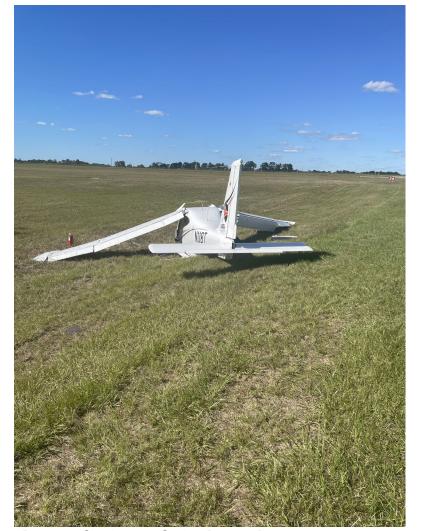
Photograph 1 - Aft view of airplane damage. (Courtesy of FAA)

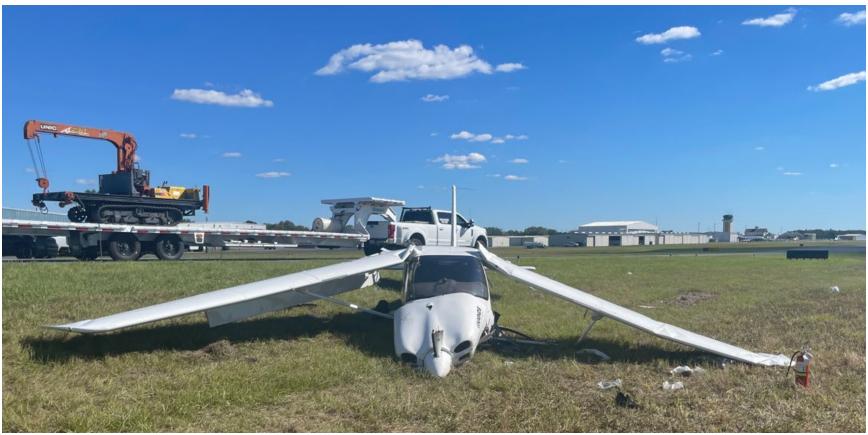
Photograph 2 - Forward view of airplane damage. Note both wings broken downwards. (Courtesy of FAA)

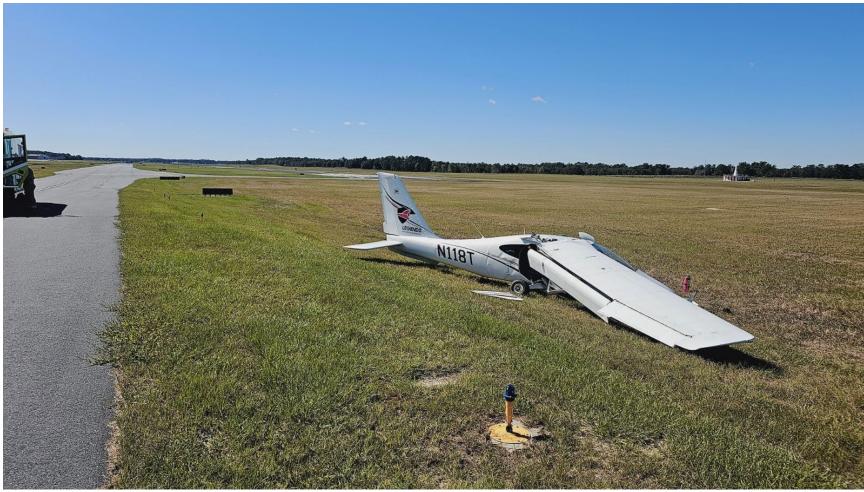
Photograph 3 - Right profile view of airplane damage. (Courtesy of FAA)

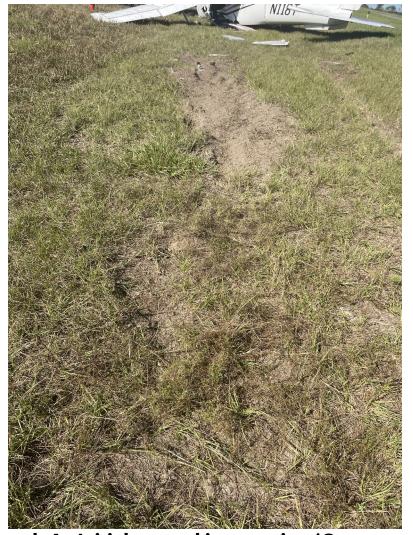
Photograph 4 - Initial ground impact site. (Courtesy of FAA)

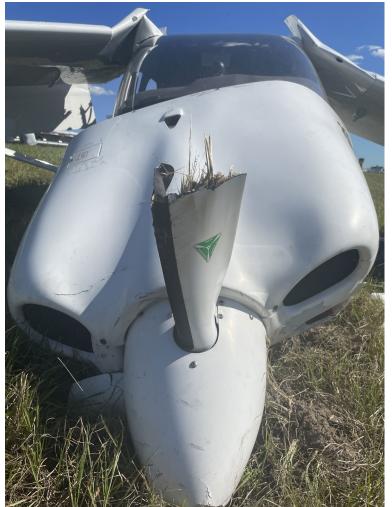
Photograph 5 - Close up view of propeller and engine compartment. (Courtesy of FAA)
