[ERA23LA334]

INVESTIGATION PHOTOGRAPHS

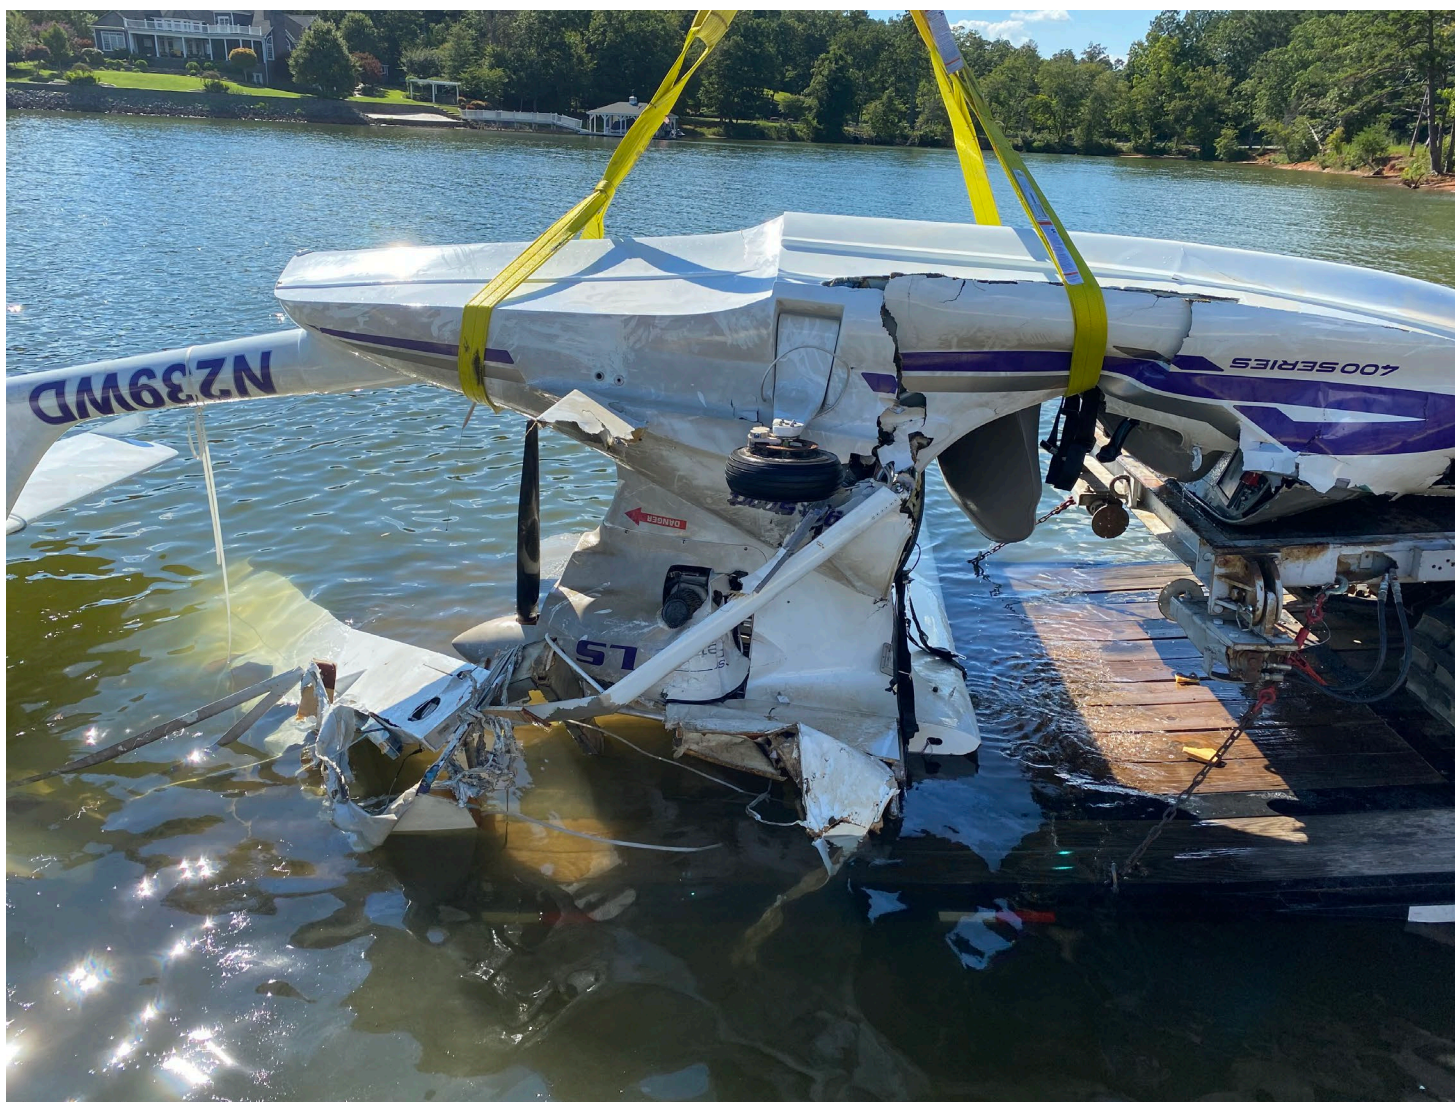
Photograph 1 - View of left side of airplane showing damage. (Courtesy of FAA)

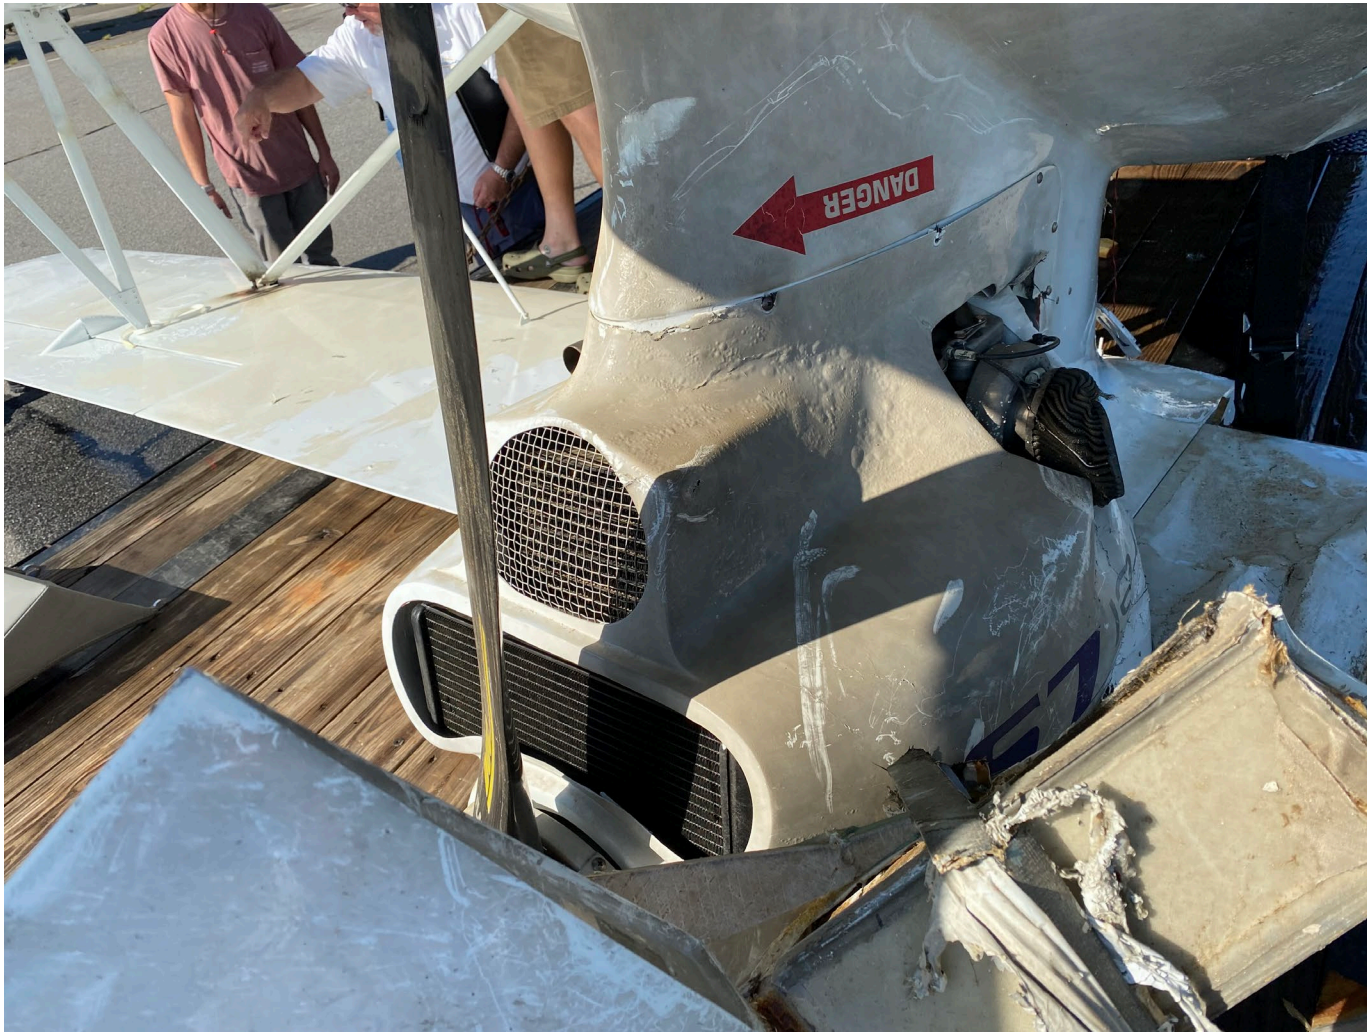
Photograph 2 - View of thermal damage to engine cowling. (Courtesy of FAA)

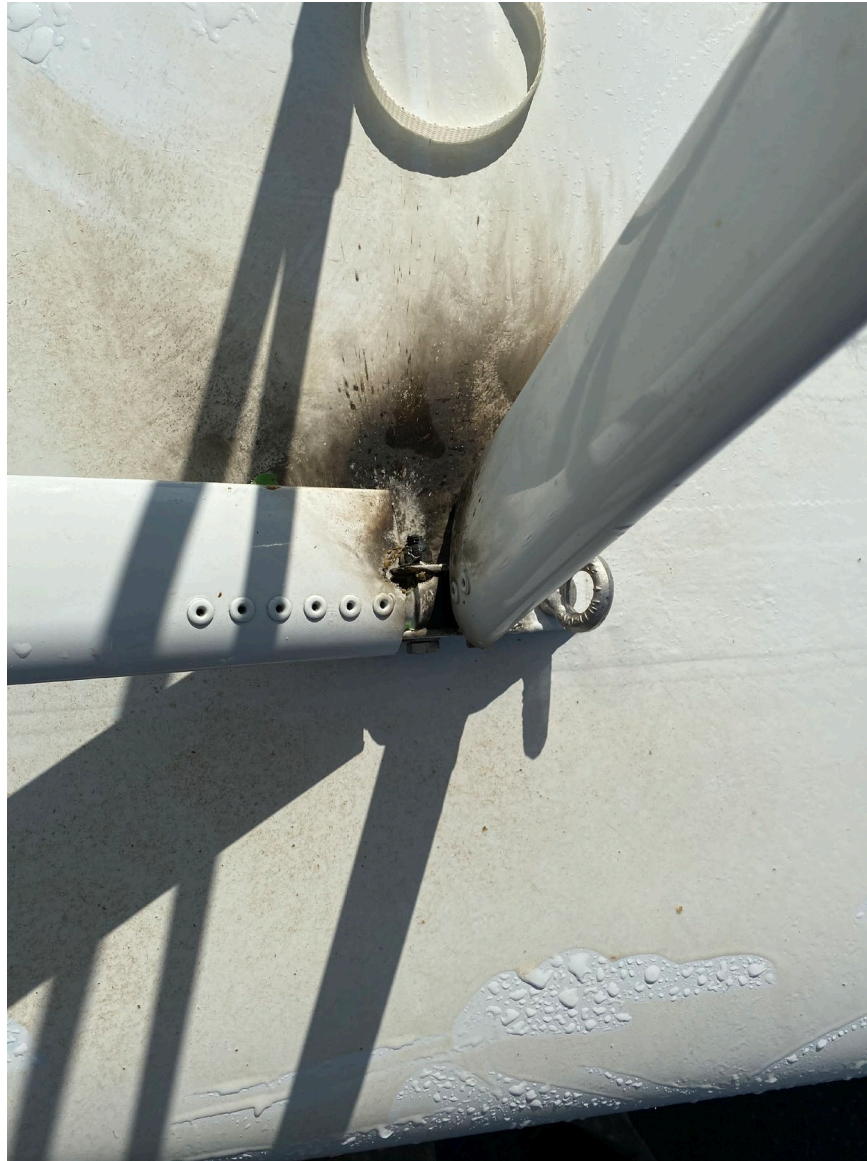
Photograph 3 - Electrical arcing damage to wing strut. (Courtesy of FAA)

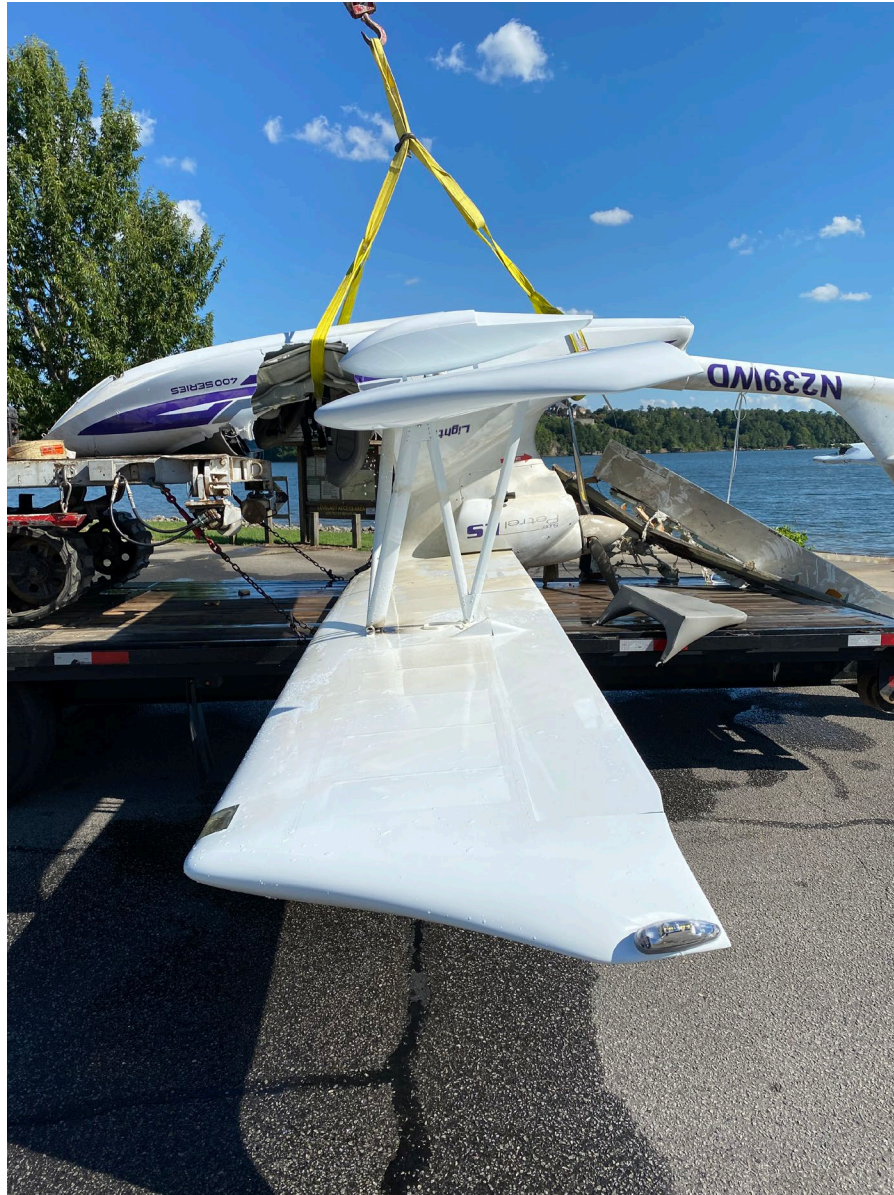
Photograph 4 - View of airplane during recovery, right side damage (Courtesy of FAA)
