## **NATIONAL TRANSPORTATION SAFETY BOARD**

# **ACCIDENT SITE EXAMINATION SUMMARY**

**WPR19FA183**

Location: Ephraim, UT  
Date: July 1, 2019  
Aircraft: Schempp Hirth Arcus M glider Robinson, N215MM  
NTSB Investigator-in-Charge: Maja Smith

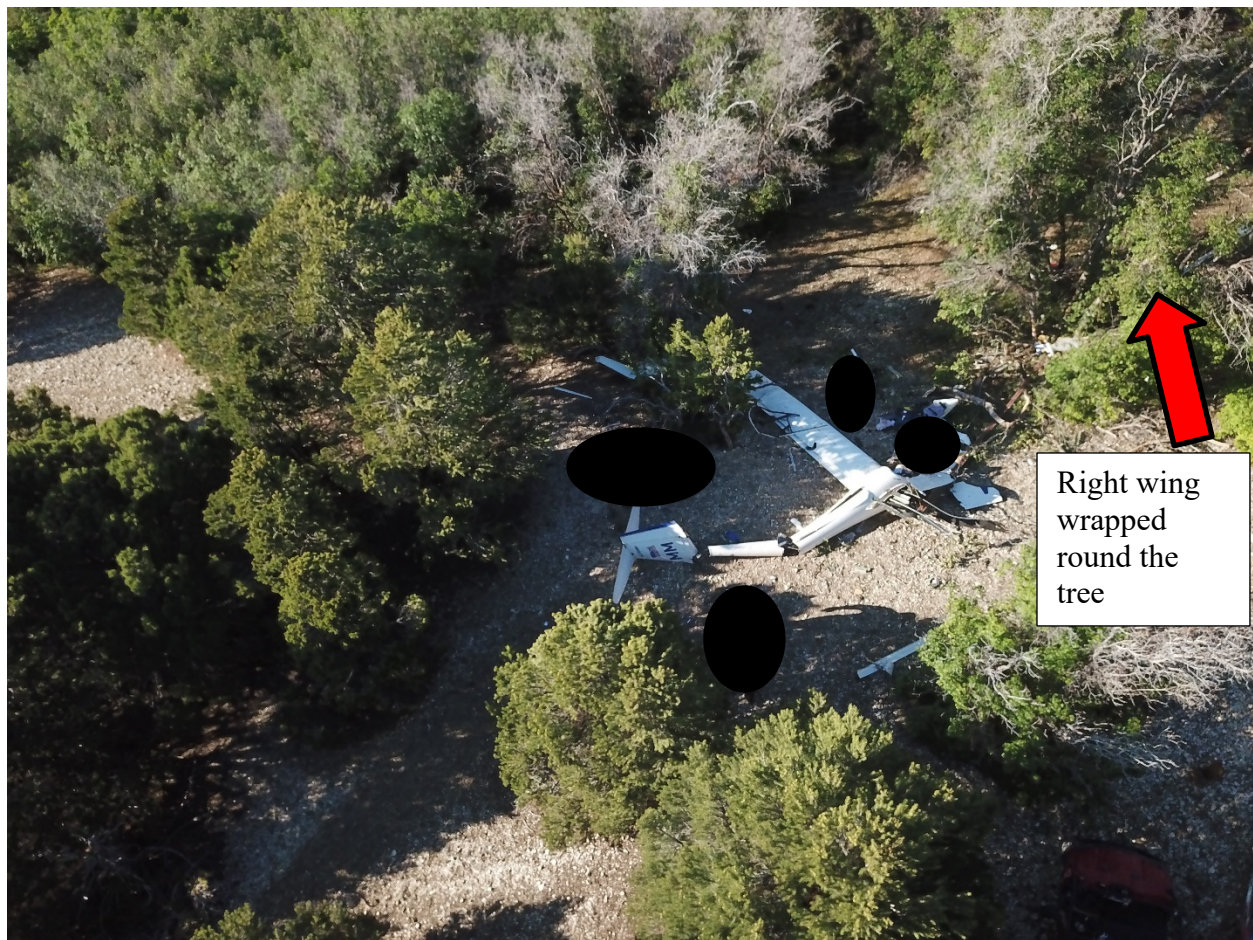
Figure 2. Accident site with the wreckage

The wreckage debris was located within mountainous terrain about 4.25 miles northeast of Ephraim, at the elevation of 7,628 ft. The wreckage was contained within 50 ft<sup>2</sup> area. The right wing separated from the glider upon impact with a tree during the accident sequence and was located about 20 ft east from the main wreckage. The main wreckage included the left wing, cockpit, fuselage, empennage, and engine. The forward fuselage and cockpit area was extensively crushed, deformed and fractured.

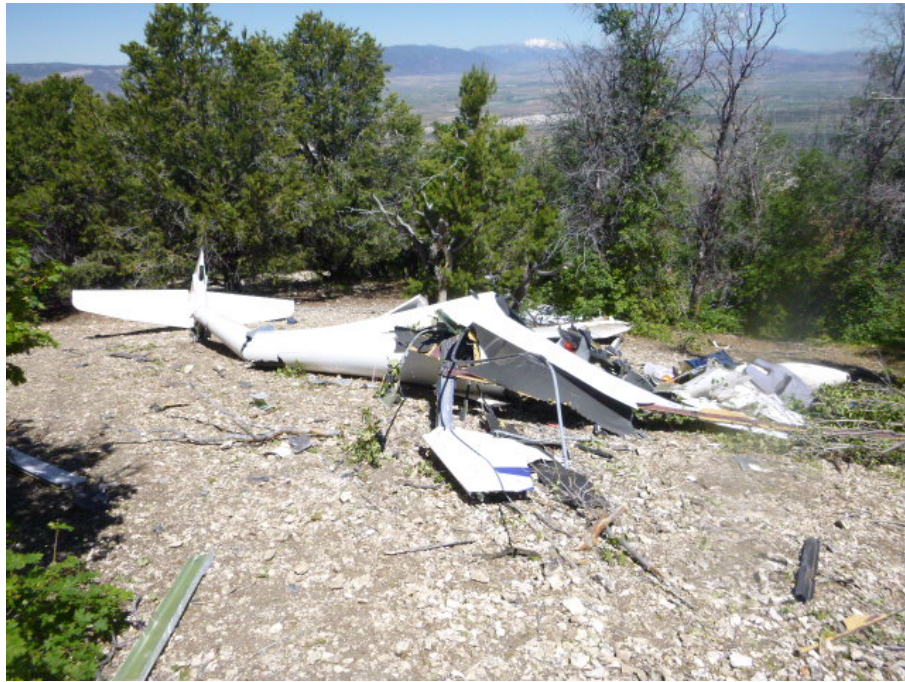
Figure 3. Main wreckage

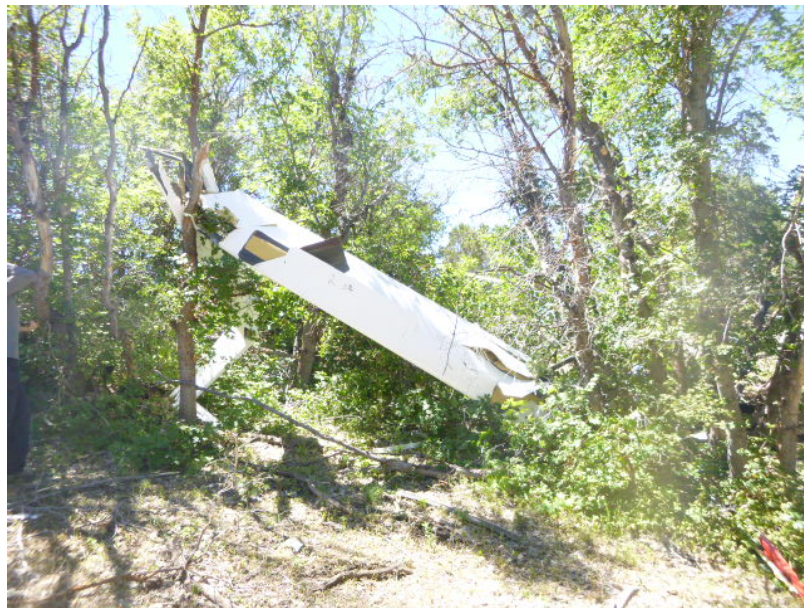
Figure 4. Right wing in the tree

Inboard and the majority of the outboard portion of the right wing were wrapped around the tree which appeared to be the first point of impact. The other outboard portion remained with the main wreckage. The right inboard section remained attached to the right outboard section; the right-wing tip separated from the wing. Inboard and outboard ailerons remained attached to the wing.

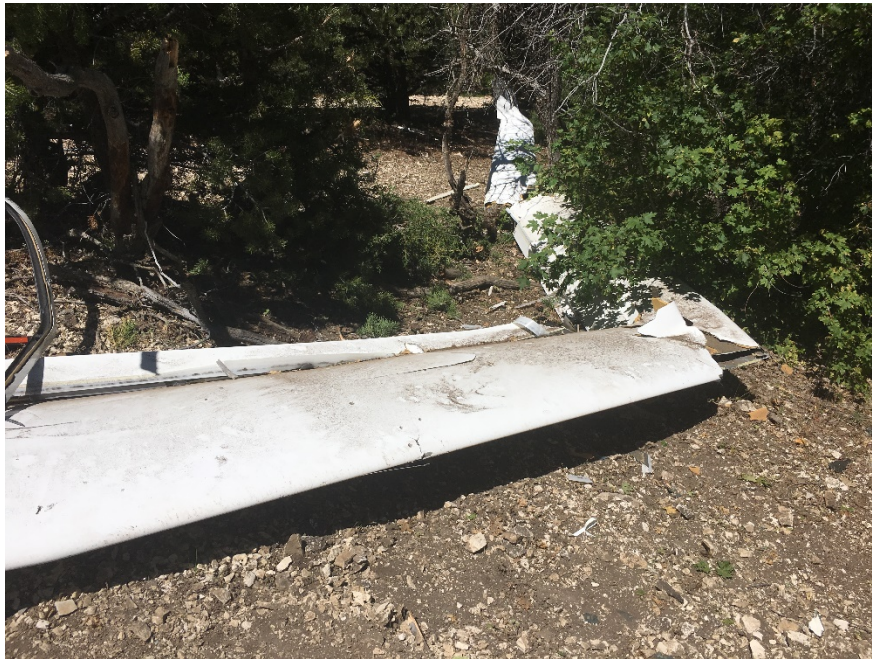
Figure 5. Left wing

The left inboard wing remained attached to the fuselage. Fractures and deformations along the wingspan were results of the impact. The outboard portion of the left wing was fractured bent backwards. Inboard and outboard ailerons remained attached to the wing. The steel fuselage truss was deformed and fractured in multiple places consistent with the fuselage damage. The fuselage shell fractured half-way, but all the cables remained attached.

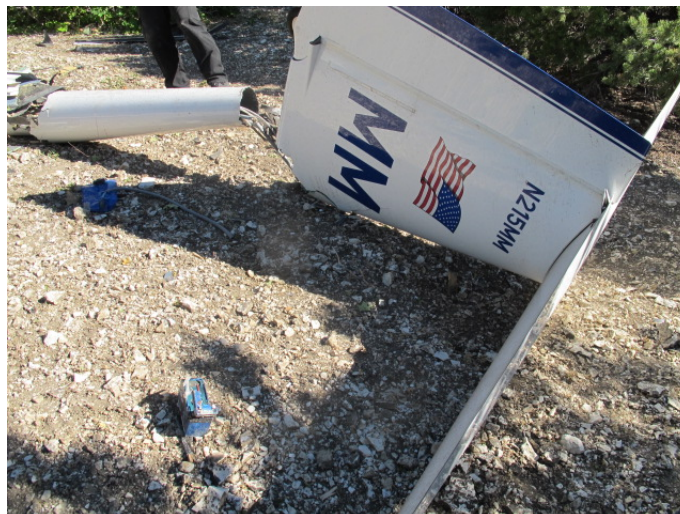
Figure 6. Empennage

The empennage was fractured from the fuselage just forward of the vertical stabilizer but remained attached by the control rods and cables. The vertical stabilizer was rotated 180° so that its leading edge was resting on the ground. The horizontal stabilizer remained

attached to the top of the vertical stabilizer and was engaged with the forward and aft mount points. The elevator hinges on the horizontal stabilizer were all intact and undamaged. The rudder remained intact. The aileron controls were fractured and deformed in multiple places between the forward control stick and the tunnels, consistent with the extensive forward fuselage damage. All of the fractures in the flight control components had a dull, grainy appearance and deformation consistent with overstress separation.
