NATIONAL TRANSPORTATION SAFETY BOARD
Office of Aviation Safety
Washington, DC 20594

SURVIVAL FACTORS SPECIALIST'S FACTUAL REPORT

Airplane : Textron Aviation B300 [N534FF]
Location : Addison, TX
Date : June 30, 2019
Time : 0911 central daylight time (CDT)¹
NTSB # : CEN19MA190

On June 30, 2019, about 0911 central daylight time, a Textron Aviation B300, N534FF, was destroyed when it was involved in an accident near Addison, Texas. The airline transport pilot, the commercial co-pilot, and eight passengers sustained fatal injuries. The airplane was operated as a Title 14 Code of Federal Regulations Part 91 personal flight.

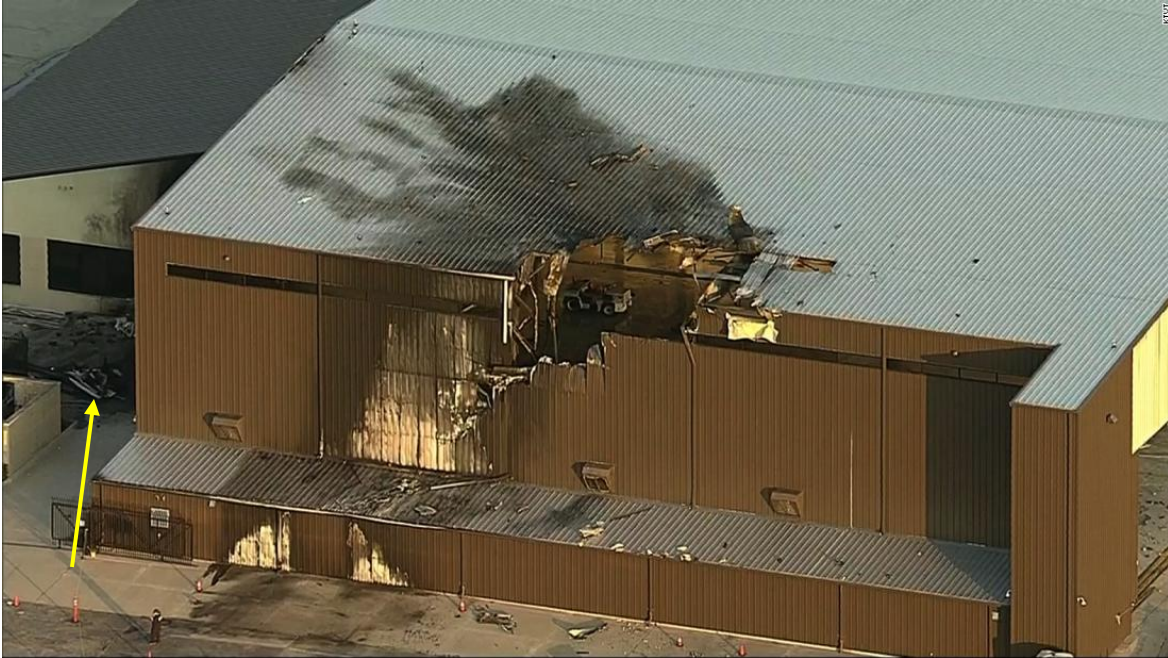
Photo 7. Aerial view of accident site and final resting location of N534FF (yellow arrow).

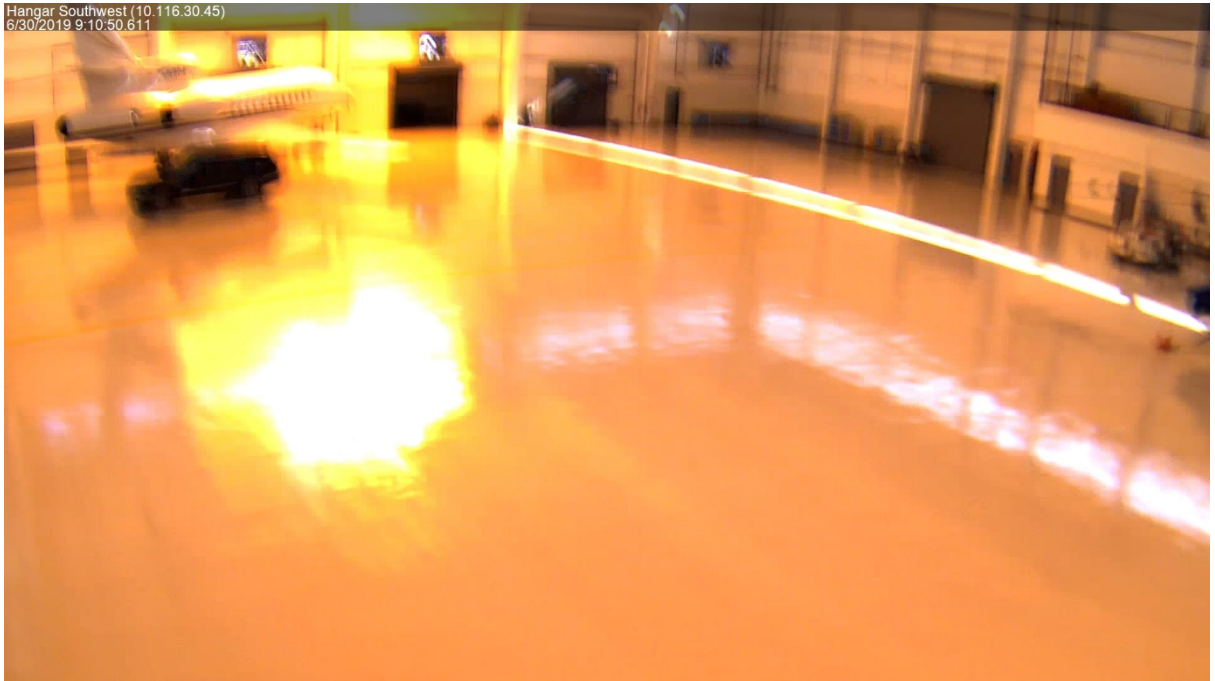
Photo 9. Interior view of hangar at the moment of impact.

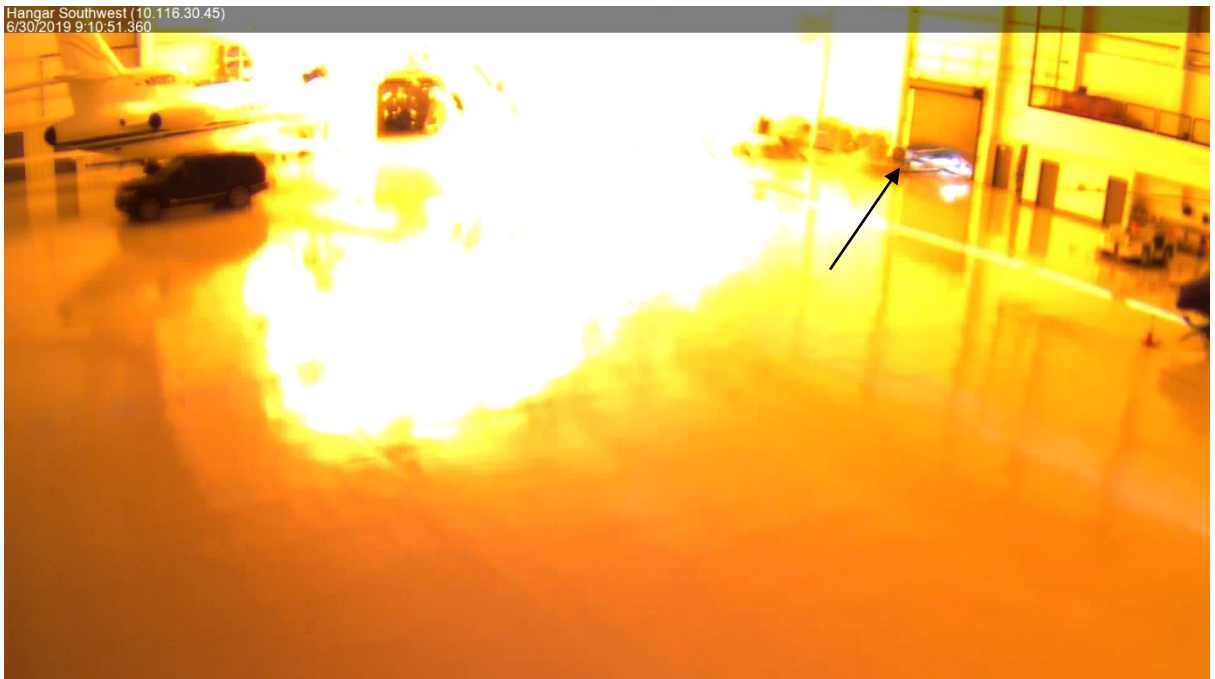
Photo 10. Interior view of hangar as N534FF (black arrow) exits the building through the roll-up garage door.

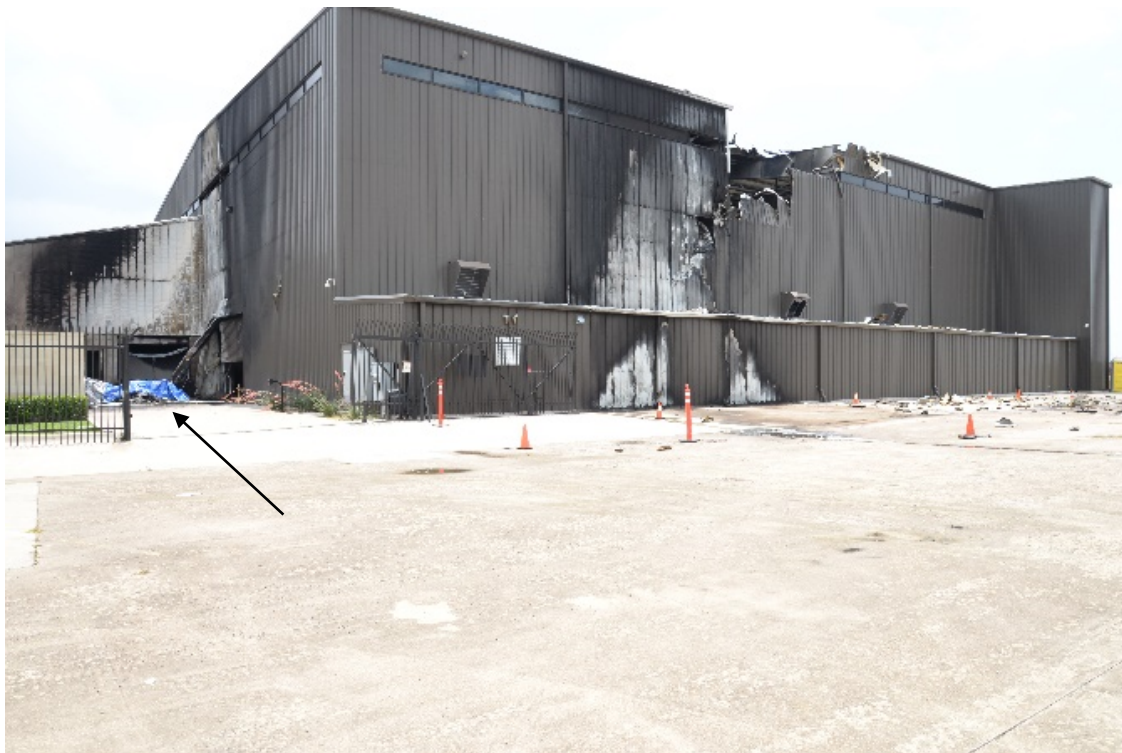
Photo 12. Ground view of the hangar impacted by accident airplane and airplane's final resting location.

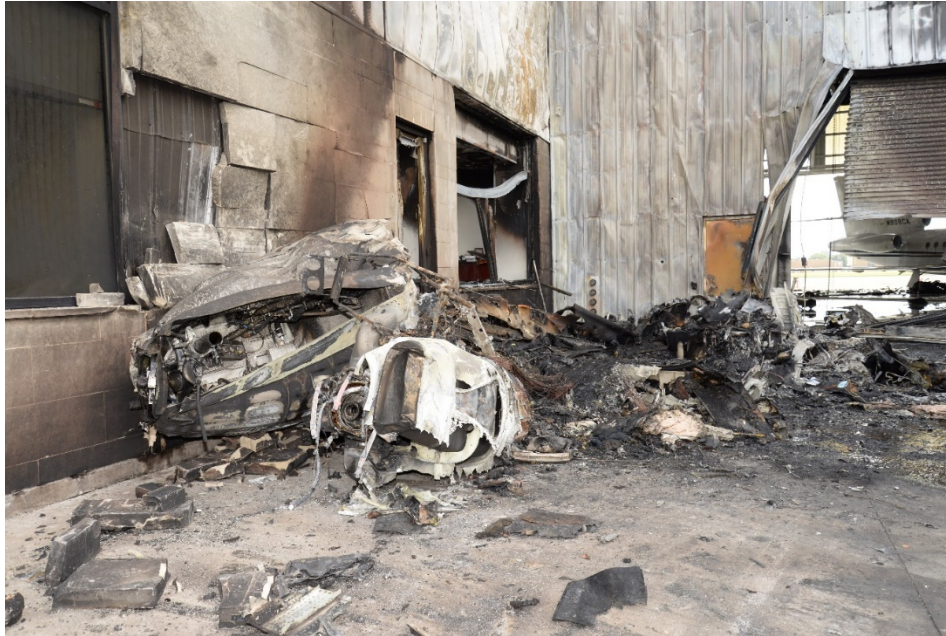
After sliding through the roll-up garage door, the airplane came to rest on its right side and was immediately involved in a postcrash fire. See photos 13 and 14. The NTSB Structures Group documented the airplane wreckage on-scene and noted that the fire

Photo 13. Airplane wreckage lying on its right side.

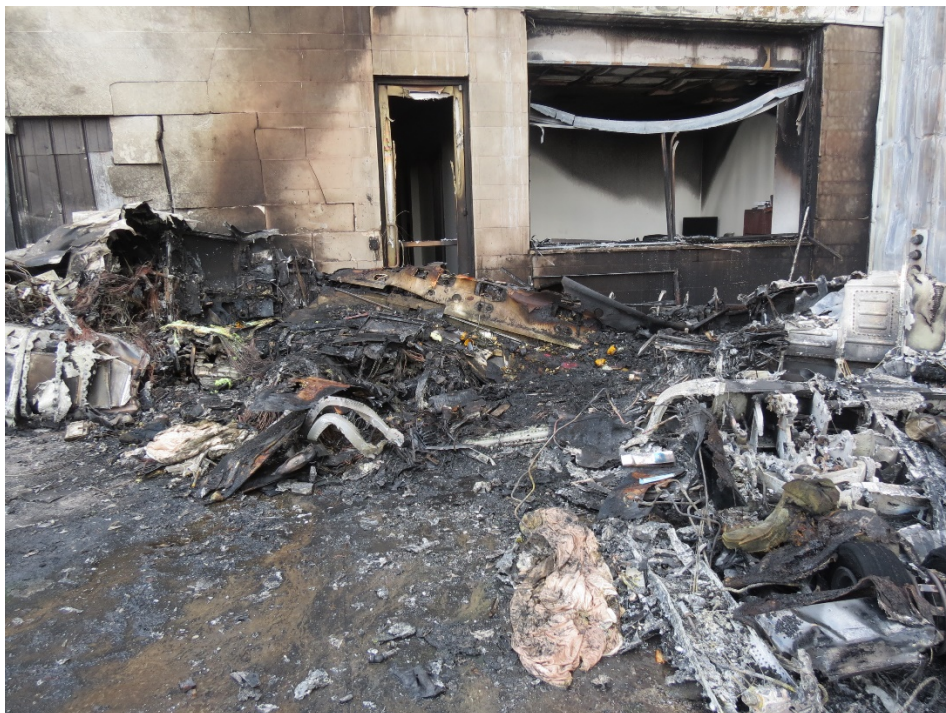
consumed a majority of the fuselage. The charred remains of the aft entry door were found in the main wreckage and one of the two overwing window exits was found partially burned in the hallway near the hangar office door, next to the main fuselage wreckage site. The other overwing window exit was not identified in the wreckage. See the Structures Group Factual Report for additional on-scene photographs.

Photo 14. Cabin area of airplane.

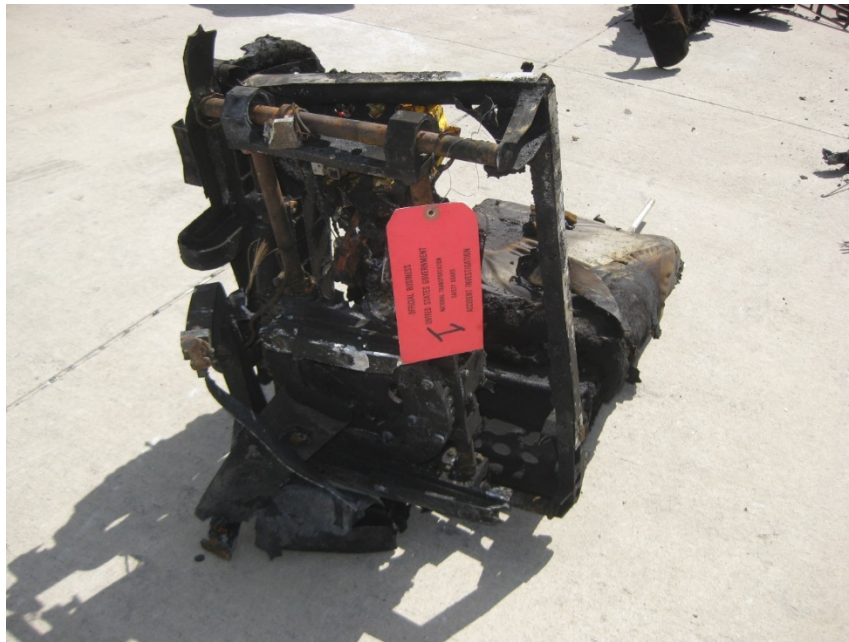
Portions of all of the crew and cabin seats were identified by the Structures Group. All seats showed evidence of various degrees of fire consumption. Some seats showed deformation consistent with impact damage and separation from seat tracks and flooring. The data tag from one passenger seat indicated it was manufactured by Aircraft Modular Products (model 252401401-3067A75, S/N 170125-07) to comply with National Aircraft Standard (NAS) 809 and Technical Standard Order C39B (Fwd 9G, Up 7G, Side 3G, Down 9G). Photographs showing the condition of some of the damaged seats are shown below.

Photo 15. Damaged and charred passenger seat.

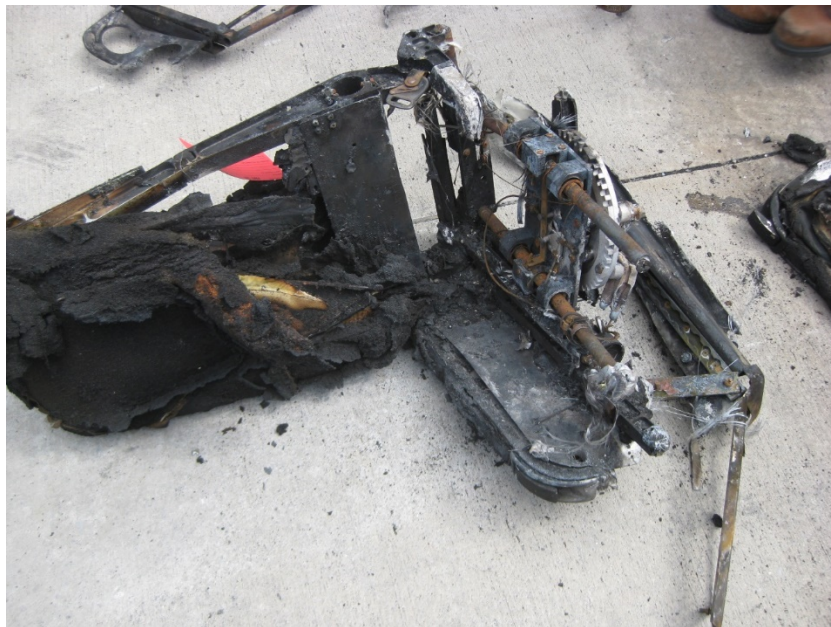
Photo 16. Damaged and charred passenger seat still attached to some seat track.

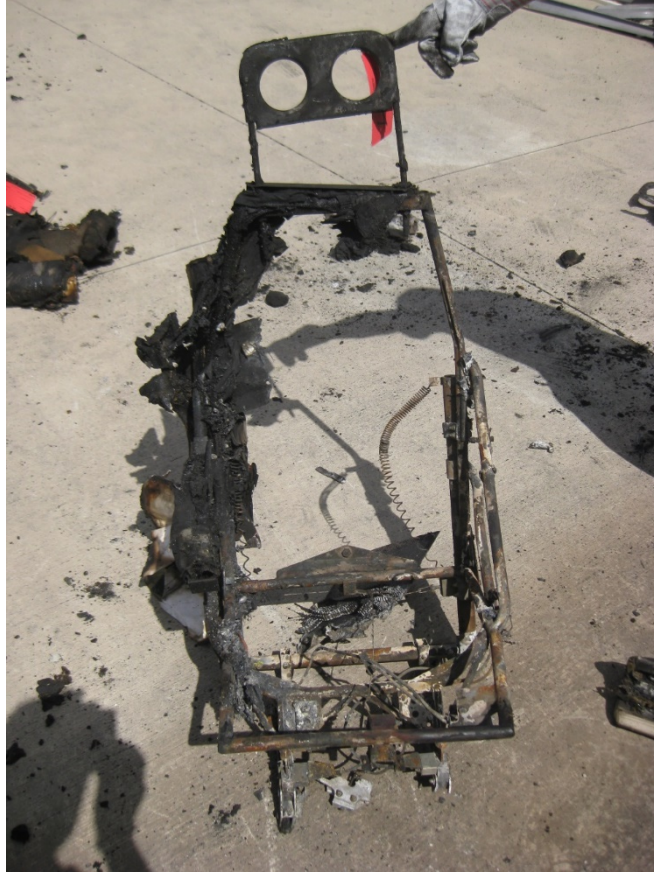
Photo 17. Fire-consumed crew seat.

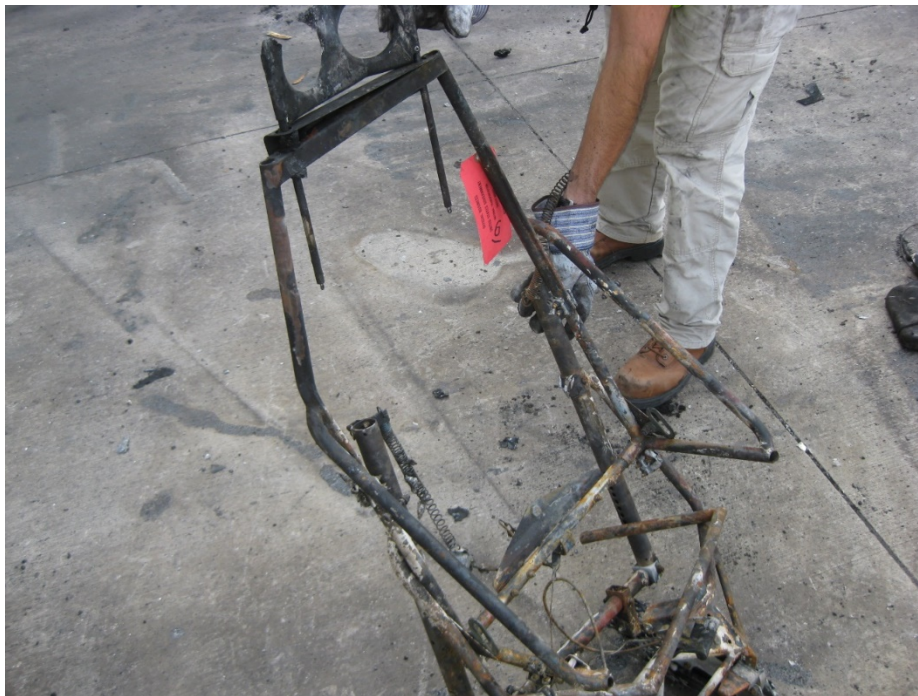
Photo 18. Fire-consumed crew seat with fractured seatpan tubes.

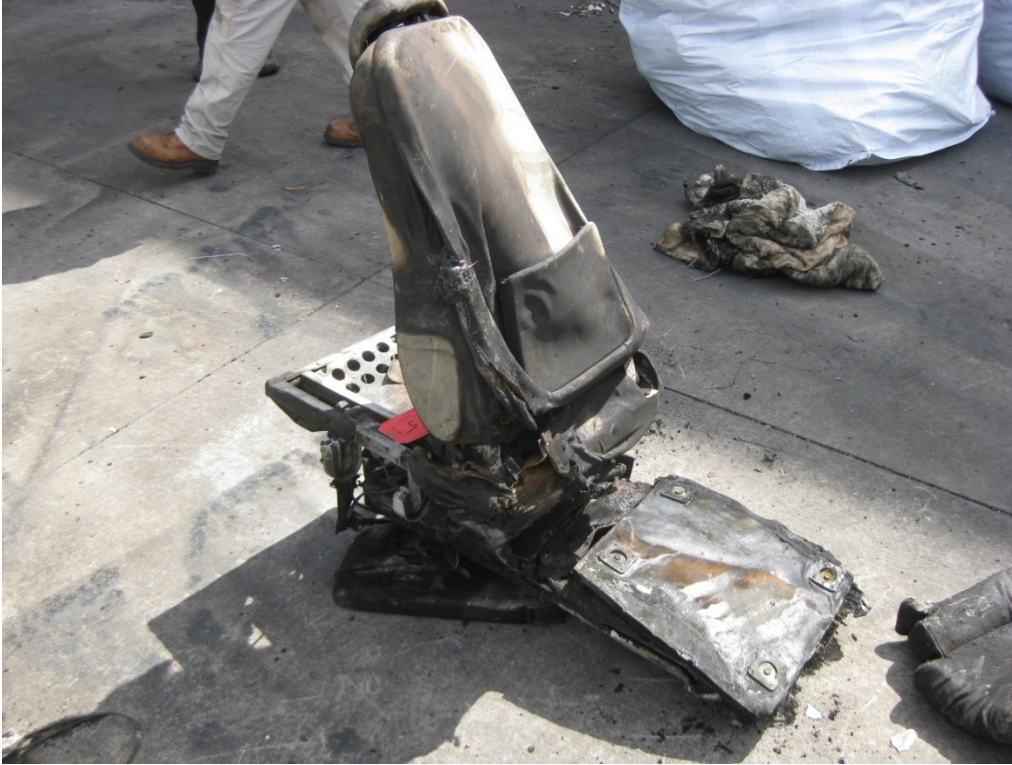
Photo 19. Damaged passenger seat still attached to a section of cabin flooring.

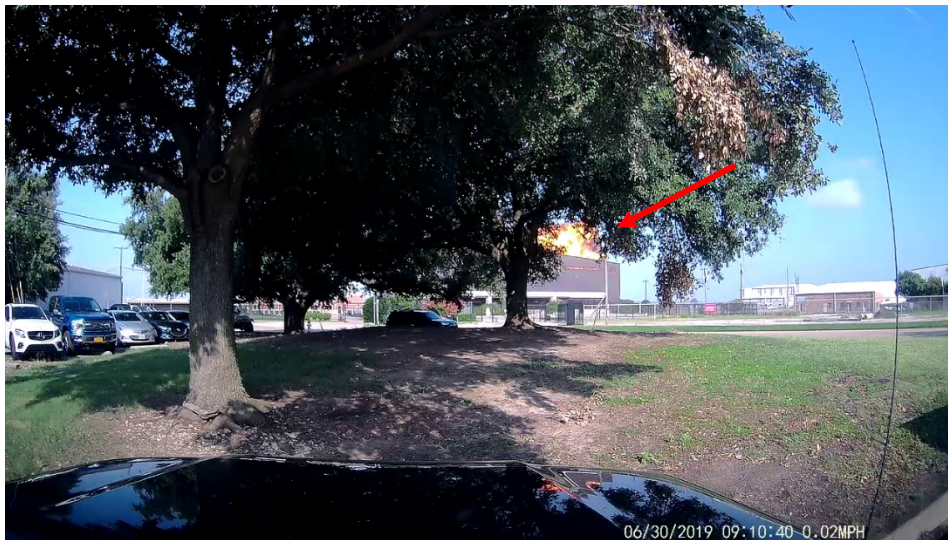
Video obtained from a camera inside a vehicle parked near Fire Station 101 showed the airplane's impact with the hangar and subsequent explosion. The video showed that the initial impact occurred at 0910:40.³ About one second later debris could be seen flying into the air in the area of the roll-up garage door, which was obscured in the frame, followed by a second eruption of fire. See photos 22 and 23.

Photo 22. Video frame from a camera mounted in a vehicle near Fire Station 1 showing the explosion after impact with the hangar.

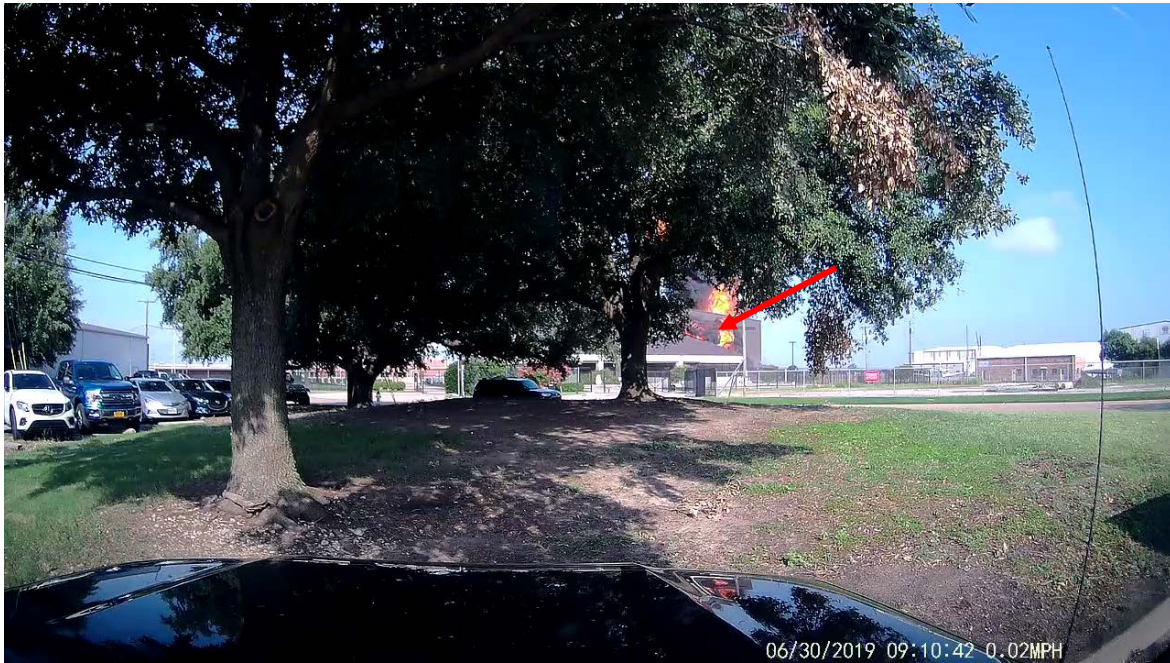
Photo 23. Video frame two seconds later showing a second eruption of fire emanating from the area of the roll-up garage door.
