## RECORD OF CONVERSATION

**Person Contacted: Louie Bettis (FAA Aviation Safety Inspector,  
Airworthiness / Principal Maintenance Inspector – FAA St. Louis FSDO)**  
**NTSB Case Number: CEN21LA312**

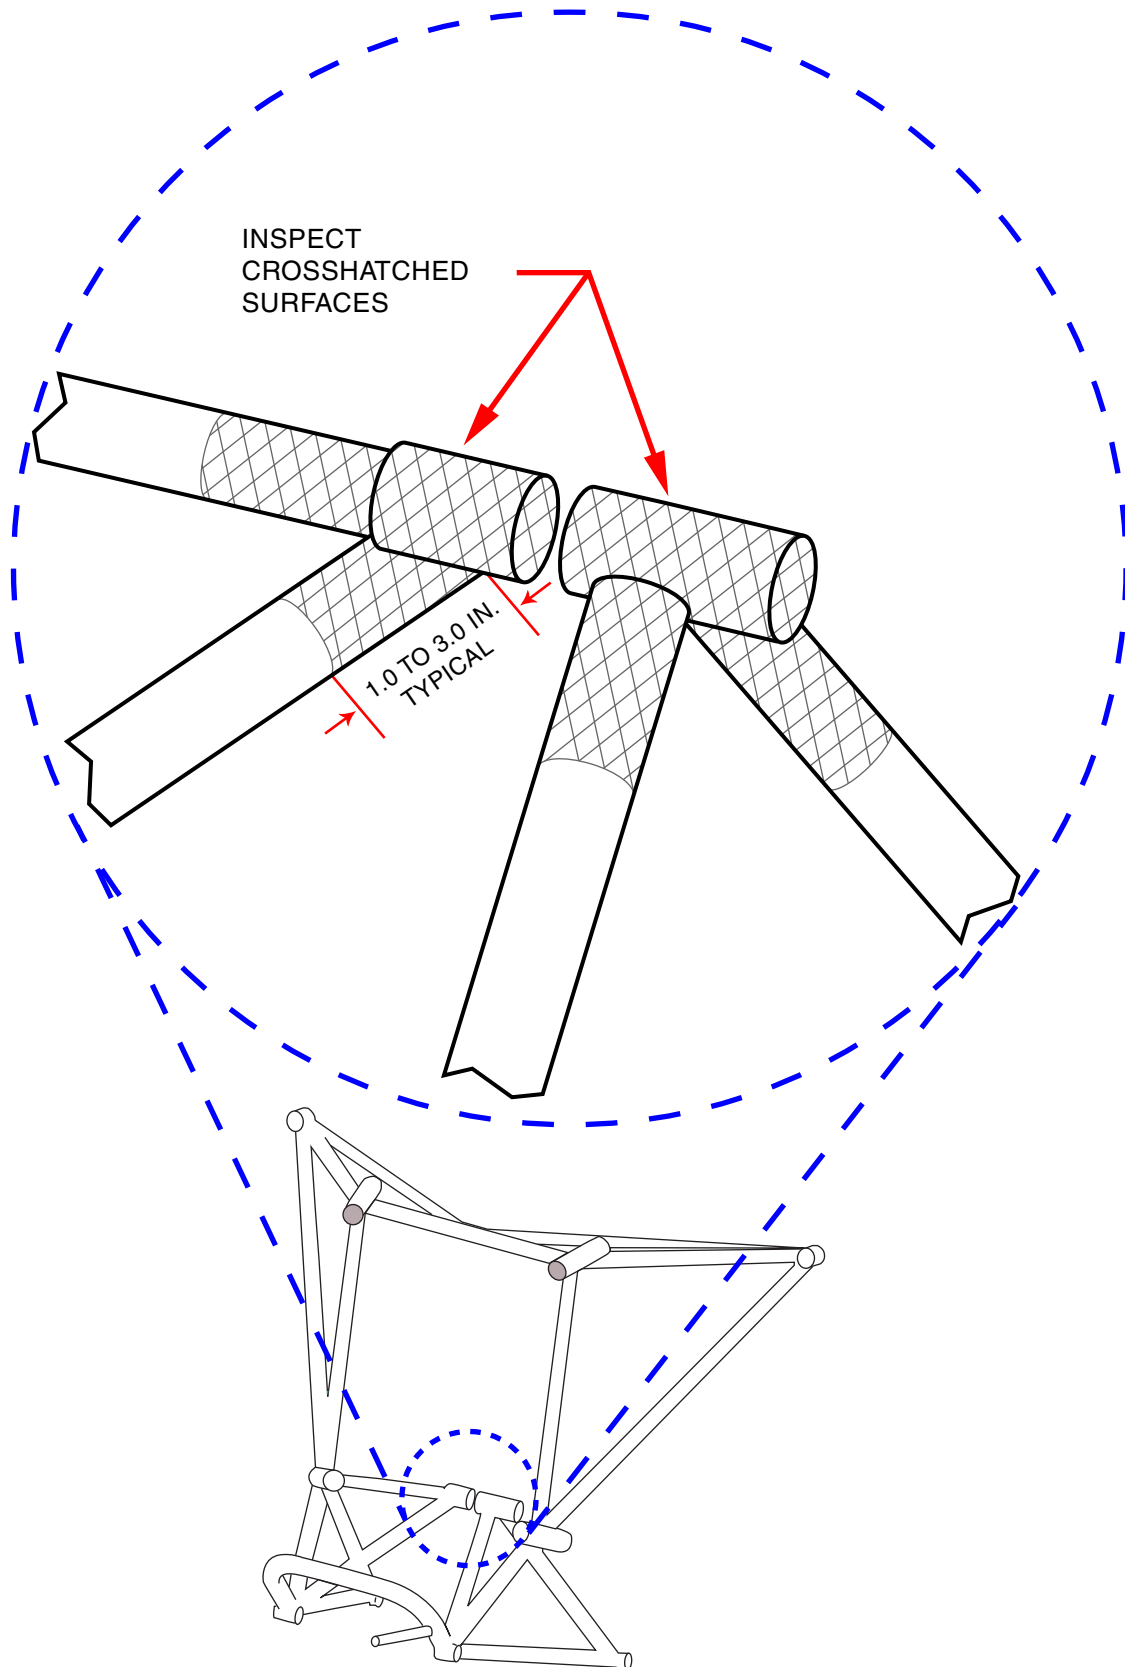
**Figure 1**  
Engine Mount Inspection Areas

Cracks may develop in the area of the nose gear actuator attach feet on the engine mount (see Figure 1). This condition can occur when the nose landing gear is subjected to excessive loads due to hard landings, rough field operations, excessive speed turns, improper airplane towing (sudden, aggressive starts and stops), or other improper operations.

3. Perform fluorescent penetrant inspection of the nose gear actuator attach feet for cracks per AC 43.13-1B, Chapter 5, Section 5. Inspect the surfaces identified in Figure 1, with specific emphasis on welded areas.
4. If a crack is discovered, the engine mount must be replaced prior to further flight (refer to Table 1).
5. If no cracks are found, continue the repetitive inspection per the compliance time above.
6. Clean the feet and apply a two-coat corrosion prevention compound (CPC) to the area where the paint was removed. This two-coat CPC consists of Dinitrol/Ardrox AV8 as a primer coating and (after the AV8 has dried) Dinitrol/Ardrox AV30 as a top coating.
7. Make an appropriate logbook entry of compliance with this service bulletin for each repetitive inspection.

1. If cracks are found on the engine mount, order the appropriate replacement engine mount found in Table 1, and hardware, as required.
2. Install the new engine mount according to procedures in the applicable Piper airplane maintenance manual. For PA-46-350P Mirage or PA-46R-350T Matrix model airplanes only: fasten the aft end of the nose gear actuator to the engine mount using the hardware arrangement shown in Figure 2. Torque nut according to requirements in section 91-10-00 of the applicable Piper airplane maintenance manual. At all other locations, hardware in serviceable condition may be reused.

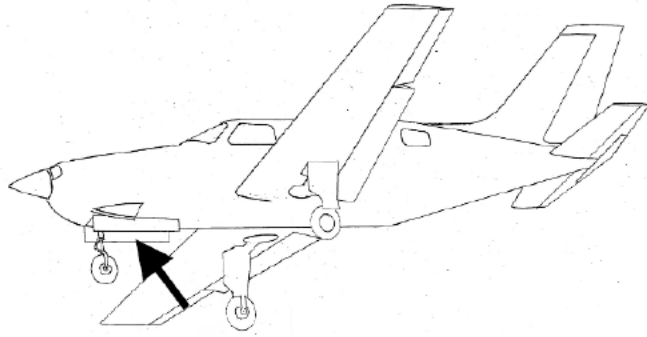
This SAIB is a result of reported cracks being found in the engine mount, both where the actuator for the nose landing gear attaches and at the pivot where the NLG trunnion attaches. Figures 1a and 1b below show the general area.

Figure 1a. General location of engine mount

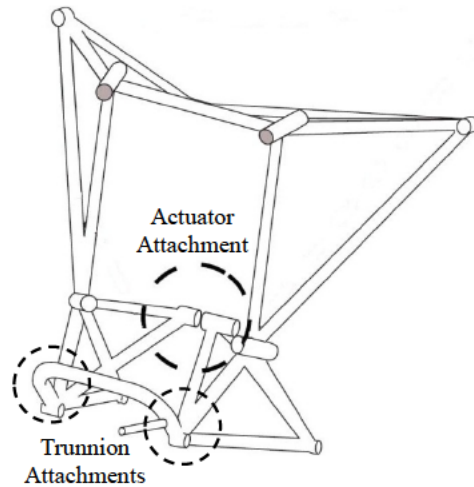
Figure 1b. Typical engine mount crack locations

After reviewing the above data, we recommend that you inspect the engine mount where the nose landing gear trunnion and actuator attach. We also recommend that you replace the mount with a new mount that relieves the repetitive inspection, where applicable. You should perform the inspection and replacement following the appropriate Piper service information SL 1001, SB 1103, and/or SB 1154 for the model and serial number of your aircraft and the configuration of your engine mount.

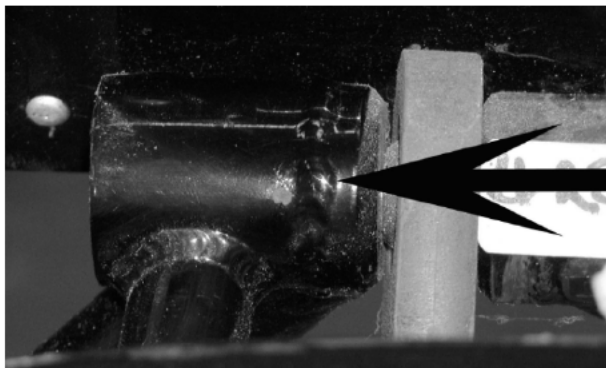
The first type, and the subject of SB 1103, is cracking around the circumference of the “foot” (the metal tube where the actuator bolt attaches). The “foot” cracks occur on some early engine mounts where the “foot” is made up of two parts; a metal disk welded to a metal tube. The cracks have been found in the welded area between the disk and tube. Some aircraft have a one-piece machined foot and have not experienced this problem. See Figures 2a and 2b below (from SB 1103C) showing pictures of both welded and machined configurations.

Figure 2a. Original Engine Mount Weld Indicates Two (2) Piece Foot

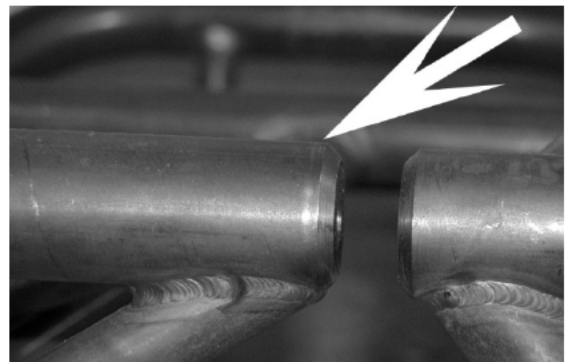
Figure 2b. Interim redesign Engine Mount One (1) Piece Machined Foot

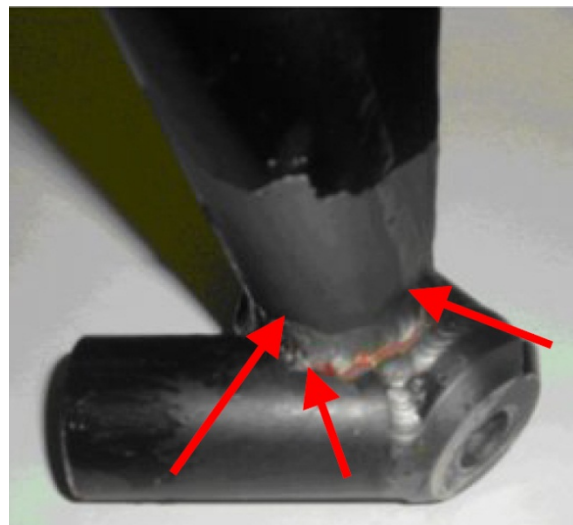
The second type of cracking is in the actuator cluster weld, which attaches the “foot” to the engine mount tubing, and is the subject of service bulletins 1103 and 1154. This second type of cracking occurs in the welded joints where the foot attaches to the engine mount tubes (cluster weld). See Figure 3 below. This type of cracking is independent of whether the foot is welded or machined.

Figure 3. Cracks around Tube Cluster  
(Note: crack extends into tube)

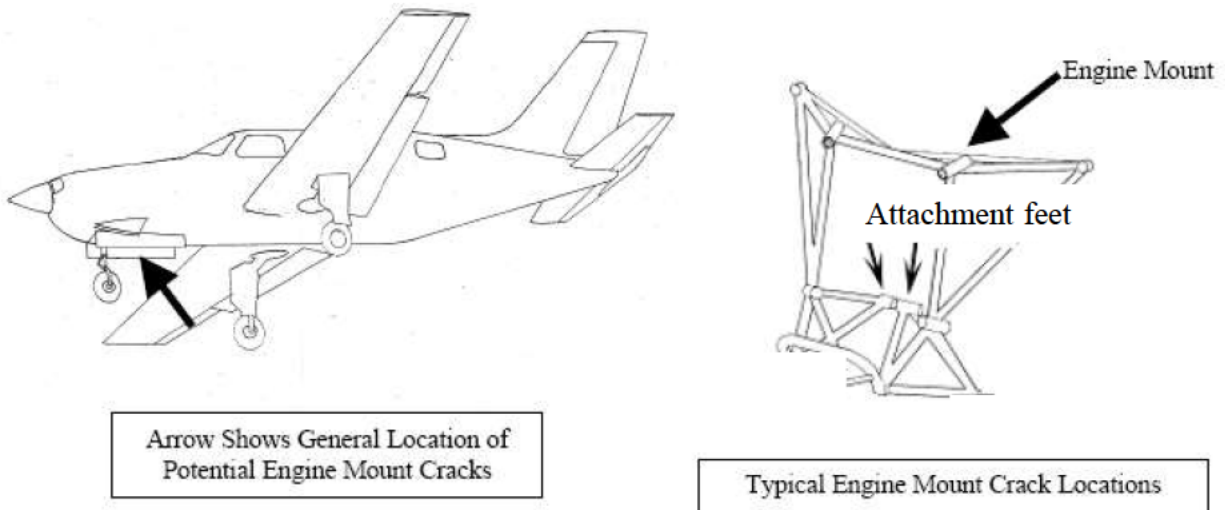
takeoff, and landing, the attachment feet transmit loads from the NLG to the engine mount, thus creating repetitive tensile stress in the engine mount attachment feet areas and, in some cases, leading to fatigue cracking.<sup>4</sup>

**Figure 1.** Piper PA-46-350P crack locations on engine mount

Require repetitive inspections for fatigue cracking of the nose landing gear actuator attachment foot areas on all Piper PA-46-310 and -350P engine mounts and require replacement, if necessary. (A-10-44)

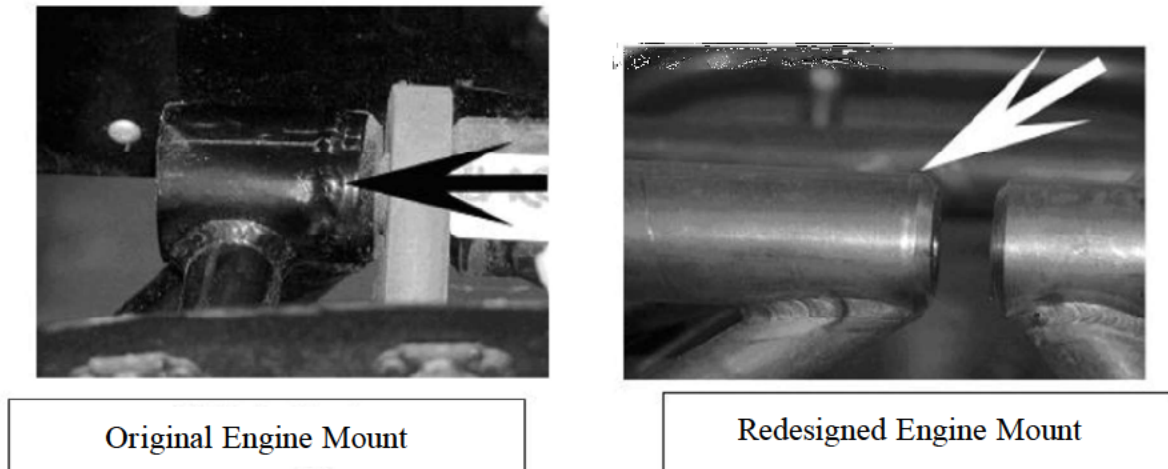
Piper PA-46-310 and -350P airplanes have either an original engine mount or a redesigned engine mount (see figure 2).<sup>5</sup> In the original design, each attachment foot is a two-piece part consisting of a metal disk welded to the end of a metal tube, which is then welded to the engine mount support tubes. In the redesigned engine mount, each attachment foot is a one-piece machined part made from a single piece of steel, eliminating the welding within the feet themselves. However, on both the original and redesigned engine mounts, the attachment feet are welded to the engine mount support tubes, which is where fatigue cracking has been identified by the NTSB.

**Figure 2.** Original engine mount with two-piece foot and redesigned engine mount with one-piece machined foot

The NTSB is concerned that the redesigned engine mounts on Piper PA-46-310 and -350P model airplanes have attachment foot areas susceptible to fatigue cracking similar to the fatigue cracks identified by Piper on the original engine mounts. The NTSB concludes that the tensile stresses applied to the redesigned engine mounts could lead to fatigue fractures in the NLG actuator attachment foot areas. However, redesigned engine mounts are not currently subject to the inspection provisions of SB 1103, nor is compliance with SB 1103 required.<sup>10</sup> Although the NTSB is not aware of incidents or accidents involving original engine mounts that have not been inspected, the NTSB believes that inspections of the original engine mounts should also be mandatory in order to detect fatigue cracking. Therefore, the NTSB recommends that the FAA require repetitive inspections for fatigue cracking of the NLG actuator attachment foot areas on all Piper PA-46-310 and -350P engine mounts and require replacement, if necessary.

Require Piper to redesign the PA-46-310 and -350P engine mounts so that they are not susceptible to fatigue cracking in the attachment foot areas. (A-10-45)
