Additional Post-Explosion Site Photographs

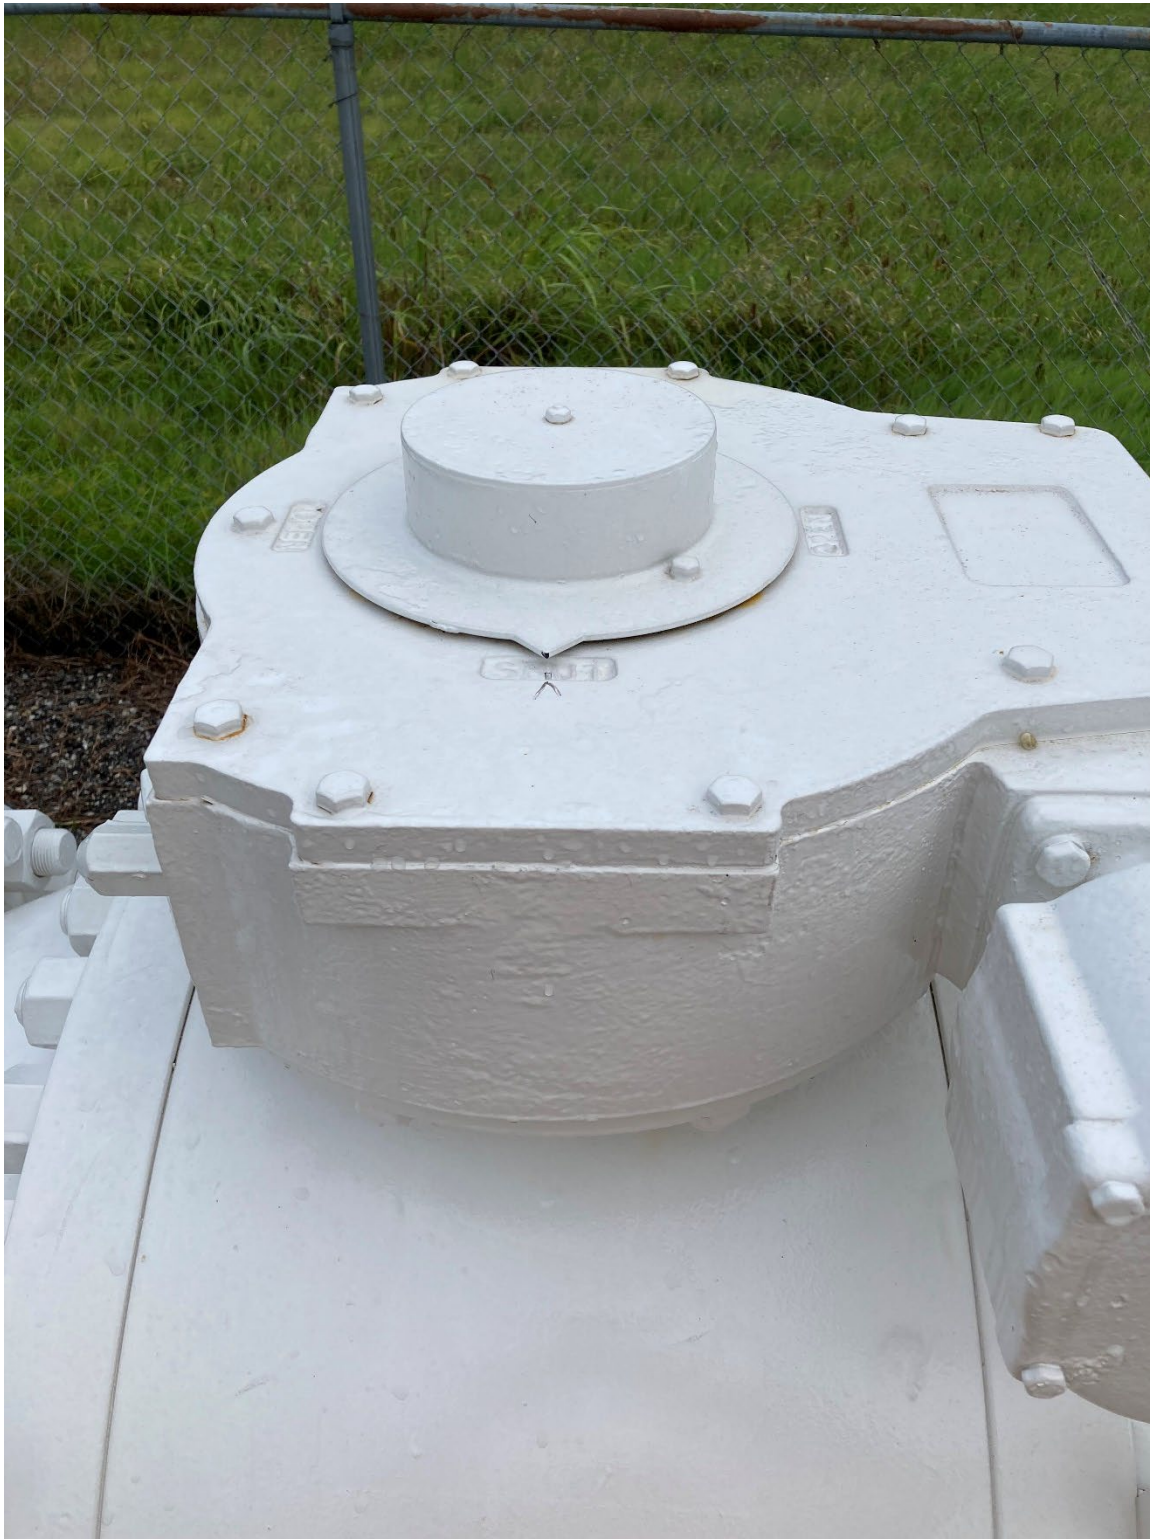
Figure 1. Indicator on Mainline Valve (6/28/2021 at 7:04PM, Courtesy of RRC)

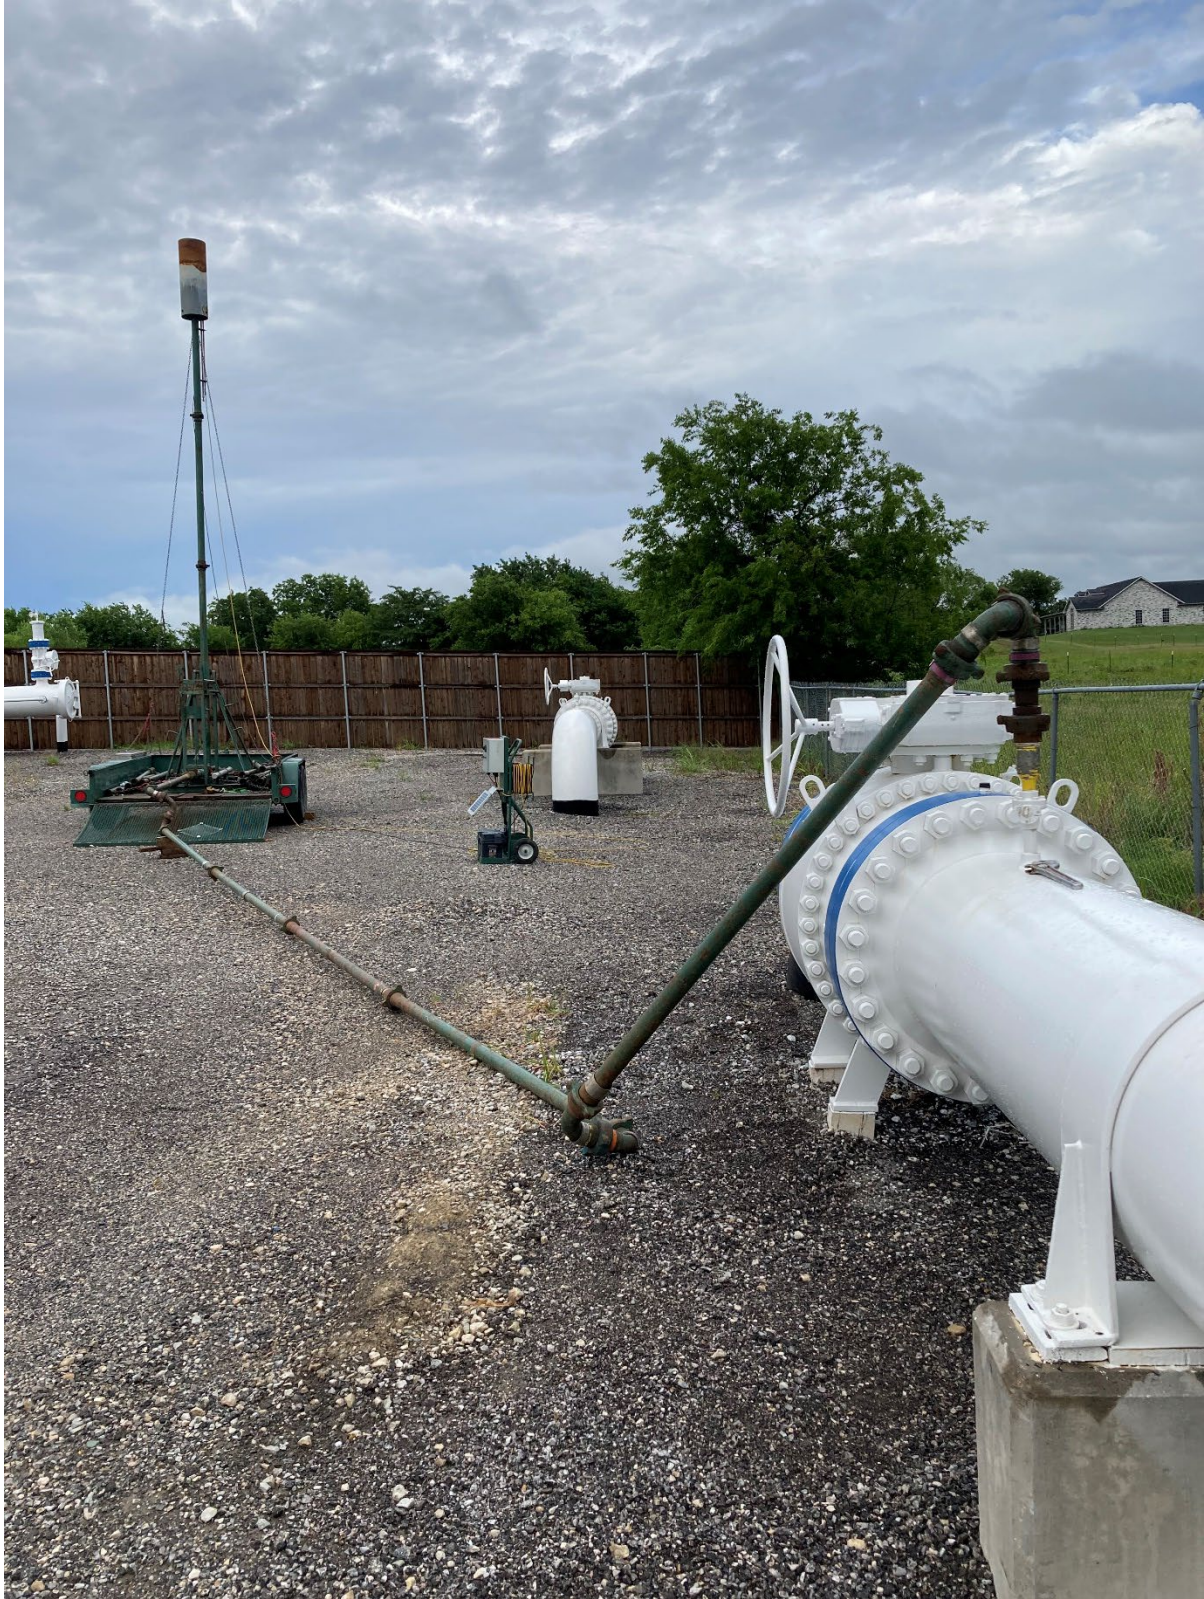
Figure 2. Flare System (6/28/2021 at 7:05PM, Courtesy of RRC)

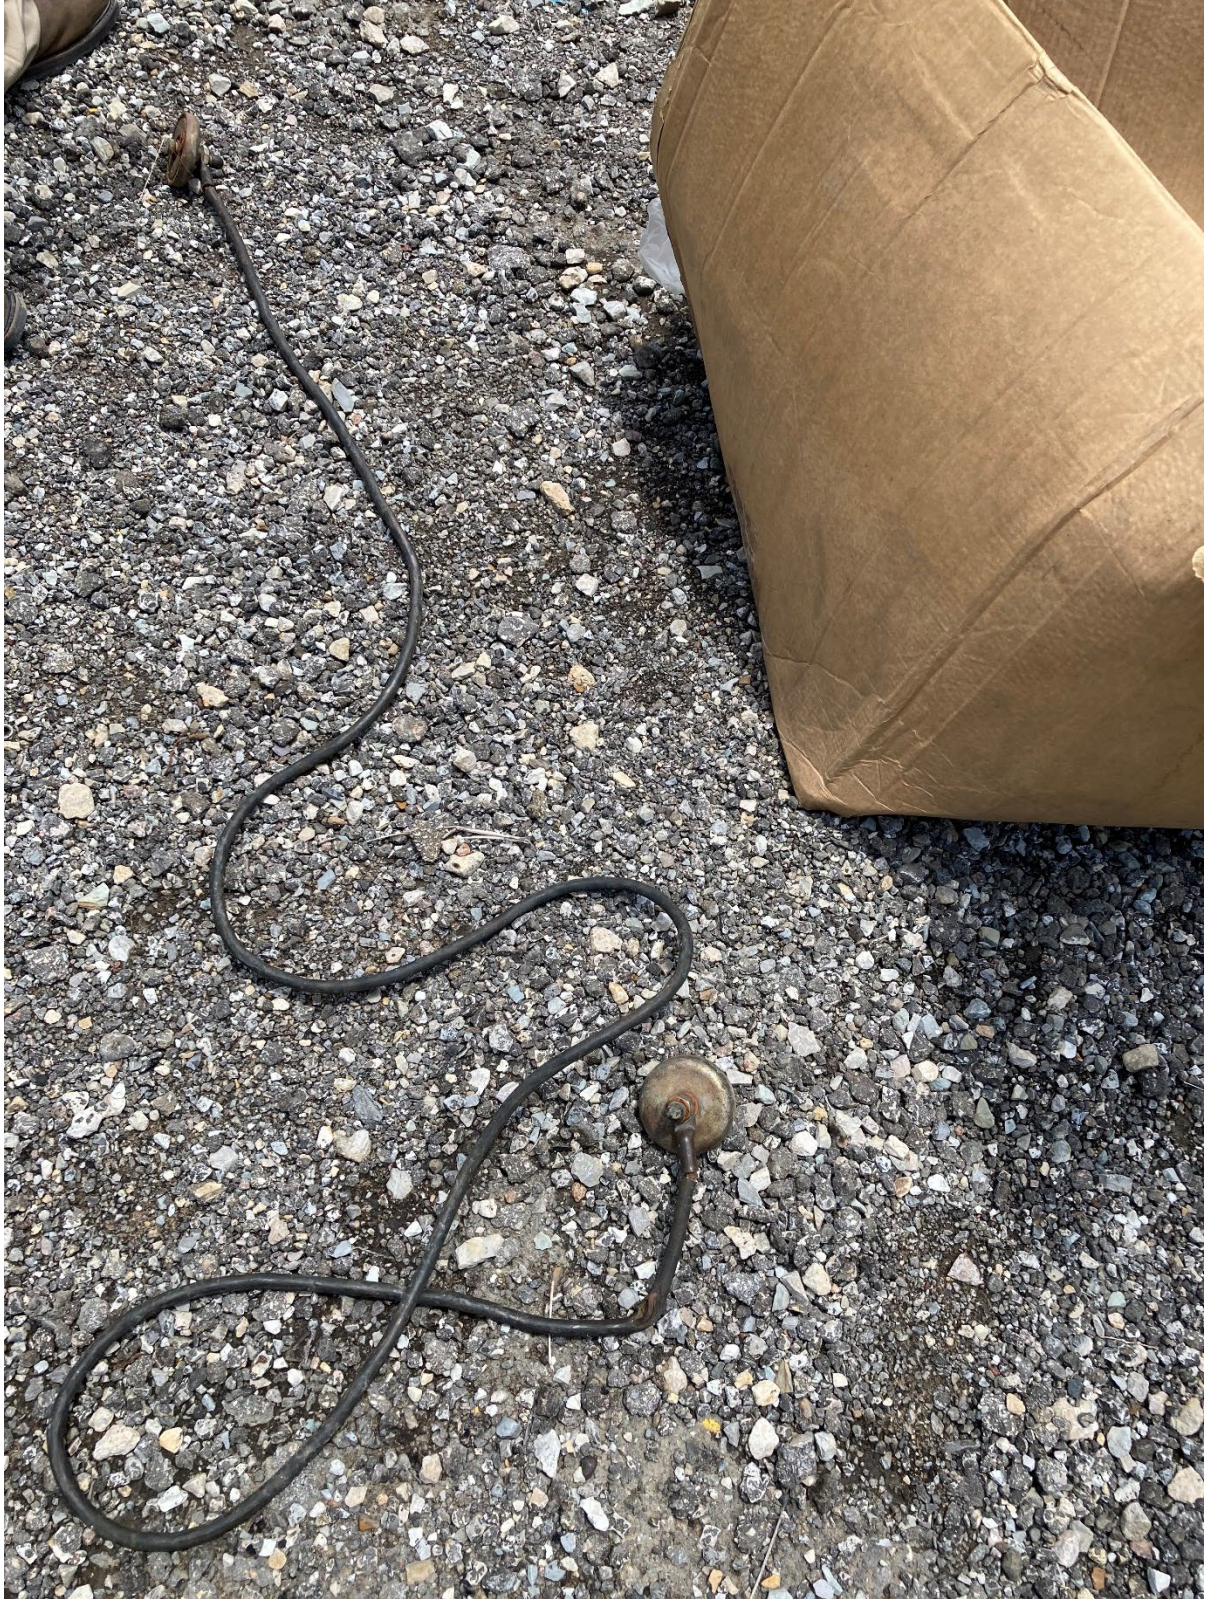
Figure 3. Grounding Cable (6/29/2021 at 1:10PM, Courtesy of RRC)

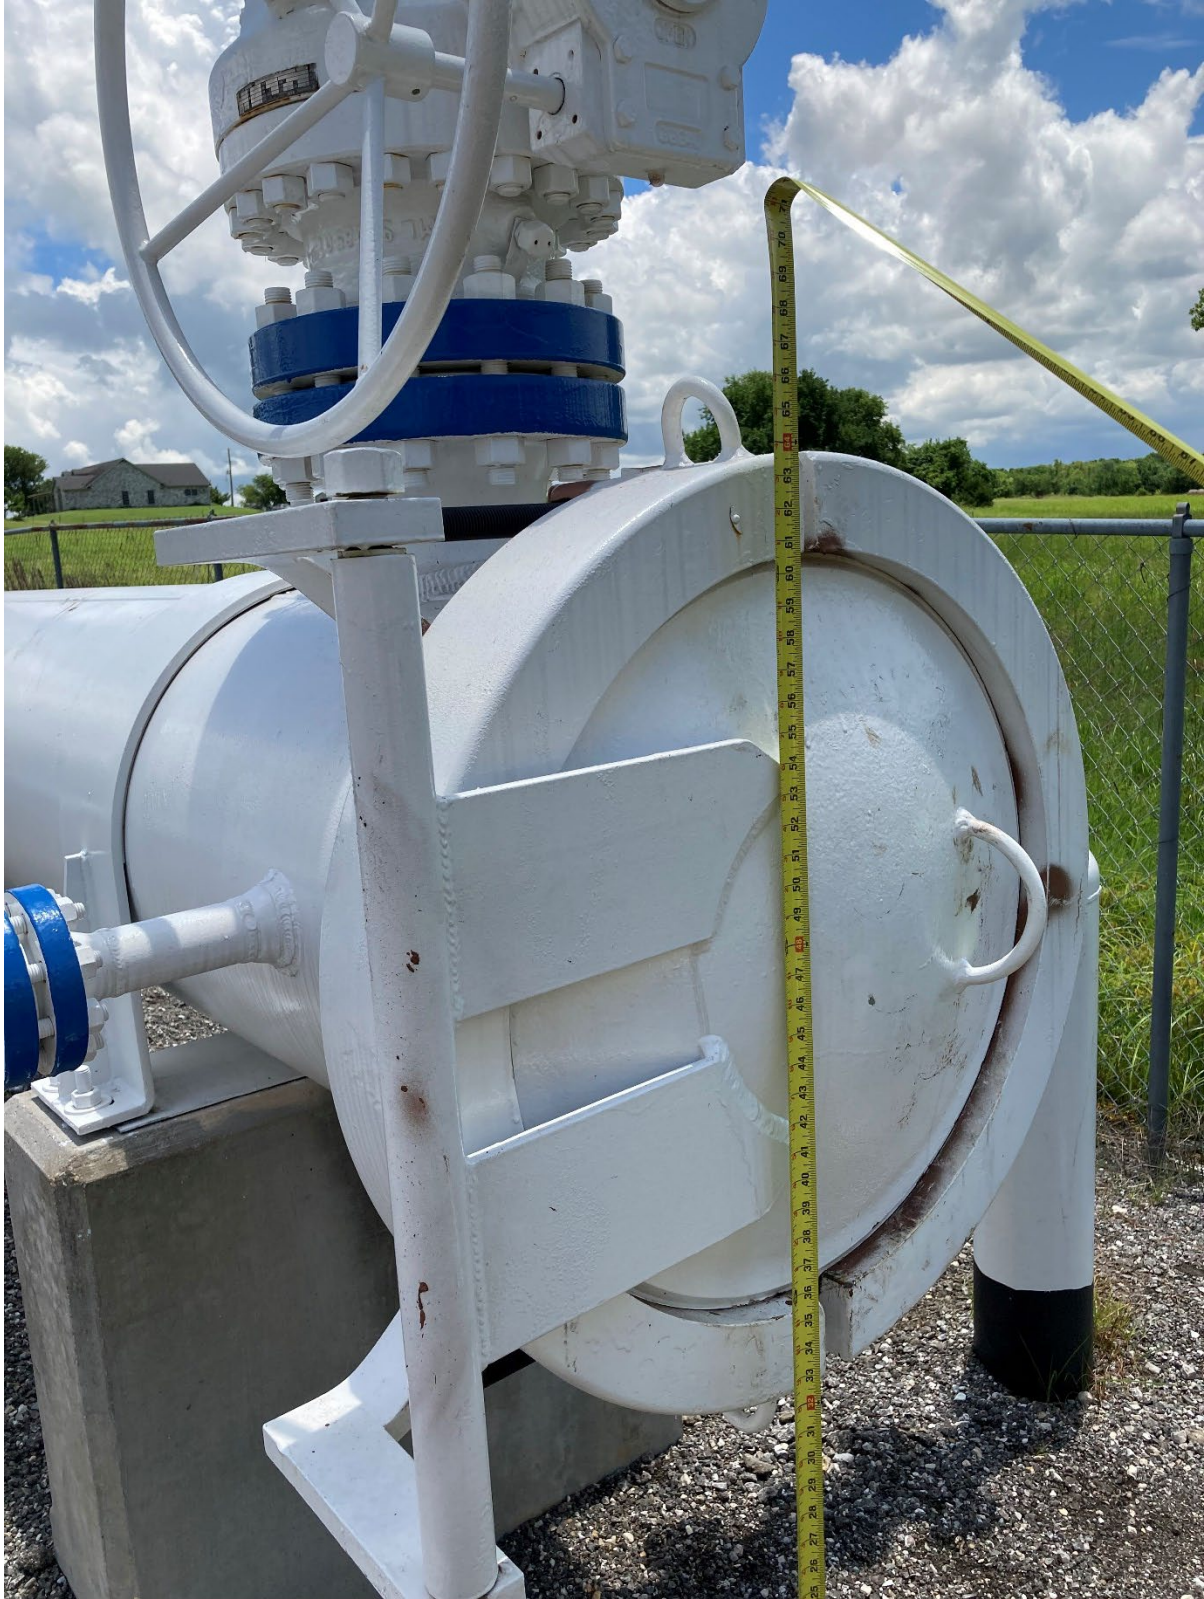
Figure 4. Launcher door (6/29/2021 at 1:17PM, Courtesy of RRC)

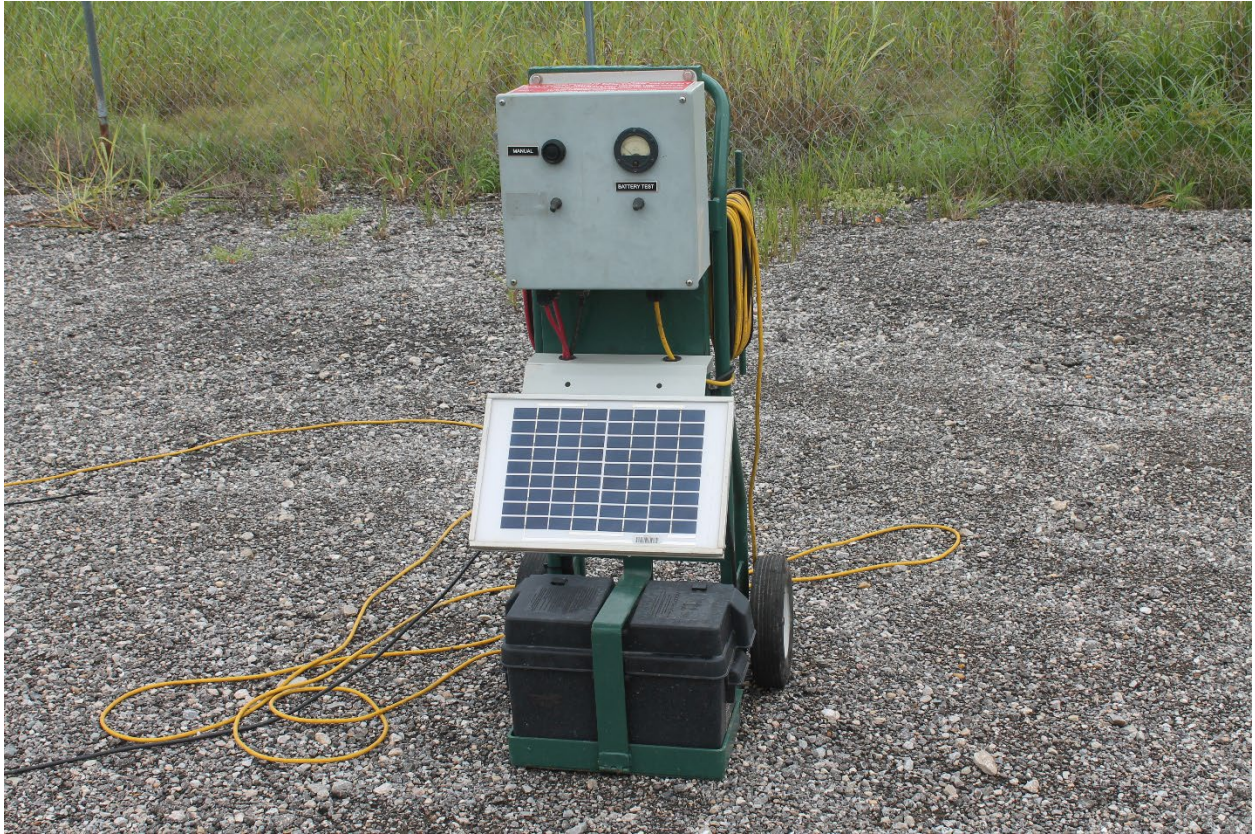
Figure 5. Ignitor – Front View (7/2/2021 at 3:39PM)

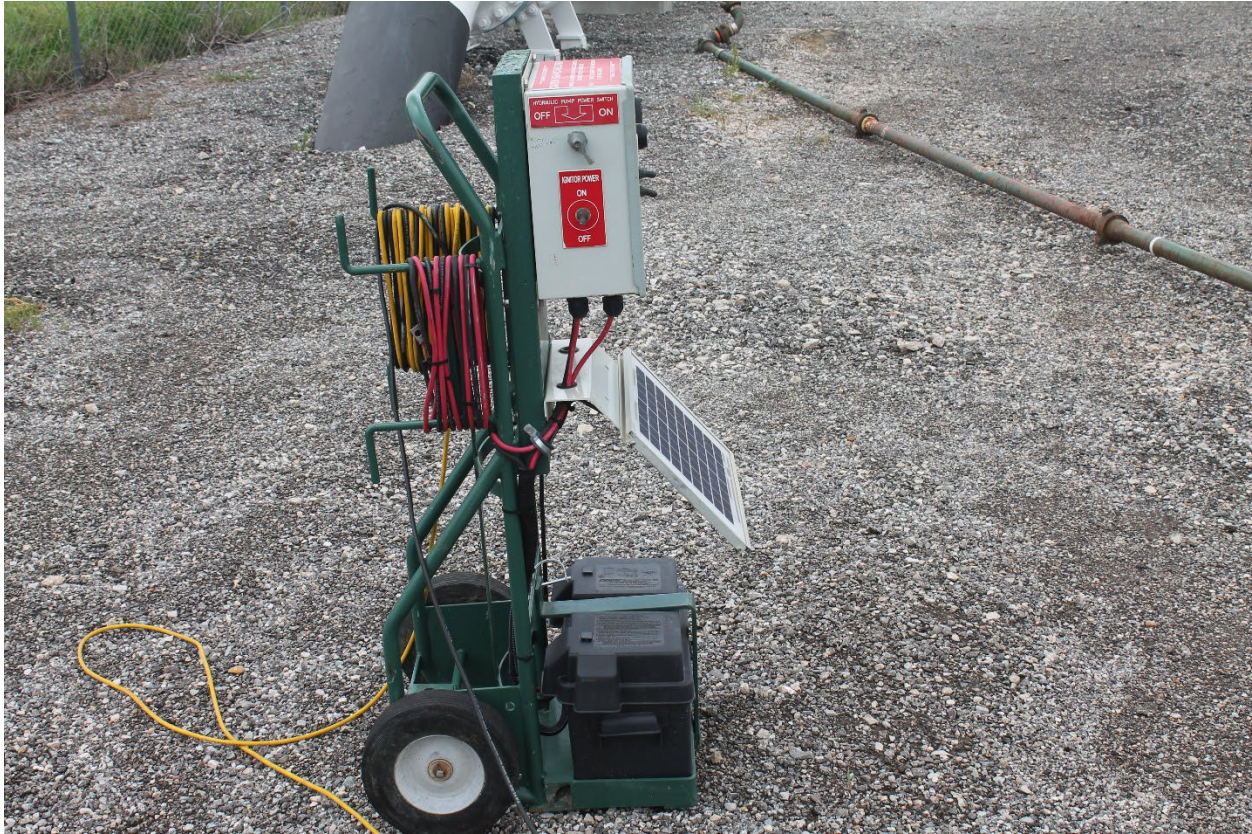
Figure 6. Ignitor - Side View (7/2/21 at 3:43PM)
