**NATIONAL TRANSPORTATION SAFETY BOARD**  
Office of Aviation Safety  
Central Region

**UAS Aerial Imagery Field Notes**

**A.    ACCIDENT            CNE19FA122**

Location:               Kingsland, Texas  
Date:                    April 21, 2019  
Time:                    1443  
Event:                   Rans S-7S impacted runway and burned

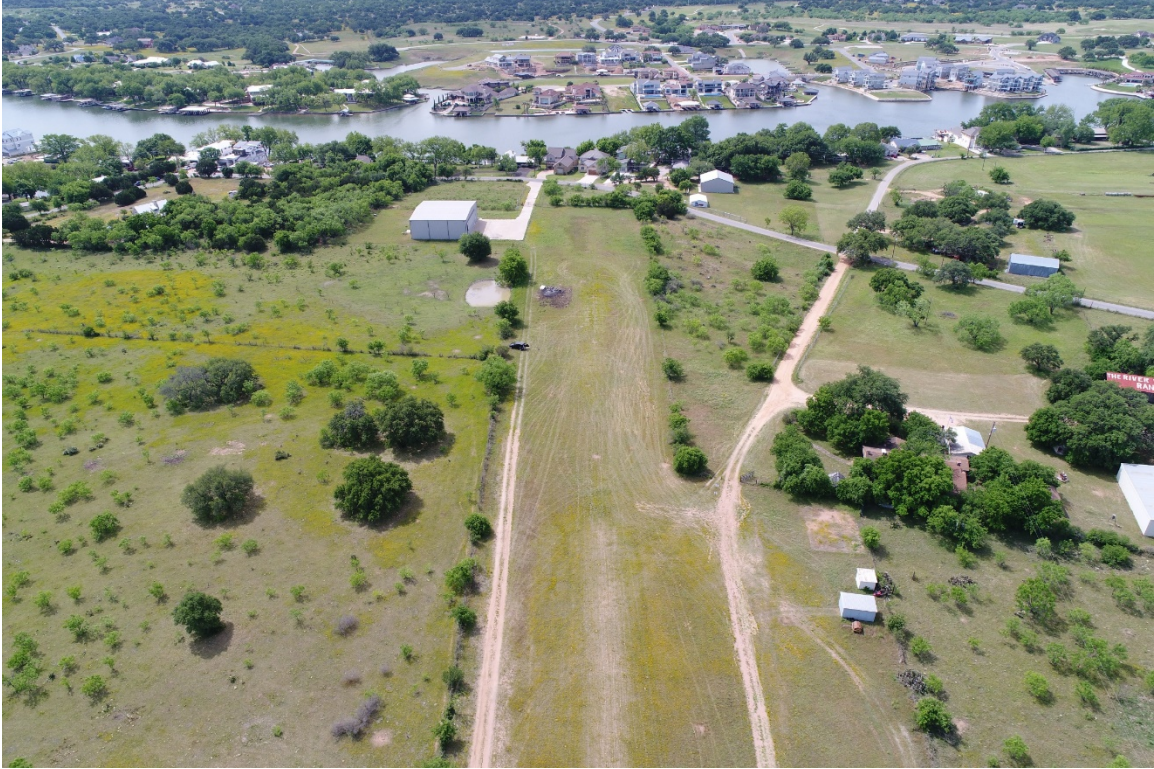
Figure 1 – Aerial from the north

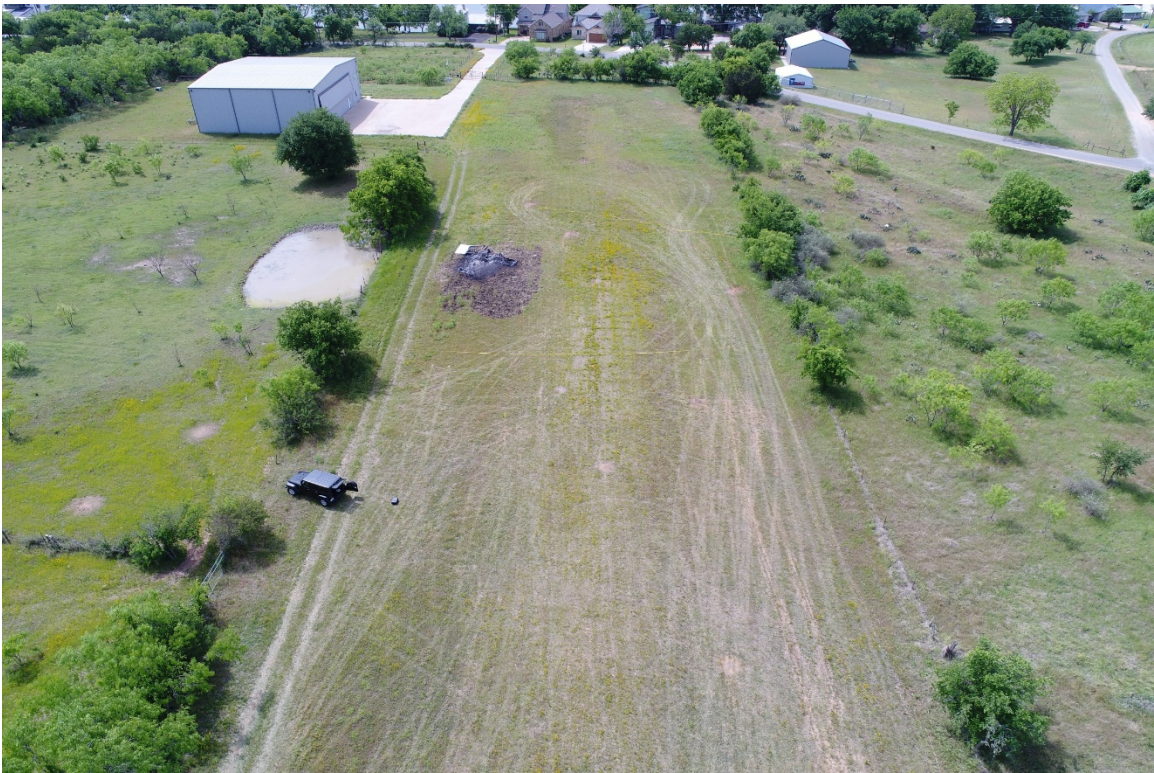
Figure 2 – Aerial from the north

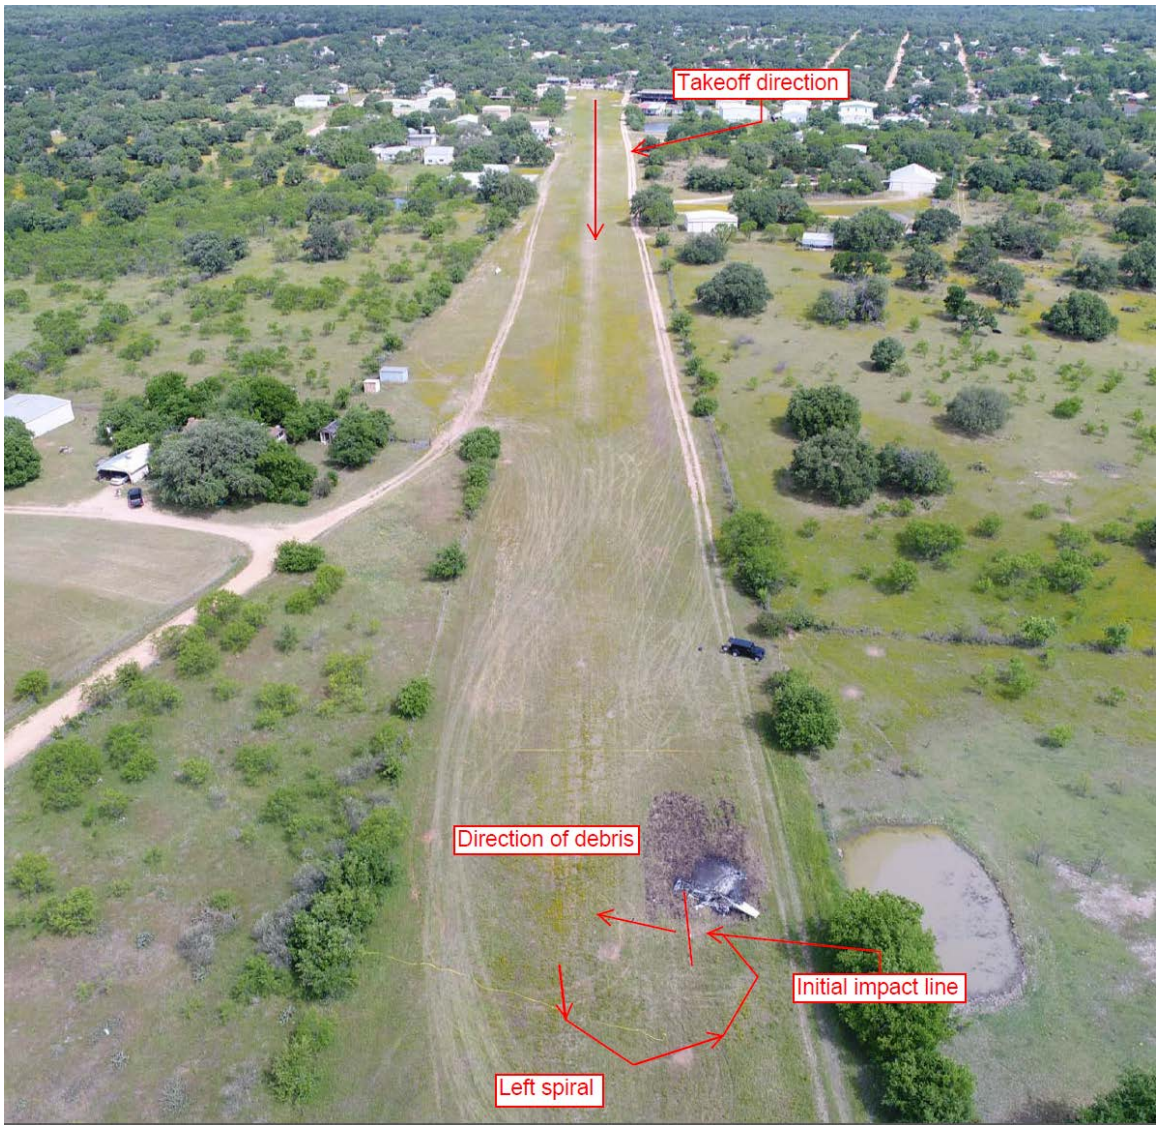
Figure 3 – Aerial runway view from south with notation. Wreckage on the lower right side

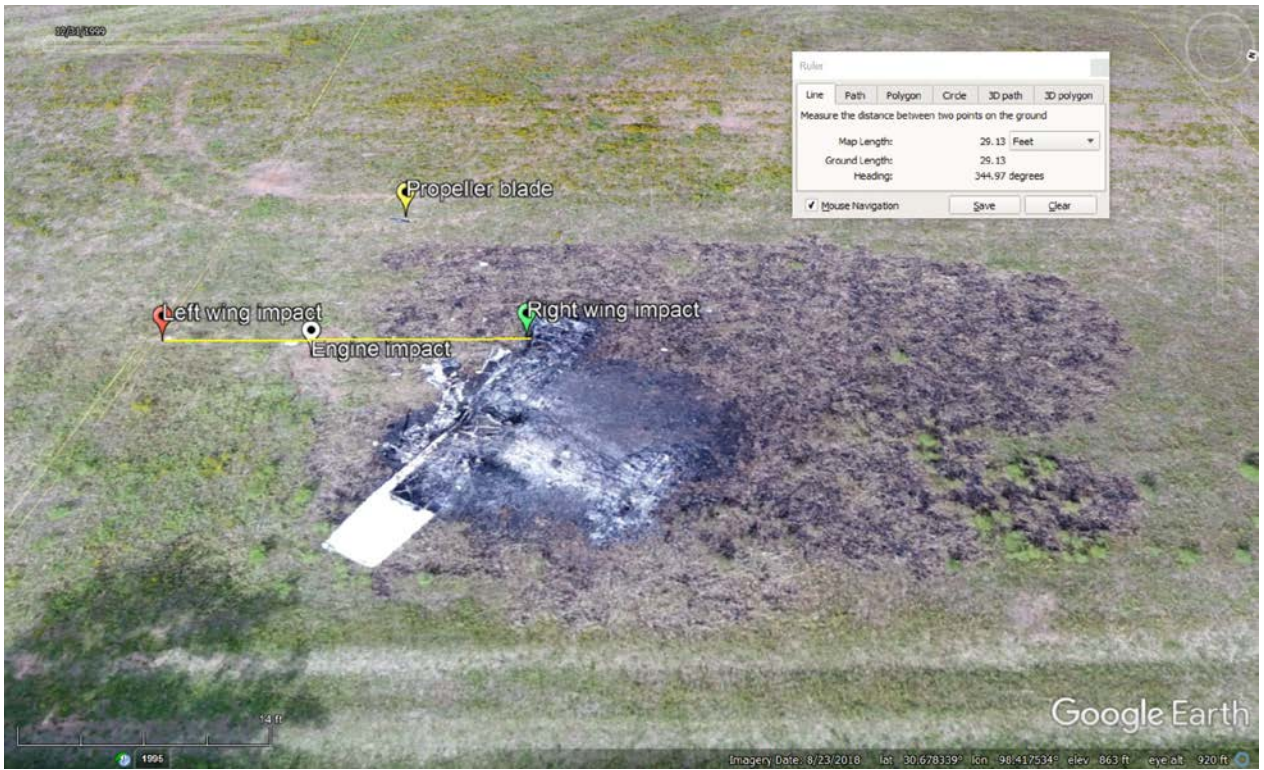
Figure 4 – Google Earth of wreckage with impact measurement

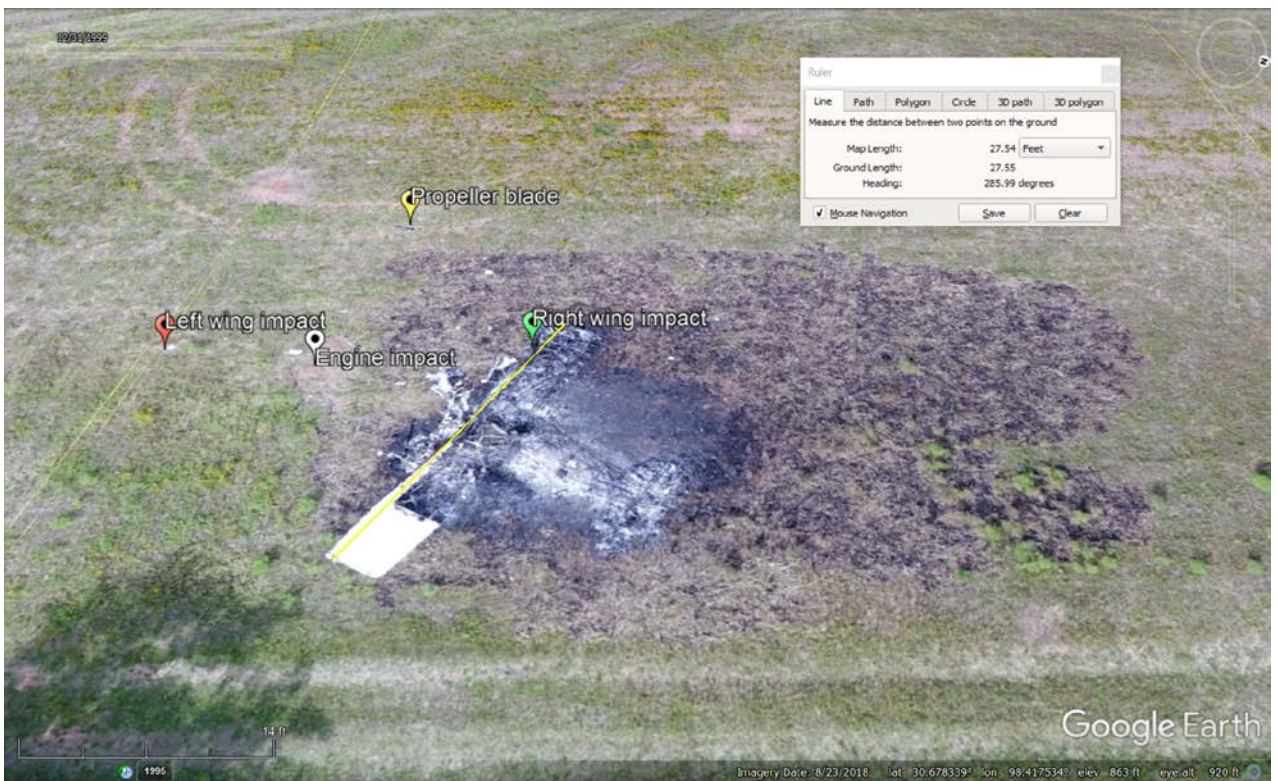
Figure 5 – Google Earth of wreckage with wing measurement
