NATIONAL TRANSPORTATION SAFETY BOARD
Office of Aviation Safety
Washington, D.C. 20594

MAINTENANCE RECORDS AND POWERPLANT GROUPCHAIRMAN'S FACTUAL REPORT

NTSB No: ERA17MA316

Operator: Air Methods Corporation
Aircraft: Airbus Helicopters Deutschland GmbH MBB-BK 117 C-2, registration number N146DU
Location: Hertford, North Carolina
Date: September 8, 2017
Time: 1120 Local Time

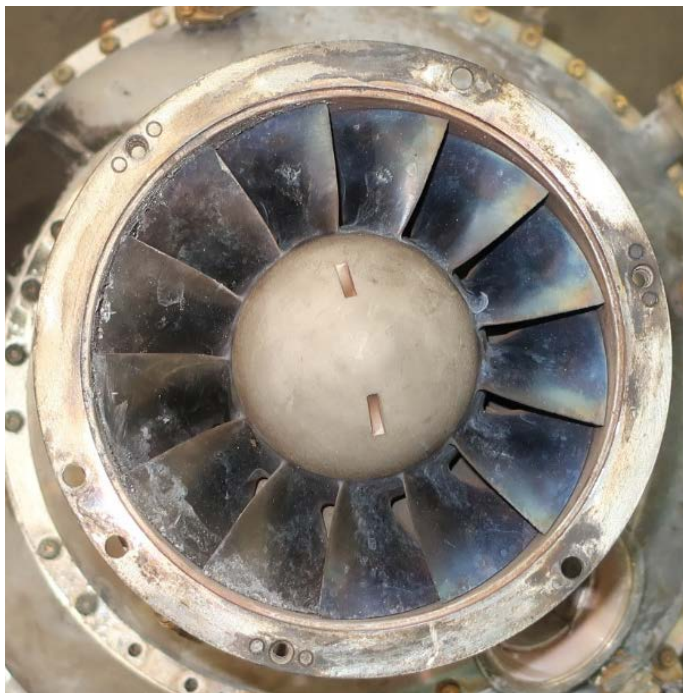
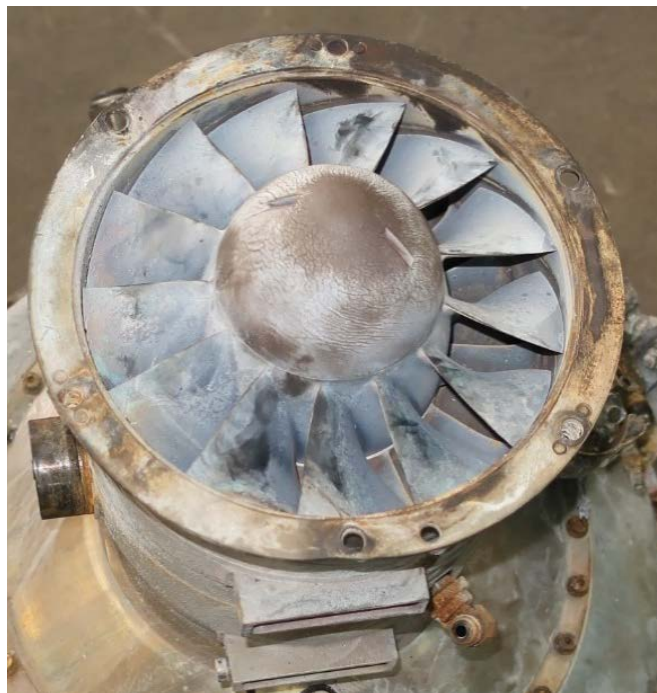
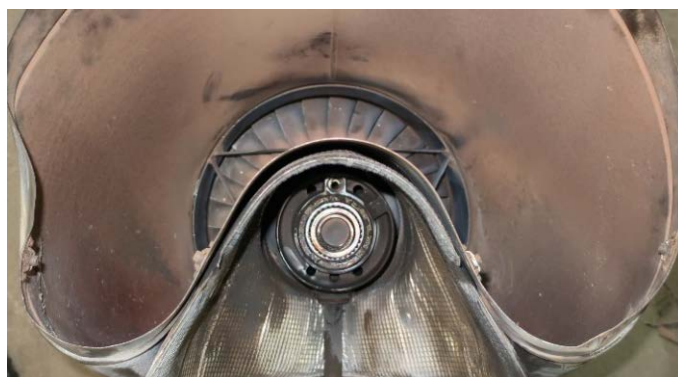
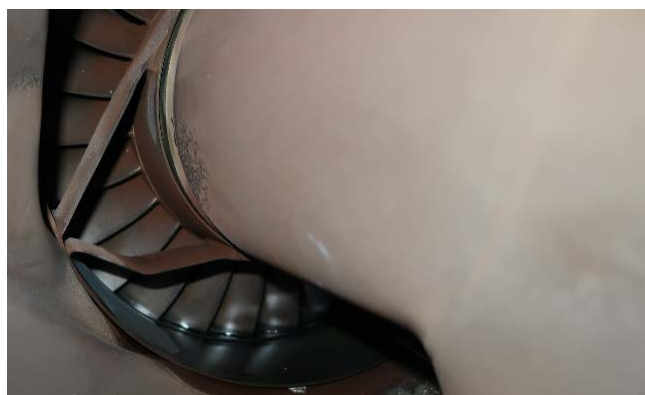
General observations for both engines were as follows: 1) engines were found in the correct orientation in the helicopter in relation to the transmission deck, 2) the outside of the engines were thermally damaged consistent with the post-crash fire; the engine thermal damage was greater near the top half of the engines (**PHOTO 2**), 3) no uncontainments or case breaches were observed, 4) input shaft was continuous and still attached to engine’s accessory gearbox and the airframe’s main transmission; no visual rotational scoring was noted on the input shaft, 5) the tail rotor drive shaft was continuous and was connected to the airframe’s main transmission and tail rotor intermediate gearbox, 6) all the axial compressor blades were present, full length, and no leading edge impact damage was observed (**PHOTOS 3 and 4**), and 7) all the power turbine blades were present, full length, and no visible damage was observed (**PHOTOS 5 and 6**).

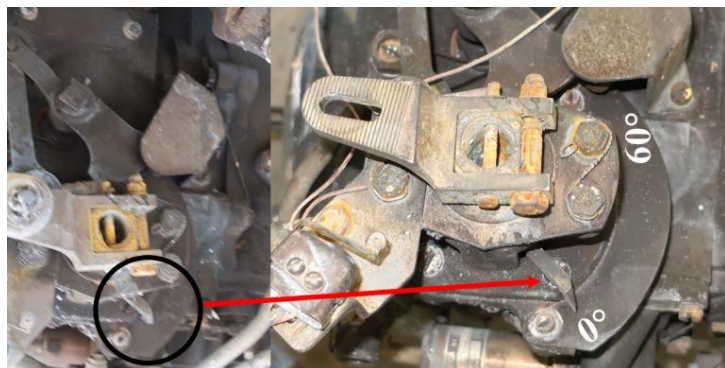
Additional No. 1 engine (ESN 47292) observations during the on-scene and partial disassembly were as follows: 1) the gas generator could not initially be turned by hand; however, after the engine starter was removed, an adapter was inserted into the AGB and the gas generator turned freely, 2) the FCU throttle indicator pointer was found at the 0° position (in this position both the main and axillary valves in the FCU are in the CLOSED position) (**PHOTO 7**), 3) the power turbine was turned by hand slightly and continuity was observed with the tail rotor drive output gear in the rear and the transmission shaft in the front, 4) after removal of the engine-to-airframe main transmission gearbox drive shaft, the power turbine was free to rotate and continuity was confirmed from the power turbine through to the engine transmission shaft, 5) the RGB module (M05) was removed and examination of the drive gear slippage mark showed no displacement, and 6) removal of the power turbine module (M04) exposed the power turbine nozzle guide vanes, the second stage gas generator turbine disk and blades, the aft end of gas generator tie-bolt, and the gas generator rear bearing compartment; no damage to

PHOTO 7: NO. 1 ENGINE FCU POSITION POINTER NEAR 0° POSITION

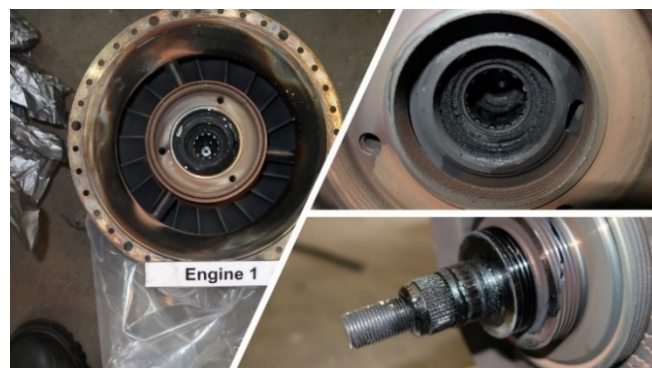
any of these items were noted; the rear bearing compartment and the aft end of the gas generator tie-rod were covered in black coke¹⁰-like material (**PHOTO 8**).

PHOTO 8: NO. 1 ENGINE BLACK COKE-LIKE BUILDUP ON GAS GENERATOR REAR BEARING AREA

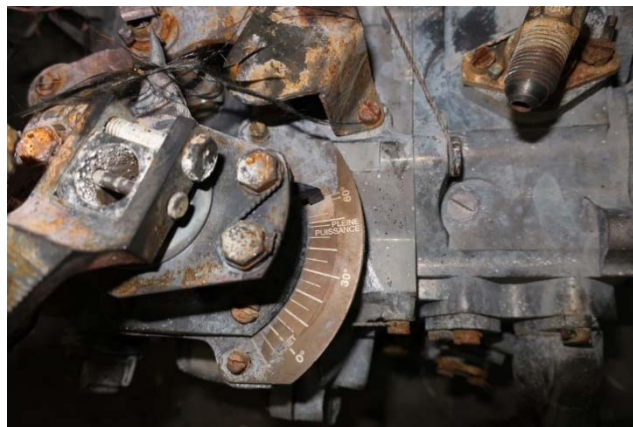
Additional No. 2 engine (ESN 47346) observations during the on-scene and partial disassembly were as follows: 1) the FCU throttle indicator pointer was found at about the 62° position (**PHOTO 9**); in this position the main valve is fully OPEN and axillary is in the CLOSED position, 2) the power turbine could not be rotated by hand, even after the transmission shaft had been removed, 3) the RGB module (M05) was removed and examination of the drive gear slippage mark showed no displacement, 4) the RGB was rotated freely by hand confirming continuity through the gear train, 5) with the power turbine module (M04) removed, the power turbine could still not be rotated by hand, 6) removal of the diffuser case exposed the back end of the HP turbine; the aft end of the HP turbine tie-bolt and the rear shaft exhibited thermal distress and wear damage (**PHOTO 10**), the rotating labyrinth seals (aft shaft also referred to as the piston shaft) exhibited wear with the greatest amount of wear observed on the smallest seal nearest the rear bearing journal, and the rear bearing inner race was fractured and no longer attached to the journal, 7) the rear bearing area was dry without coke buildup, the roller elements were flattened, and the abradable seal lands were heavily gouged and grooved (**PHOTO 11**), 8) the gas generator rear bearing oil scavenge EMP was removed and partially disassembled (the hollow bolt and electrical magnetic plugs could not be separated) and debris was found (**PHOTO 12**); some of the particles were magnetic and some debris particles were found bridging the gap between chip detector electrodes, and 9) the remaining external pipes and lines were removed from the rest of the engine and nothing abnormal was noted with the integrity of the fuel, oil, and air lines.

PHOTO 9: NO. 2 ENGINE FCU POSITION POINTER NEAR 62° POSITION

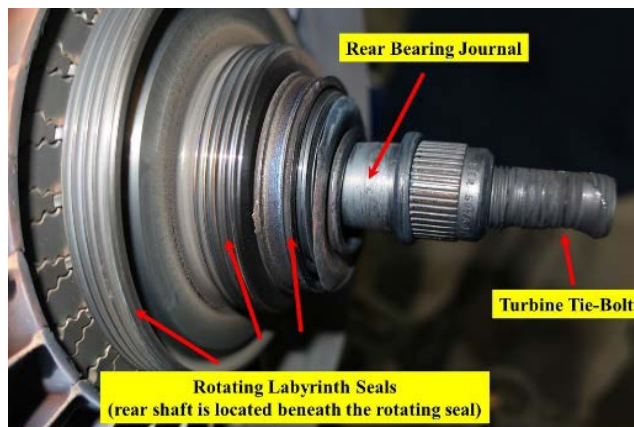
PHOTO 10: NO. 2 ENGINE TIE-ROD AND SEAL DAMAGE

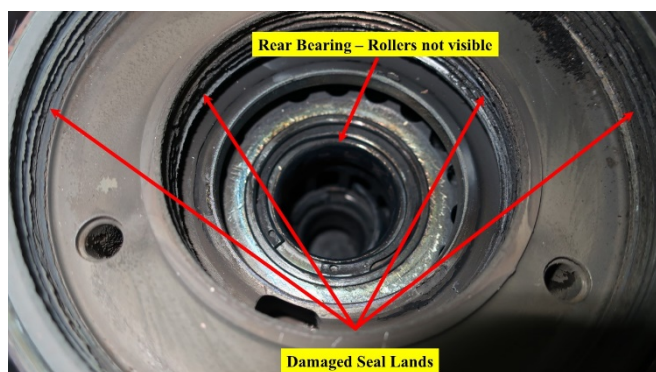
PHOTO 11: NO. 2 ENGINE REAR BEARING DAMAGE – NO COKE BUILD UP NOTED

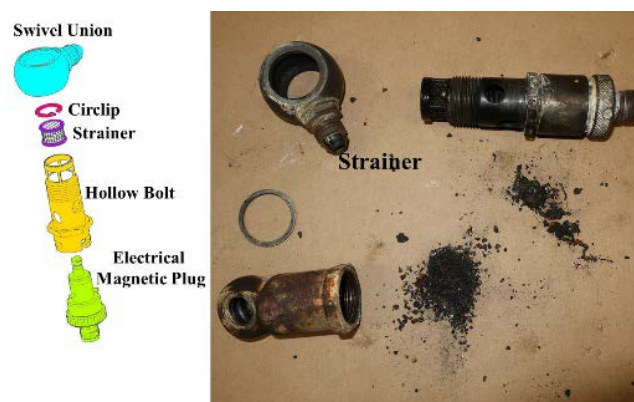
PHOTO 12: NO. 2 ENGINE REAR BEARING SCAVENGE DEBRIS

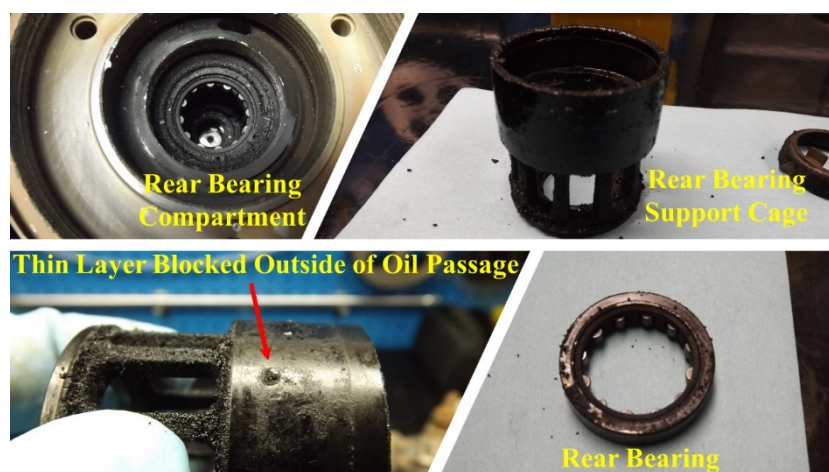
Black coke-like material covered the components of the gas generator rear bearing compartment (**PHOTO 13**). The rear roller bearing was intact and all the roller elements were in place, had a shiny appearance, and rotated freely and smoothly. The rear bearing support cage was removed and the black coke-like material was found throughout on the inside of the cage where the rear bearing is located as well as on the outside where it is press fit into the bearing housing. Examination of the cage oil passage hole on the outside of the cage found it to be visually covered with black coke-like material while the oil passage from the inside of the rear bearing support cage was visually free of obstruction. To access the depth and compactness (hardness) of the possible oil passage obstruction a pin was inserted into the passage from the inside and it poked through to the outside with no effort (**PHOTO 14**). The passage was found to be free of any obstruction consistent with just the outside of the hole being covered with thin layer of black coke-like material. During normal operation, oil traveling from the outside of the rear bearing support cage through the oil passage in order to lubricate the bearing. The engine parts and components were shipped to SafranHE in Tarnos and Bordes facilities in France for further evaluation (See Section 3.1.1 No. 1 ENGINE – ESN 47292 HARDWARE EXAMINATION for details).

PHOTO 13: NO. 1 ENGINE GAS GENERATOR REAR BEARING COMPARTMENT COVERED IN BLACK COKE-LIKE MATERIAL

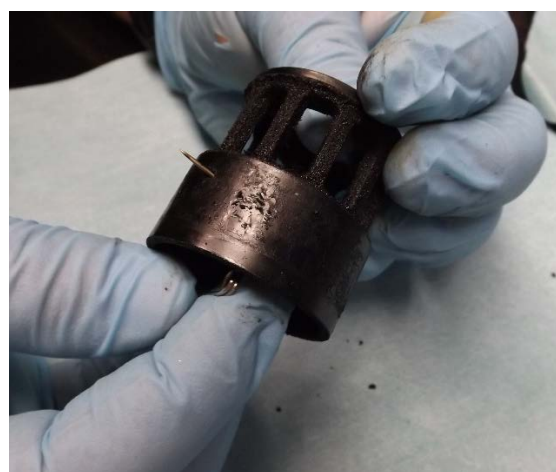
PHOTO 14: NO. 1 ENGINE REAR BEARING SUPPORT CAGE OIL PASSAGE CLEAR

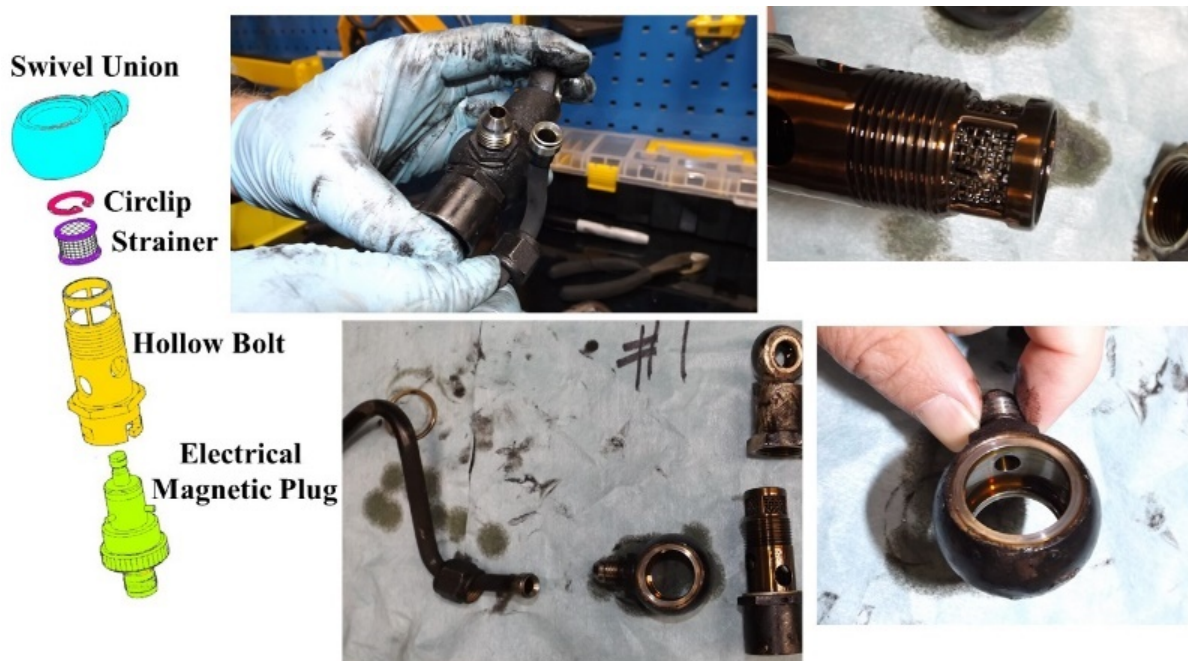
The gas generator rear bearing oil scavenge duct, oil scavenge line, and the electrical magnetic plug and strainer unit were examined and were found to be clean, without obstructions, and with the presence of oil (**PHOTO 15**).

PHOTO 15: NO. 1 ENGINE REAR BEARING SCAVENGE

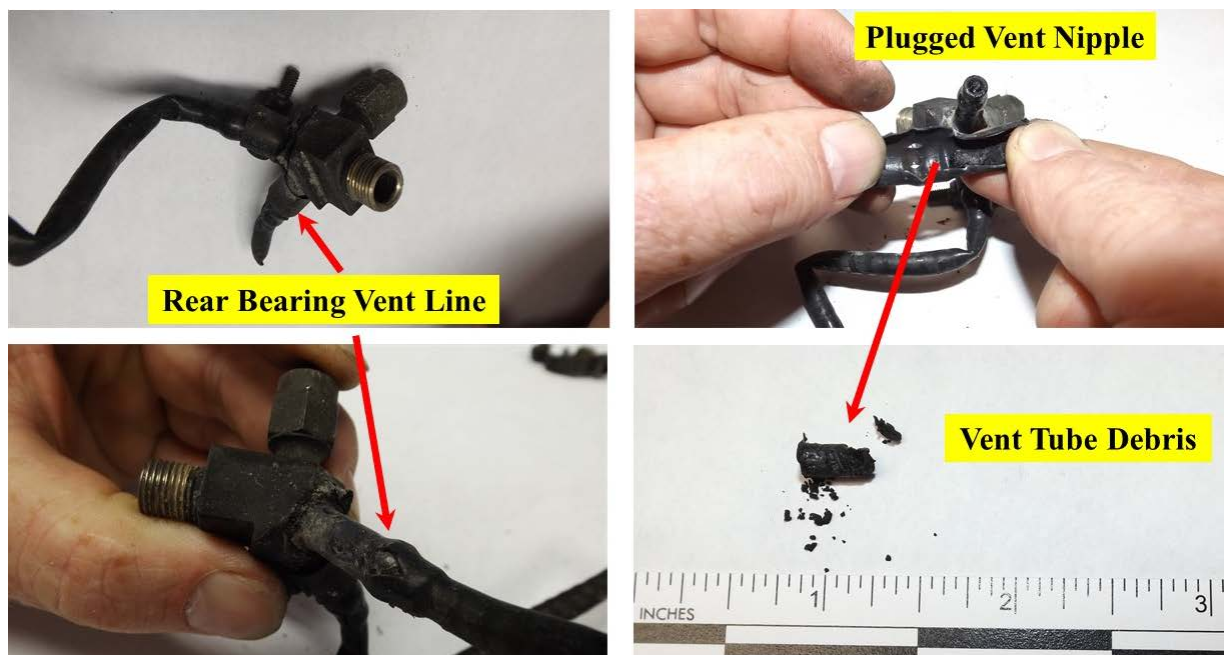
The clamp that secures the rear bearing chamber vent line drain (flexible elastomer line) to the 3-way union deck drain fitting was removed and the remnants of the elastomeric drain were sliced lengthwise to facilitate its removal. The oil vent line drain port was plugged with black coke-like debris and the oil vent line drain itself had an approximately 3/4-inch long cylindrically-shaped black coke-like obstruction (PHOTO 16). The No. 1 engine oil vent line drain, 3-way union deck drain fitting, and the black coke-like debris were sent to the NTSB’s Materials Laboratory in Washington, DC. For further evaluation (See Section 3.2 3-WAY UNION DECK DRAIN FITTING EVALUATION AT THE NTSB for details).

PHOTO 16: NO. 1 ENGINE VENT LINE OBSTRUCTION AT THE DECK FITTING

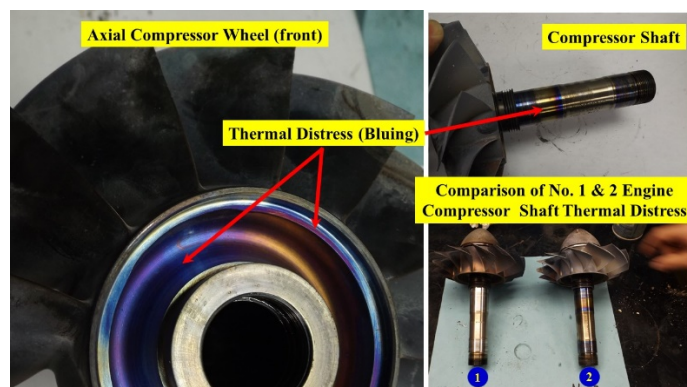
The gas generator (compressor, combustion chamber, and turbine) and the reduction gearbox were disassembled and examined. The axial compressor wheel exhibited no appreciable blade damage but did exhibit circumferential bluish heat distress on both the forward and aft sides hub as well as on the surface of the blades; the leading edges of the blades felt rough to the touch. The outside of the aluminum inlet nose cone was wrinkled consistent with exposure to high temperatures. The axial compressor shaft exhibited bluish heat distress located at three distinctive axial locations (360° circumferentially around the shaft); the forward most was in-line with the No. 1 bearing (gas generator front bearing), the middle in-line with the bevel gear, and the rearmost in-line with the No. 2 bearing (gas generator rear bearing) (PHOTO 17). Both the gas generator front bearings were visually undamaged. The leading edge exducer part of a centrifugal compressor blade exhibited contact wear; however, the wear was not present on all the exducers. The compressor front cover circumferential scoring of around the aft side outer edge; the scoring was along an approximately 180° arc and was in-line with the wear observed on the centrifugal compressor exducer blade (PHOTO 18). The No. 1 and No. 2 bearings were intact, all the roller balls were present, and all appeared in good condition; the bearings did however exhibit slight bluish discoloration.

PHOTO 17: NO. 2 ENGINE AXIAL COMPRESSOR HEAT DISTRESS

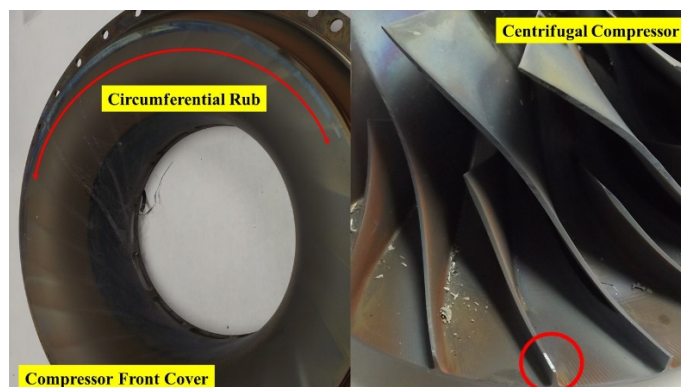
PHOTO 18: NO. 2 ENGINE CENTRIFUGAL COMPRESSOR CONTACT WEAR

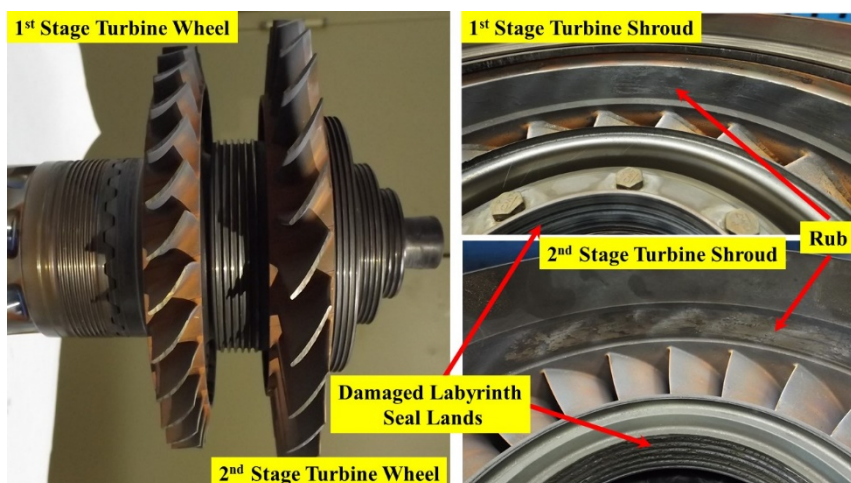
The blades on both stages of the gas generator turbine exhibited light contact wear on the tips; corresponding circumferential scoring was noted on the 1st and 2nd stage gas generator turbine shrouds in-line with the blade running path (PHOTO 19). Such blade tip wear may lead to a degradation in engine performance and instability in the combustion section. Instability in the combustion section may result in incomplete combustion, smoke out the back of the engine and, possibly, engine flameout. The power turbine blades are secured into the power turbine disk by locking tabs that crimped radially to prevent the blades from sliding or migrating out of the individual blade slots.

PHOTO 19: CONTACT RUB IN THE GAS GENERATOR AREA

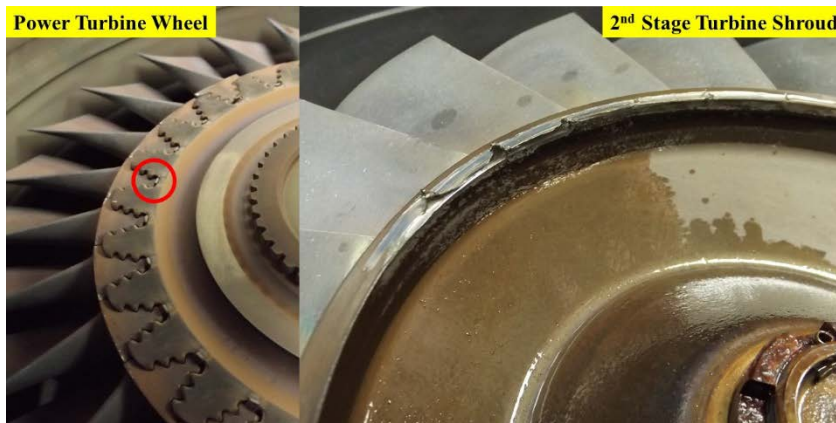
Examination of the power turbine found that all the blades were present but about half had translated aft in the blade slot slightly and that the corresponding locking tabs on the front of the disk were no longer crimped but were bent straight. All the locking tabs were present and whole under the blade roots. The shroud of the power turbine nozzle guide vane exhibited a localized area around the inner vane ring aft face with wear and raised/gouged material. The raised area was distinctive and not continuous, a little over 180° arc, and was more consistent with a static impact mark and slight rotation than a pure rotating impact mark (**PHOTO 20**).

PHOTO 20: POWER TURBINE CONTACT DAMAGE – RED CIRCLES SHOWS LOCK TAB BENT STRAIGHT

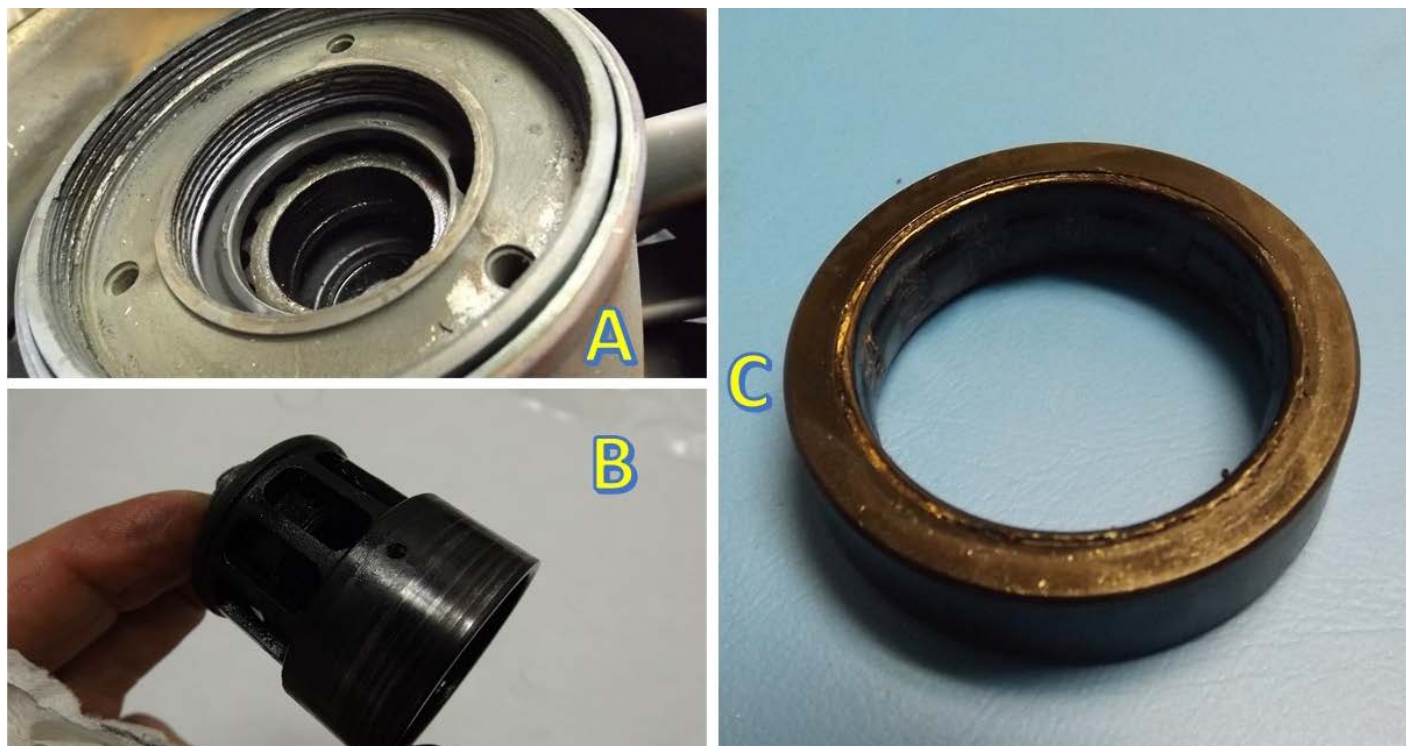
Examination of the gas generator rear bearing compartment revealed that it had no significant amount of black coke-like material like what was observed in the No. 1 engine (**PHOTO 21, 'A'**). This is consistent with the condition of the rear bearing chamber as observed at Atlanta Air Salvage in Atlanta. The rear bearing housing was removed and it showed some black coke-like material. Examination of the rear bearing support cage showed that some black coke-like material as well but not the amount that was observed on the No. 1 engine. No obstruction of the rear bearing support cage oil passage was noted (**PHOTO 21, 'B'**). Removal of the rear bearing from its support cage revealed that all the roller elements as well as the roller cage was still present and that all the roller elements were flattened flush the cage; the rear bearing was dry and lacked any lubrication (**PHOTO 21, 'C'**). The examination of the cavities around the rear bearing's chamber showed that they were dry without signs of oil or coke and there were no indications of a bearing compartment fire. The gas generator rear bearing compartment components were shipped to SafranHE in France for further evaluation (See Section 3.1.2 NO. 2 ENGINE – ESN 47346 HARDWARE EXAMINATION for details). The gas generator rear bearing oil supply, scavenge, and vent lines and drains, were examined and were found to be clean without obstructions. The No. 2 engine oil vent line, 3-way union deck fitting, and the black debris were sent to the NTSB's Materials Laboratory in Washington, DC. For further evaluation (See Section 3.2 3-WAY UNION DECK DRAIN FITTING EVALUATION AT THE NTSB for details).

PHOTO 21: NO. 2 ENGINE REAR BEARING COMPARTMENT CONDITION

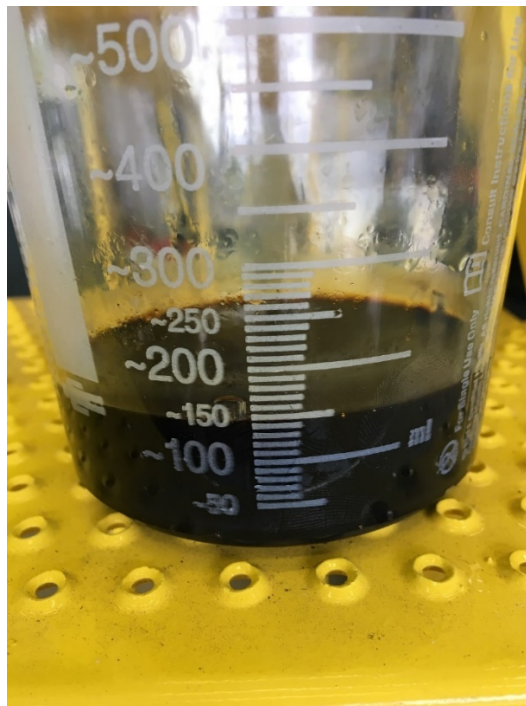
The No. 2 was motored for 15 seconds and oil started to flow approximately five seconds after initial engine rotation. The collection vessel was held in place until the engine rotation spooled down after the motoring and no additional oil was flowing from the oil scavenge line. The oil scavenge line was disconnected and placed vertically above the collection vessel to ensure no residual oil remained. No additional oil remained. Approximately 145ml (4.9 oz) of oil was collected (**PHOTO 23**).

PHOTO 23: ENGINE NO. 2 TOTAL OIL COLLECTED

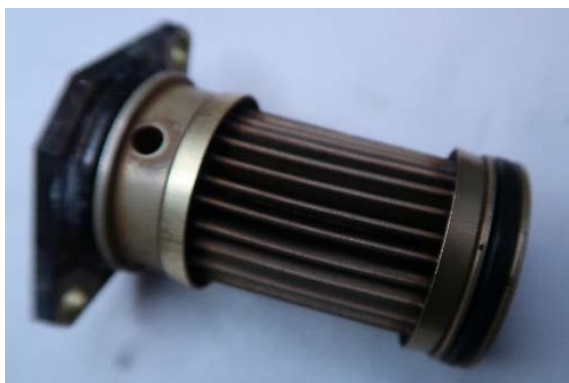
PHOTO 24: HP FILTER CLEAN

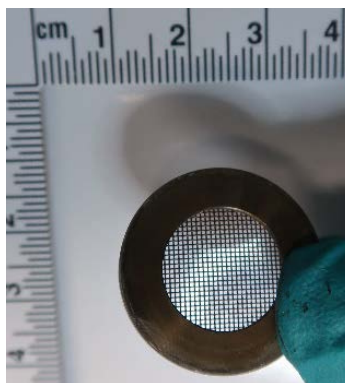
PHOTO 25: FUEL INLET STRAINER CLEAN

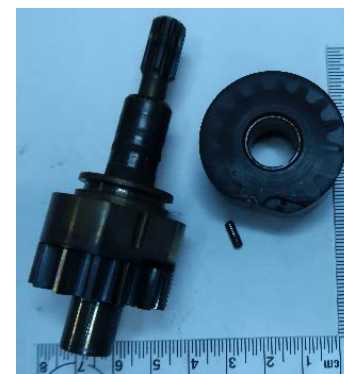
PHOTO 26: FUEL PUMP GEAR UNDAMAGED

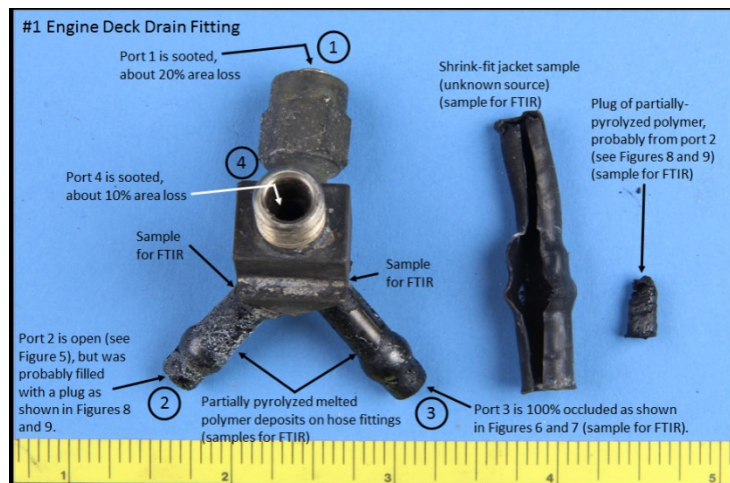
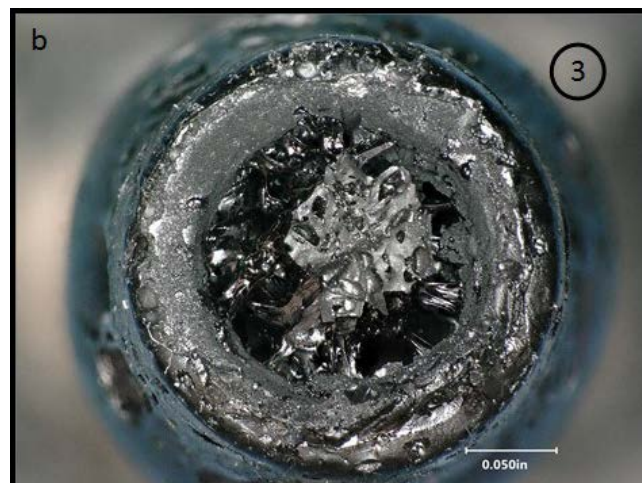
Each port of the No. 1 engine 3-way union deck fitting was visually inspected for the presence of sludge, coking deposits, or other obstructions and 0.033-inch diameter stainless steel wire was used to access the extent of the obstruction (**PHOTO 30**). The Module M01 oil drain port was sooted and was estimated that about 20% of the area was reduced. The oil supply line deflector port (**PHOTO 31**) and the rear bearing oil vent ports were 100% blocked and analysis of the black obstruction within each port found them to be consistent with material of the shrink wrap jacket. No obstructions were found in any of the ports the No. 2 engine 3-way union deck fitting and no obstructions were found in the No. 2 drain line.

PHOTO 30: DECK FITTING PORT EXAMINATION RESULTS **PHOTO 31: OIL SUPPLY DRAIN OBSTRUCTION**
