NATIONAL TRANSPORTATION SAFETY BOARD Office of Aviation Safety (AS-30) Air Traffic Investigations

NTSB Investigation Number CEN20FA009

Figure 1 - N249BW - Flight Track - Overview

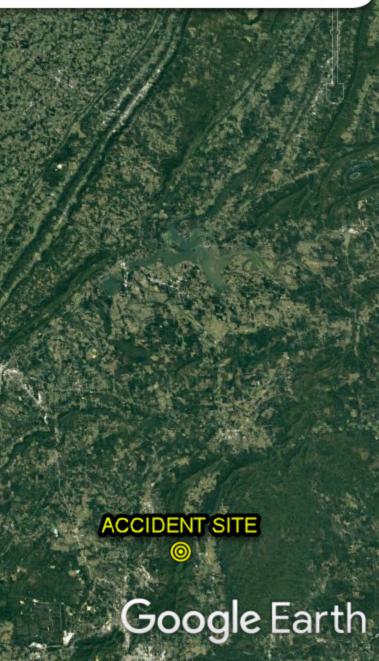
First Track Data 0949:57 CDT / 675 ft msl

> Last Track Data 1015:29 CDT / 1,050 ft msl

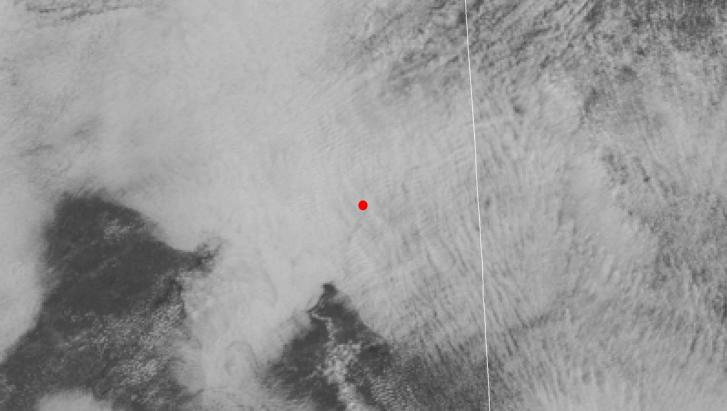
The following satellite image from about the accident time (red dot denotes accident location) depicts cloudy conditions across the region...
