**NATIONAL TRANSPORTATION SAFETY
BOARD
Office of Aviation
Safety Washington,
DC 20594**

SUMMARY OF AIRCRAFT EXAMINATIONS

-- CEN21FA360 --

On August 7, 2021, about 1740 central daylight time, a Mooney M20M airplane, N9156Z, was destroyed when it was involved in an accident near Victoria, Minnesota. The private pilot and two passengers sustained fatal injuries. The airplane was operated as a Title 14 *Code of Federal Regulations* Part 91 personal flight.

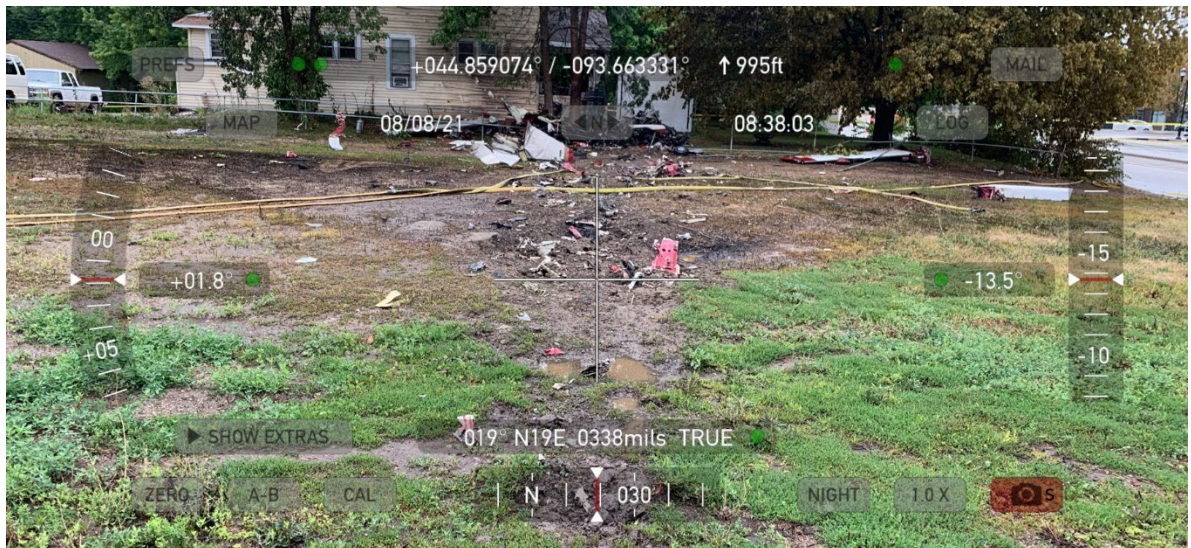
The airplane impacted an open grassy lot on a northerly heading and a post impact fire ensued (see Figure 1). Most of the wreckage was highly fragmented, with both wings separated from the fuselage.

Figure 1 – Airplane Wreckage at Accident Site (NTSB Photo)

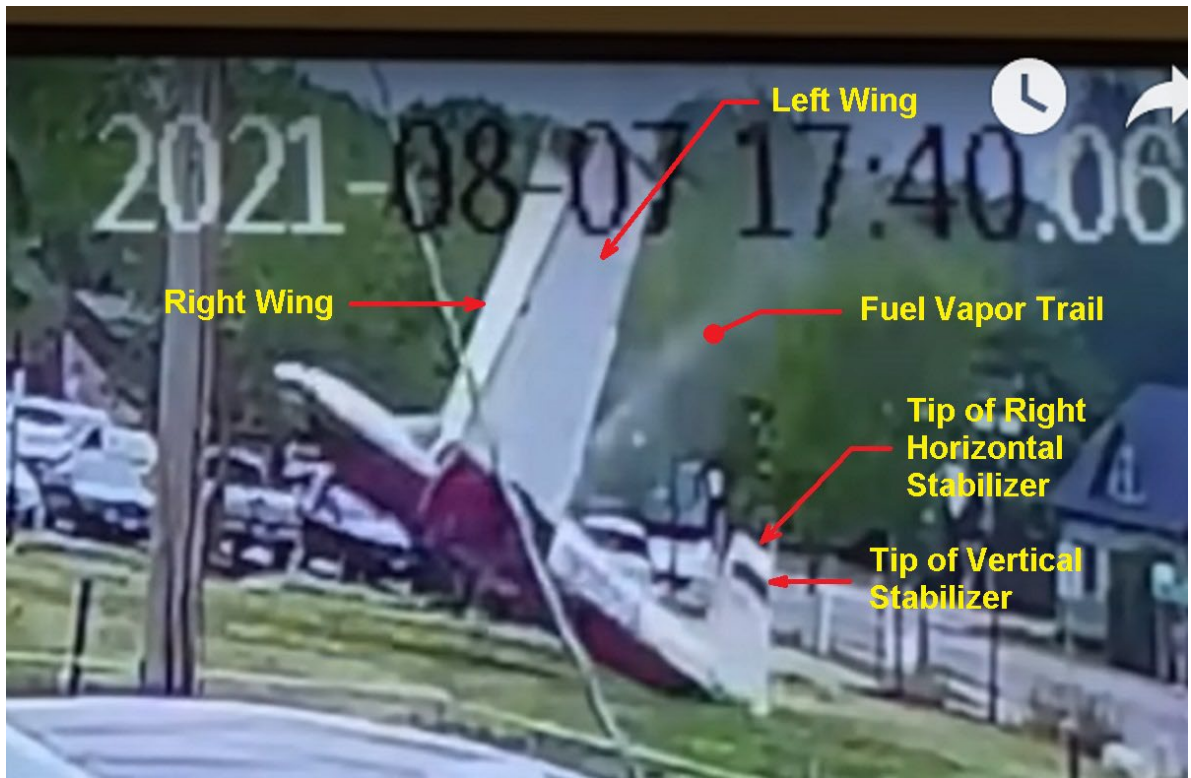
Several witnesses heard loud popping noises and observed the airplane in a rapid descent with both wings “folded up”. Review of security video near the accident site revealed the airplane was upright and in a nose high attitude at ground impact, with both wings and the right horizontal stabilizer deflected up toward a vertical position (see Figure 2).

Figure 2 – Airplane Prior to Impact (Screen Capture of Security Video)

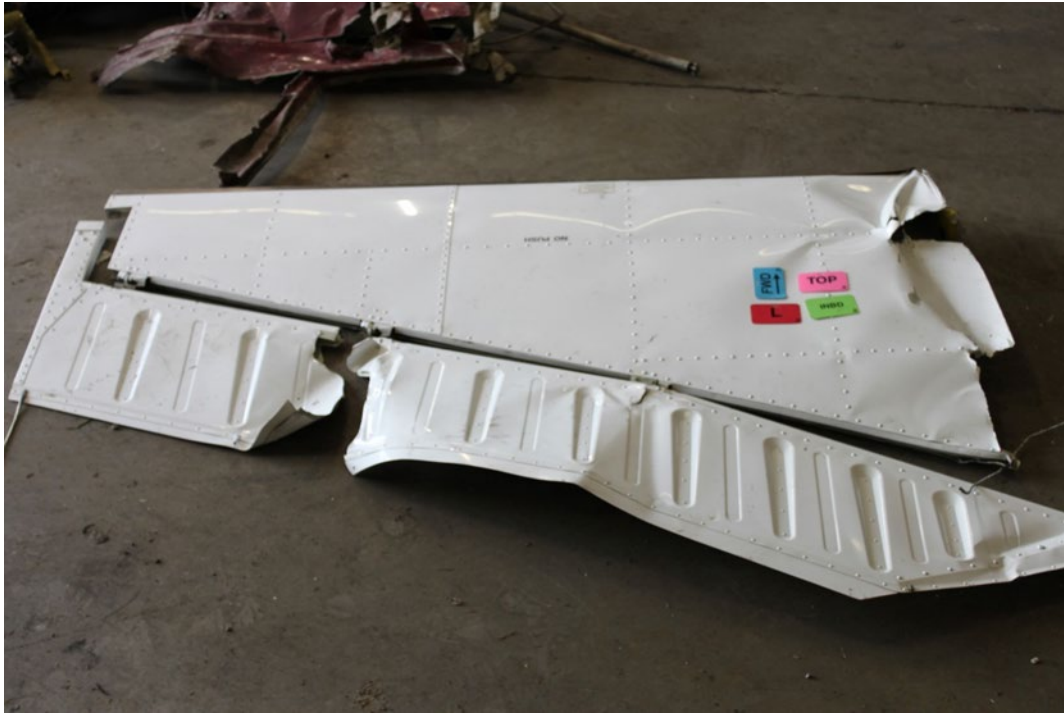
The left- and right-wing main and rear spars were fractured near the outboard ends of their respective main landing gear wheel wells. The left elevator, which was fractured in two pieces, separated from the left horizontal stabilizer and was found about 820 ft southwest of the accident site (see Figure 3). The left horizontal stabilizer separated from the fuselage and was found about 750 ft southwest of the wreckage site.

Figure 3 – Left stabilizer and elevator at the recovery location (NTSB Photo)

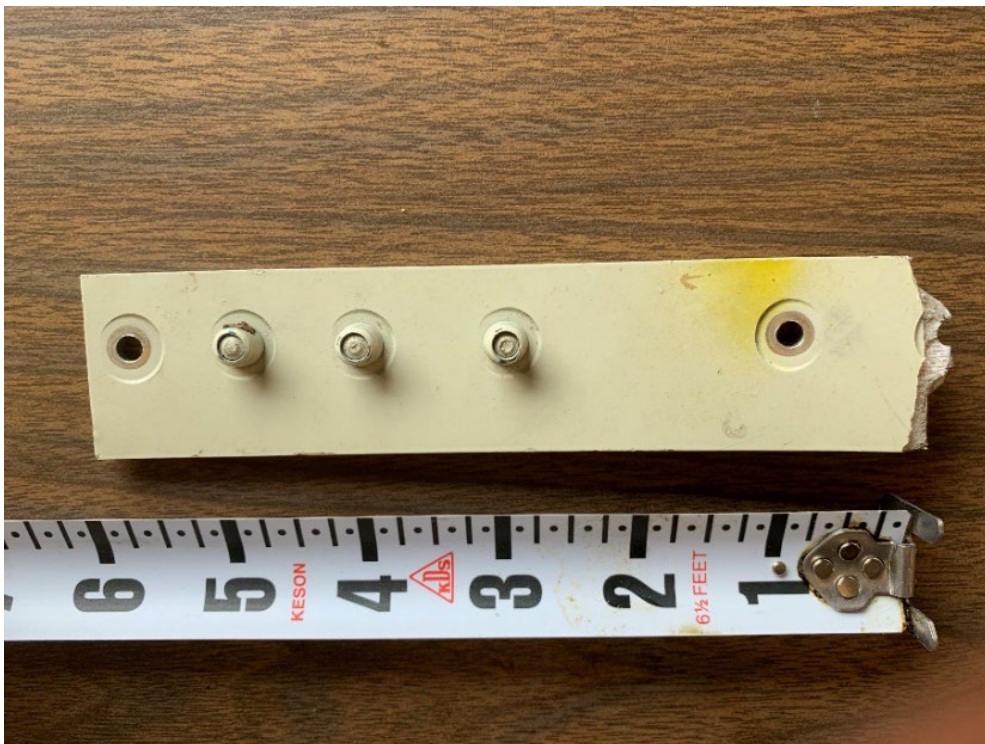
A 6-inch section of the main wing upper spar cap splice plate was found about 300 ft southwest of the wreckage site (see Figure 4).

Figure 4 - Section of the upper cap splice plate of the main wing spar (NTSB Photo)

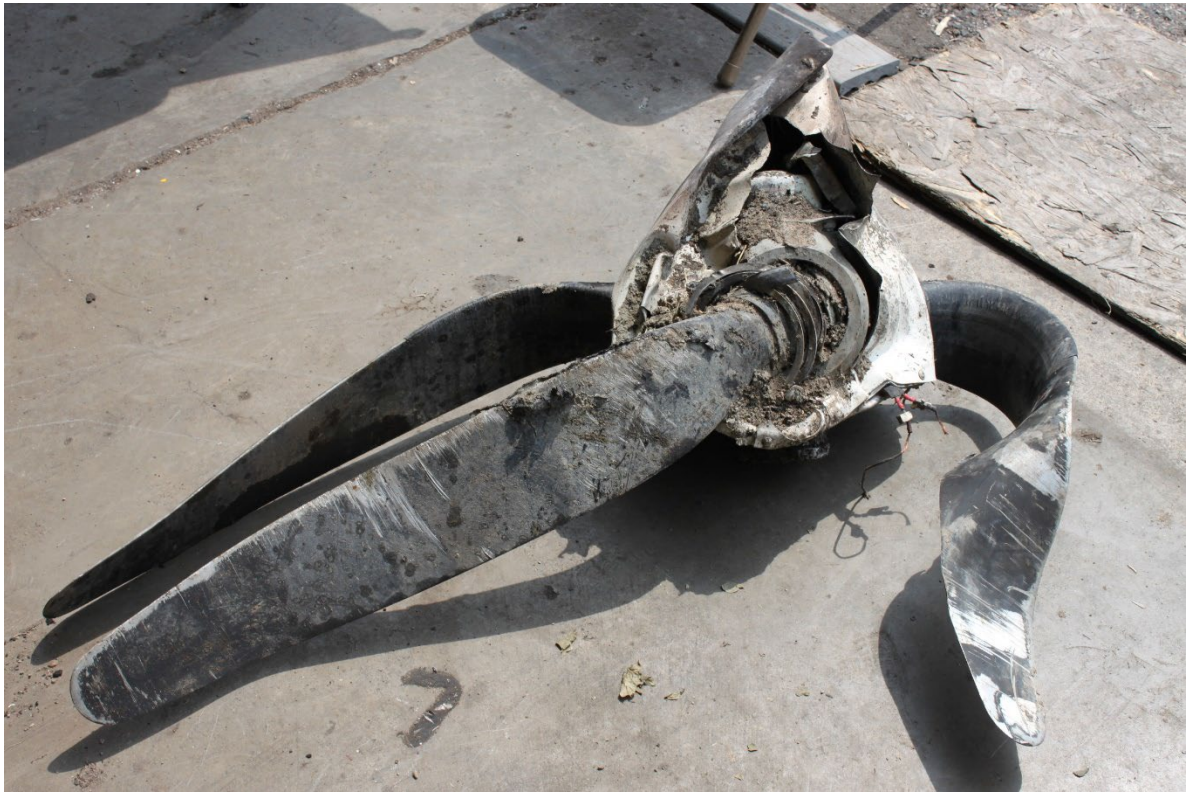
The propeller was separated from the crankshaft due to impact damage. Two propeller blades were bent aft, one blade was curled forward, and all three blades exhibited chordwise and leading-edge scarring (see Figure 5).

Figure 5 – Propeller at Recovery Location (NTSB Photo)

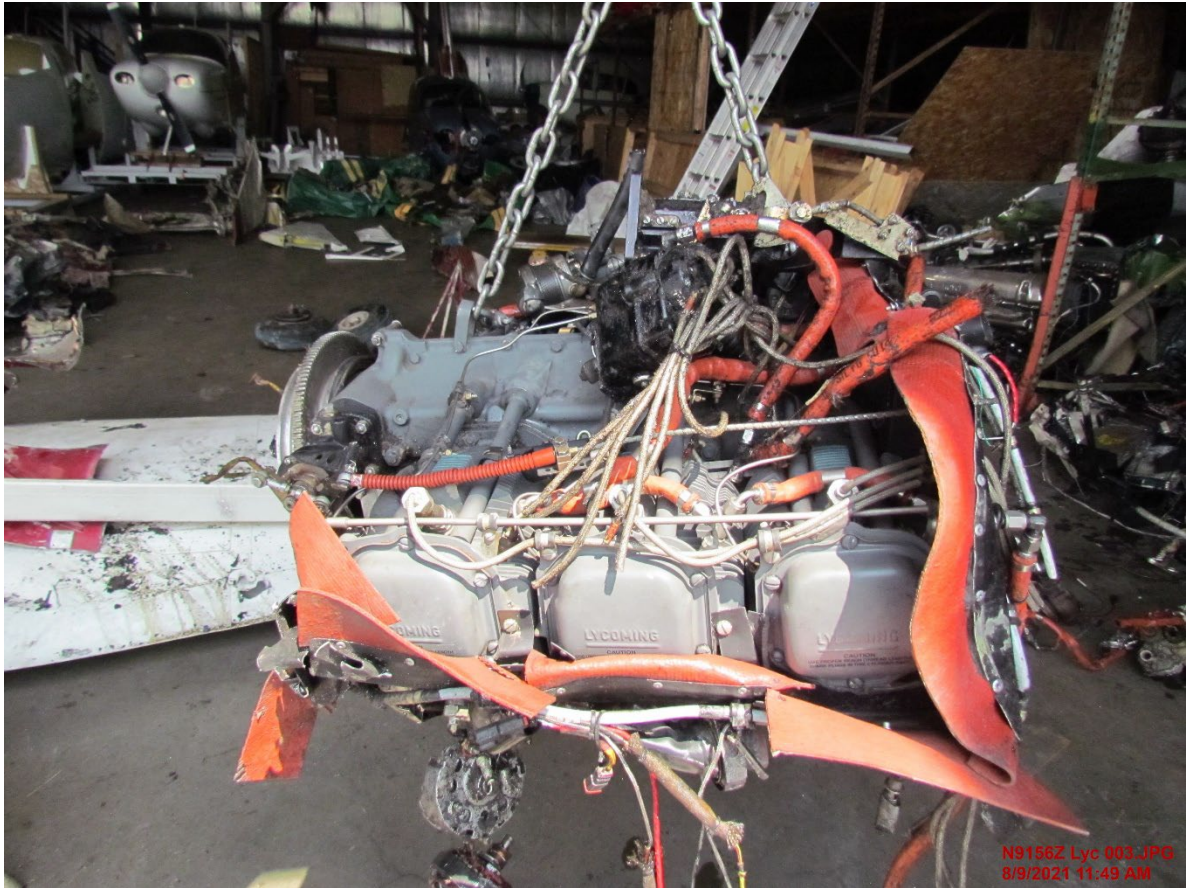
The engine was found mostly separated from the firewall with cables, hoses, and wires remaining attached. The cables, wires and hoses were cut, and the engine was hung from a forklift for the examination (see Figure 6).

Figure 6 – Engine at Recovery Location (NTSB Photo)

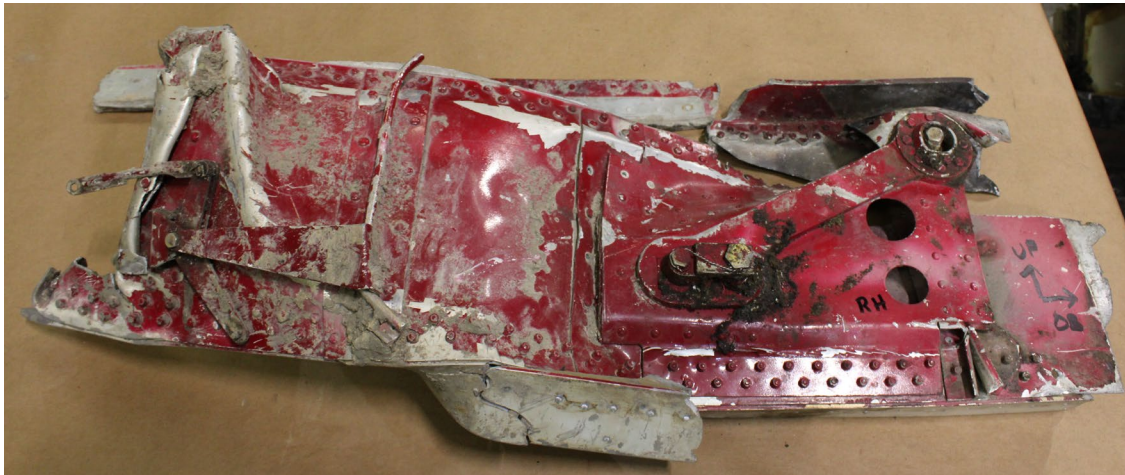
The right wing was mostly intact from about wing station (WS) 57 outboard to the tip. The right aileron remained attached. The right flap and right main landing gear were separated. The inboard end of the separated right wing sustained some fire damage. The lower leading edge skin inboard to about WS 24 remained attached. The wing right root rib with fuel pickup and fuel sending unit was separated. The right wing main spar upper and lower caps fractured near WS 57. The lower spar cap had no obvious deformation adjacent to the fracture at WS 57. The upper spar cap exhibited S-bending adjacent to the fracture location at WS 57.

A section of the right wing main spar from WS 26 to WS 57 with the right main landing gear fitting was recovered along with separated portions of the upper and lower spar caps (Figure 7). The upper spar cap aft flange was separated and fractured into two pieces between WS 26 and WS 48. The upper spar cap with a portion of spar web was separated between WS 48 and WS 57. The lower spar cap was fractured near WS 45 but remained attached to the web.

Figure 7 – Right wing main spar aft side, wing station 26 to 57 (NTSB photo)

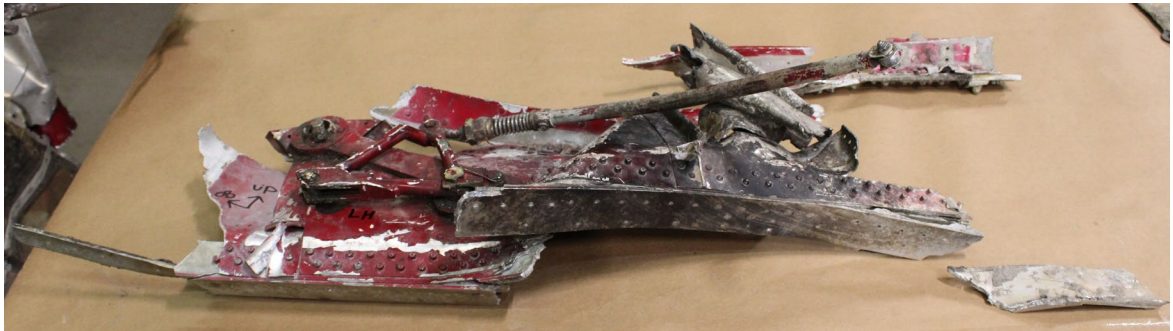
A section of the left wing main spar from WS 26 to WS 57 with the left main landing gear fitting was recovered along with separated portions of the upper and lower spar caps (Figure 8). The upper spar cap was fractured and separated between WS 26 and WS 43 and between WS 43 and WS 55. The lower spar cap was

fractured near WS 45 but remained attached. A small section of lower spar cap forward flange between WS 21 and WS 26 was separated.

Figure 8 – Left wing main spar aft side, wing station 26 to 57 (NTSB photo)

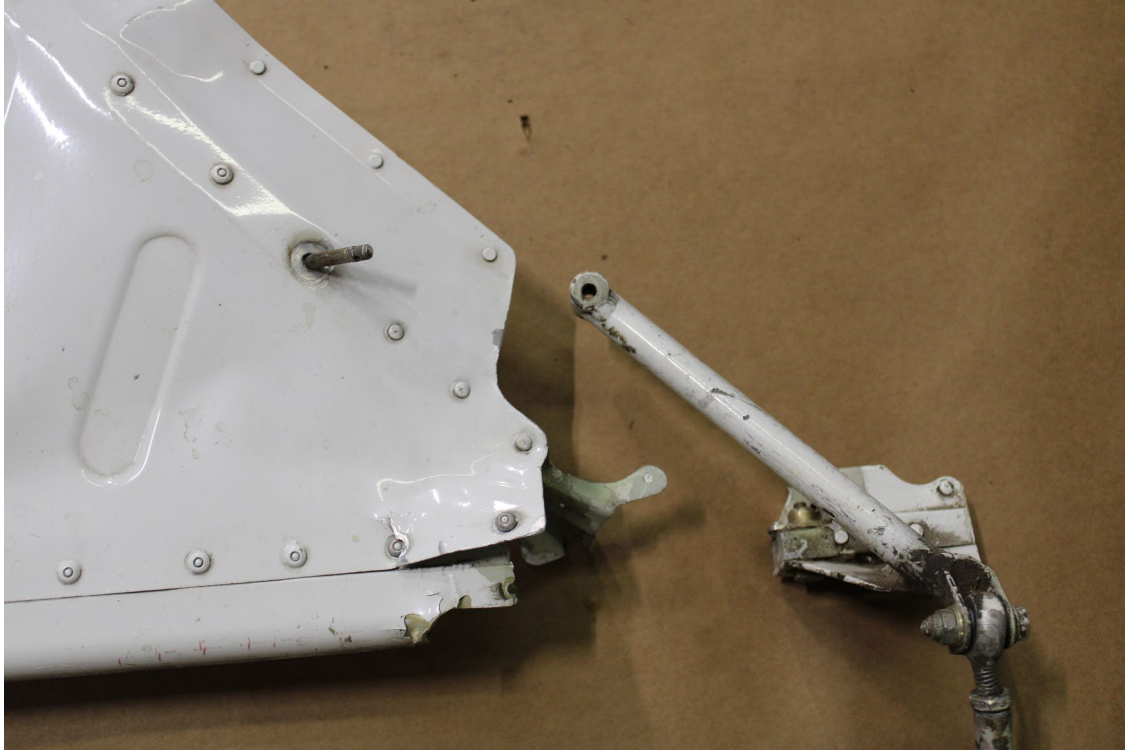
The left side of the horizontal stabilizer was separated near LSS 10. The left elevator was separated from the horizontal stabilizer and fractured into two pieces. The left elevator was fractured near LSS 46. The left elevator hinges were all intact on the horizontal stabilizer and the hinge blocks were pulled from the elevator. The damage and deformation of the left horizontal stabilizer and elevator were indicative of separation in an upward direction. The left elevator control rod was separated from the left elevator (Figure 9). The control rod fitting was fractured from the inboard leading edge and separated from the aft attach point. There was no obvious deformation of the control rod aft attach point hole. The left elevator control rod aft

attach bolt remained installed in the left elevator but was deformed inboard about 45°. There was some smearing of the bolt threads and the nut and cotter pin were not identified in the recovered wreckage. There was no evidence of fretting on the elevator around the bolt location.

Figure 9 – Left elevator inboard end and control rod (NTSB photo)
