**SUMMARY OF AIRCRAFT EXAMINATION**

-- CEN21FA299 --

On July 1, 2021, about 0755 central daylight time, a Cirrus SR22 airplane, N123RE, was destroyed during an accident at Lamoni Municipal Airport (LWD), Lamoni, Iowa. The private pilot and passenger were fatally injured. The airplane operated under the provisions of Title 14 *Code of Federal Regulations* Part 91 as a personal flight.

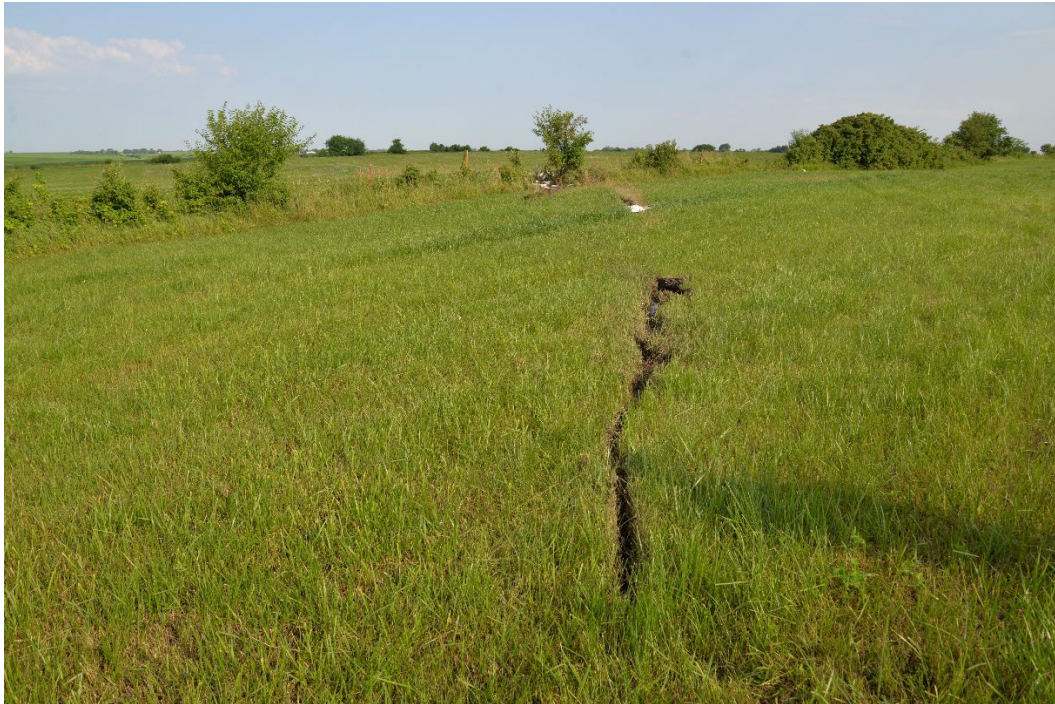
The airplane initially contacted the ground about 75 ft left of the runway edge and about 1,050 ft from the Runway 36 threshold. Left wingtip debris was located about 60 ft beyond the initial ground scar (reference Figure 1) and the debris path was on a northwesterly heading of about 300°.

*Figure 1 – Initial Impact Ground Scar in Foreground, Left Wingtip Debris and Main Wreckage Site in Background*

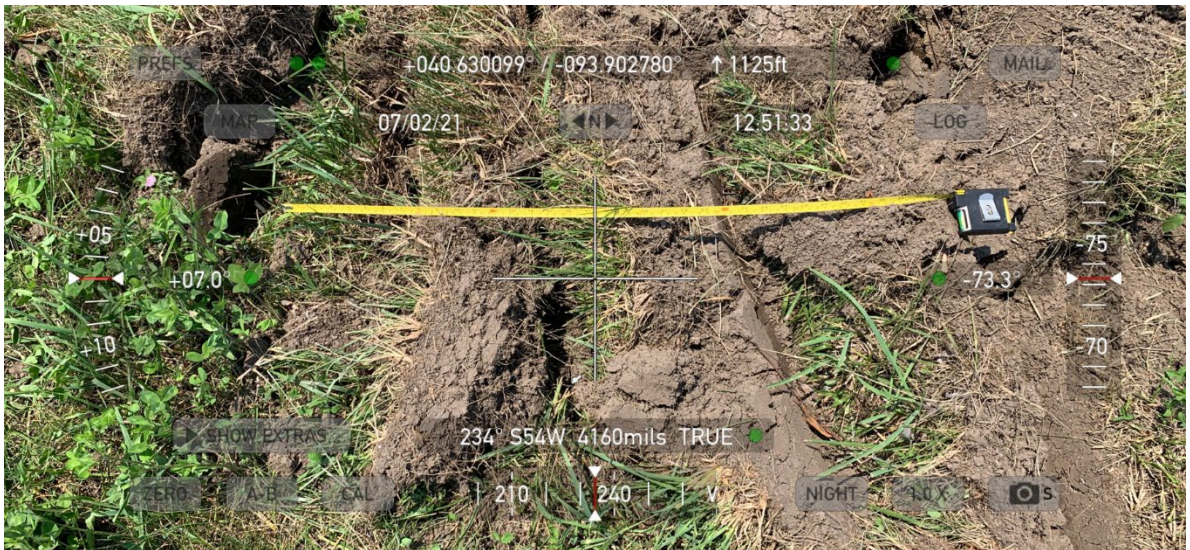
Ground scars from propeller strikes (reference Figure 2) were located about 15 ft beyond the left wingtip debris were. The measured distance between 5 of the ground scars was about 3 feet.

*Figure 2 – Propeller Strike Ground Scars*

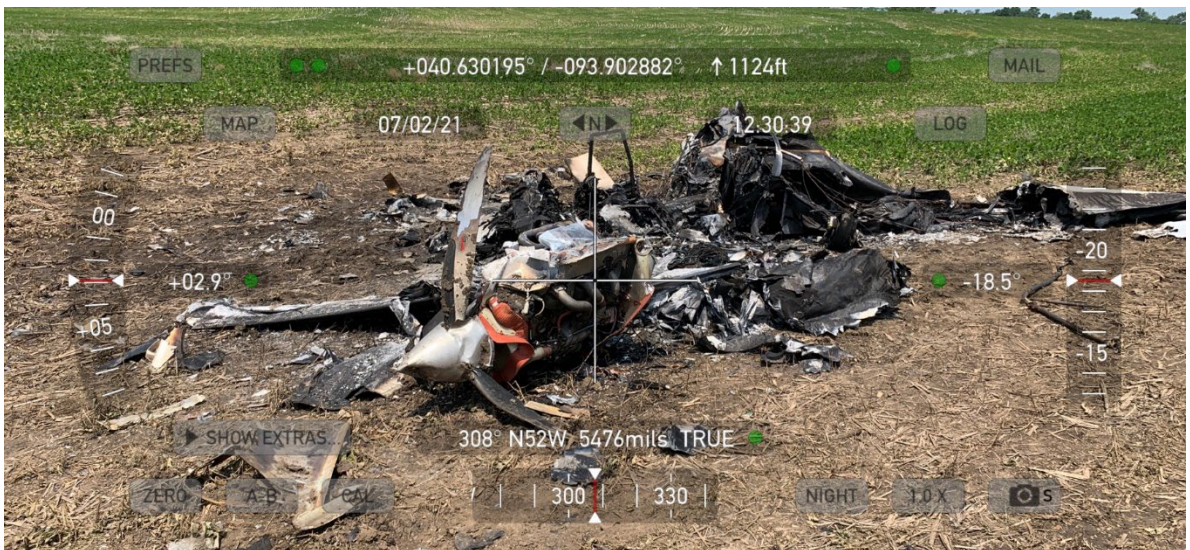
The airplane came to rest in a soybean field (reference Figure 3) about 60 ft beyond the propeller strike ground scars.

*Figure 3 – Airplane at Accident Site Looking Away from the Runway*
