Summary of Aircraft Examination

**NATIONAL TRANSPORTATION SAFETY BOARD
Office of Aviation Safety
Washington, DC 20594**

SUMMARY OF AIRCRAFT EXAMINATIONS

-- CEN22FA203 --

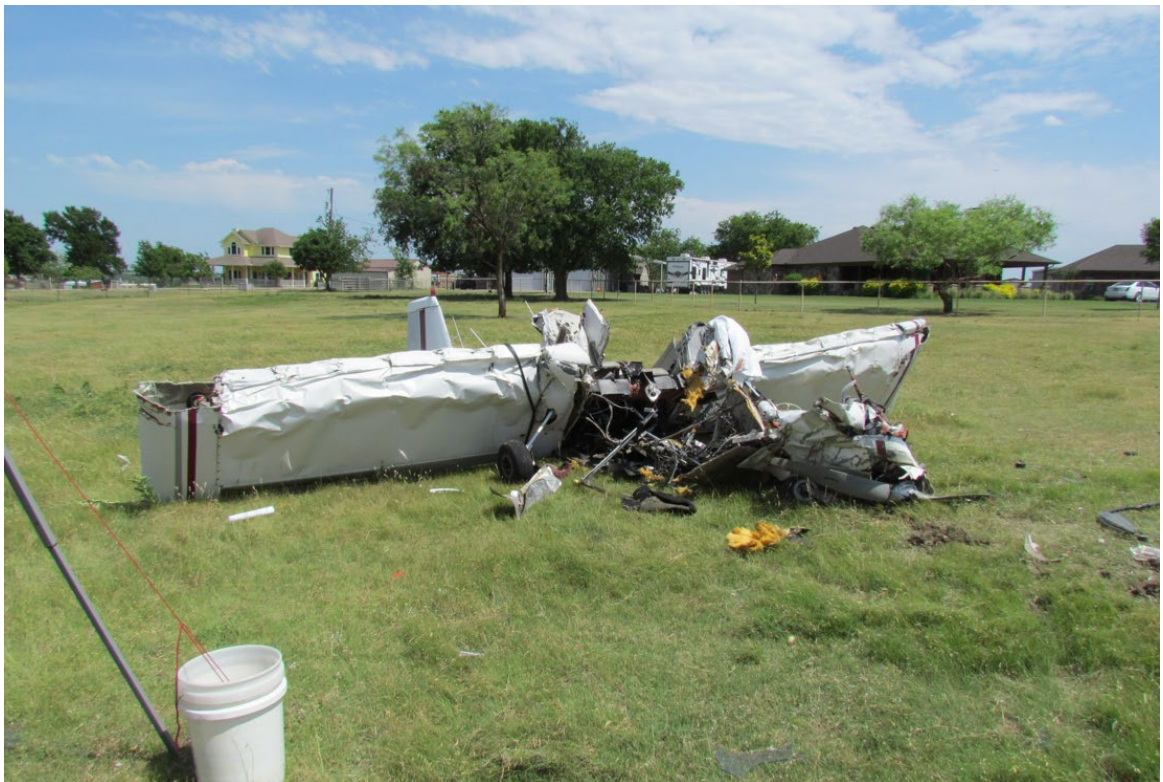
The airplane impacted a grassy field in a rural, residential area with a nose down attitude and minimal forward momentum (see Photo 1). The airplane came to rest upright on a northwesterly heading, with both wings crushed downward. The tail section was twisted slightly to the right of the fuselage as viewed from the rear of the airplane.

Photo 1 – Accident Site

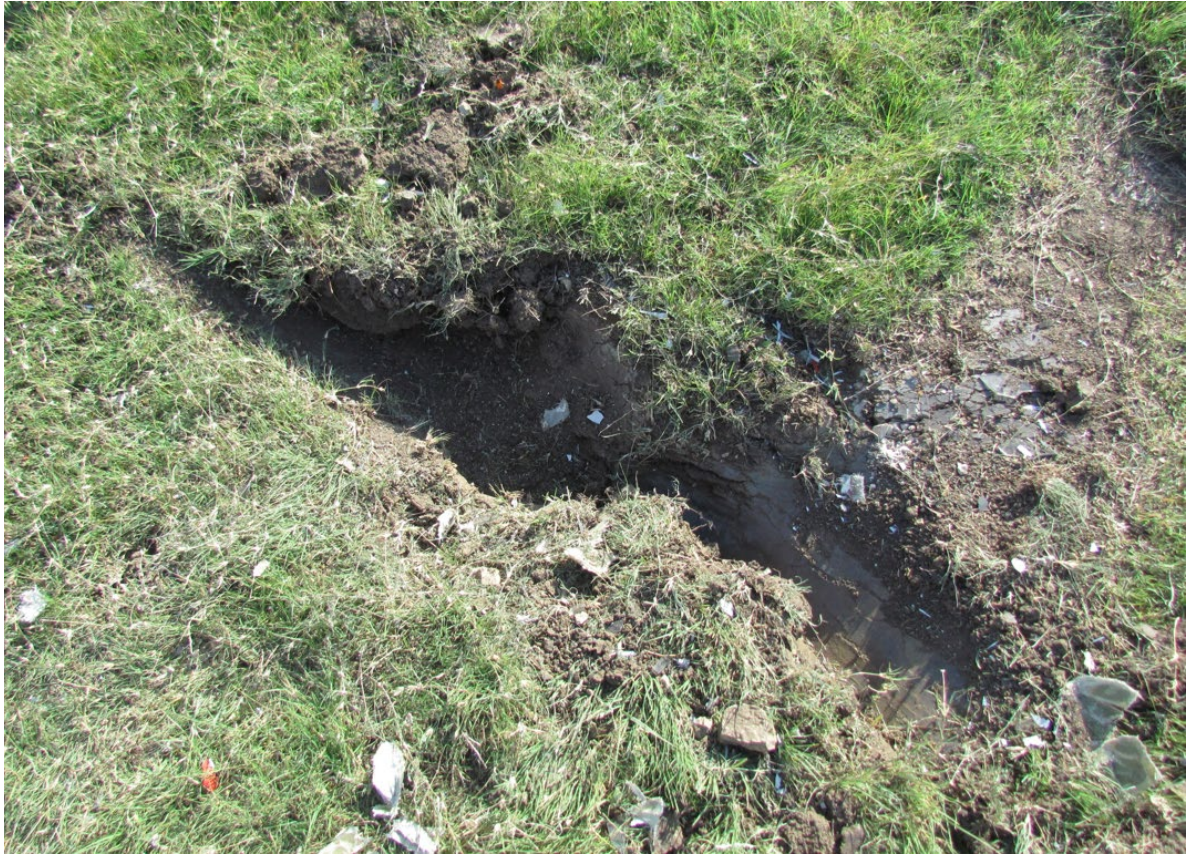
Two propeller strike ground scars were located immediately in front of the wreckage. The two ground scars were about 3 ft apart and the largest ground scar was about 9 inches deep.

Photo 2 – Propeller Ground Scar After Wreckage Debris was Removed
