National Transportation Safety Board

CEN21FA459

AIRCRAFT EXAMINATION SUMMARY

Location: Hiles, WI
Date: September 28, 2021
Time: 09:00 Central Daylight Time
Aircraft: Rockwell International 690B

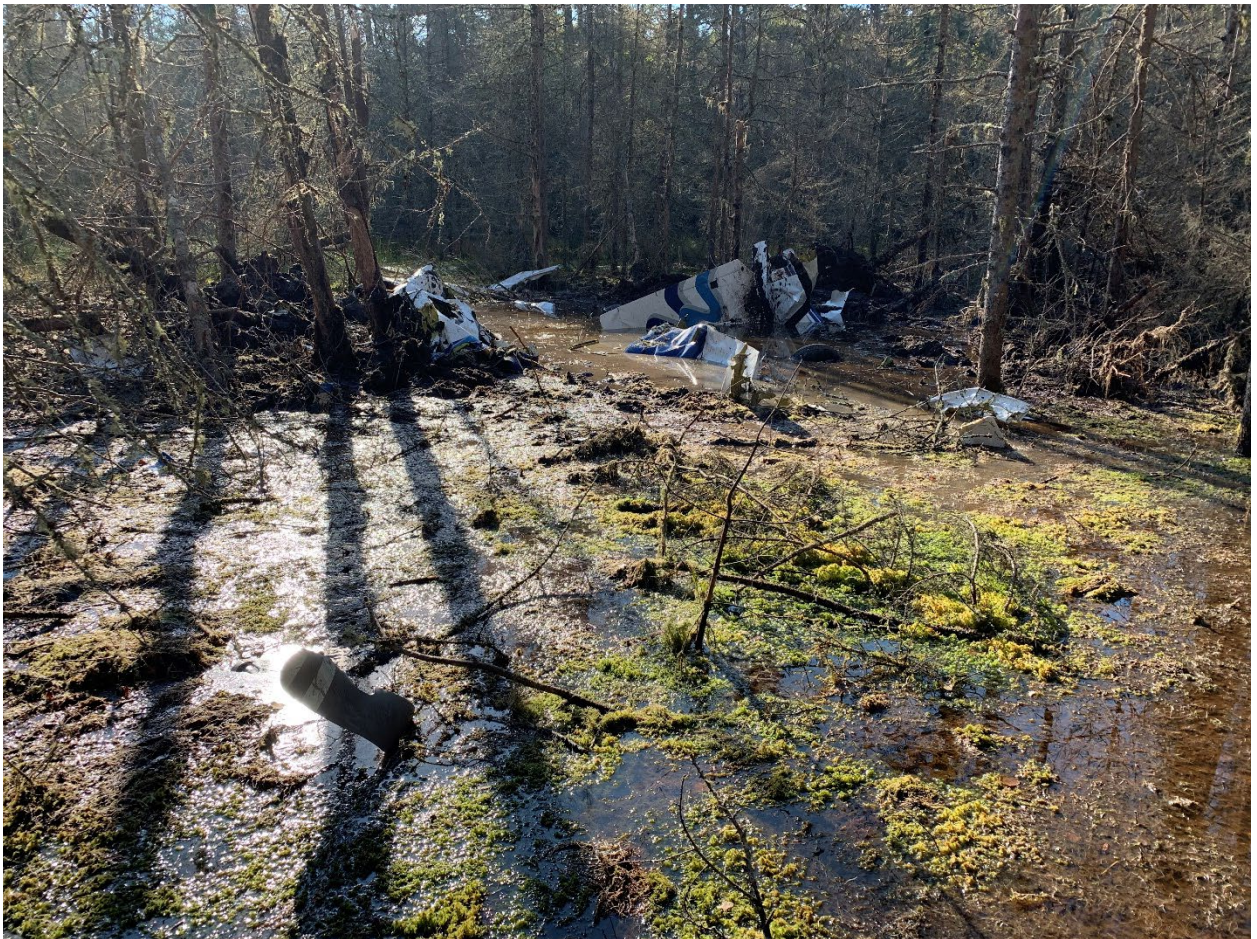
The wreckage was distributed in heavily wooded and wetlands terrain in a diameter of about 50 yards. A majority of the main wreckage, which was highly fragmented, was found beneath the water surface with some debris located in the adjacent trees (see figure 1). The forward fuselage, fragmented sections of the wings, and a portion of the rear fuselage was submerged in the wetlands. An odor and sheen on the wetlands water of Jet A aviation fuel was noted at the accident site by first responders.

Figure 1. Accident site and main wreckage
