NATIONAL TRANSPORTATION SAFETY BOARD

Aircraft Examination Summary

CEN23LA028

Location: Slidell, Louisiana
Date: November 6, 2022
Aircraft: Beech E-90
NTSB IIC: Michael Folkerts

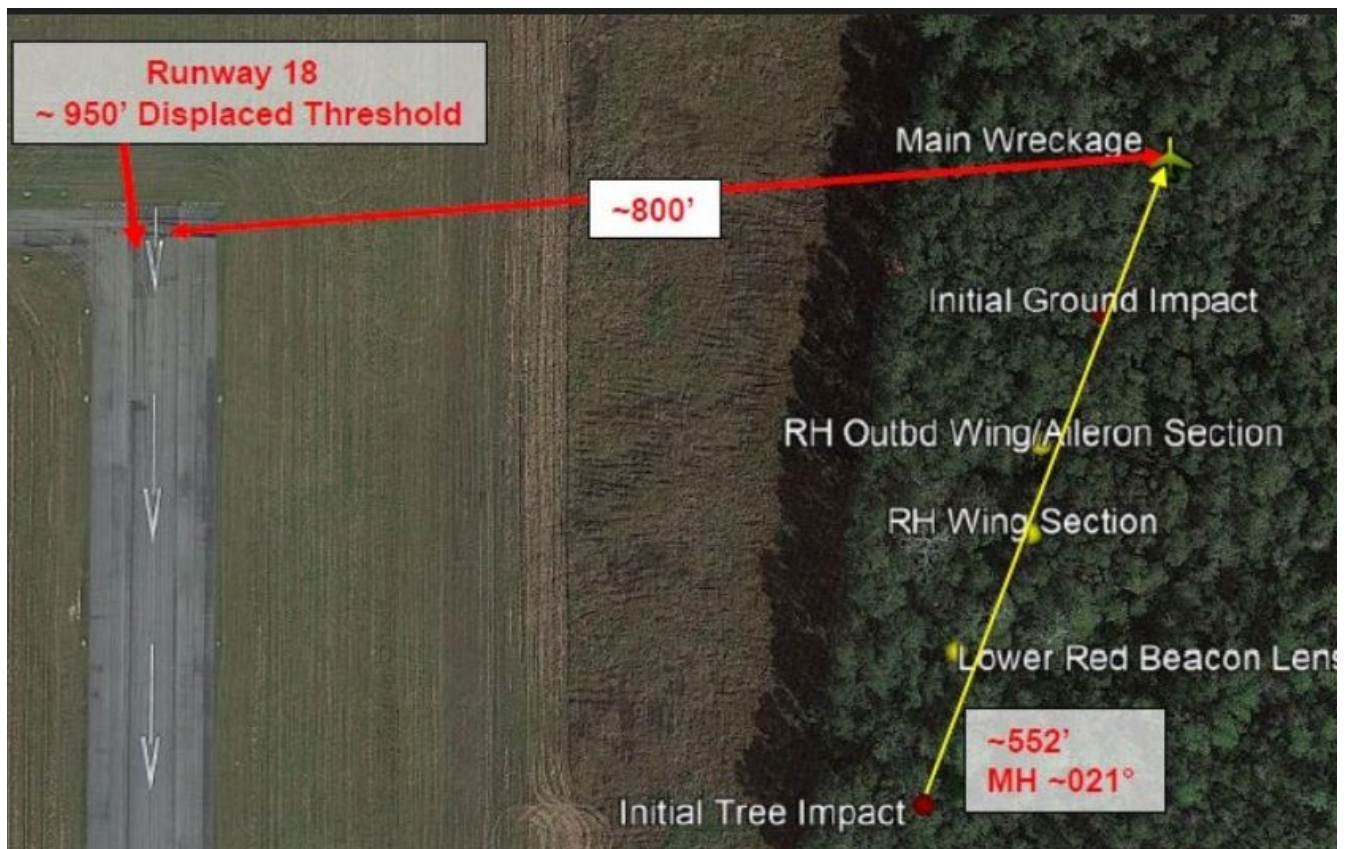
The initial tree impact point to the main wreckage was about 552 ft. (see Figure 1.)

Figure 1. Accident Site Diagram, Courtesy of Textron Aviation

At the initial tree impact point, a section of the right wing at W.S. 266.735” was found with 15 inches of semi-diameter aft crushing. About 122 ft from the initial tree impact, the lower red beacon lens was found. About 304 ft from the initial tree impact, a right wing outboard section consisting of the aileron was found.

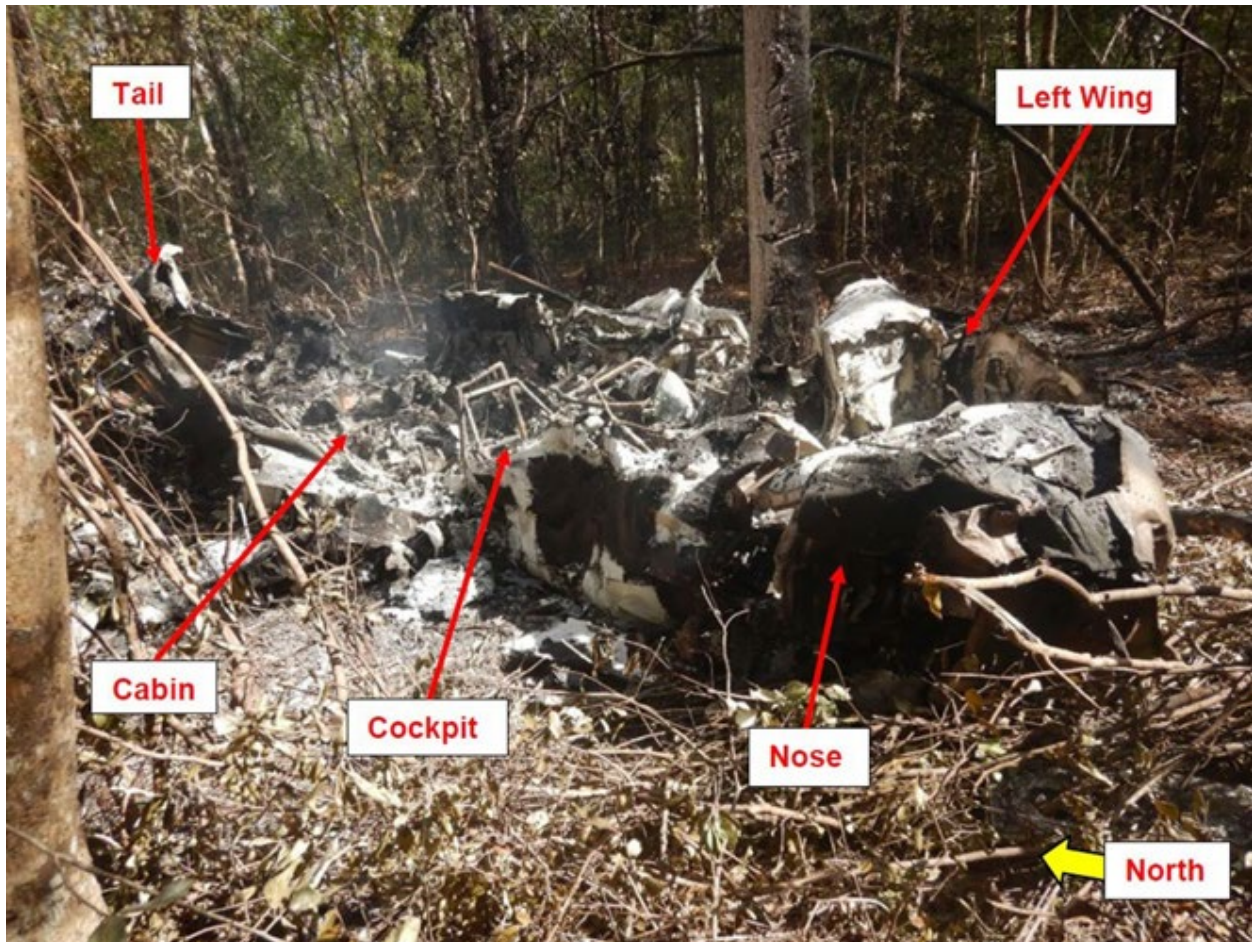
The main wreckage came to rest upright. The main wreckage consisted of the nose, cockpit, fuselage, and inverted tail section, with attached partial vertical and both horizontal stabilizers.

Figure 2. Main Wreckage at Accident Site, Courtesy of Textron Aviation

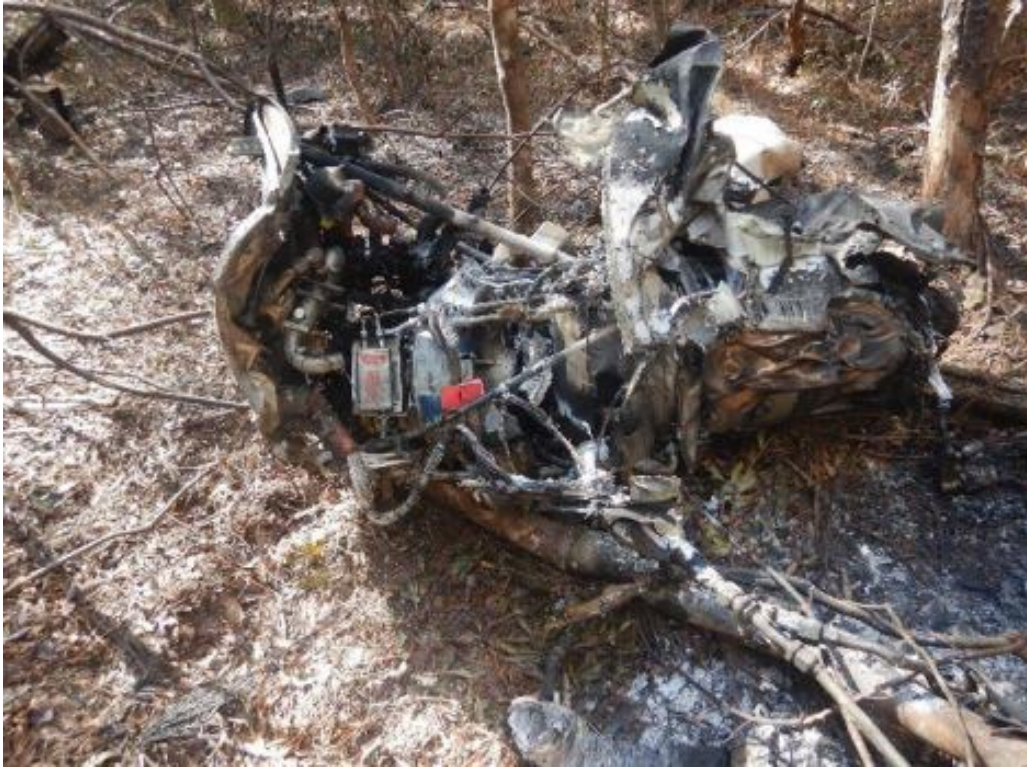
Both engines separated from their respective airframe attachments. The left engine was located about 150 ft south of the main wreckage (see Figure 3). The right engine was located about 50 ft west of the main wreckage (see Figure 4). Both McCauley 4-bladed propellers separated from their respective engine. The left propeller was located about 75 ft south of the main wreckage (see Figure 5). The right propeller was located about 100 ft south of the main wreckage (see Figure 6). All propeller blades exhibited varying degrees of twisting, buckling, and bending.

Figure 3. Left Engine at Accident Site, Courtesy of Textron Aviation

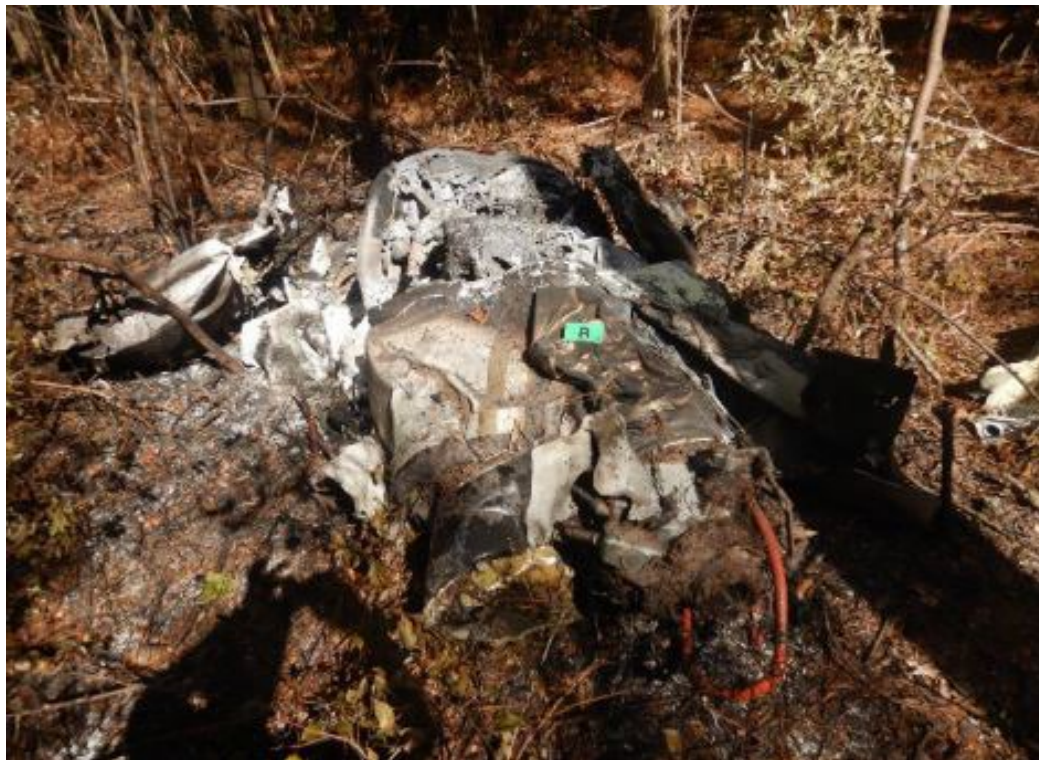
Figure 4. Right Engine at Accident Site, Courtesy of Textron Aviation

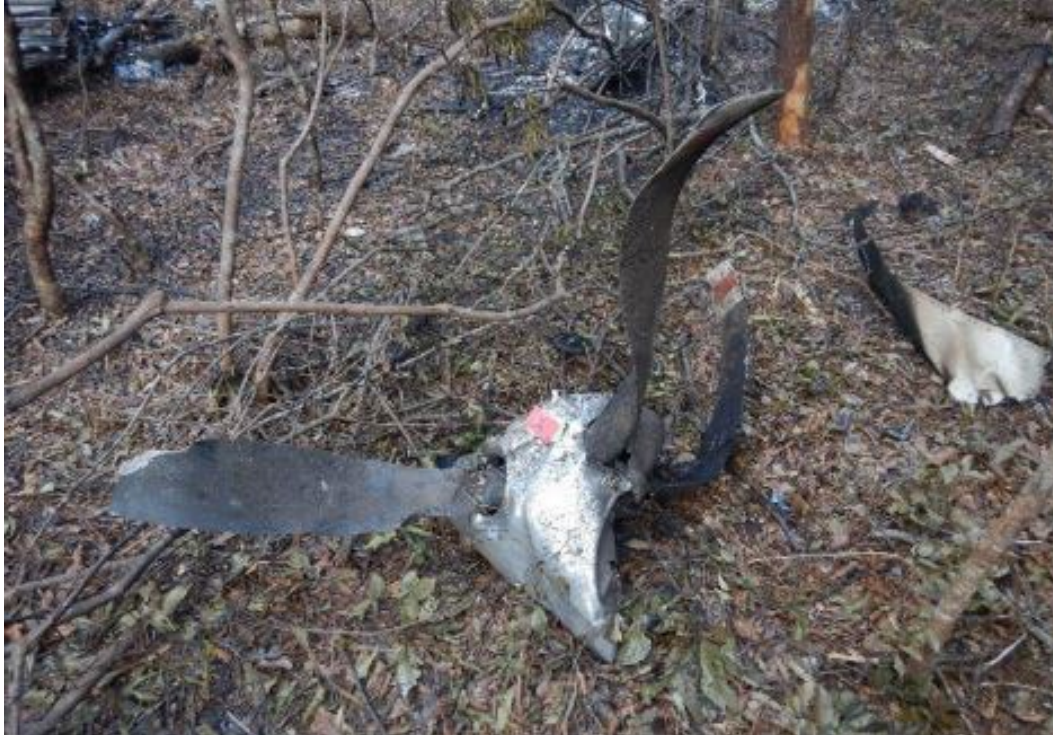
Figure 5. Left Propeller at Accident Site, Courtesy of Textron Aviation

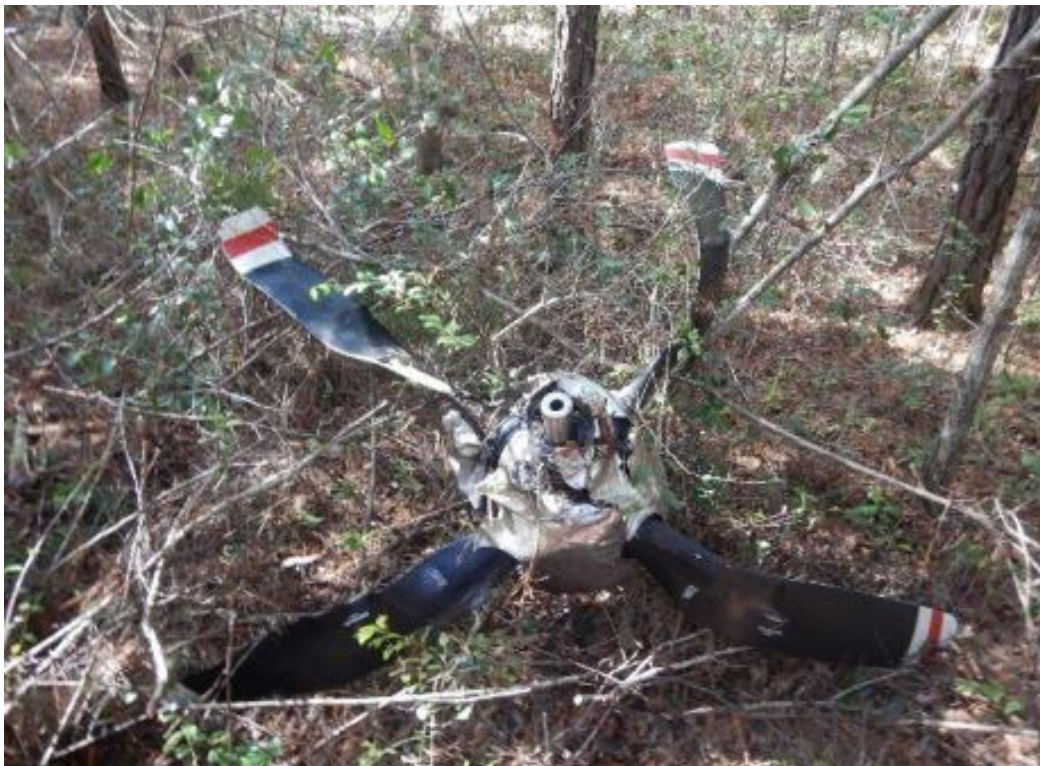
Figure 6. Propeller at Accident Site, Courtesy of Textron Aviation
