National Transportation Safety Board
Office of Research and Engineering

Airplane Performance Study

Specialist's Report of Investigation
Timothy Burtch
12/23/10

Location: Butte, MT
Date: March 22, 2009
Time: 2030 GMT (2:30 pm MDT)
Airplane: Pilatus PC-12/45, N128CM
NTSB Number: WPR09MA159

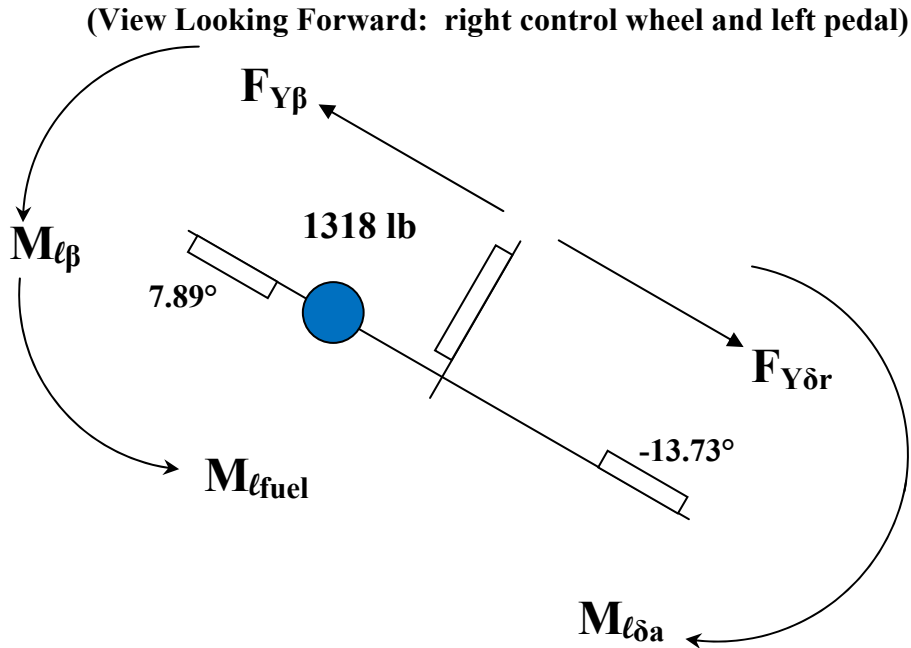
The trim positions recorded in the wreckage suggest a steady-heading sideslip to left (i.e., RWD and ANL of the true airspeed velocity vector, V_T), and this is consistent with a left-wing heavy fuel condition. The sideslip to the left is a maneuver that the accident pilot could have used to balance the fuel asymmetry while positioning the airplane for landing in Butte. Pilatus’ analysis of the maneuver indicates that a 1318 lb fuel imbalance (1368 lb – 50 lb) is controllable. Pilatus calculated that a steady-heading sideslip at the accident conditions and at speeds close to stall would require just over 50% of the 40° of available aileron (i.e., $\delta_{aL} - \delta_{aR} = 8.0^\circ + 14^\circ = 22^\circ$) and that it would produce approximately 20 lb of wheel force³.

Figure 2: Sideforce and Rolling Moments with a Left-Wing Heavy Fuel Asymmetry

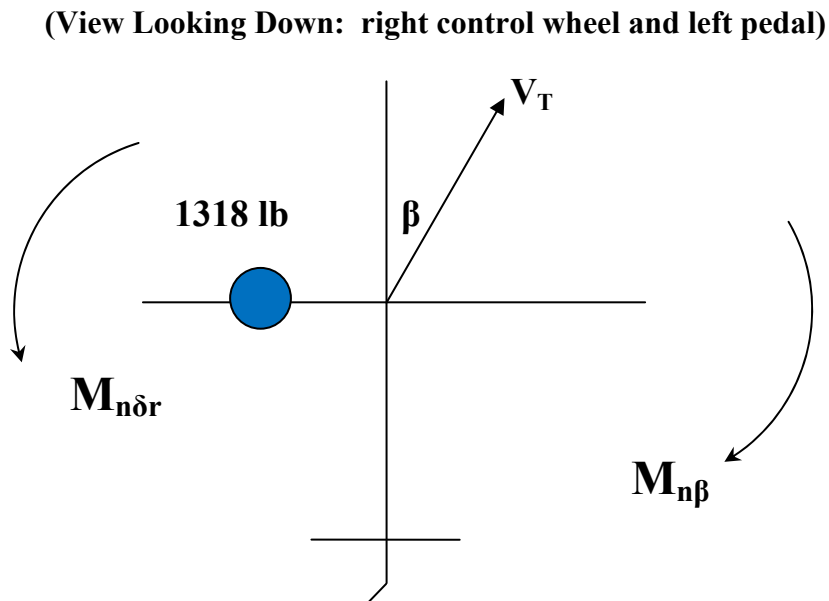
Note that the Pilatus calculations assume enough rudder exists to balance the yawing moment due to sideslip and that rudder has little effect on airplane rolling moment.

Figure 3: Yawing Moments with a Left-Wing Heavy Fuel Asymmetry

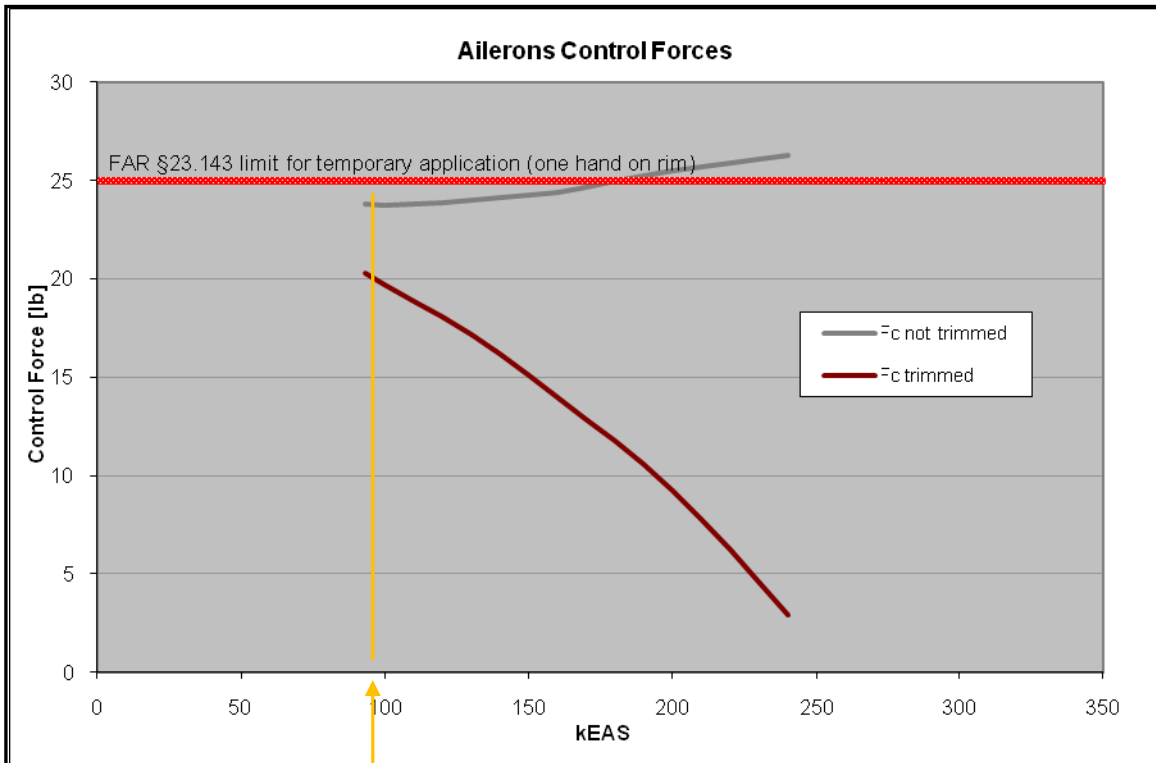
³ The calculated wheel force of 20 lb is less than both the 50 lb limit prescribed under CFR 23.143, controllability and maneuverability, with two hands and the 25 lb temporary wheel force limit with just one hand

Figure 4: Pilatus' Estimate of Wheel Force as a Function of Speed, 1318 lb Fuel Imbalance

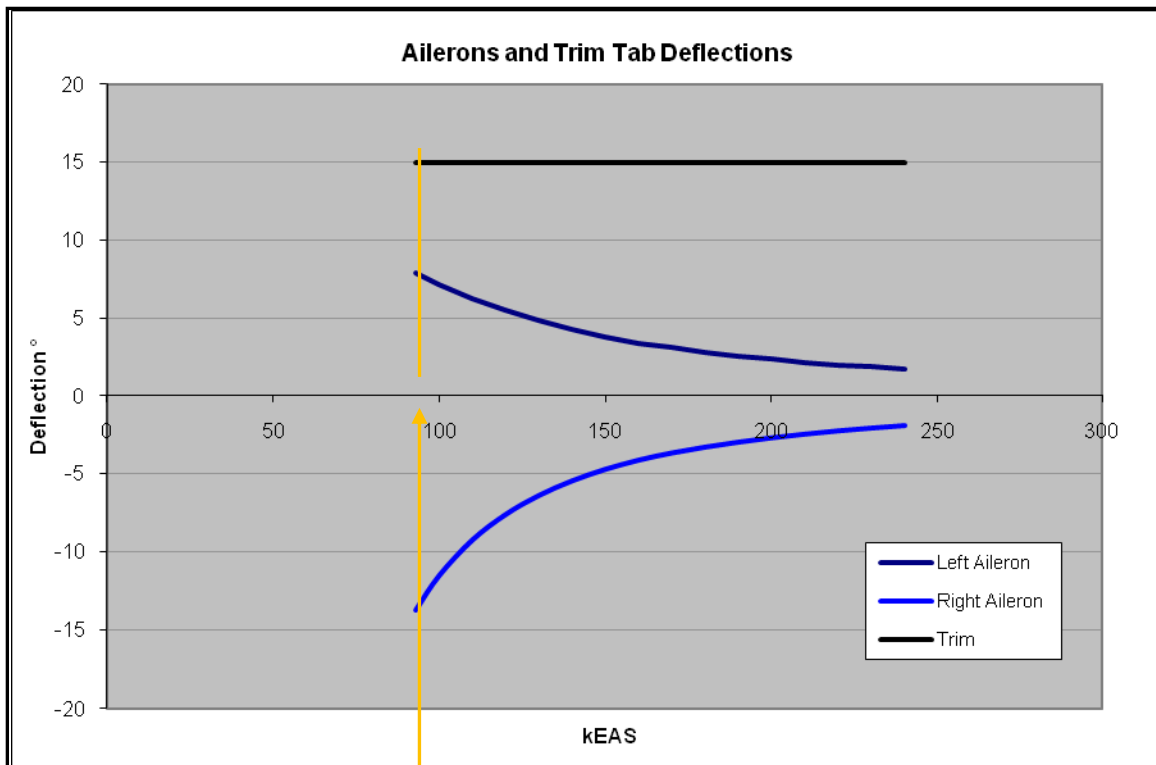
Figure 5: Pilatus' Estimate of Aileron Deflection as a Function of Speed, 1318 lb Fuel Imbalance

Pilatus' post-accident calculations indicate that the fuel asymmetry suspected in this accident was controllable. The calculations also describe how the required control forces and surface deflections increase at lower airspeeds. Pilatus flight tests were performed with a maximum fuel imbalance of 380 lb; however, this is significantly less than the 1318 lb fuel asymmetry calculated for the accident. In addition, the calculations performed by Pilatus assumed static conditions and did not account for airplane dynamics associated with the turning and torque effects typical of high-powered, propeller-driven airplanes. Several witnesses reported seeing the airplane several hundred feet high over the runway threshold and that it appeared the pilot was attempting to circle back around for landing. The larger turning and torque effects associated with low speeds/high angles-of-attack and go-around power, combined with the effects of the fuel imbalance, would make the accident airplane increasingly difficult to control as the pilot maneuvered for landing in Butte.
