NATIONAL TRANSPORTATION SAFETY BOARD

AIRFRAME AND ENGINE EXAMINATION

ERA19FA265

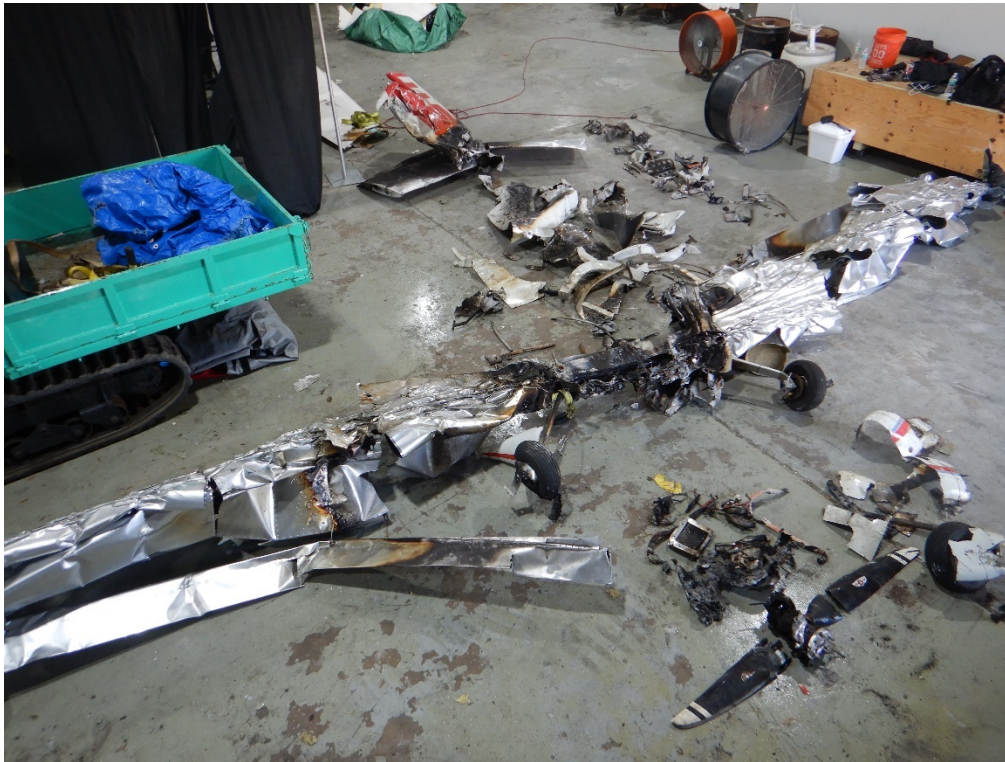
The airplane was significantly fragmented and partially consumed by a postcrash fire. The wreckage was laid out at the recovery facility. Both wings were crushed aft from the leading edge against the main spar, and from the trailing edge forward to the main spar. The right flaperon was impact and fire damaged, and the inboard half was separated from the wing. The left flaperon was impact and fire damaged and completely separated from the wing. The fuselage forward of the stabilator was severely fragmented and partially fire damaged. The stabilator, vertical stabilizer, and rudder were separated from the aft fuselage. The stabilator was largely intact, with most of the fire and damage near its center. The stabilator spar was fractured at midspan. The pitch trim tab remained attached to the stabilator; however, the input control rod and attachment bracket were fractured and separated from the trim tab. The rudder remained attached to the vertical stabilizer; it was damaged and the lower 4 inches of the trailing edge was bent toward the right.

Photo 1: Wreckage Layout

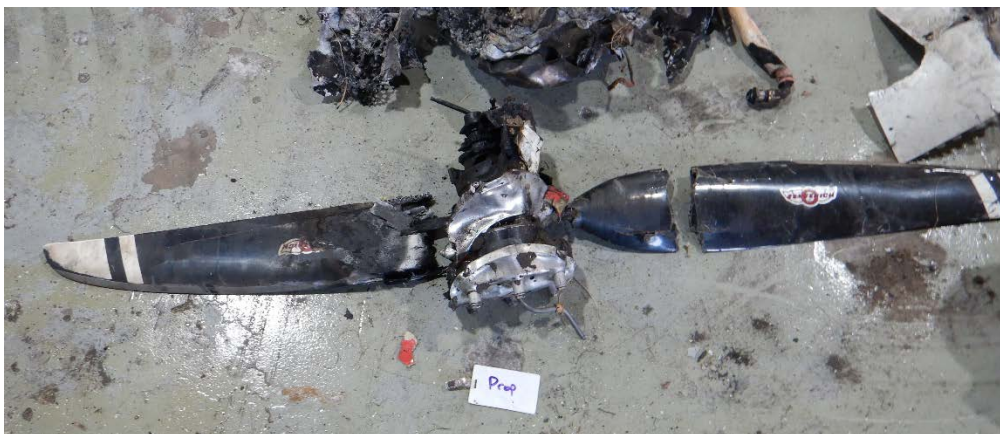
Photo 2: Propeller

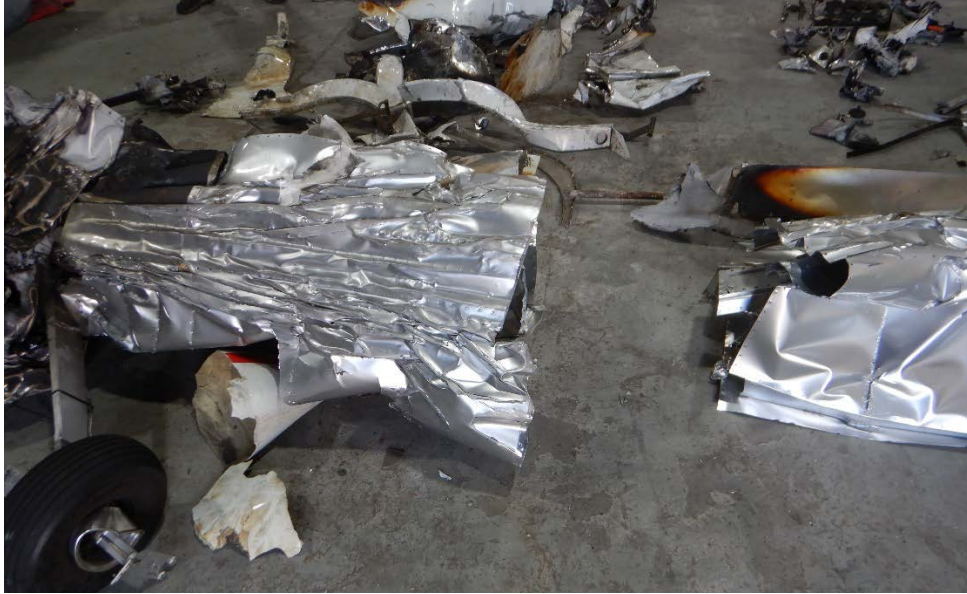
Photo 3: Left Wing Leading Edge

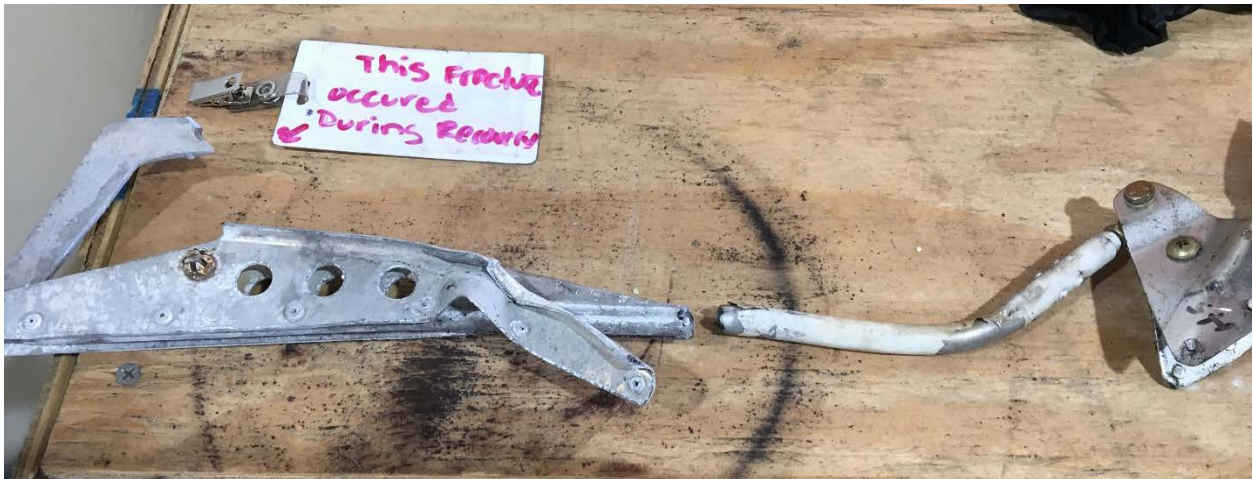
The examination of N767FS was conducted on September 8-9, 2019 at Florida Air Recovery, Jacksonville, FL. Initial examination of the airframe revealed no preimpact anomalies. Examination of the engine revealed no preimpact anomalies that would have precluded normal flight. The elevator trim actuator control assembly and a Dynon Primary Flight Display were retained for further examination.

Photo 4: Elevator Trim Actuator Control Assembly

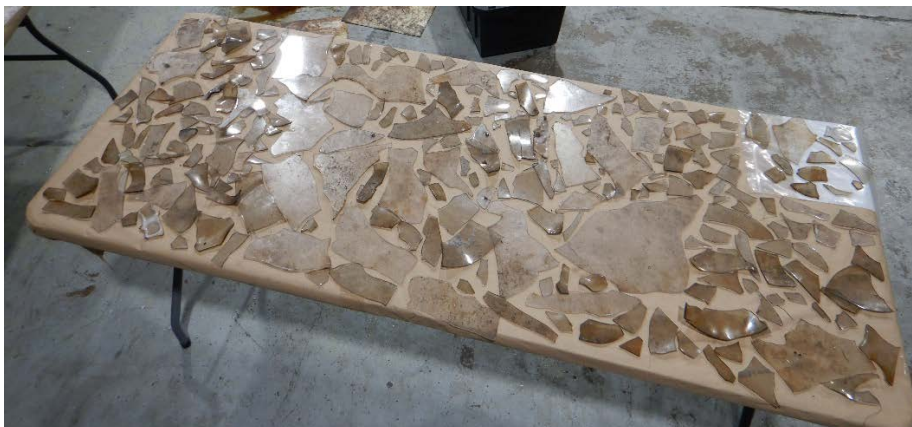
Layout of canopy fragments revealed no evidence of bird impact/snarge.

Photo 5: Canopy Fragment Layout

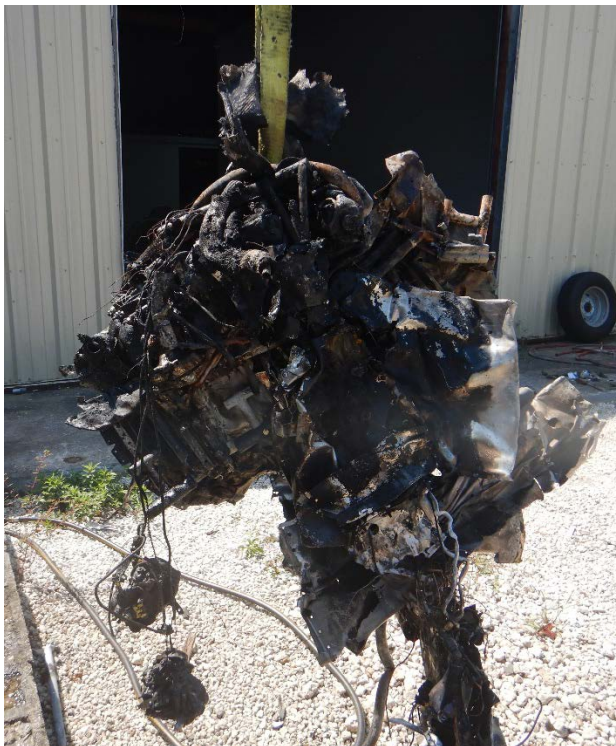
One partial circumferential scrape mark was present on the front of the engine case near the main drive gear. The engine would not rotate by hand. A borescope inspection of all four cylinders revealed normal coloration and condition of the piston tops, cylinder walls, and valves. All rocker arms and valve spring assemblies remained intact and were undamaged. Cylinder head No. 3 was coated in soot. The gascolator was breached by a puncture, empty of fuel, and contained a small amount of debris in the filter screen. The inside of the gascolator bowl was sooted. Both carburetors were thermally damaged and separated from the engine and found hanging by their control cables. Each throttle control cable remained attached to its respective control arm on the carburetor. Both carburetor bowls were melted away and the floats were not present. Both slides remained in place but were unable to move. The sparkplug electrodes and insulators appeared normal and were clean, except for the No. 2 top spark plug which had white deposits on the bottom of the electrode. The Nos. 1 and 3 bottom sparkplugs were slightly wet with oil. None of the intake or exhaust manifold tubing remained attached to the intake and exhaust ports of the engine. The muffler remained partially attached and the springs were in place, with the case, inlet and exit tubes partially damaged. The engine driven fuel pump remained attached to the engine case; however, the fittings were separated, and the ports were partially fractured. The pump was removed and could be rotated by hand with some binding. A small amount of debris was found inside the pump, primarily on the side exposed by the fractured fitting port.

Photo 6: Engine Before Exam

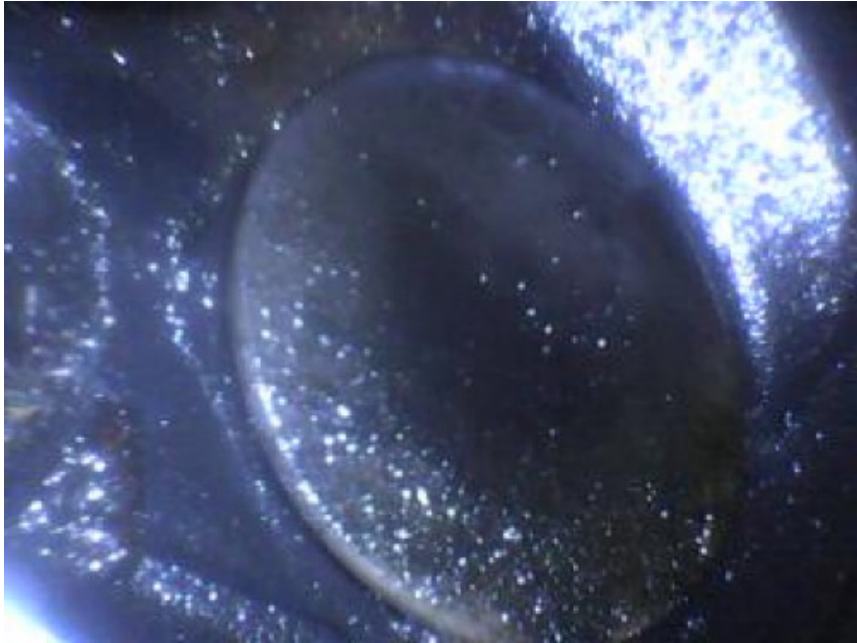
Photo 7: Borescope Cylinder 2

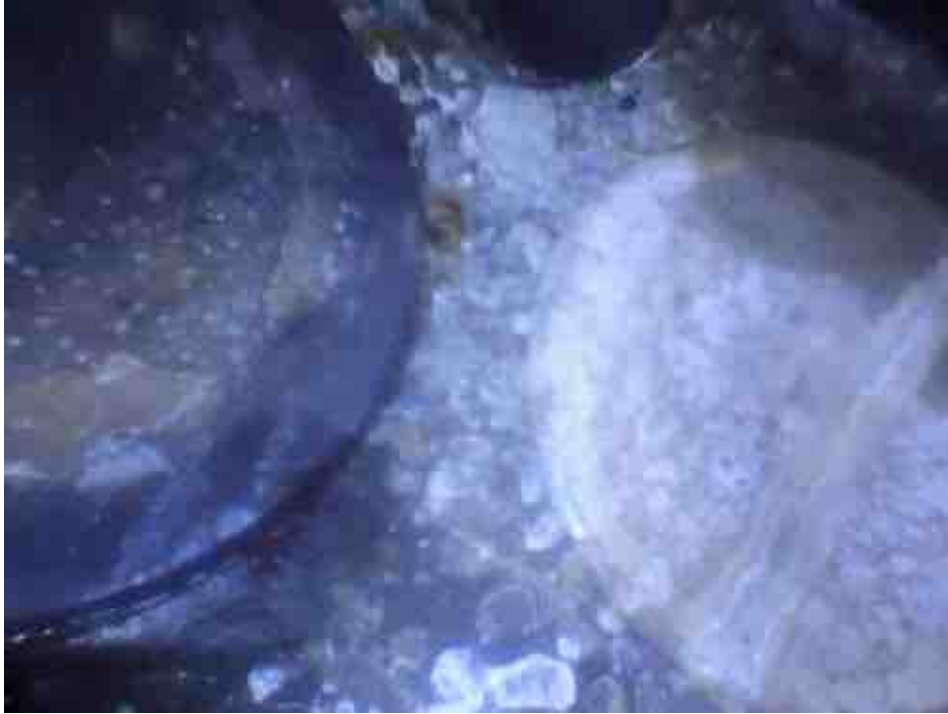
Photo 9: Borescope Cylinder 4

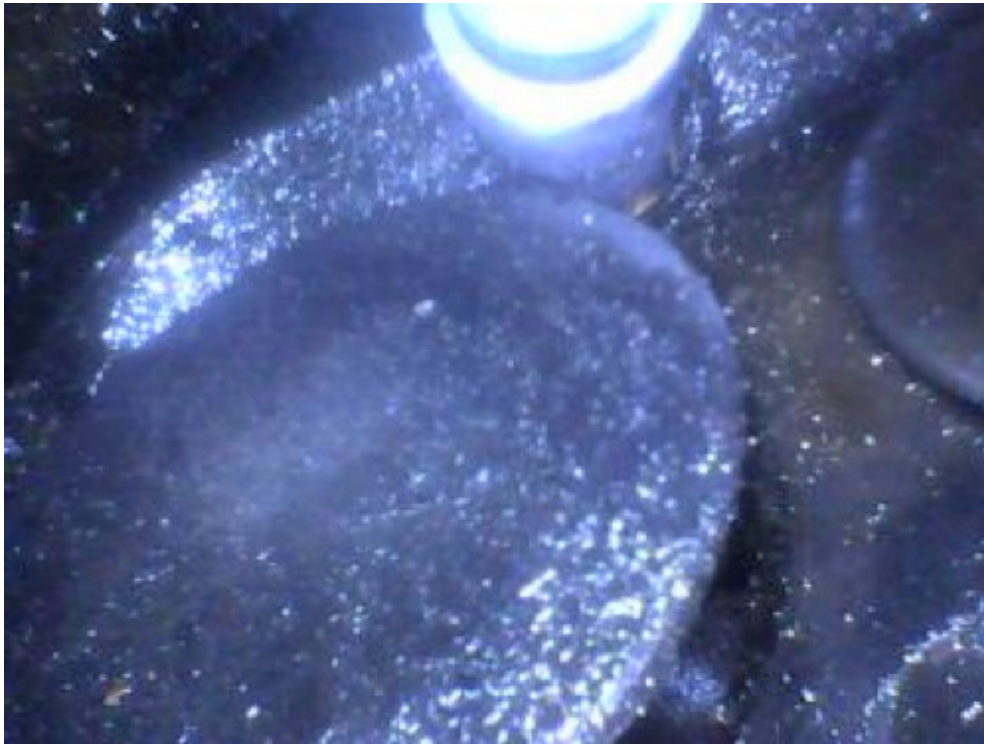
Photo 10: Borescope Cylinder 1

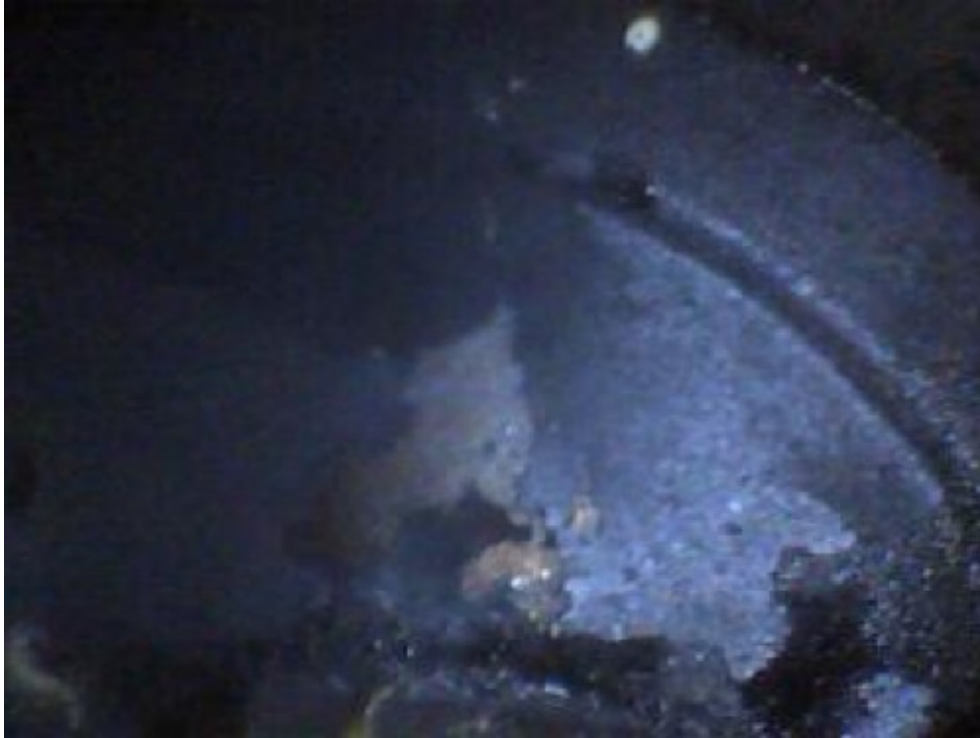
Photo 11: Borescope Cylinder 3

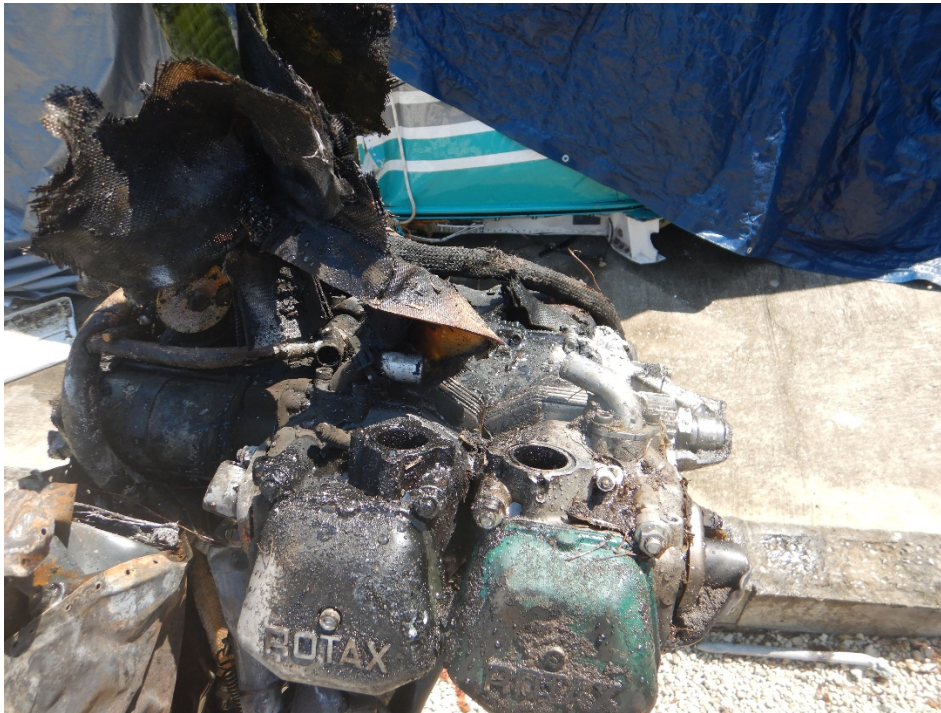
Photo 12: Close-up of Engine
