NATIONAL TRANSPORTATION SAFETY BOARD

AIRFRAME AND ENGINE EXAMINATION

WPR19FA154

Location: Grover, UT
Date: May 24, 2019
Aircraft: Cirrus SR22, Registration N809SR, Serial #2129
NTSB IIC: Samantha Link

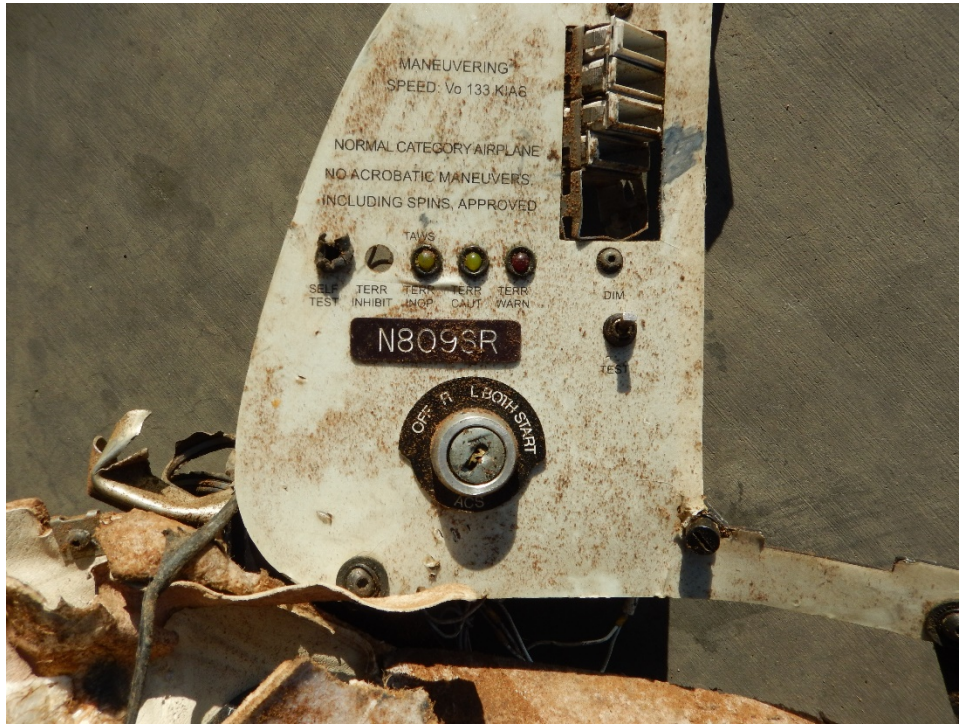
Figure 1: Ignition Switch

- The fuel strainer was not attached at the firewall and was unable to be located; however, the fuel line leading to it was present.
 - The fuel system was heavily fragmented throughout.
 - The fuel selector valve was fracture separated and unable to be located.
- The airframe was laid out for further examination and additional photographs were taken of the flight control components.
- A portion of the airplane's key was found in the ignition switch.
 - The switch was found in the "both" position.

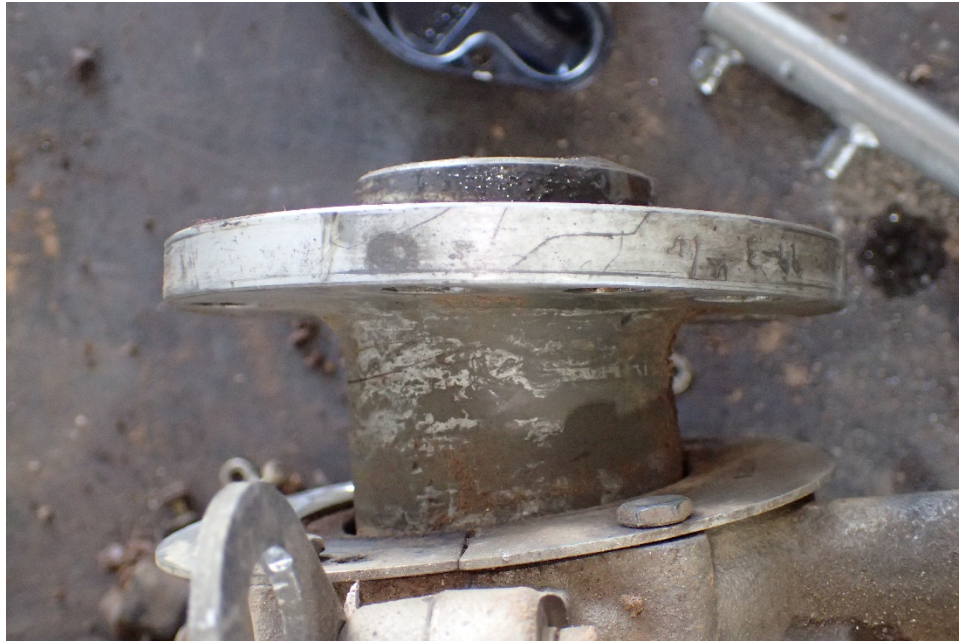
Figure 7: The Propeller Flange

- The propeller hub was removed from the engine
- The propeller flange was bent at about a 10-degree angle and several cracks were noted on the outside of the crankshaft.

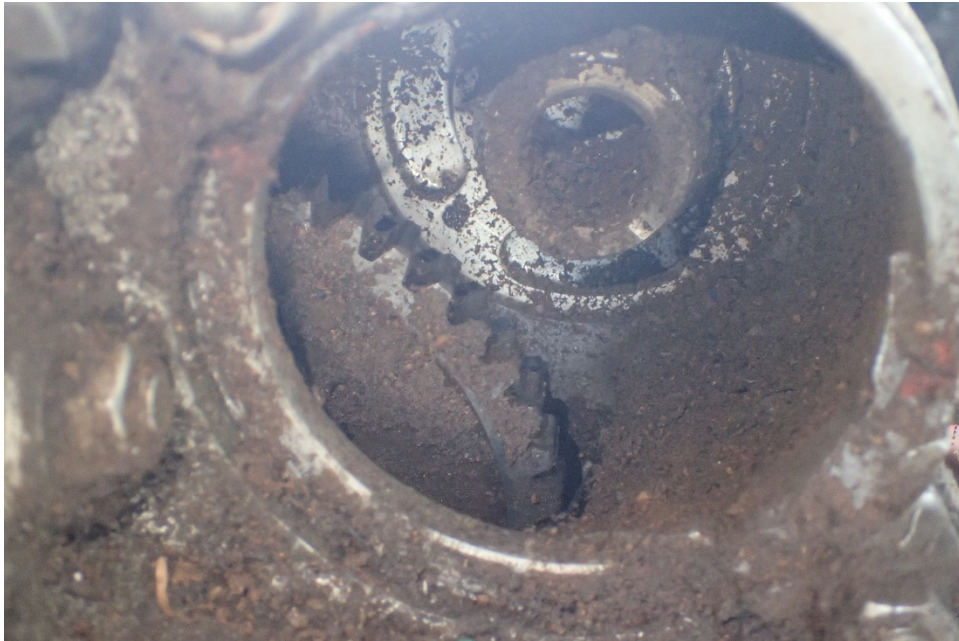
Figure 9: Crankshaft Gear

- The starter adapter was removed from the engine
- The upper spark plugs were removed
- The engine rotated when manipulated by hand. Grinding was noted at the aft crankshaft gear.

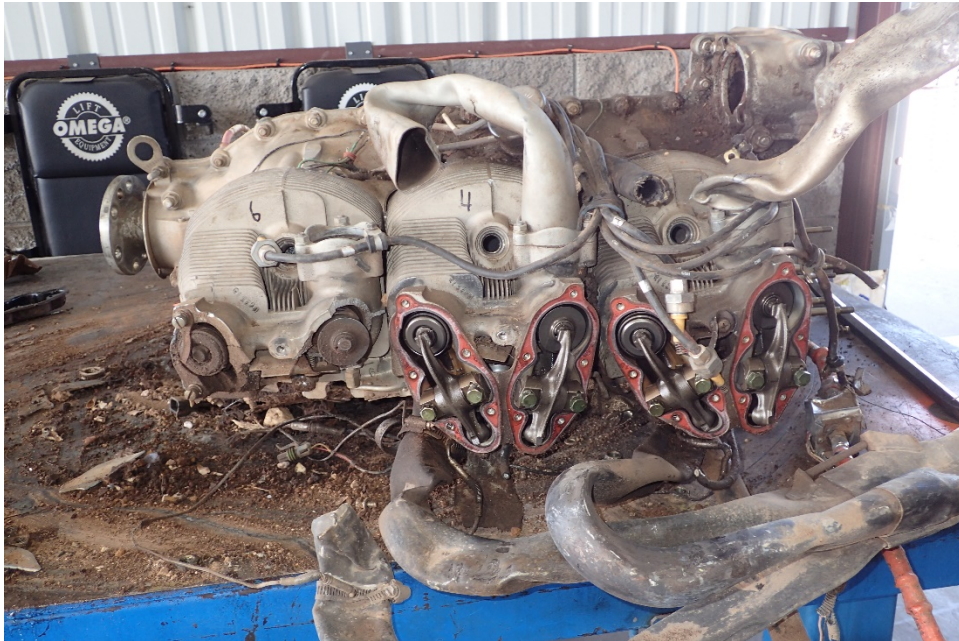
Figure 10: Left Side Cylinders

- The rocker arms were fracture separated from the number 1, 3, 5, and 6 cylinder heads.
- The rocker covers were removed from the number 2 and 4 cylinders

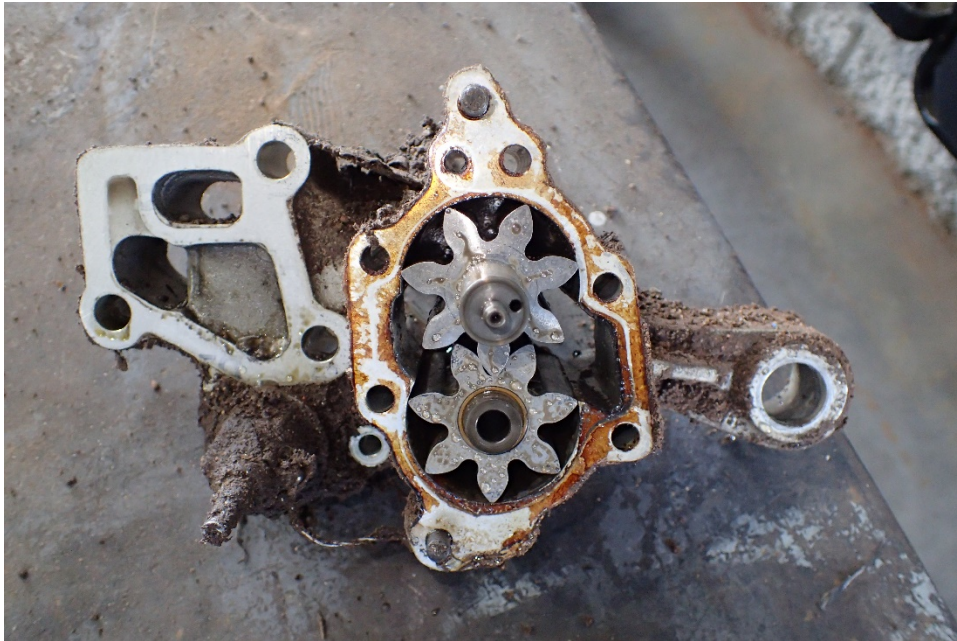
Figure 11: The Oil Pump

- The internal engine core was overall lubricated and consisted with normal operations
- The oil pump was removed and disassembled
 - All components were intact and consistent with normal operations

- Some organic debris was noted within the pump
 - One score mark was noted on the housing, but there was no damage elsewhere.
