National Transportation Safety Board

WPR22LA268

AIRFRAME AND ENGINE EXAMINATION REPORT

Location: Huntington Beach, California
Date: July 22, 2022
Time: 1342
2142
Airplane: N3666K

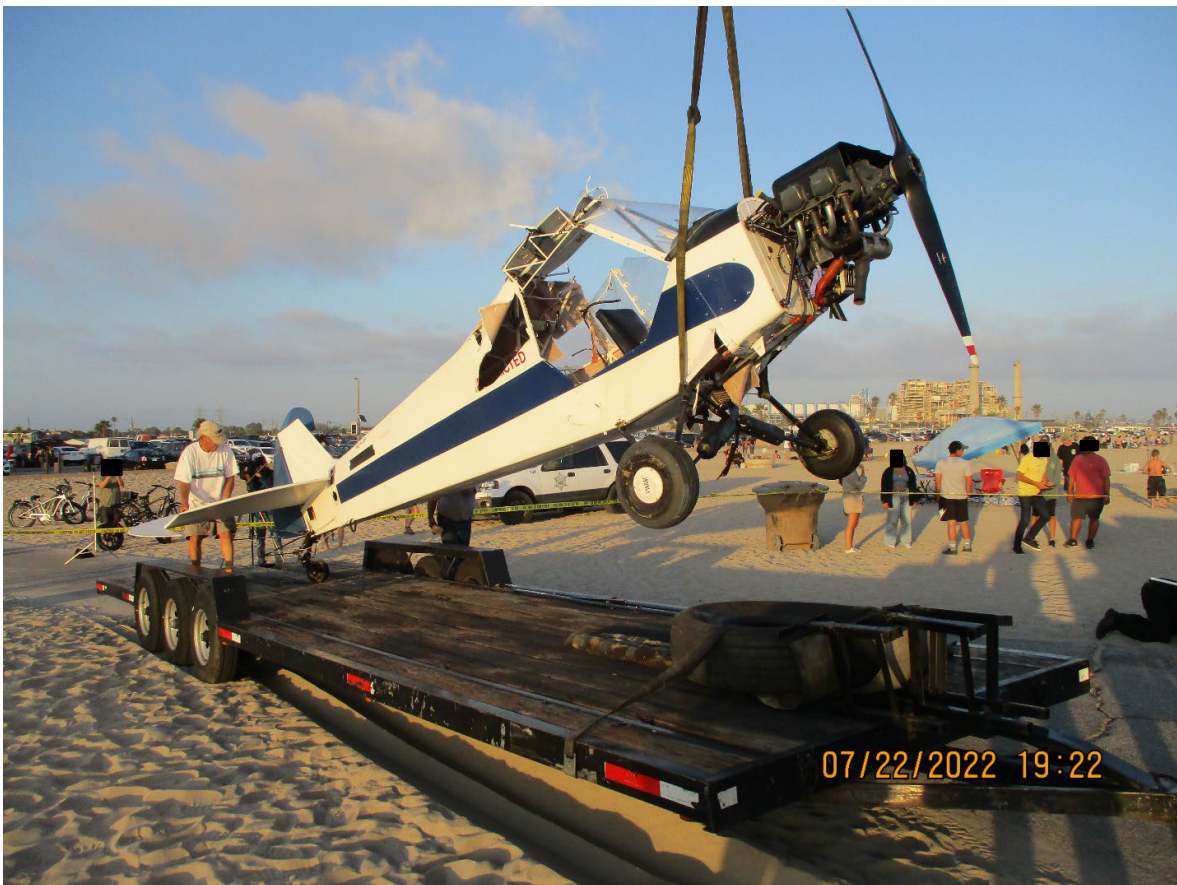
The airplane impacted the ocean and was recovered to an adjacent beach. The fuselage sustained substantial damage.

Figure 1. N3666K during the recovery process. Photo FAA.

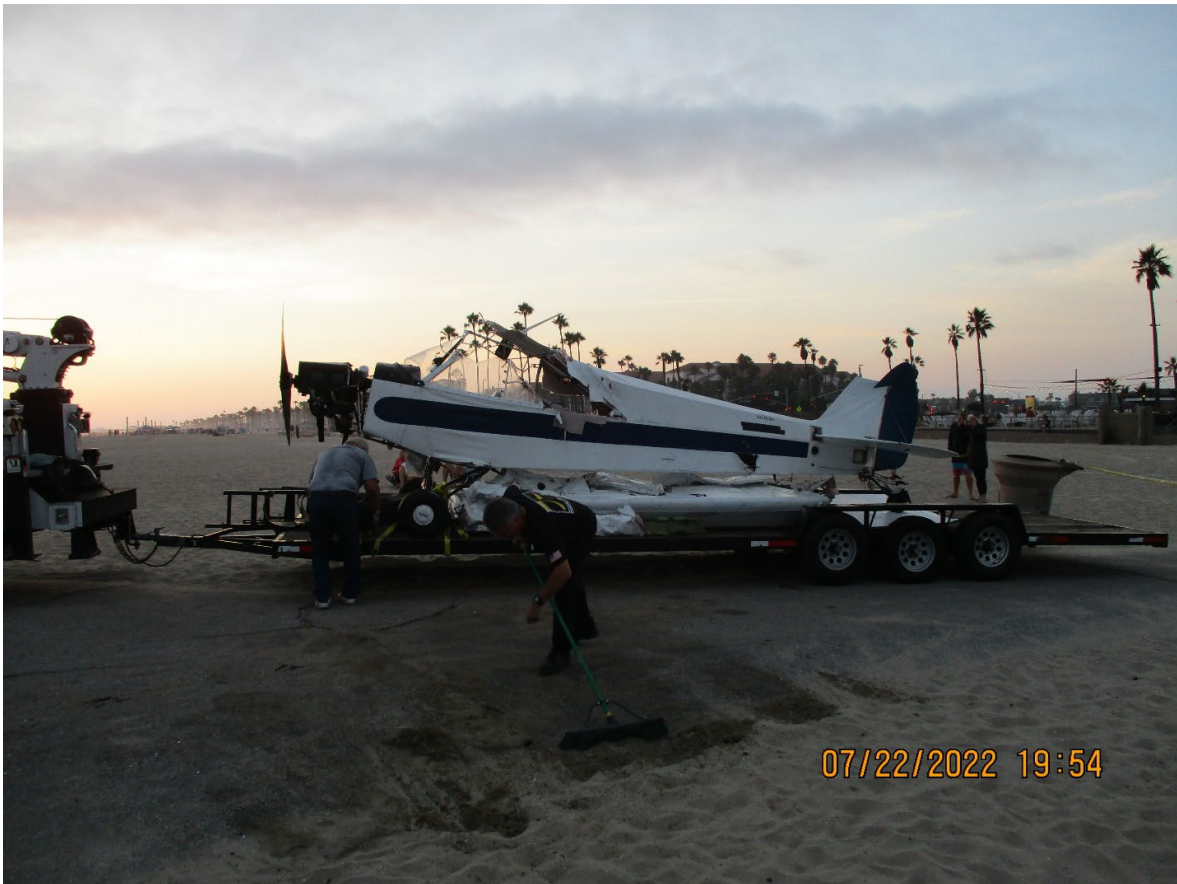
The fuselage sustained substantial damage to the area between the wings and aft of the cabin area. According to the FAA, the airplane had 18-gallon fuel tanks installed.

Figure 2. Left-side view of the fuselage. Photo FAA.

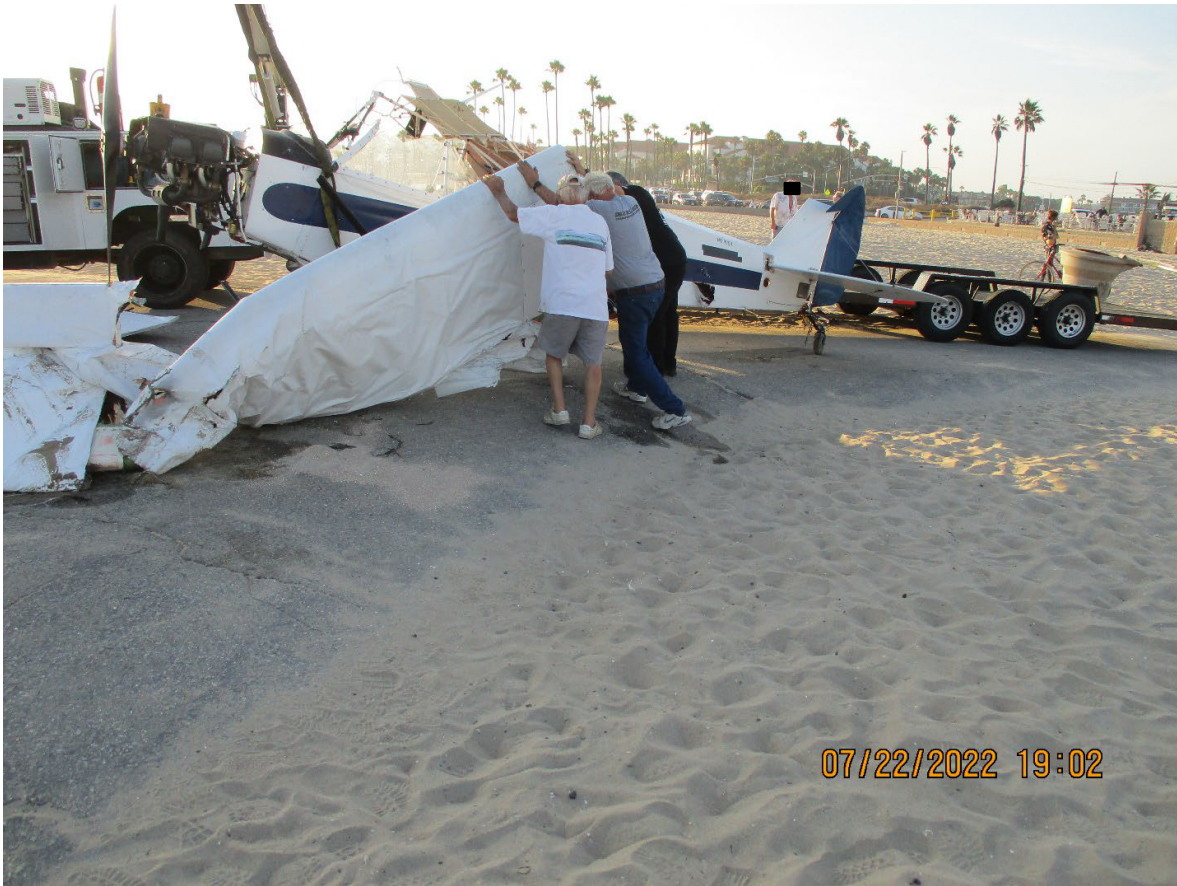
The left and right wings partially separated from the upper fuselage. Both wings exhibited substantial damage to the wing structure.

Figure 3. Left wing damage. Photo FAA.

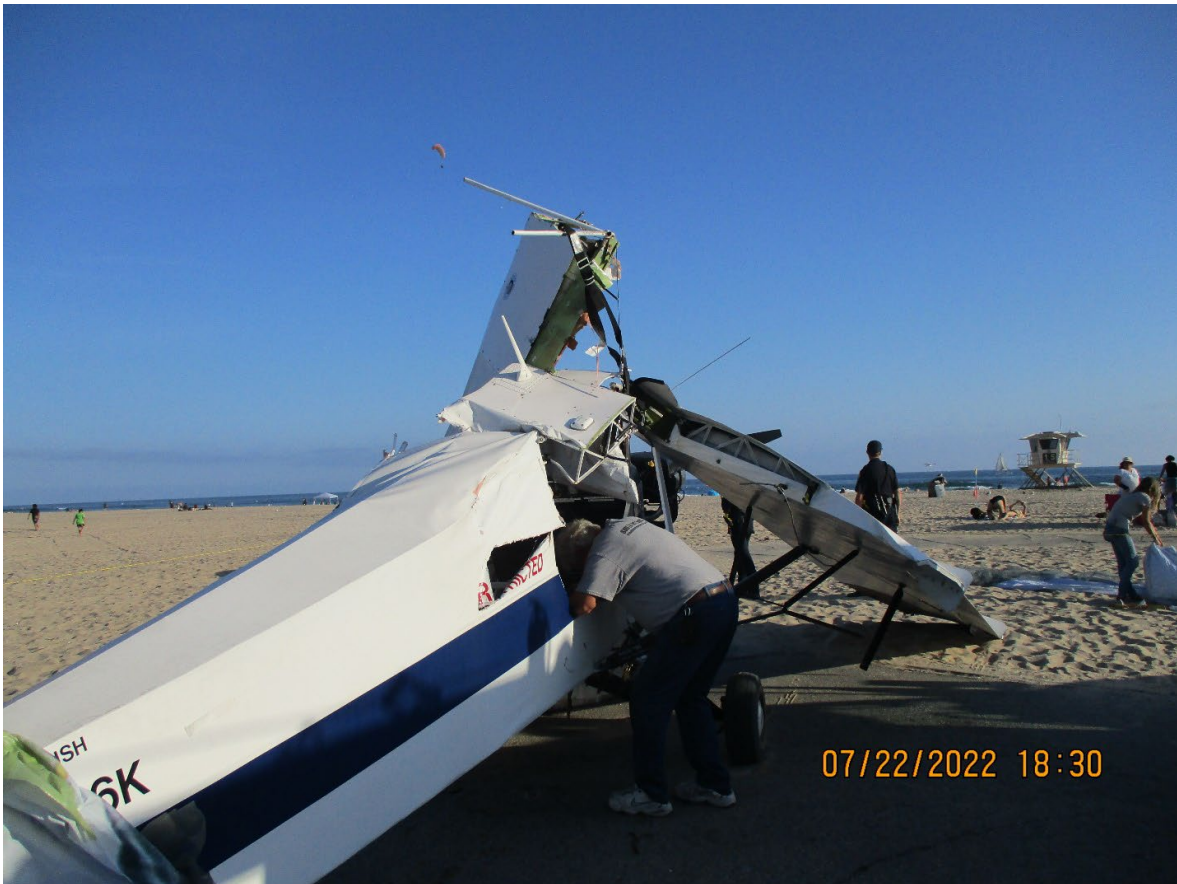
Figure 4. Right side. Photo FAA.

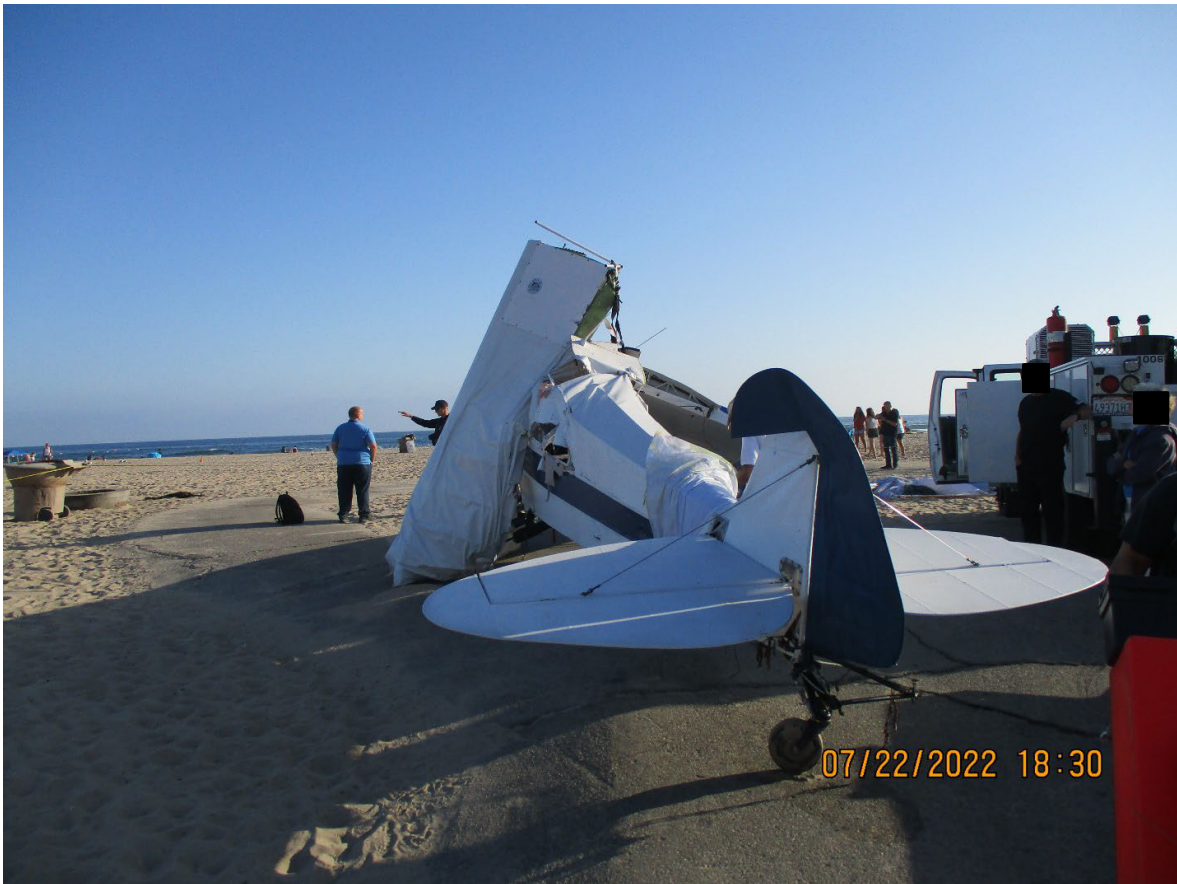
The empennage exhibited substantial damage at the vertical stabilizer and the rudder. The left and right horizontal stabilizers and elevators remained attached to the empennage and exhibited minor damage.

Figure 5. Aft view. Photo FAA.

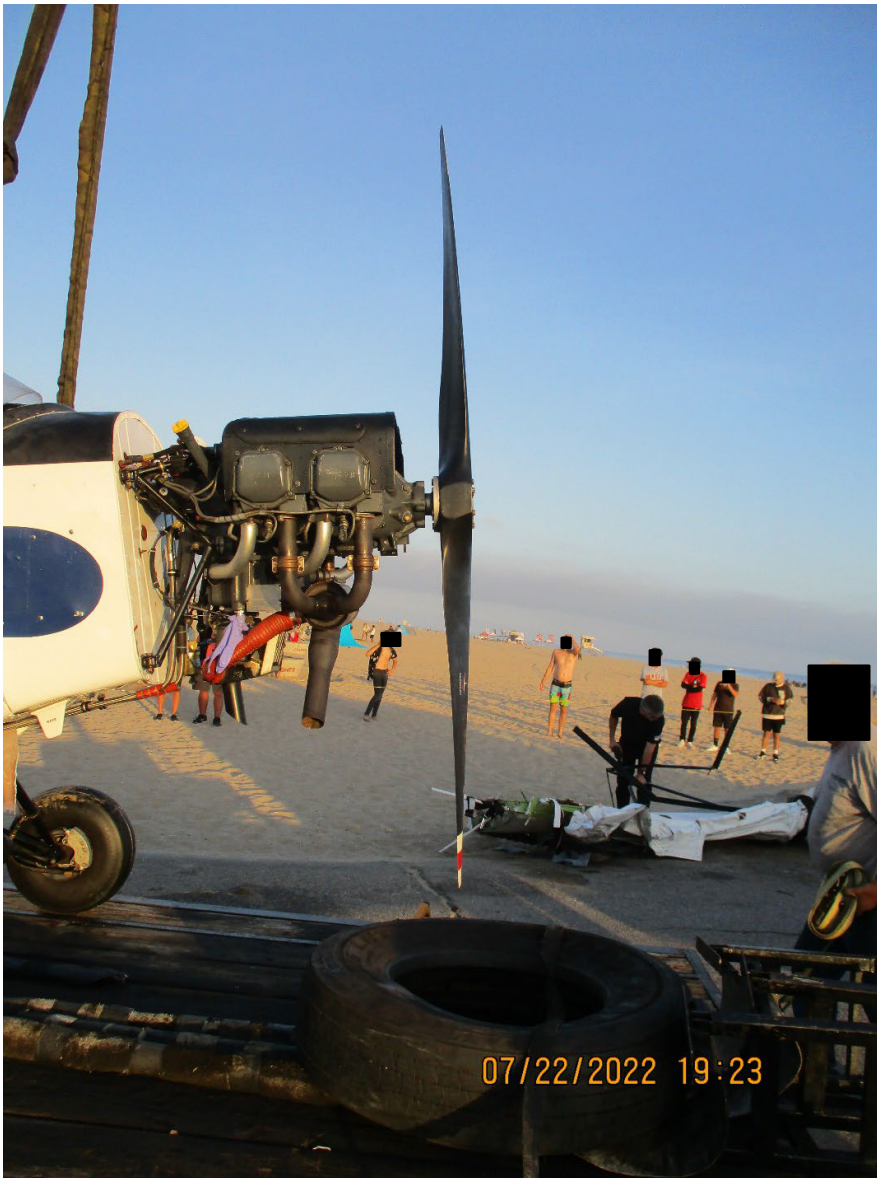
Figure 6. Right-side view of engine. Photo FAA.

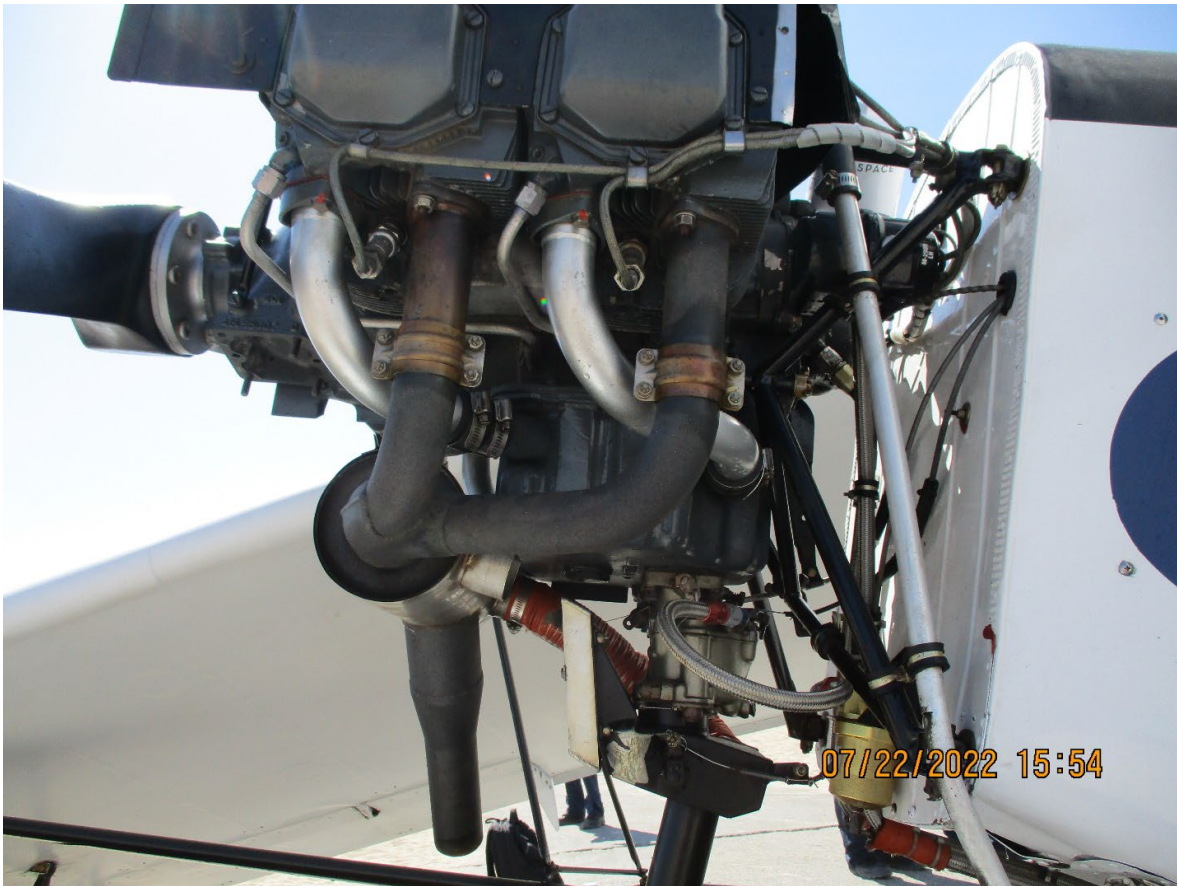
Figure 7. Left-side view of engine. Photo FAA.

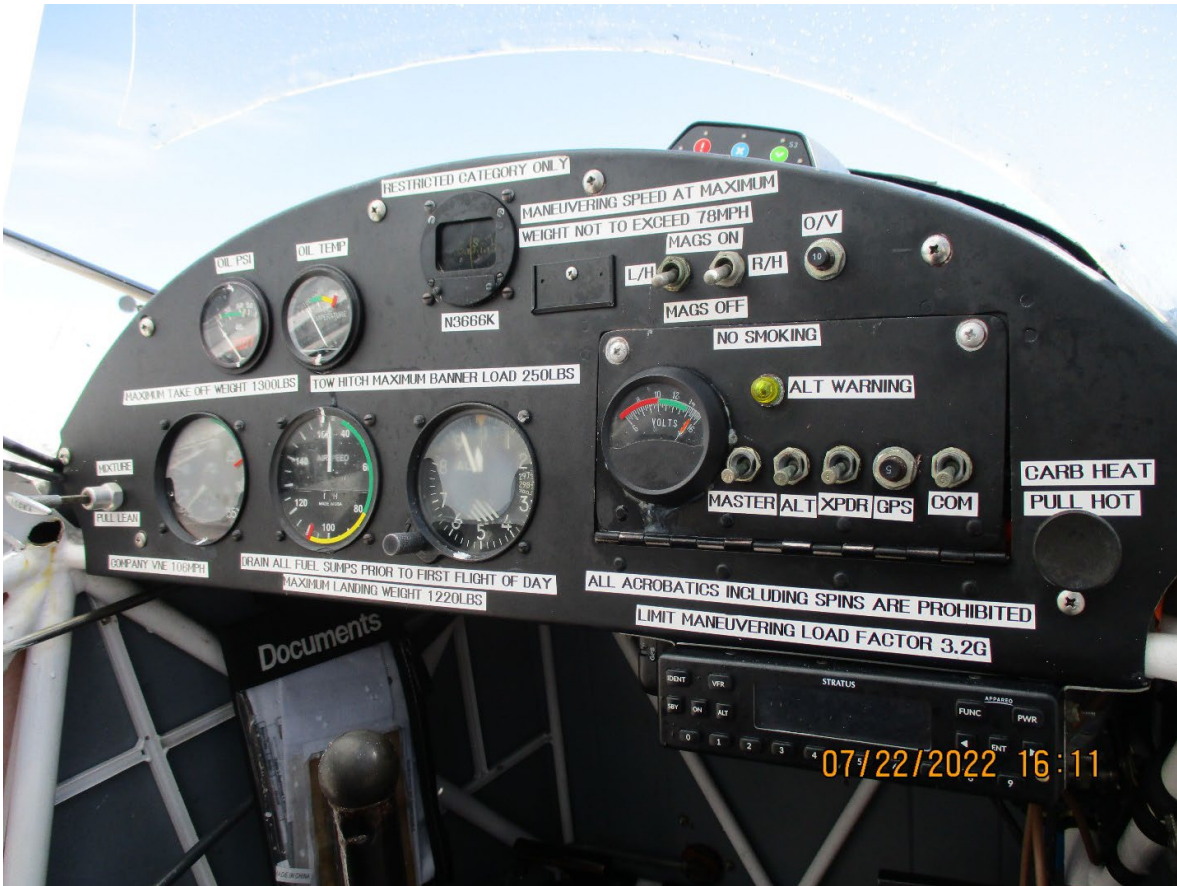
The cockpit remained intact with minor damage throughout.

Figure 8. Instrument Panel. Photo FAA.

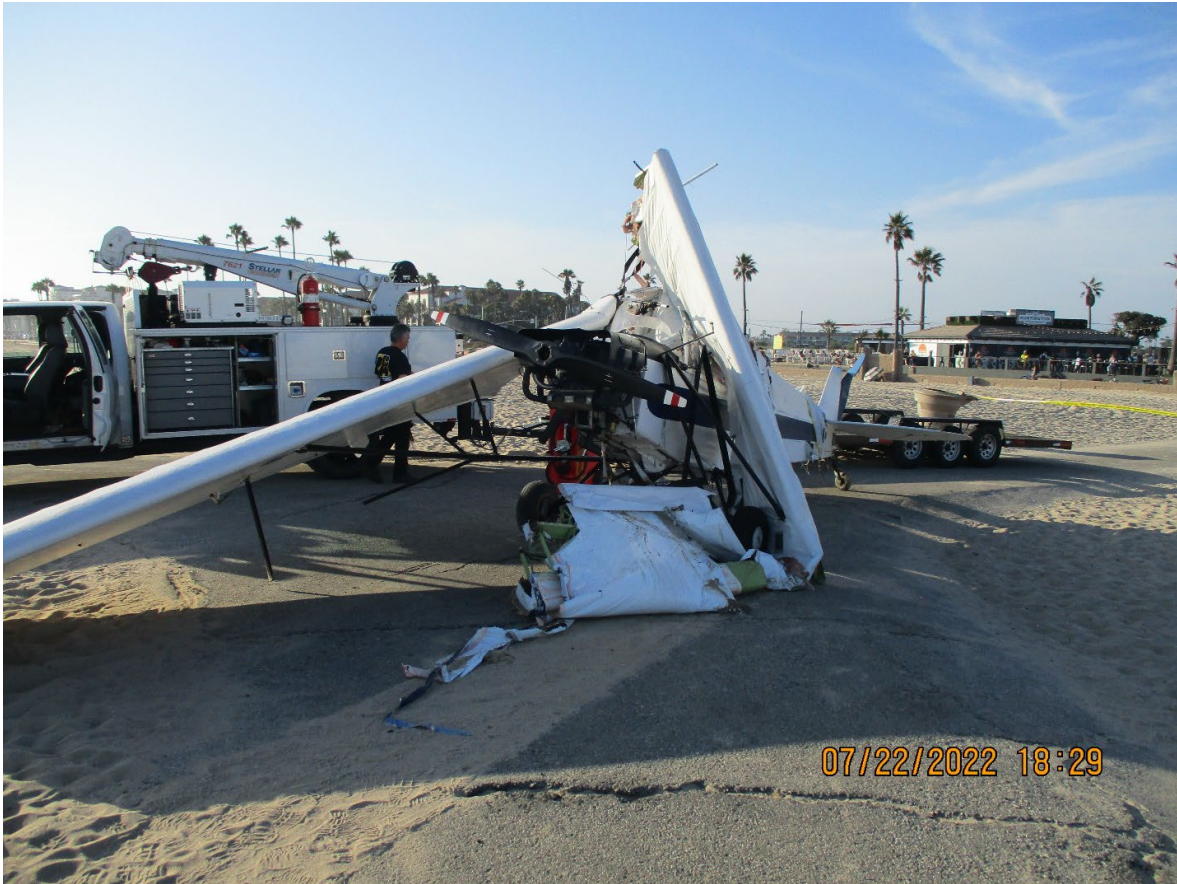
Figure 9. Front view. Photo FAA.
