NATIONAL TRANSPORTATION SAFETY BOARD

Airframe and Engine Exam

WPR19FA148

Aircraft: Robinson R44 II, Registration Number: N744TW

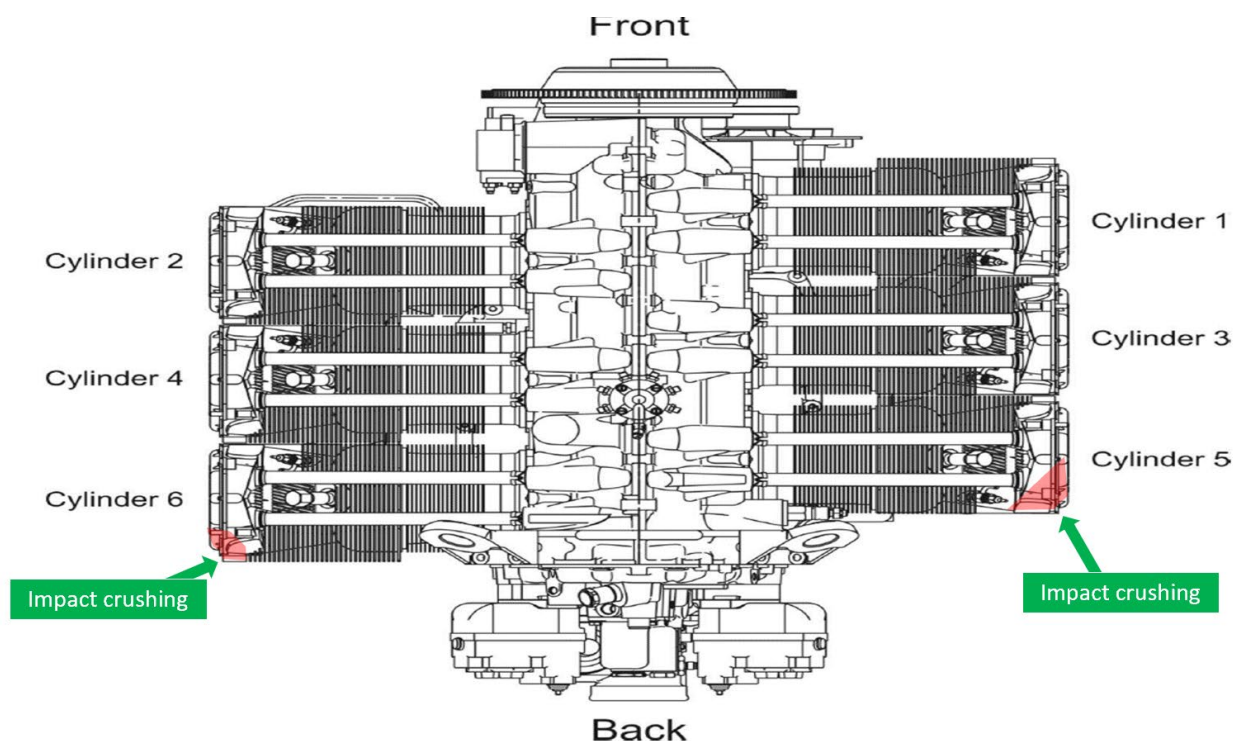
The Lycoming IO-540-AE1A5, SN: L-30076-48A was removed from the airframe for examination. The engine meter was recorded at 2,137.2 hours. Impact crushing was noted to the rocker box covers and rocker arms on cylinder Nos. 5 and 6. Both magnetos, oil filter, and engine driven fuel pump remained attached to the accessories case and no impact damage was noted. The alternator was partially separated from the engine but remained attached to the electrical line and part of the bracket. Figure 1. Showing where impact damage was found.

Figure 1. Drawing of engine showing location of damage.

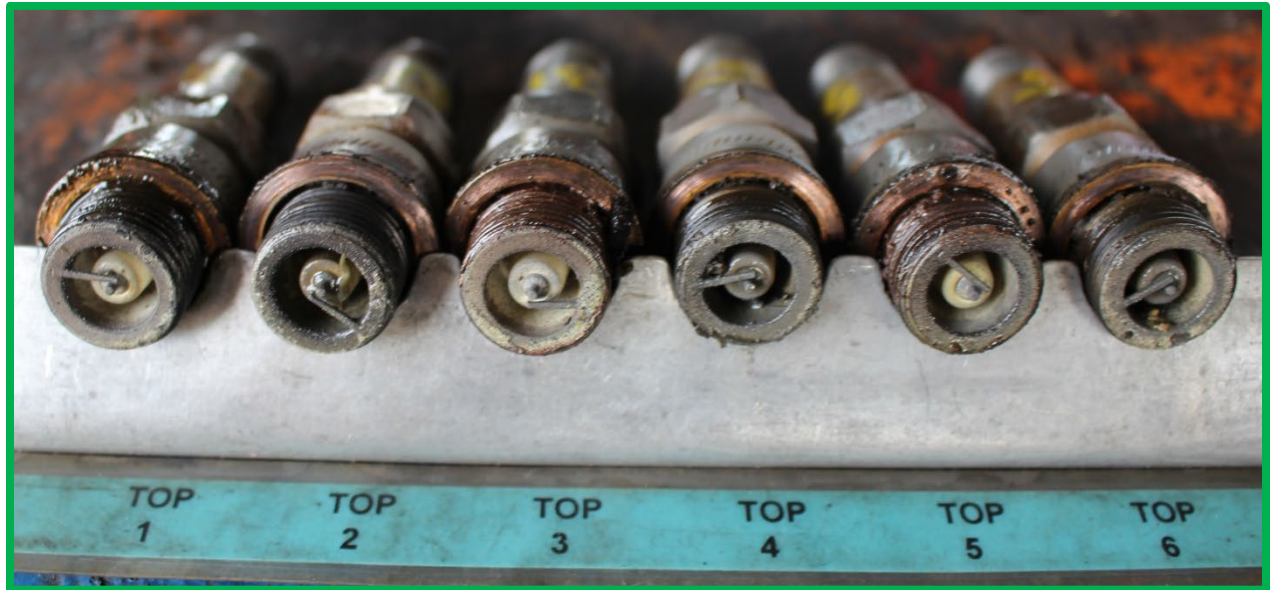
The top spark plugs (Campion REM38S) were removed and exhibited normal wear (Figure 2.)

Figure 2. Showing top spark plugs and normal wear indications.

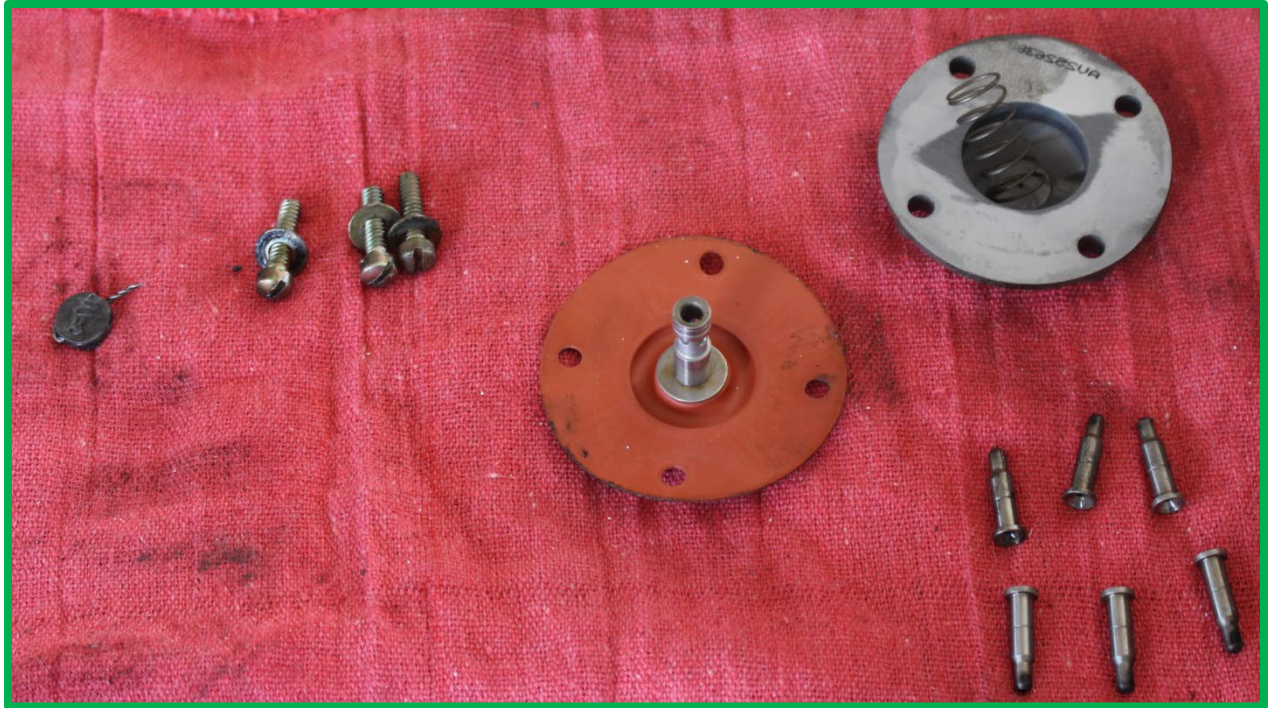
The fuel lines were removed from the injectors and the injectors were removed from the cylinders and examined with no anomalies noted. The flow divider disassembled and examined and no anomalies were noted. Figure 3 shows the flow divider disassembled.

Figure 3. Showing flow divider disassembled.

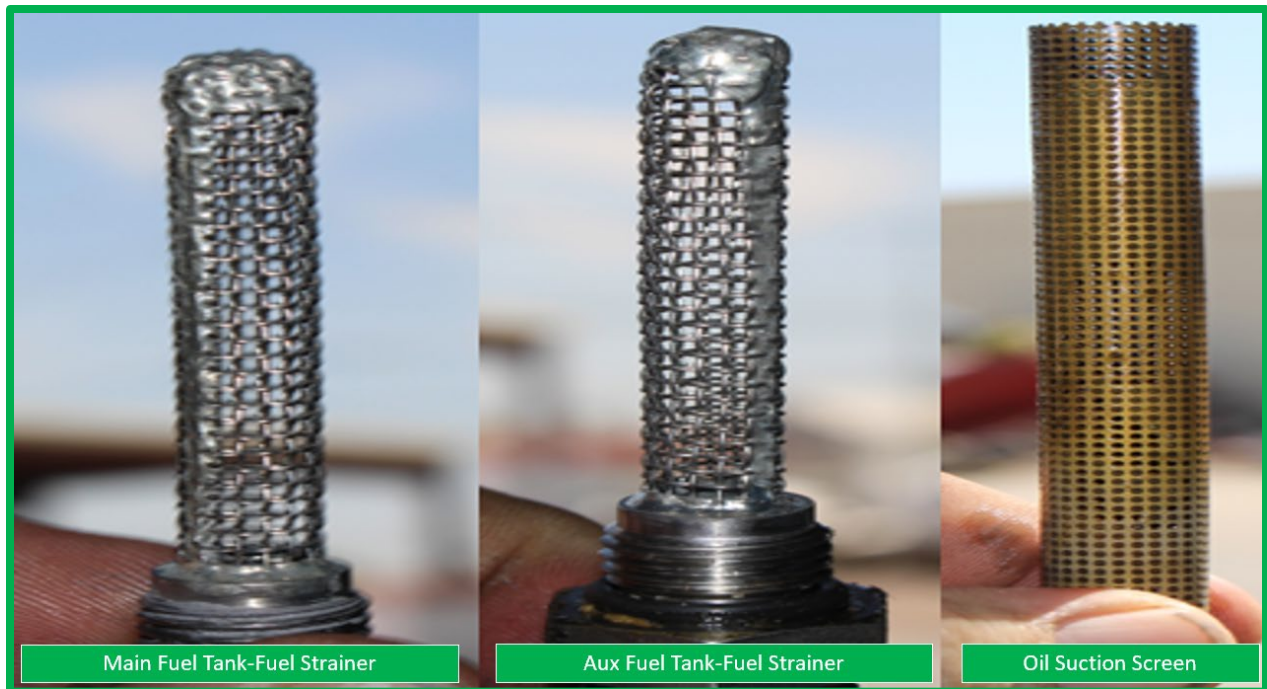
The oil suction screen was removed and no anomalies were noted.

Figure 4. Showing the fuel and oil strainer screens.

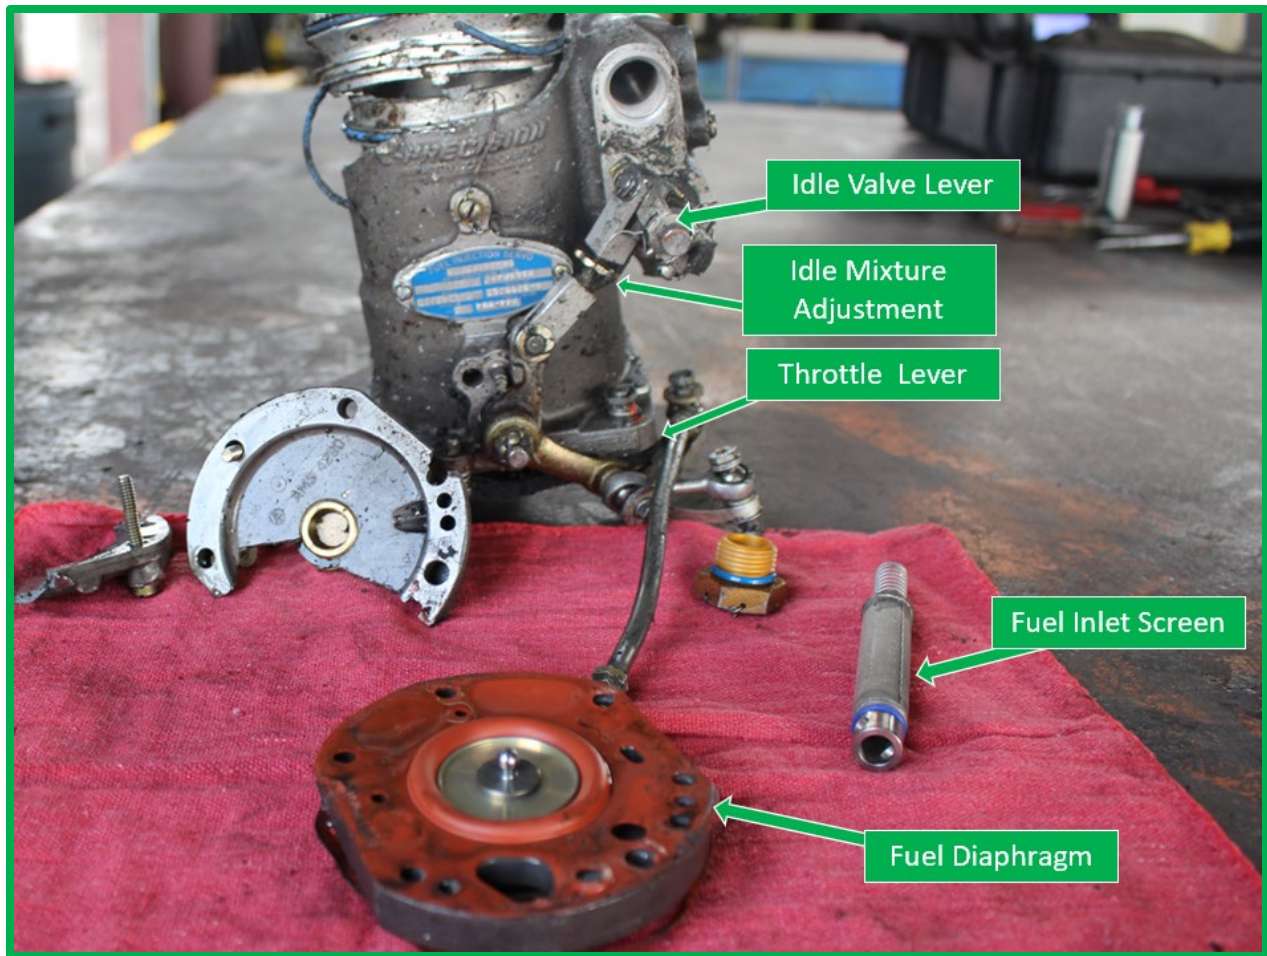
The Precision fuel servo was found separated from the engine. Model RSA10AD1 (Serial No. 2576630-4) was examined and no anomalies were noted. Damage to the top and bottom of the throttle body was noted. The throttle linkage was bent and bound. The throttle control arm was fracture separated. The fuel inlet screen was removed, and no debris were noted. The fuel diaphragm was removed, and impact damage was noted to both the fuel and air side.

Figure 5. Showing the fuel servo, fuel inlet screen and fuel diaphragm.

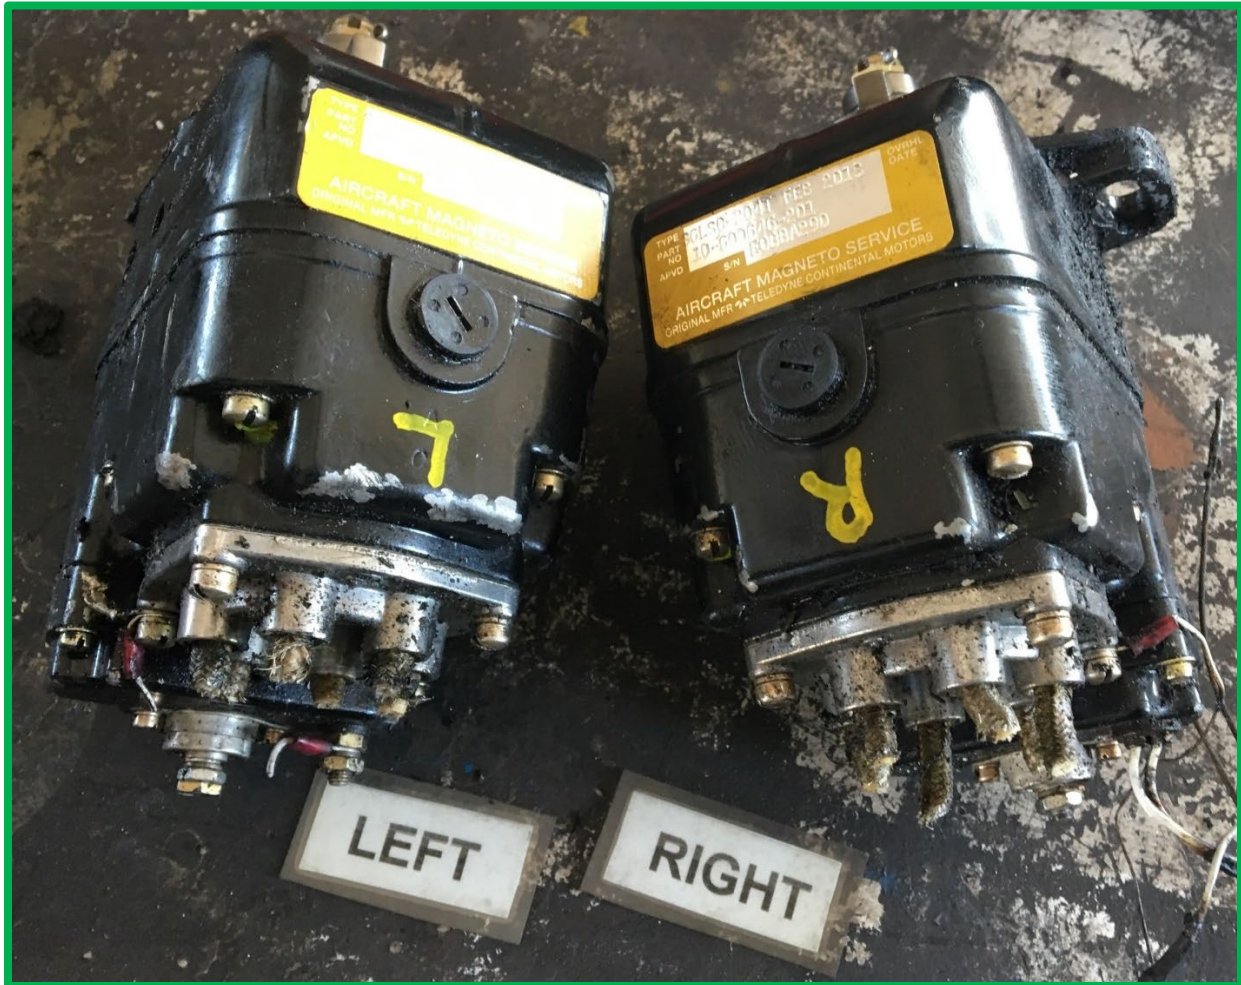
Both magnetos were removed and examined. The drive couplers were manually rotated, and spark was observed on all six ignition leads on both magnetos. The left magneto was timed at 23° and the right was timed at 20°.

Figure 6. Left and right magnetos.
