NATIONAL TRANSPORTATION SAFETY BOARD

AIRFRAME AND ENGINE EXAMINATION

WPR18FA013

Location: Four Corners, CA
Date: October 21, 2017.
Aircraft: Extra 330/LC, Registration N414MT, Serial: 1300
NTSB IIC: Elliott Simpson

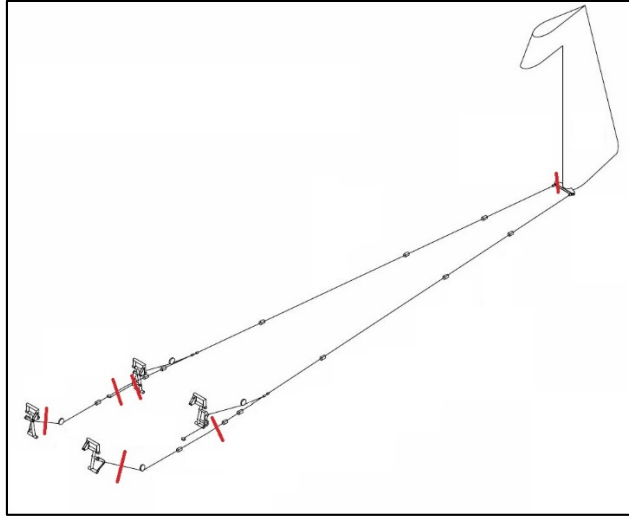
Image 1 – Rudder Control System Separation Points

The rudder spar had fragmented into two sections, and the rudder weight had detached (Photo 6). Both spar hinges were bent downwards, and their bolts had pulled through the hinge webbing. The lower hinge bellcrank remained attached to the spar, and the corresponding airframe-side of the hinge remained attached to the tail, with remnants of the hinge bolt still inside the hinge bearing. The left rudder and tailwheel cables remained attached to the bellcrank (Photo 7). The right rudder and tailwheel cable had detached from the bellcrank, which exhibited melting damage at the point of attachment (Photo 7, 8).

The right rudder cable was continuous through the three aft fairleads and aft pulley fixture to the “S” tube of the rear pedal, where it had separated at the cable exit point. The separation appeared to have been pinched off at the exit. Forward of the separation (Photo 9), the cable end remained attached by its fastening to the airframe. The forward portion of the cable had separated into multiple fragments, and the cable end remained attached to the forward pedal.

The left rudder cable was continuous through the three aft fairleads and aft pulley fixture, through the “S” tube of the rear pedal and continuous to its fastening at the airframe (Photo 10). The forward portion of the cable had separated into multiple fragments; the cable end remained attached to the forward pedal.

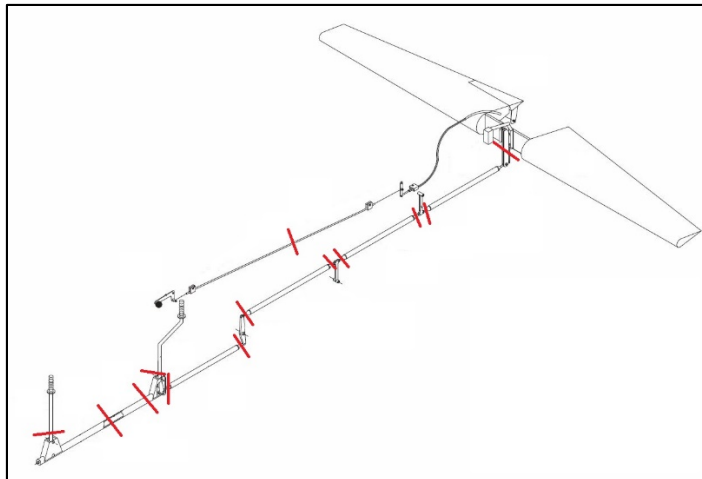
Image 2 – Elevator Control System Separation Points

The elevator center hinge assembly remnants were composed of center fragments of the elevator spar, mass balance, base of the actuator arm, and hinge tab (Photo 11). The hinge tab had detached from the airframe, leaving the rivet shafts in place. A 24-inch-long section right elevator spar remained connected to the outboard rib via its hinge. Similarly, a 6-inch-long section left elevator spar remained connected to the outboard rib via its hinge. Both inboard hinge arms were located; the right arm remained attached to burnt rib fragments, no rib remnants remained on the left arm (Photo 12).

All three bellcranks were deformed and had torn away from the airframe, and all push-pull tubes had detached from their respective eyebolts at each bellcrank and the elevator actuator arm (Photo 13). All eyebolt heads remained attached to their respective bellcranks and exhibited bending deformation damage to their threaded rod ends. The base of the aft and forward control columns had detached from the torque tube assembly. Neither control stick was positively identified (Photo 14).

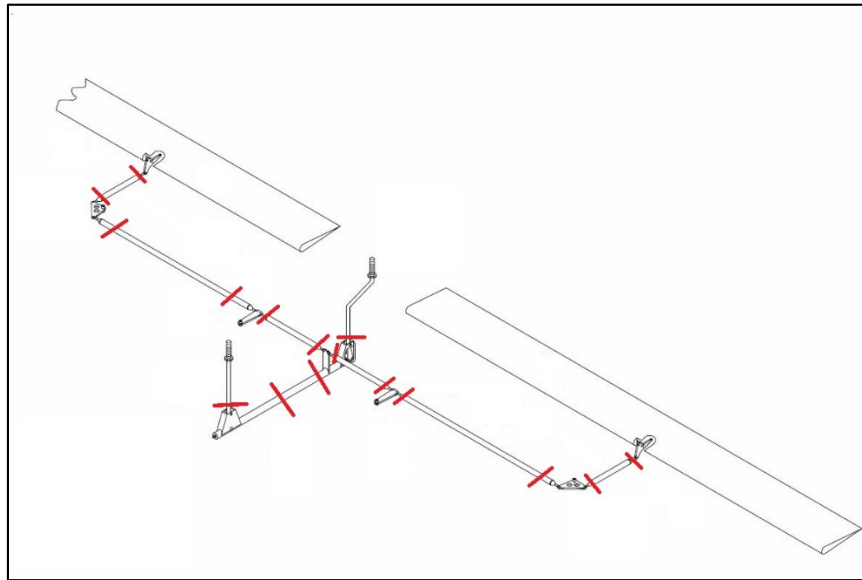
Image 3 - Aileron Control System Separation Points

Sections of burnt carbon fiber remnants of both wing trailing edge spars were located, along with the left aileron tip cap (Photo 15). All aileron hinge bars were located, and each exhibited a combination of bending and thermal damage. The right aileron spade assembly was bent and intact, with burnt remnants of the composite spade remaining (Photo 16). The left spade arm had broken away from the hinge, and the smaller quantities of spade remnants remained, along with a section of the aileron (Photo 17).

All bellcranks were deformed and had torn away from the wing, and all push-pull tubes had either detached from their respective eyebolts at each bellcrank or torn away from their tube ends. All damaged eyebolt heads exhibited bending deformation to their threaded rod ends.

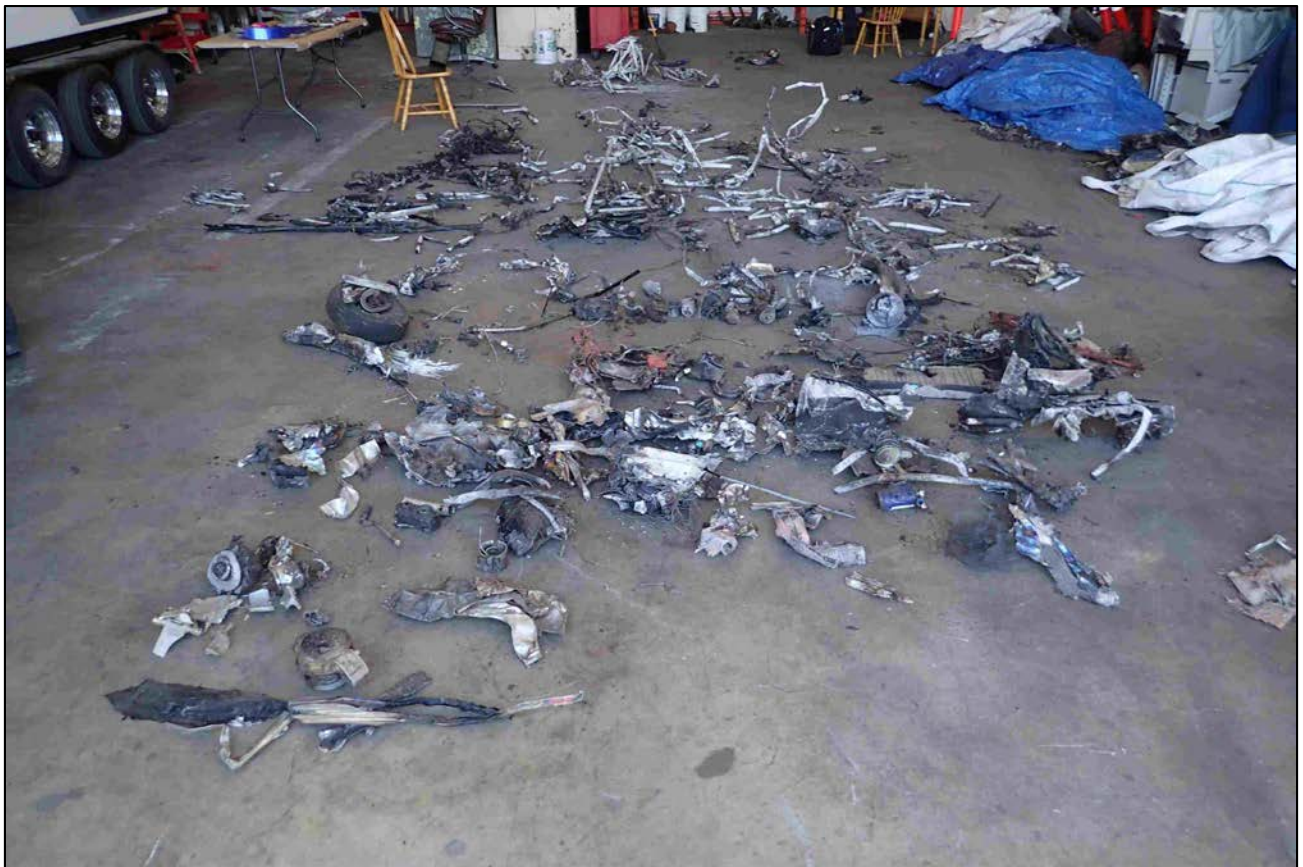
Photo 1 – Airframe Remnants

The identifiable components were separated, and then organized into their respective subsystems for examination (Photo 1). Except for the tail section, all steel airframe tubing members had fragmented and deformed into sizes varying from 3 to 24 inches. Except for the separated skin sections, the canopy, tailwheel assembly, and all composite components had been eviscerated by fire.

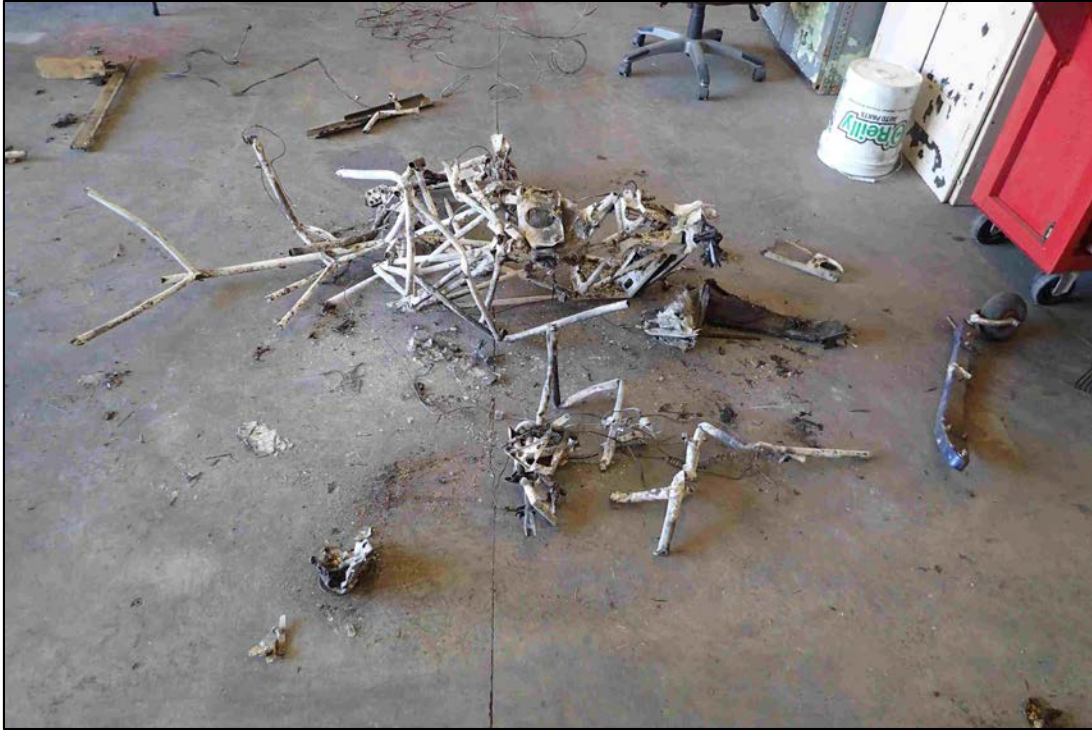
Photo 2 – Tail Section

The last 24 inches of the tubular steel tail section was crushed, but largely intact, with fire consuming most of the alloy and plastic components attached to it (Photo 2). Two parachute “pilot” springs were found entangled in the forward section of the frame members. (Photo 3). Remnants of the vertical stabilizer aft spar remained attached to the upper airframe attachment bracket and the lower mounting bolts. The vertical stabilizer forward spar attachment bolt was in place at the airframe member (Photo 4). The horizontal stabilizer forward and aft spar attachment members were intact but bent, with all four attachment bolts in place. Remnants of the forward spar were still present sandwiched against their respective fittings (Photo 5).

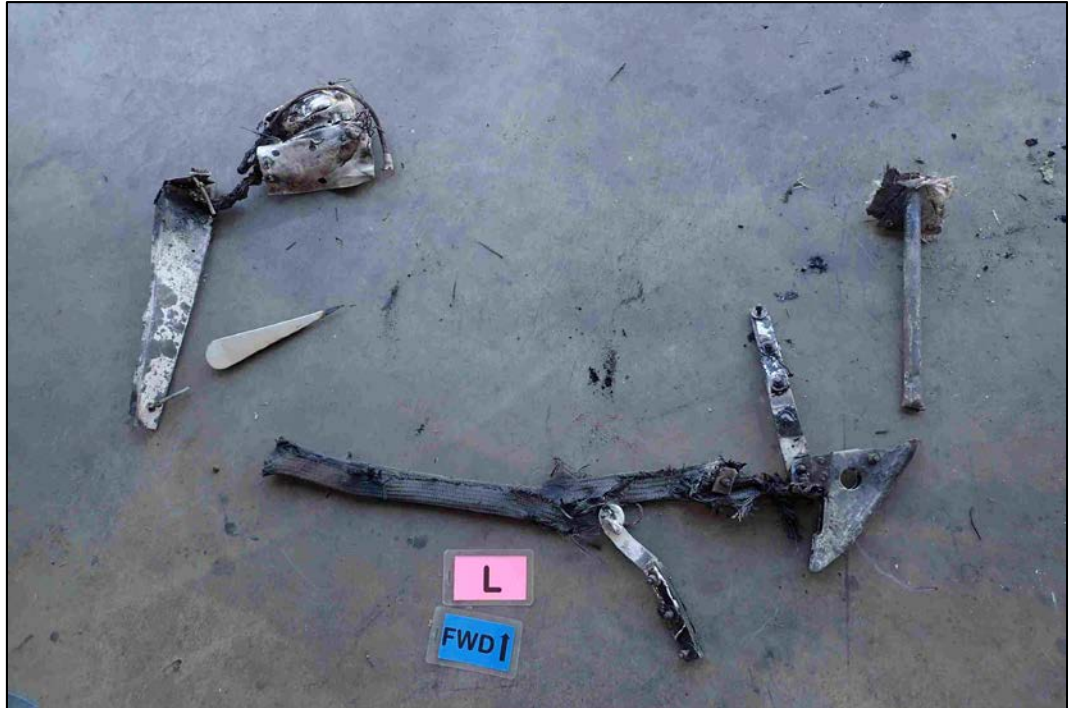
Photo 17 – Left Aileron Spade and Wingtip

Most of the wing primary structure was consumed by fire, and no wing fuel tank remnants could be found. Each wingtip rib and strobe light power assembly was identified (Photo 19, 17).

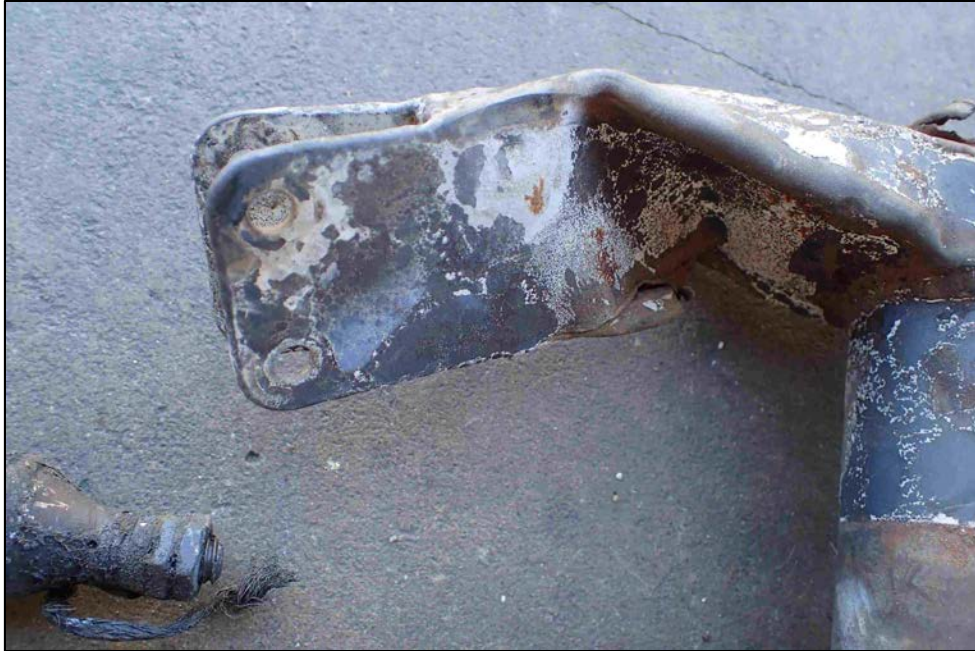
Photo 18 – Aileron Control Bellcrank Tangs

The tangs of the control stick bellcrank were bent and had detached from the push-pull tubes (Photo 18).

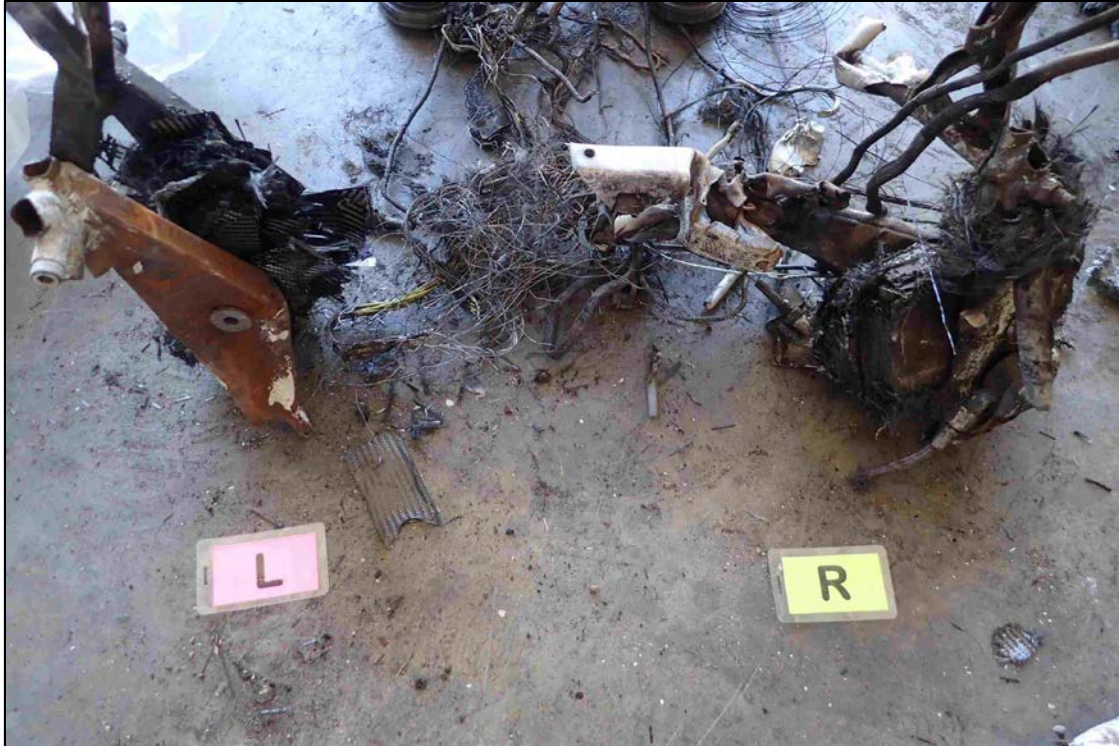
Photo 20 – Wing Main Spar Flanges

The left and right main spar attachment flanges remained partially attached to the fragmented airframe members (Photo 20). Both main wing bolts and flange bushings were in place, and burnt remnants of wing spar were still sandwiched between their respective spar attachment flange assemblies.

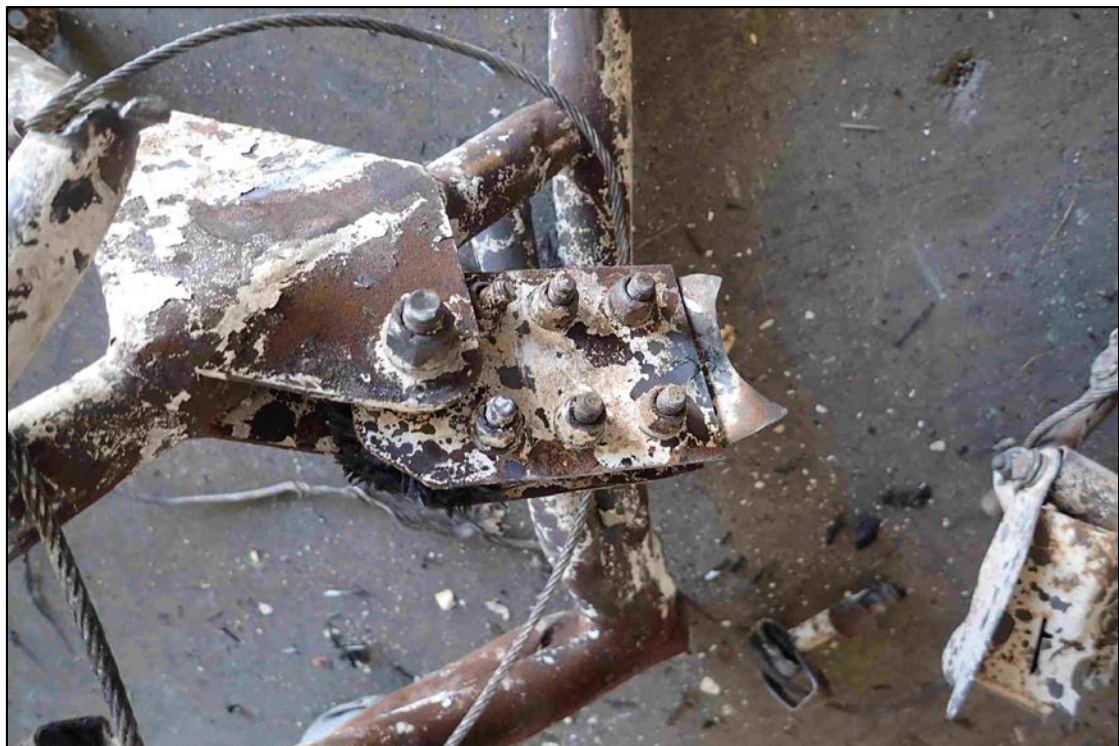
Photo 21 – Right Aft Attachment Lug

Both wing aft spar attachment lugs had broken away from their respective spars. The right lug remained attached to its airframe fitting (Photo 21). The left lug had detached and exhibited inward deformation to the airframe mounting hole (Photo 22).

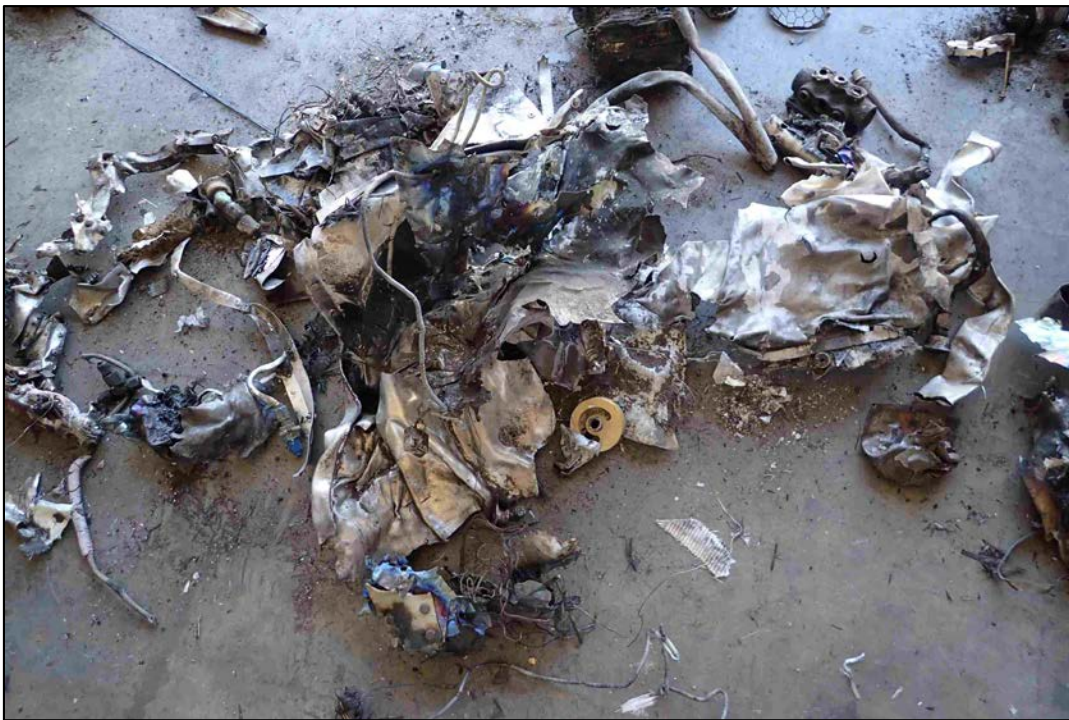
Photo 23 – Center Fuel Tank Remnants

All avionics and instruments sustained extensive crush and/or fire damage, preventing an accurate assessment of their settings and indications at impact. The fuel selector valve was not located. The center fuel tank and fuel system lines were crushed, torn and fragmented (Photo 23).

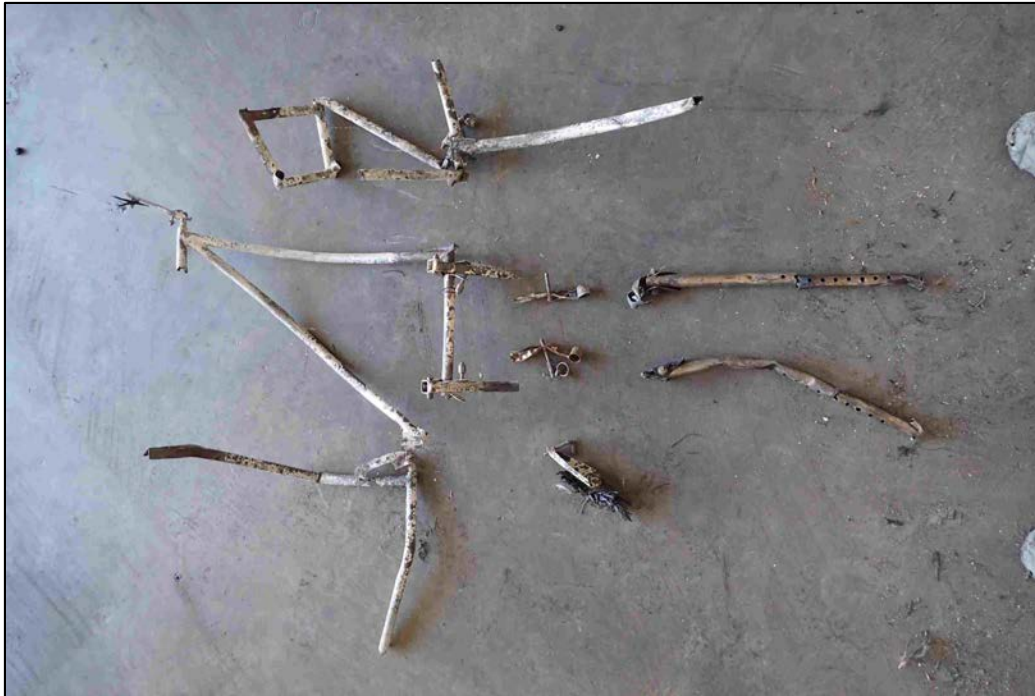
Photo 24 – Seat Frames

Four rear seat assembly adjustment pins were all located in their respective seat fixtures (Photo 24). The front seat was the fixed type.

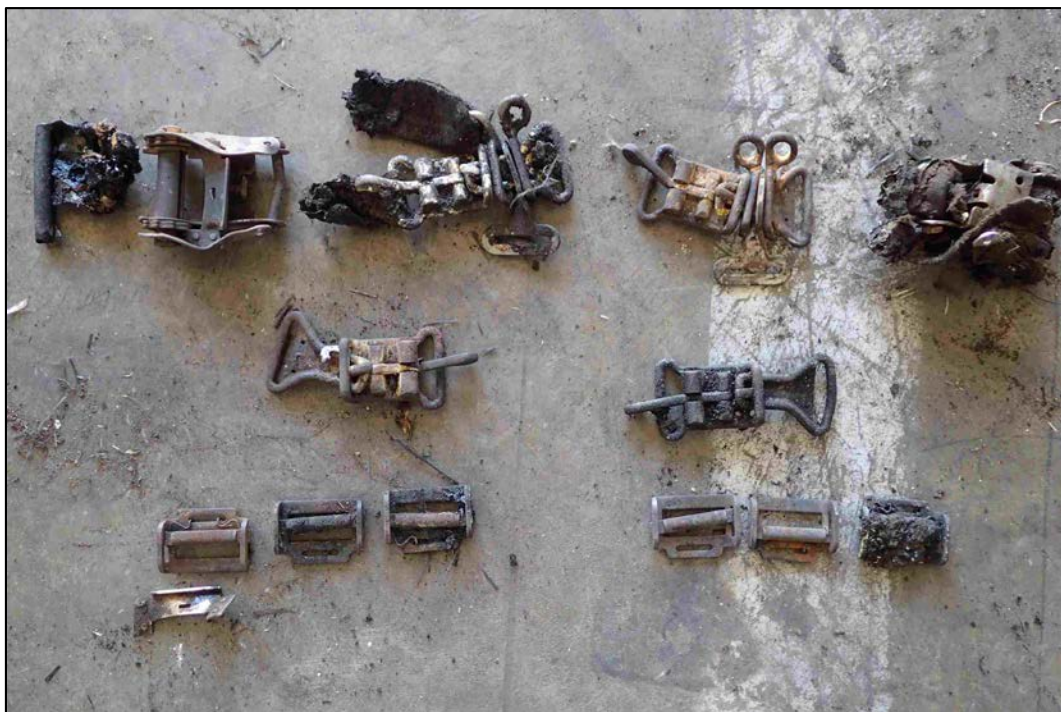
Photo 25 – Seat Belt Buckles

Both the front and rear main and supplementary seatbelt latches were accounted for, along with both belt ratchets. Both systems were in the belt-locked position (Photo 25). Eight of the seatbelt mount points were located, all remained firmly bolted to their respective airframe members.

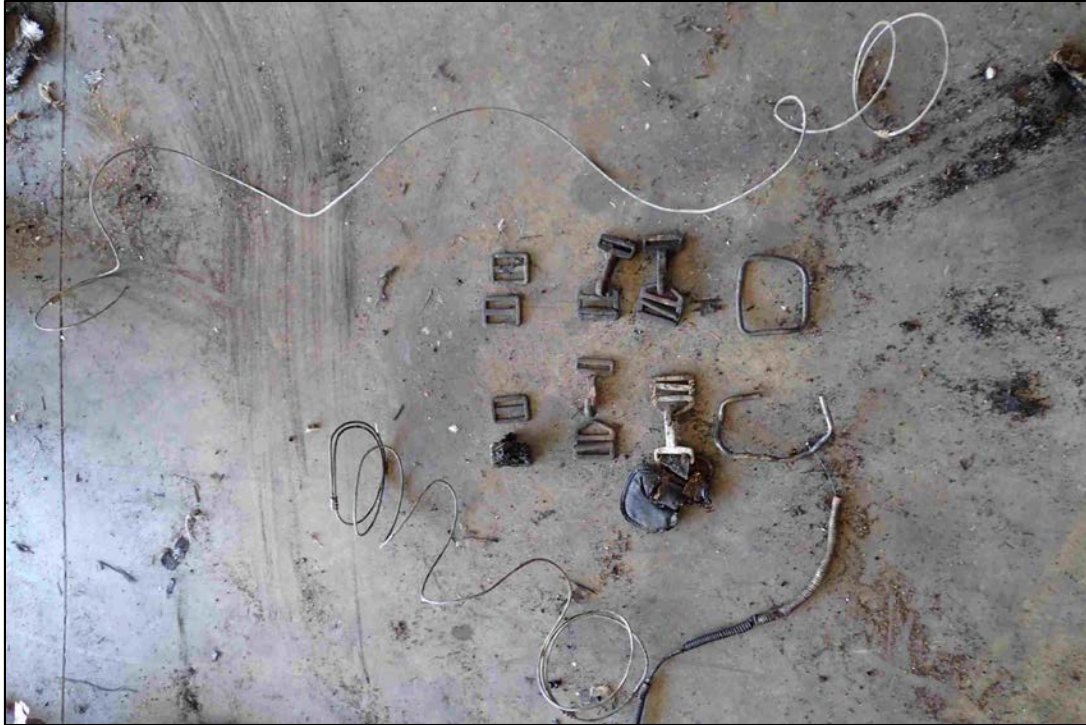
Photo 26 – Parachute Buckles and Pilot Springs

Remnants of both parachutes were found, including two D-rings, two pilot springs, and four locking buckles (Photo 26).

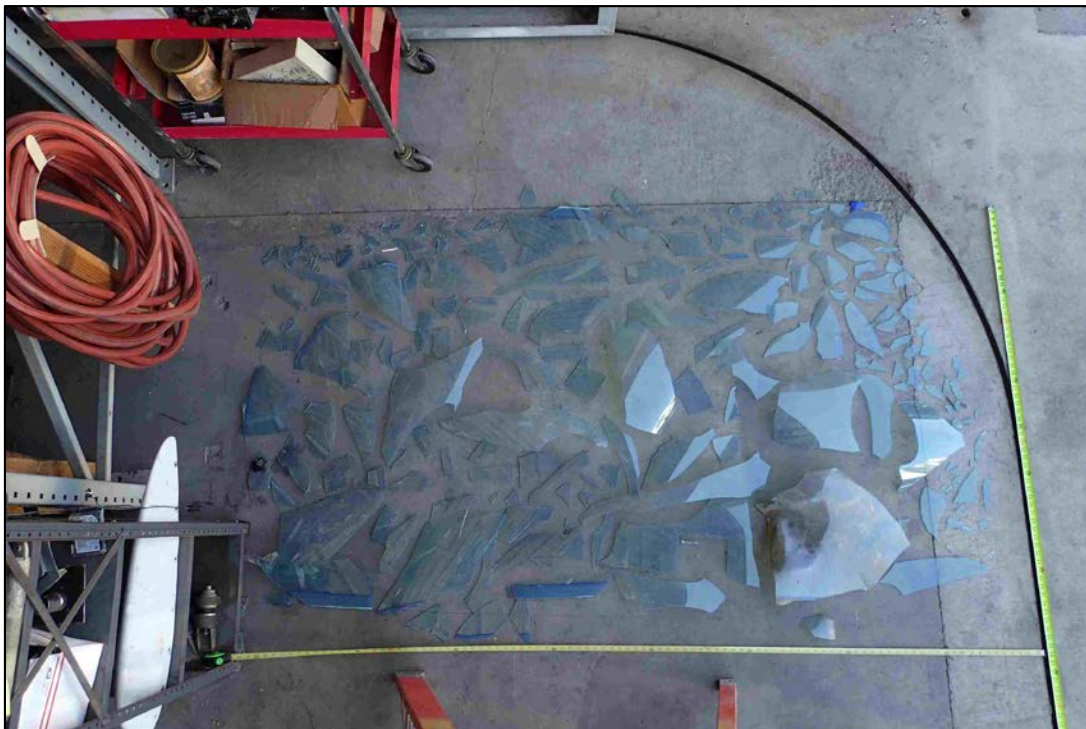
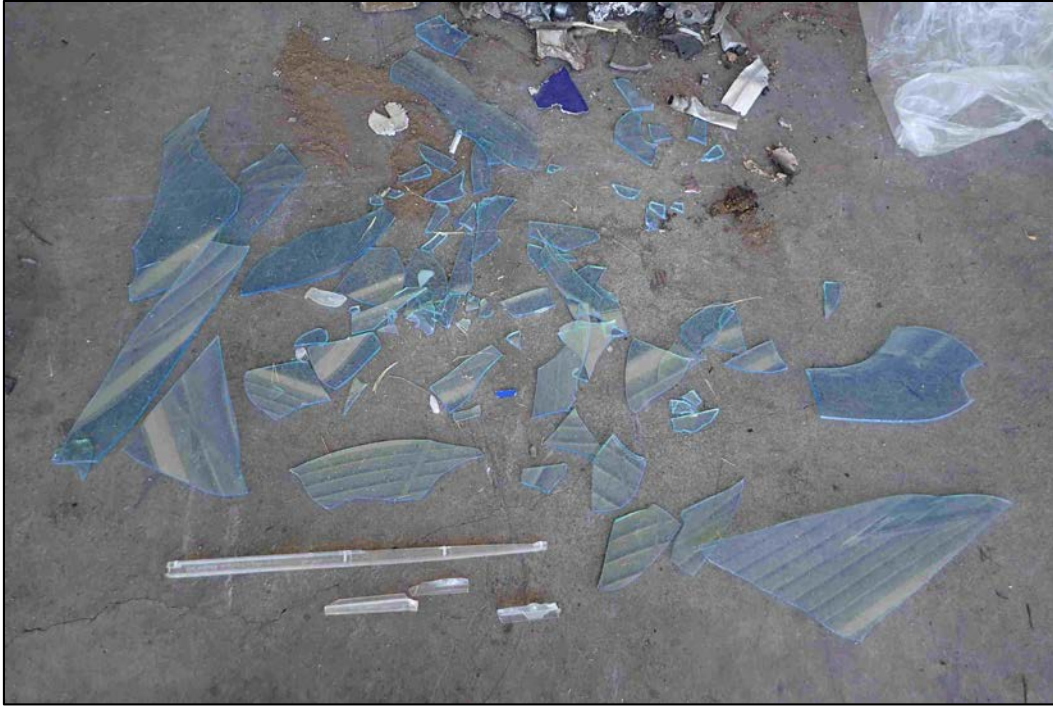
The plexiglass of the canopy had shattered into multiple fragments (Photo 27, 28) and were all located in the secondary debris field. The largest piece was found in the wildfire burn area and exhibited thermal damage. The camera mount for the rear facing camera remained attached to a section of plexiglass (Photo 29).

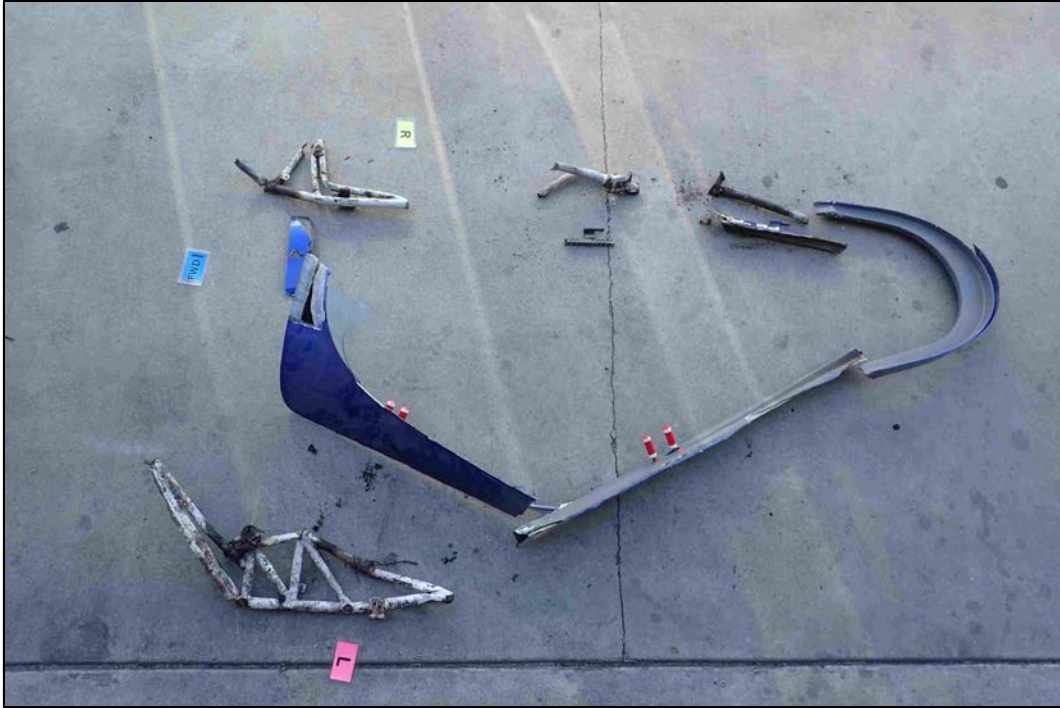
Photo 30 – Canopy Frame

The remaining canopy frame sections and corresponding hinge and latch barrels were laid out and examined (Photo 30). Five distinct sections of the canopy frame were identified and included

The 12-inch-long section of the aft right canopy (hinge side – Photo 30) had detached from the airframe and was located unburnt within an area of the debris field that had escaped flames.

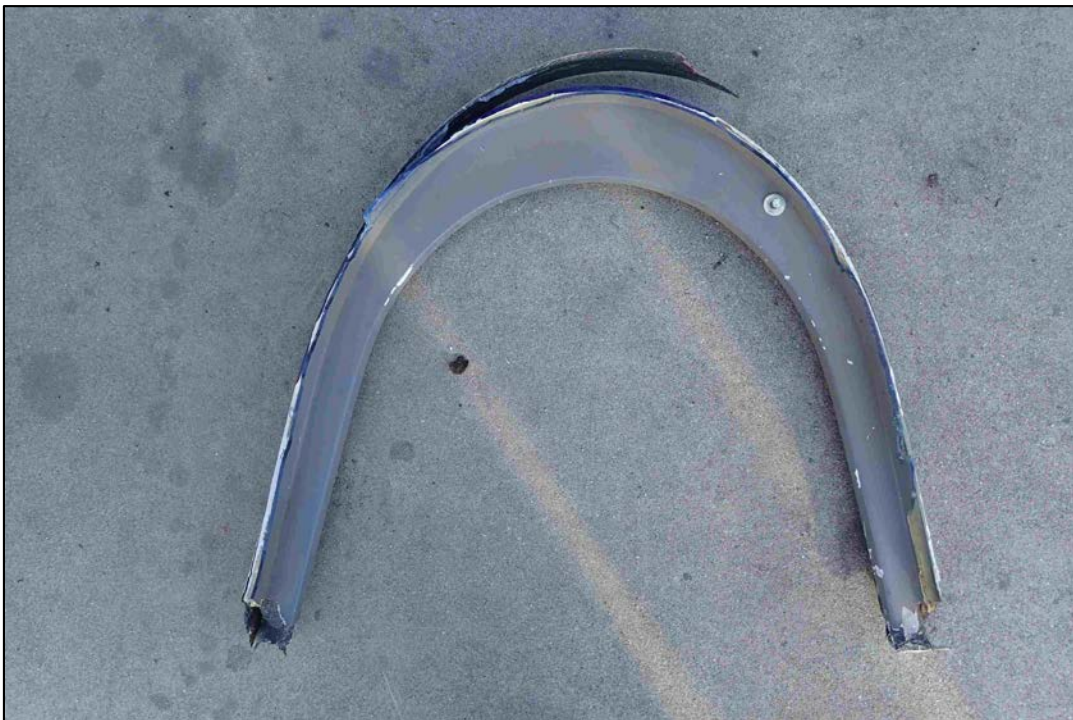
Photo 31 – Aft Canopy Frame

the left canopy frame with both lock handles and incorporating and all three locking pins; the rear canopy arch, which included the door overtravel lanyard bolt (Photo 31); an aft section of the right canopy frame with hinge pin; the center hinge pin; a 12-inch section of the forward canopy skin radius.

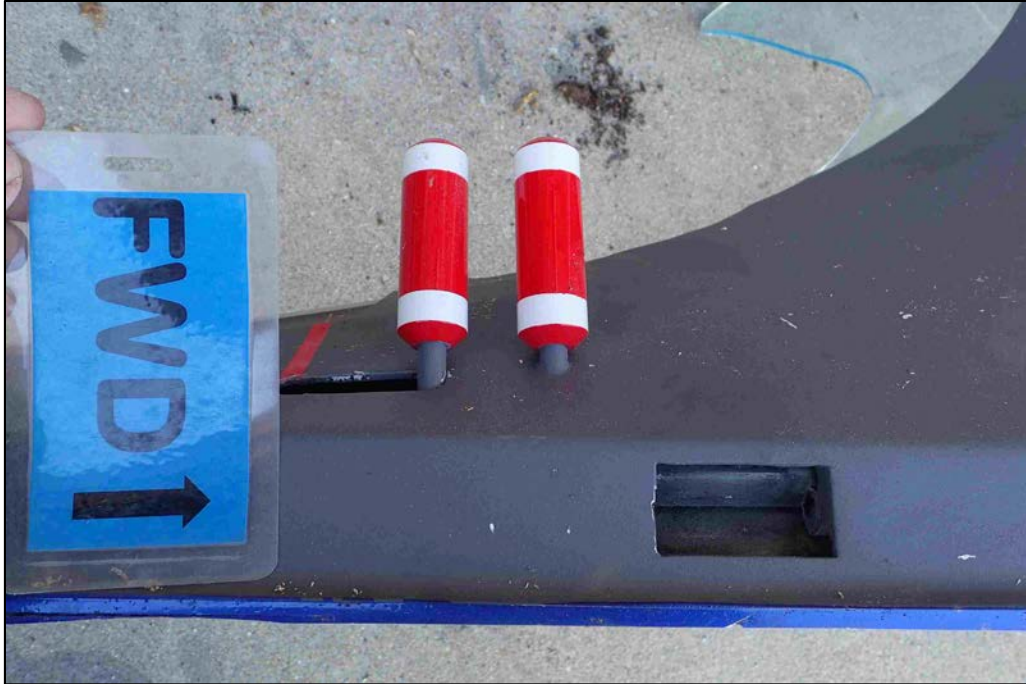
Photo 32 – Canopy Forward Locking Pin and Handle

The left frame had fractured mid-span, revealing the canopy lock interconnect components. The rear latch was 1/2 inch short of the “LOCK” position (Photo 36), and the forward latch was in the “UNLOCK” position (Photo 32). The forward locking pin was completely retracted, consistent with the “UNLOCK” position (Photo 32). The center locking pin was in the midway position (Photo 33). The aft pin was 3/8 in short of the “LOCKED” position (Photo 34). The forward locking barrel remained attached to the airframe; the chamfered channel appeared undamaged, although it was coated in thermal deposits and corrosion (Photo 35).

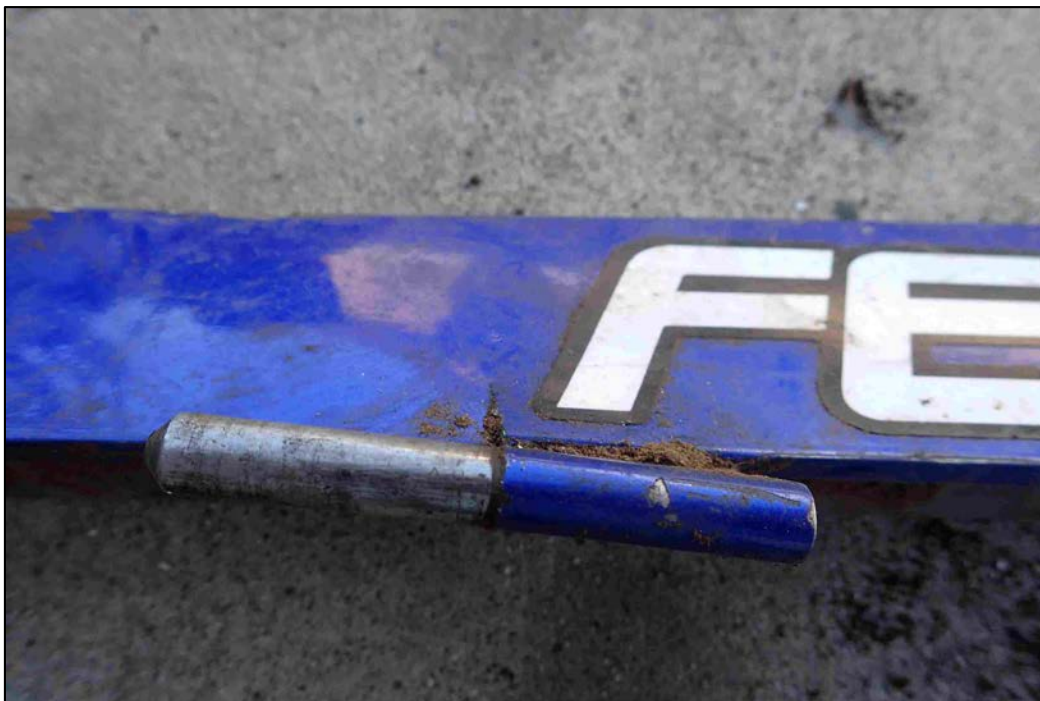
Photo 37 – Canopy Aft Right Hinge Pin

The aft end of the hinge pin had bent about 10° outwards, cracking the painted coating (Photo 37). Another hinge pin, identified as pin #2 pin was blackened and soot-covered, and was not attached to the canopy. It exhibited a similar 10° outward bend (Photo 38). A third hinge pin, identified as pin #3 sustained similar thermal exposure with more pronounced bending damage, and was located at the accident site following this examination by family of the pilot. (Photo 46)

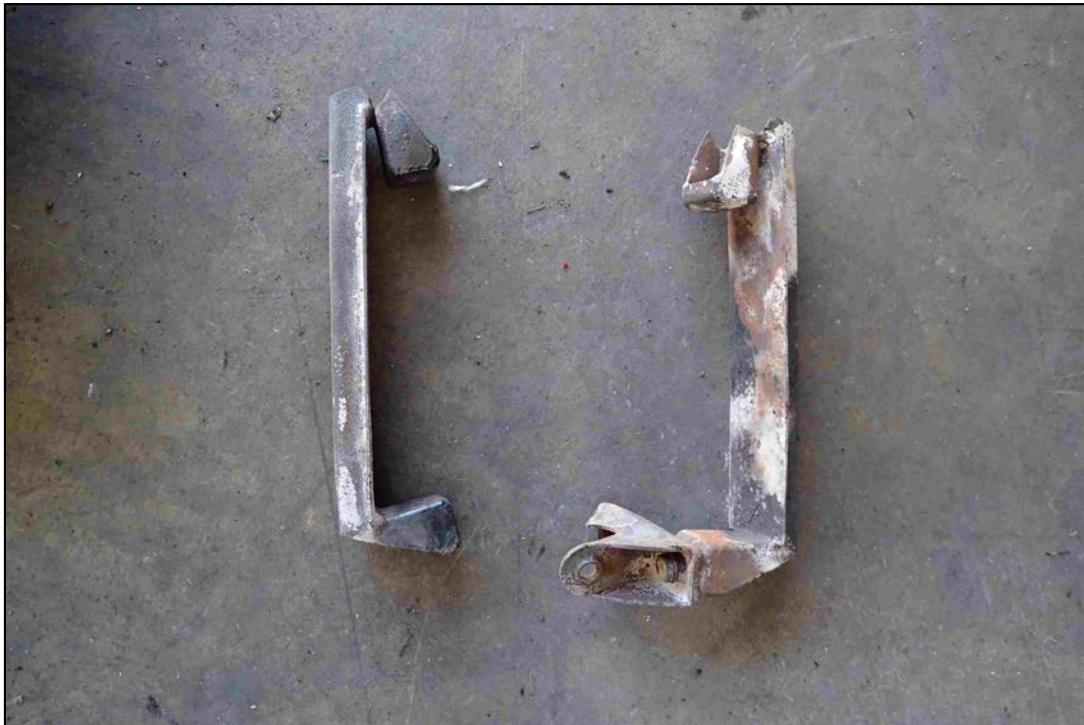
Photo 39 – Landing gear Clamps

The main landing gear had detached from the airframe. The two landing gear clamps exhibited similar deformation to their mounting tabs (Photo 39). The composite tailwheel assembly had detached from the airframe at its attachment bolts, and neither of the steering springs or chains were attached.

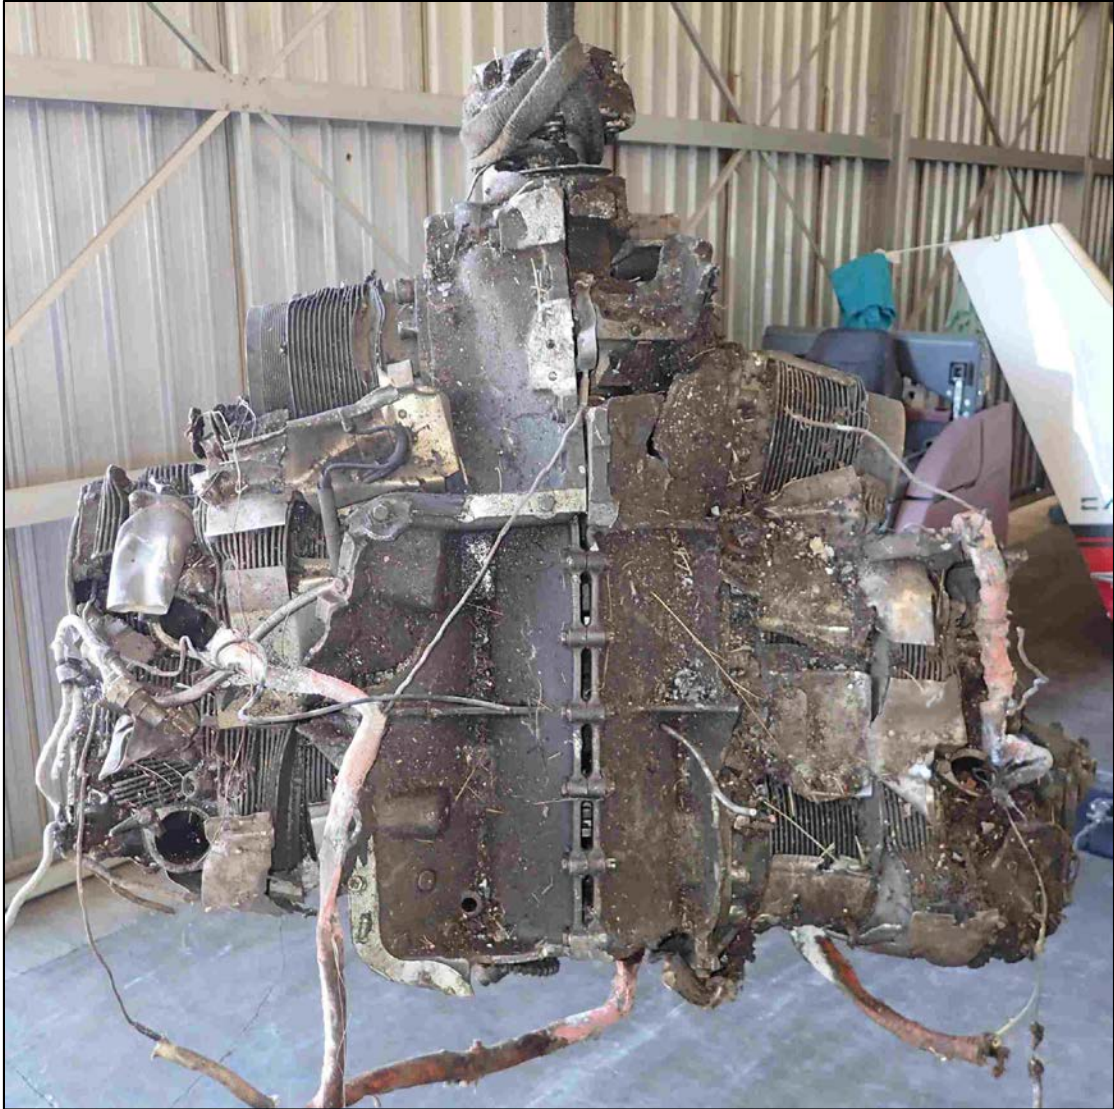
Photo 40 – Engine

The engine had detached from the airframe, and experienced significant impact damage, liberating most of the ancillary components including the starter motor, governor, alternator, fuel injection servo, both magnetos, and all but one push rod (Photo 40). The cylinder heads from cylinders 1 and 2 had detached from their respective barrels, which were both bent aft. The oil sump had fragmented, exposing the lower engine crankcase and bottom half of the oil dipstick, which was bent aft. The

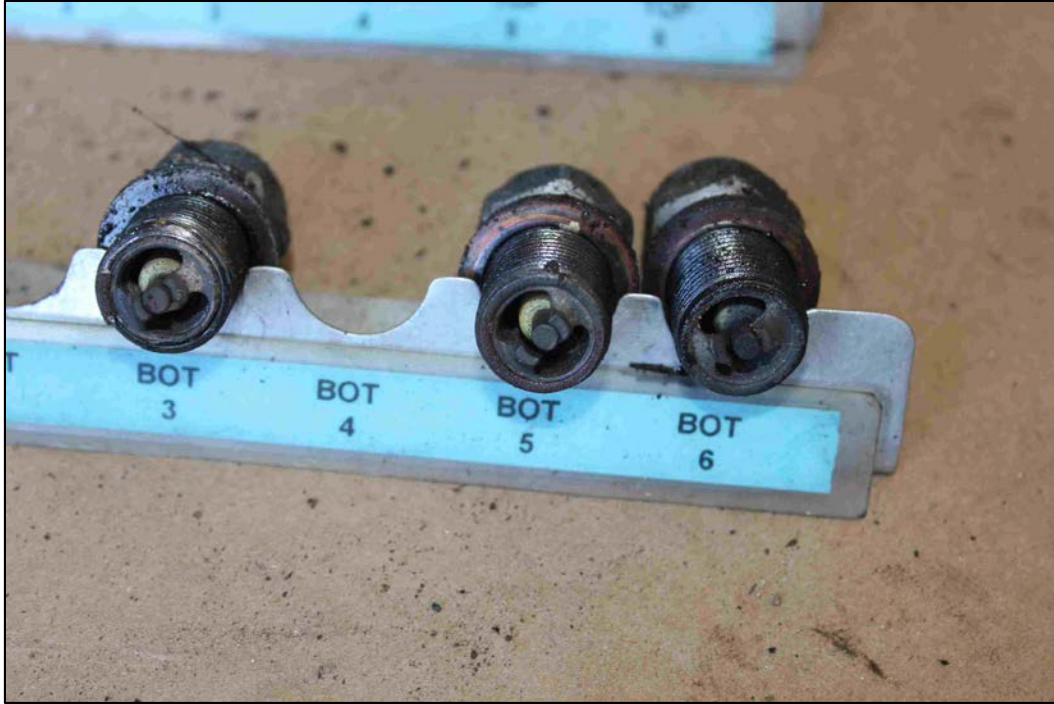
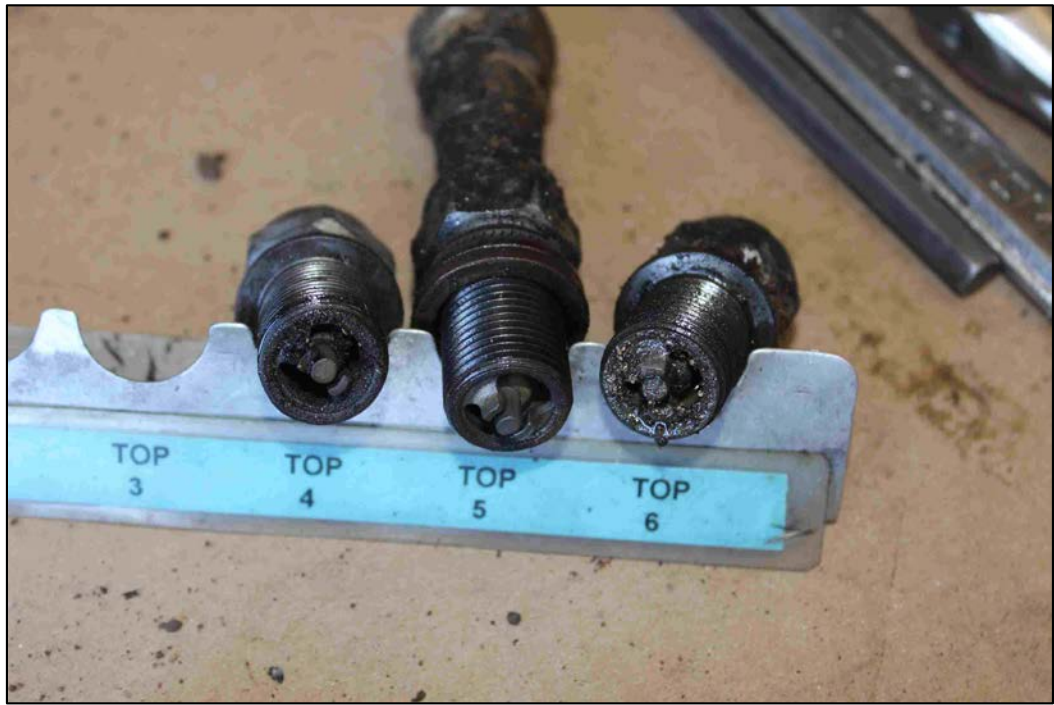
The only recovered components for the left magneto were the internal drive shaft and the coil. The right magneto sustained impact damage and could not be rotated. Burnt and torn remnants of the ignition harness remained attached at the rocker cover clamps. The top spark plugs from cylinder 4, 5, 6, and the bottom plugs for 3, 5, and 6 were removed and examined. All plug electrodes exhibited normal to worn out-normal wear signatures when compared to the Champion AV-27 Check-A-Plug chart. The top plugs for cylinder 4 and 6 were coated in oil, all other plugs exhibited dark grey discoloration (Photo 41,42). All remaining plugs which were located, had fragmented.

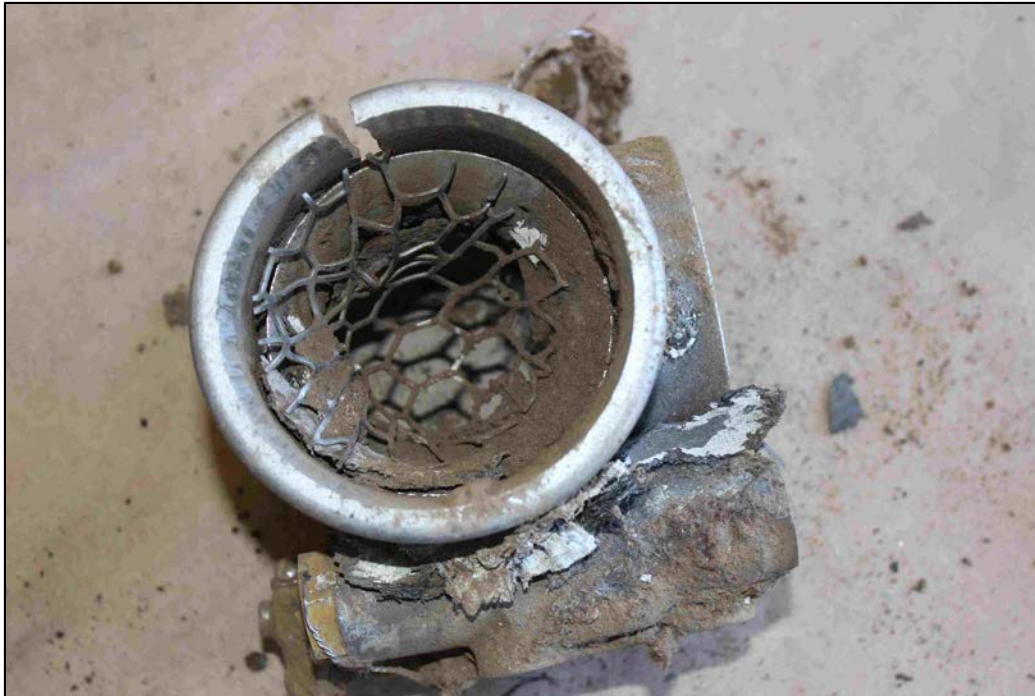
Photo 43 – Fuel Injection Servo Induction Bore

The fuel injection servo diaphragm section had detached from the throttle body. The throttle control arm and its associate fitting remained attached. The fuel inlet screen was clear. The induction screen appeared to have been forced into the induction bore, along with dirt and composite debris (Photo 43).

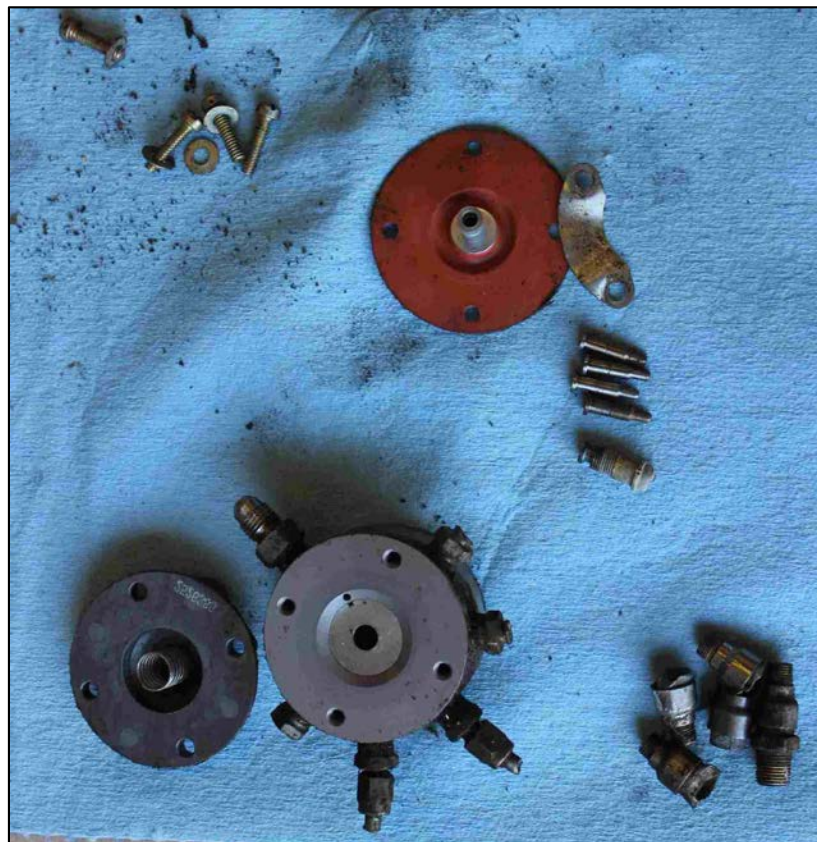
Photo 44 – Fuel Flow Divider Components

The flow divider along with its respective lines had detached from engine. The unit was disassembled and examined. No obstructions were noted, and the diaphragm was intact and pliable (Photo 44). The fuel pump had detached, and the valve housing assembly had bent away from the diaphragm assembly.
