NATIONAL TRANSPORTATION SAFETY BOARD

AIRFRAME AND ENGINE EXAMINATION

WPR18FA013

Location: Four Corners, CA
Date: October 21, 2017.
Aircraft: Extra 330/LC, Registration N414MT, Serial: 1300
NTSB IIC: Elliott Simpson

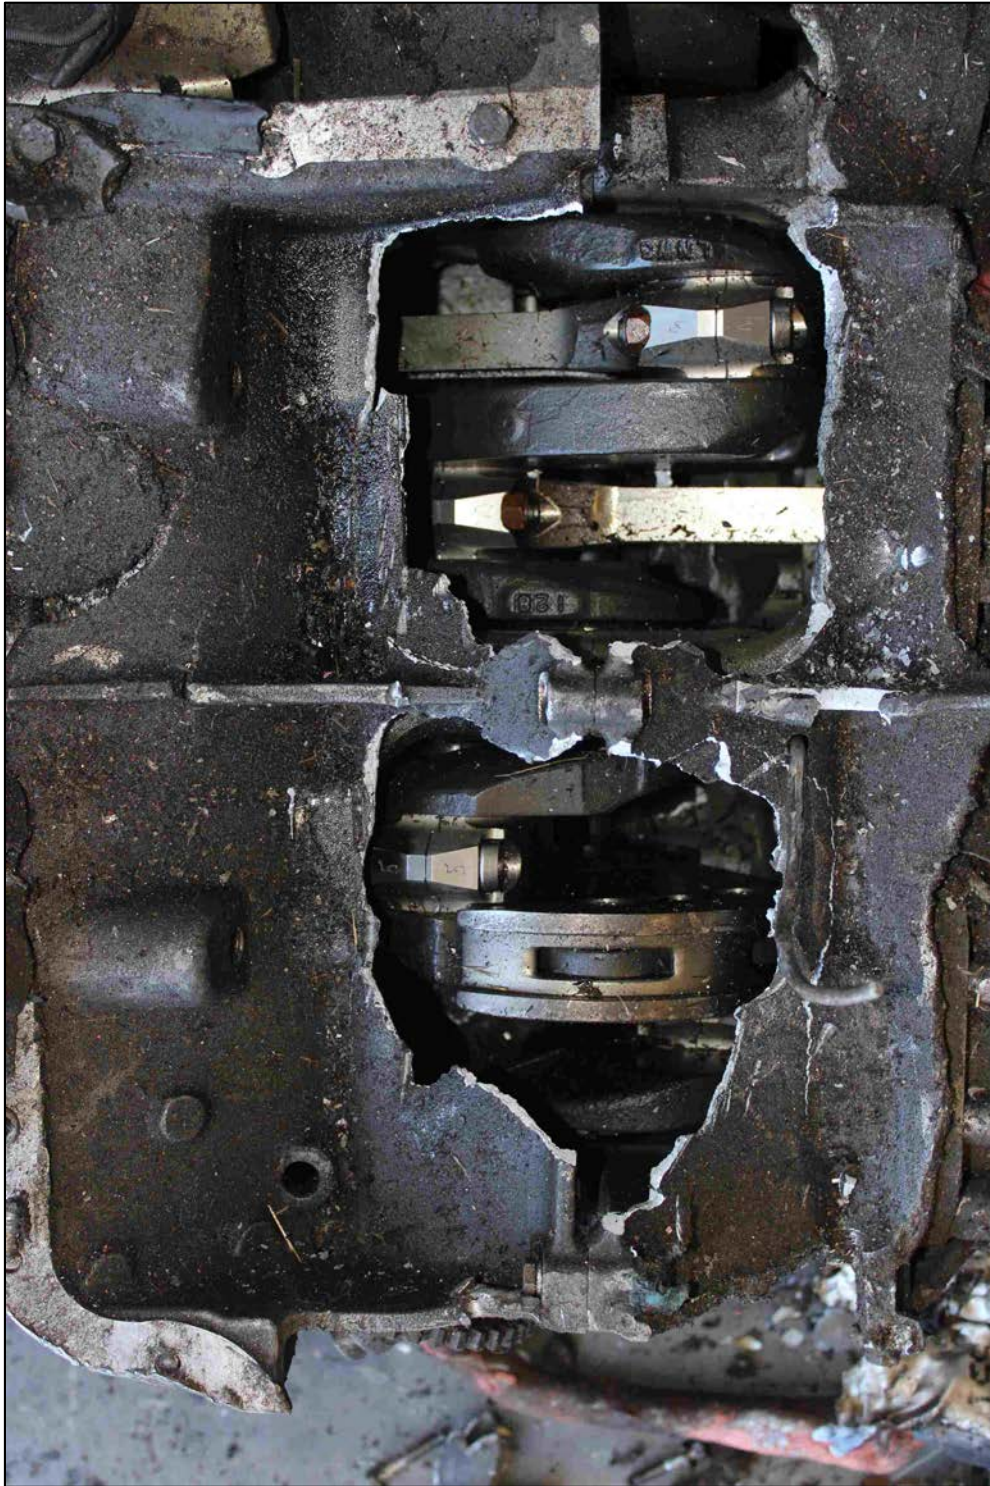
Photo 45 – Inside Crankcase

The crankcase webs on the underside of the engine were broken open to facilitate internal examination. From the opening, the crankshaft, camshaft lifting surfaces, and connecting rods could be observed. A light coating of oil was present throughout, and all components were clean and free of any indications of catastrophic damage or heat discoloration (Photo 45).

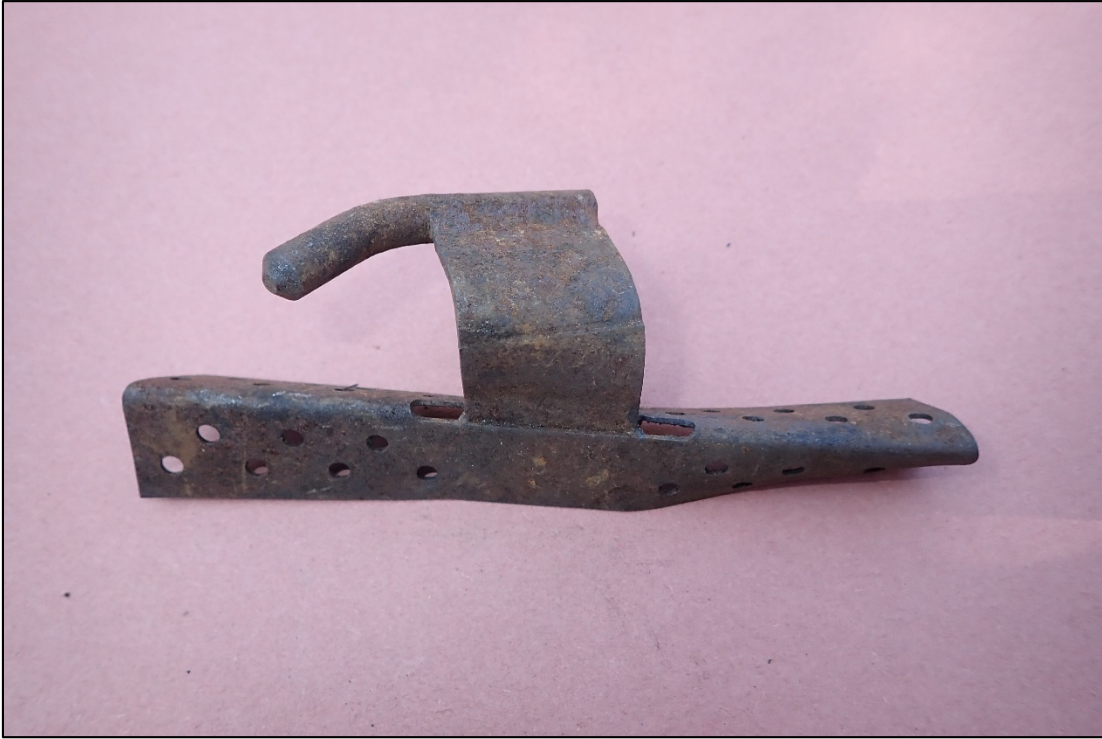
Photo 46 –Hinge Pin #3

The aft end of the hinge pin had bent about 10° outwards, cracking the painted coating (Photo 37). Another hinge pin, identified as pin #2 pin was blackened and soot-covered, and was not attached to the canopy. It exhibited a similar 10° outward bend (Photo 38). A third hinge pin, identified as pin #3 sustained similar thermal exposure with more pronounced bending damage, and was located at the accident site following this examination by family of the pilot. (Photo 46)
