NATIONAL TRANSPORTATION SAFETY BOARD

AIRFRAME AND ENGINE EXAMINATION

WPR19FA256

Aircraft: Piper PA32-300, Serial Number: 32-40487

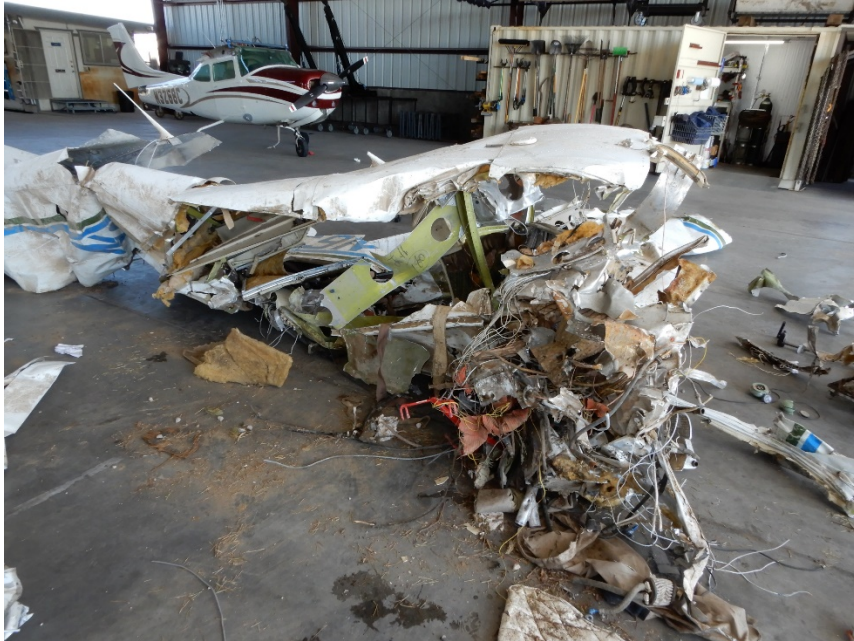
Photo 1. Right Side View of N6300Z

Fuselage. The fuselage was destroyed as it descended through trees to the terrain.

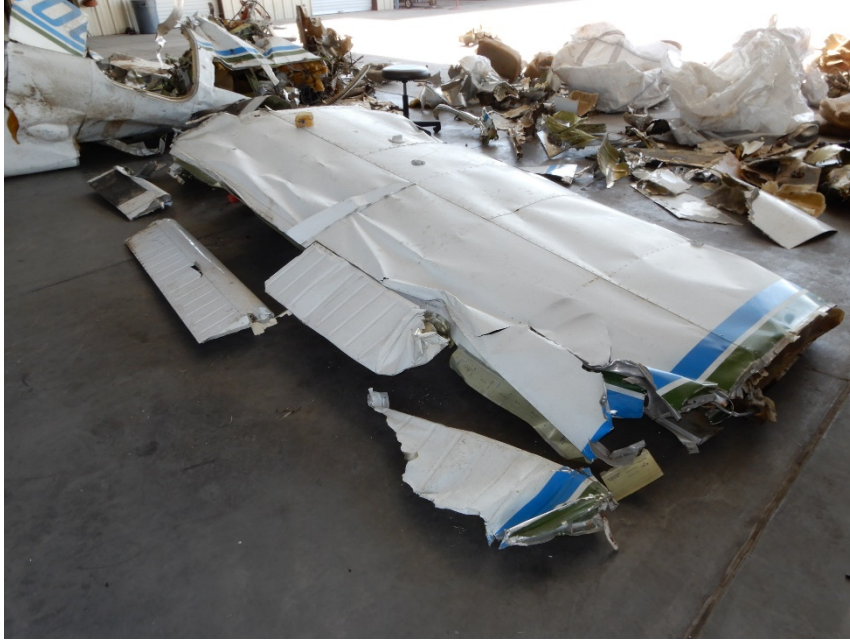
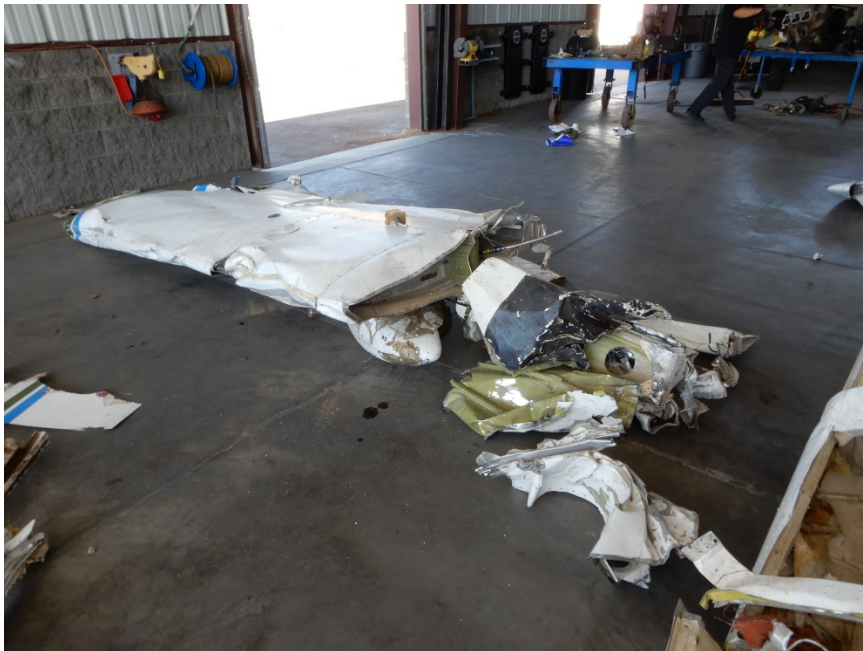
Right Wing. The wing was separated from the fuselage at the root. The outer portion, from the tip of the wing to the main landing gear remained intact. The remaining portion of the wing, from the main landing gear to the wing root, was fragmented into several portions. The leading edge displayed a dent about 12 inches from the root that was consistent with an 8-inch diameter

object. A brown material consistent with tree bark was found embedded into the dented aluminum. The fuel cap was intact and secured to the wing. The rubber seal was intact soft and pliable. There was no fuel in the fuel tank. The outer half of the aileron was separated from the wing. The inner half remained attached at the hinge. The flap was separated from the wing at the attachment points and fractured into two pieces. The fiberglass tip tank was separated from the wing and fragmented into multiple pieces. The tip tank fuel cap was recovered and found to be secured with the rubber seal soft and pliable. The navigation light was shattered with the mount still attached to a fragment of the tip tank.

Photo 4. Right Wing. Photo 1 of 2.

Photo 5. Right Wing. Photo 2 of 2

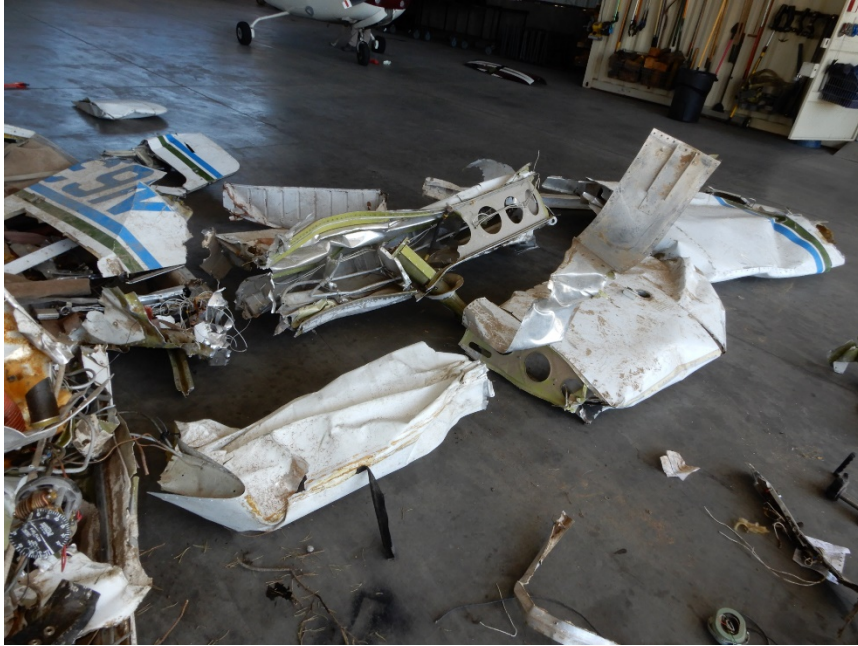
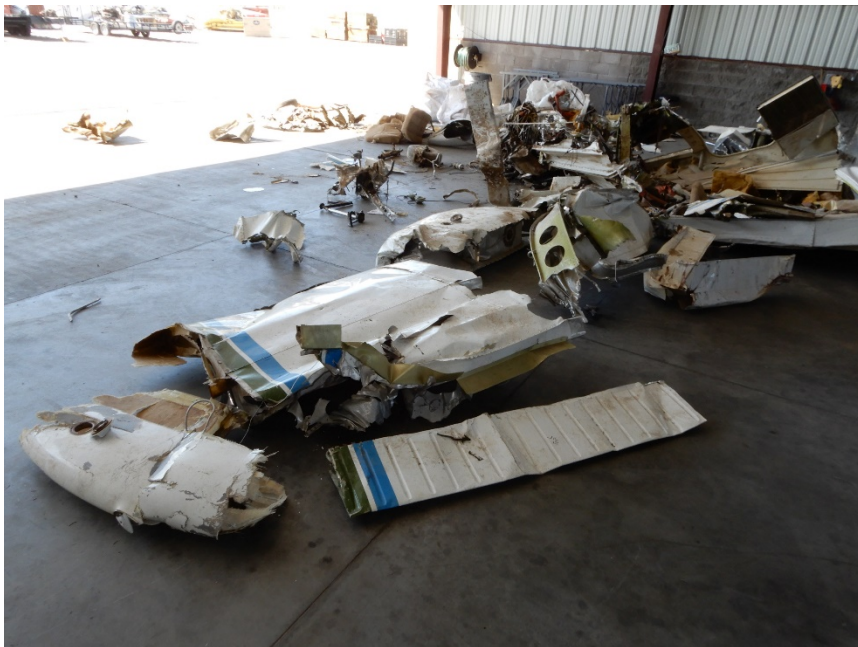
Left Wing. The wing was separated from the fuselage at the root and fractured into five major portions, the tip tank and four pieces of the wing. All portions of the wing displayed damage. The outer portion, from the tip of the wing to about the main landing gear, displayed damage from the leading edge and the trailing edge. The fuel cap was intact and secured to the wing. The rubber seal was intact soft and pliable. There was no fuel in the fuel tank. The stall warning tab was secure and undamaged. The aileron was separated from the wing, damaged, but remained intact. The flap was separated from the wing at the attachment points and damaged from the trailing edge forward and distorted into a V-shape. The fiberglass tip tank was separated from the wing and fragmented into multiple pieces. The tip tank fuel cap was recovered and found to be secured with the rubber seal soft and pliable. The navigation light was shattered with the mount still attached to a fragment of the tip tank.

Photo 6. Left Wing. Photo 1 of 2

Photo 7. Left Wing. Photo 2 of 2

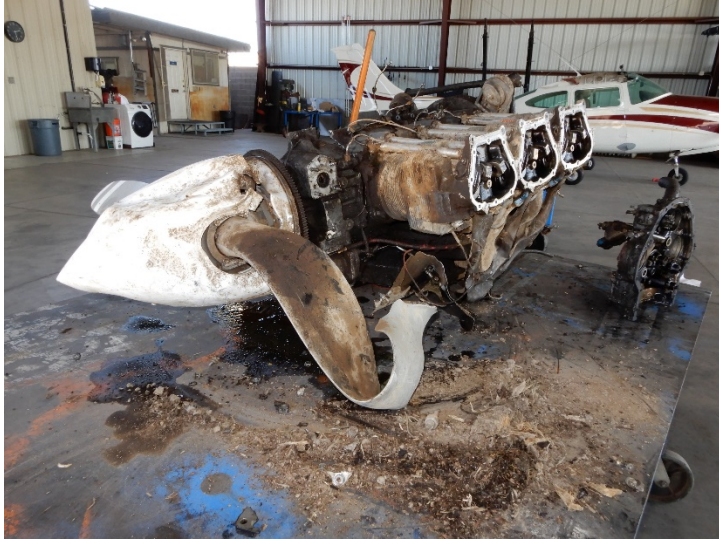
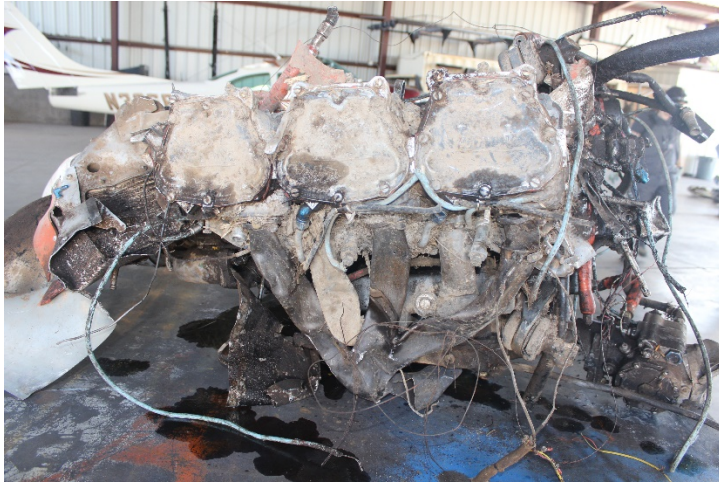
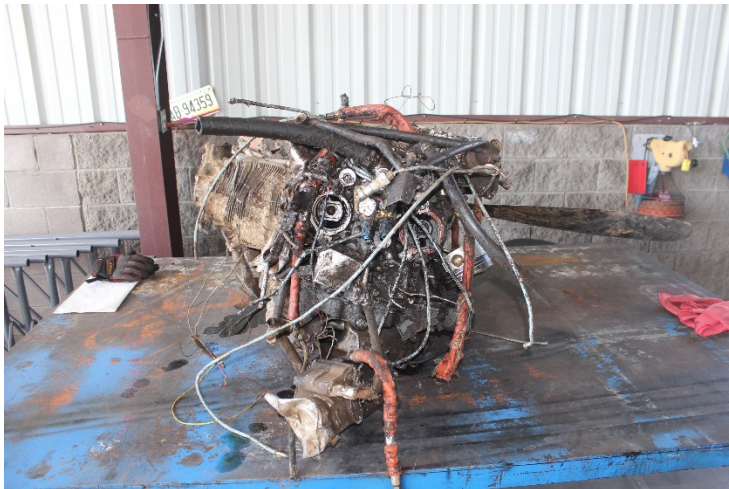
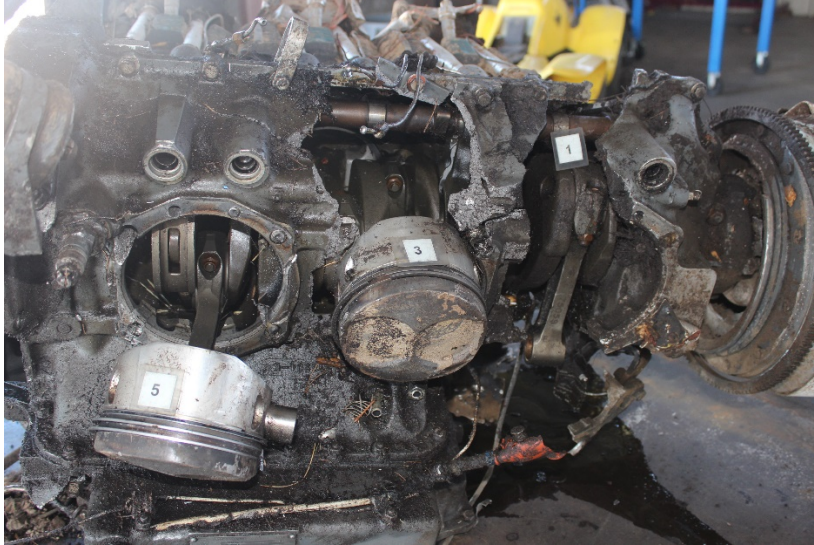
Engine. The engine nacelle was fragmented and found in multiple pieces throughout the debris field. The engine separated from the firewall along with the engine mounts. The three right-hand cylinders (1, 3, and 5) were absent, and the number 1 piston was separated from the piston rod. The number 1 cylinder had tree bark and wood embedded in the cooling fins. The crank case was damaged with fractures of the block behind the number 1, 3, and 5-cylinder bosses. The fuel

servo was separated but remained attached via a cable. The intake and exhaust manifolds were crush damaged.

The accessory gearbox remained attached to the rear of the engine. The two magnetos impact separated from the accessory gearbox and received damage to the magneto housings.

Photo 8. Engine. Photo 1 of 5

Photo 9. Engine. Photo 2 of 5

Photo 10. Engine. Photo 3 of 5

Photo 11. Engine. Photo 4 of 5

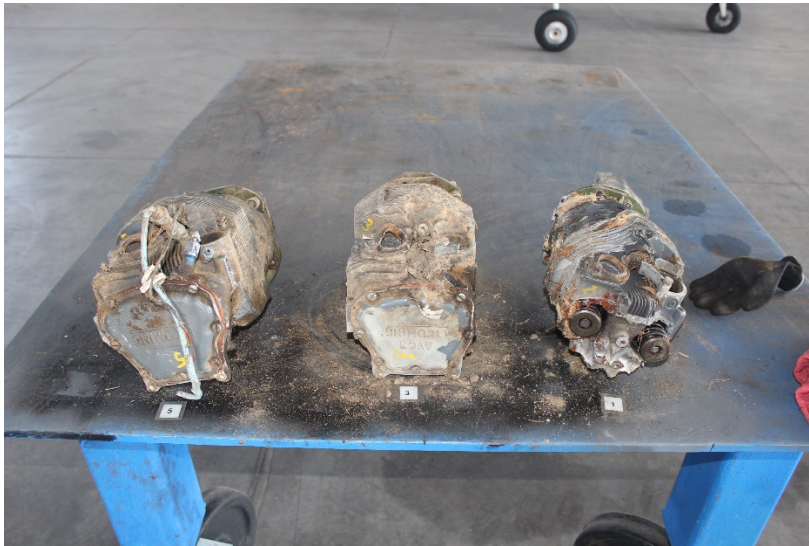
Photo 12. Engine. Photo 5 of 5, showing engine cylinders 1, 3 and 5.

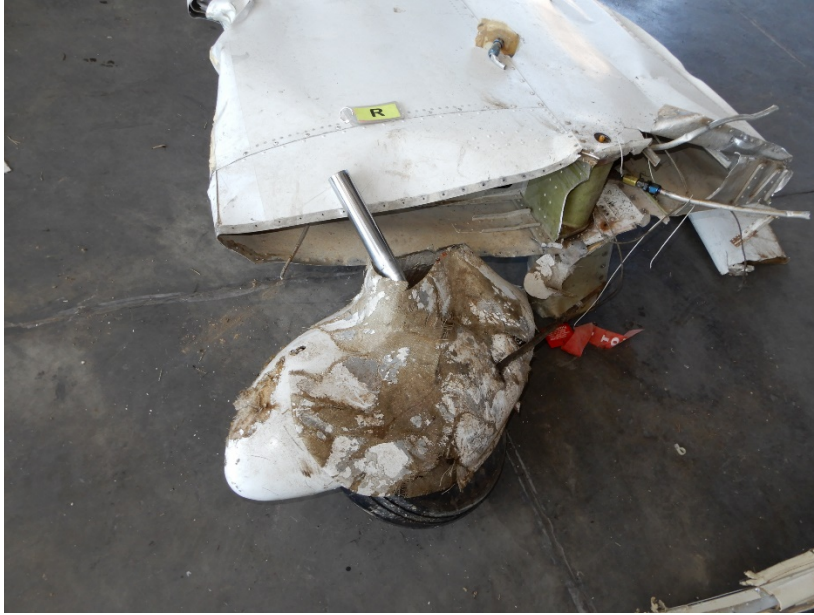
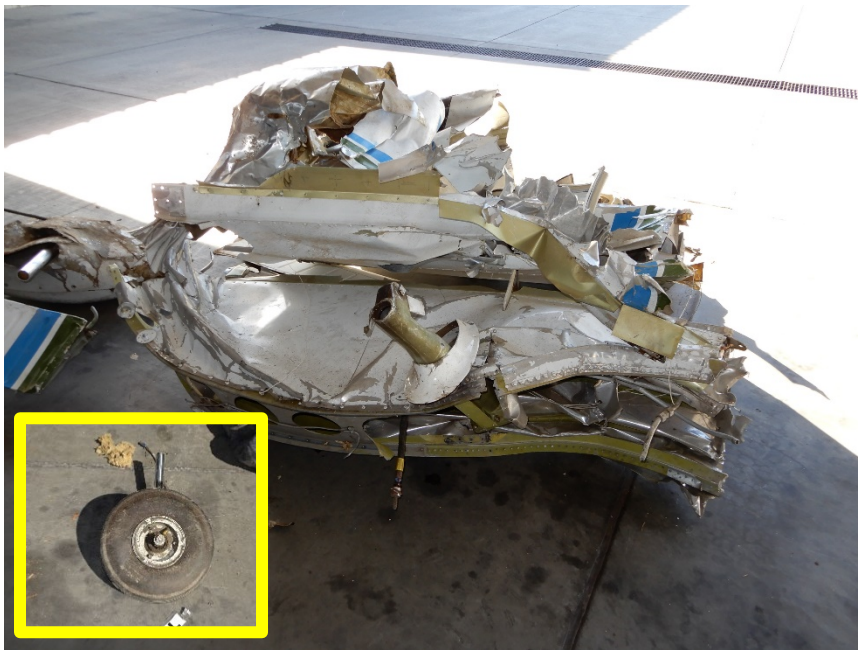
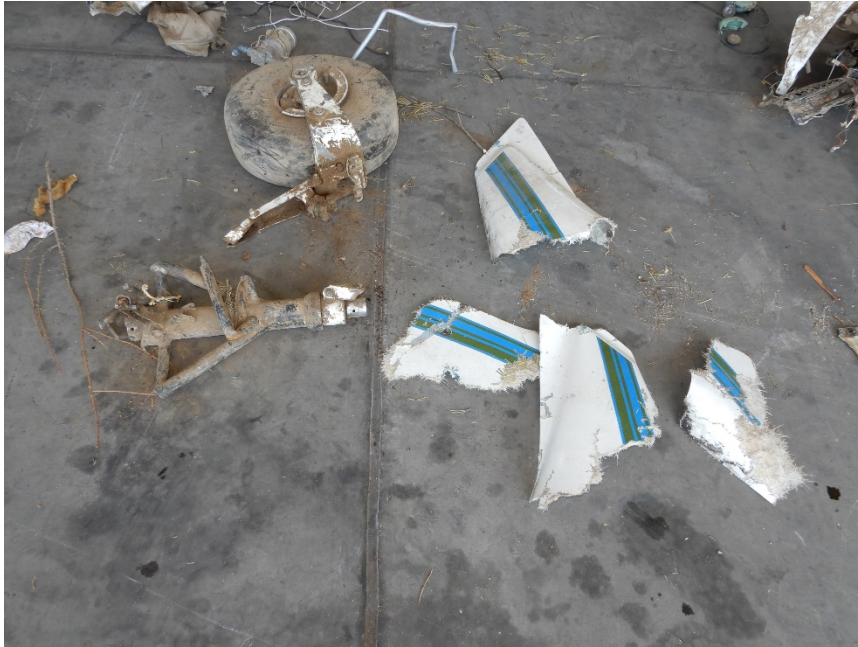
Landing Gear. The main landing gear was damaged and partially separated from the fuselage. The upper half of both main landing gear assemblies remained attached to their respective wings. The left wheel and lower oleo strut separated from the left wing as a unit. The right wheel and lower oleo strut separated from the upper half of the oleo strut but remained attached to the wing by the brake hose. The nose gear was separated from the fuselage and fragmented into two pieces. The nose wheel and the lower portion of the nose gear assembly and the upper portion of the nose gear assembly.

Photo 13. Right Main Landing Gear

Photo 14. Left Main Landing Gear

Photo 15. Nose Gear
