AIRFRAME AND ENGINE EXAMINATION REPORT

NTSB ACCIDENT NUMBER: ERA20FA088

AIRCRAFT REGISTRATION: N214K

ACCIDENT LOCATION: Grafton, West Virginia

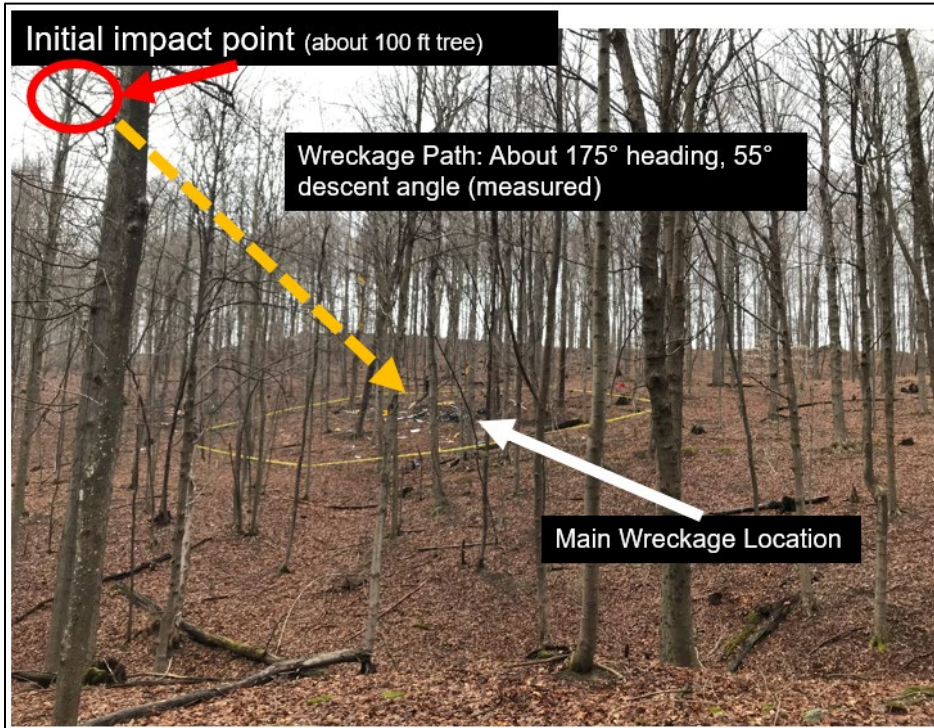
The initial impact point coincided with about a 100 ft tall tree, about 110 ft from where the main wreckage was located. Debris was found along a path of about 175° true heading. The descent angle was about 55°. Flight control continuity could not be established as the wreckage was highly fragmented and a postcrash consumed a majority of the fuselage. However, fragments of all flight control surfaces, forward and rear wing spars, and wingtips were located at the main wreckage.

Figure 1: Overview of the main wreckage site looking eastward (NTSB Photo)

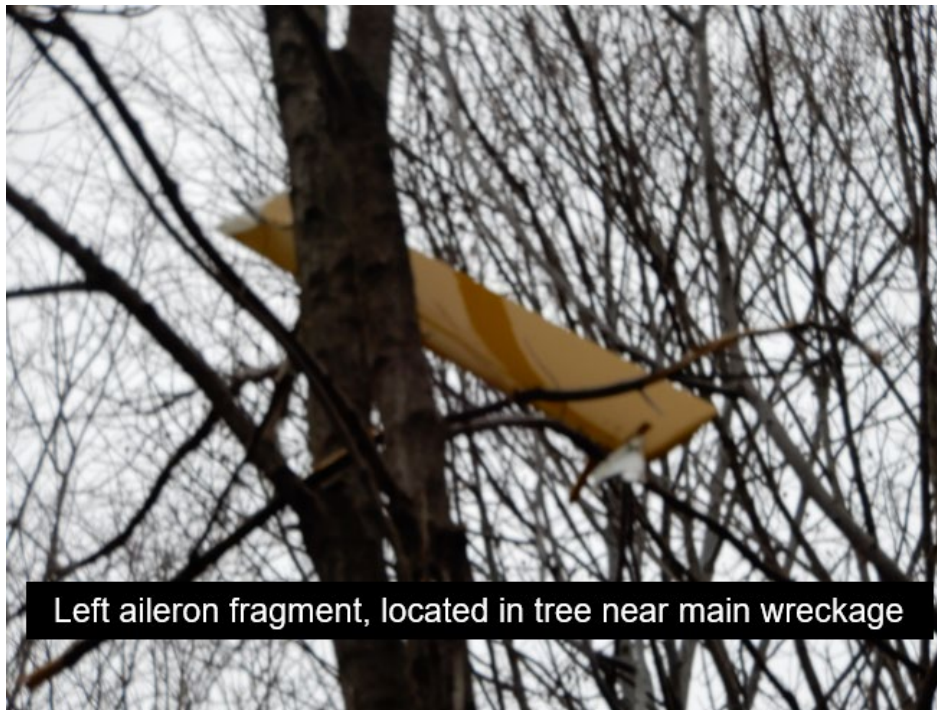
Figure 2: View of an aileron fragment lodged in a tree near the main wreckage (NTSB Photo)

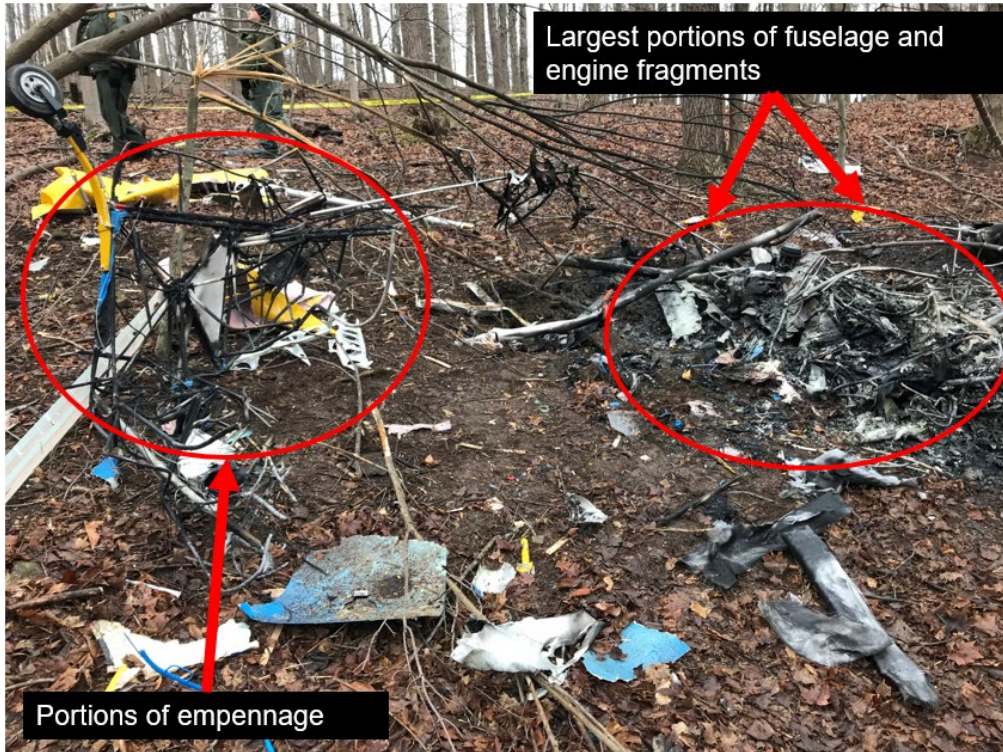
Figure 3: Closer view of the main wreckage (NTSB Photo)

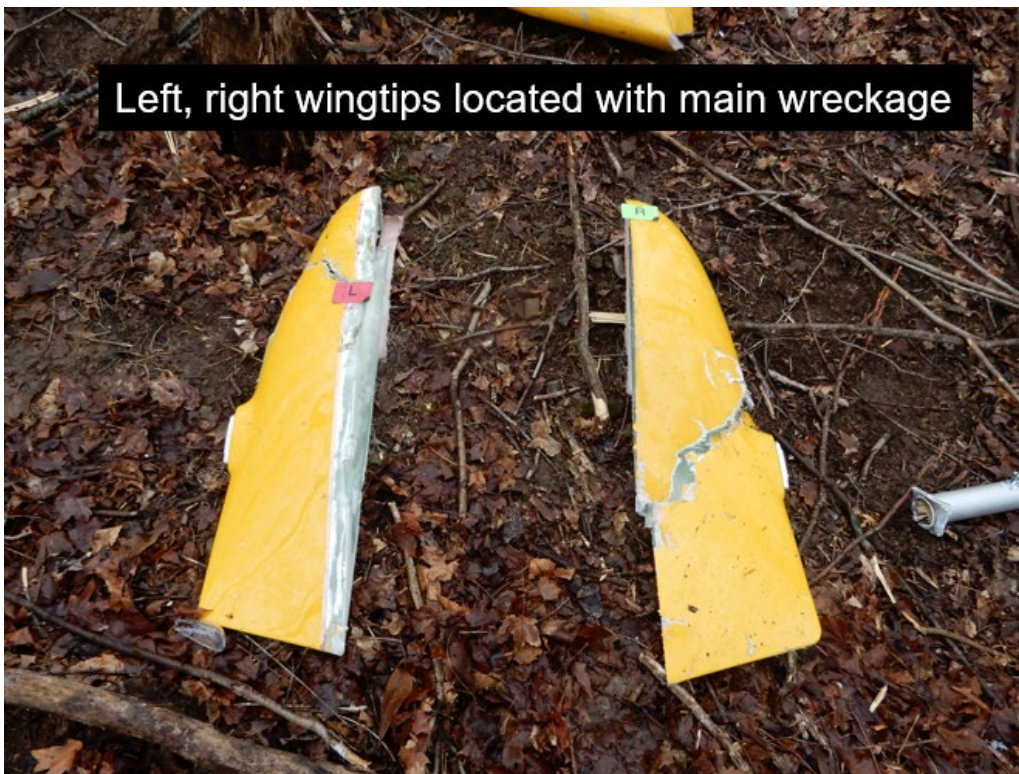
Figure 4: View of the left and right wingtips laid out at the accident site (NTSB Photo)

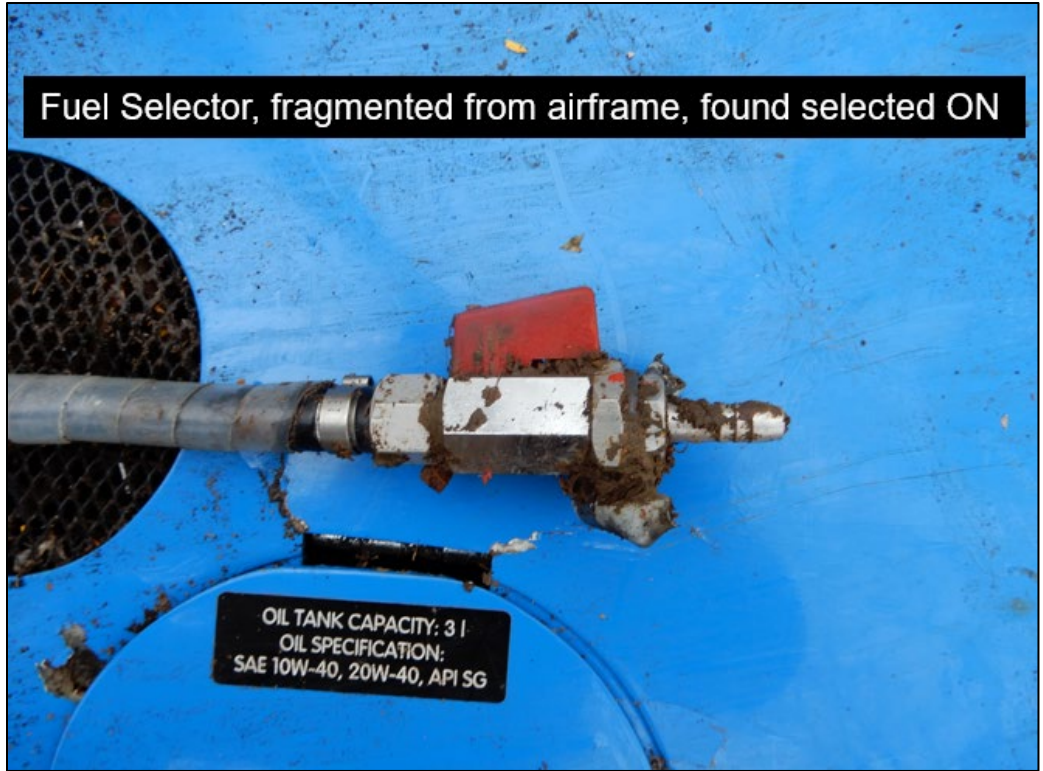
The cockpit, instrument panel, and fuselage were largely consumed by the postcrash fire. A fragmented airspeed indicator was found indicating about 40 mph (35 kts). Several instrument housings were located, but each sustained significant fire damage. One fuel selector on/ off valve was located in the debris, found selected to an ON position. The selector was found loose in the debris near the main wreckage. A search was unable to discover any identifiable remnants of the BRS parachute system, performed at the accident site and again at the recovery facility.

Figure 5: View of the fuel selector valve (NTSB Photo)

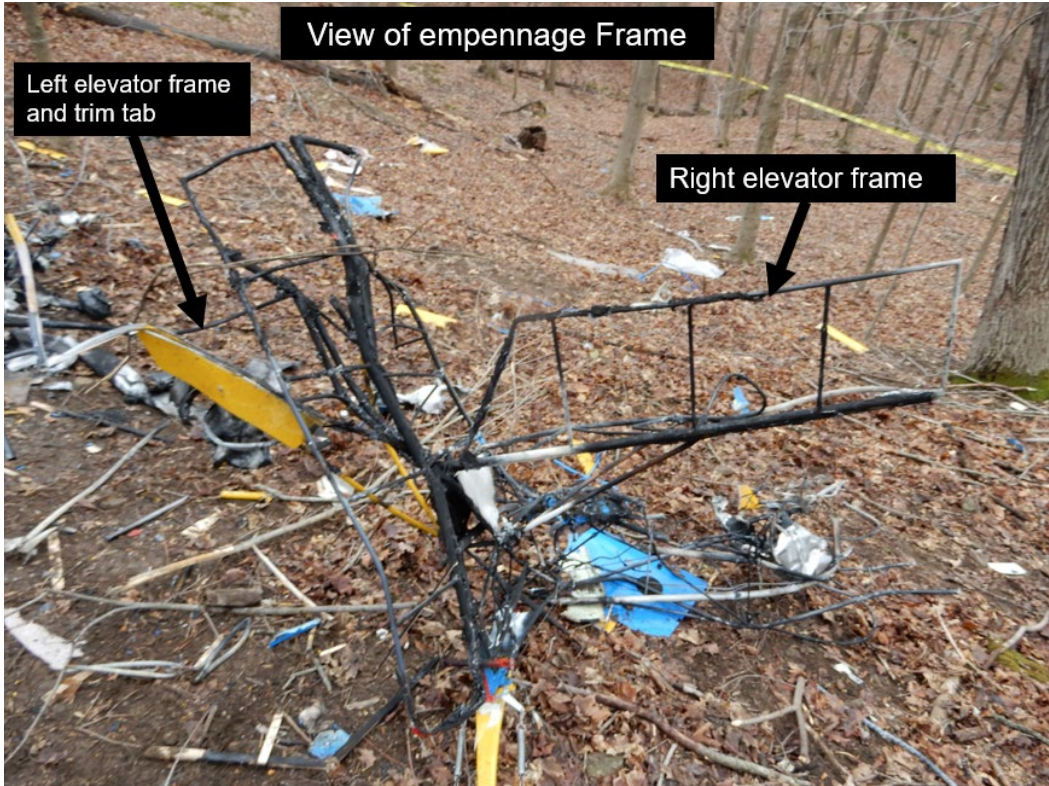
Figure 6: View of the empennage frame at the accident site (NTSB Photo)

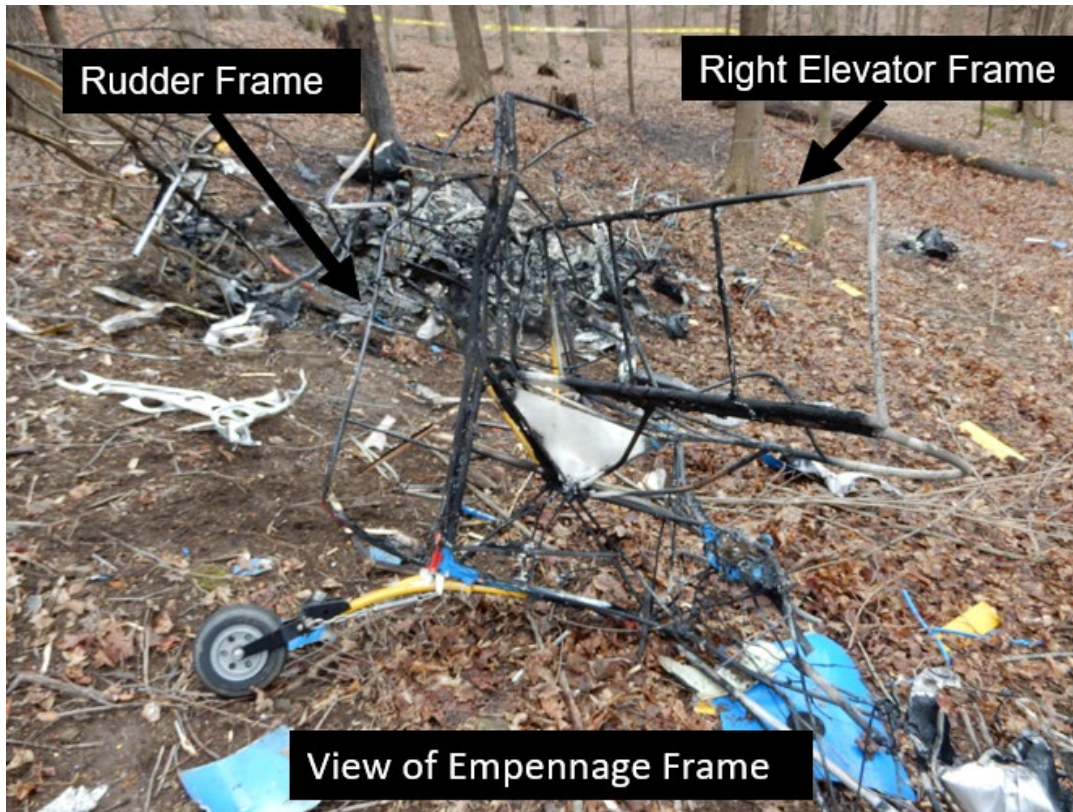
Figure 7: An additional view of the empennage framing (NTSB Photo)

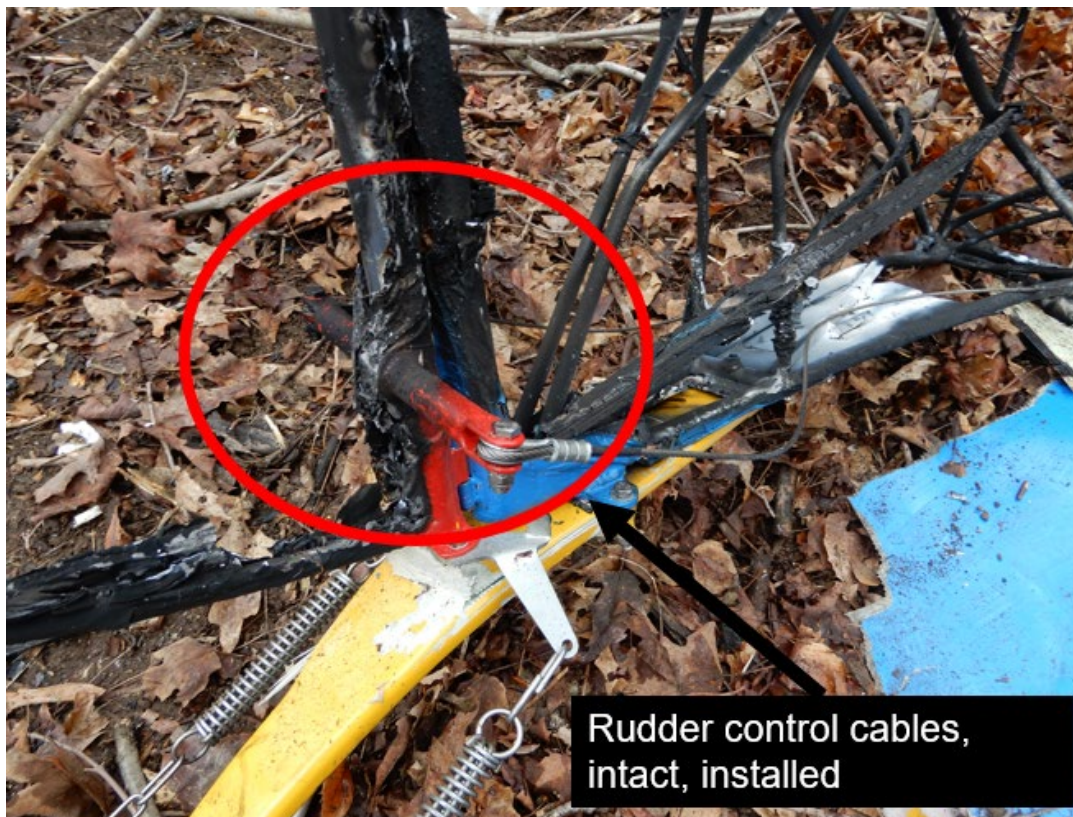
Figure 8: View of the rudder control cables (NTSB Photo)

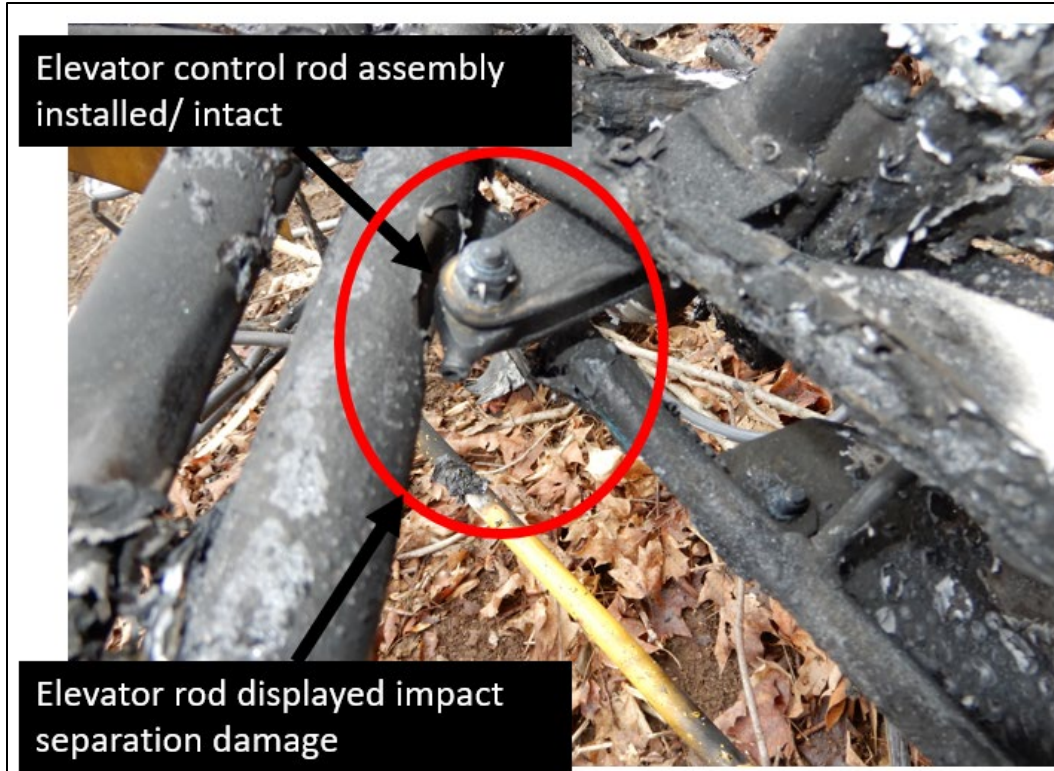
Figure 9: View of the elevator control assembly (NTSB Photo)

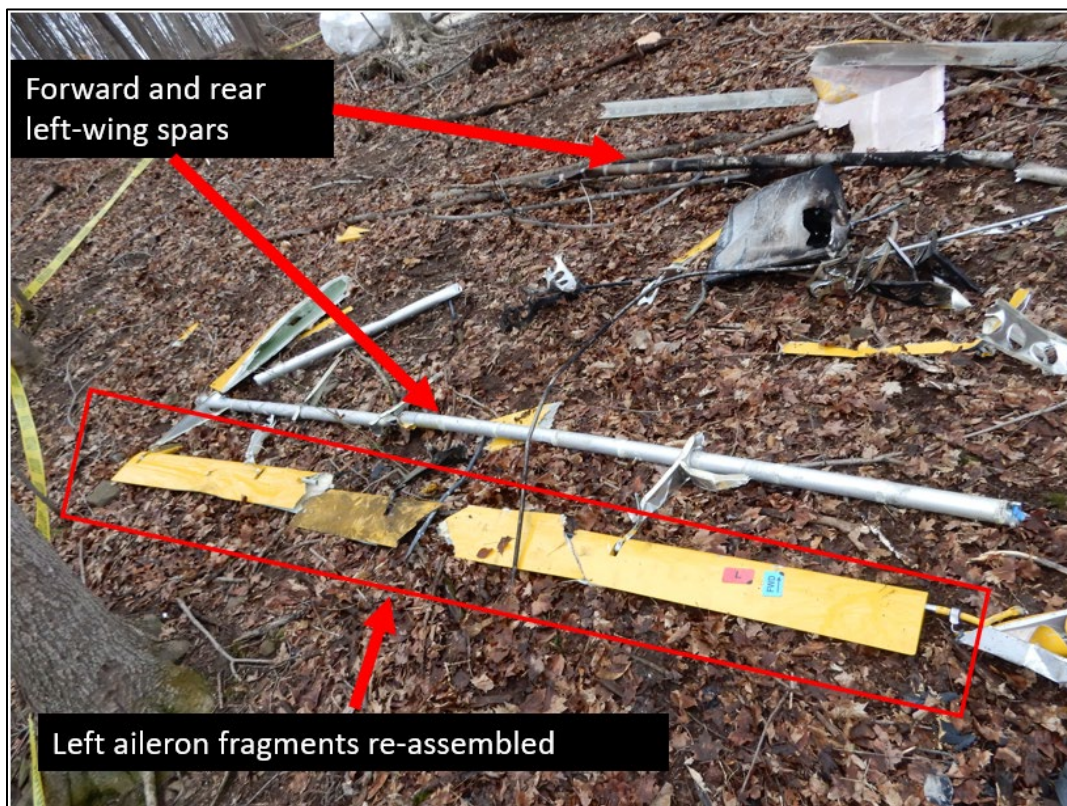
Figure 10: The left-wing components laid out at the accident site (NTSB Photo)

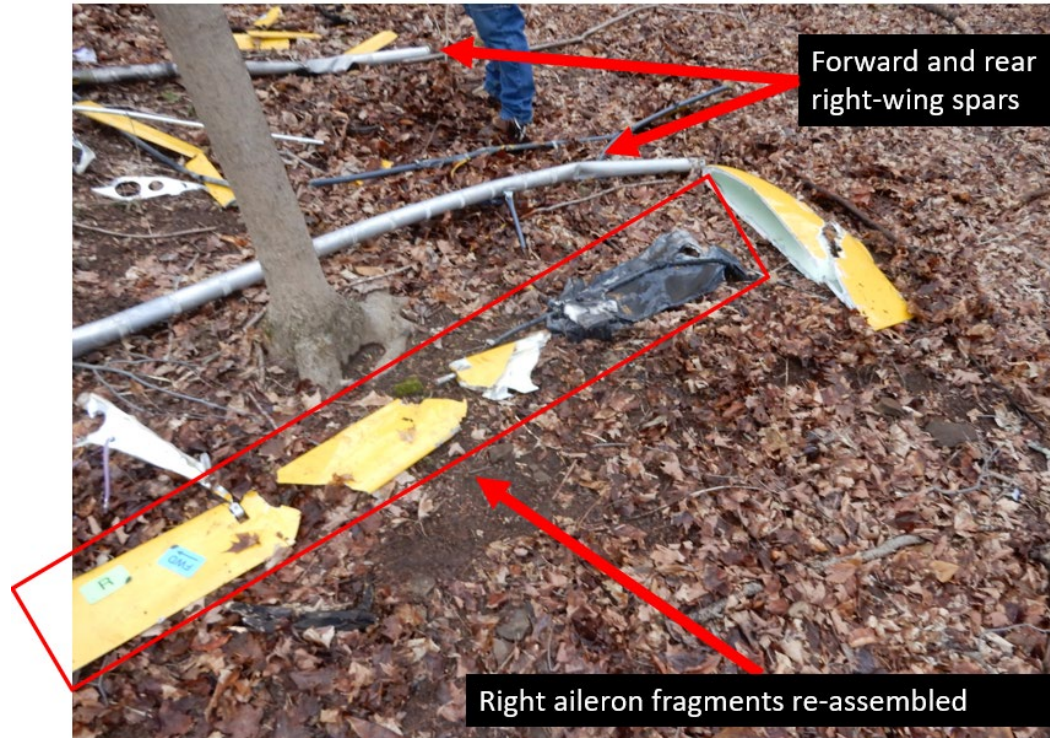
Figure 11: The right-wing aileron fragments laid out at the accident site (NTSB Photo)

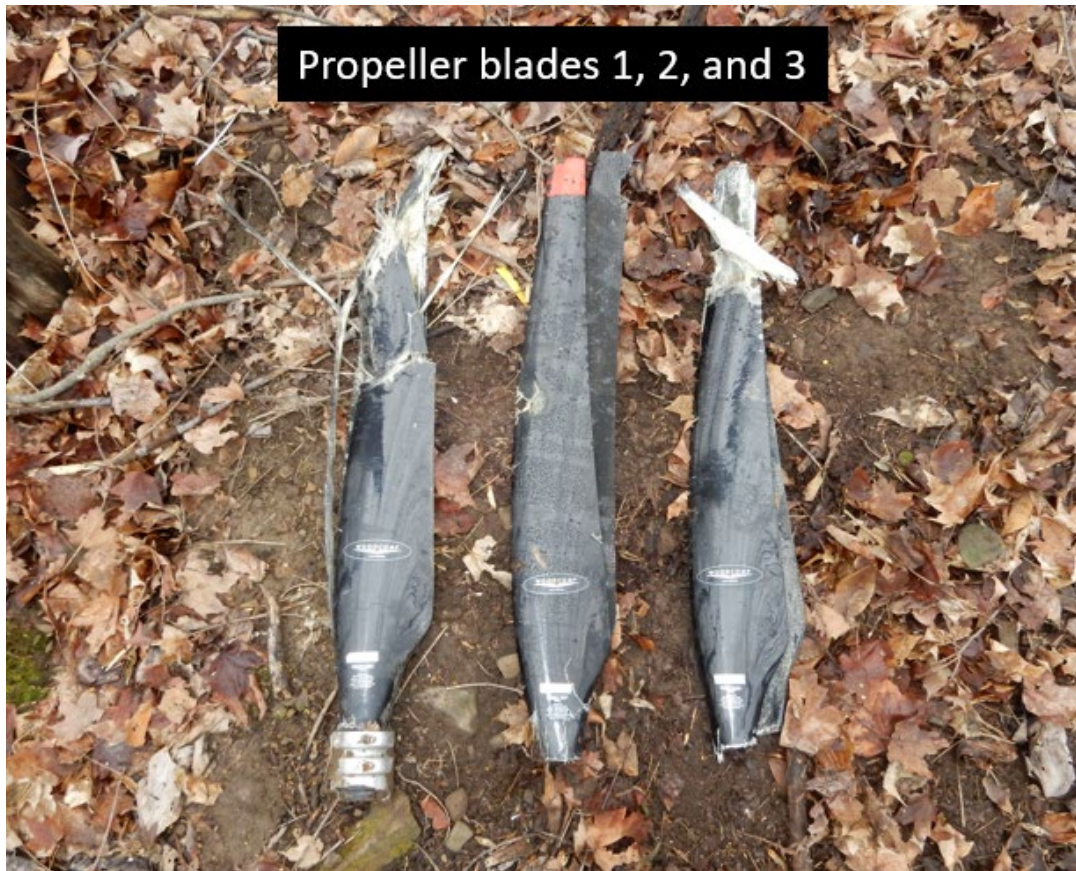
The engine was located under the main wreckage, partially submerged in the terrain. It sustained heavy impact and fire damage; the No. 2 cylinder had partially fragmented and was located submerged in terrain about 5 ft from the remainder of the engine. The propeller hub had fragmented into several pieces. All three propeller blades had

separated from the engine; however, each were located around the main wreckage. The carburetor sustained impact damage but remained partially connected to the engine. The butterfly valve was observed closed and could not be moved, as it also sustained impact damage.

Figure 12: View of all three propeller blades laid out at the accident site (NTSB Photo)

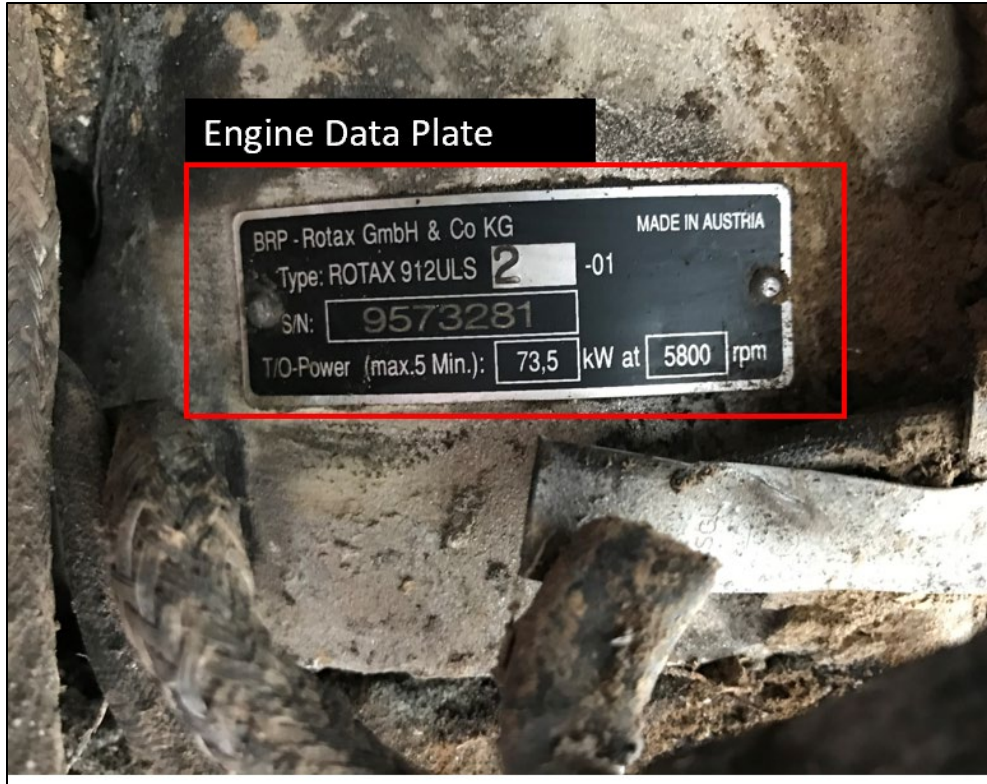
The Rotax Engine Model Number was Rotax 912ULS-2, serial number 9573281. The engine was still attached to engine mount. The intake manifolds were displaced from cylinder heads due to impact damage. The coolant lines were consumed by the post impact fire. The oil radiator was damaged and crushed against engine. The oil lines were consumed by the post impact fire. No fuel pump was located in the debris. The oil pump was impact damaged and no oil filter was attached. The oil tank was crushed in the impact. The ignition system was consumed by the post impact fire.

Figure 13: View of the engine data plate (NTSB Photo)

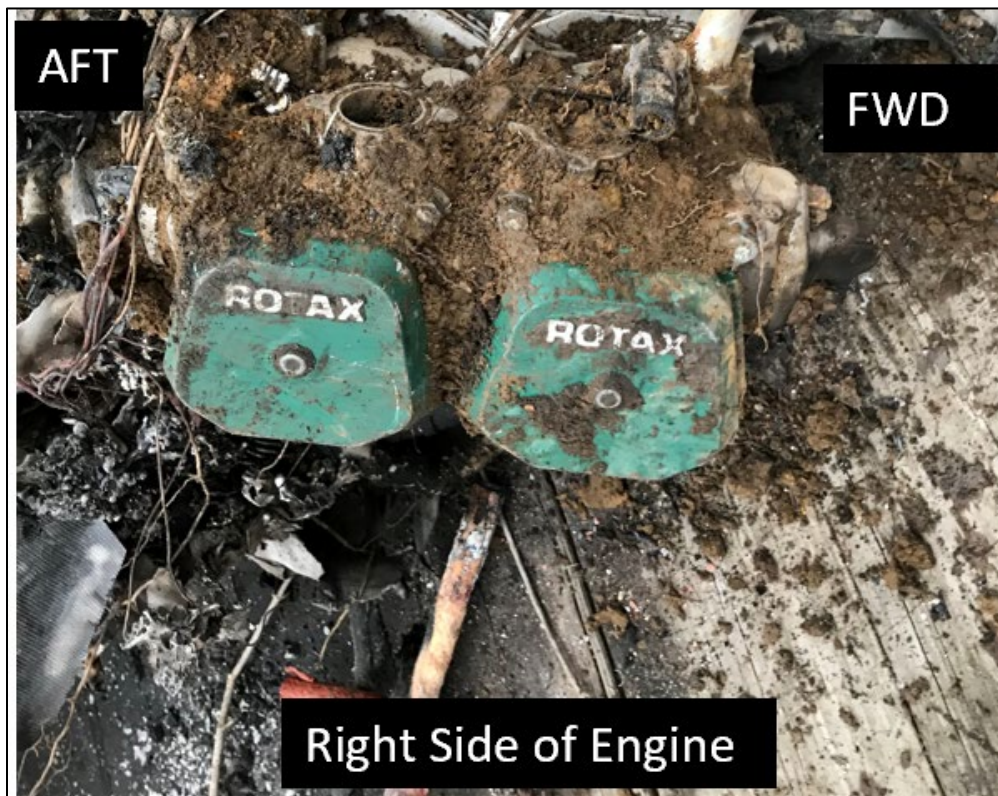
Figure 14: View of the right side of the engine at the accident site (NTSB Photo)

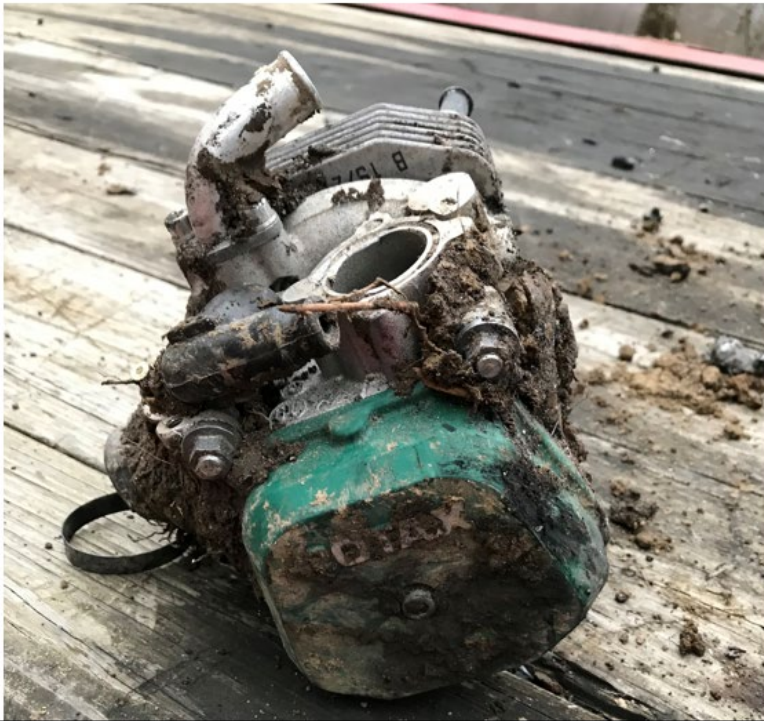
No. 2 Engine Cylinder, Separated from Engine

The Nos. 1, 3-, and 4-cylinder heads and cylinders remained attached to the crankcase and were removed and inspected. No anomalies were observed with the rocker arms, valve springs, or valves. The No. 2 cylinder head remained attached to its cylinder, but the cylinder had separated from the engine. The cylinder head was removed and inspected, and no anomalies observed with its rocker arms, valve springs, or valves.

Figure 15: View of the No. 2 cylinder, found separated from the engine (NTSB Photo)

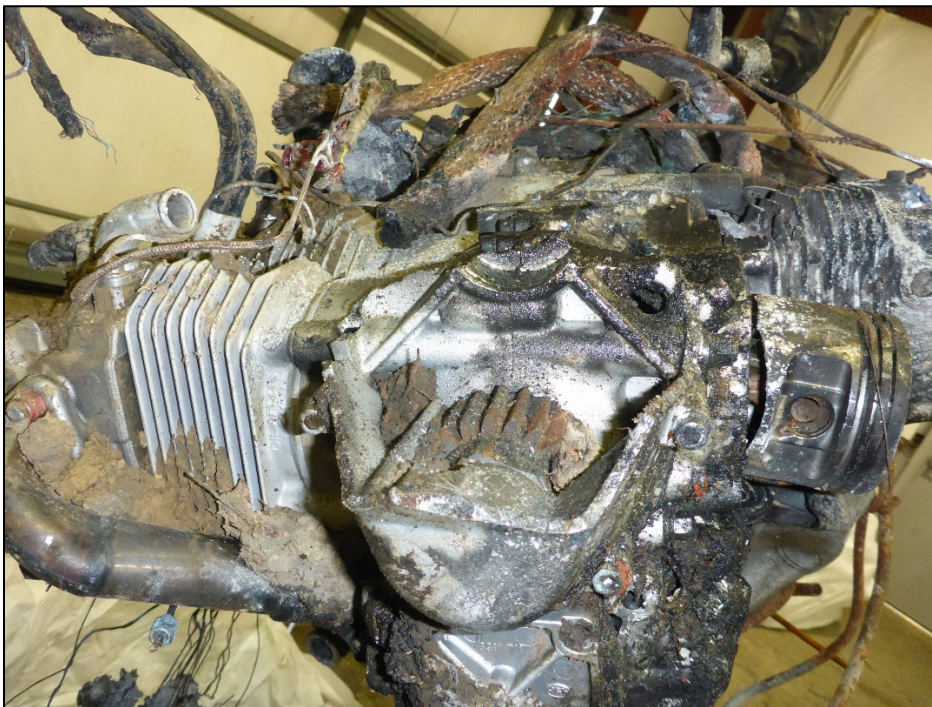
Figure 16: View of the accessory section of the engine.
