AIRFRAME AND ENGINE EXAMINATION

NTSB ACCIDENT NUMBER: ERA21FA189

AIRCRAFT REGISTRATION: N4303G

ACCIDENT LOCATION: Brownsville, TN

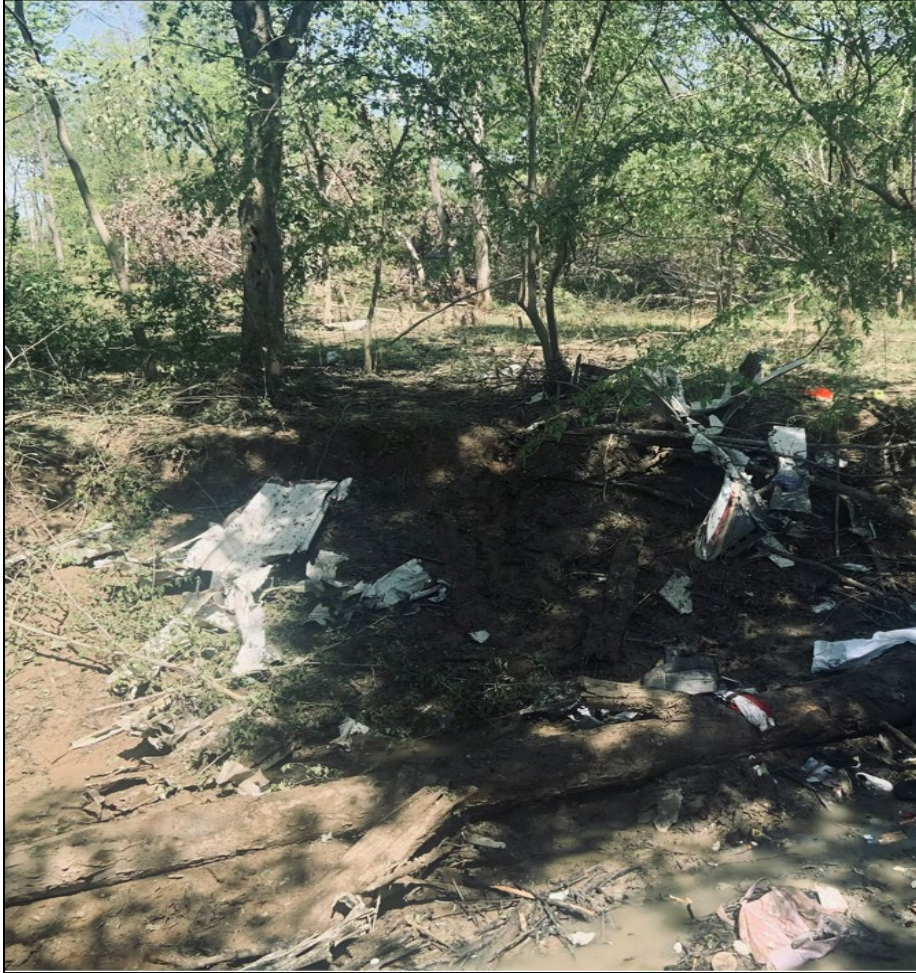
The main wreckage was located partially submerged in a creek and along a creek bed. All major components of the airframe and engine were located within about a 100 ft debris path oriented on an easterly heading. The engine was located multiple feet below the surface of mud and water. An excavator was required to dig down several feet into thick mud to recover the engine. The propeller separated from the engine but was located within a few feet of the main wreckage. The wreckage was highly fragmented. There was no evidence of a post-crash fire. A faint smell of fuel was reported from one of the first responders, while the airplane was being lifted from the creek.

Photo 1: View of the fragmented wreckage at the accident site (Photo Courtesy of FAA)

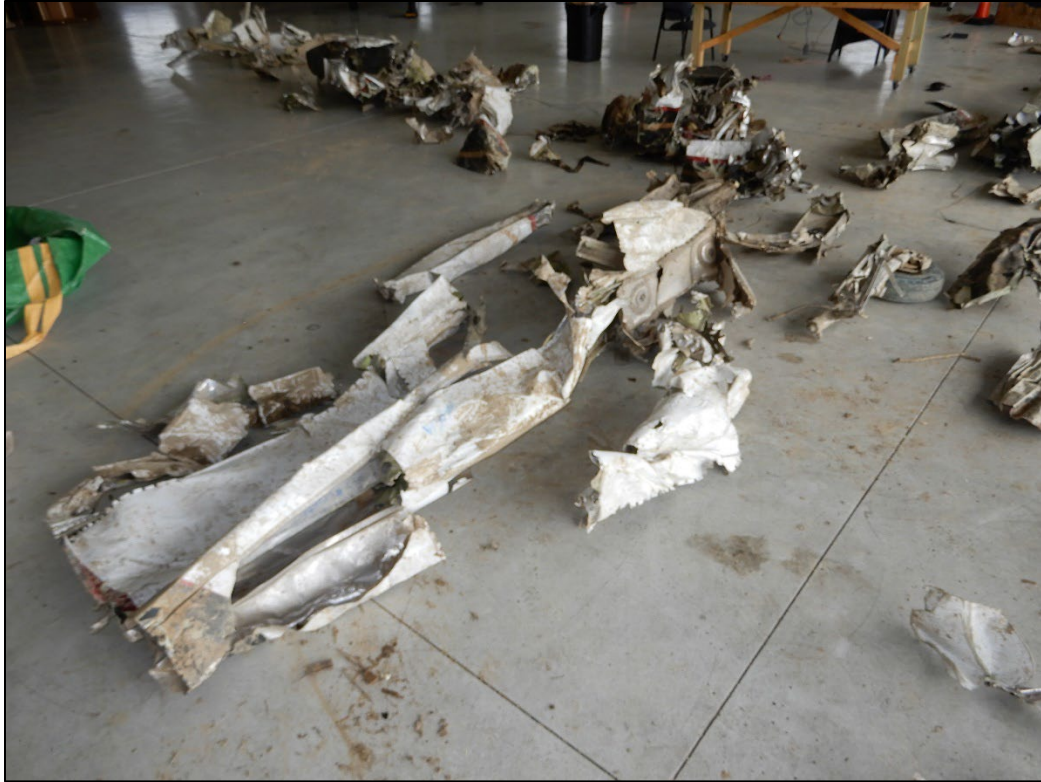
The right wing was heavily fragmented. The right flap outboard 58 inches was located and had separated from the wing. The inboard 26 inches were not located. The full span of the right aileron was located and had fragmented and separated. The right aileron balance weight was not located. The aileron bell crank was pulled from its support structure. The aileron cables remained attached and were cut by the recovery crew. There were no repeated contacts on the aileron travel stops. The full tank was fragmented. The fuel cap receded into its receptacle. The pickup screen was free of obstruction. The main gear separated. The right landing gear actuator was not located. All fragmented surfaces on the right wing were consistent with impact damage overload.

Photo 2: View of right wing fragments

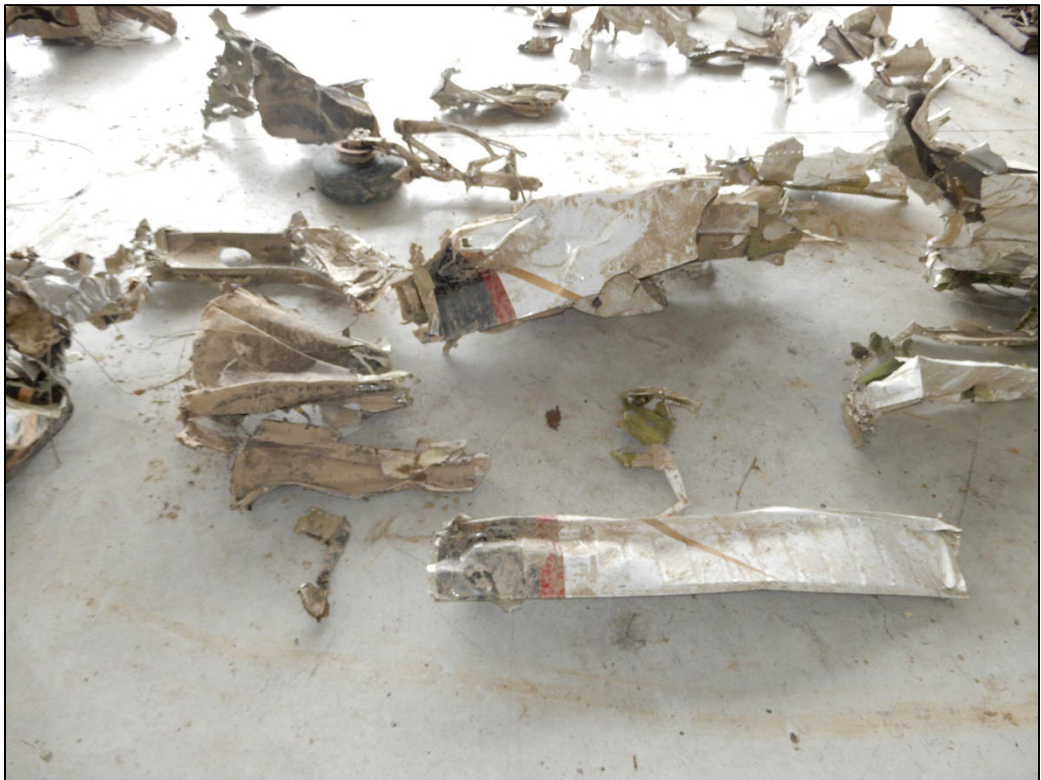
The left wing was heavily fragmented. The left flap separated and was impact damaged. The left aileron remained attached and fragmented into two sections. The left aileron balance weight was not located. The left bell crank impact damage and cables remained attached and separated at the fuselage area. The cable ends displayed tension overload. The left aileron travel stops were not located. The pitot mast was not observed. The lift detector was impact

damaged and separated. The left fuel tank was fragmented, and the cap receded into the receptacle. The pickup screen was clear. The left main landing gear was impact damaged. The actuator was consistent with an UP selection. The nose gear displayed impact damage and separated. The nose gear actuator was not located.

Photo 3: View of left wing fragments

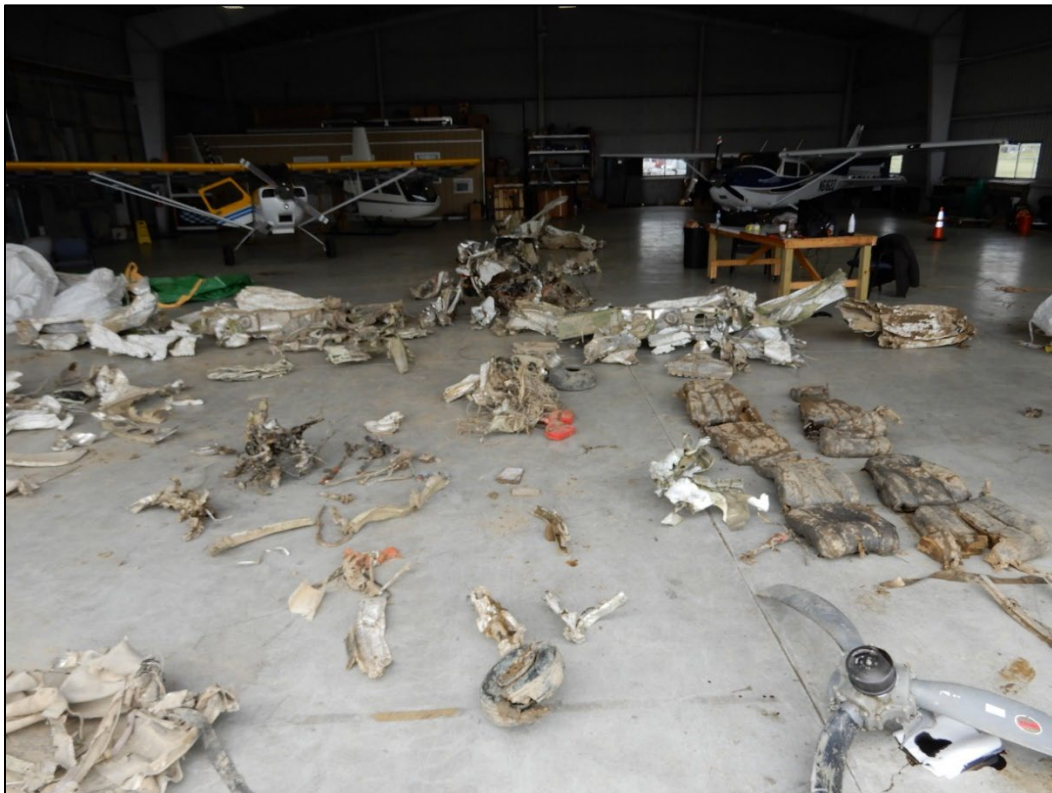
Photo 5: Overview of the fragmented wreckage during examination of wreckage

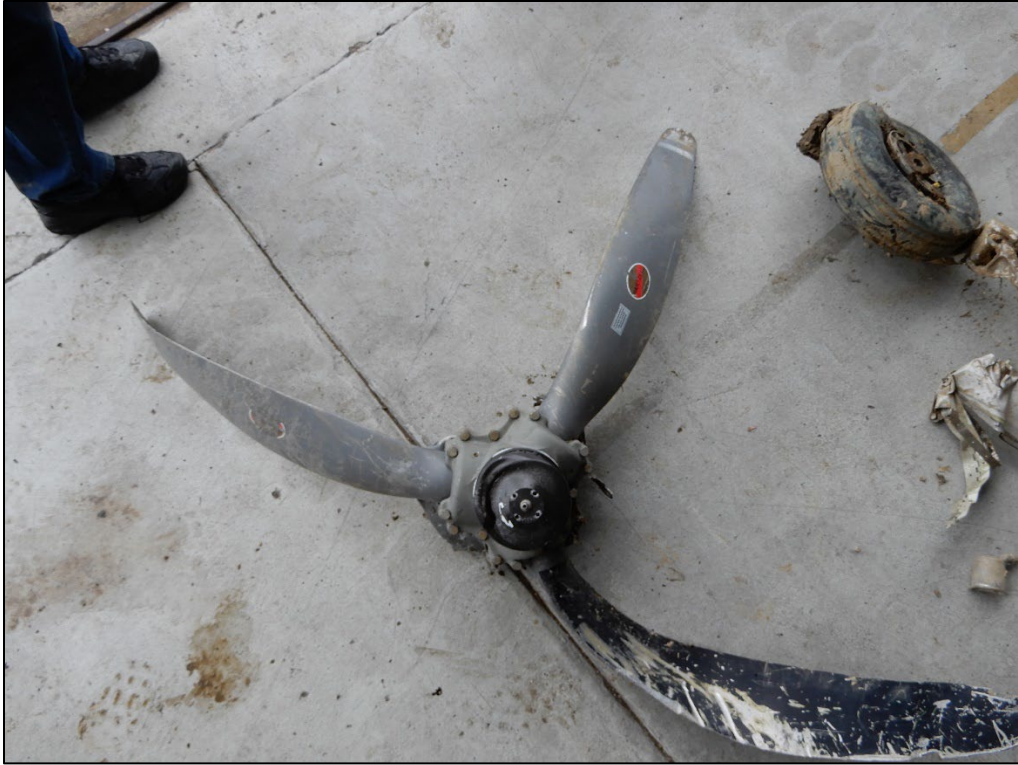
The propeller departed from the engine and was found co-located with the engine. The flange exhibited a 45-degree fracture consistent with overload. Partial s-bending, leading edge gouges, and chord wise scratches were observed on the propeller.

Photo 6: View of the propeller

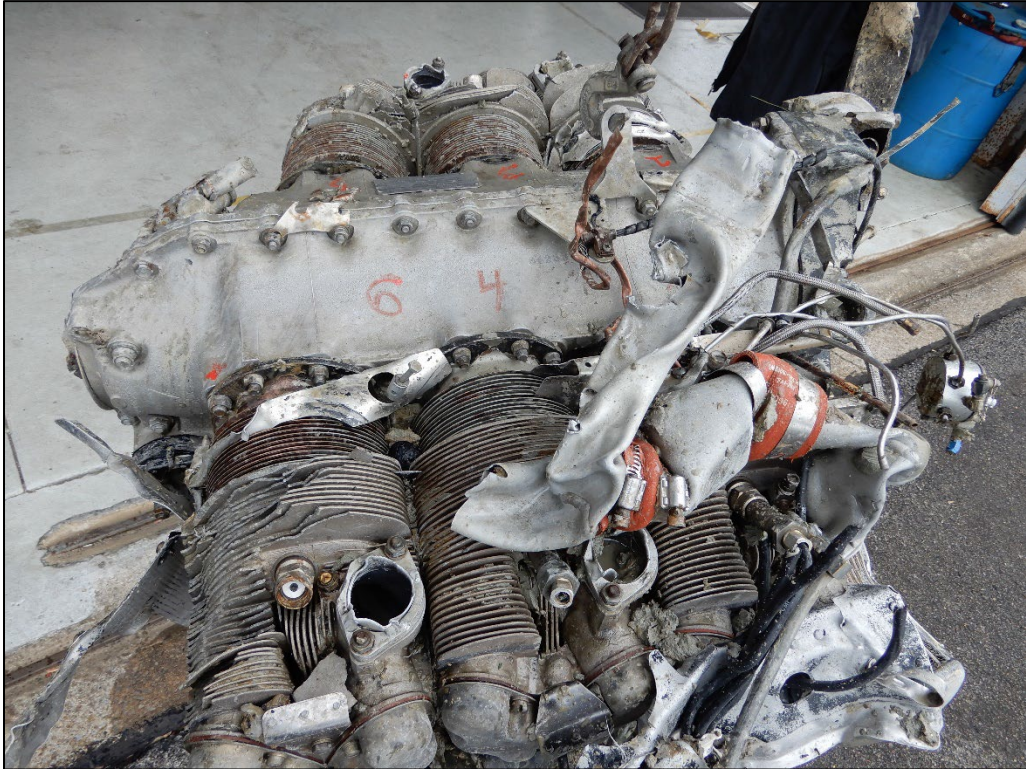
The engine displayed significant impact damage. The crankcase exhibited a crack above the No. 1 cylinder. The crack extended to an area of significant impact damage. The rear section of the engine was heavily fragmented; the internal gears to the engine were exposed at the aft section of the engine. The drive gears remained intact. The turbocharger remained attached to

the engine. Signs of rotational scoring and bending with several fan blades were observed.

Photo 7: View of the engine after thick mud had been removed

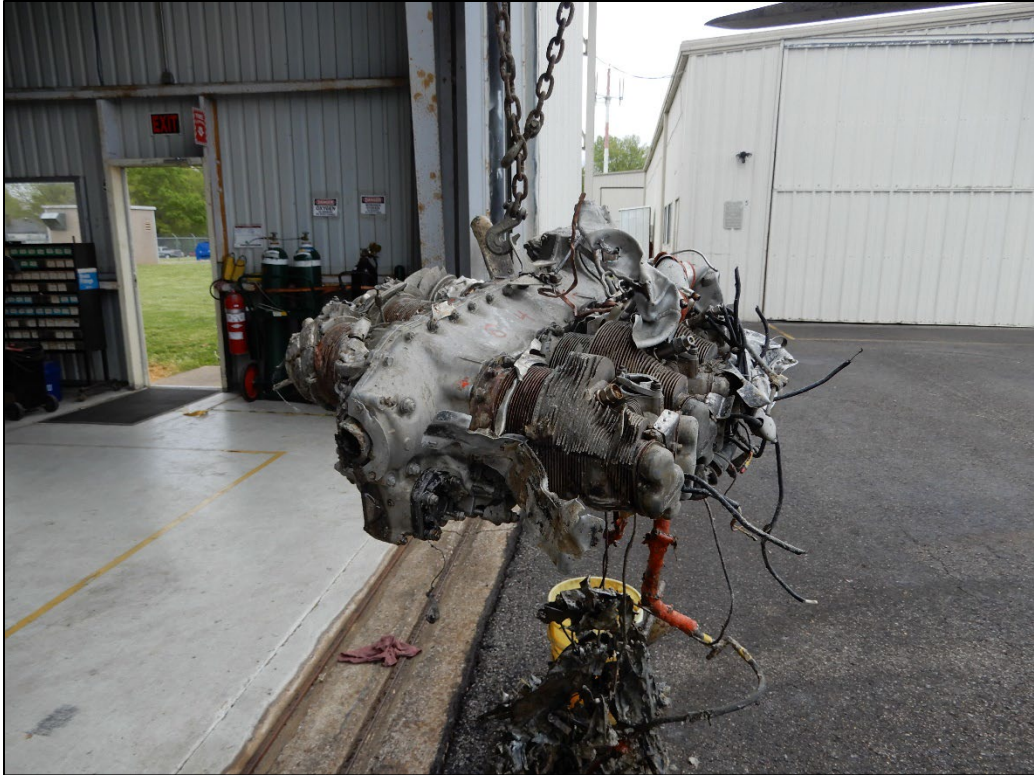
Photo 8: Additional view of the engine

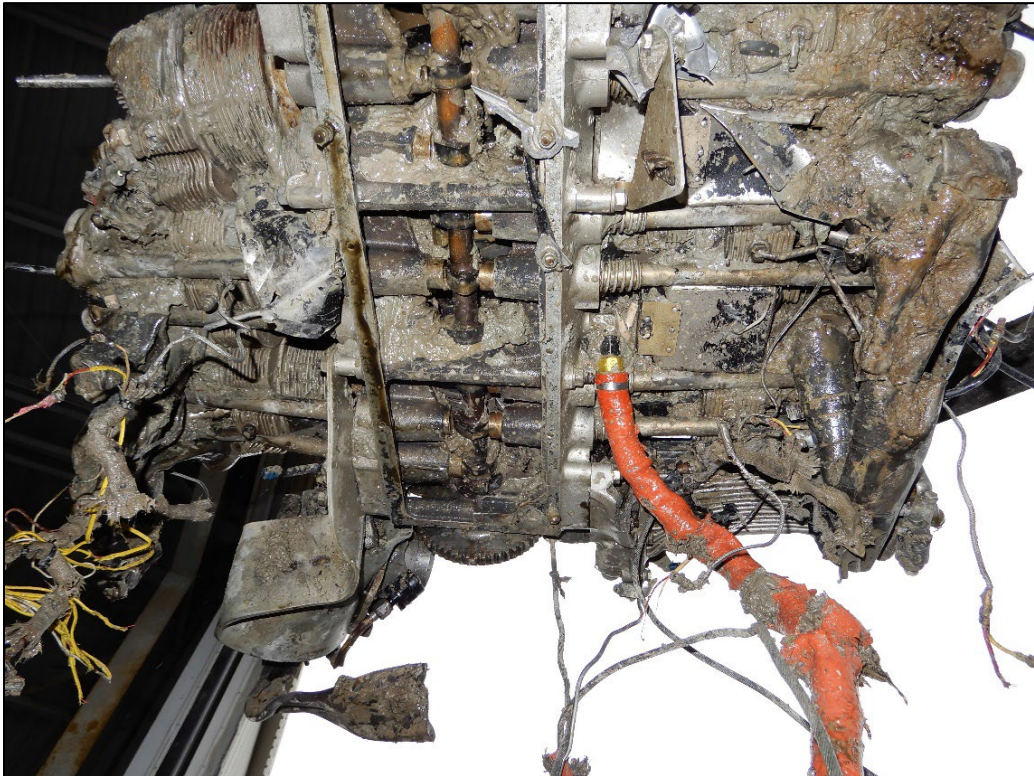
Photo 9: View of the underside of the engine
