NATIONAL TRANSPORTATION SAFETY BOARD

AIRFRAME AND ENGINE EXAMINATION

WPR22FA361

Location: Sahuarita, Arizona
Date: 9/28/2022
Aircraft: Grumman AA5B / N74349
NTSB IIC: Fabian Salazar

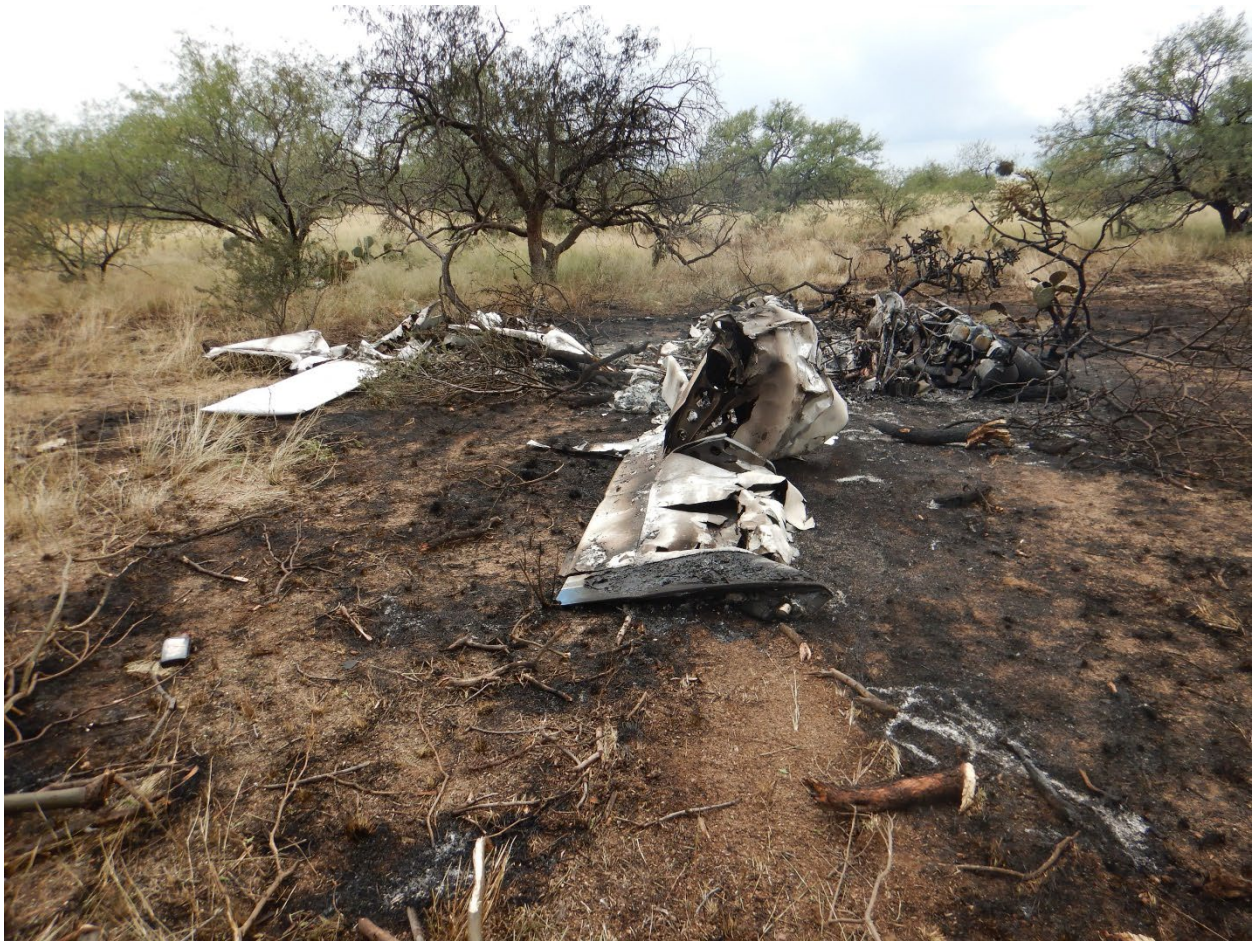
Figure 1. View of N74349 at the accident site, showing the right wing, aileron, flap, the right side of the empennage and the right side of the engine.

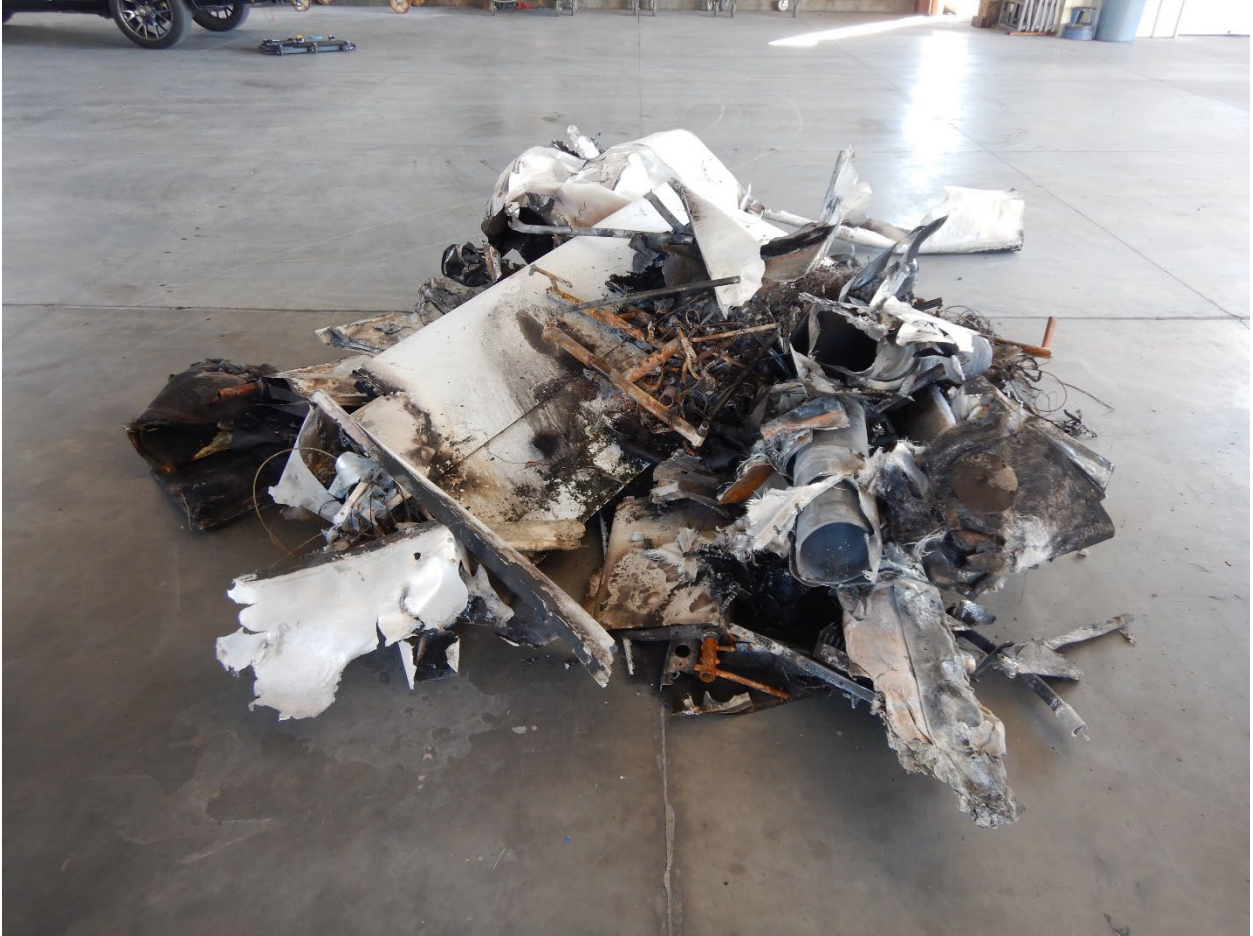
Figure 2. 1st bag wreckage items including wing, cabin, and empennage components.

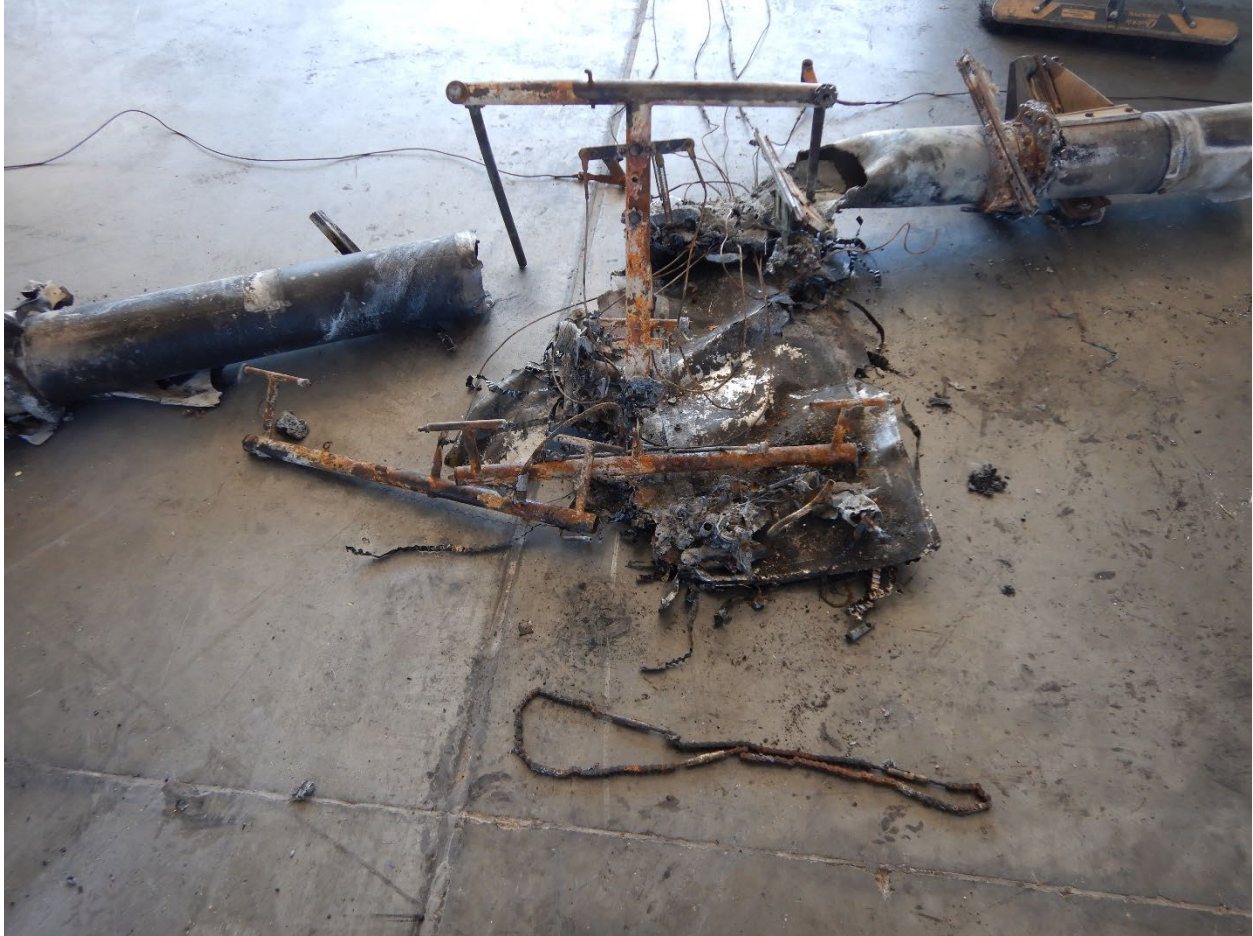
Cockpit Documentation. The entire cockpit area except for one pair of seat rails was thermally destroyed. The entire instrument panel was thermally destroyed. The few flight instruments found in the wreckage were all destroyed and unreadable.

Figure 3. Cabin area with control yoke, and rudder pedal assembly.

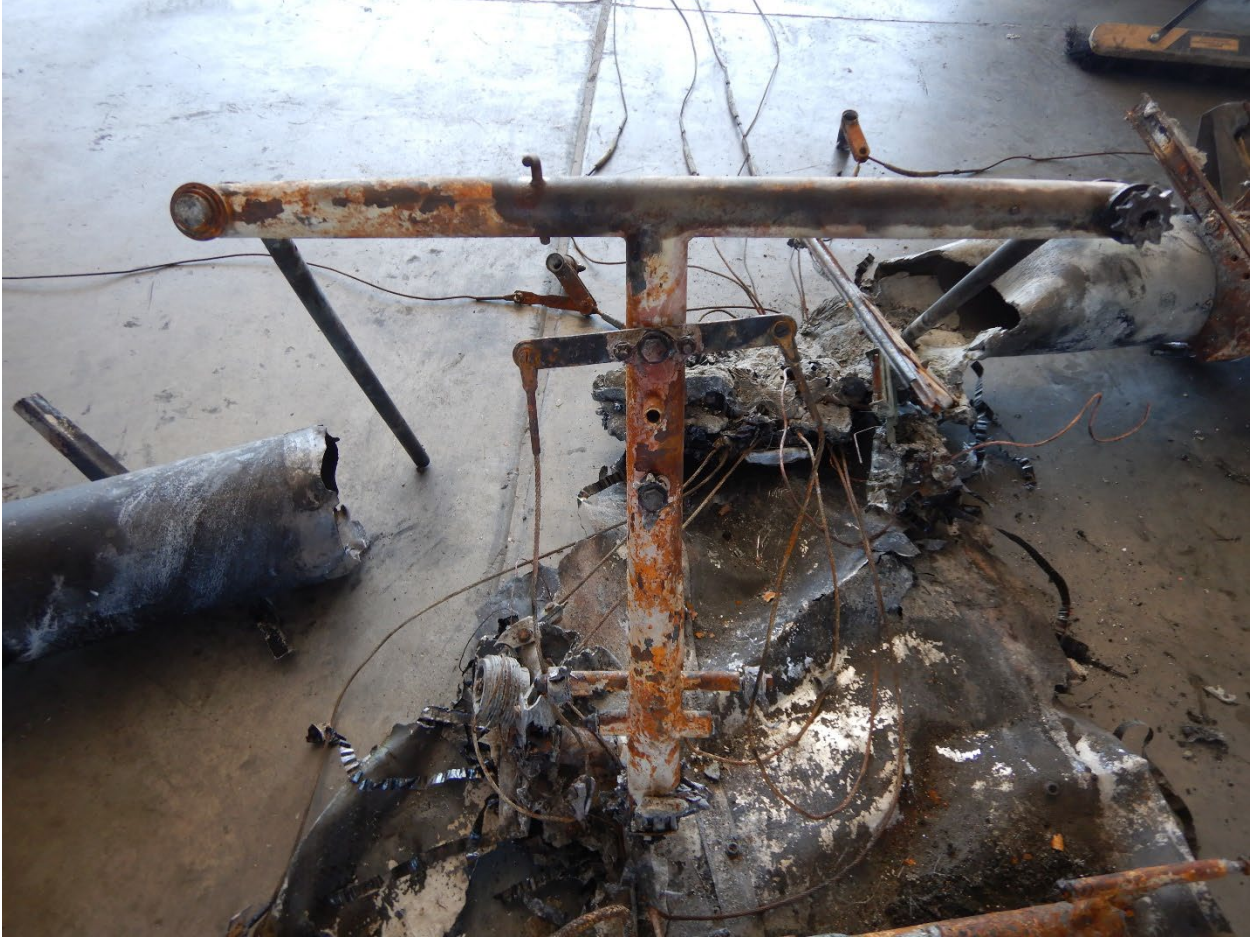
Figure 4. Control yoke assembly with control cables attached.

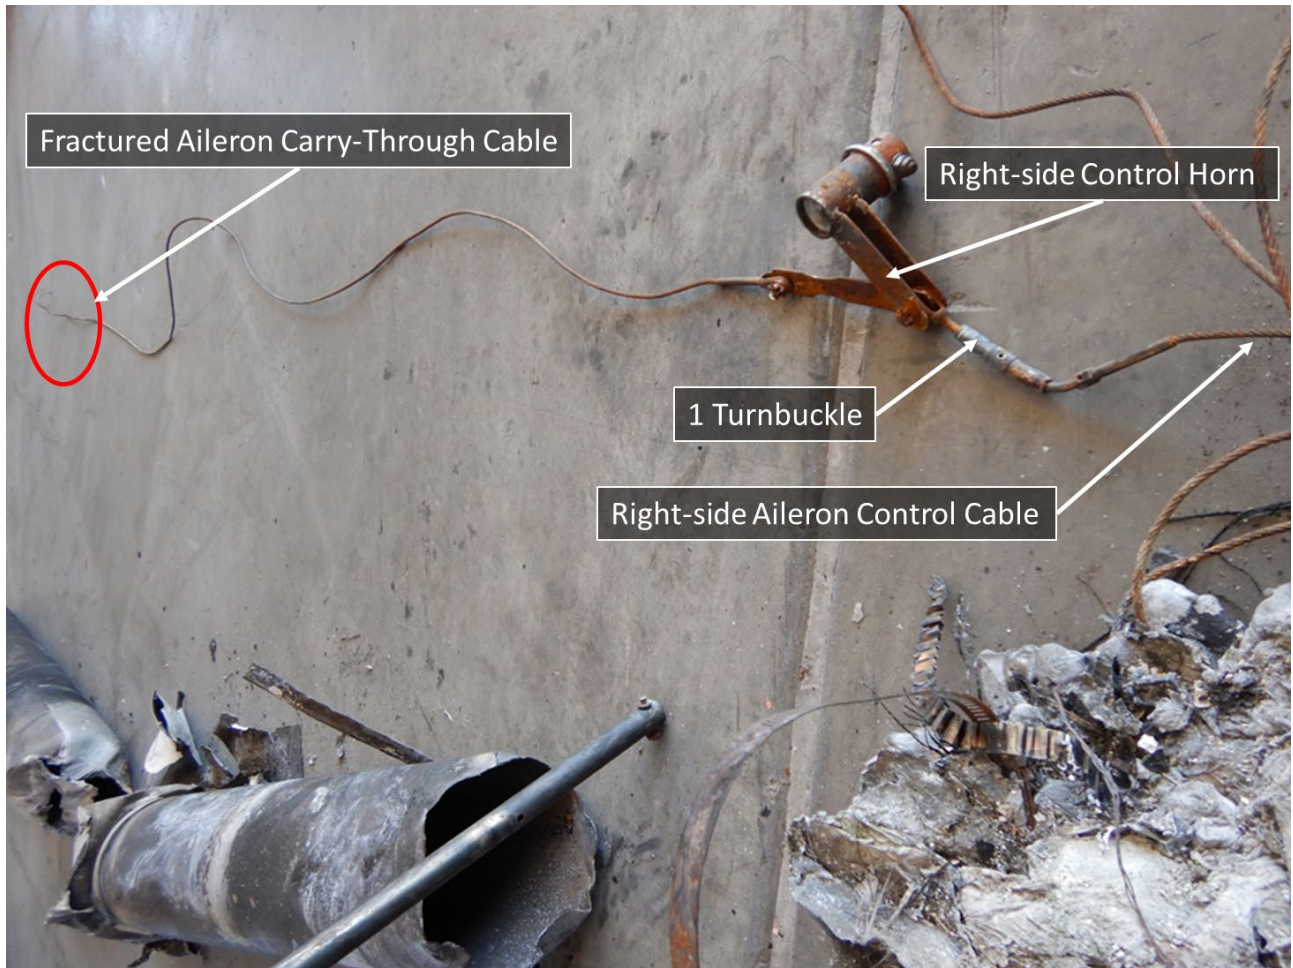
Flight control continuity was not fully established due to the thermal damage to the airframe. Flight control continuity for the ailerons was established from the control yoke to the control horns. The torque tubes to the ailerons were reduced to ash. The right side was identified as the side with one turnbuckle at the carry-through cable. The left side was identified as the side with two turnbuckles, one on the control cable side and one on the carry-through cable side of the control horn. The carry through cable exhibited an anomaly near the carry-through pulley. There was a fracture that appeared to have occurred at two different locations about 5 inches apart. That fracture did not appear to be from the recovery effort. The fractured area was removed and shipped to the NTSB Materials Lab for further examination.

Figure 6. Image of the right-side aileron control cable system. The fractured end of the carry-through cable is circled in red.

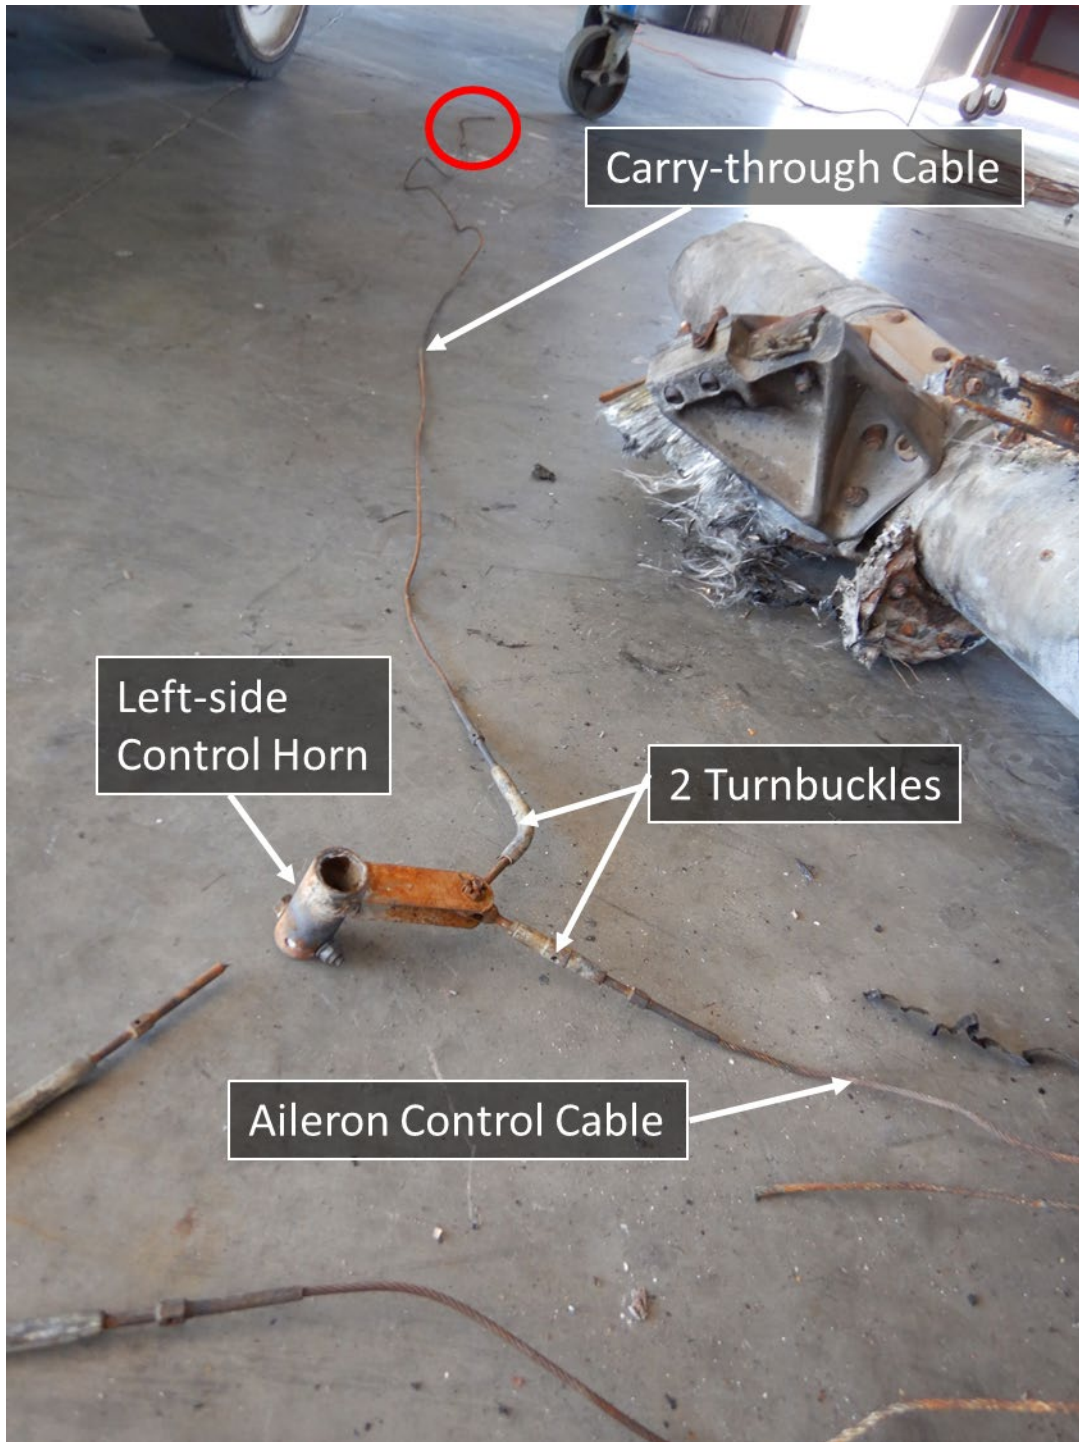
Figure 7. Left-side aileron control cable system. The carry through cable break is circled in red.

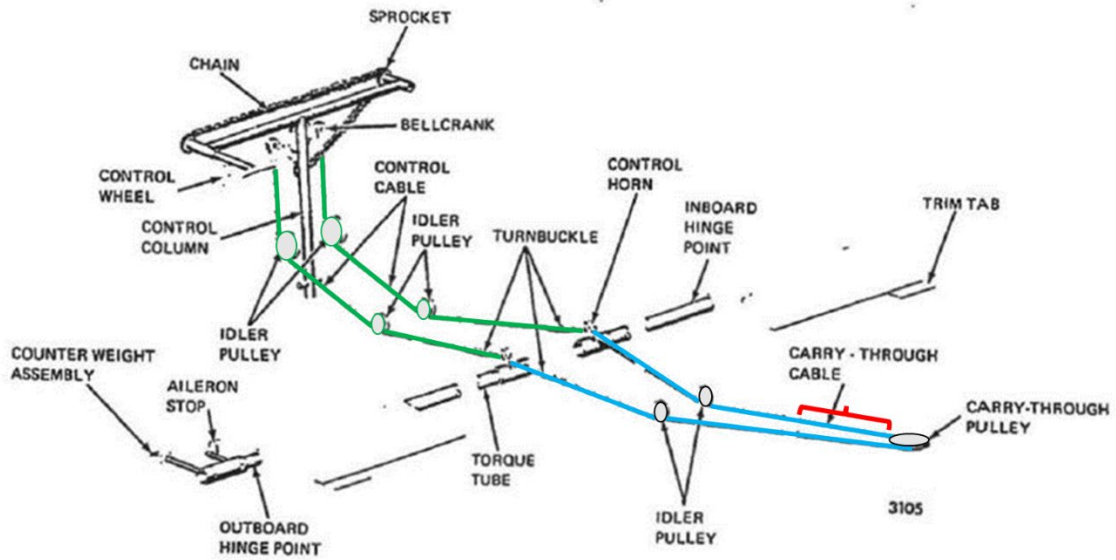
Figure 8. Illustration of the aileron control system. The control cables are highlighted in green, the carry-through cable is highlighted in blue, and the estimated location of the break is identified in red. Illustration courtesy of the AA-5 Series Maintenance Manual.

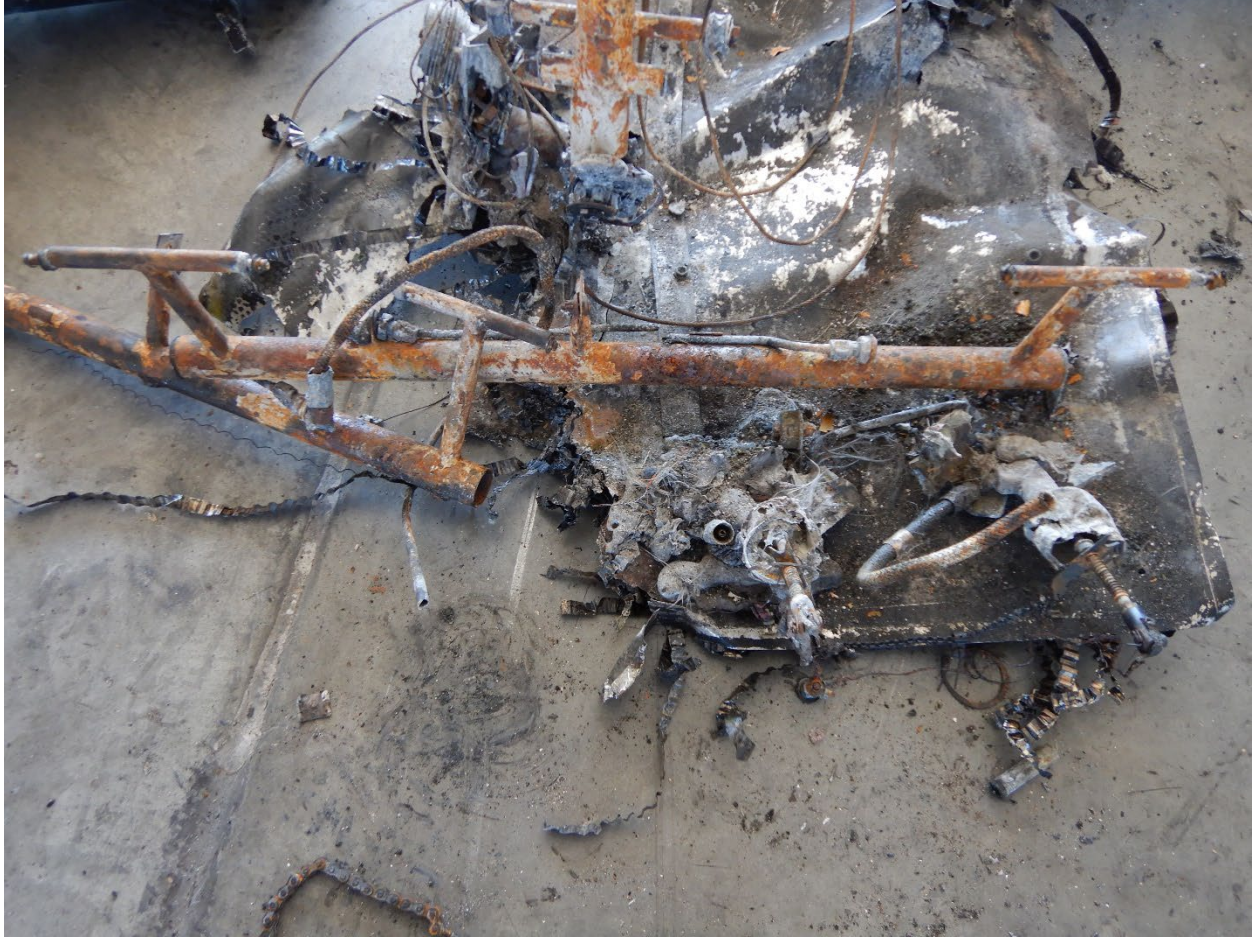
Figure 9. Rudder pedal assembly with control cables attached.

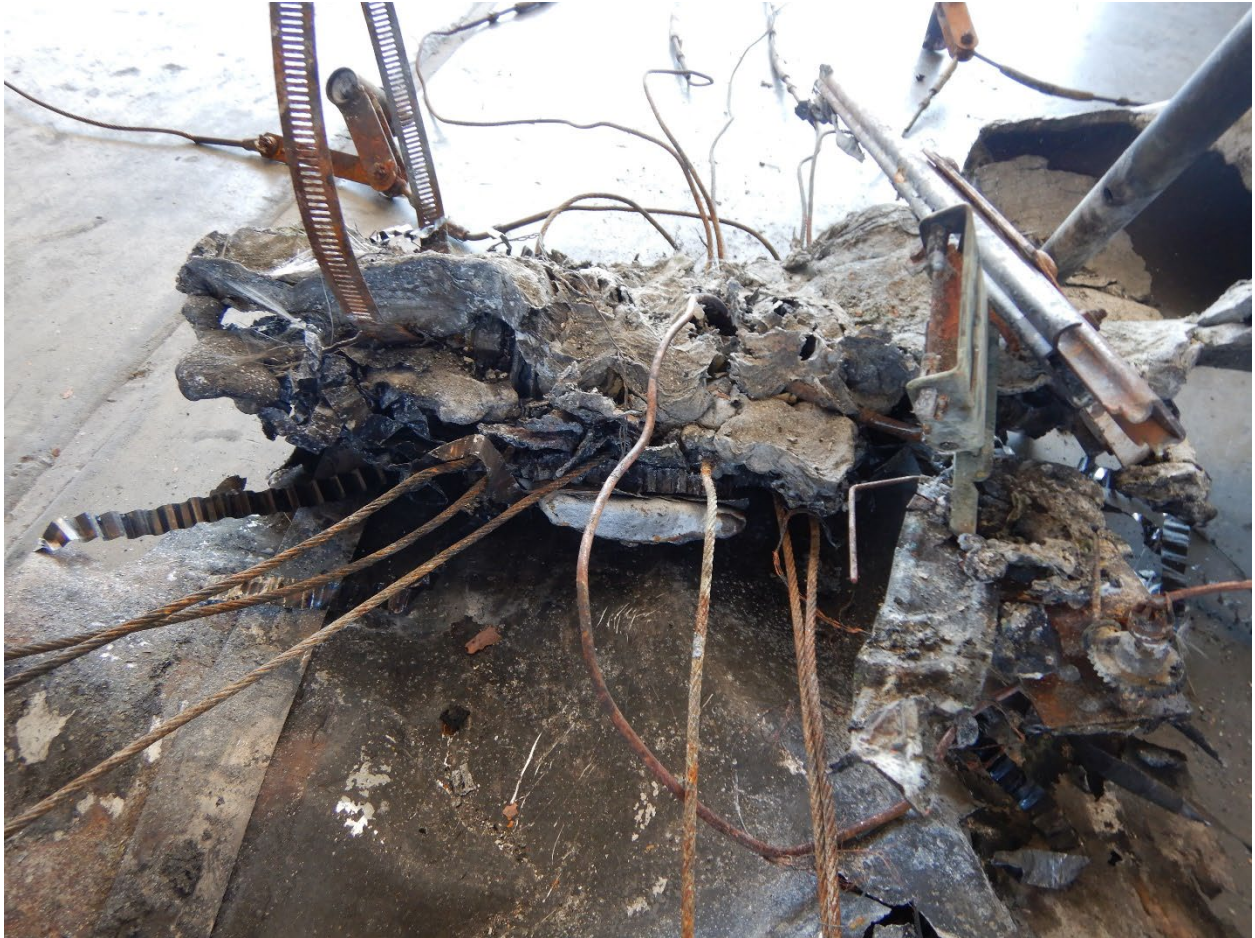
Figure 10. Flight control cables from the control yoke and the rudder pedals running through solidified aluminum.

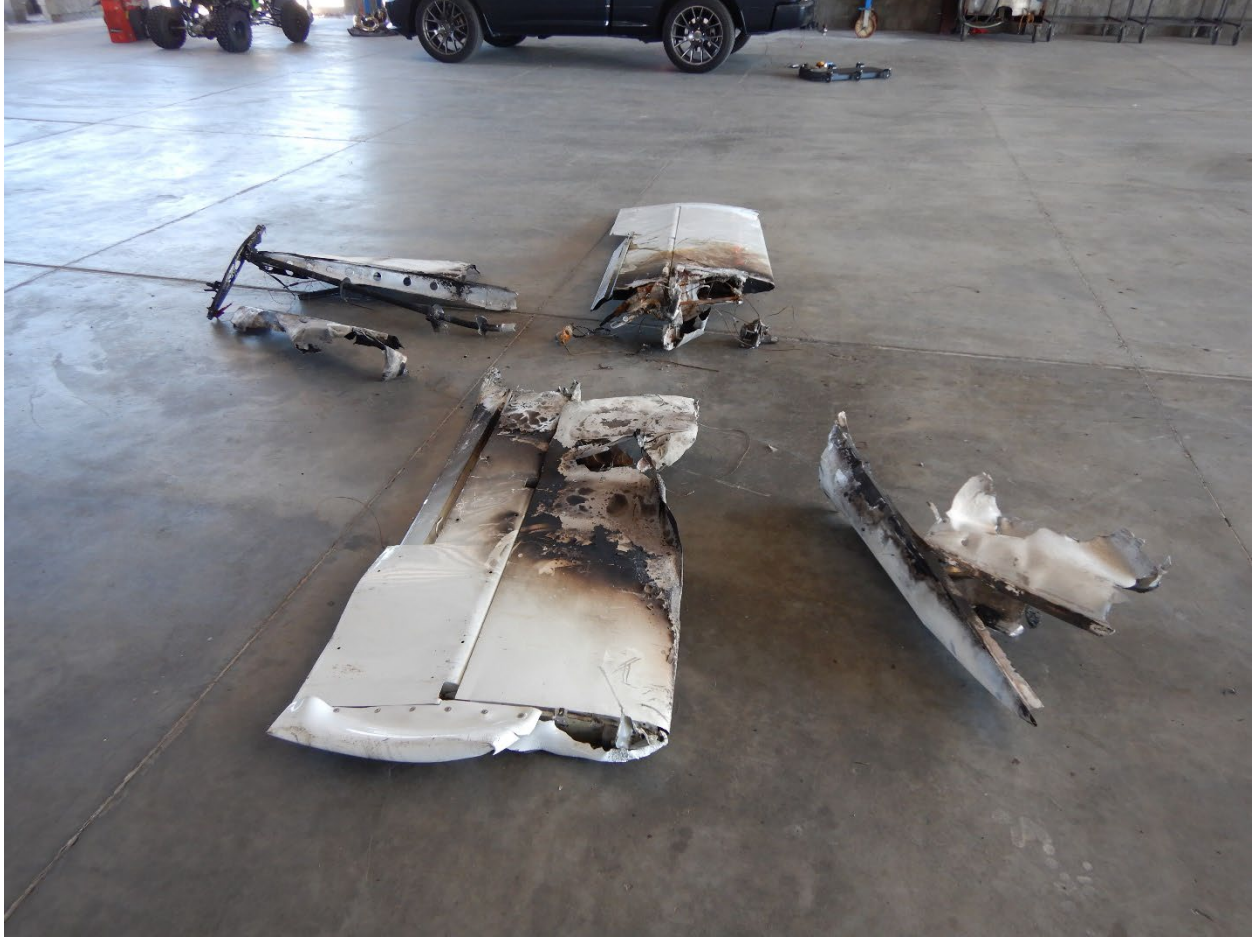
The empennage was thermally damaged. The vertical stabilizer was thermally damaged. One side was completely burned away. The rudder was thermally damaged with only a small amount of sheet metal and the metal control rod remaining. The base of the rudder with the control cables remained but was partially separated due to the thermal damage.

Figure 11. Right-side view of the empennage.

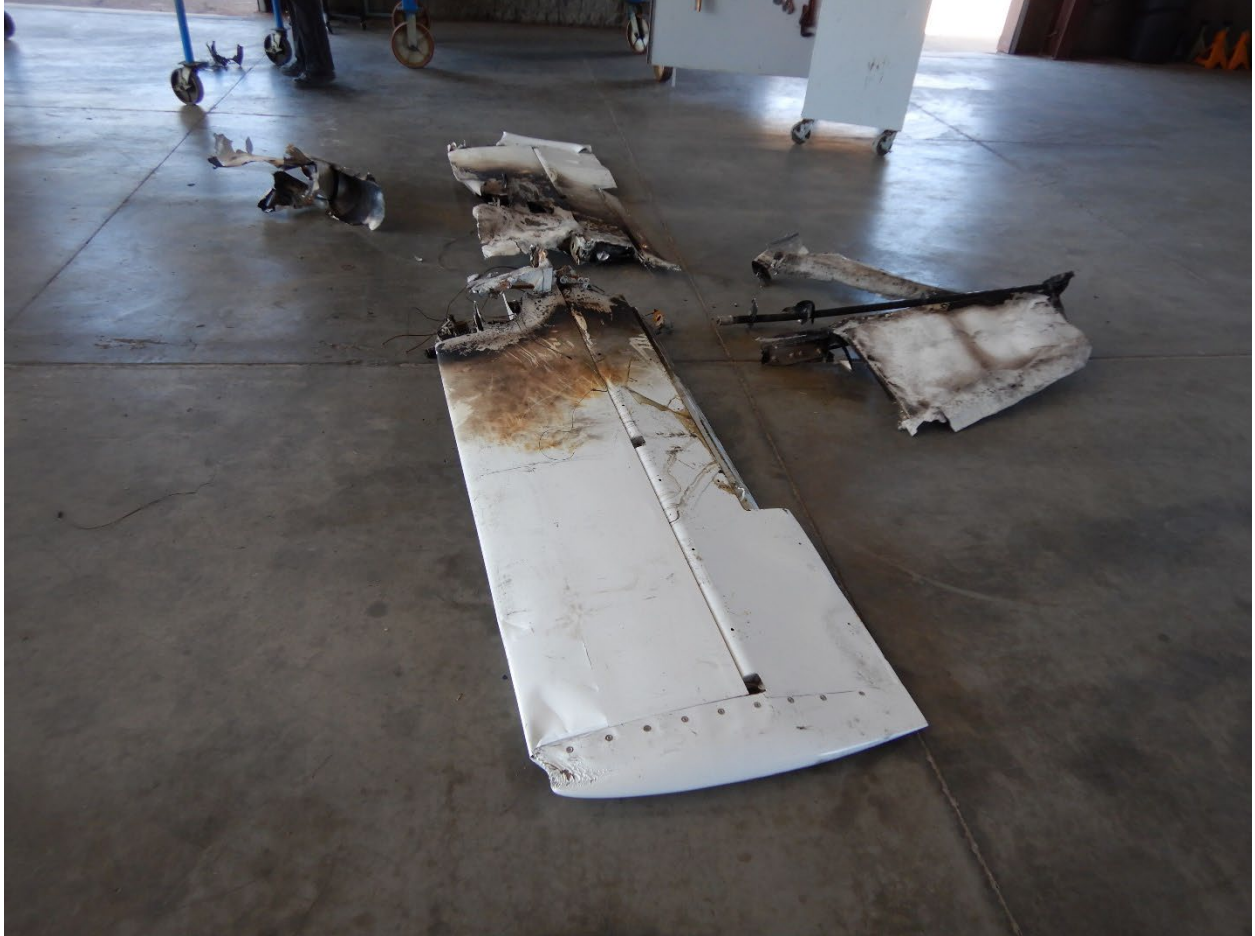
Figure 12. Left-side view of the empennage.

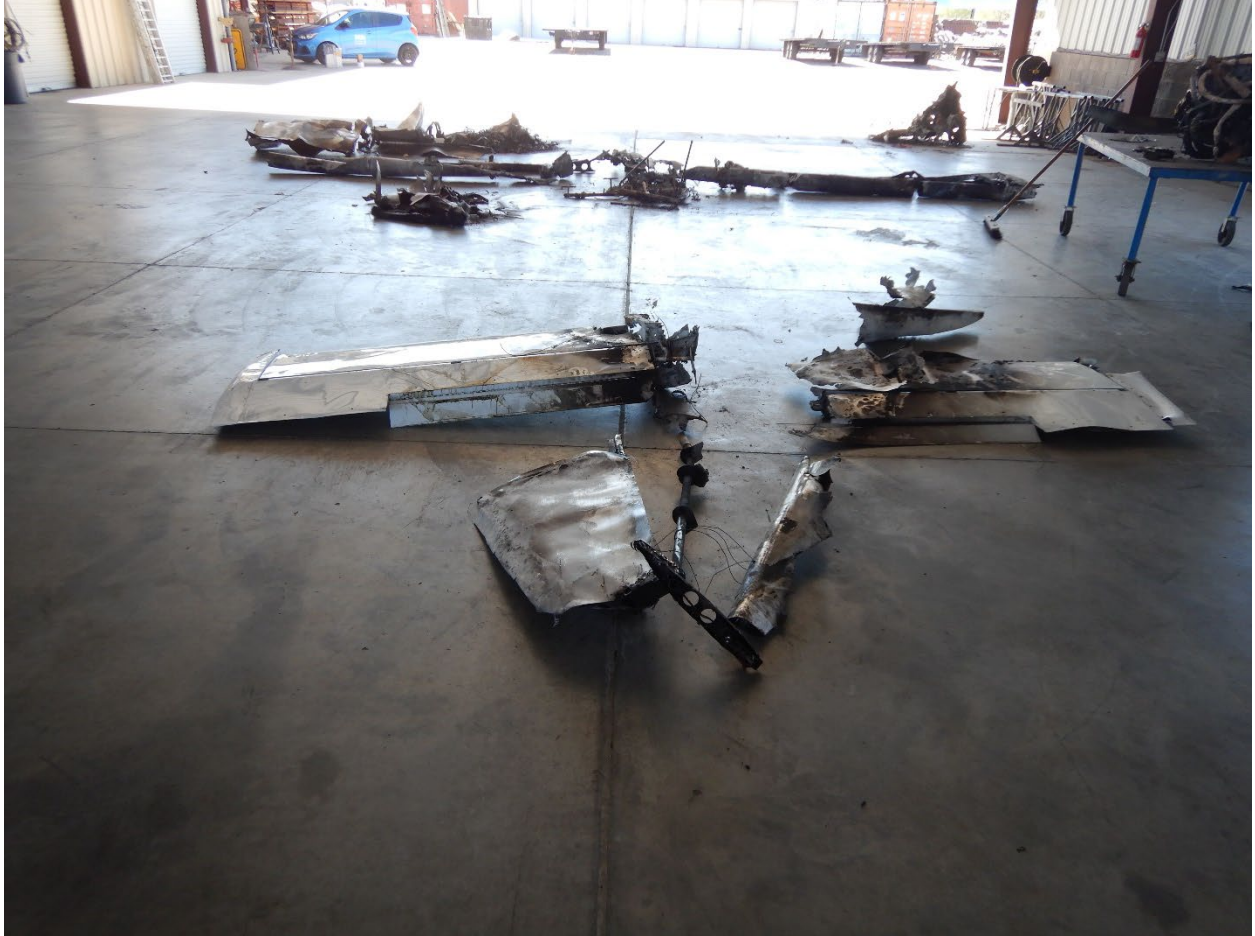
Figure 13. Rear view of the empennage, showing the rudder and vertical stabilizer.

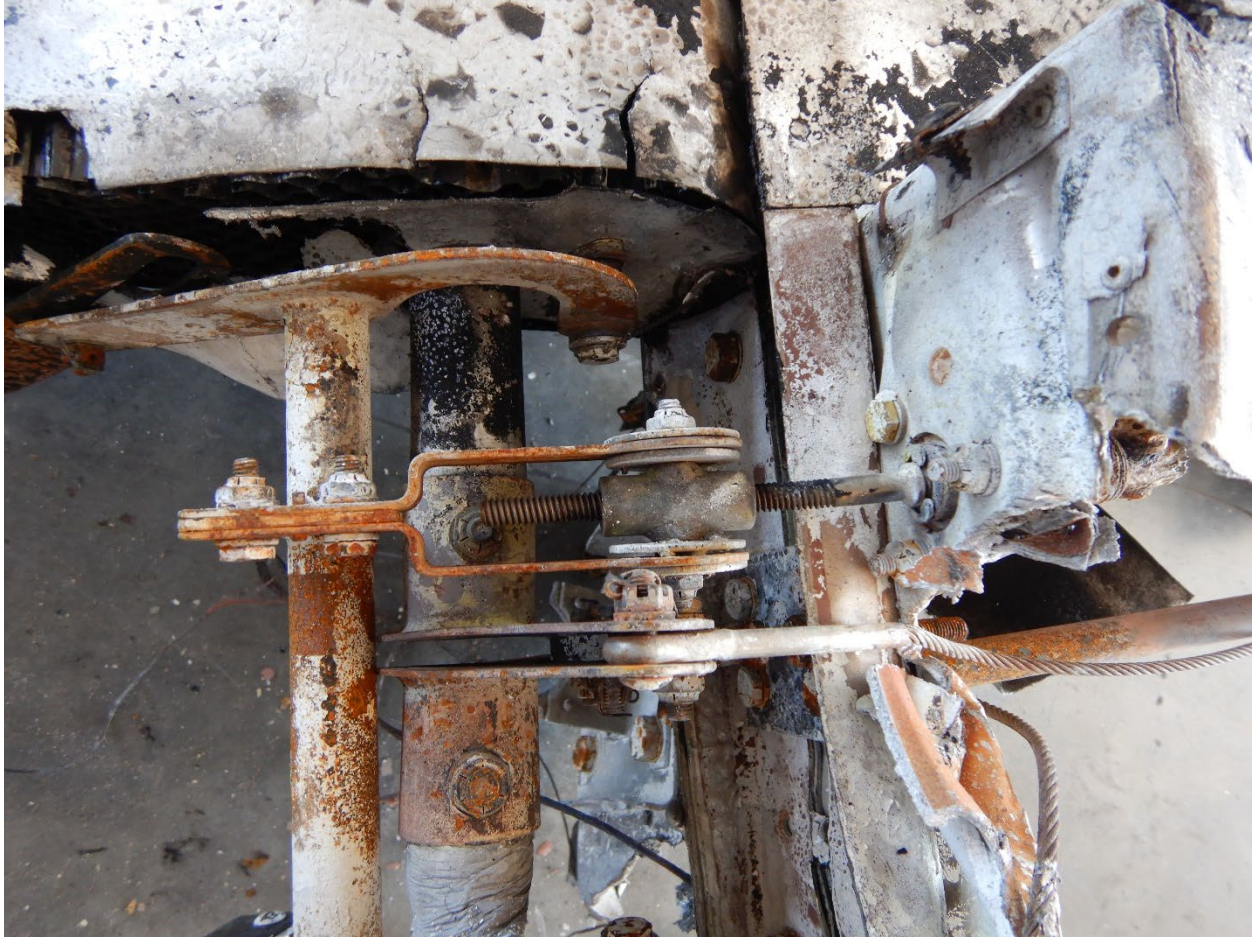
The right horizontal stabilizer and right elevator were thermally damaged. And separated from the airframe. The right-side elevator trim remained secured to the elevator. The left side horizontal stabilizer and left-side elevator were thermally damaged and separated from the airframe. The left-side elevator trim remained secured to the elevator. All control cables to the elevators and rudder horn remained secured to their respective mounts.

Figure 14. Center section of the elevators.

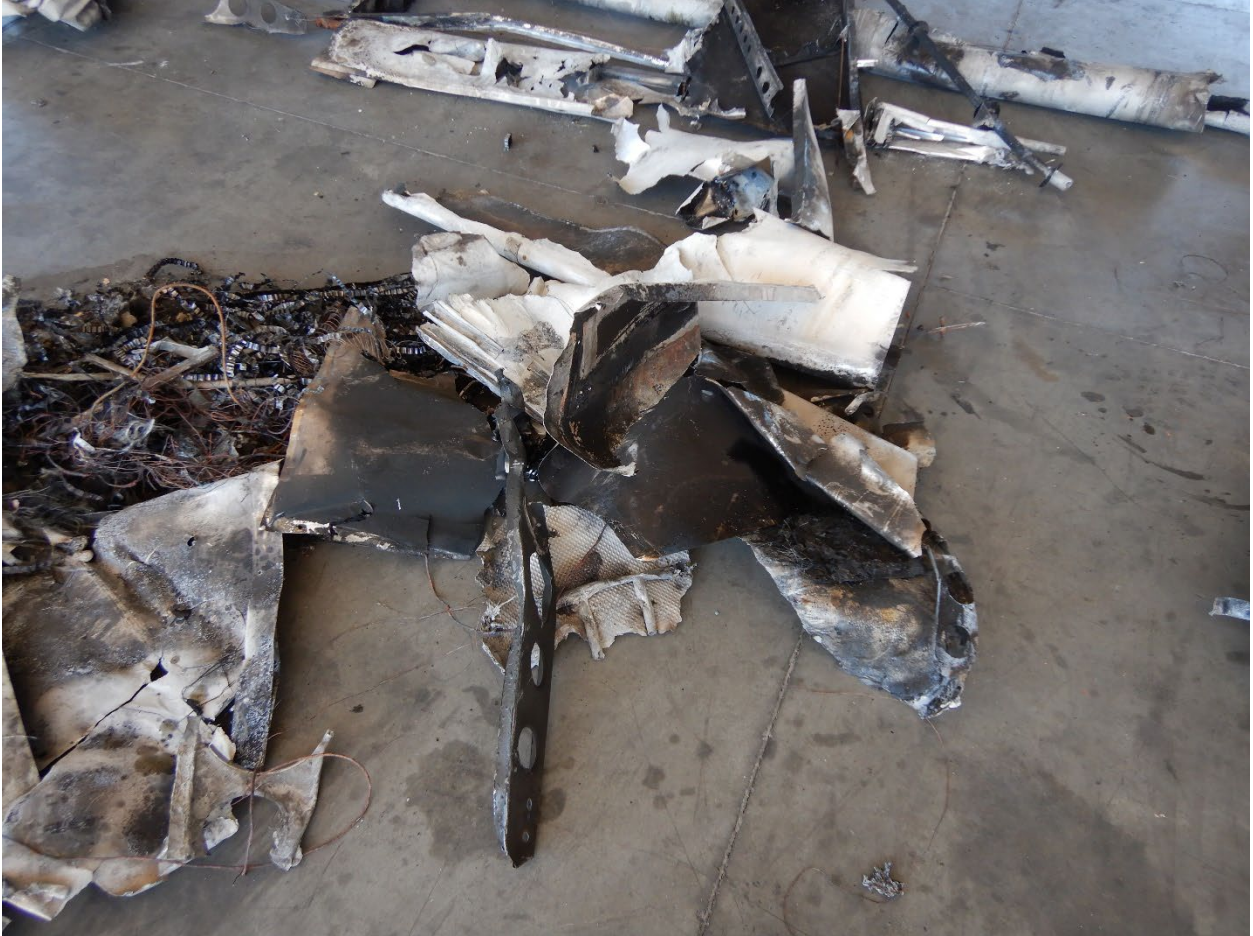
Figure 15. Remaining airframe sheet metal.

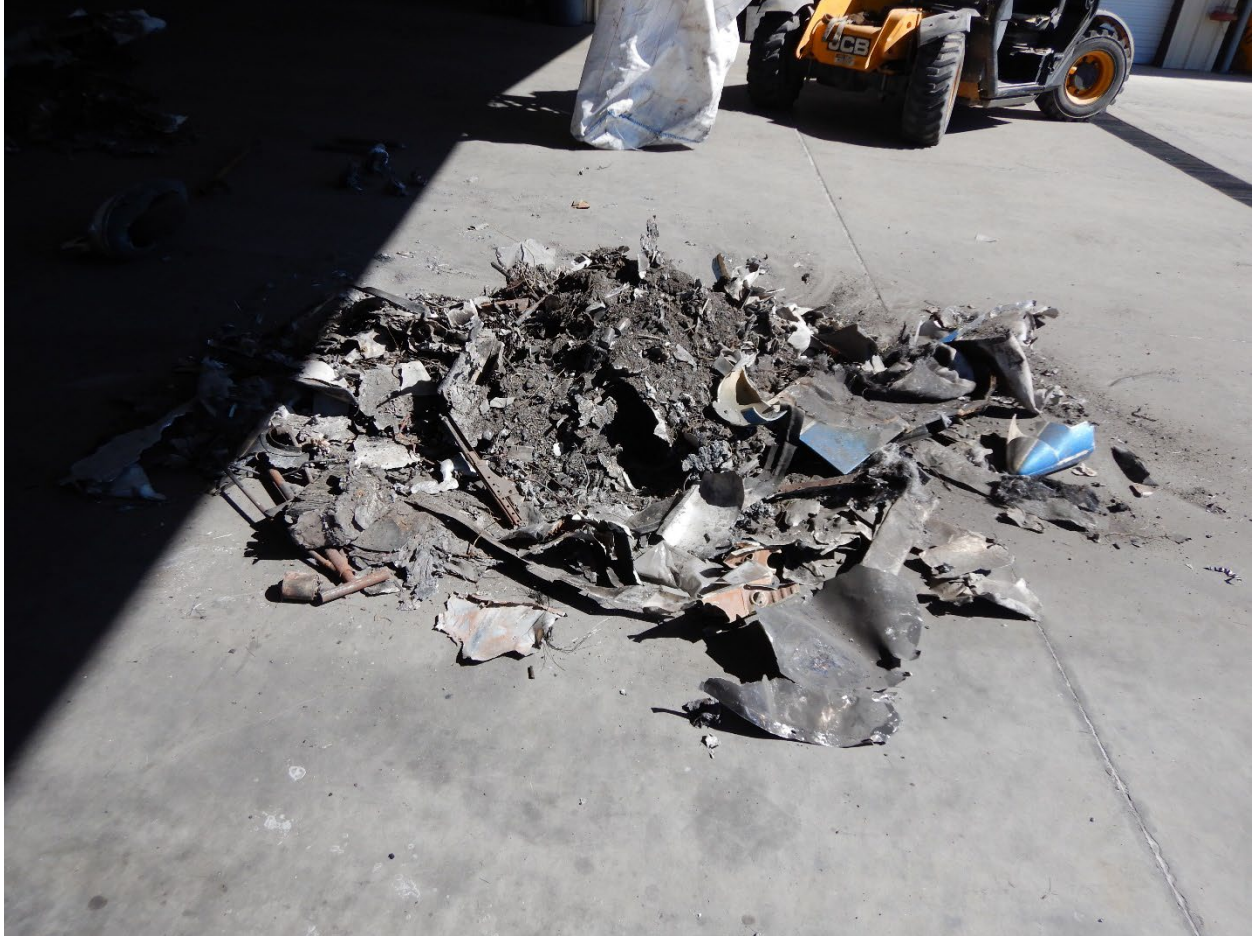
The main landing gear remained attached to the wing spar and was thermally damaged. The composite struts were thermally damaged. The only remnants to the wheel were the steel brake disks. The brake assemblies were thermally damaged. The nose gear separated from the airframe and was not thermally damaged, however, the nose gear was damaged consistent with impact forces.

Figure 16. Second bag containing wreckage debris including, nose wheel, and main landing gear brake assemblies.

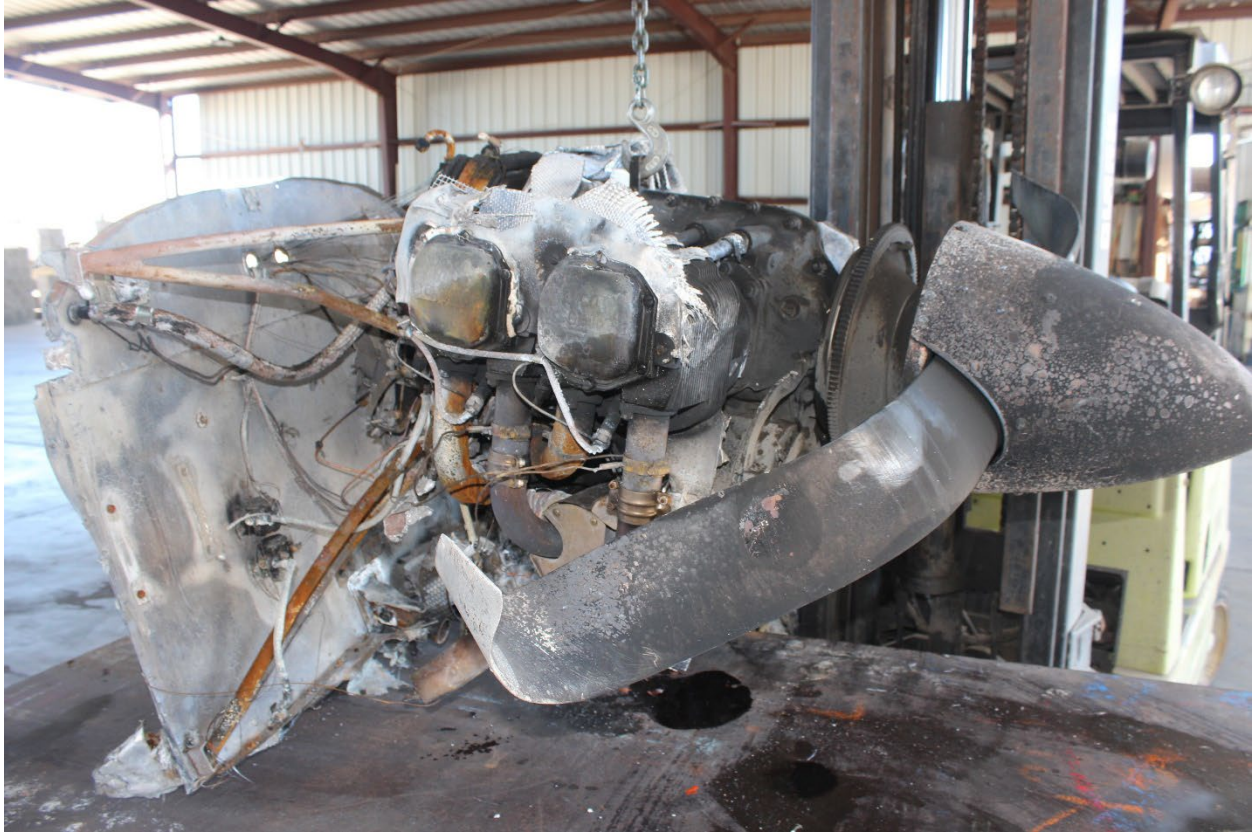
Figure 17. Right-side view of engine. Photo Lycoming.

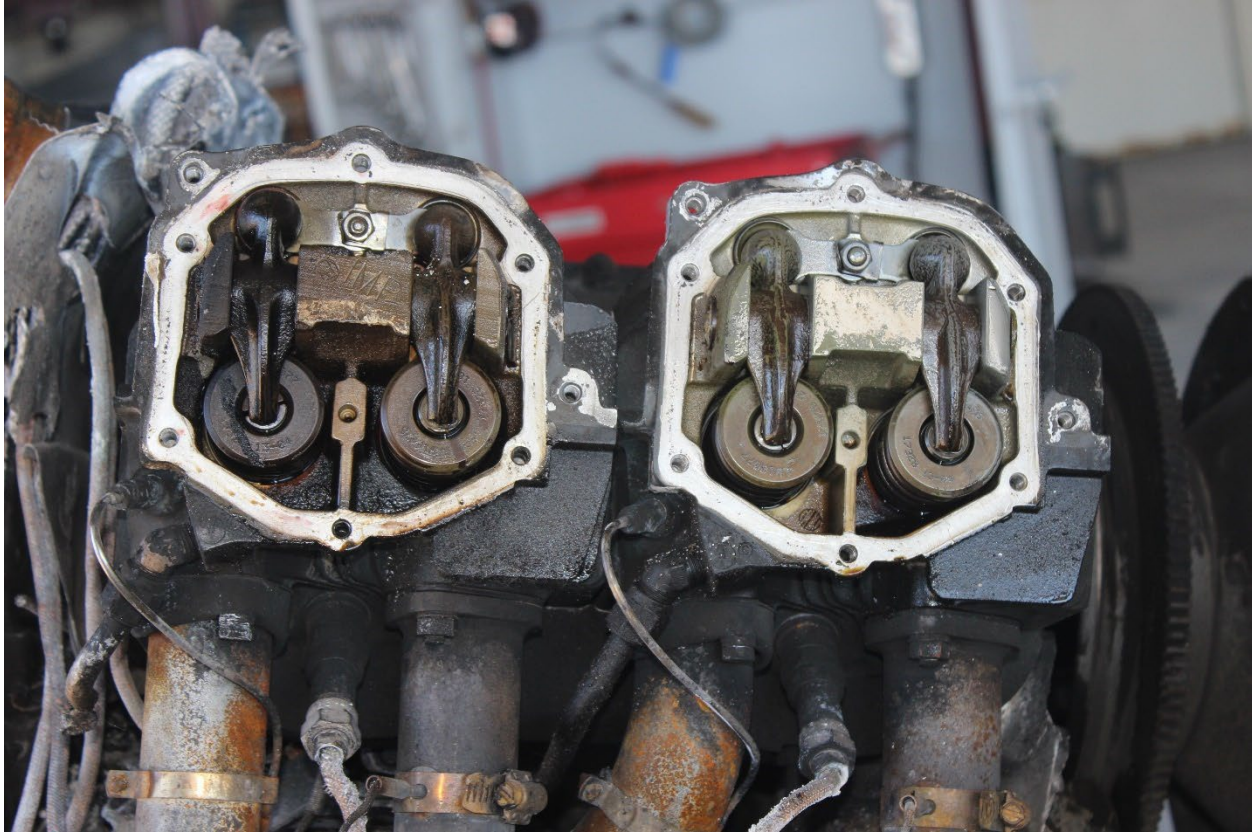
The valve covers were removed, and all four chambers exhibited a wet, clean, and normal chamber with no damage exhibited.

Figure 23. Valve cover chambers, right side. Photo Lycoming.

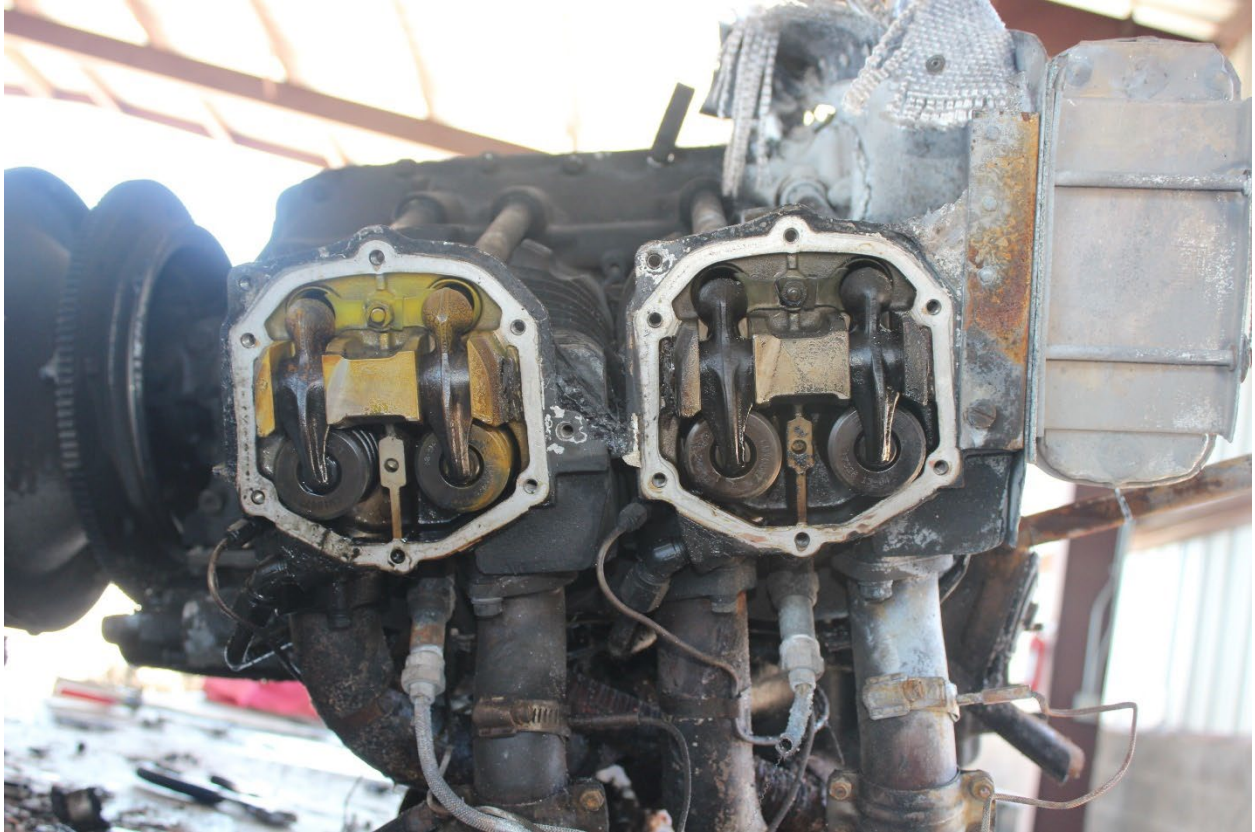
Figure 24, valve chambers, left side. Photo Lycoming.

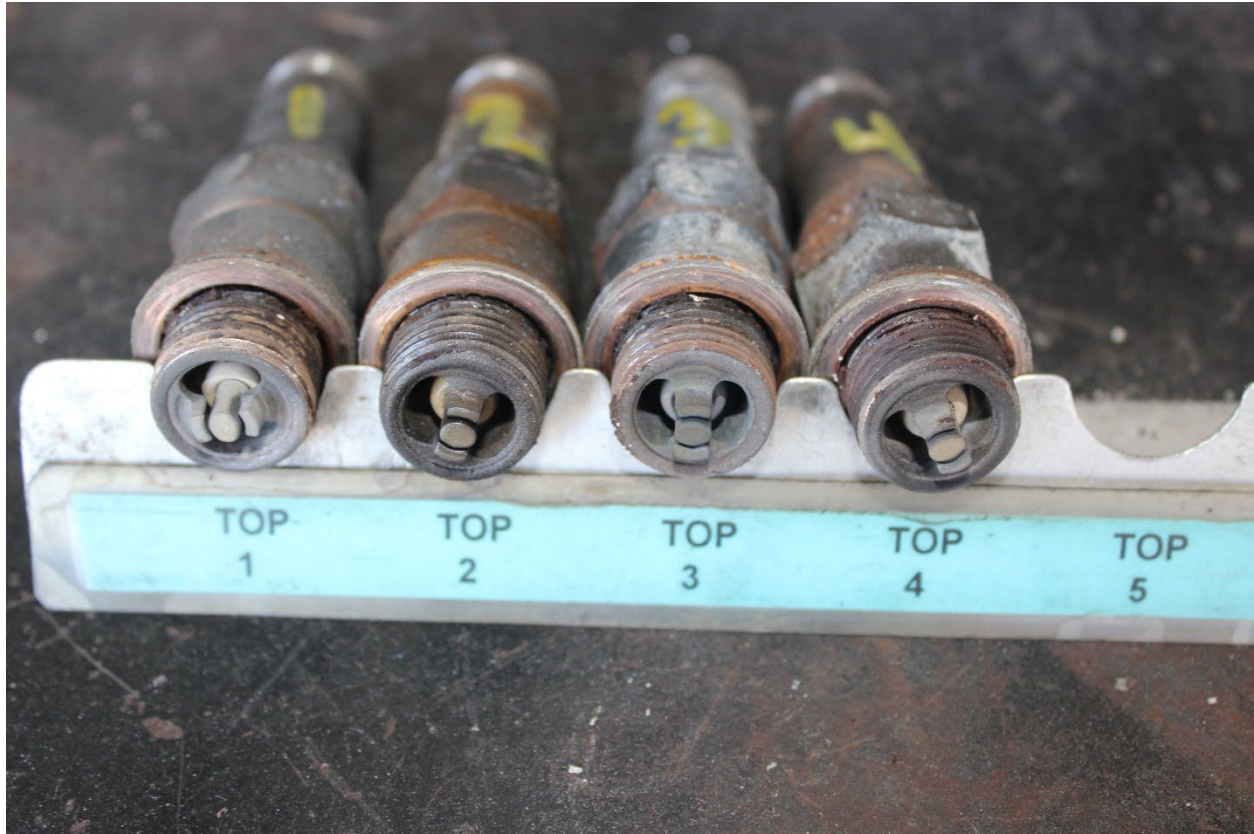
The top spark plugs were removed and appeared normal when compared to the Champion Check-A-plug chart.

Figure 25. Top spark plugs. Photo Lycoming.
