NATIONAL TRANSPORTATION SAFETY BOARD

AIRFRAME AND ENGINE EXAMINATION

WPR22FA361

Location: Sahuarita, Arizona
Date: 9/28/2022
Aircraft: Grumman AA5B / N74349
NTSB IIC: Fabian Salazar

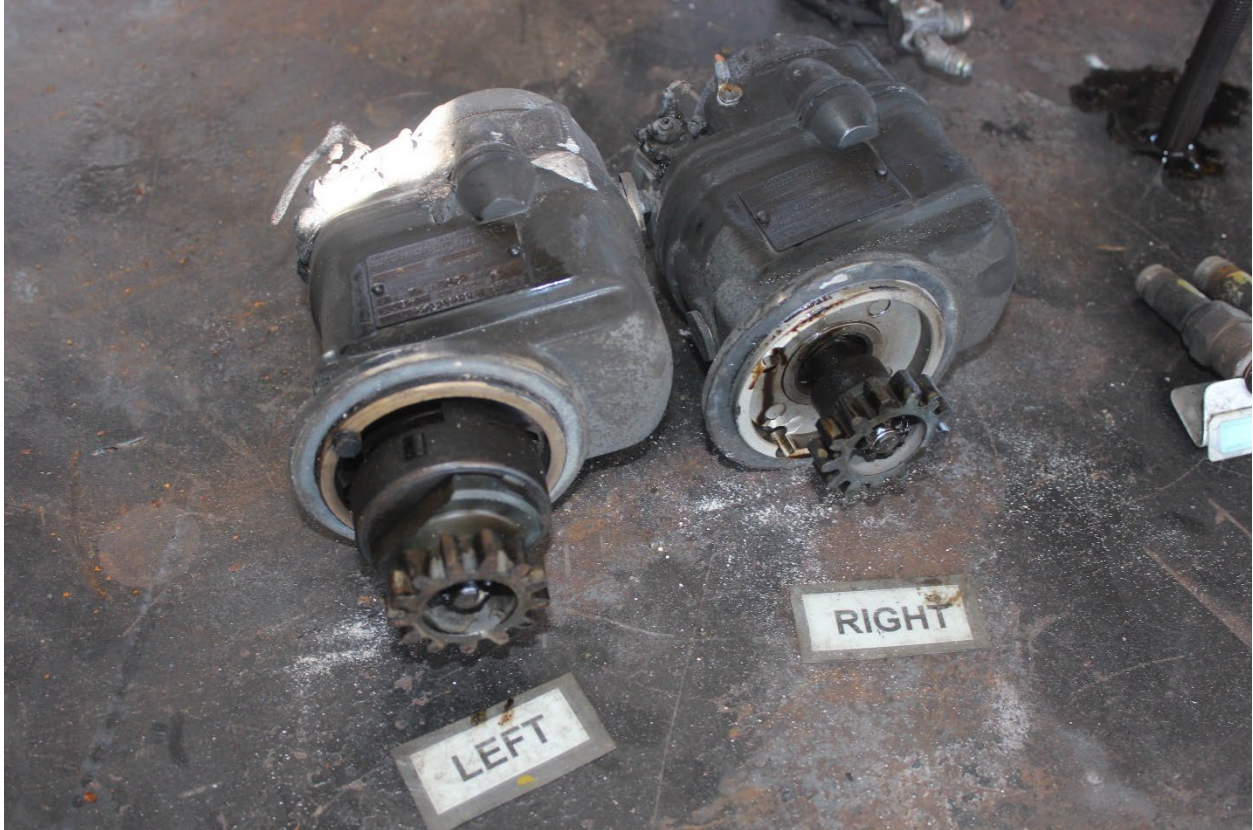
The two magnetos remained secured to their respective mounts. The left magneto, serial number 90090512, with impulse coupler, and right magneto, serial number 04061177 were examined. Both exhibited thermal damage and neither would rotate. The spark plug leads exhibited thermal damaged but remained secured to the magnetos and the spark plugs.

Figure 26. Magnetos. Photo Lycoming.

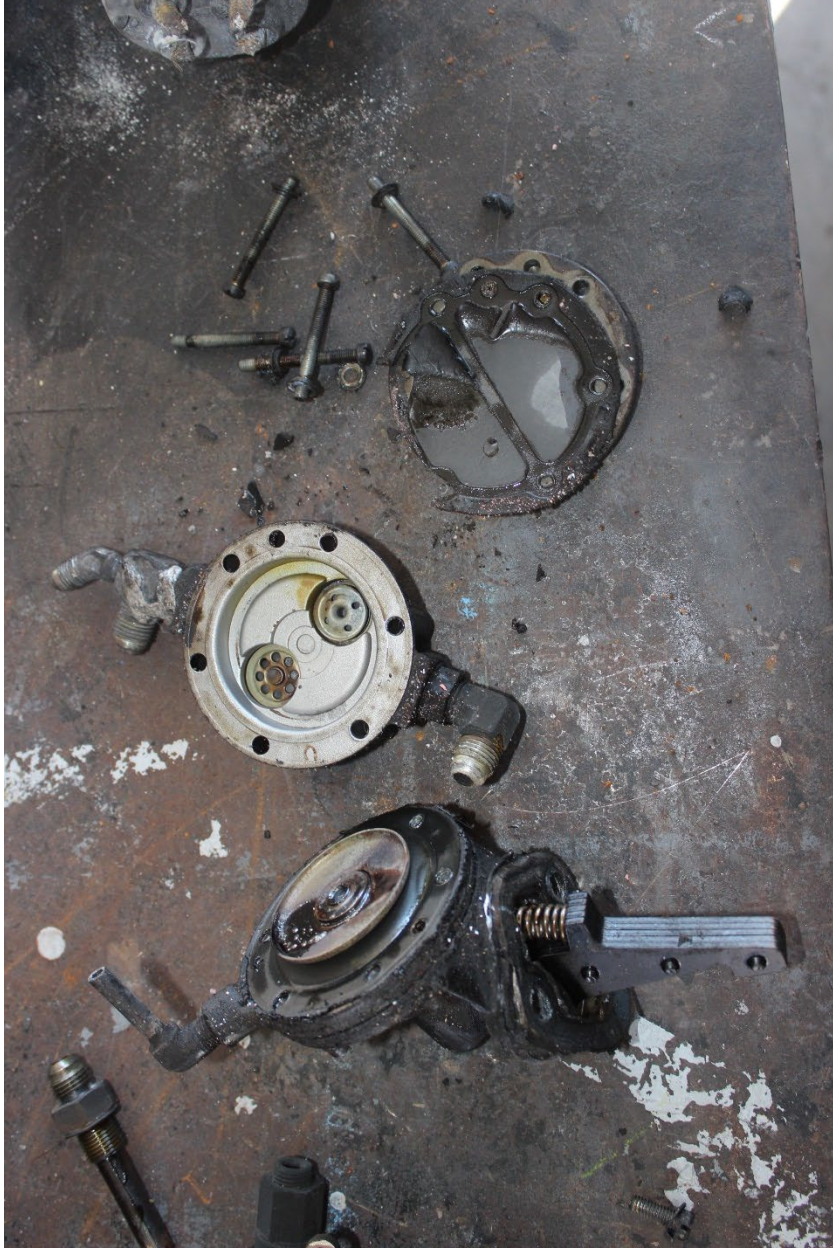
The engine mounted fuel pump was removed and exhibited thermal damage.

Figure 27. Fuel pump. Photo Lycoming.

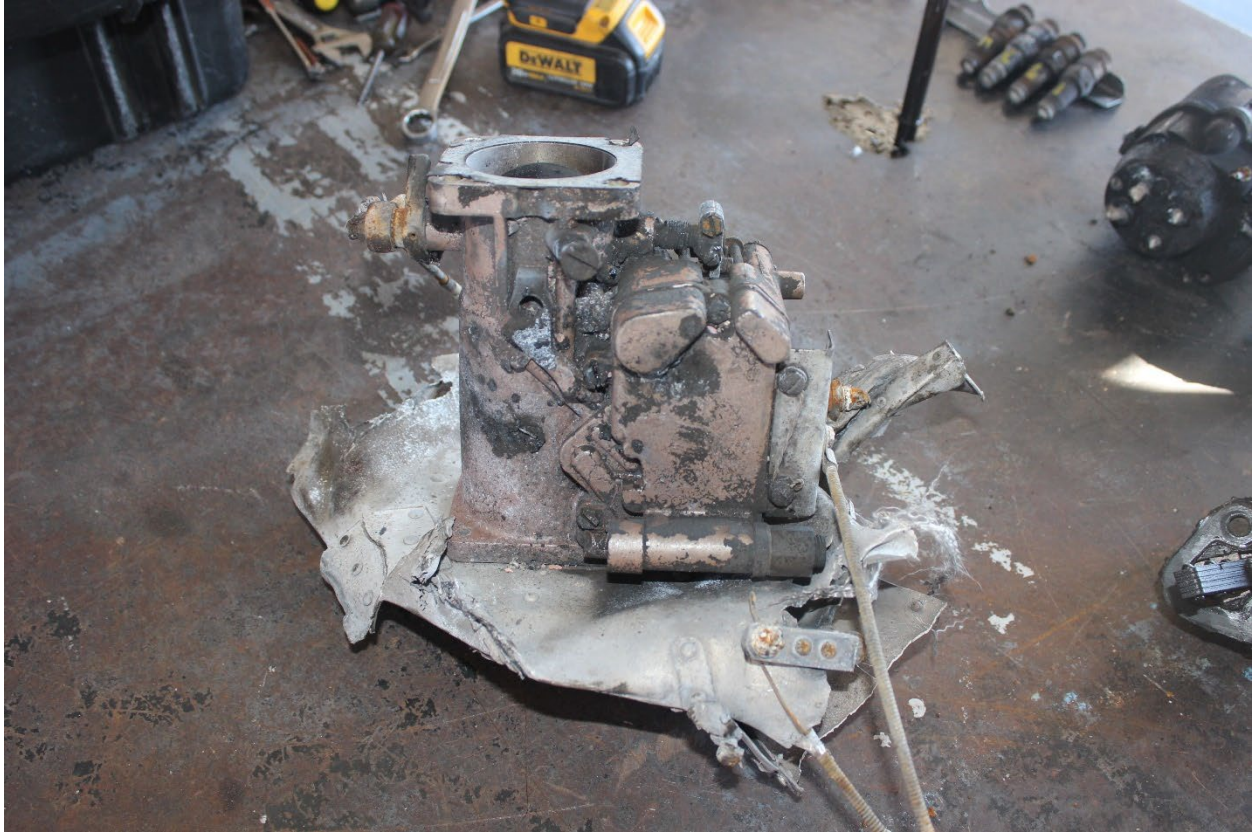
The carburetor remained secured to the damaged air filter box. The throttle lever remained secured to the throttle arm. The bowl was removed from the carburetor. The composite material floats were thermally damaged and melted.

Figure 28. Carburetor. Photo Lycoming.

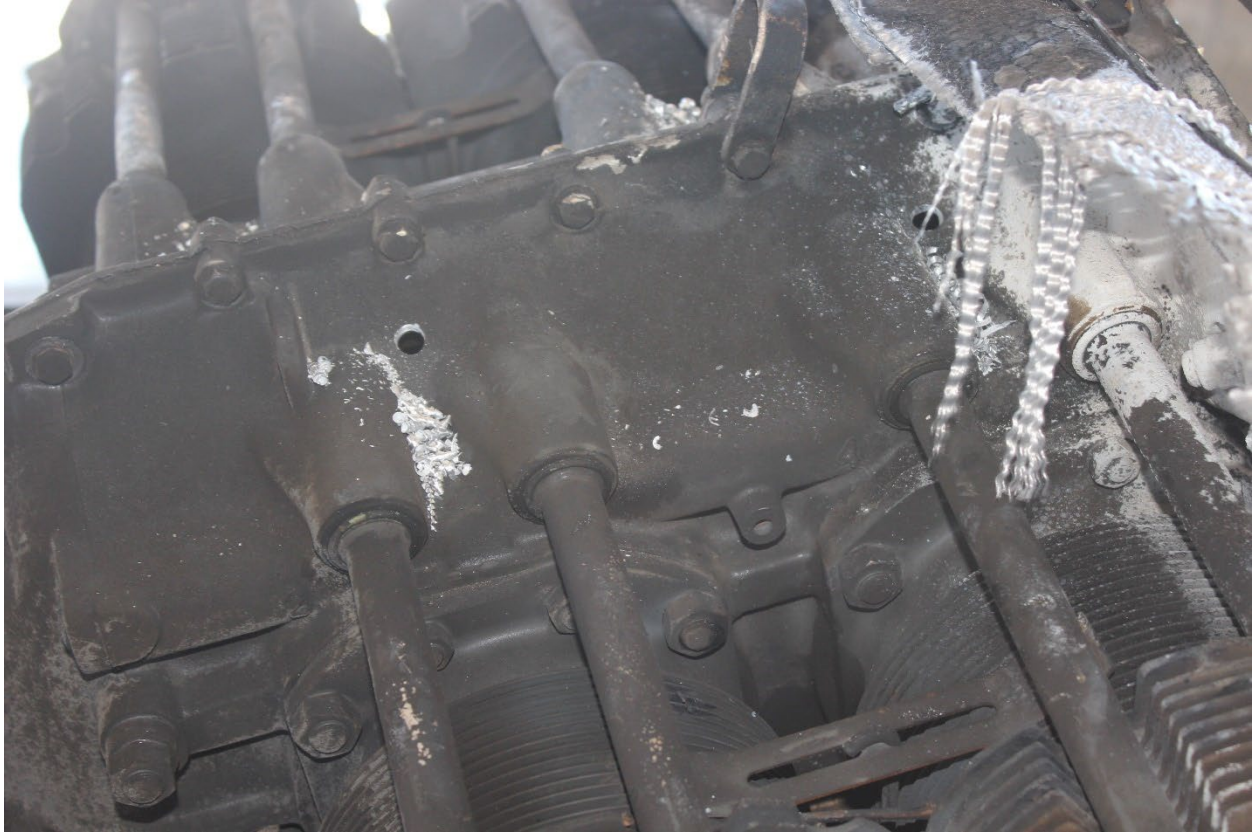
The engine would not rotate. When the cylinders were borescope inspected, one cylinder exhibited rust build up and is likely the reason for not rotating. Four holes were drilled into the top of the cases. When borescope inspected, all cam lobes appeared to have retained their original shape. There was no internal damage observed in the engine.

Figure 29. Two of four holes drilled into cases. Photo Lycoming.

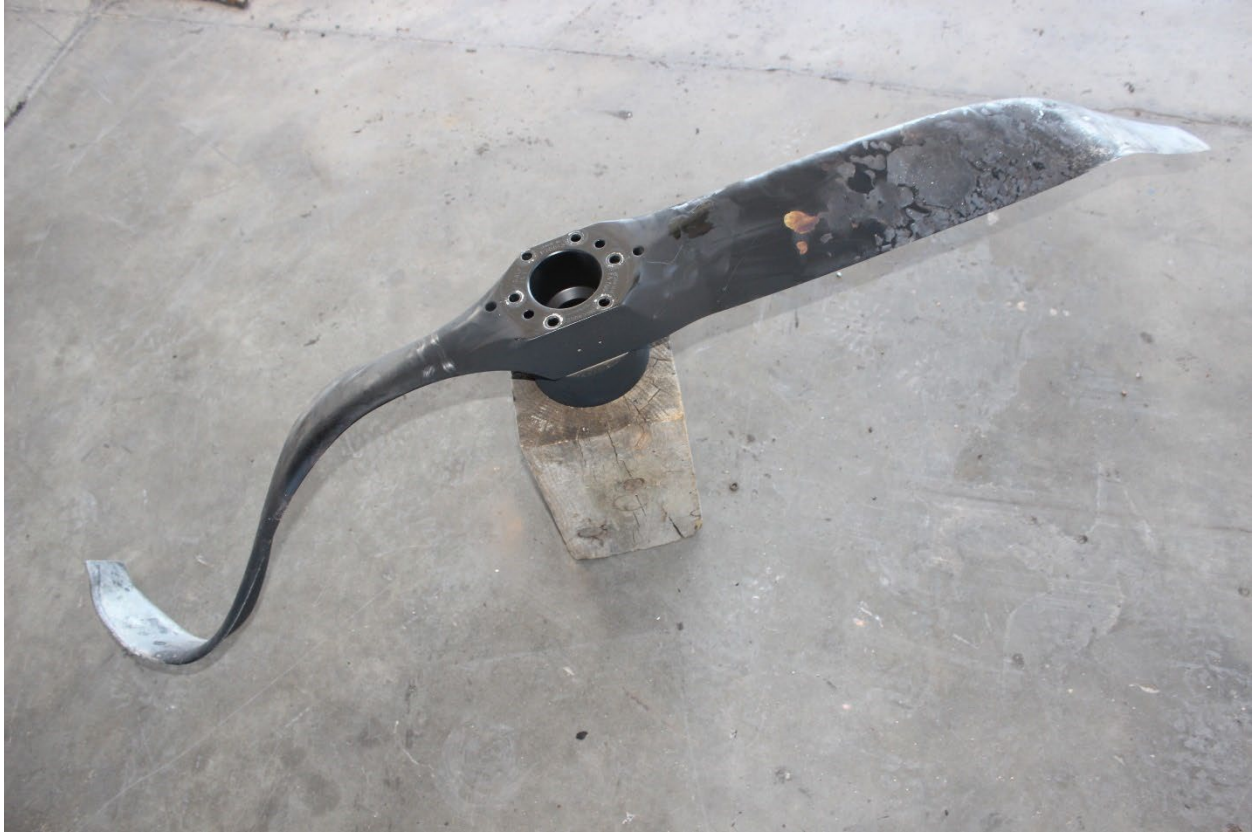
The two-blade propeller remained attached to the engine and exhibited thermal damage. One blade exhibited S-bends and chordwise bends along with gouging of the leading edge. The other blade exhibited a chordwise bend along with gouging of the leading edge. The spinner exhibited only thermal damage and did not exhibit impact damage.

Figure 30. Propeller. Photo Lycoming.
