NATIONAL TRANSPORTATION SAFETY BOARD

AIRFRAME AND ENGINE EXAMINATION

WPR19FA123

Location: Kailua, Hawaii
Date: April 29, 2019
Aircraft: Robinson R44, Registration N808NV, Serial #0926
NTSB IIC: Samantha Link

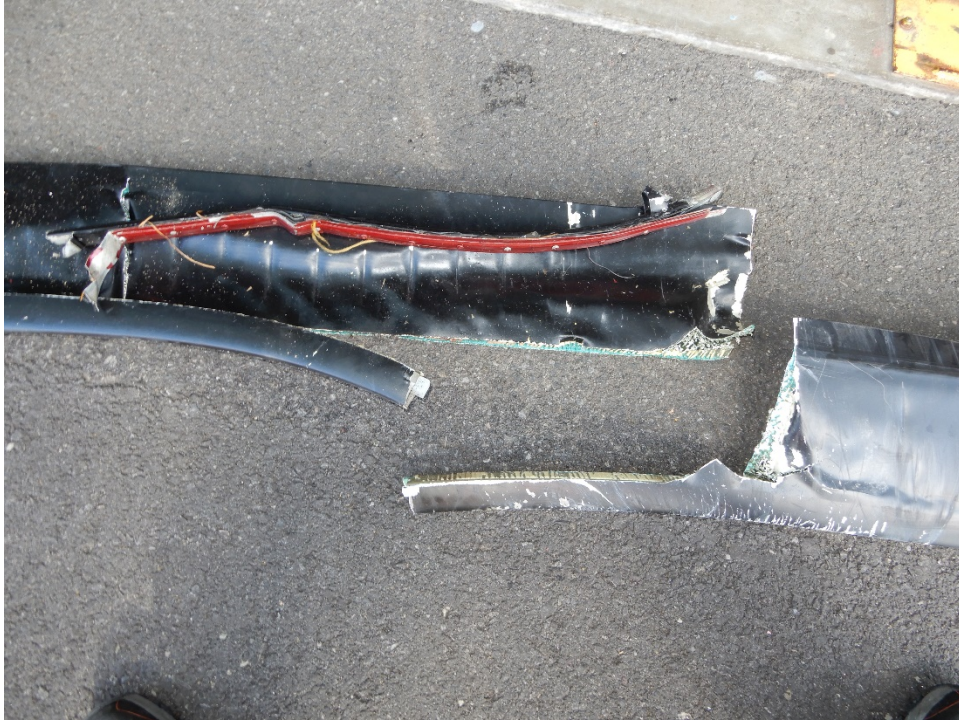
- The spar was fractured and bent forward in the direction of rotation about 94.5 inches from the blade tip.
 - The beginning of rotation scoring from the blade leading edge chordwise to the trailing edge was observed about 65.5 inches from the tip.

Figure 2: Rotational Scoring in the Red Blade

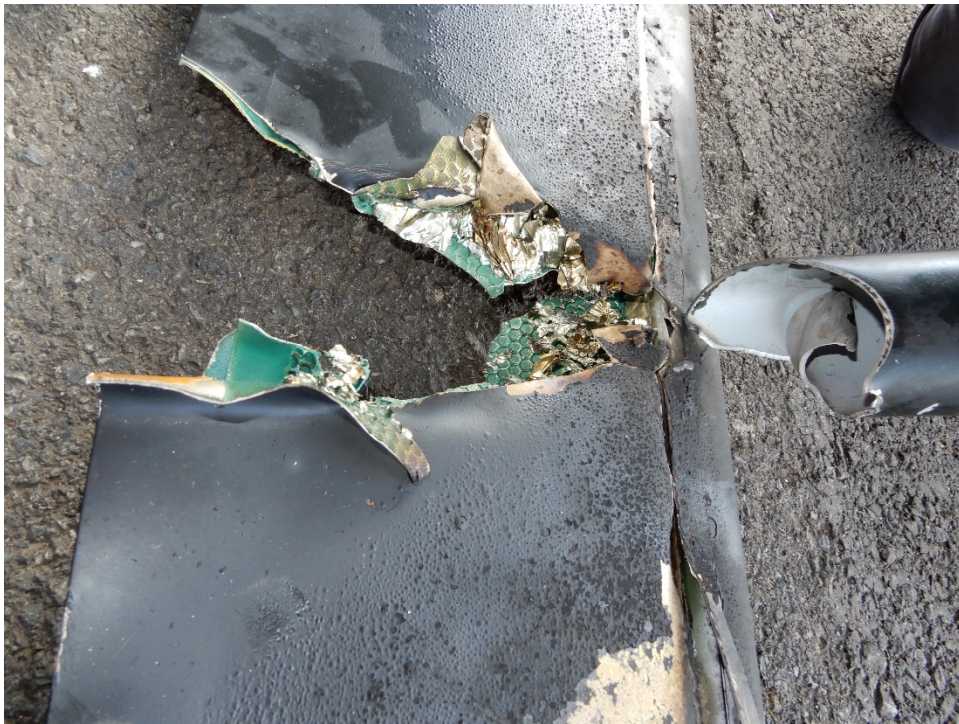
- In the afterbody of the blade, about 58 inches from the outboard tip, was contact damage that appeared to be the same shape as the left skid toe.
 - About 140 inches from the blade tip, the spar was bent down about 90 degrees

- The left skid tube was fractured forward of the aft strut
 - The left skid toe exhibited impact related damage to its leading edge which appeared to match the damage in the blue main rotor blade

Figure 3: Afterbody damage to the Blue Blade Compared to the Left Skid Toe

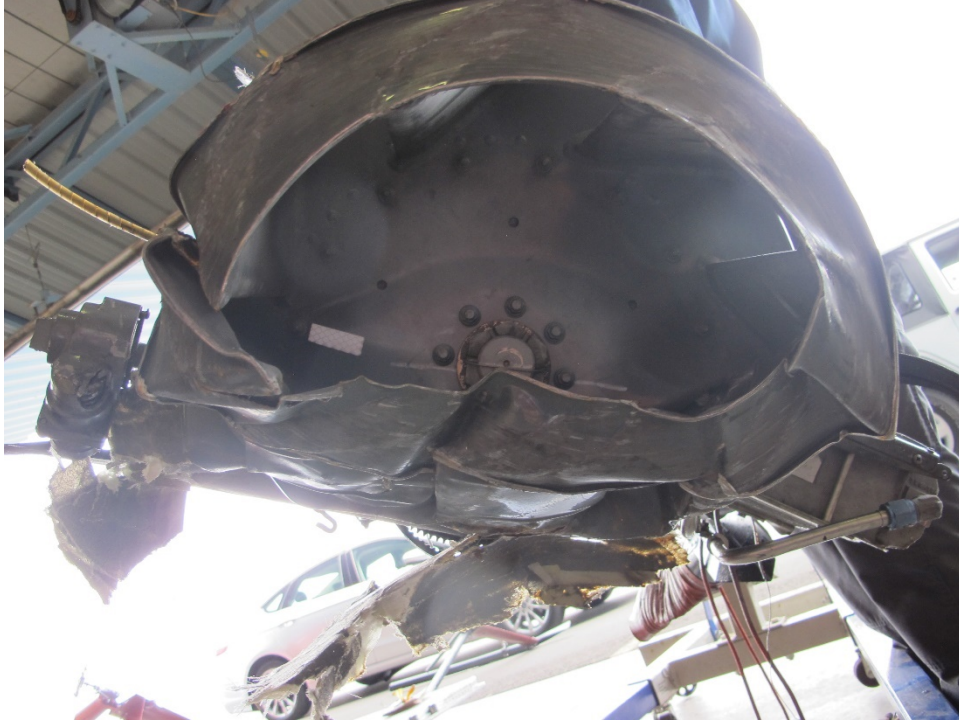
- The mast fairing exhibited impact and thermal damage
- The engine cowling exhibited severe impact damage
- The cooling fan exhibited rotational scoring on its aft face

- The scoring appeared light grey with a red tint, which is consistent with the paint on the engine cowling.
 - The lower half of the cooling fan was also flat at the 6 o'clock position.

- The inside of the cooling fan scroll exhibited rotational scoring
- The oil cooler exhibited an about one-inch deep indentation consistent with contact with the starter ring gear.

Figure 4: The Cooling Fan

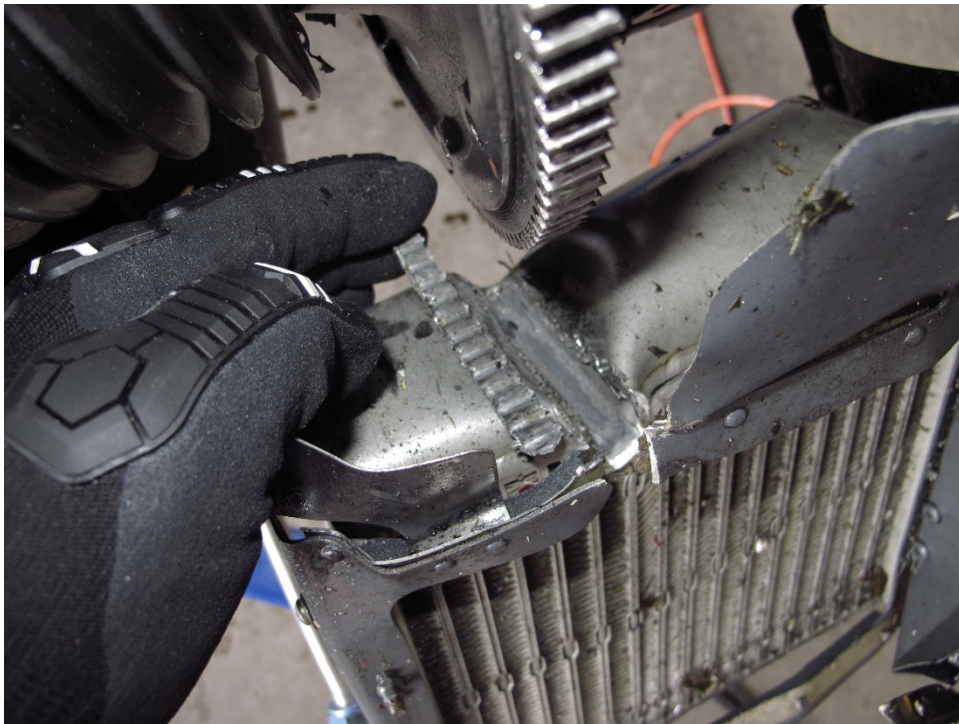
- The indentation exhibited both grinding and teeth impression marks
- Powerplant controls
 - The fuel mixture knob was found in the full rich position
 - It operated smoothly when manipulated by hand.

Figure 5: Oil Cooler

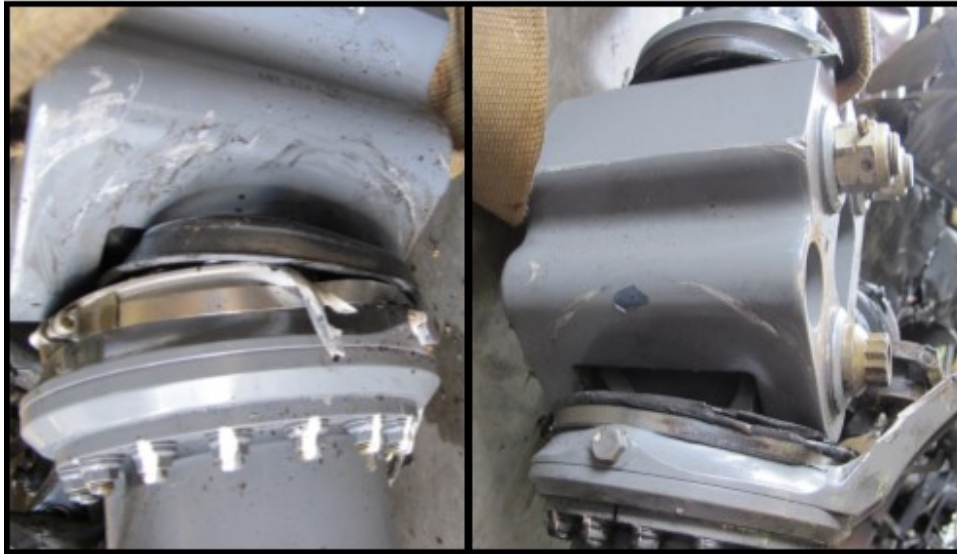
- Both droop stop tusks were in place and undamaged
 - The droop stop bolt at the nut end was sheared but remained in place
 - Arc shaped scoring was observed on both sides of the main rotor hub adjacent to the pitch horns

- Consistent with extreme coning, and the blades were pitching while in that position
 - Main rotor teeter and coning bearings moved freely
 - Blue blade

Figure 6: Main Rotor Hub

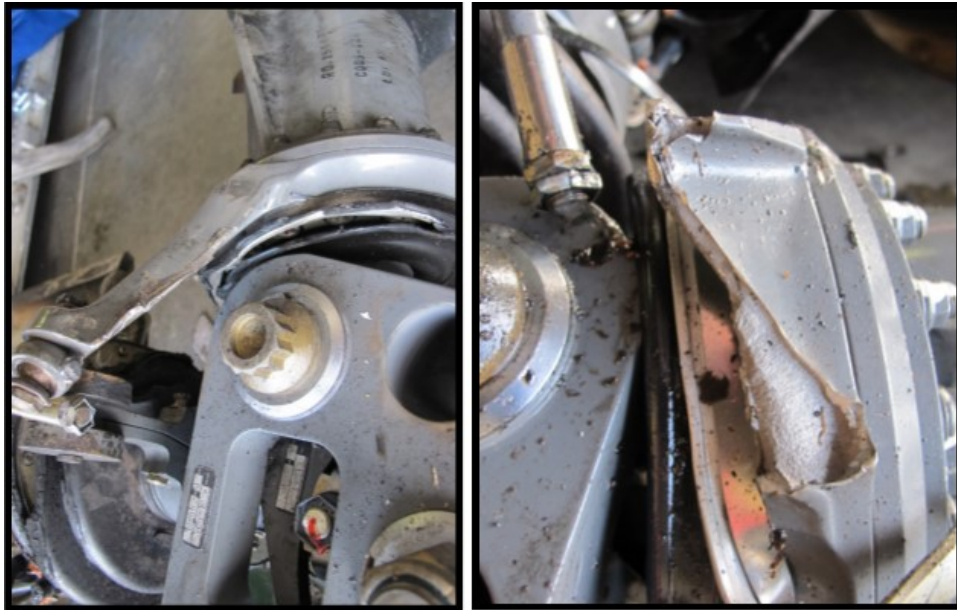
- Disconnects consistent with impact damage were observed at the upper rod end of both pitch control links.
 - One pitch horn and the attached rod end were fracture separated and not located

Figure 7: Pitch Horns

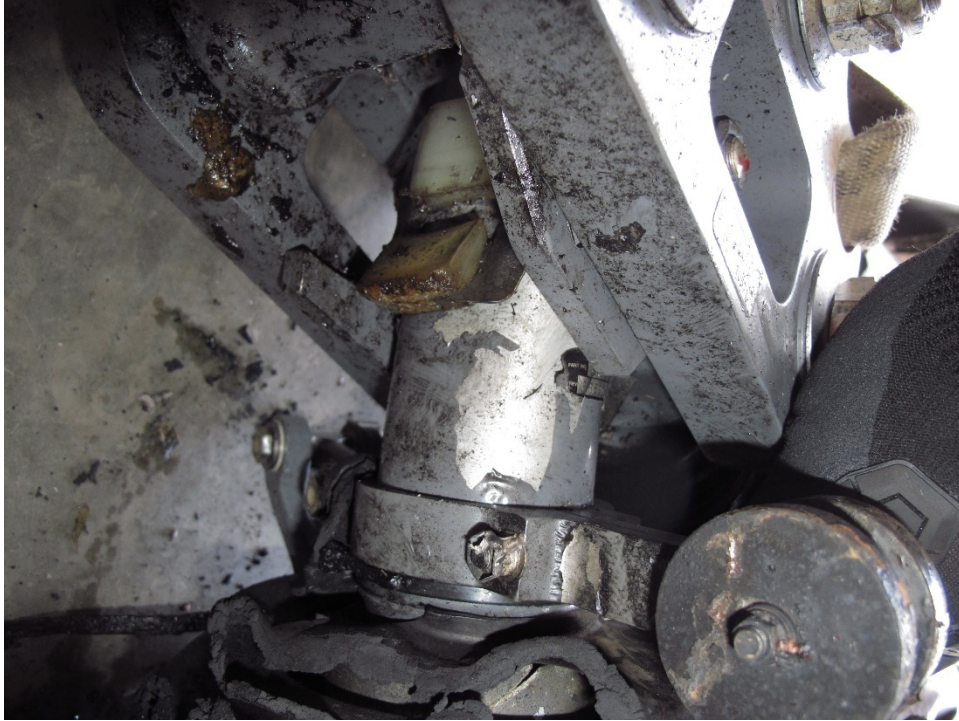
- The main rotor driveshaft was seized and would not rotate by hand.
 - It was bent at about a 20-degree angle above the swash plate

Figure 8: Main Rotor Driveshaft

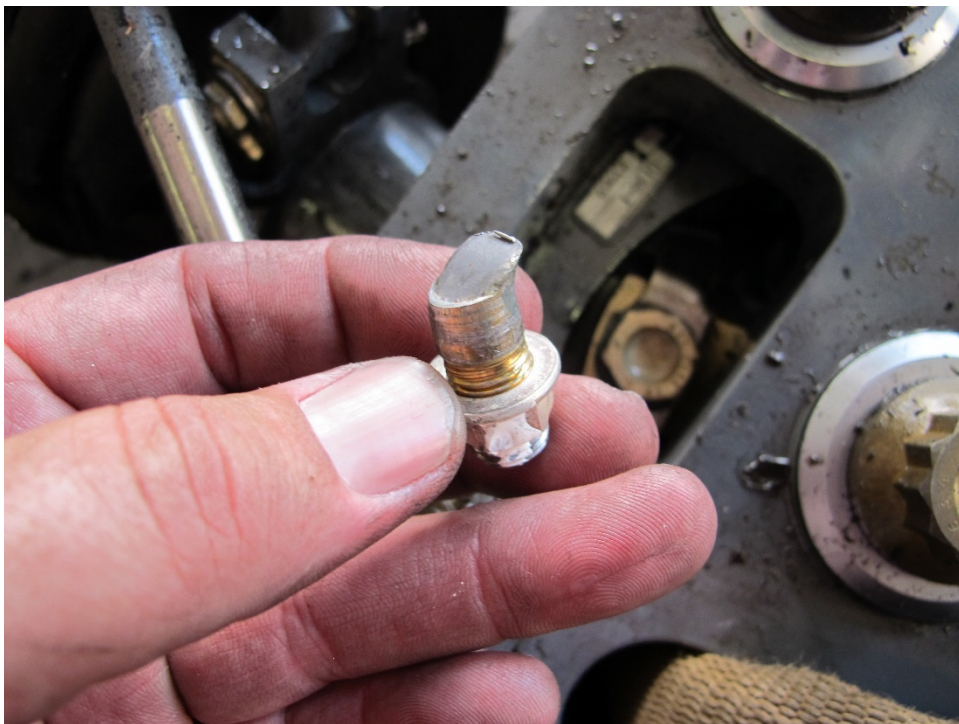
Figure 9: Droop Stop Bolt

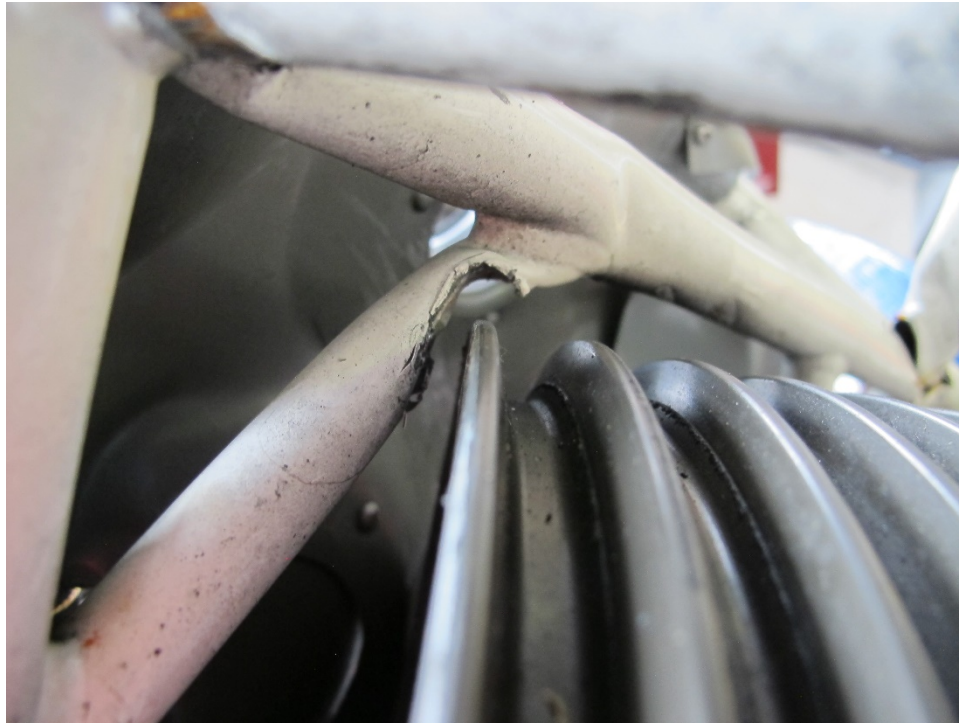
- The upper sheave appeared serviceable
 - Rotational scoring was observed on the forward face along with scoring on the nearby support tubes
 - The aft face had single impact marks adjacent to the centering strut

Figure 10: Upper Sheave to upper frame contact

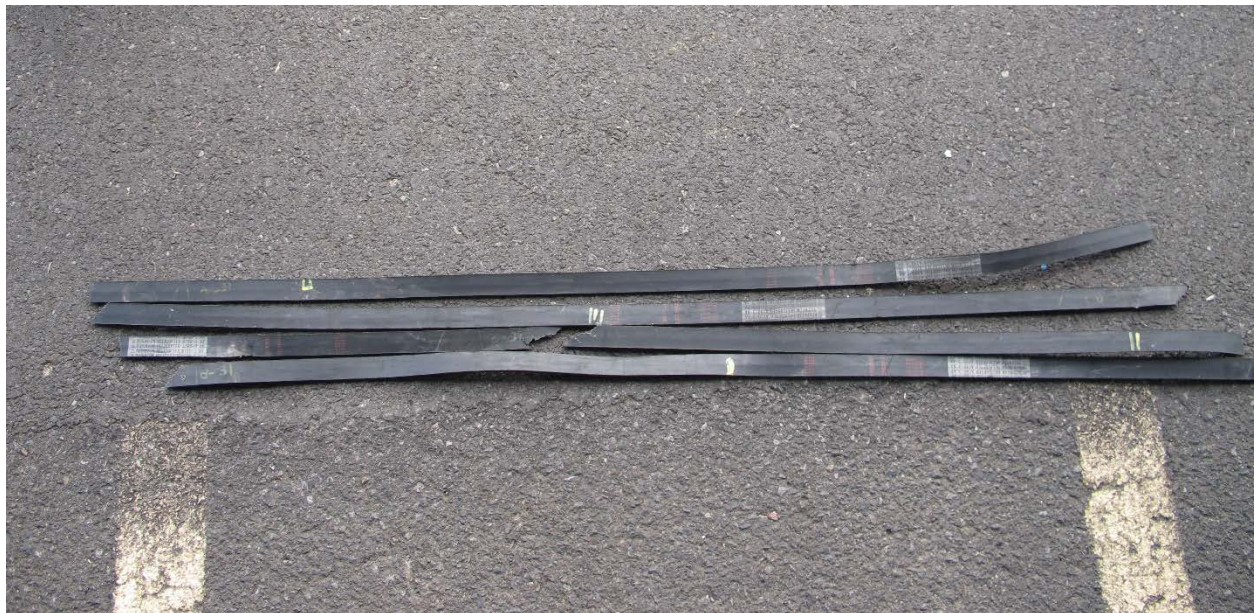
- Drivetrain:
 - The lower sheave appeared serviceable
 - V-belts
 - One V-belt was intact, but out of the grooves
 - Three V-belts were fracture separated consistent with overload and appeared serviceable.

Figure 11: V-Belts

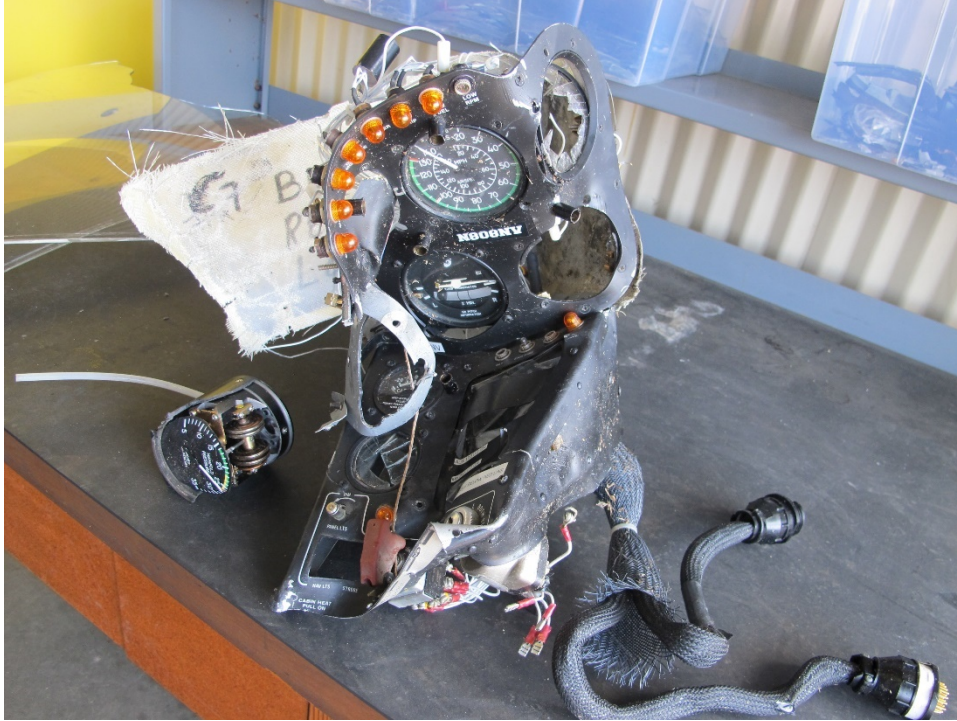
- The instrument counsel was separated from the keel panel
 - It was found on scene completely separated, and outside of, the main wreckage.
 - The left corner of the counsel was bent inward toward the passengers.

Figure 12: Instrument Counsel

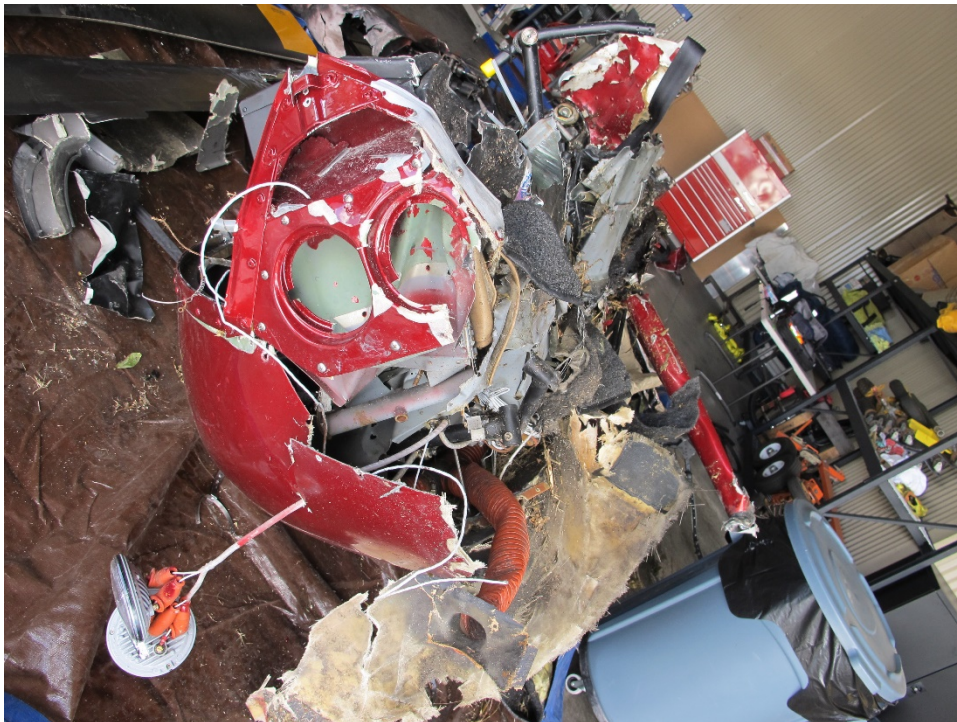
- The forward left elbow was partially fractured
- The cabin
 - Airframe exhibited heavy impact damage to the left side
 - Seats
 - The left front seat structure was completely collapsed outboard to inboard

Figure 13: Significant left side fuselage damage (Nose of Airframe Looking Aft)

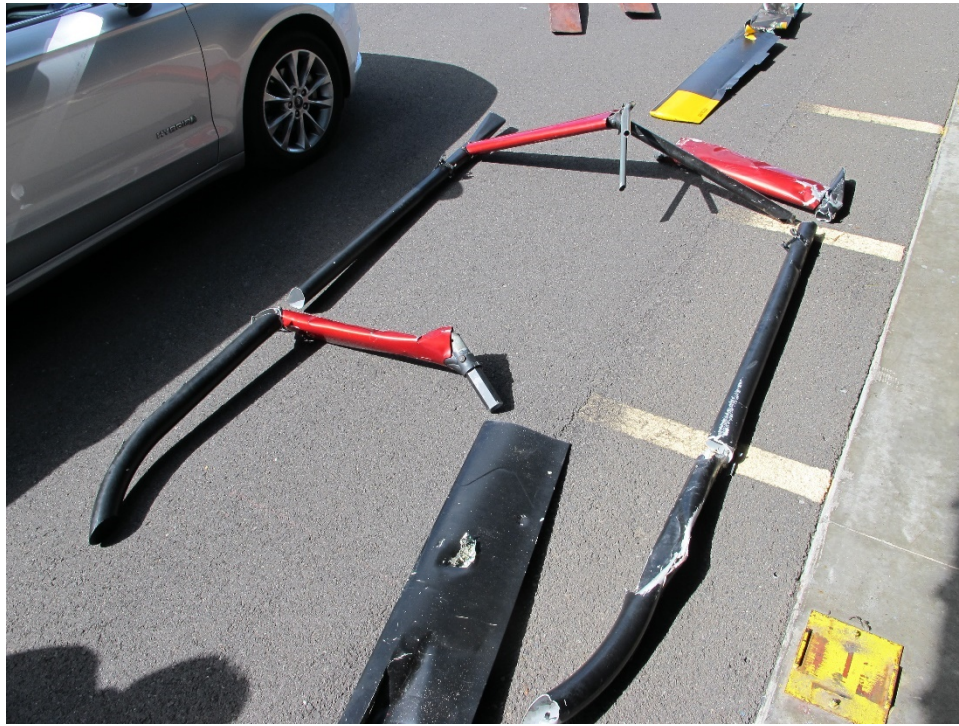
- About 27.5 inches from the root fitting the main rotor spar was fractured and bent downward.
 - The afterbody sustained impact damage
- Landing gear
 - Both toe sections were separated at the strut mounts

- The aft and front cross tubes were straight
 - The aft cross tube was fractured at the left elbow
 - The cross tube elbow showed no indication of rotation

Figure 14: Landing Gear Assembly

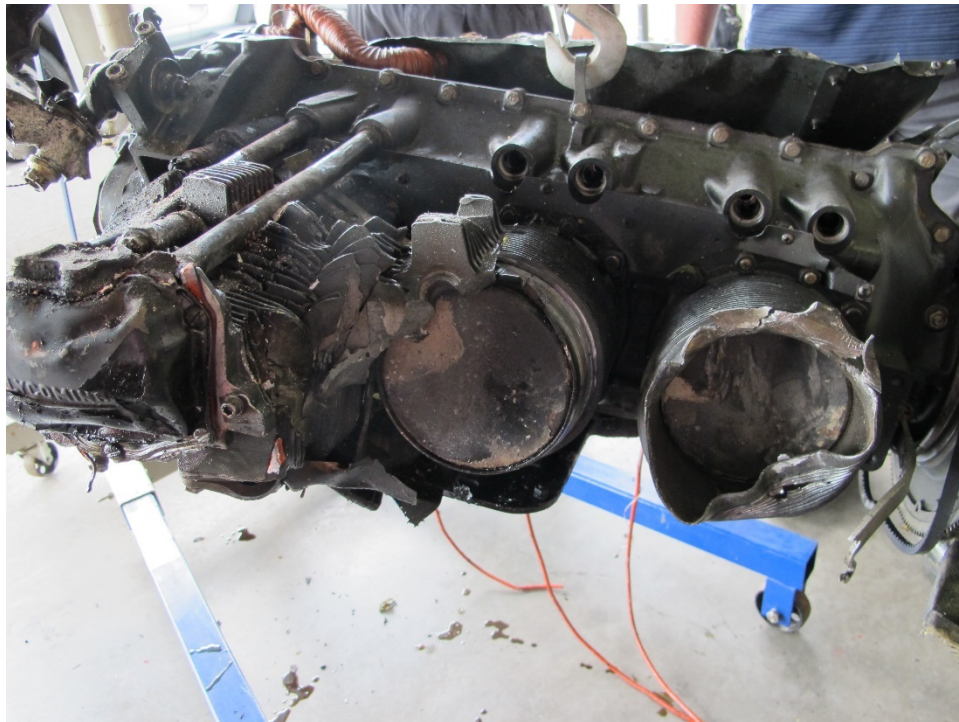
- The engine was removed from the airframe
 - There were no obvious signs of catastrophic anomalies prior to impact
- The number 1 and 3 Cylinder heads were fracture separated

- The cylinders were heavily fragmented
 - Valves, rocker arms, springs, and push rods were heavily damaged and found fracture separated from the engine

- The spark plugs from cylinders 1, 3, and 5 exhibited impact damage
- The engine was borescoped and exhibited normal operating signatures.
- The crankshaft was rotated by hand and continuity was established throughout

Figure 15: Cylinders 1, 3, and 5

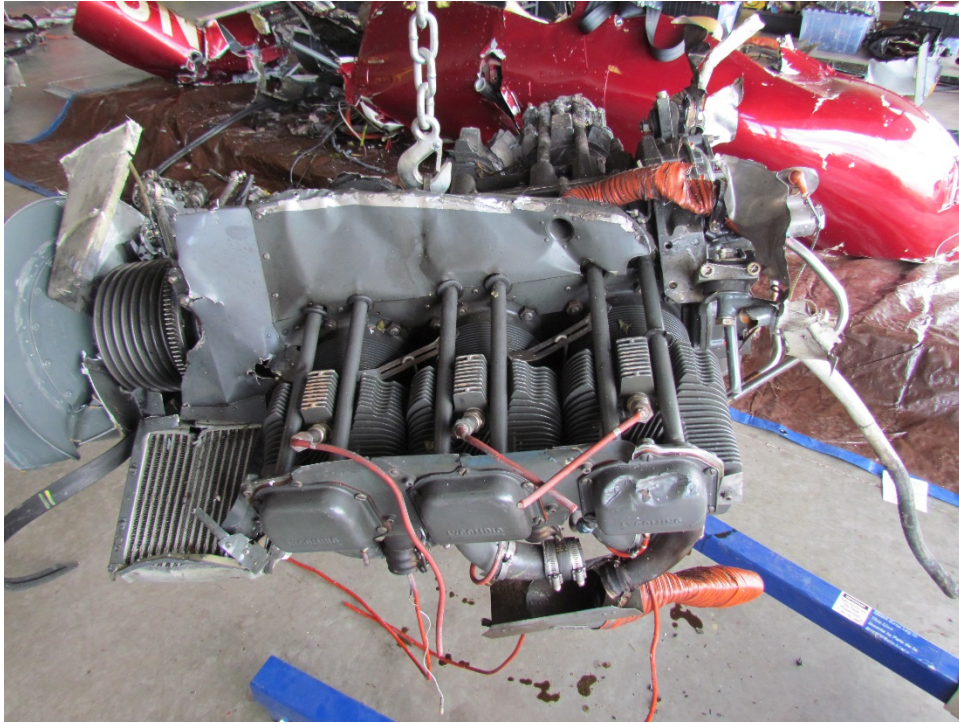
- The number 1 and 3 cylinders were removed from the engine.
- The spark plugs were removed from the engine
 - The spark plugs from cylinders 2, 4, and 6 exhibited normal operating wear signatures

Figure 16: Cylinders 2, 4, and 6

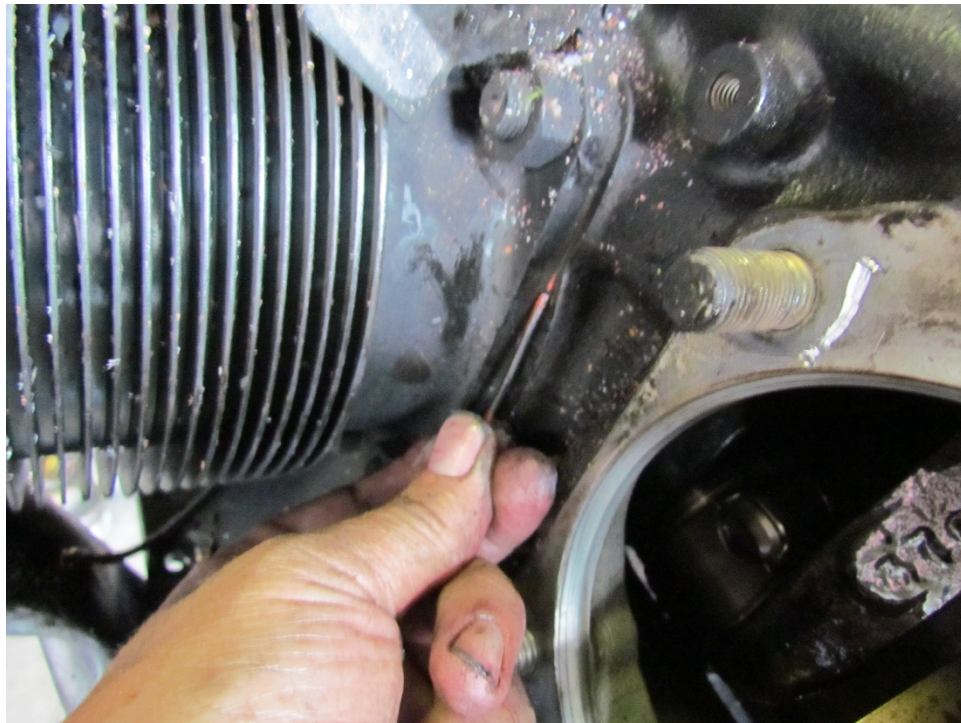
- An O-ring, which was painted grey, was observed slightly extruding from the number 5 cylinder
- The muffler and exhaust were fracture separated from the engine
 - They were flattened
- Magnetos
 - The left magneto was found broken at the flange. When rotated, spark was obtained throughout.
 - The right magneto was found separated from the engine
 - When rotated, no spark was obtained
 - Condenser exhibited impact related damage
- The oil sump was fracture separated from the engine
 - The pickup screen was clear of debris
- The carburetor was fracture separated from the engine and partially broken apart
 - The fuel line was disconnected at carburetor
 - The Inlet screen was clear of debris
- Alternator and starter were fracture separated from the engine.

Figure 19: Extruding O-ring on Number 5 cylinder

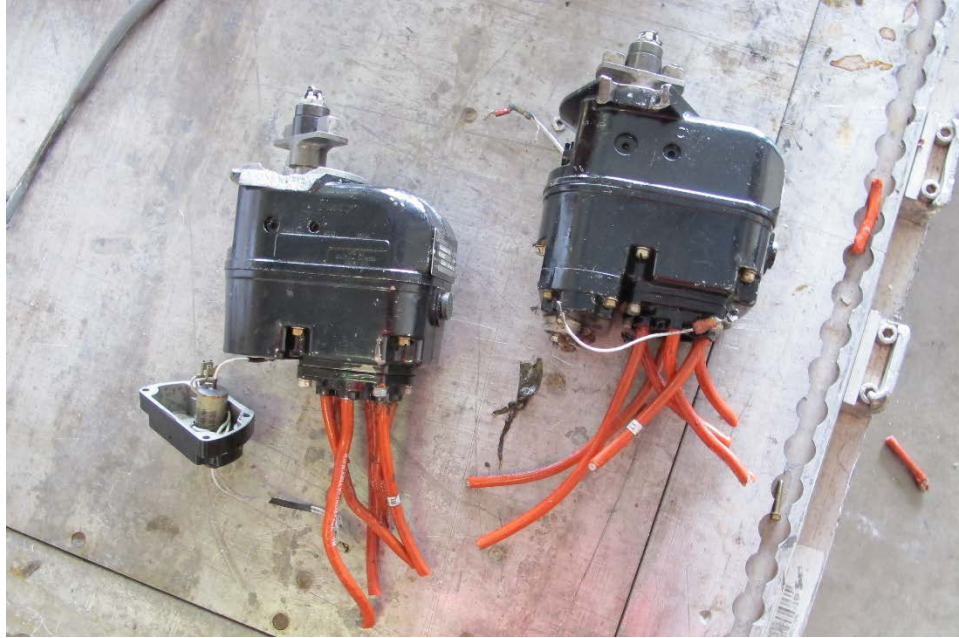
Figure 20: Magnetos

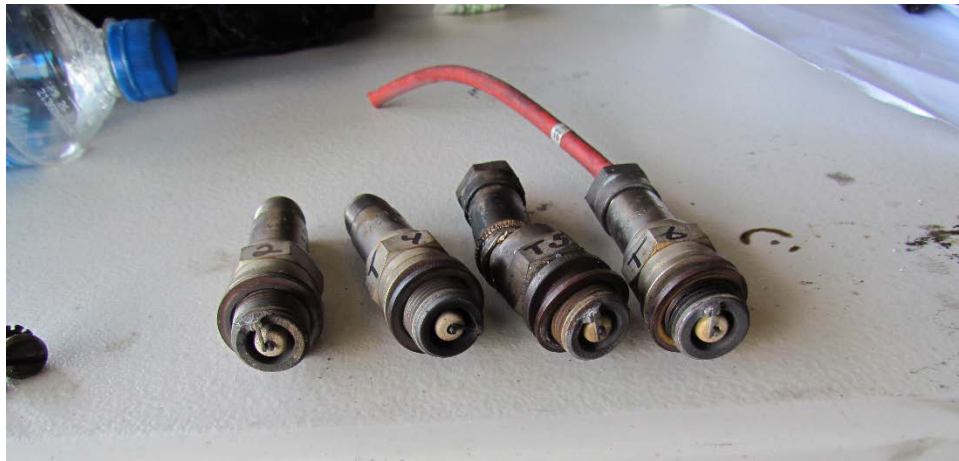
Figure 21: Spark Plugs for cylinders 2, 4, 5, and 6
