NATIONAL TRANSPORTATION SAFETY BOARD

AIRFRAME / ENGINE EXAMINATION SUMMARY

WPR19FA124

Location: La Center, Washington
Date: April 29, 2019
Aircraft: Vans RV-6, N90LK
NTSB Investigator-in-Charge: Michael Huhn

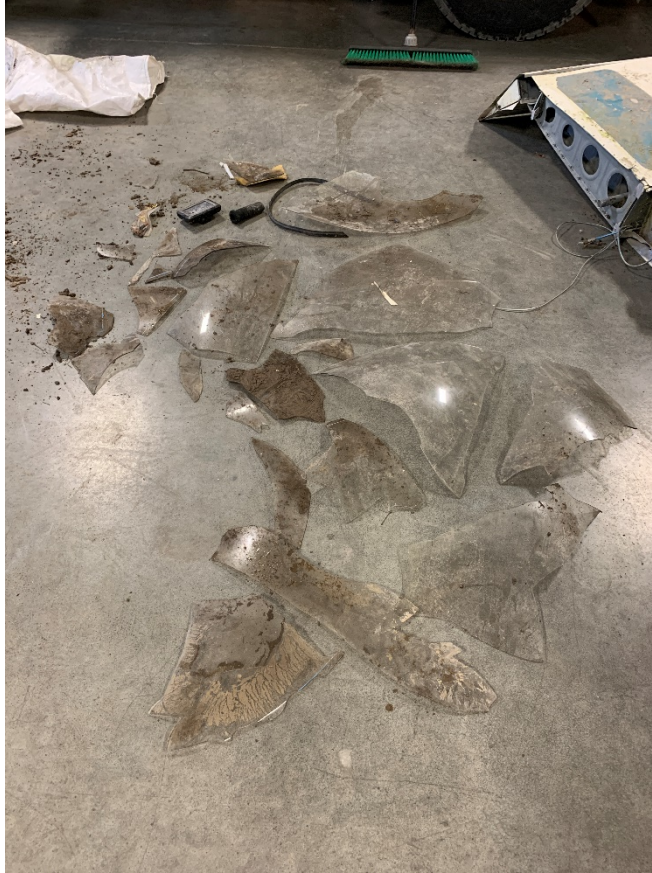
Recovered portions of plexi glass, consistent with the airframe canopy and rear windows were examined. While a majority of the plexiglass was recovered, there was an unmeasured portion that appeared to not have been recovered.

Figure 1: Recovered canopy fragments

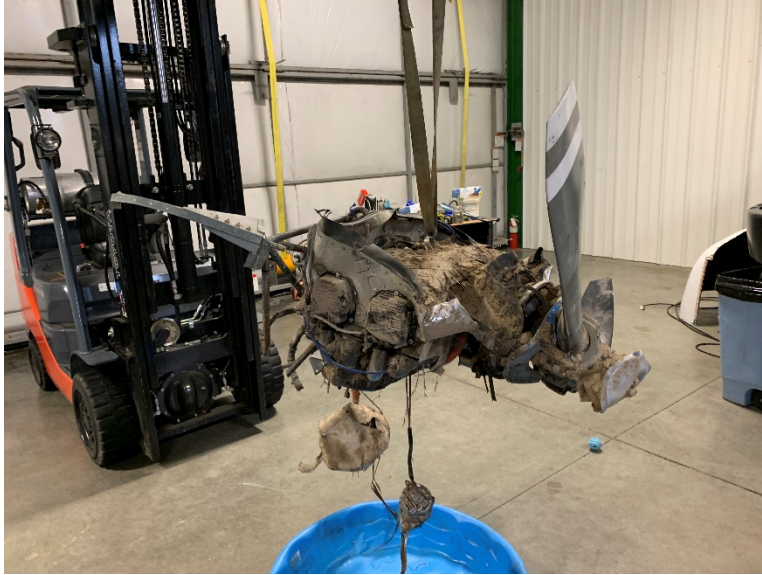
The engine remained attached to the engine mount. A considerable amount of dry mud/dirt covered a majority of the engine. During removal of the dirt from the engine, evidence of bird remains were located in multiple areas, including feathers embedded into the upper right engine mount attachment bolt area, and surrounding the engine driven fuel pump. The bird remains were retained for further examination.

Figure 2: View of the recovered engine

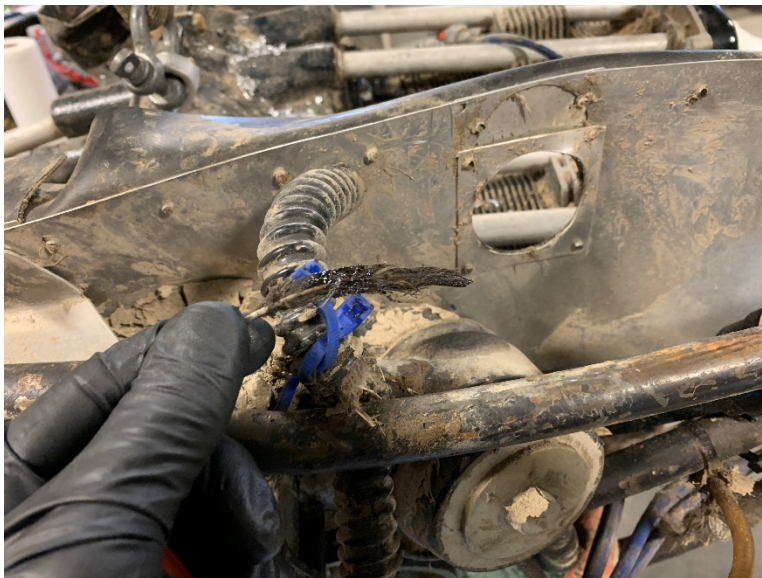
Figure 3: View of recovered bird remains

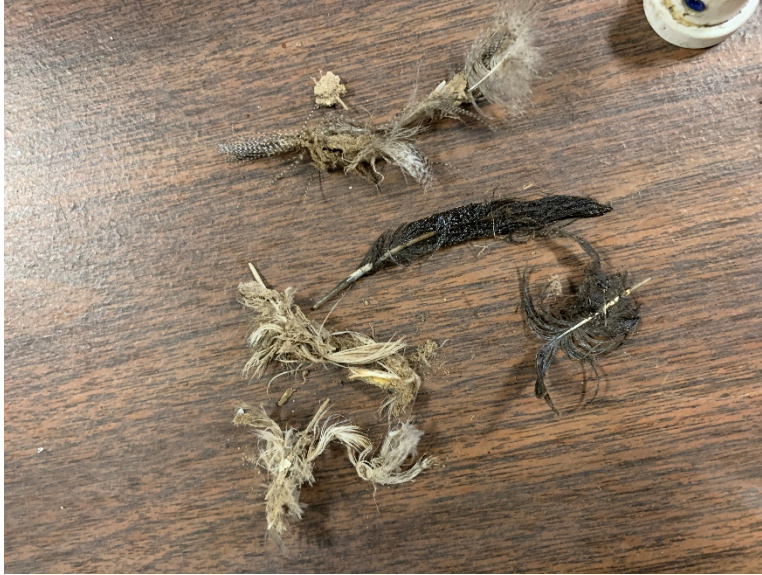
Figure 4: View of recovered bird remains
