# National Transportation Safety Board

WPR22FA254

## **AIRFRAME AND ENGINE EXAMINATION**

Location: Topeka, Kansas  
Date: July 16, 2022  
Time: 1153 central daylight time  
Airplane: experimental amateur-built, RV-7, N283S

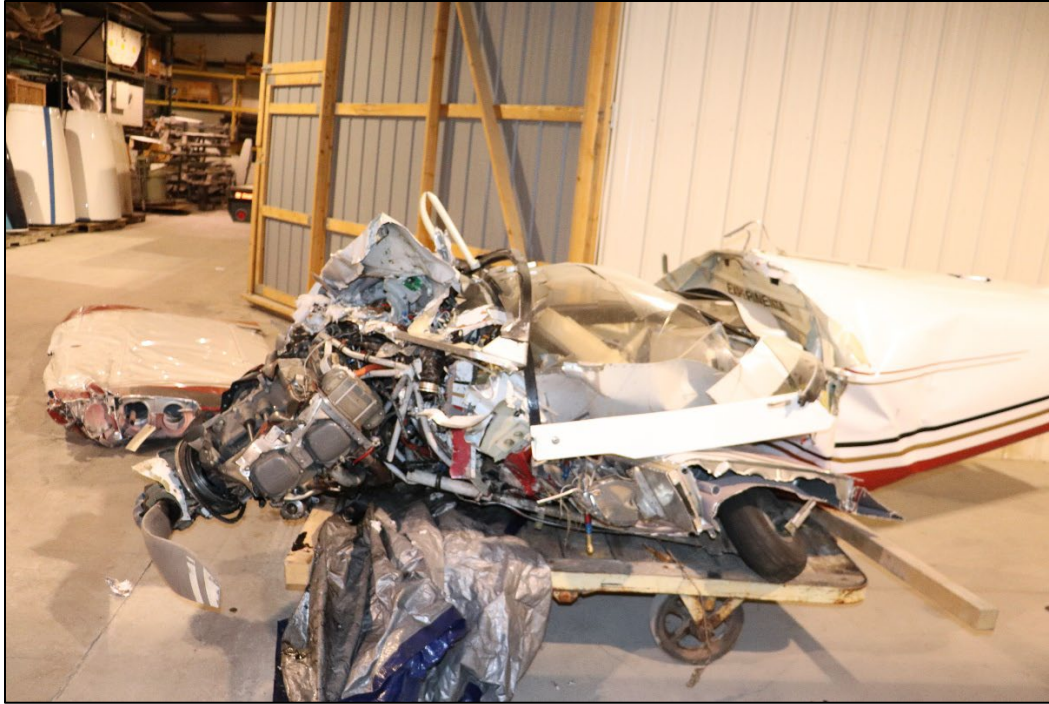
Examination of the recovered airframe revealed that the recovery organization had removed both wings, both horizontal stabilizers, vertical stabilizer, right elevator and rudder for transport. The forward section of the cockpit was impact damaged and crushed aft. Crushing and bending was observed throughout the fuselage. The instrument panel was impact damaged with multiple instruments displaced.

**Figure 1: View of accident airplane during examination.**

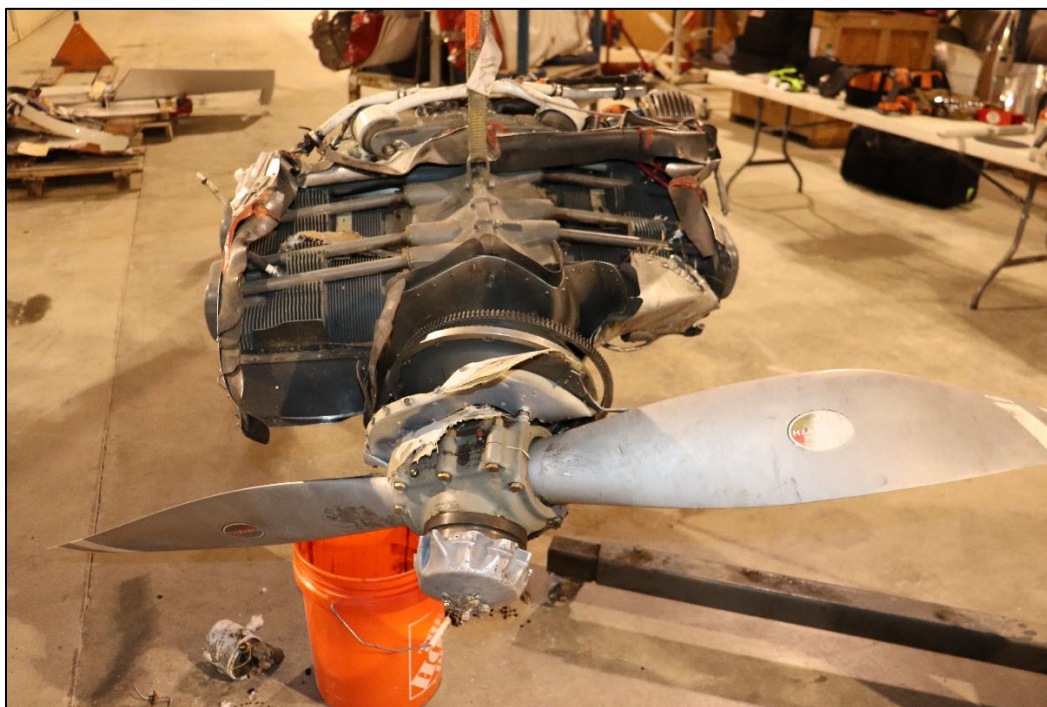
Examination of the recovered engine revealed that the engine remained attached to the engine mount. Several fractures were observed throughout the engine mount. All four cylinders remained attached. The engine starter, carburetor and oil filter were separated. All fuel and oil lines that were removed were tight. No evidence of any mechanical damage was observed to the engine crankcase.

**Figure 2: View of engine during examination.**

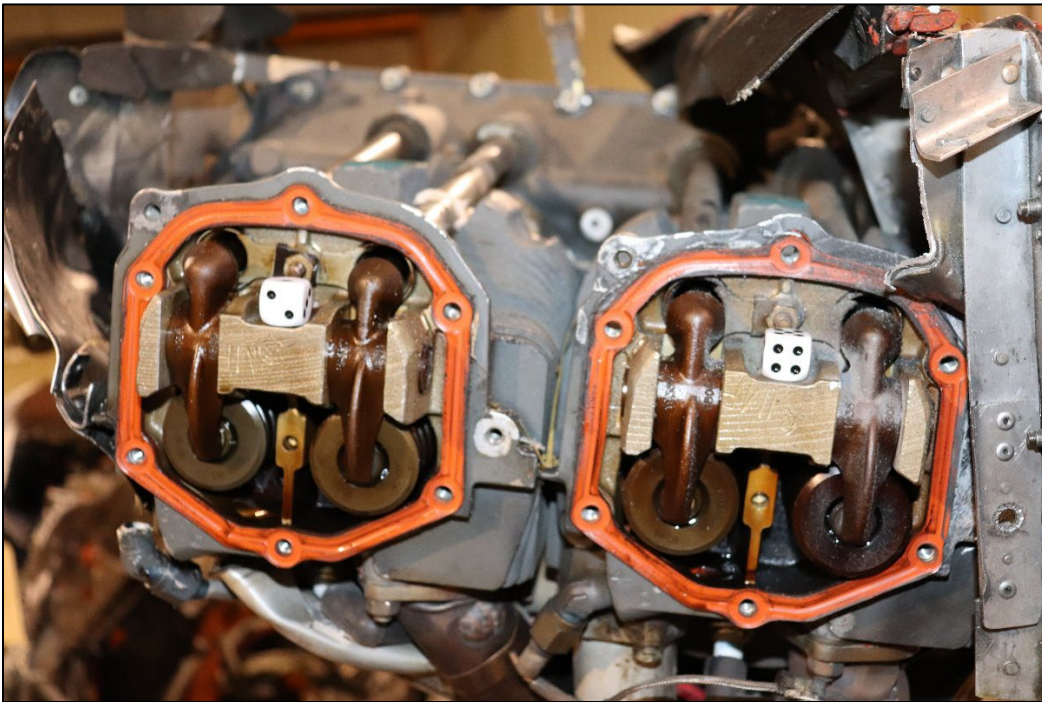
**Figure 3: View of left side of the engine.**

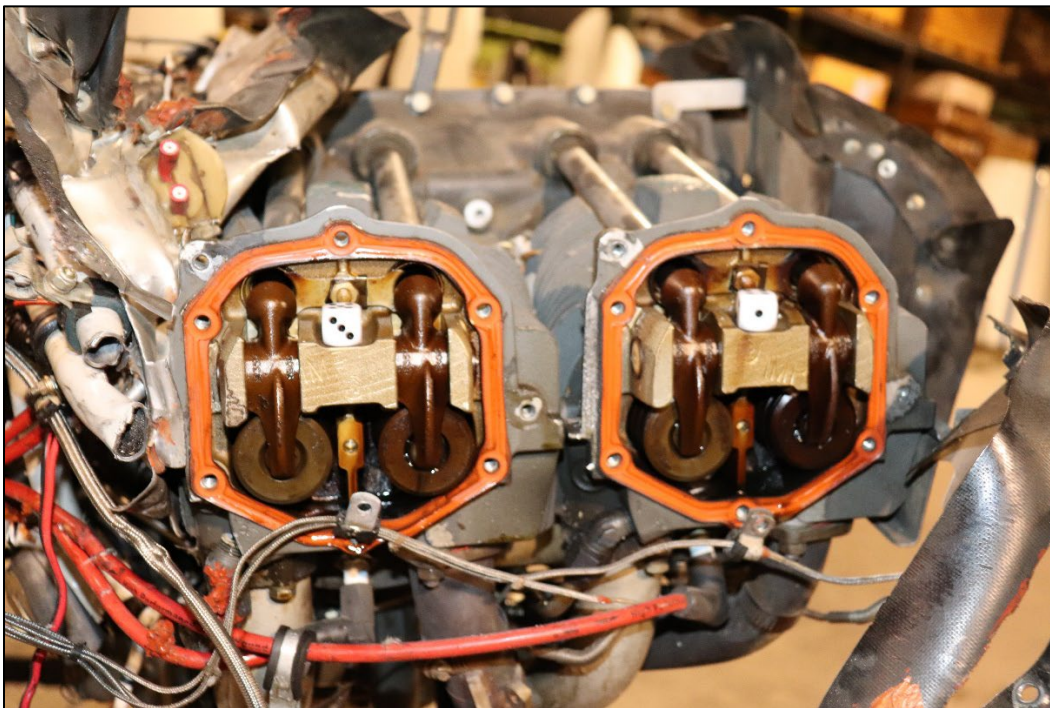
**Figure 4: View of right side of the engine.**

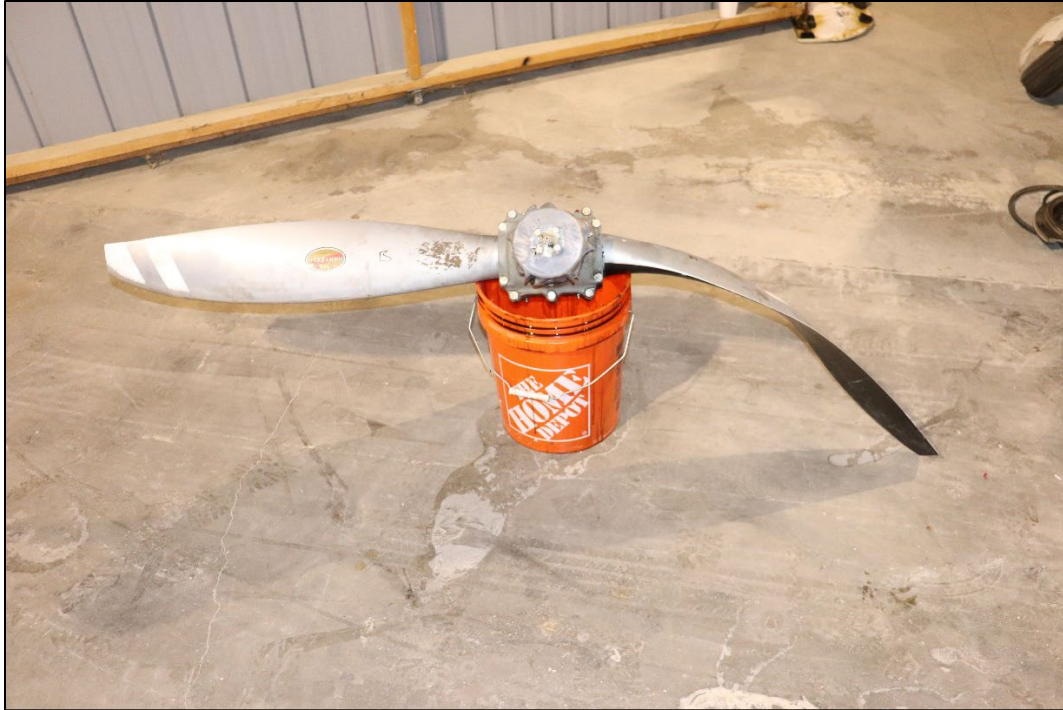
The airplane was equipped with a two blade Hartzell propeller. The propeller and propeller hub remained attached to the engine at the crankshaft. Both blades remained attached to the propeller hub. Propeller blade A exhibited bending aft, with polishing along the leading edge, along with unidirectional striations on the cambered side of the blade. Propeller blade B exhibited polishing along the leading edge, along with unidirectional striations on the cambered side of the blade.

**Figure 5: View of accident airplane propeller.**
