National Transportation Safety Board

WPR23FA044

AIRFRAME AND ENGINE EXAMINATION

Location: Banning, California
Date: November 22, 2022
Time: 1824 PST
Airplane: Amateur-built Gallagher XLT-RG (Velocity); N101BH

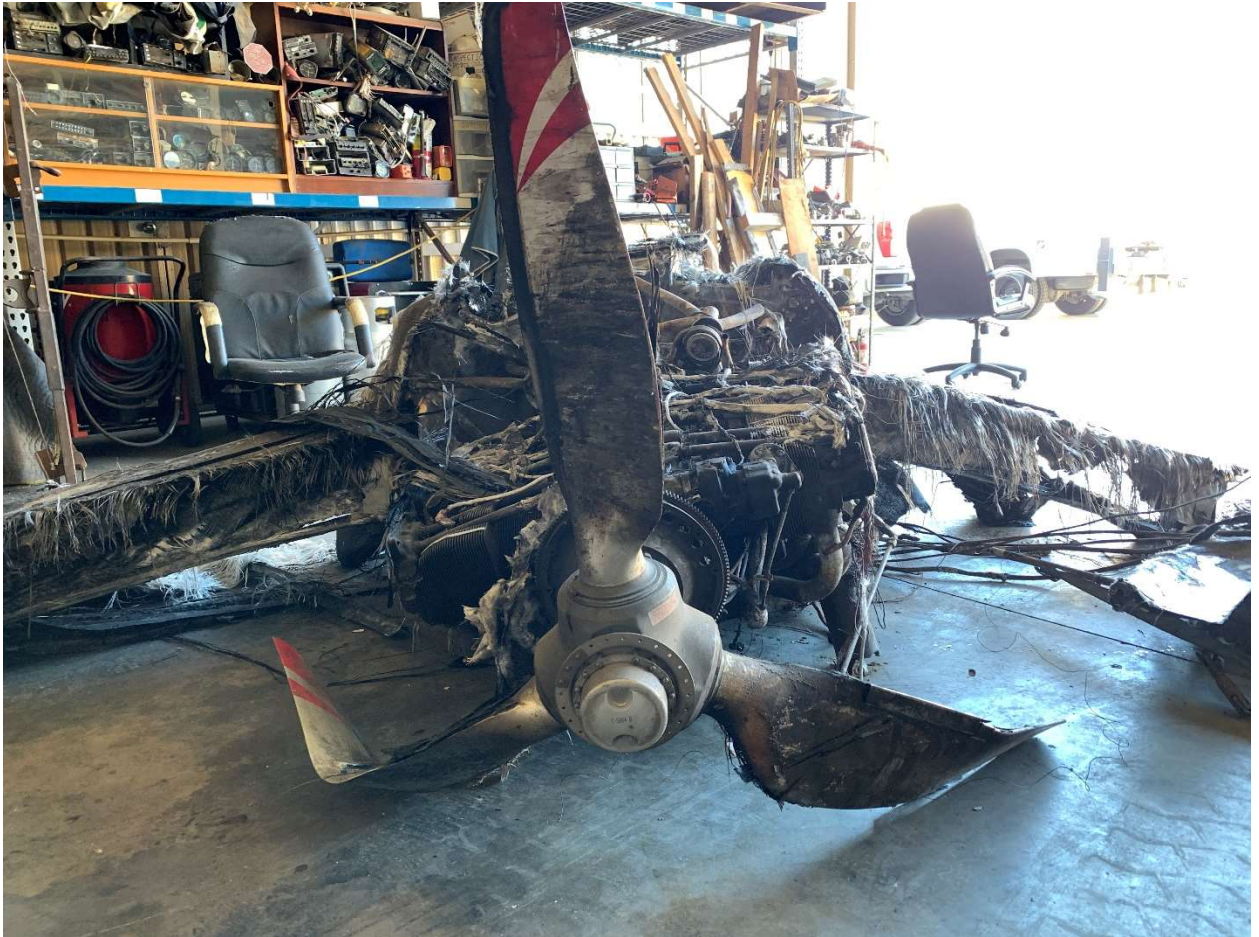
Picture 1. Rear View of Airplane

Visual examination of the airframe revealed that the engine was intact with fire damage throughout.

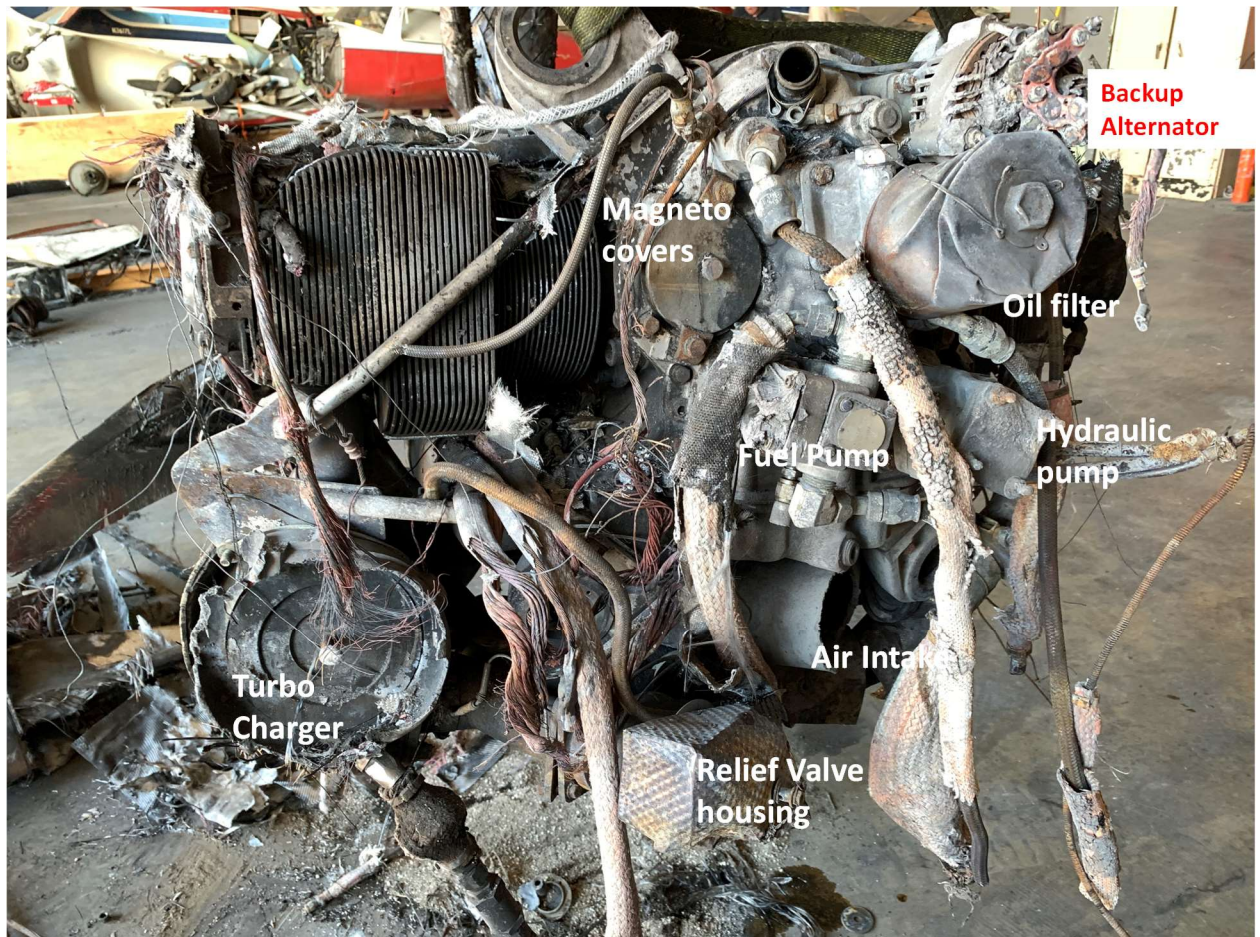
Picture 2. View of Accessory Section

The accessory section remained intact and secured to the crankcase but fire damaged. The oil filter remained attached but had suffered impact damage. The alternator remained attached and secured on its mount to the engine and sustained heat related damage; the outer casing was melted. The fuel pump remained attached and had thermal related damage to one side. The supply and return fuel lines

remained attached. The magneto mounting pads had been covered with plates; there were no magnetos.

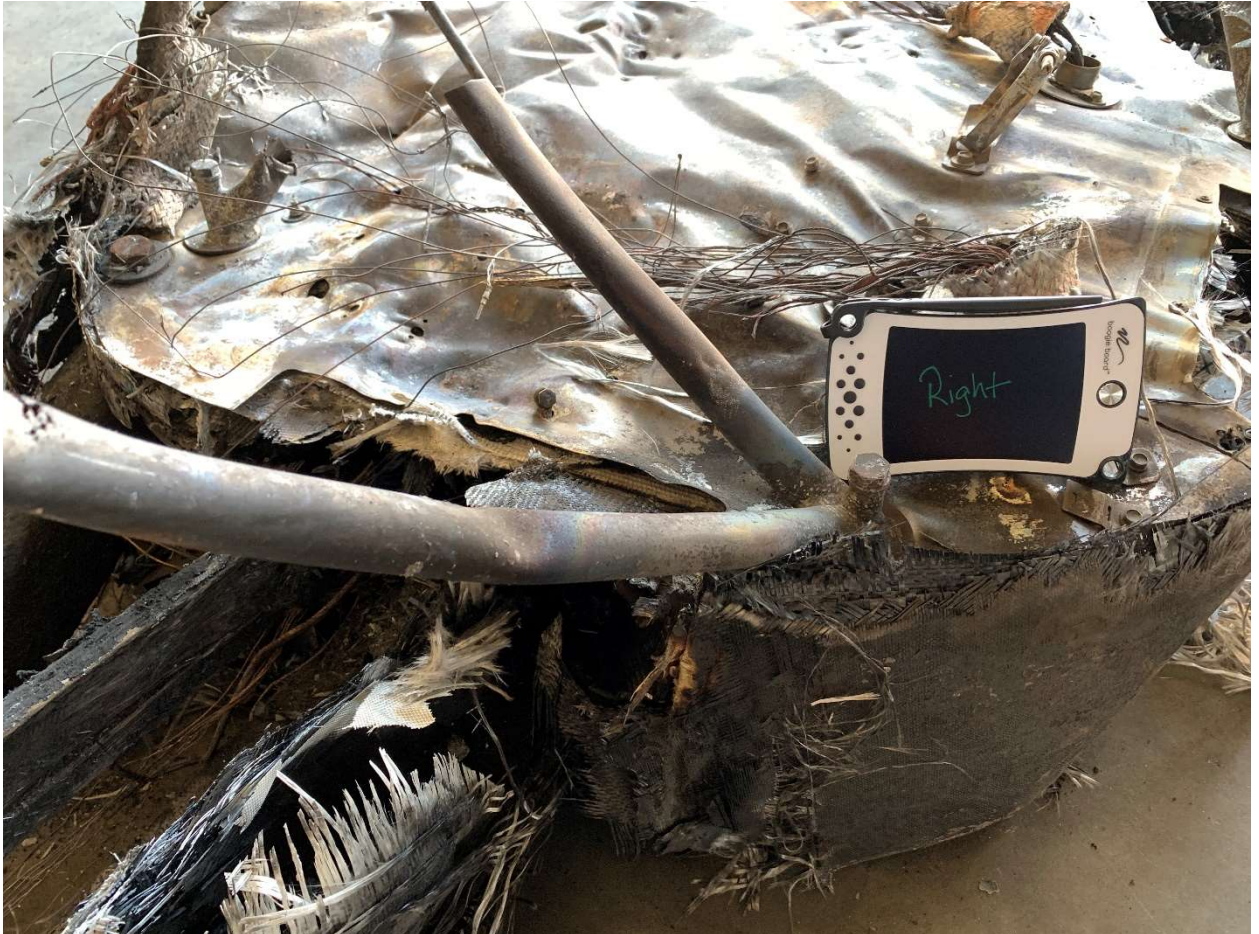
Picture 3. Right Side Firewall and Wing Spar

The right-wing spar had more fire damage to the wing root area than the left-wing spar.

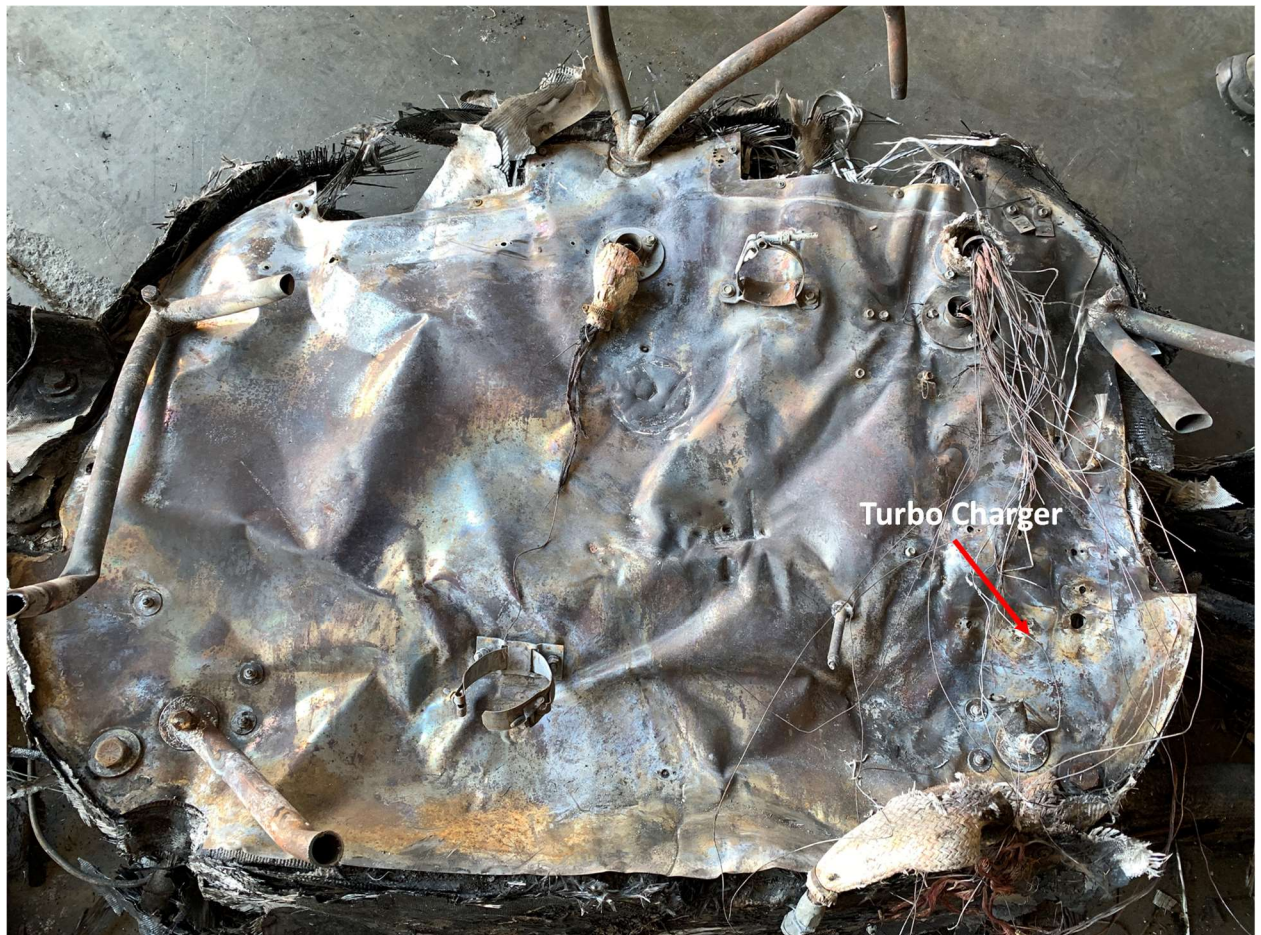
Picture 5. View of Firewall

The firewall - the lower right quadrant had significant thermal damage compared to the rest of the firewall. The entire firewall sustained various amount of thermal discoloration.

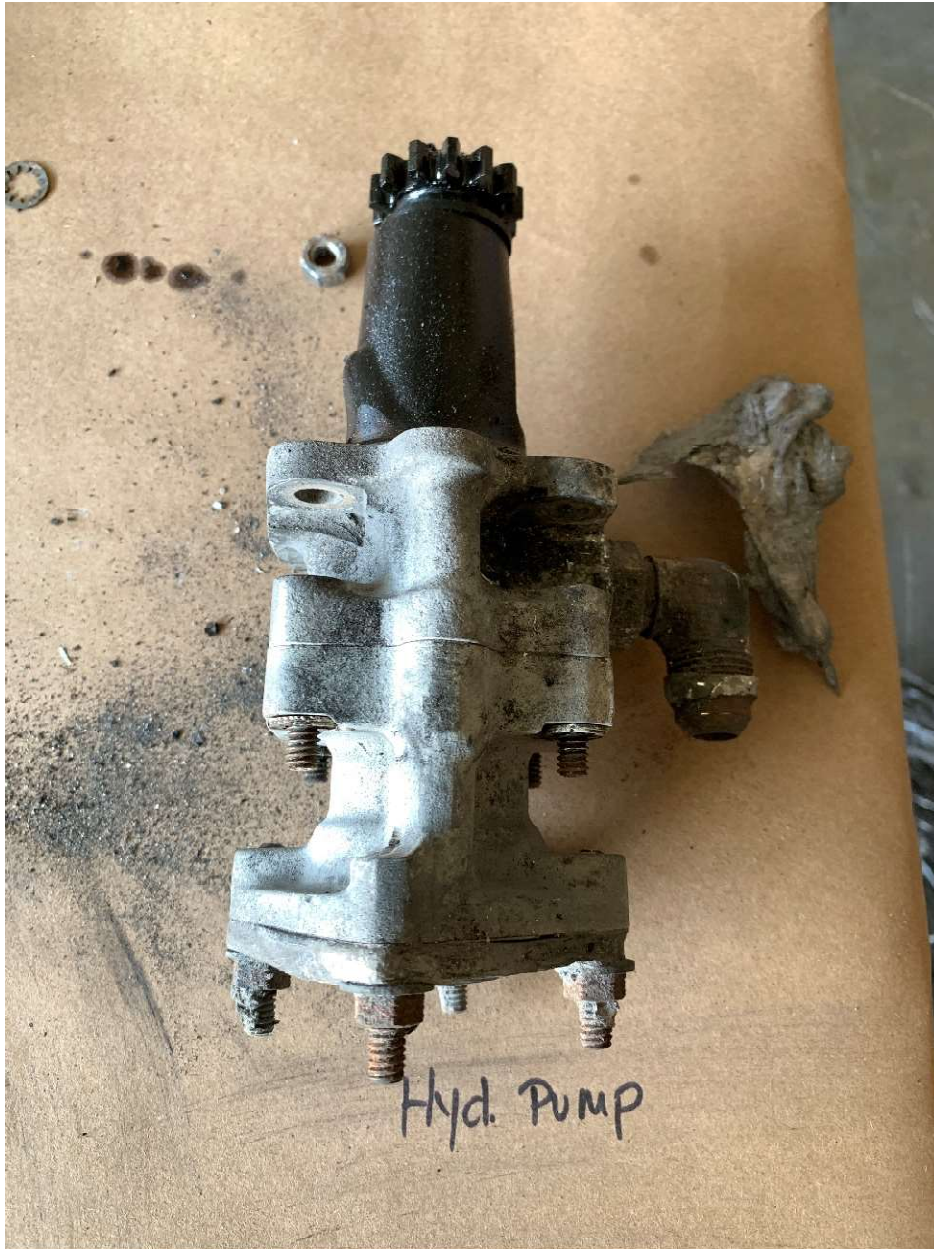
Picture 15. Hydraulic Pump

Hydraulic pump cover had some melting, but the internal components were intact and appeared undamaged.
