NATIONAL TRANSPORTATION SAFETY BOARD

AIRFRAME AND ENGINE EXAMINATION

WPR20LA176

Location: Safford, Arizona
Date: June 9, 2020
Aircraft: Vans Aircraft RV4, N173CW
NTSB IIC: Elliott Simpson

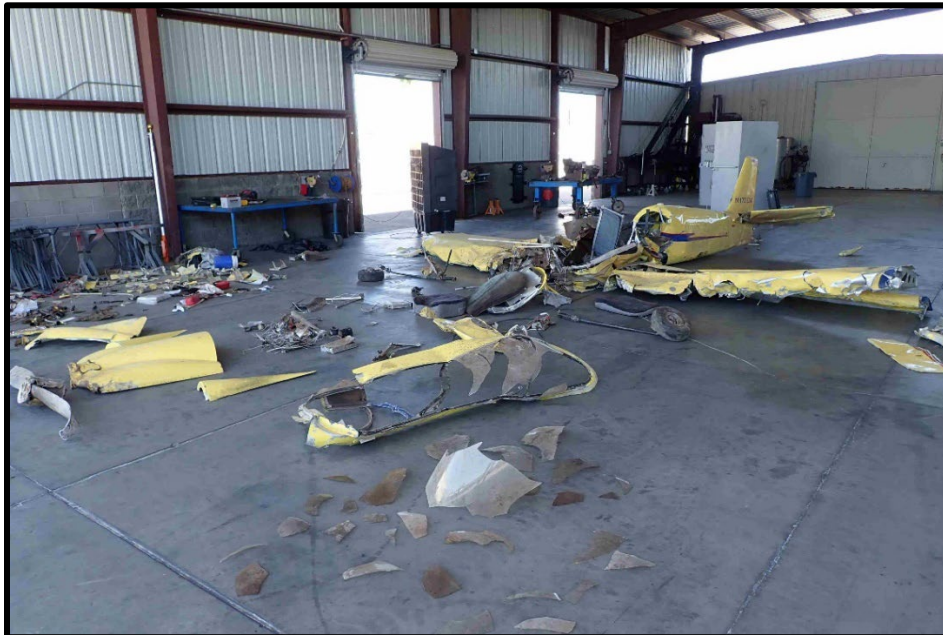
Figure 1 – Complete Wreckage

The entire cabin sustained crush damage through to the aft cabin bulkhead (figure 1). The leading edges and forward undersides of both wings sustained crush damage along their entire length, with outward and forward deformation of the skins at the fuel tanks (figure 2, 3). There was no evidence of cracks to the wing spar as noted in Vans Aircraft Service Bulletin 16-03-28.

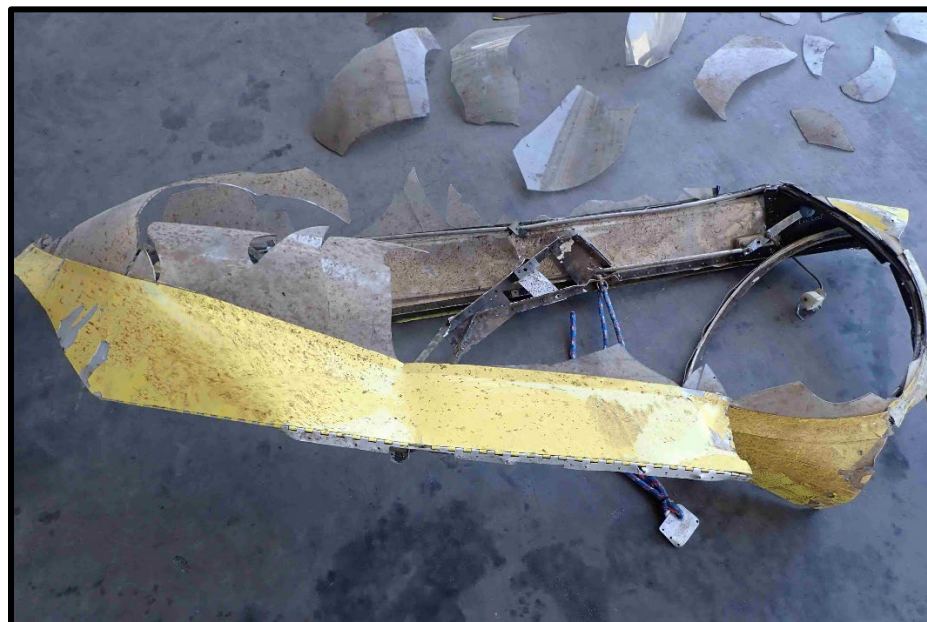
Figure 4 – Canopy

The canopy frame was bent but intact, with most of its Perspex screen broken away (figure 4). The canopy latch handle was in the “locked” position (figure 4). The aft canopy lock pin was in the extended, locked position (figure 5), and the forward lock pin had bent around its guide block (figure 4). The airplane was equipped with a canopy lanyard consisting of rope tied between the canopy and the airframe. The lanyard remained attached to the canopy, and its airframe mount (figure 6).

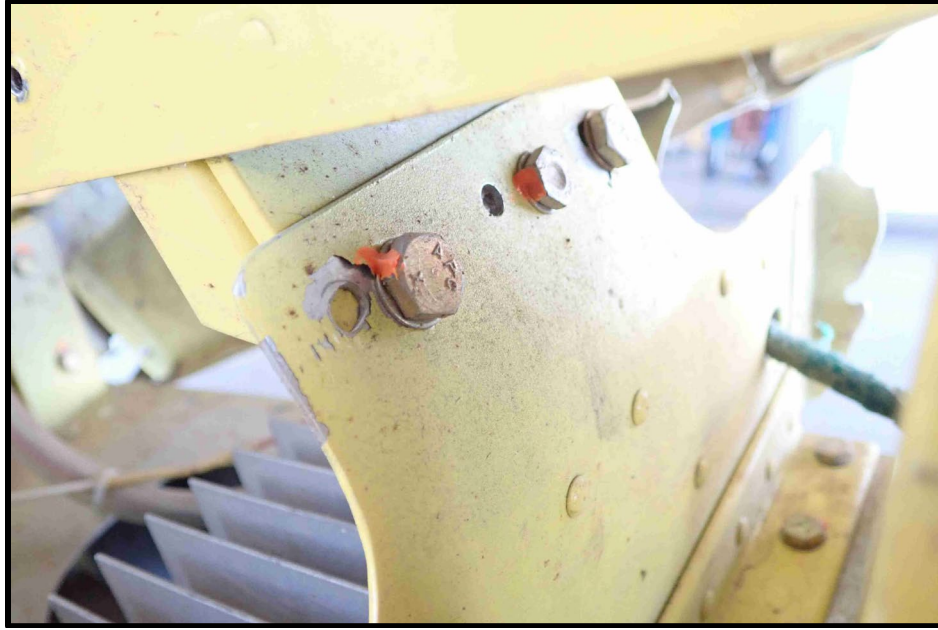
Figure 7 – Vertical stabilizer forward spar

The vertical stabilizer remained attached to aft fuselage and empennage structure. There was evidence of non-standard modification to the forward spar (VS-402), attach-point at the F-410 bulkhead in an apparent effort to adjust the leading edge of the vertical stabilizer about ½ inch to the left (figure 7).

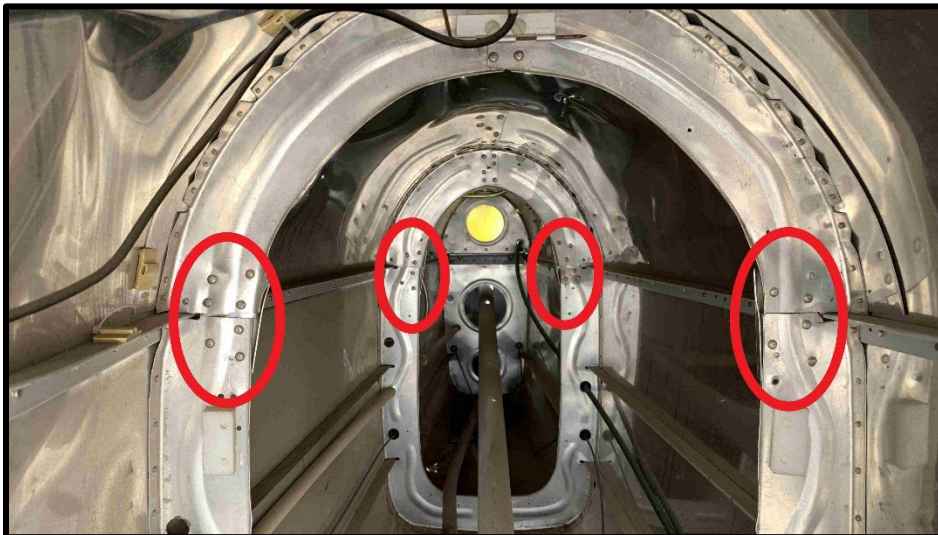
The bulkheads in the aft section of the airplane appeared to have been cut and refitted with doublers in their center sections (figure 8).

The trim cable was continuous through to the forward airframe (*although cut by the recovery crew mid-length*). The cable and tab could be moved freely, with no evidence of binding. The cable remained firmly attached to the aft airframe bulkheads (figure 8) where it appeared to have been cut by recovery personnel. Forward of the cut, the trim system sustained impact damage including separation of the trim cable from the cable end. The separation surface features were grainy in appearance consistent with overload failure. The damage to the remaining trim fittings, along with the trim control arm and its friction assembly, prevented a determination of its operating status at impact. The trim cable was fitted with a spring that appeared to be configured to apply a forward force on the cable. The direction of this force would have resulted in the trim tab moving down, which corresponded to nose-up pitch attitude (figure 35).

Figure 8 – Tail section (doublers highlighted)

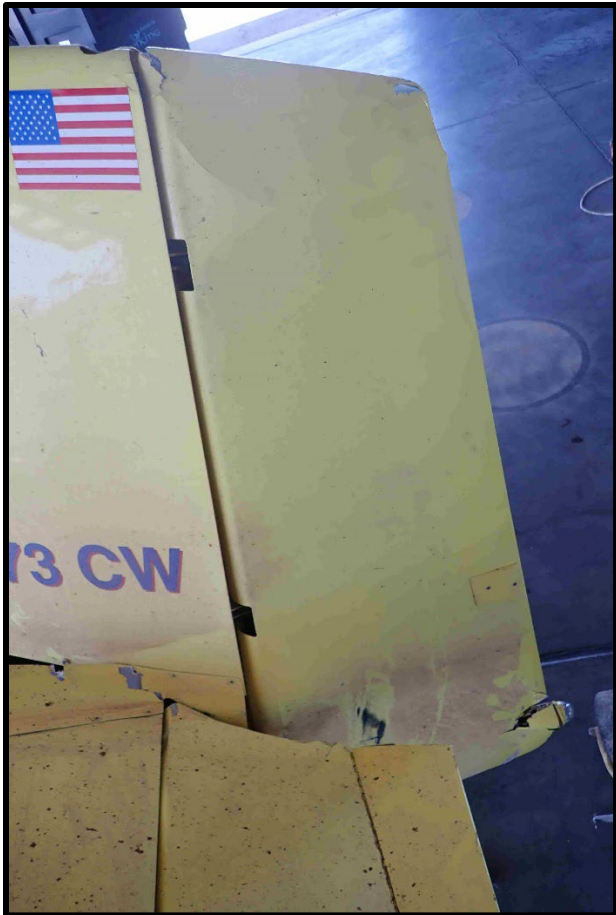
Figure 9 – Rudder

The rudder remained attached to the vertical stabilizer by its three hinges (figure 9), and the rudder cables were continuous from the rudder control horn to their respective forward foot pedals in the cabin. *The rudder cables had been cut by recovery personnel.*

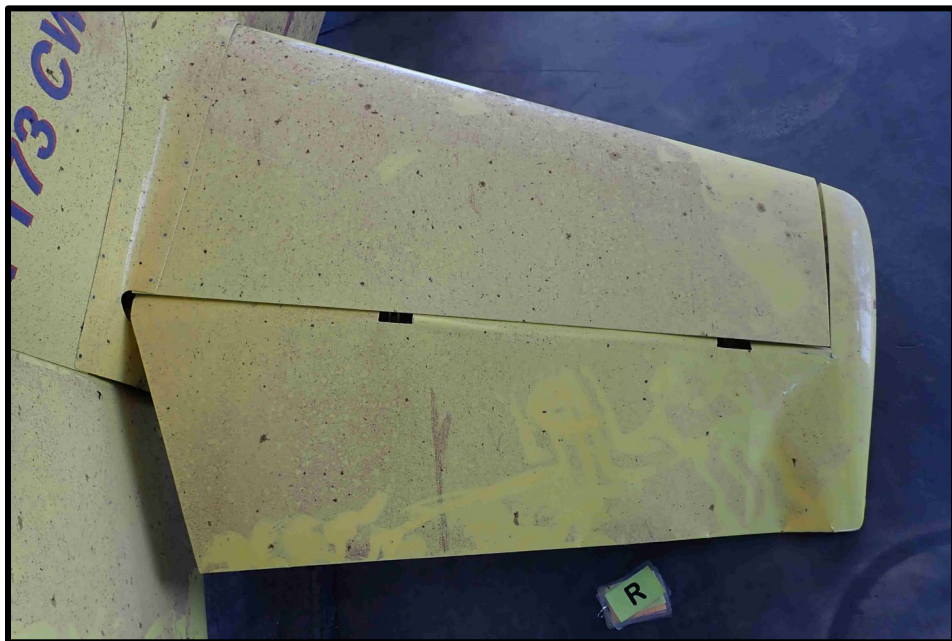
Figure 10 – Right horizontal stabilizer

The right horizontal stabilizer appeared undamaged and remained attached to the tailcone. The right elevator remained attached to the horizontal stabilizer by its two hinges. The balance weight was still attached (figure 10).

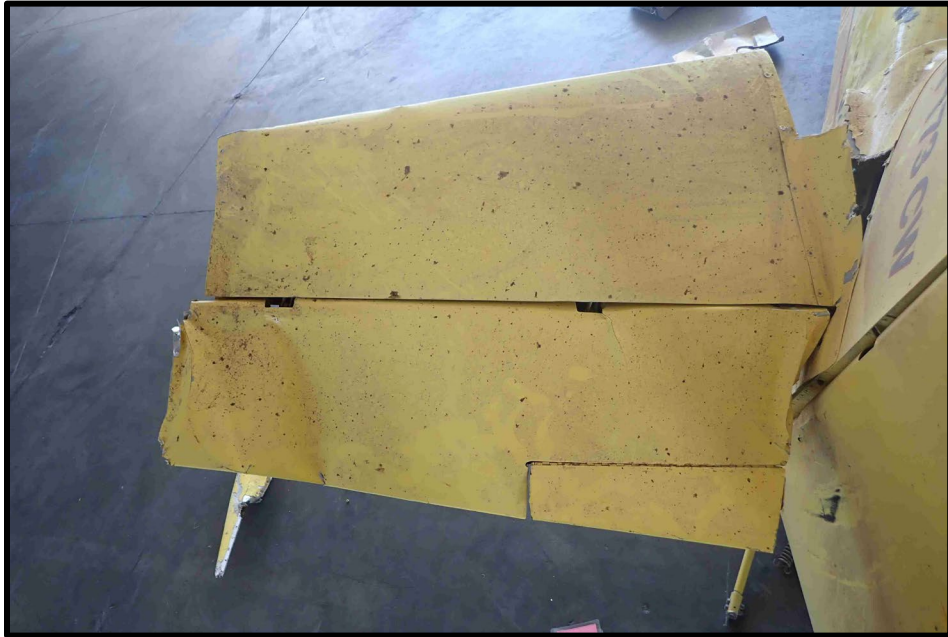
Figure 11 – Left horizontal stabilizer

The left horizontal stabilizer remained attached by its aft spar. The forward spar had detached from the empennage fitting, and the stabilizer was bent back about 20° aft at the separation point (figure 11, 12). The left elevator remained attached by its two hinges, and its inboard root was crushed consistent with impingement against the rudder and vertical stabilizer. *The rudder exhibited black marks indicative of repeated contact with the root of the elevator, however when compared to accident site figures, it was evident that this was caused during aircraft recovery and transportation.* The left elevator balance weight had detached (figure 13) and was located at the main wreckage site. The left and right elevators remained interconnected through the torque tube.

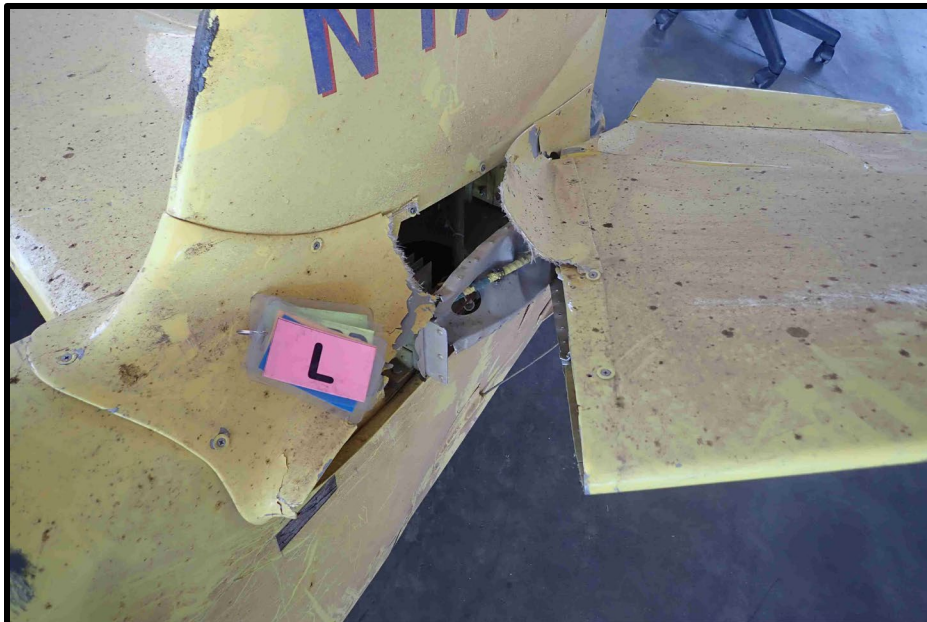
Figure 12 – Left horizontal stabilizer forward mount

The elevator trim tab remained attached to the left elevator and was in the tab down (nose up) position at the accident site (figure 14). The trim cable was still attached to the tab control arm (figure 15). The trim fitting weldment remained attached to the elevator and appeared to comply with Vans Service Bulletin SB 06-9-20; a logbook entry also reflected this. The outer sheath of the cable in the left horizontal stabilizer exhibited peeling to the outer sheath in the area where it passed through the forward spar, inboard stabilizer rib, and aft spar (figure 16, 17, 12).

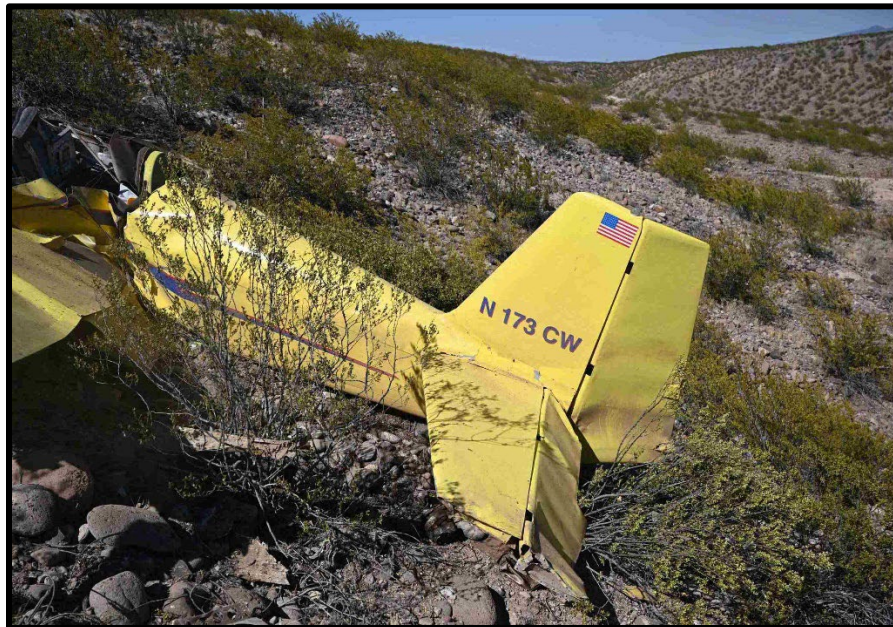
Figure 14 – Empennage at accident site (figure courtesy of Safford Police Department)

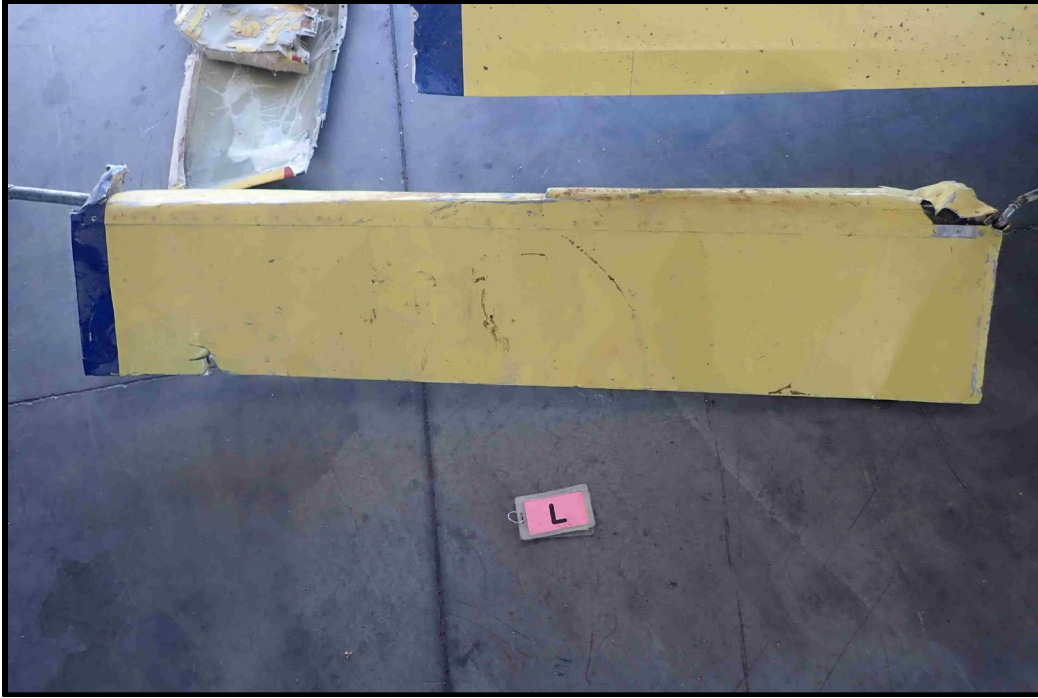
Figure 21 – Left aileron

Both hinges remained attached to the left aileron, which had completely detached from the wing (figure 21). The push-pull control tube remained attached to its inboard aileron arm, and the forward rod end for the ball had separated at the wing bellcrank.

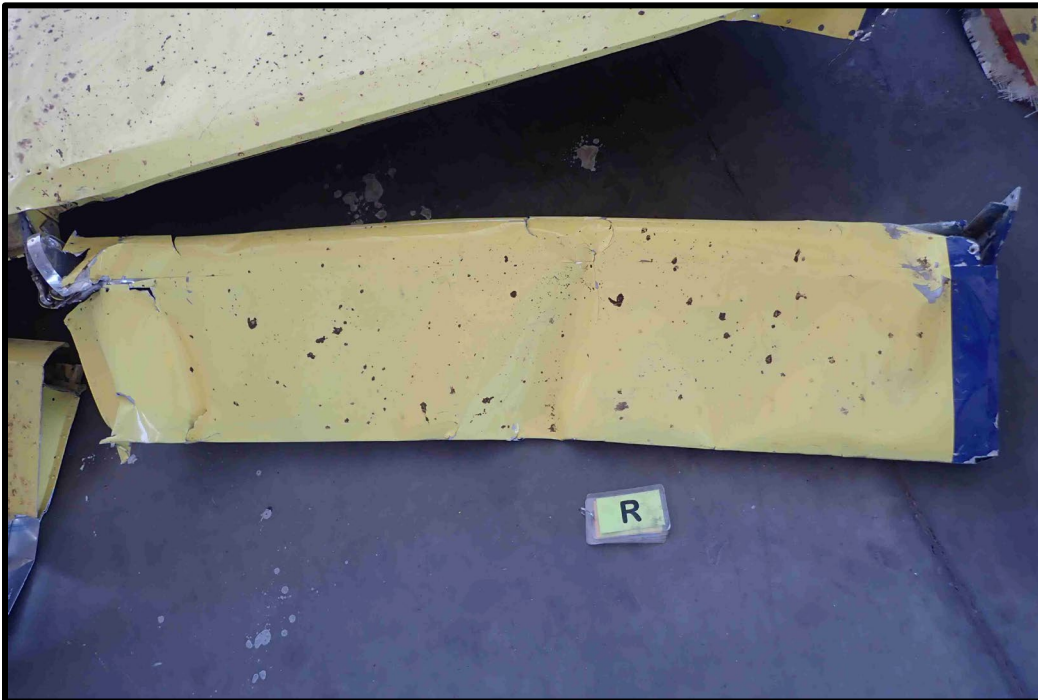
Figure 22 – Right aileron

The right aileron remained partially attached to the wing by both its left hinge and the push-pull control tube, which remained attached to the wing bellcrank (figure 22).

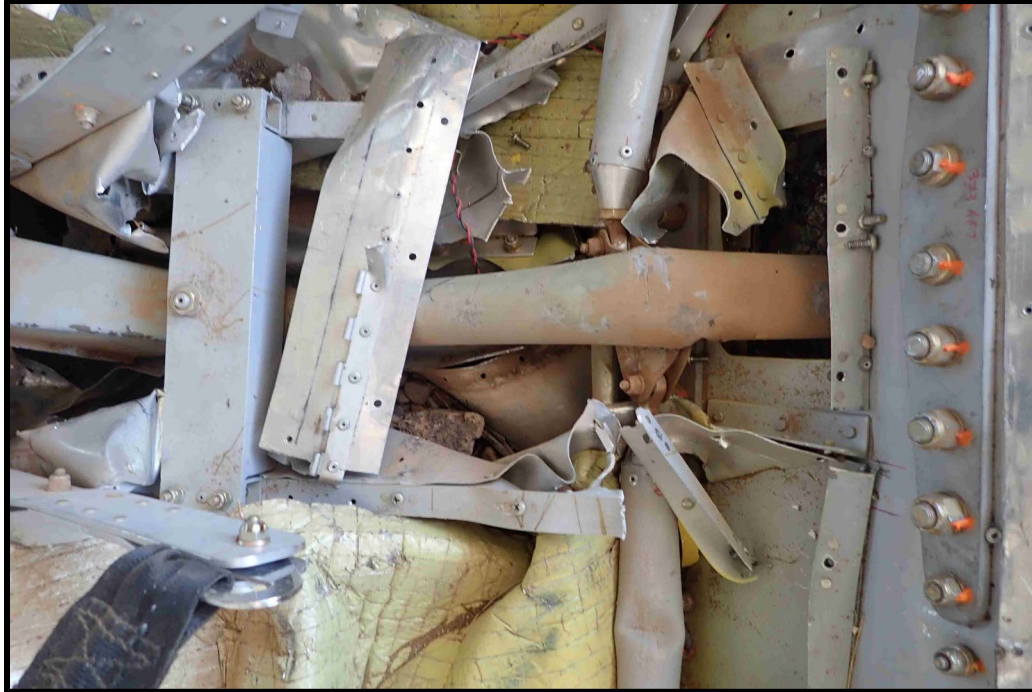
Figure 23 – Aileron push-pull tubes in underfloor

Both the right and left wing aileron push-pull tubes remained connected to the outboard wing bellcranks and the cabin control column assembly (figure 23). Side-to-side movement of the control stick assembly resulted in lateral movement of the push-pull tubes at the wing bellcranks. A servo device, which appeared to be the remnants of a previously installed autopilot, was installed on the center section of the wing spar and connected to the root of the forward control column assembly. The unit had sustained crush damage, and the rod end that connected the unit the control to the aileron control assembly was deformed and had detached.

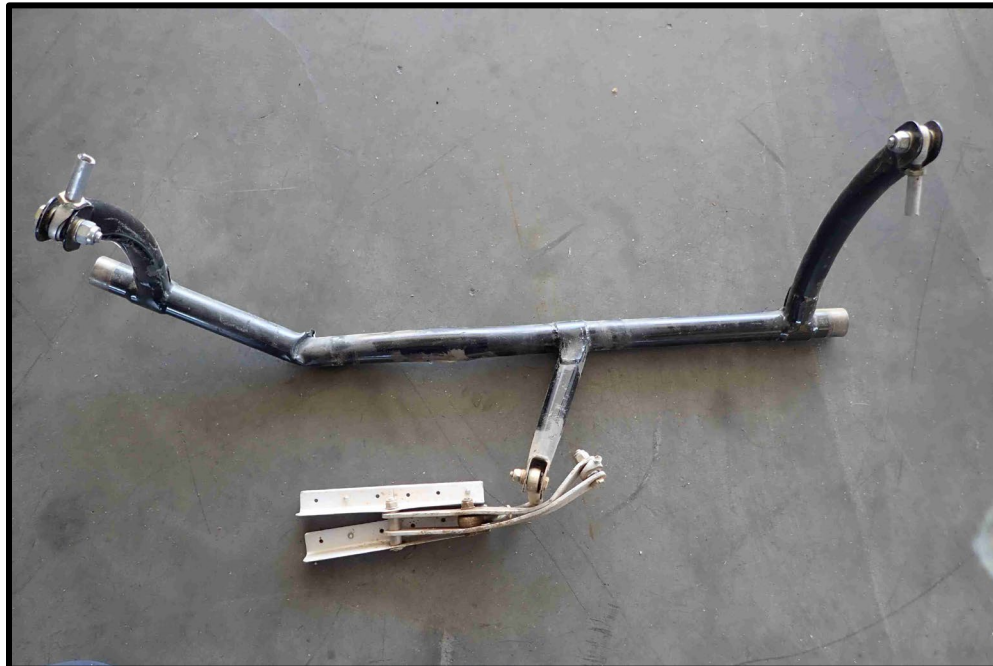
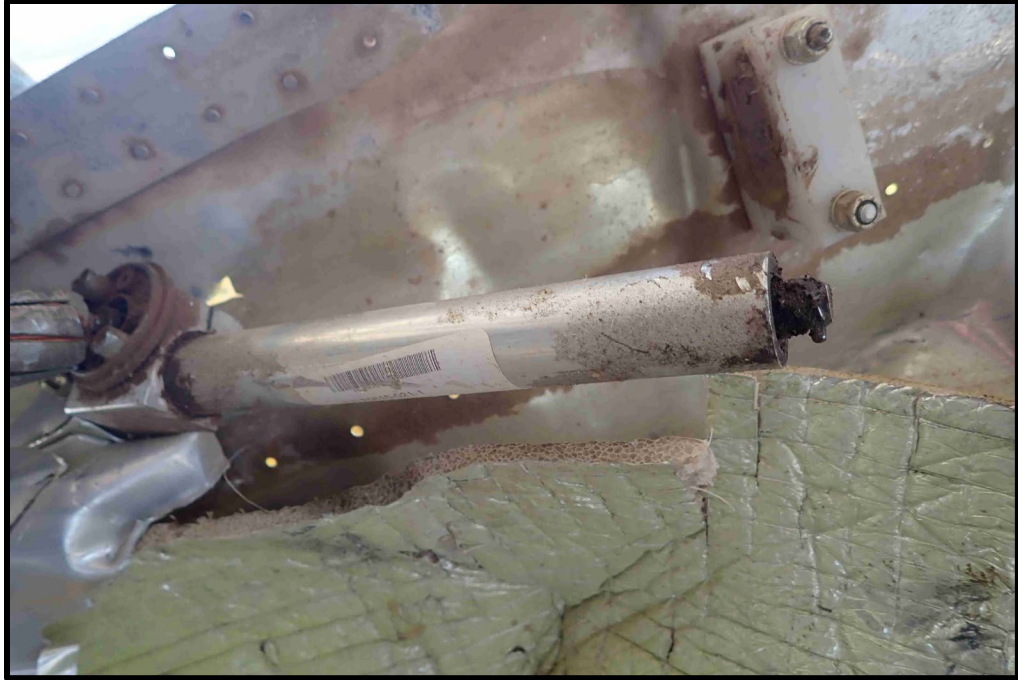
The flap actuator was attached to the airframe and its drive motor had broken away against the airframe structure. The output coupling of the flap actuator was bent and had detached from the flap assembly bellcrank (figure 24, 25). The actuator was in the fully retracted position, which according to the assembly instructions corresponded to fully extended flaps. Visual examination of the flap system configuration confirmed this finding. The throttle control had bent almost 180 degrees around the quadrant, resulting in damage to the flap switch, and its electrical cables (figure 34). Similarly, airframe damage had resulted in multiple breaks in the flap electrical system wiring.

Figure 24 – Flap control assembly

Figure 25 – Flap motor

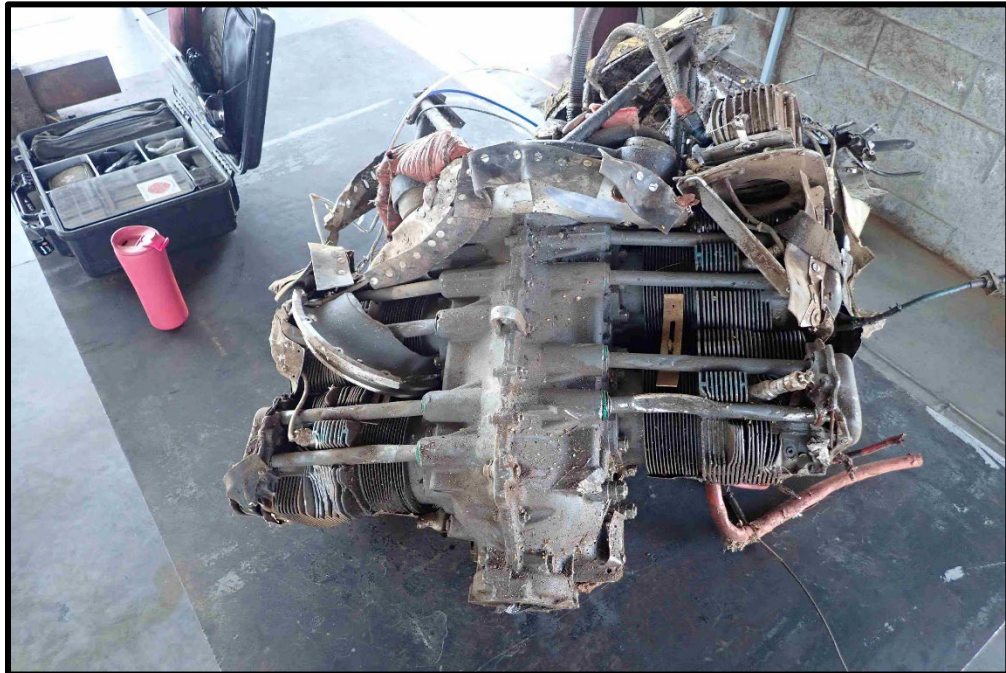
Figure 26 – Engine

The engine remained attached to its mount, which had detached from the firewall (figure 26). The bulk of the engine remained largely intact, having sustained crush damage to the forward pushrod tubes, and rocker covers, along with the detachment of the oil sump, the propeller and hub, flywheel, and ring gear. There was no streaking along the airframe sides or any other evidence significant engine oil leakage.

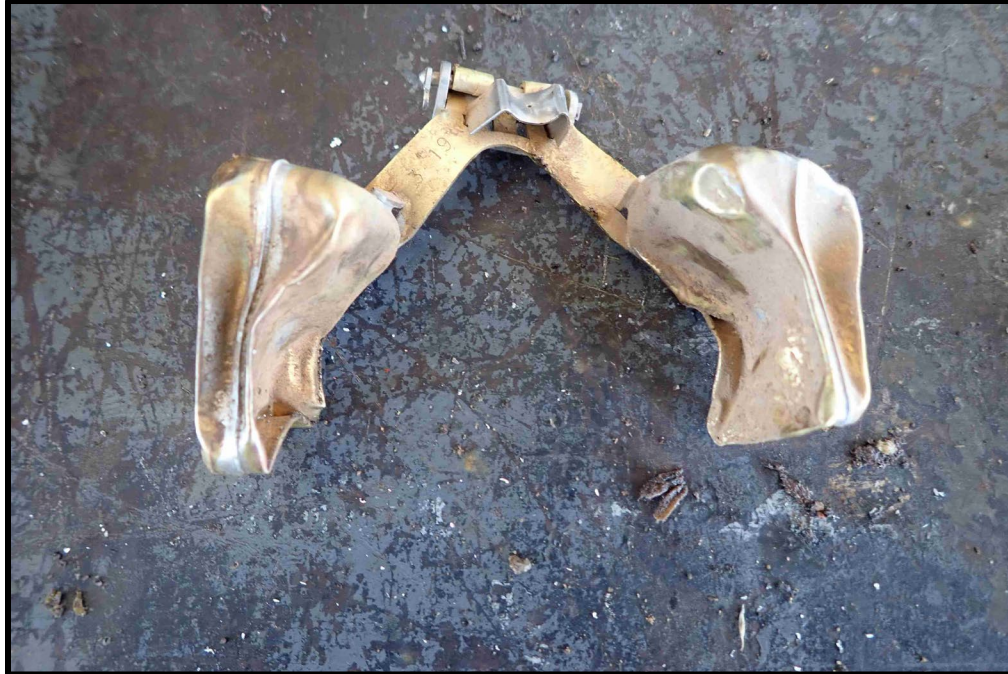
Figure 27 – Carburetor floats

The carburetor had detached from the sump and had broken open at the bowl seam. The float assembly was the brass type and had detached from the assembly. The floats exhibited significant hydrodynamic crushing (figure 27). The data plate information could not be determined, however it appeared to be manufactured by AVSTAR. The mixture control arm had detached, and the throttle control arm was found securely attached at the control arm of the carburetor. The throttle control castellated nut and cotter pin remained secure and the serrated interface at the throttle arm remained securely mated.

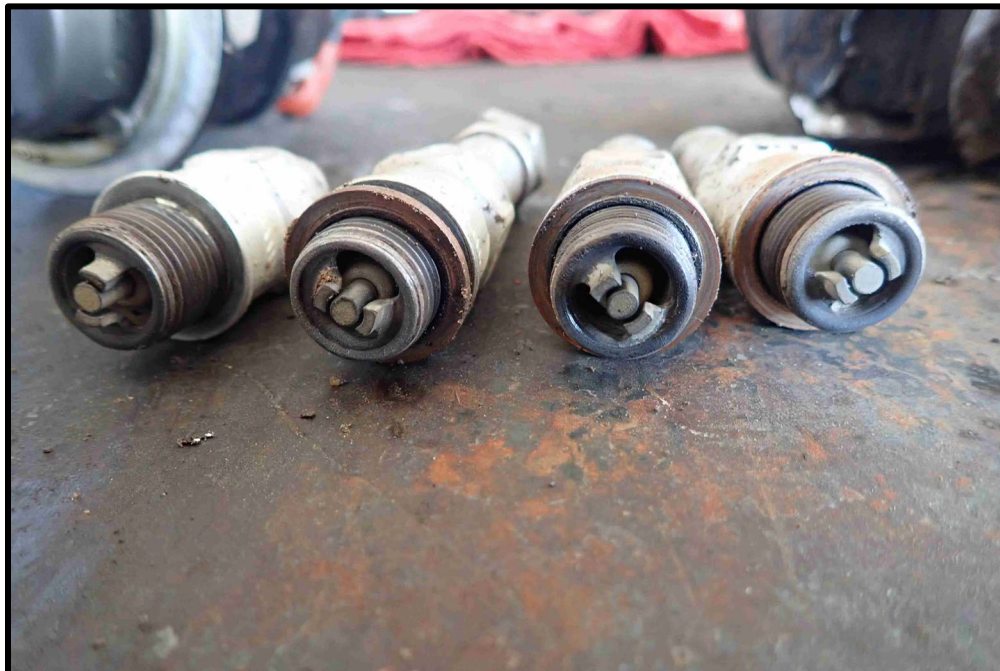
Figure 28 – Top spark plugs

The spark plugs were secure at each cylinder. The top spark plugs were removed and examined. The electrodes remained mechanically undamaged, and according to the Champion Spark Plugs AV-27 Check-A-Plug chart, the electrodes displayed grey coloration and deposits consistent with normal operation, and wear signatures consistent with a short service life (figure 28).

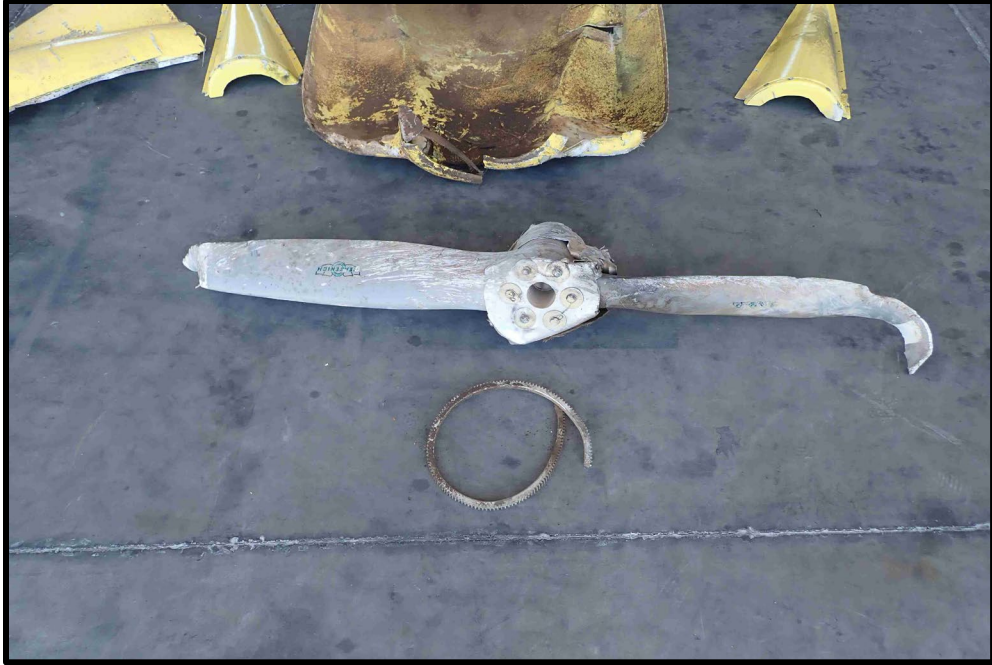
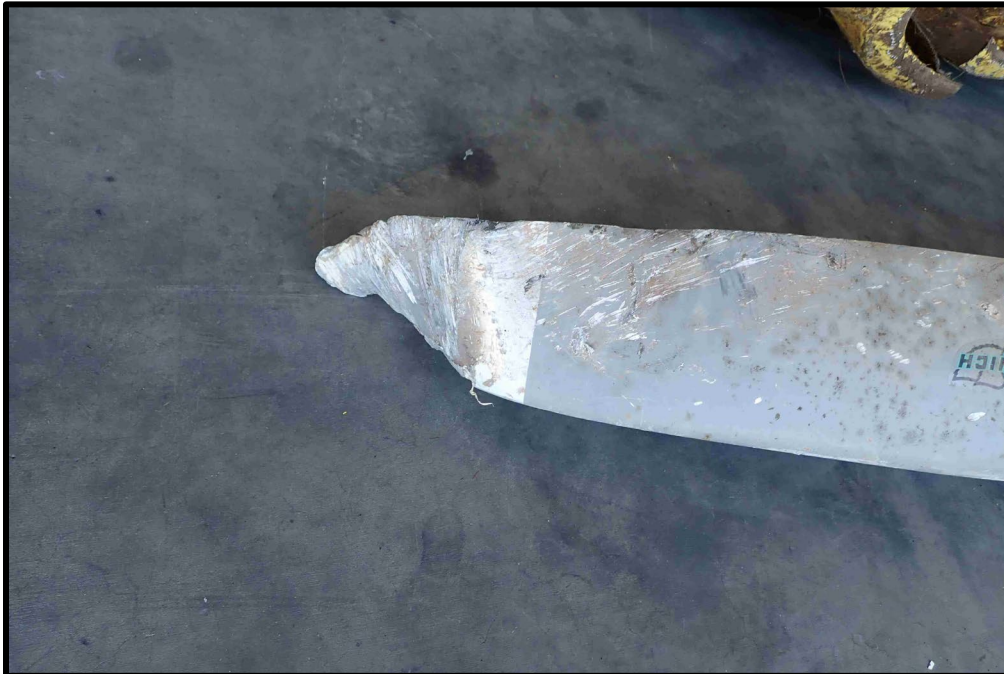
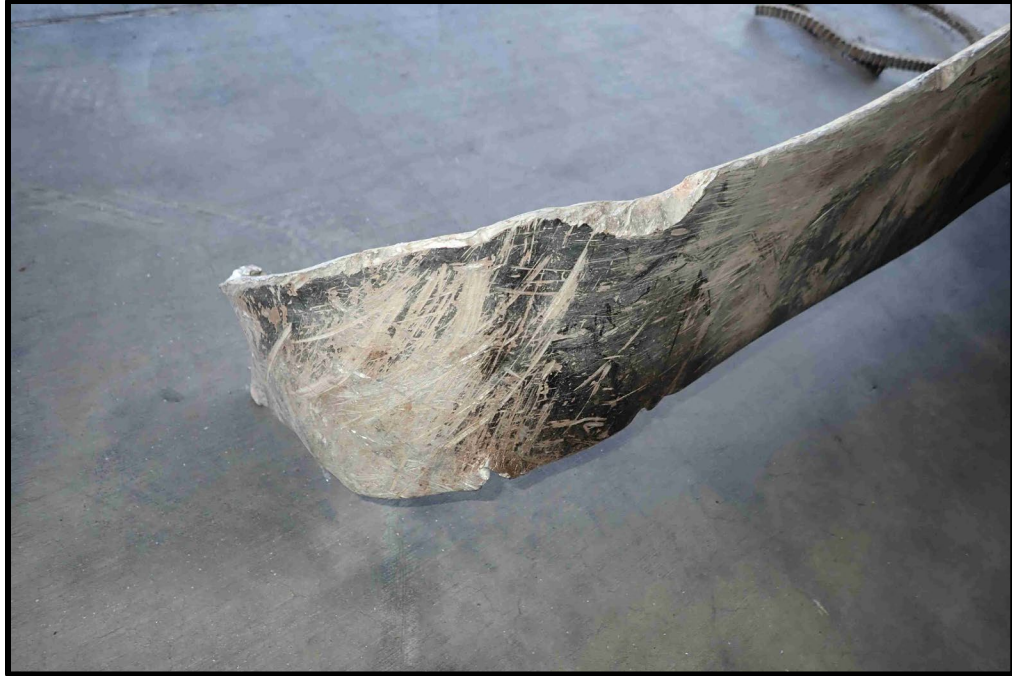
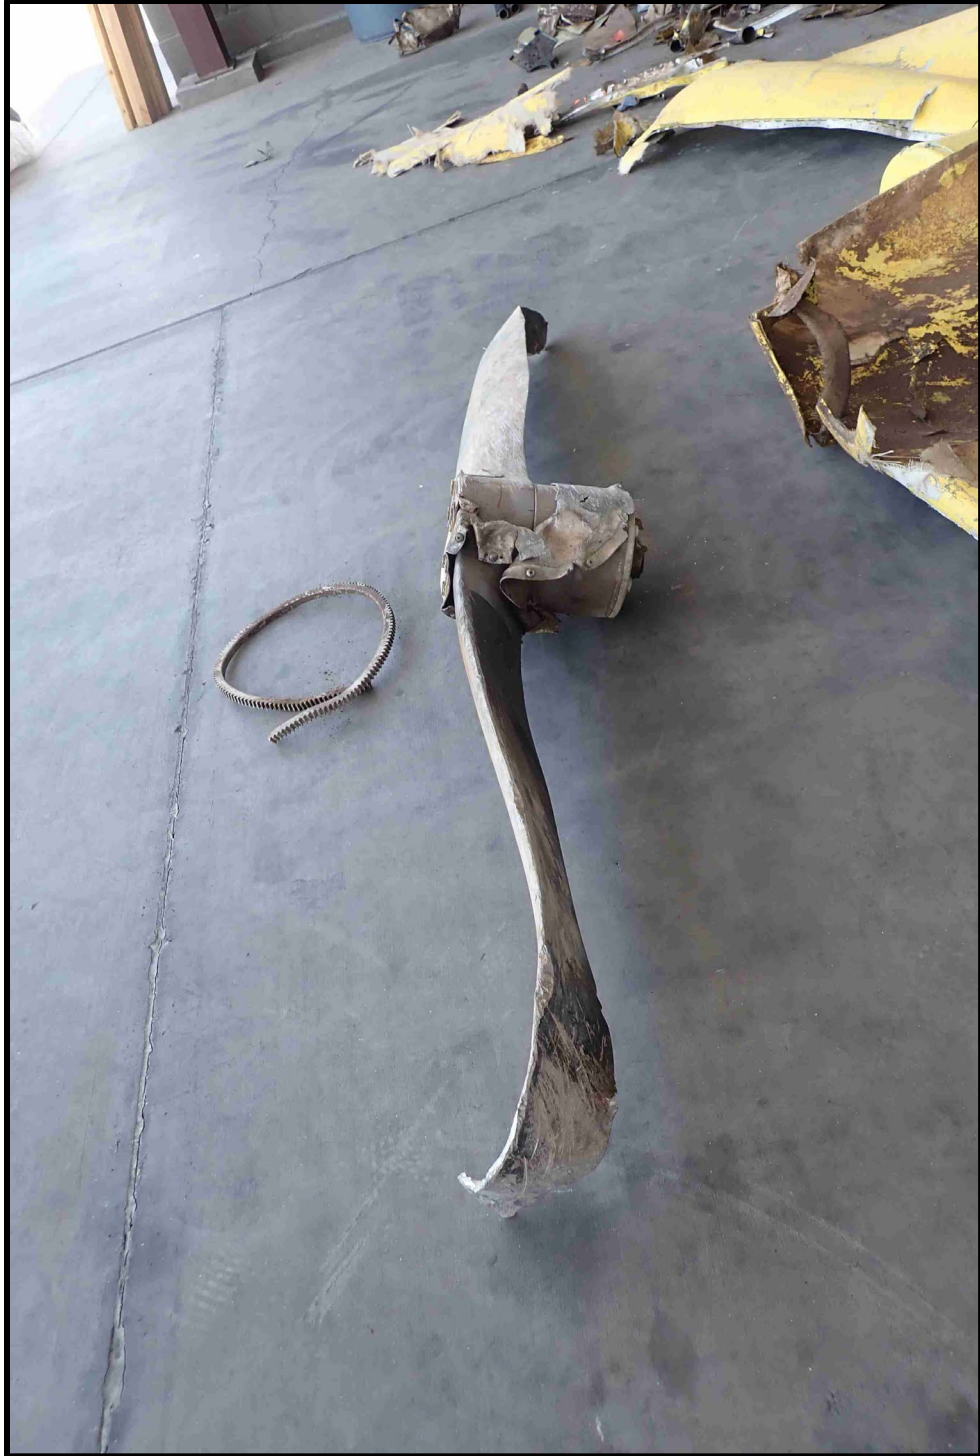
Both propeller blades exhibited leading edge gouging, torsional twist, chordwise striations across the cambered surface and trailing edge "S" bending (figure 29, 30, 31,32)

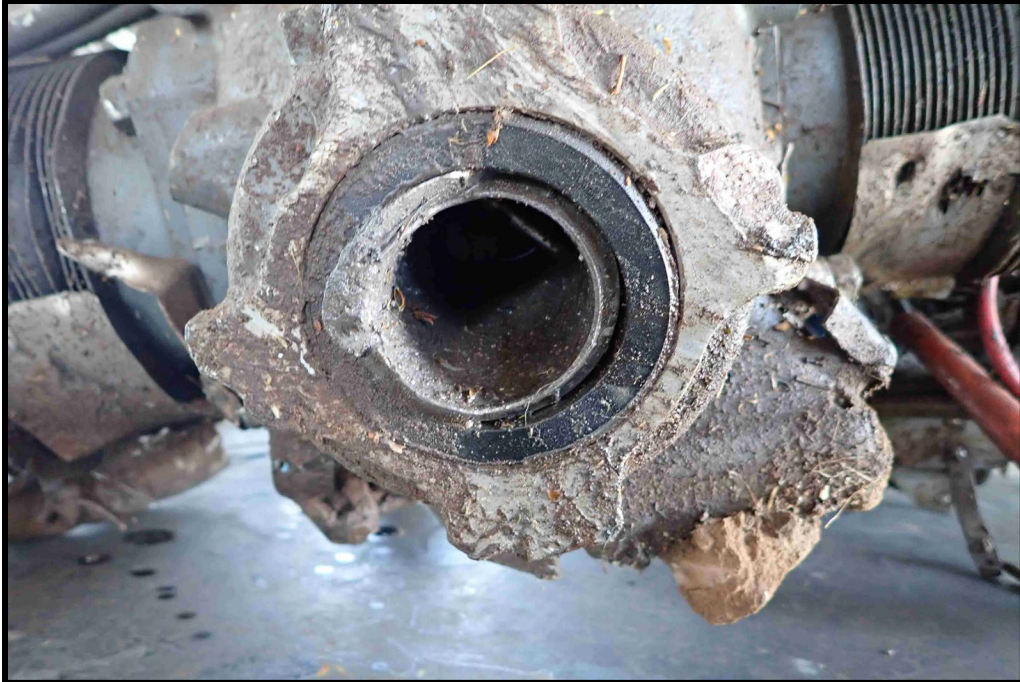
The propeller remained attached to the crankshaft flange, which had broken away from the engine at the forward crankshaft bearing. The crankshaft separation surfaces exhibited a radial 45° radial lip around its circumference (figure 33).

Figure 33 - The crankshaft separation surfaces

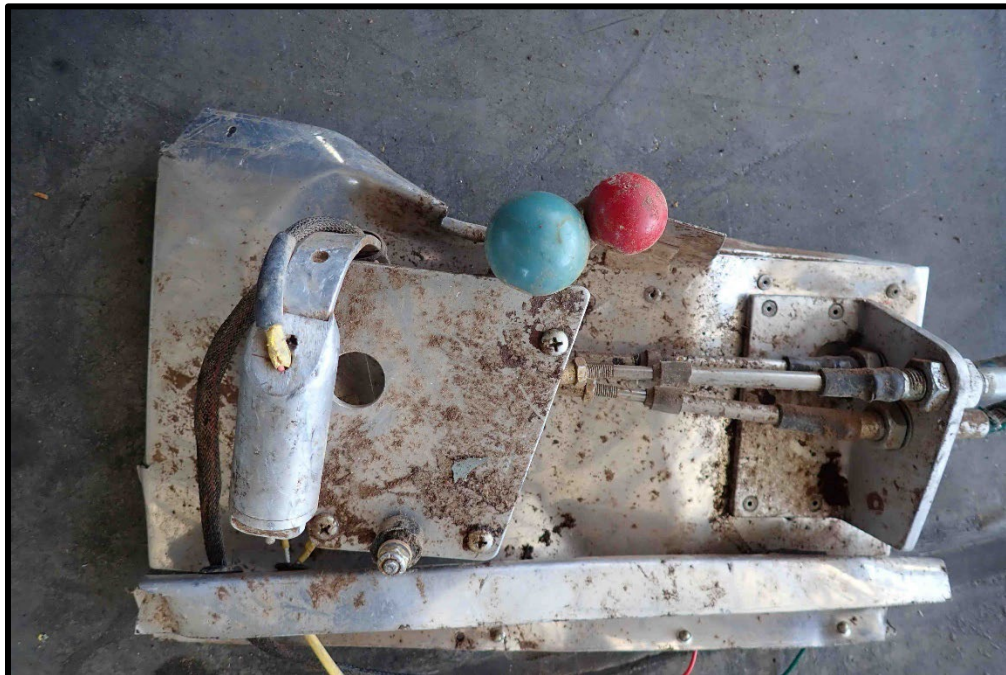
Figure 34 – Throttle quadrant with flap switch (bottom left)

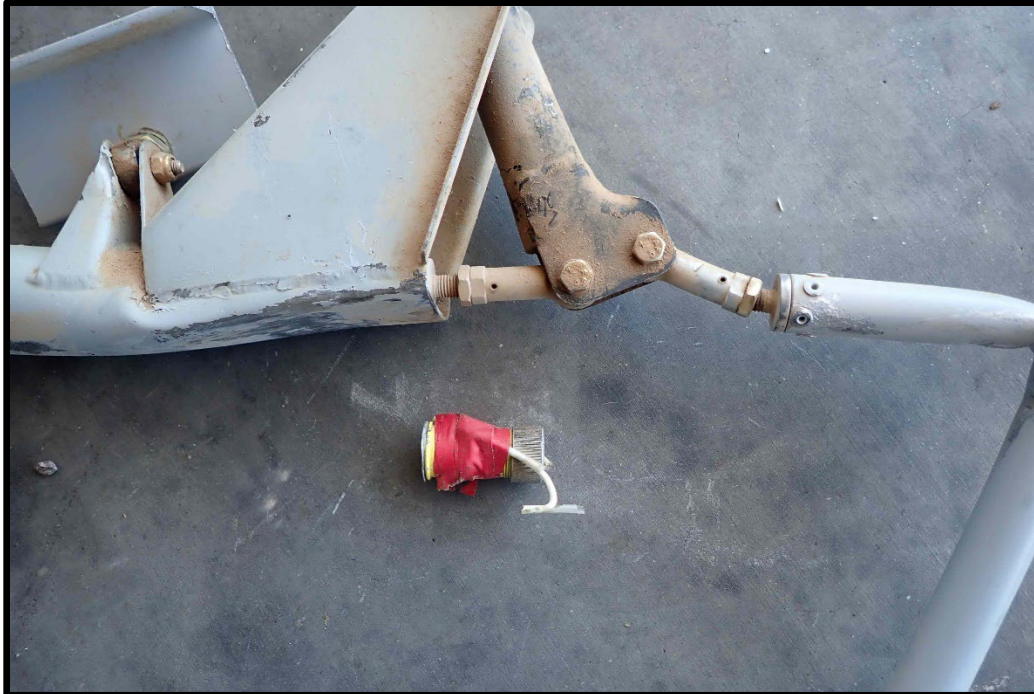
case appeared corroded and one of its sides was bent inwards. Figure 39 depicts the lamp case in reference to the lower section of the aft control column assembly.

Figure 39 – Lamp socket and lower aft control column assembly

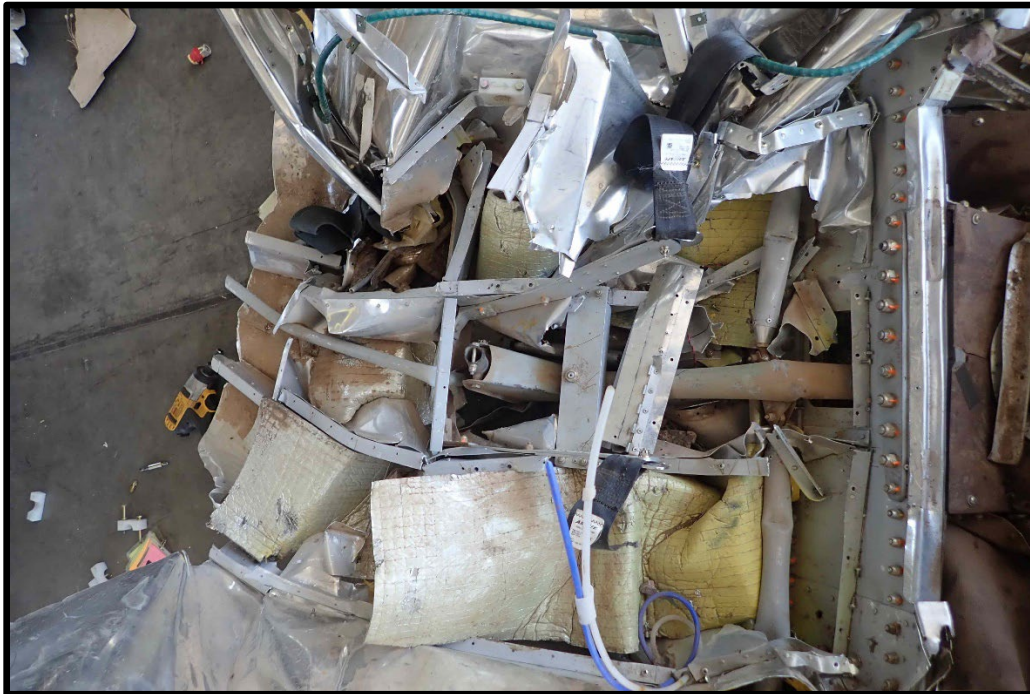
The aft control stick had been previously removed, and there was no boot around its base (figure 40). The opening in the bulkhead for the stick is about 8 inches square. The belly was breached and was crushed against the lower aft control stick assembly. According to Vans Aircraft, the clearance between the base of the control stick assembly and the belly skin of the is between 2.25 and 2.4 inches (figure 41). A position light socket was located within the underfloor area of the control column assembly. The socket was slightly crushed, and wrapped with electrical insulating tape, which exhibited shredding and dark fretting marks. The conductor wires had been cut, and the metal case of the lamp was still in the socket. The internal surface of the lamp

Figure 40 – Aft control stick and column with no boot
