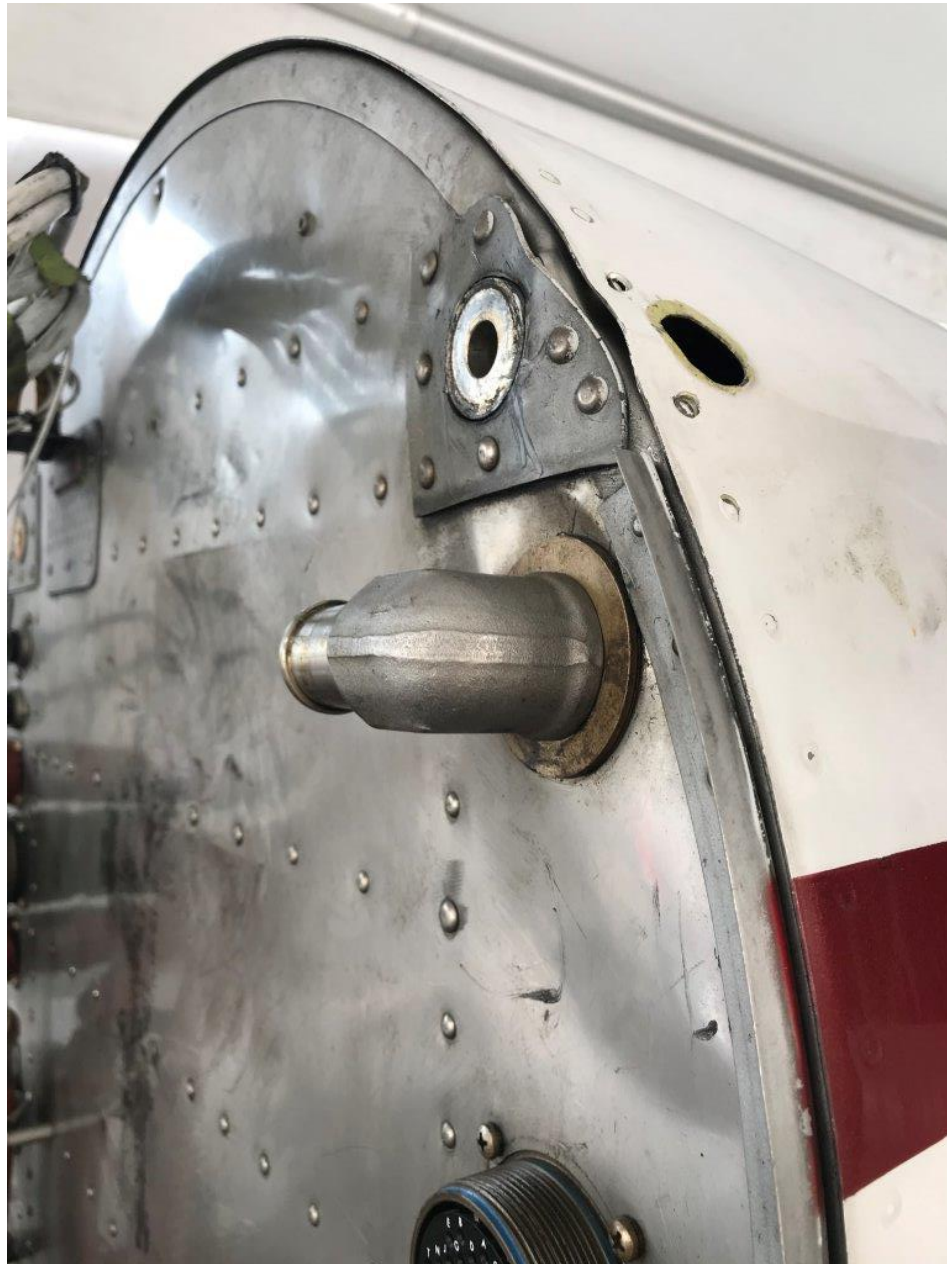
Photo 1 – View of engine mount damage (photo courtesy of the FAA).
