# Airworthiness Concern Sheet

Date: 09/04/2020

<p><b>Reply to:</b> Name: David Swartz Title: Senior Engineer Office: Anchorage Aircraft Certification Office Department: Street Address: 222 W 7<sup>th</sup> Ave City, State, ZIP: Anchorage Alaska, 99513 Telephone: 907-271-2671 Email: <a href="mailto:Dave.swartz@faa.gov">Dave.swartz@faa.gov</a></p>	<p><b>Make: Piper/FS2003 Corp</b> <b>Model / Series: J-5A, J-5B, J-5C, J-5D, AE-1, HE-1, PA-12, PA-12S, PA-14, PA-16, PA-18, L-21, PA-20, and PA-22</b> <b>Serial Numbers: All</b></p> <p><b>Reason for Airworthiness Concern: In flight failure of rudder just above the upper hinge.</b></p>
--	--

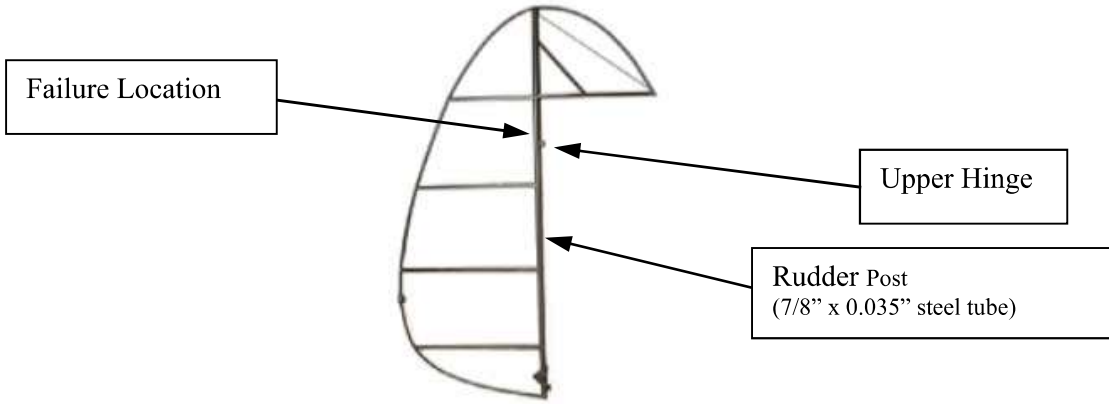
Recently an accident occurred where the rudder on a PA-12 failed in flight. The airplane was a seaplane equipped with a 160 hp Lycoming O-320 engine. The original tail surfaces had been replaced with PA-18 tail surfaces in accordance with a Supplemental Type Certificate (STC). The broken upper part of the rudder post broke just above the top hinge and the upper part of the rudder folded over the tail brace wires in such a way that rudder control was severely limited and as to effectively create an additional horizontal tail, driving the tail down and the nose up. It was possible for the senior flight instructor to control the airplane in pitch, but required a lot of the available elevator deflection to do so. By dropping the water rudders, some directional control was established and the airplane was able to return to base and land, but with difficulty.

At this time, it is not clear whether the rudder was an original Piper part, or one of the several PMA replacement parts available from aftermarket manufacturers. The accident airplane was equipped with an LED beacon on top of the rudder. The rudder had been overhauled about 6 years prior to this accident and some minor corrosion had been blended out from the exterior surface of the rudder post and the rudder had been powder coated. The inside of the rudder post was blackened, indicating the corrosion prevention oil that was applied there during original manufacture had burned off during the powder coating process. The inside of the tube exhibited some very minor corrosion pitting but was otherwise unremarkable other than evidence that corrosion prevention oil was burned off during the powder coating operation. This rudder has been submitted to the NTSB laboratory for further evaluation.

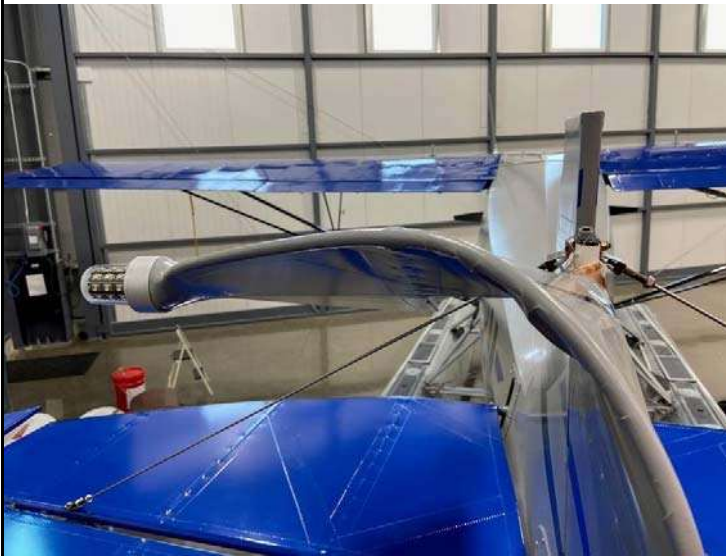
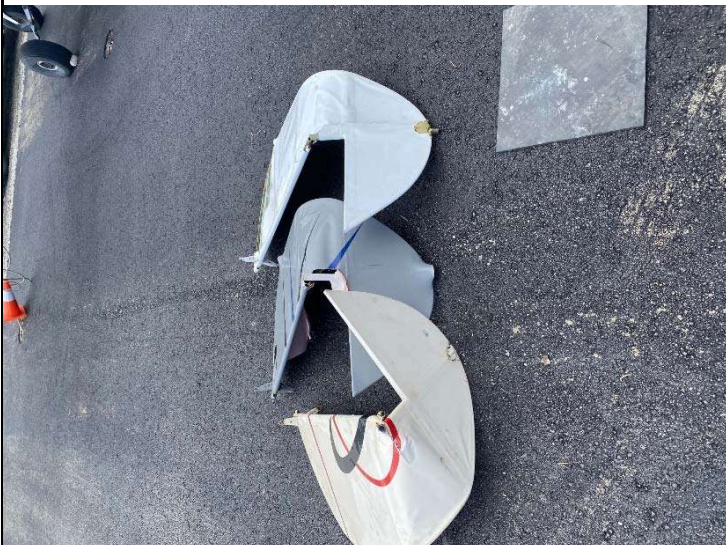
FS2003, the current type certificate holder for the PA-12 airplane, is aware of two rudder failures of the front rudder post, above top hinge, on PA-12 airplanes. One was caused by a cable strike. The other was caused by previous damage not being detected after the airplane went over on its back while operating on skis in deep snow.

Two additional instances have also come to light, that did not result in an accident, both on PA-12s equipped and higher horsepower than stock engines, one with a 180 HP Lycoming O-360 and one with a 150 HP Lycoming O-320. Both of these also had some kind of strobe or

beacon on top of the rudder as well. Neither of these two airplanes was equipped with floats at the time of failure.
