National Transportation Safety Board

CEN22FA317

AIRWORTHINESS

Group Chair's Factual Report

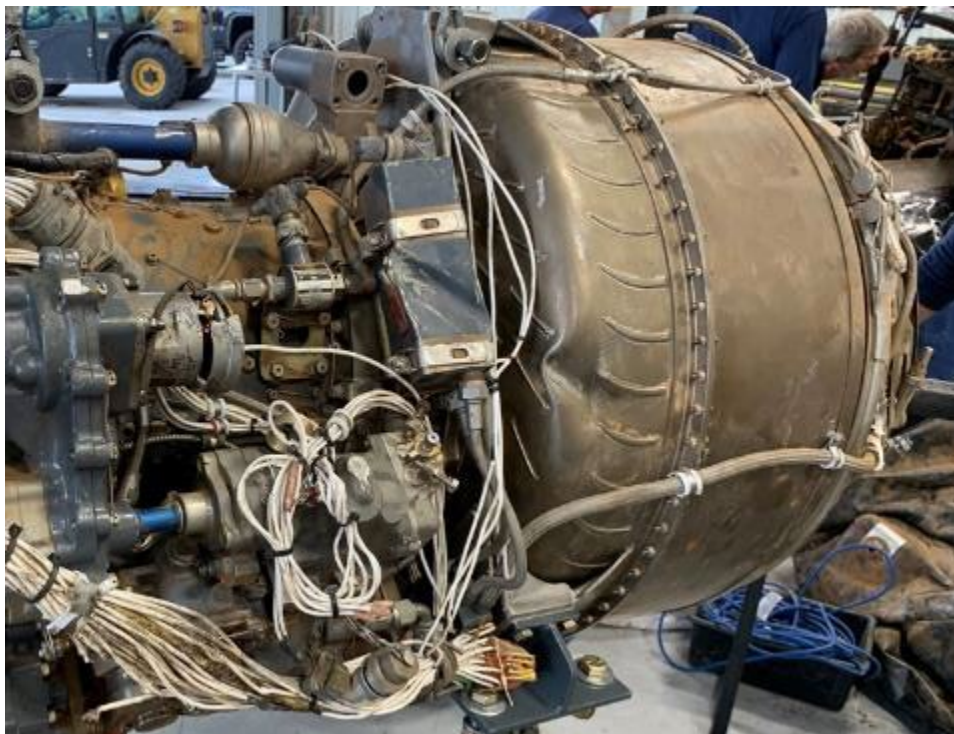
PHOTO 4: DENT ON THE IGNITER AND AIR DIFFUSER

There was a large dent stretching from approximately 9:00 to 11:00 o'clock from the ignition unit aft to the air diffuser section (**Photo 4**). Looking through the exhaust,

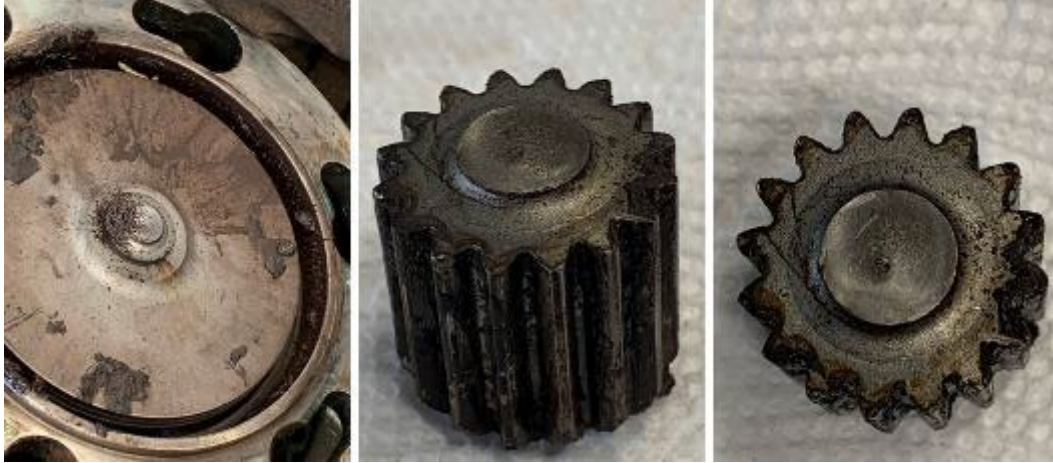
Photo 5: Sheared Starter-Generator Driveshaft

The N1 tachometer-generator was clean but would not rotate. Removal of the starter-generator revealed that its driveshaft was sheared (**Photo 5**). The starter-generator turned freely by hand via the remains of the input shaft. According to the maintenance records, the starter-generator was previously overhauled and installed on the accident engine on February 14, 2022, during the Phase 5 maintenance inspection.

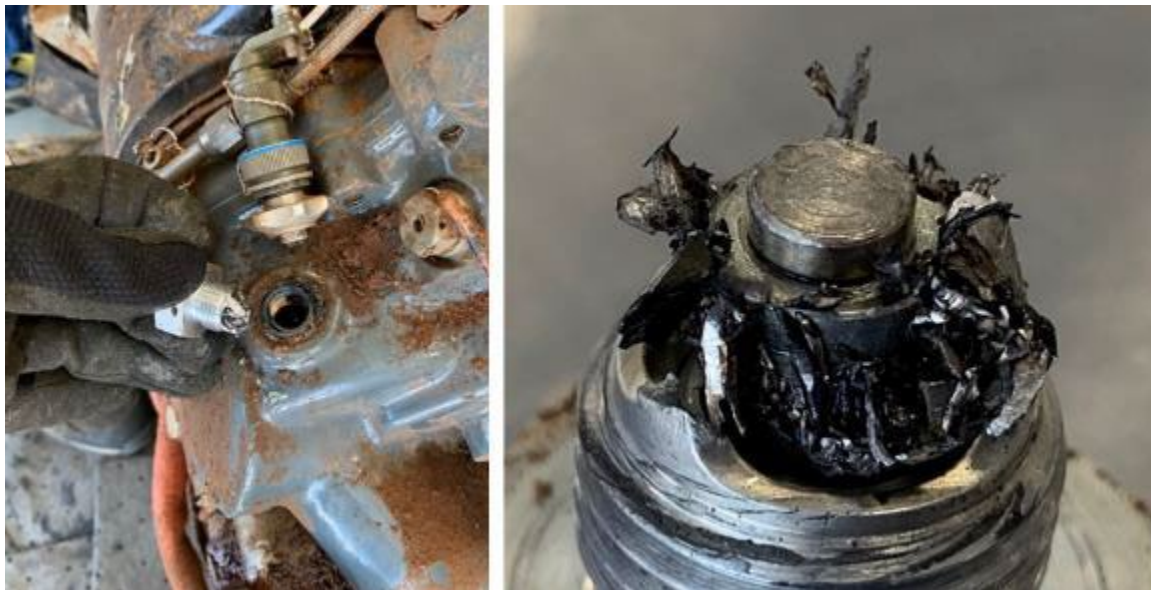
PHOTO 6: N1 AGB CHIP DETECTOR WITH DEBRIS

Removal of the N1 AGB magnetic chip detector plug revealed a large quantity of large metallic chips on the magnetic tip (**Photo 6**). The electrical half of the chip detector was broken at the housing. This was the new style, SB) T53-098 compliant, chip detector.

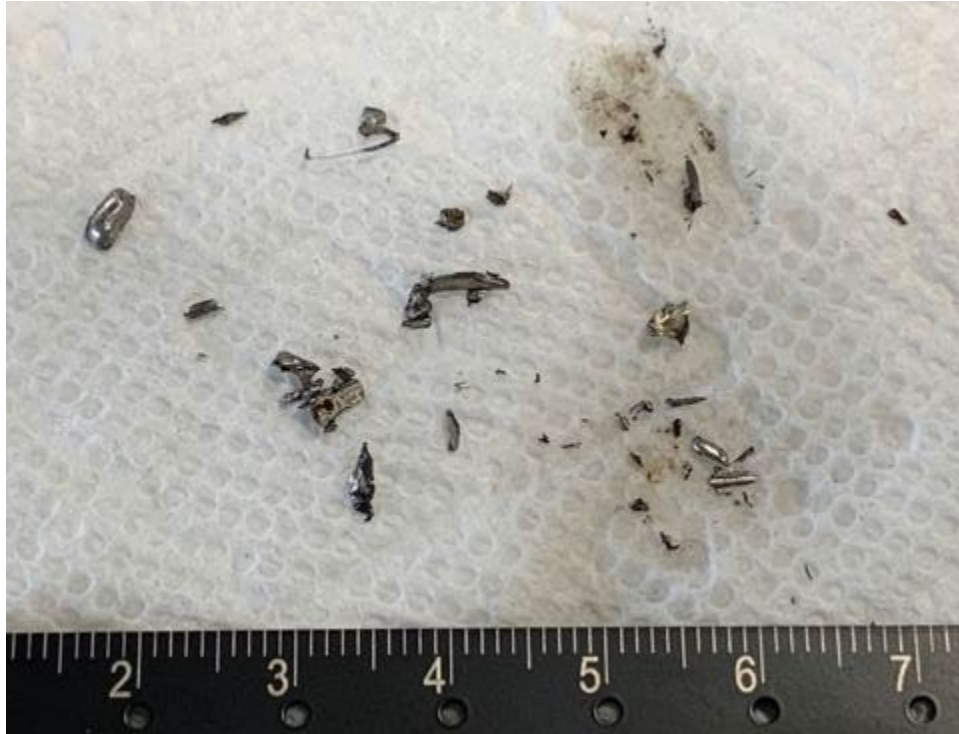
PHOTO 7: DEBRIS FROM THE N1 AGB

The main oil supply line was full of lubrication oil. Multiple metallic fragments were found in all the bearing compartment oil return/scavenge lines (**Photo 7**); the supply lines were clean of debris or obstructions. The engine-mounted oil filter was clean and oil-wetted. The airframe-mounted oil cooler was empty of oil, and the attached oil filter was missing and not recovered. The No. 2 bearing last chance oil

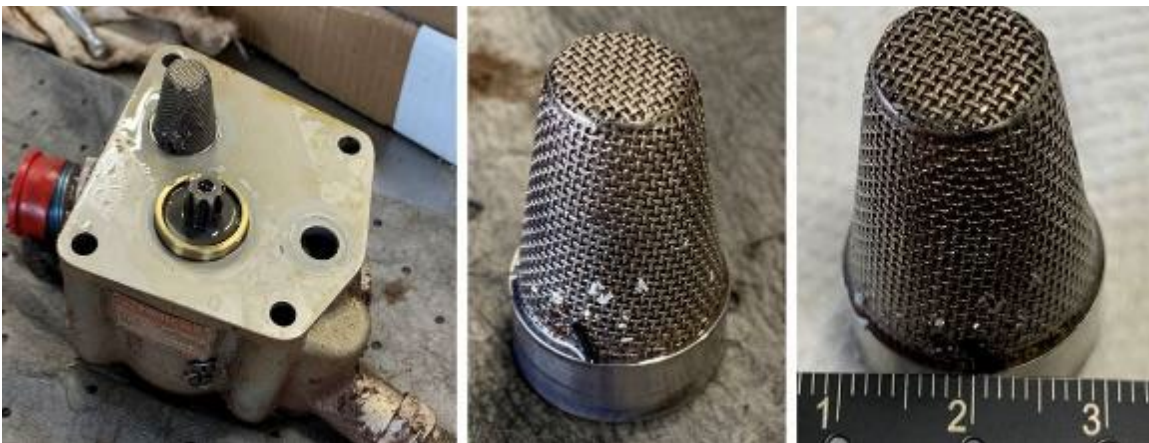
PHOTO 8: SCAVENGE FUEL PUMP (LEFT) AND STRAINER W/DEBRIS (CENTER, RIGHT)

The N1 AGB main oil pump rotated freely. Small metallic shards were found in the scavenge pump strainer (**Photo 8**).

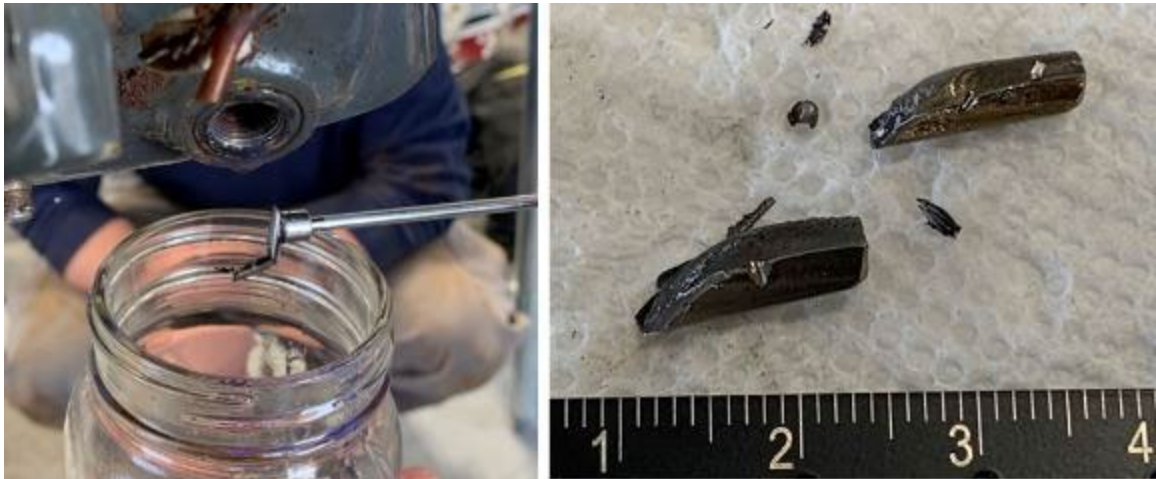
PHOTO 9: GEAR TEETH FOUND IN THE N1 AGB

Two helical-cut gear teeth were found in the N1 AGB oil, similar to starter/generator drive gear (also referred to as the zero gear) teeth. Both teeth exhibited expected wear patterns, with no other damage noted (**Photo 9**, right-most photo).

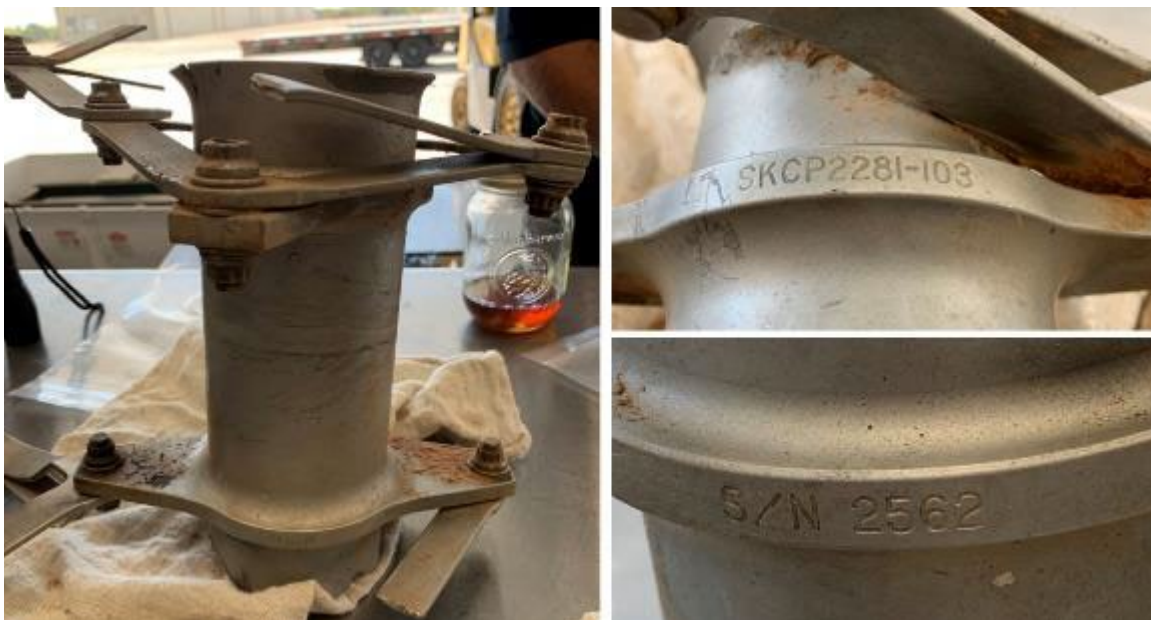
PHOTO 10: KAFLEX DRIVESHAFT COUPLING INTERCONNECT SHAFT, WITH P/N AND S/N

The accident Kaflex driveshaft coupling was part number (P/N) SKCP 2281-103, serial number (S/N) 2562. (**Photo 10**, right side). Roughly half of the flex frames at each end of the interconnect shaft were fractured but remained with the end fittings at the engine and main gearbox, respectively (**Photo 10**, left side).

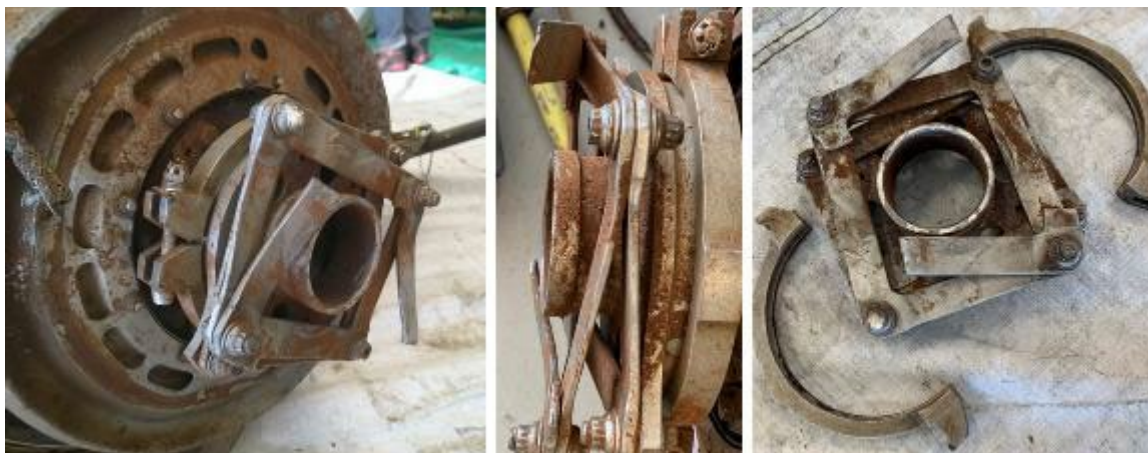
PHOTO 11: ENGINE-SIDE END FITTING (LEFT), FLEX FRAMES (CENTER), AND RETAINING CLAMP (RIGHT)

The Kaflex driveshaft coupling engine-side end fittings were clamped in the correct position, with the nut and cotter pin in place and tight (**Photo 11**). Uneven wear and scuffing to the lip and exterior of the shaft, which sits inside the interconnect (**Photo 12**).

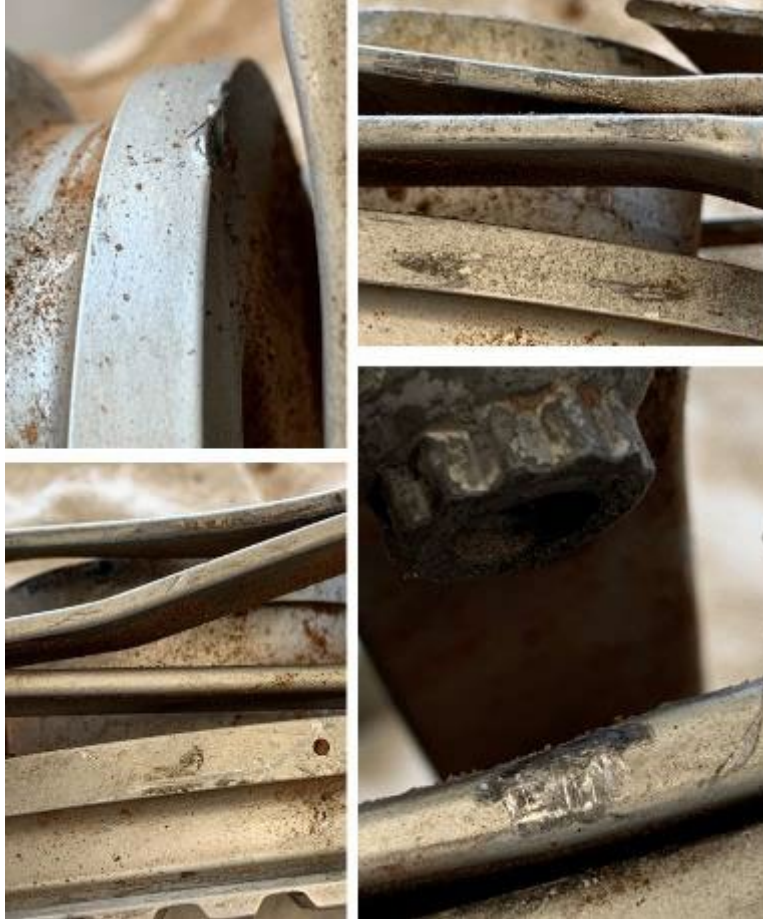
PHOTO 13: CONTACT DAMAGE ON THE ENGINE END FITTING FLEX FRAMES

The flex frames on the engine-side exhibited evidence of contact between the fittings, and the retaining nuts showed wear (**Photo 13**). The broken flex frame pieces spun within the plane of rotation for the Kaflex driveshaft coupling (**Photo 14**).

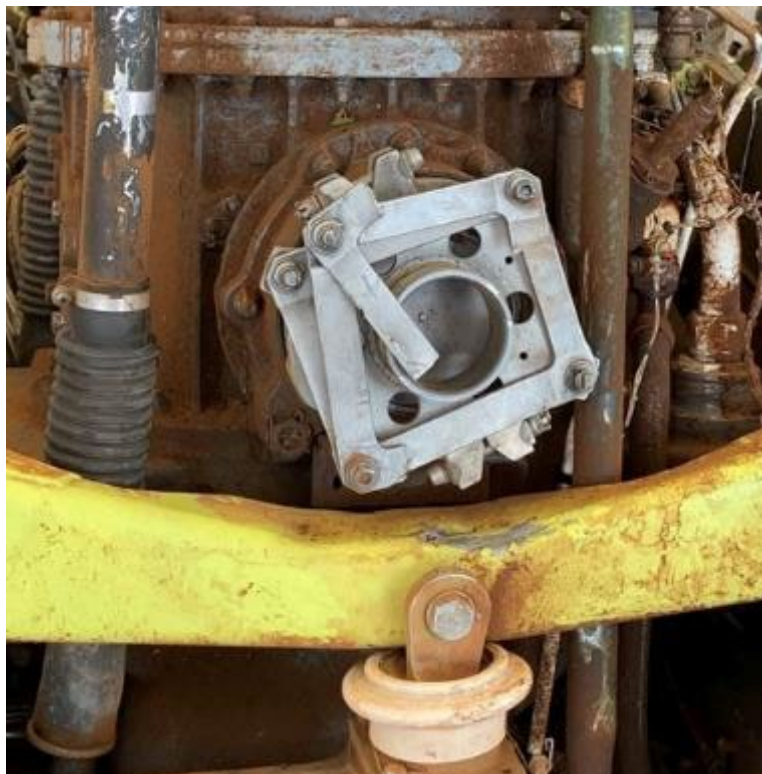
PHOTO 16: END FITTING AND FLEX FRAMES ATTACHED TO THE HELICOPTER MAIN TRANSMISSION GEARBOX

The helicopter's main transmission gearbox side end fitting remained attached to the gearbox by roughly half the flex frames (**Photo 16**). The flex frames were fractured and displayed similar evidence of contact between the flex frames (**Photo 17**).

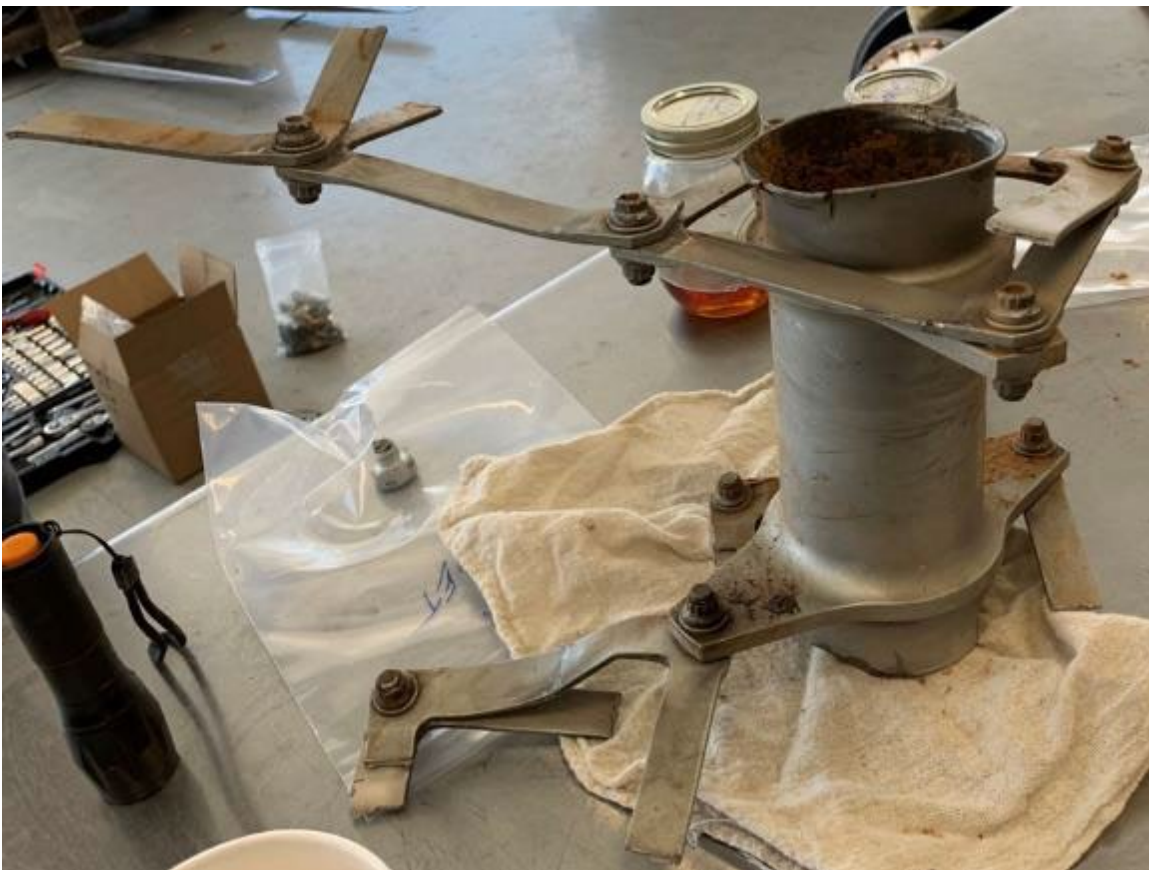
PHOTO 18: INTERCONNECT SHAFT WITH FLEX FRAMES STILL ATTACHED

The interconnect shaft, which was recovered approximately 120 feet away from the main wreckage, had half of the flex frames still attached at each end. The flex frames were twisted in the plane of rotation of the retaining nuts, roughly 180-degrees from their normal position **(Photo 18)**.

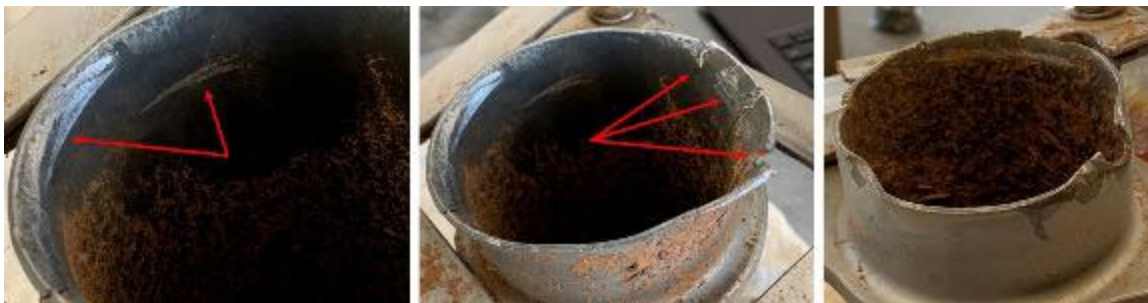
PHOTO 19: INTERCONNECT SHAFT DEFORMATION

Shiny, rough-edged scuffing was noted inside the interconnect shaft. Both ends of the Kaflex driveshaft coupling were deformed to an elliptical shape. One end was cracked in three locations along the greatest deformation (**Photo 19**).

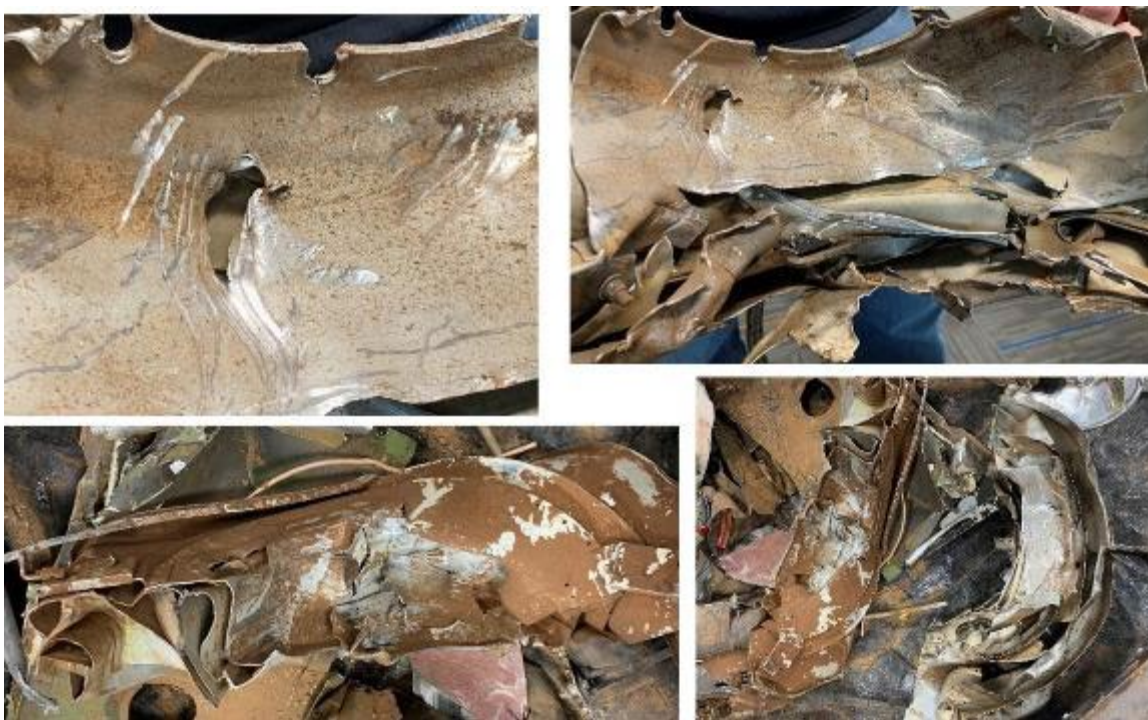
PHOTO 20: AIRFRAME COWLING AROUND THE PARTICLE SEPARATOR AND DRIVESHAFT

Two sections of airframe cowling that would have covered the particle separator and Kaflex driveshaft coupling were recovered. Both sections exhibited scrape marks and were torn (**Photo 20**).

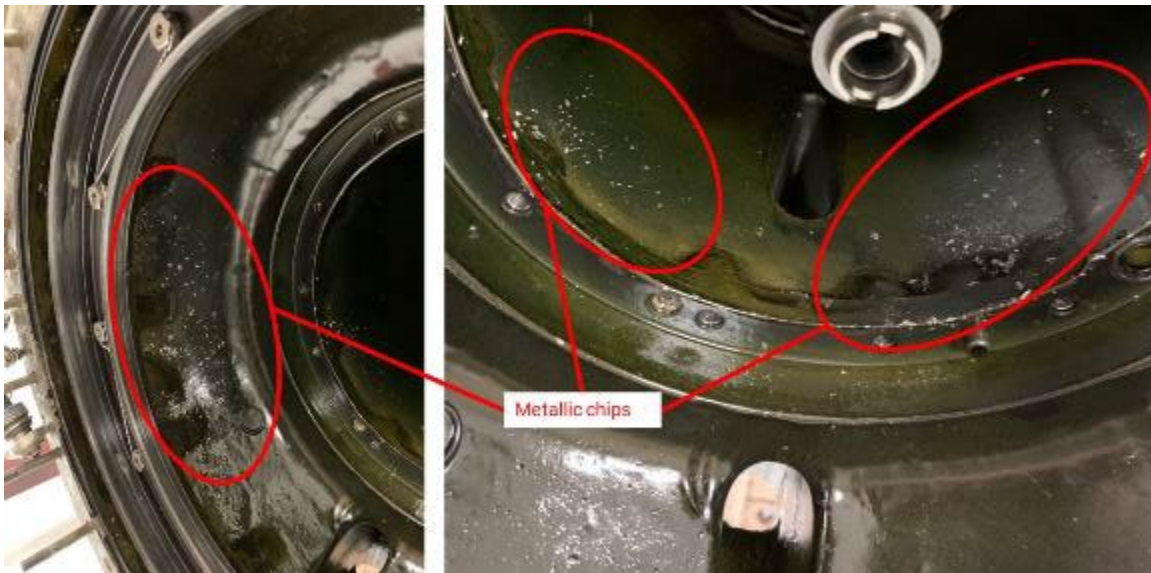
PHOTO 23: METALLIC FLAKES INSIDE THE REDUCTION CARRIER

The reduction gear carrier front cover was removed, and metallic flakes were noted inside at the 3:00 and 9:00 o'clock positions (**Photo 23**). The N2 drivetrain was rotated by hand with no binding and the sun gear turned in unison. The N2 power shaft was also clean, oil wetted, and otherwise unremarkable.

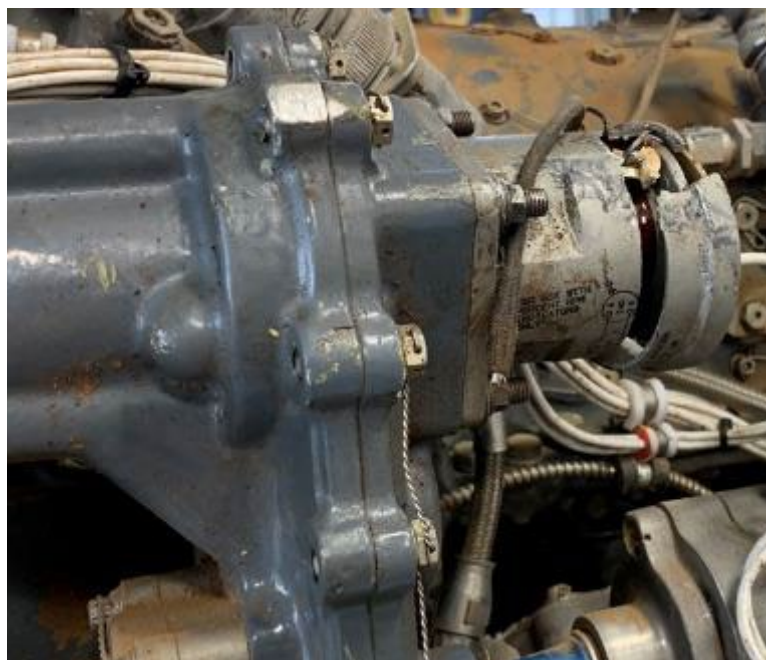
PHOTO 24: PARTIALLY FRACTURED N2-TACH GENERATOR HOUSING

The N2-tachometer-generator housing was partially fractured circumferentially (**Photo 24**).

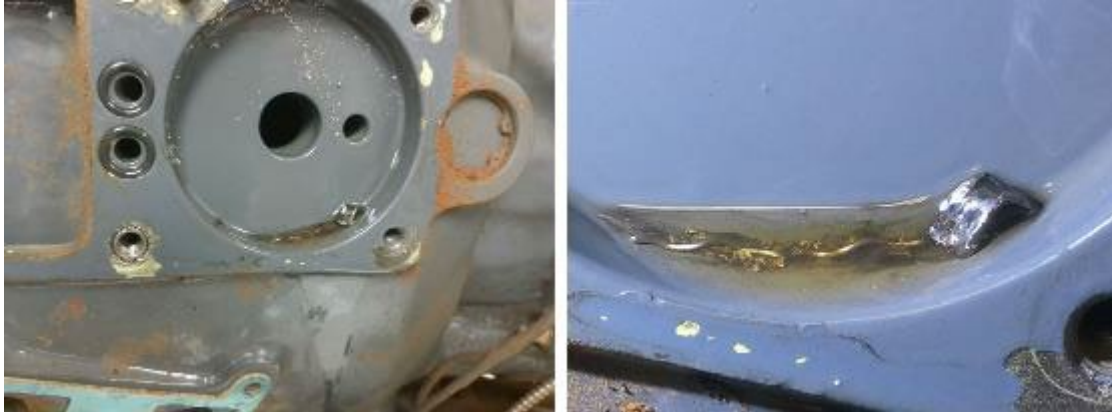
PHOTO 25: METALLIC FRAGMENTS ON THE N2 OVERSPEED GOVERNOR MOUNT PAD

Metallic fragments were found on the mount pad for the PT overspeed governor-tachometer drive, including one large piece and some smaller flakes (**Photo 25**). The two oil lines, one for lubrication and the other for provide torque indications, were intact and free of debris.

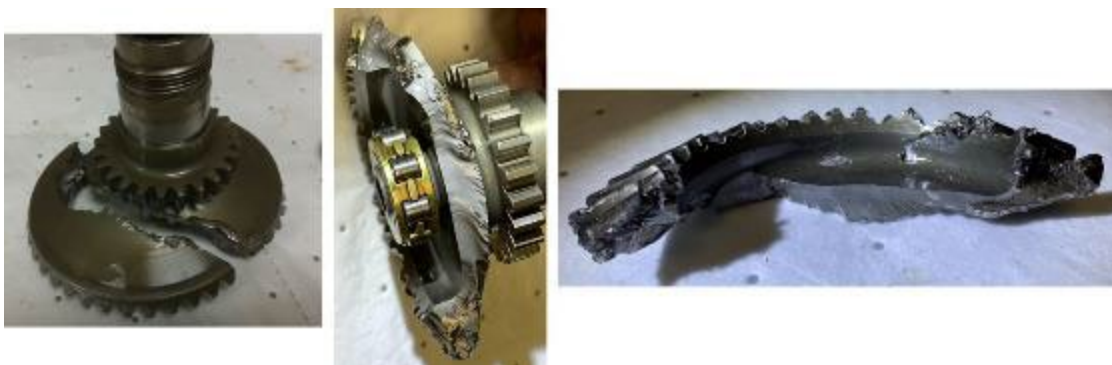
PHOTO 26: FRACTURED ZEROL GEAR (STARTER/GENERATOR GEAR ASSEMBLY)

The zerol gear (also referred to as the starter/generator gear (See Figure 5 and Figure 6), was fractured (**Photo 26**), and the cover plate bulged outward. The zerol gear assembly had the following identification markings: P/N 1-080-153-01 (the gear, without the plug installed, is P/N 1-080-153-03), National Stock Number 3040-00-475-0058, S/N EG 1553, manufacturing cage code number 23715⁴, government cage code number 81996. The starter/generator gear was identified as an U.S. Army Aviation and Missile Command military surplus part by its cage code number 81996⁵.

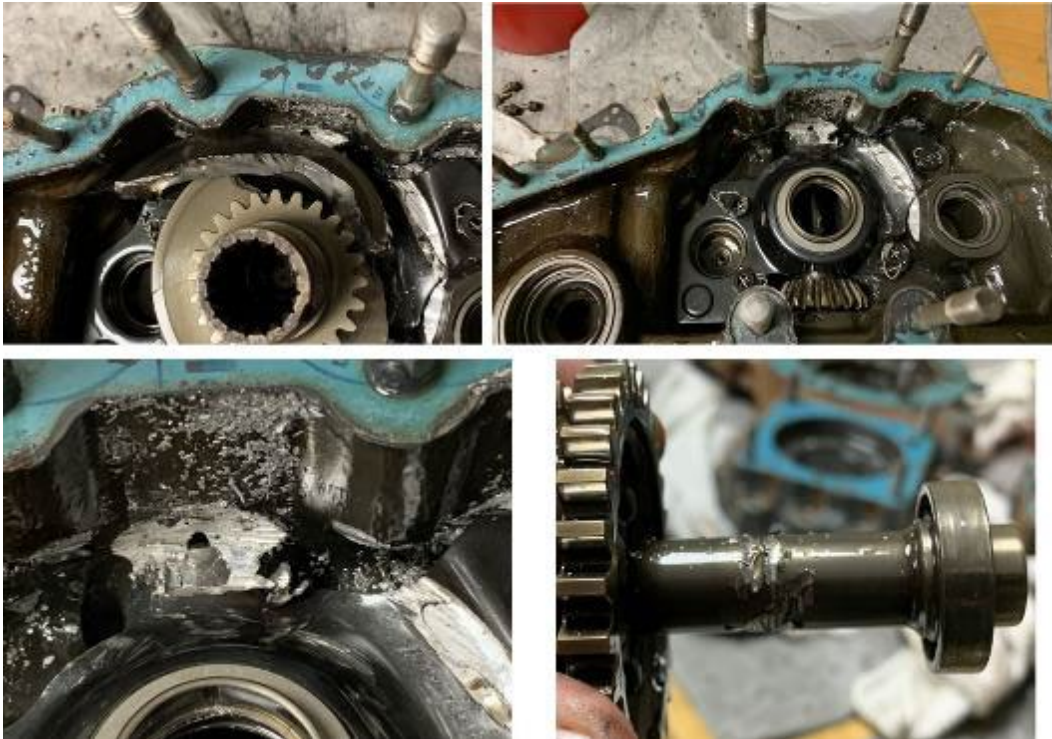
PHOTO 27: INTERIOR OF THE N1 AGB HOUSING; SCORED FCU GEAR SHAFT

The outside of FCU gear drive shaft was scored circumferentially 360-degrees (**Photo 27**, lower left). The baffle and N1 AGB housing were both scored (**Photo 27**, upper right and upper left), and a hole was present in the N1 AGB housing.

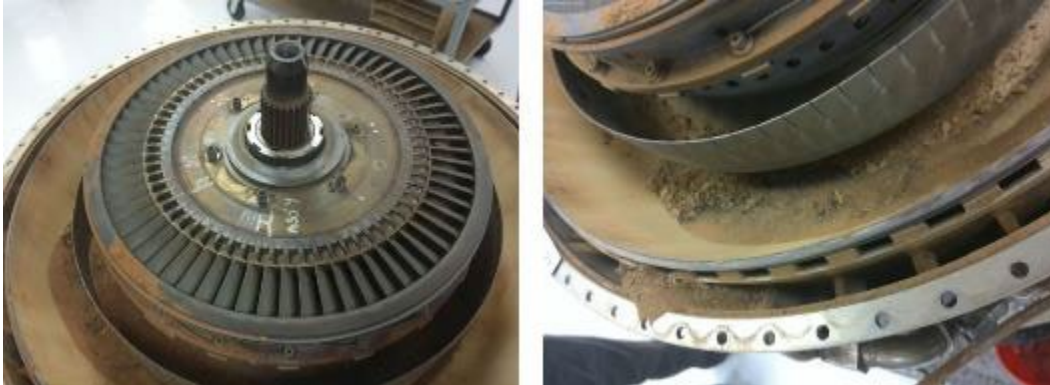
PHOTO 29: COMBUSTION CHAMBER DEFLECTOR, WITH DIRT BUILD-UP AT THE 6:00 O'CLOCK POSITION

More dirt was found throughout the gas producer section, predominantly at the 6:00 o'clock position along the combustion chamber deflector (**Photo 29**).

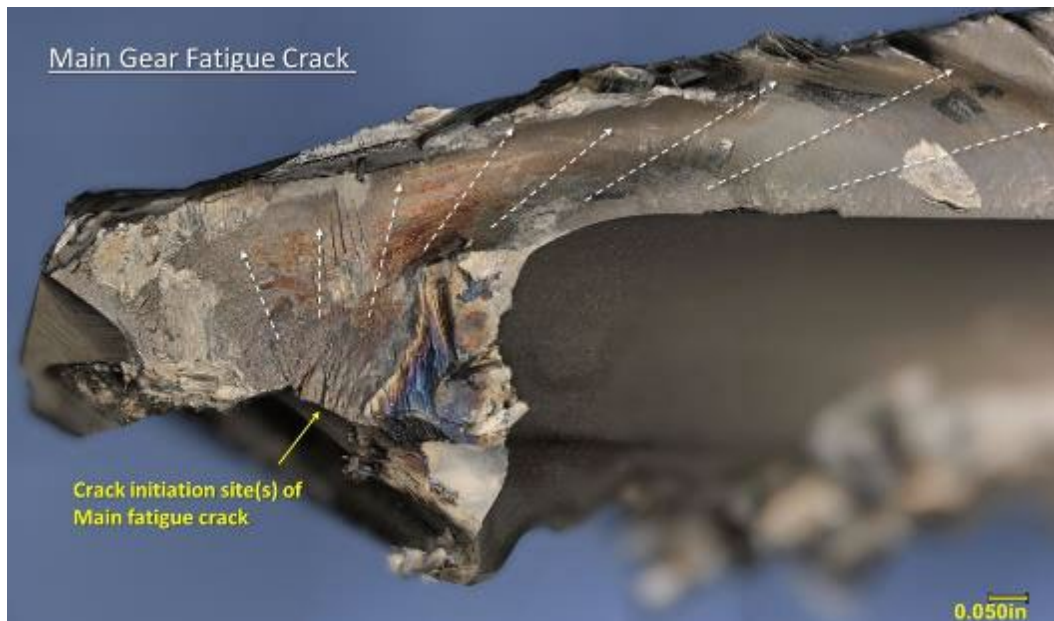
PHOTO 34: MAIN FRACTURE IN THE ZEROL GEAR

The zerol gear was shipped to the NTSB Materials Lab in Washington DC for examination. The gear fractured along a fatigue crack. The crack initiated on the face of one tooth of the gear from multiple sites (**Photo 34**). Multiple initiation sites and indicators of fatigue and crack propagation were present on both the initial and secondary fracture surfaces, as well as features consistent with ductile overstress fracture. The gear did not exhibit any corrosion pits or oxide inclusions at the initiation sites and no local deformation adjacent to the fracture surface was seen.

The chemical composition of the gear was examined using EDS and XRF with results showing the material to be consistent with AMS 6260, a low-alloy steel. The hardness was inspected per ASTM E18.1, resulting in an average hardness of 68 HRA. Case hardening depth was also found to be consistent with drawing requirements. Further details can be found in the NTSB Materials Laboratory Lab Report in the docket of this investigation.

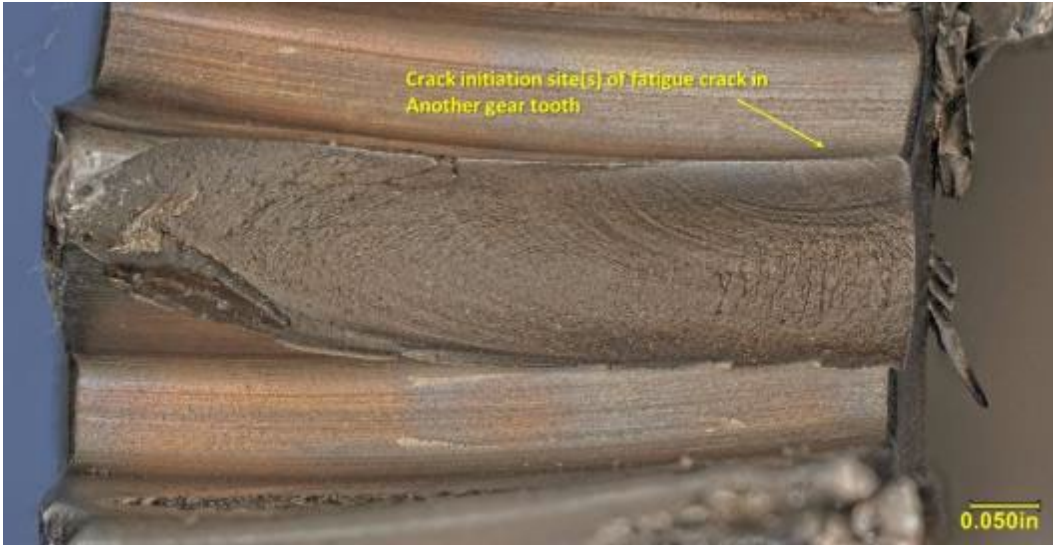
PHOTO 35: GOUGING ON ZEROL GEAR TOOTH

The zerol gear, however, exhibited at least six other fatigue cracks in other teeth locations, though those cracks did not grow as large (**Photo 35**). Gouging was present on both the leading and lagging flanks and lands of the gear teeth (**Photo 36**). Optical metallography discovered small microcracks in these locations, significant enough to likely develop stress concentrations and surface defects.
